ASBESTOS SURVEY REPORT FOR LEECHMERE TRAINING CENTRE (INCLUDING TELECARE HOUSE), SUNDERLAND

Asbestos Register for LEECHMERE CENTRE, SUNDERLAND

Premises Manager / Samo: - Tenant Date: 16 January 2025

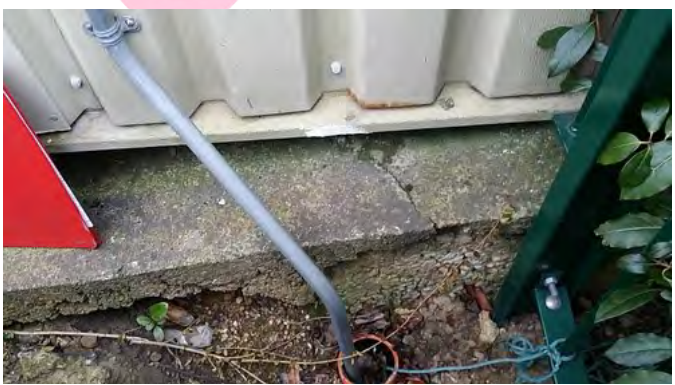
Item 146 - Ref: 70826-39

The coating to metal wall cladding (External) contains asbestos.

Any change in its appearance should be recorded and passed to Property Services.

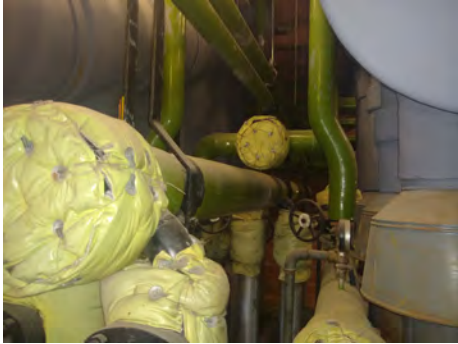
Item 149 Ref: 421249-5

The large bore pipework feeding 12 x bank of boilers in Boiler Room 0/001 does not contain asbestos.

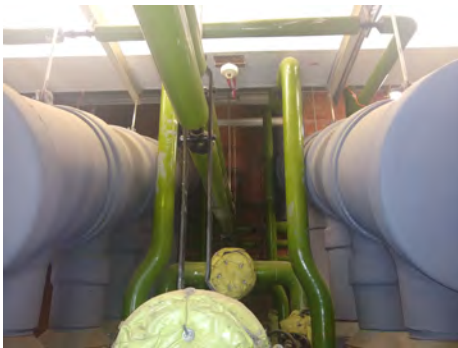
Item 150 Ref: 421249-6

The small bore pipework feeding 12 x bank of boilers in Boiler Room 0/001 does not contain asbestos.

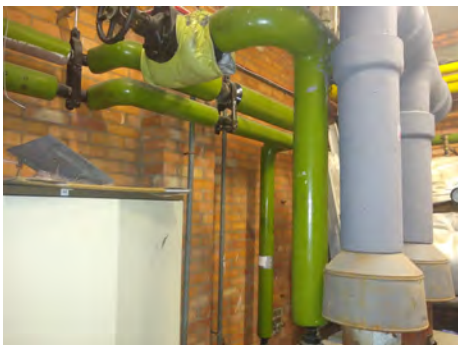
Item 151 Ref: 421249-7

The lagging to pipework feeding 2 x boilers in Boiler Room 0/001 does not contain asbestos.

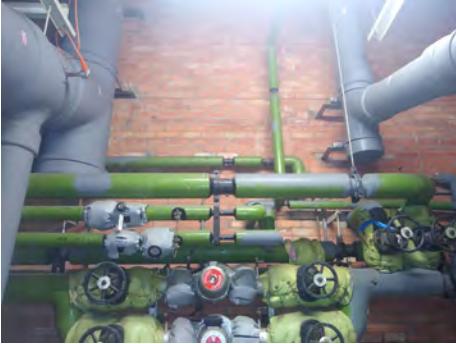
Item 152 Ref: 421249-8

The large bore pipework lagging to rear wall in Boiler Room 0/001 does not contain asbestos.

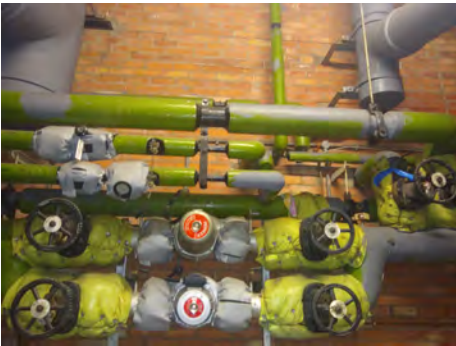
Item 153 Ref: 421249-9

The small bore lagging to rear wall in Boiler Room 0/001 does not contain asbestos.

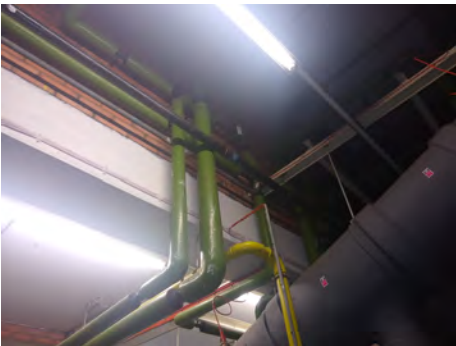
Item 154 Ref: 421249-10

The lagging to high level pipework above boilers in Boiler Room 0/001 does not contain asbestos.

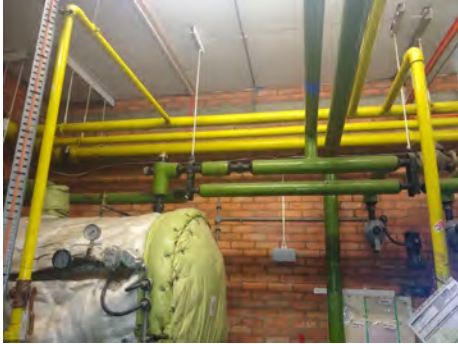
Item 155 Ref: 421249-11

The lagging to pipework feeding water tank in Boiler Room 0/001 does not contain asbestos.

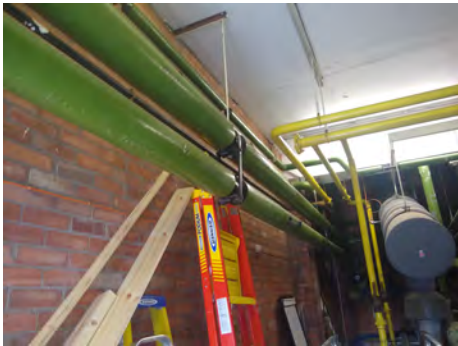
Item 156 Ref: 421249-12

The large bore pipework lagging adjacent door in Boiler Room 0/001 does not contain asbestos.

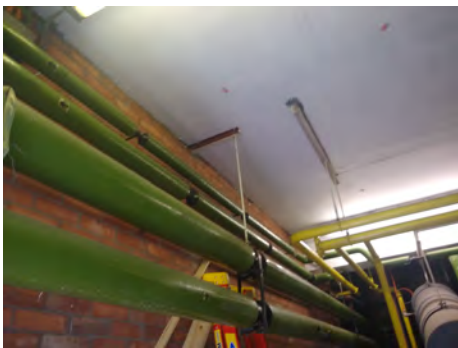
Item 157 Ref: 421249-13

The small bore lagging adjacent door in Boiler Room 0/001 does not contain asbestos.

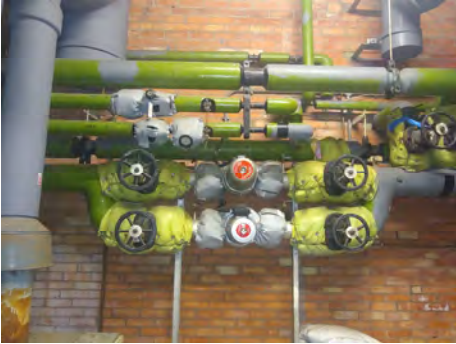
Item 158 Ref: 421249-14

The gaskets to pumps flanges in Boiler Room 0/001 do not contain asbestos.

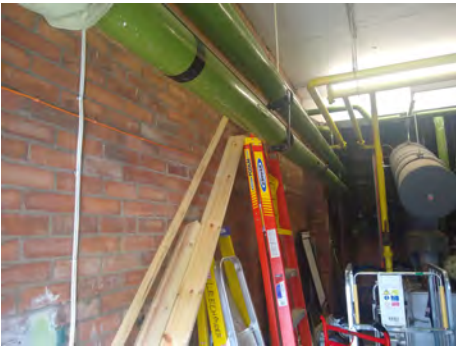
Item 159 Ref: 421249-15

The debris to wall adjacent door in Boiler Room 0/001 does not contain asbestos.

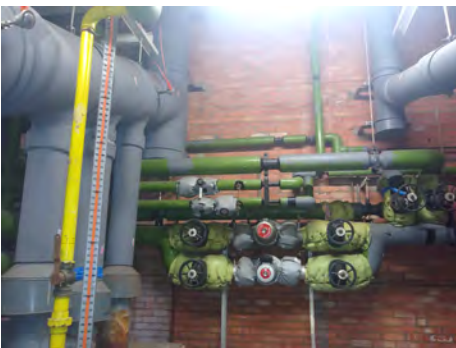
Item 160 Ref: 421249-16

The debris to rear wall in Boiler Room 0/001 does not contain asbestos.

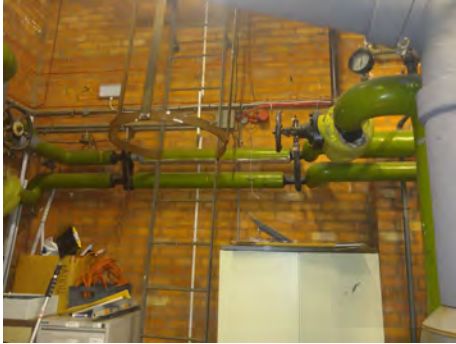
Item 161 Ref: 421249-17

The debris to tank room ladder wall in Boiler Room 0/001 does not contain asbestos.

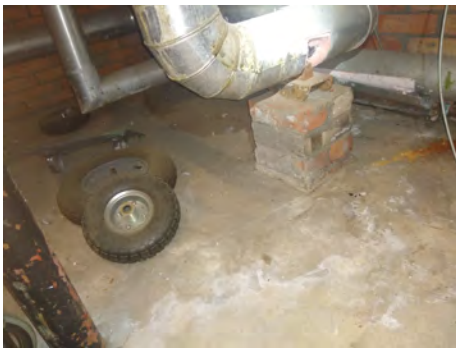
Item 162 Ref: 421249-24

The debris to floor below tank in Boiler Room 0/001 does not contain asbestos.

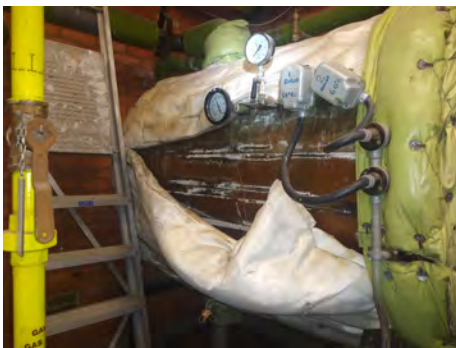
Item 163 Ref: 421249-25

The debris to water tank in Boiler Room 0/001 does not contain asbestos.

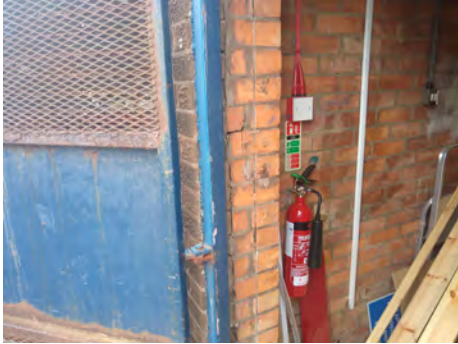
Item 164 Ref: 421249-26

The mastic to old entrance door line in Boiler Room 0/001 contains asbestos.

Removed Oct '20

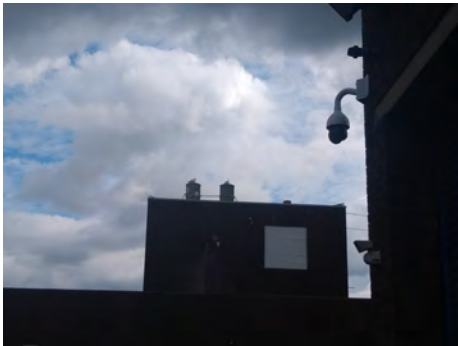
Item 165 Ref: As 421249-3

The high level flue cowls in Boiler Room 0/001 contains asbestos.

Removed Oct 2020

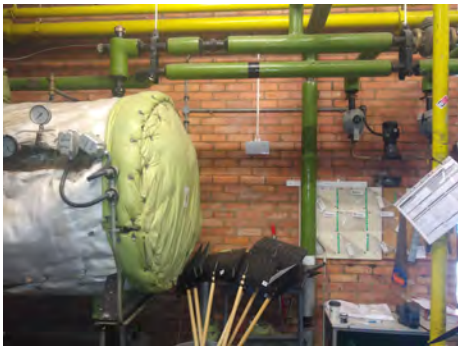
Item 166 Ref: 421249-18

The debris to water tank wall in Boiler Room 0/001 does not contain asbestos.

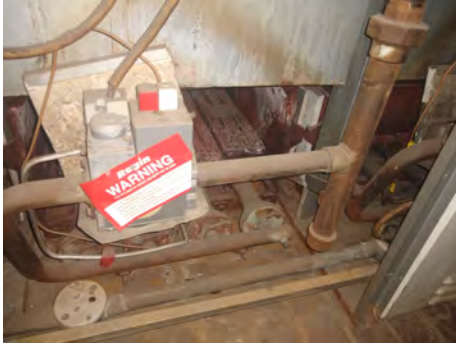
Item 167 Ref: 421249-19

The boards to front and sides of boilers in Boiler Room 0/001 do not contain asbestos.

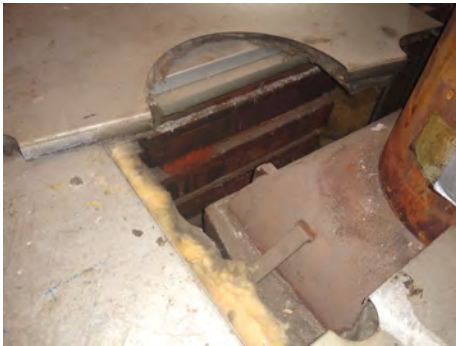
Item 168 Ref: 421249-20

The rope to boiler sections in Boiler Room 0/001 contains asbestos.

Removed Oct '20

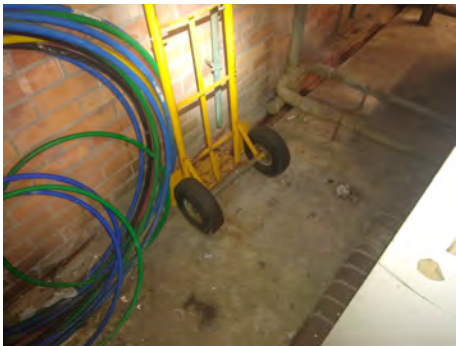
Item 169 Ref: 421249-21

The debris to floor behind boilers in Boiler Room 0/001 does not contain asbestos.

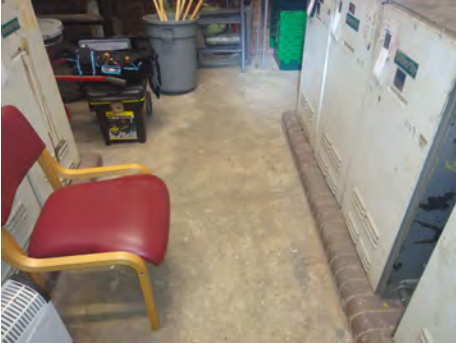
Item 170 Ref: 421249-22

The debris to floor between boilers in Boiler Room 0/001 does not contain asbestos.

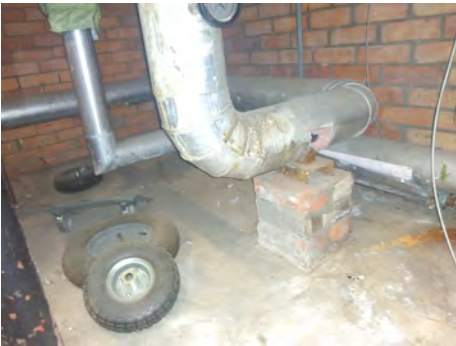
Item 171 Ref: 421249-23

The lagging to clad pipework below tank in Boiler Room 0/001 does not contain asbestos.

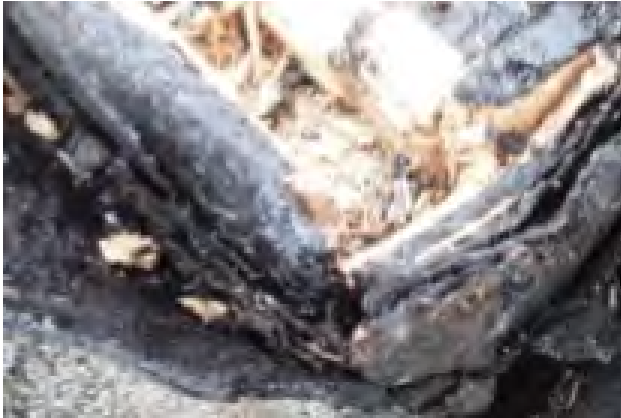
Item 173 Ref: 20-28782-1

The felt to the upstanding original roof (External/Roof 1) does contain asbestos.

Any change in appearance should be reported to Property Services.

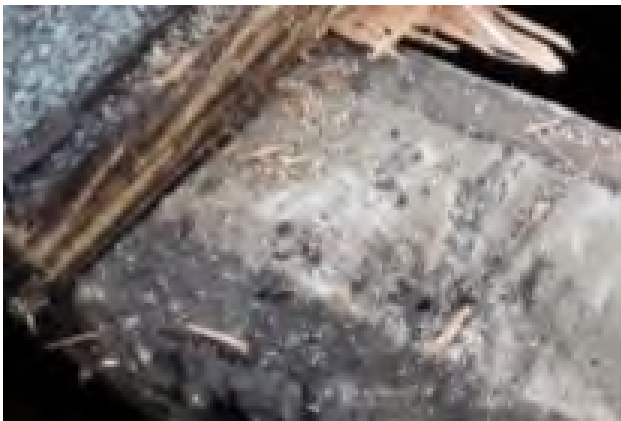
Item 174 Ref: 20-28782-1

The felt under the new bitumen (External/Roof 1) does contain asbestos.

Any change in appearance should be reported to Property Services.

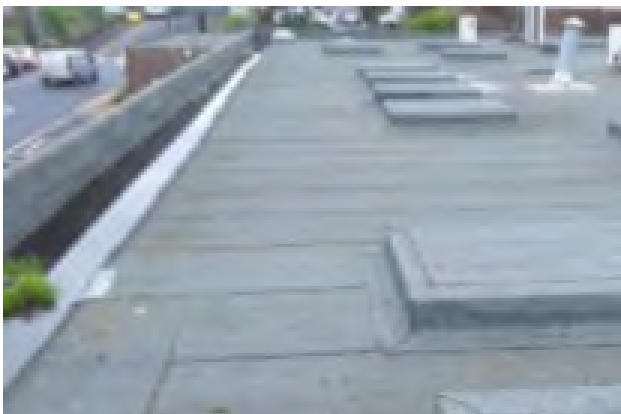
Item 175 Ref: 20-28782-2

The roof felt (External/Roof 1) does not contain asbestos.

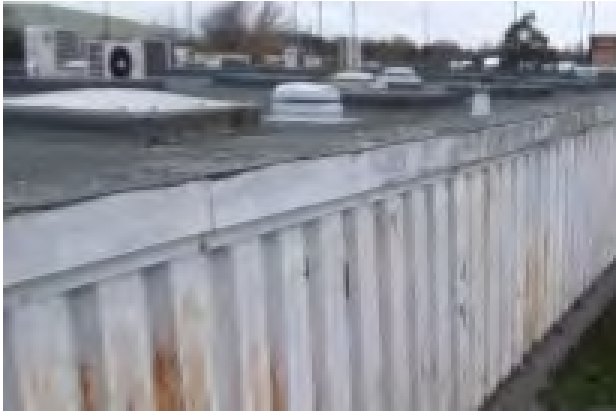
Item 176 Ref: 20-28782-3

The paint to the metal fascia (External/Roof 2) does contain asbestos.

Any change in appearance should be reported to Property Services.

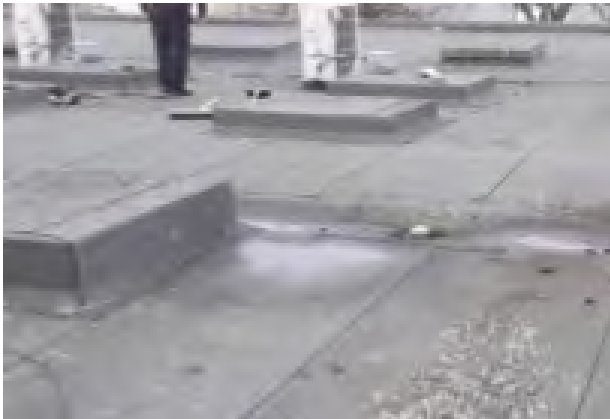
Item 177 Ref: 20-28782-4

The roof felt (External/Roof 2) does not contain asbestos.

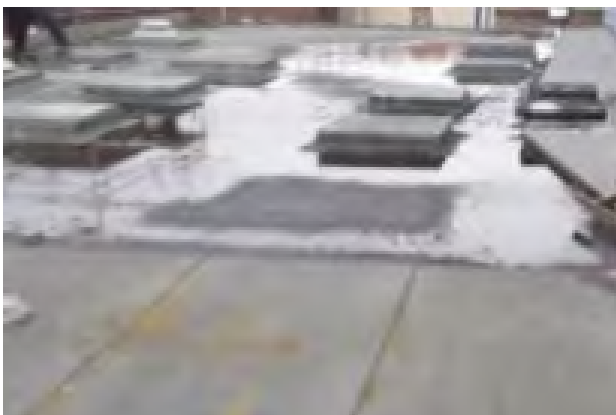
Item 178 Ref: 20-28782-5

The roof felt (External/Roof 5) does not contain asbestos.

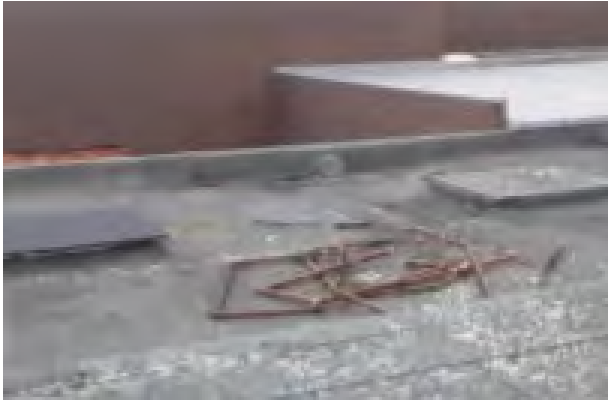
Item 179 Ref: 20-28782-6

The roof felt (External/Roof 8, 10, 11 and Workshops and Stores) does not contain asbestos.

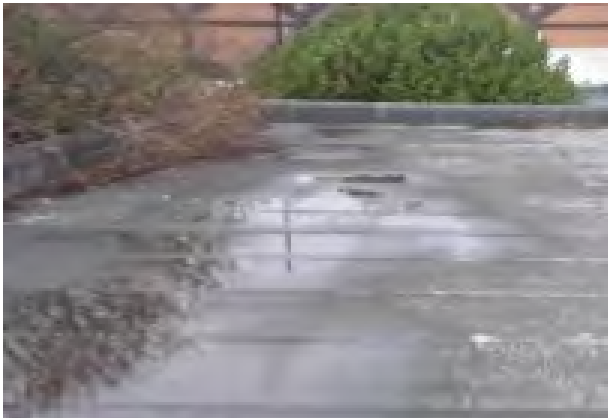
Item 180 Ref: 20-28782-7

The roof felt (External/Roof 12 to archives) does not contain asbestos.

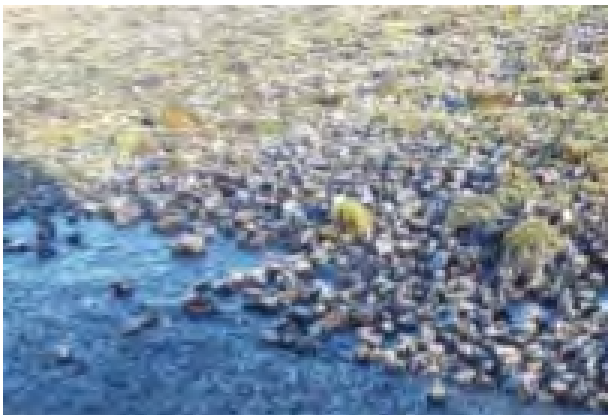
Item 181 Ref: 20-28782-8

The roof felt (External/Roof 4 to archives) does not contain asbestos.

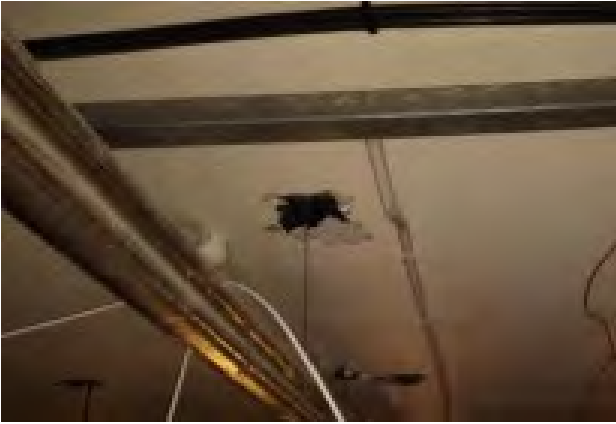
Item 182 Ref: 21-31963-1

The textured coating ceiling in the ceiling void above the canteen does contain asbestos.

Any change in appearance should be reported to Property Services.

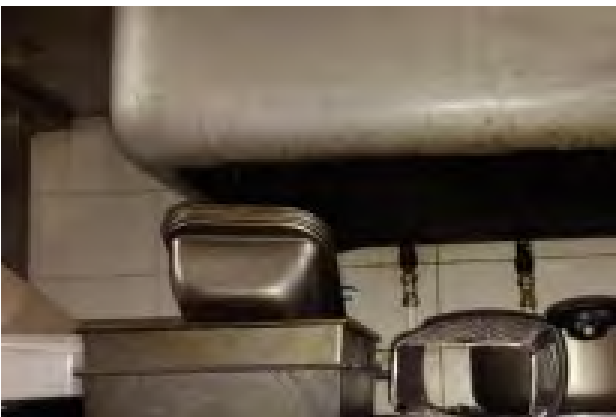
Item 184 Ref: 21-31963-3

The sink pad in the Kitchen does not contain asbestos.

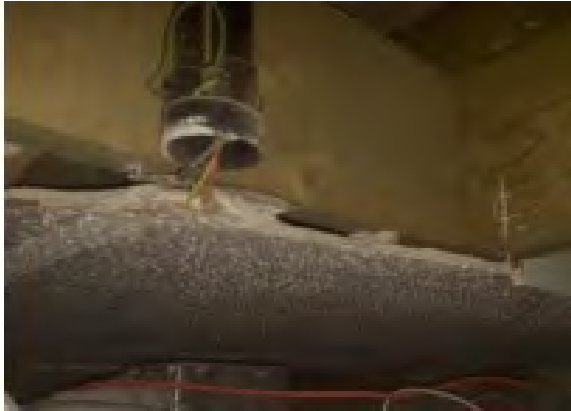
Item 185 Ref: 21-32786-1

The textured coating ceiling in the ceiling void in the office (Area 1) does contain asbestos.

Any change in appearance should be reported to Property Services.

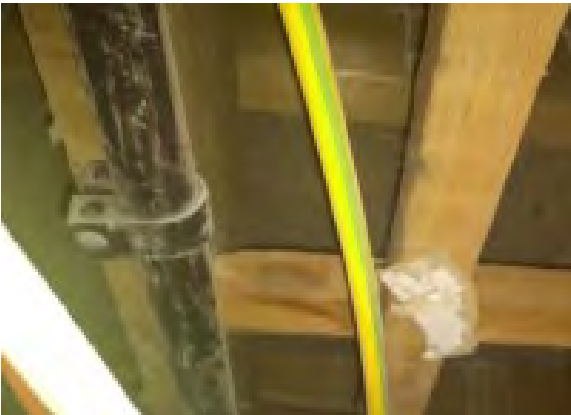
Item 186 Ref: 21-32786-2

The residual plasterboard sections to the wood beams in the office ceiling void (Area 1) does contain asbestos.

Any change in appearance should be reported to Property Services.

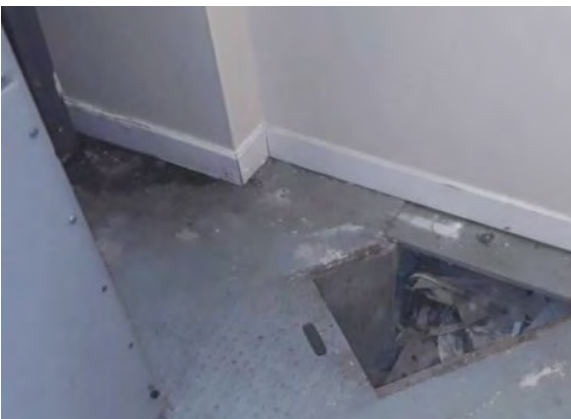
Item 198 Ref: NZ000796

The debris/residue within floor void duct in the ground floor electrical cupboard (Room G/001) does not contain asbestos.

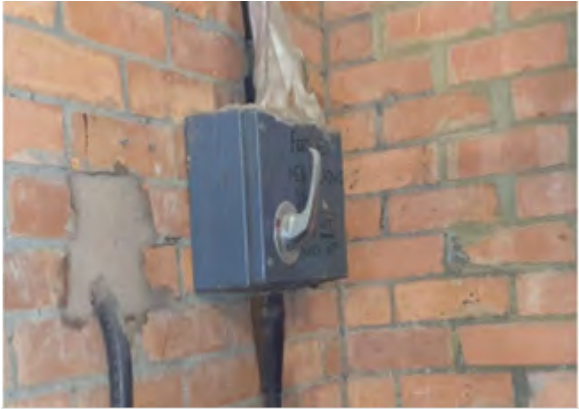
Item 200 Ref: Presumed

The fuses in electrical fuse box (Boiler room G/001) is presumed to contain asbestos.

Any change in appearance should be reported to Property Services.

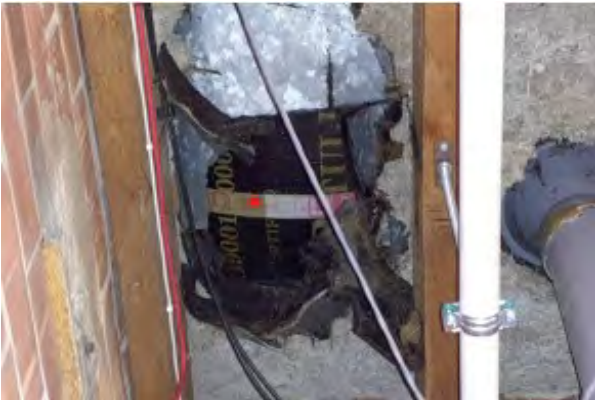
Item 201 Ref: PK000396

The roof felt in the Boier Room (Room G/001) does contain asbestos.

Any change in appearance should be reported to Property Services.

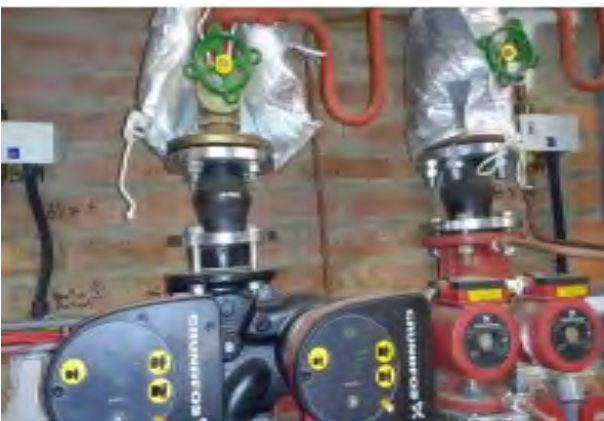
Item 202 Ref: PK000394

The green gasket pipework in the Boiler Room (Room G/001) does not contain asbestos.

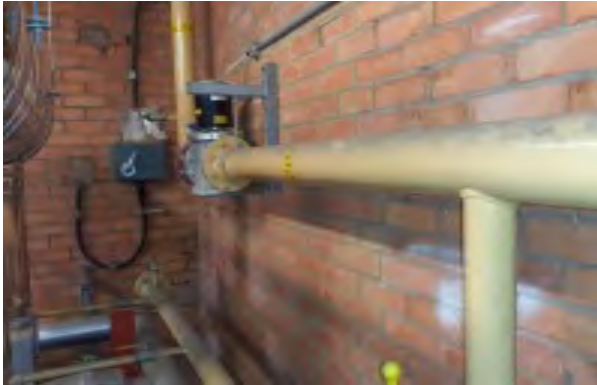
Item 203 Ref: PK000395

The gasket gas pipe in the Boiler Room (Room G/001) does not contain asbestos.

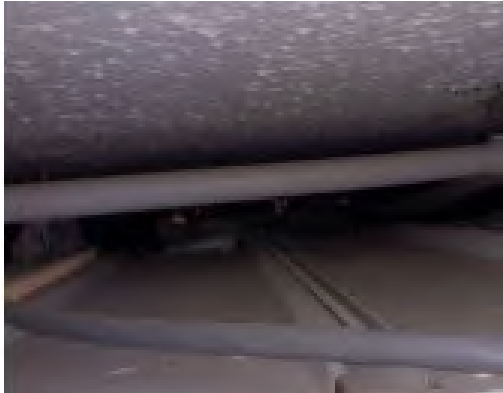
Item 206 Ref: PK000708

The textured coating debris – top of ceiling tiles and light fittings in Meeting Room 2 (G/01) does contain asbestos.

Removed – confirmed on reinspection survey J142852 Dec 2025

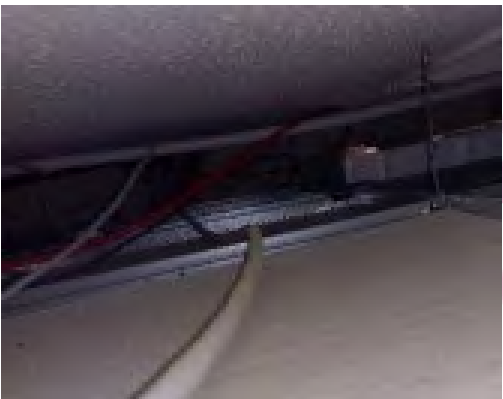
Item 207 Ref: As PK000708

The textured coating debris – top of ceiling tiles and light fittings in Meeting Room 1 (G/02) does contain asbestos.

Removed – confirmed on reinspection survey J142852 Dec 2025

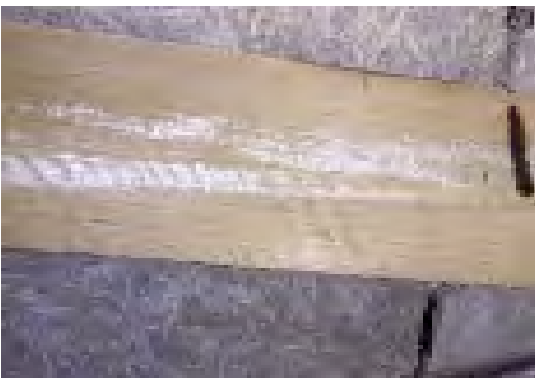
Item 208 Ref: PK000700

The bitumen drip walls and roof structure in IT suite touchdown space 22 (G/03) does not contain asbestos.

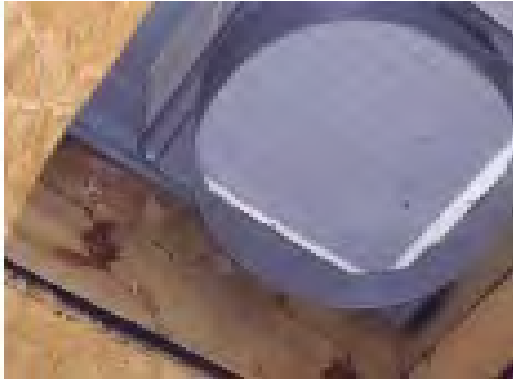
Item 209 Ref: As PK000700

The bitumen drip skylight roof cover in the Drop-in room A (G/05) does not contain asbestos.

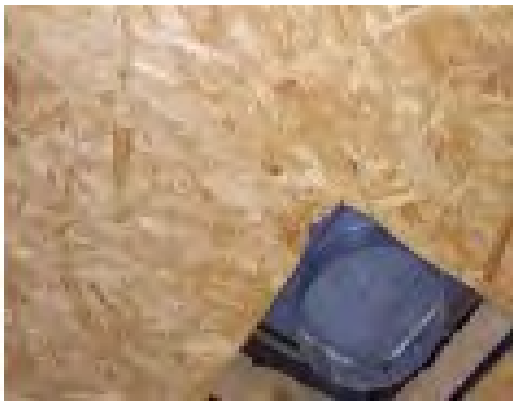
Item 210 Ref: As PK000700

The bitumen drip skylight roof cover in the Drop-in room B (G/06) does not contain asbestos.

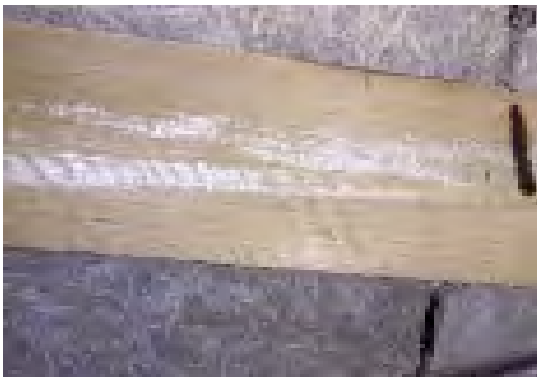
Item 211 Ref: As PK000708

The textured coating debris – top of ceiling tiles and light fittings in Drop-in room B (G/06) does contain asbestos.

***Removed – confirmed on reinspection survey
J142852 Dec 2025***

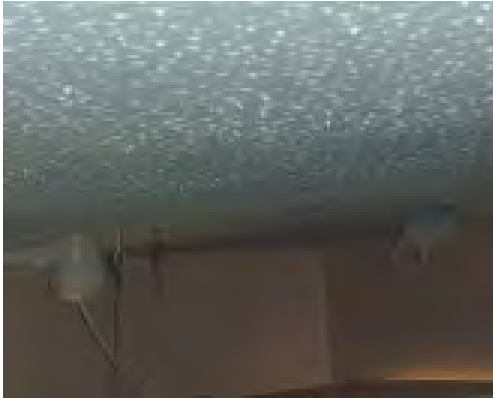
Item 212 Ref: As PK000708

The textured coating debris – top of ceiling tiles and light fittings in Office 19 (G/07) does contain asbestos.

Removed – confirmed on reinspection survey J142852 Dec 2025

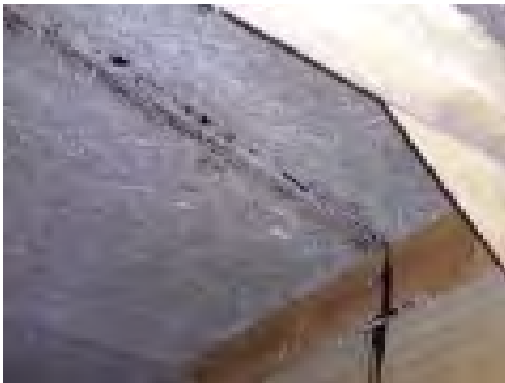
Item 213 Ref: As PK000700

The bitumen drip walls and roof structure in the Washroom (G/08) does not contain asbestos.

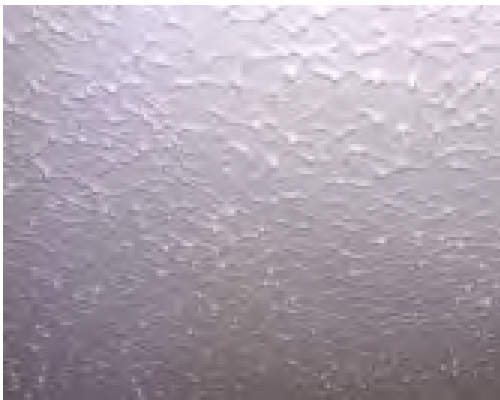
Item 214 Ref: PK000702

The textured coating upper ceiling above suspended tiles in the Office 16a (G/09) does contain asbestos.

Any change in appearance should be reported to Property Services.

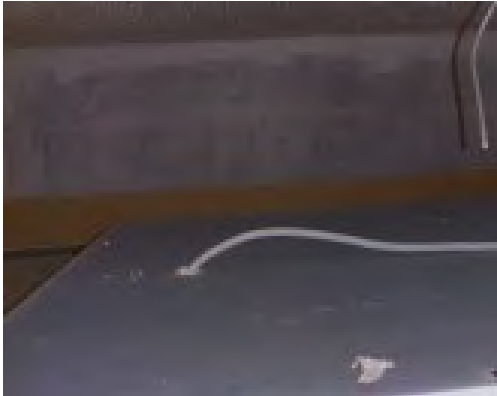
Item 215 Ref: As PK000708

The textured coating debris – top of ceiling tiles and light fittings in Office 16a (G/09) does contain asbestos.

***Removed – confirmed on reinspection survey
J142852 Dec 2025***

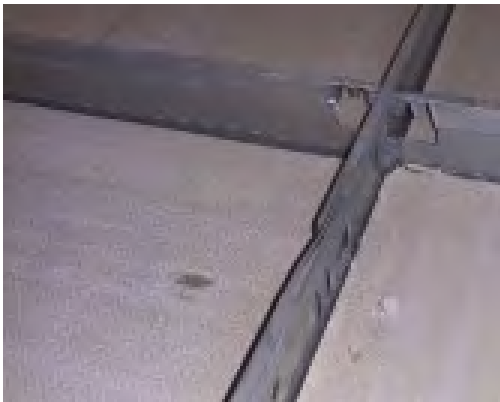
Item 216 Ref: As PK000708

The textured coating debris – top of ceiling tiles and light fittings in Office 16 (G/010) does contain asbestos.

***Removed – confirmed on reinspection survey
J142852 Dec 2025***

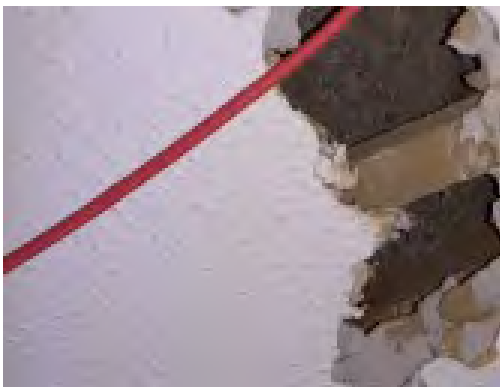
Item 217 Ref: As PK000708

The textured coating debris – top of ceiling tiles and light fittings in Office 15 (G/012) does contain asbestos.

***Removed – confirmed on reinspection survey
J142852 Dec 2025***

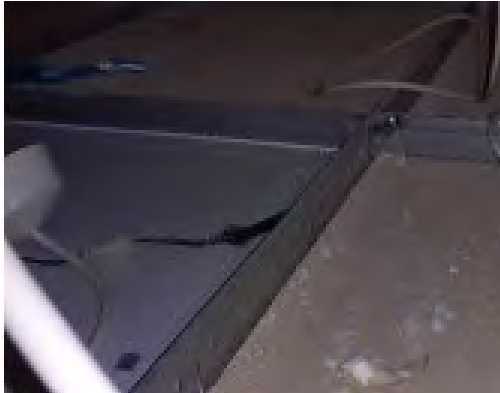
Item 218 Ref: As PK000708

The textured coating debris – top of ceiling tiles and light fittings in Female Toilets (G/014) does contain asbestos.

Removed – confirmed on reinspection survey J142852 Dec 2025

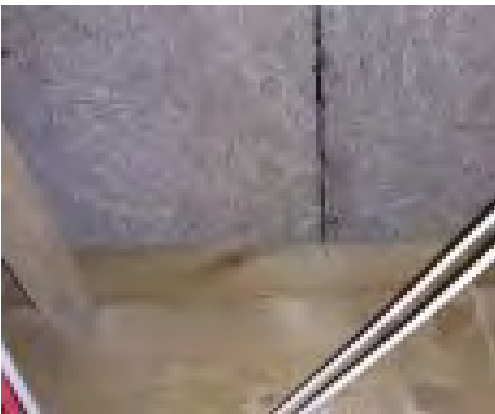
Item 219 Ref: As PK000700

The bitumen drip walls and roof structure in Office 12 (G/015) does not contain asbestos.

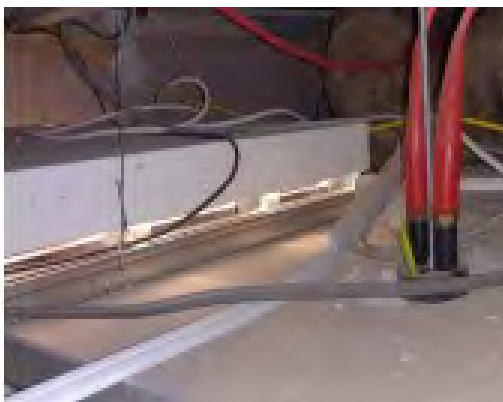
Item 220 Ref: As PK000708

The textured coating debris – top of ceiling tiles and light fittings in Office 9 (G/016) does contain asbestos.

Any change in appearance should be reported to Property Services.

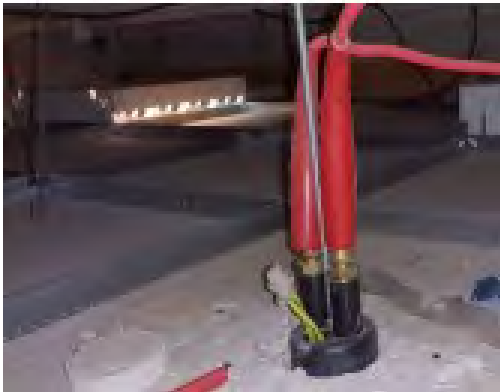
Item 221 Ref: As PK000708

The textured coating debris – top of ceiling tiles and light fittings in Office 10 (G/017) does contain asbestos.

Removed – confirmed on reinspection survey J142852 Dec 2025

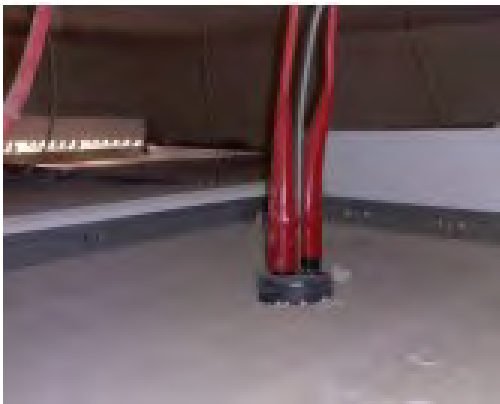
Item 222 Ref: As PK000708

The textured coating debris – top of ceiling tiles and light fittings in Office 6 (G/021) does contain asbestos.

Any change in appearance should be reported to Property Services.

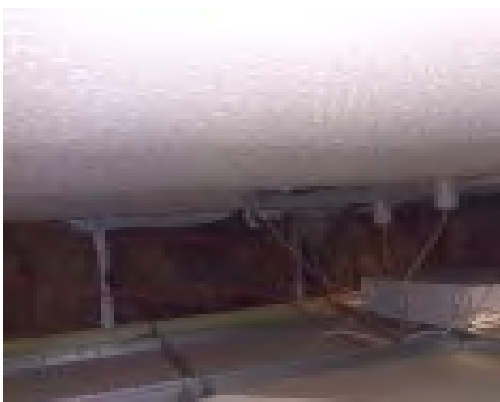
Item 223 Ref: As PK000709

The textured coating debris – top of ceiling tiles and light fittings in Office 4 (G/022) does not contain asbestos.

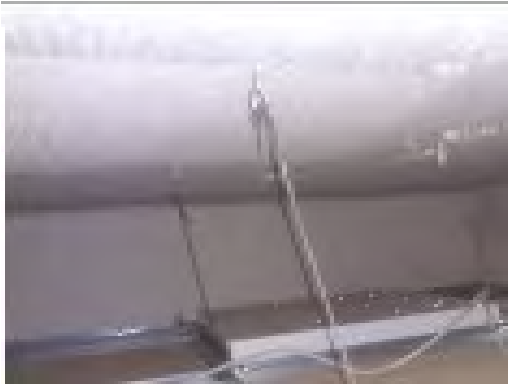
Item 224 Ref: As PK000709

The textured coating debris – top of ceiling tiles and light fittings in Office 2 (G/024) does not contain asbestos.

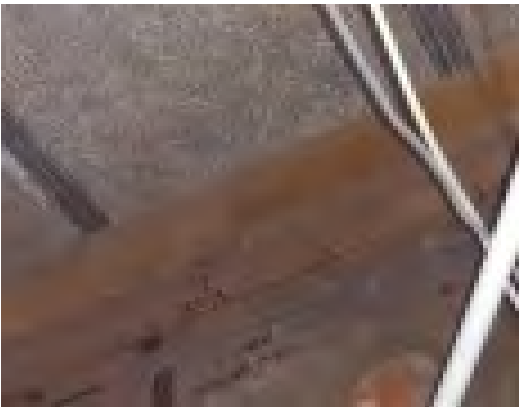
Item 225 Ref: As PK000700

The bitumen drip walls and roof structure in the Store cupboard 1 (G/025) does not contain asbestos.

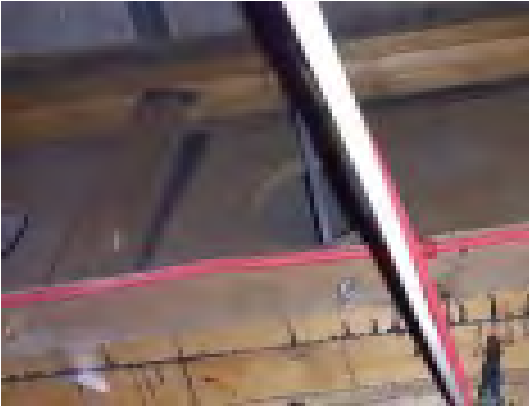
Item 227 Ref: As PK000700

The bitumen drip walls and roof structure in the Main kitchen (G/027) does not contain asbestos.

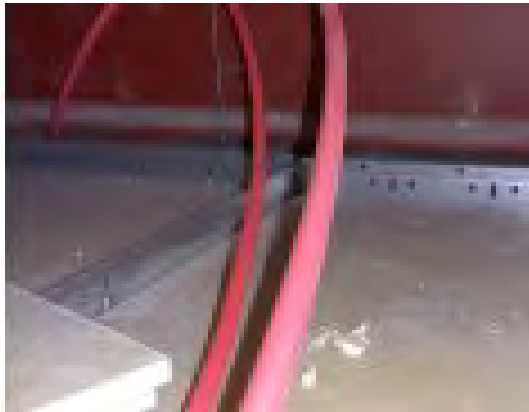
Item 228 Ref: As PK000709

The textured coating debris – top of ceiling tiles and light fittings in Training Room 30 (G/030) does not contain asbestos.

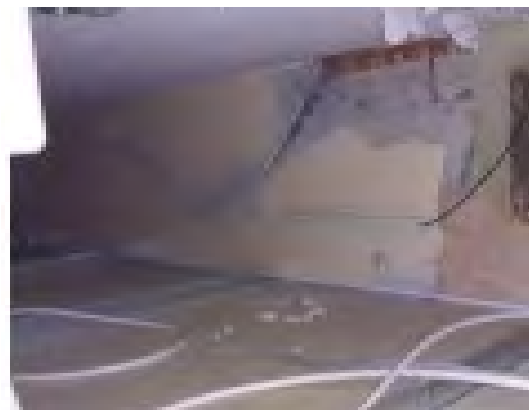
Item 229 Ref: As PK000709

The textured coating debris – top of ceiling tiles and light fittings in Training Room 39a (G/031) does not contain asbestos.

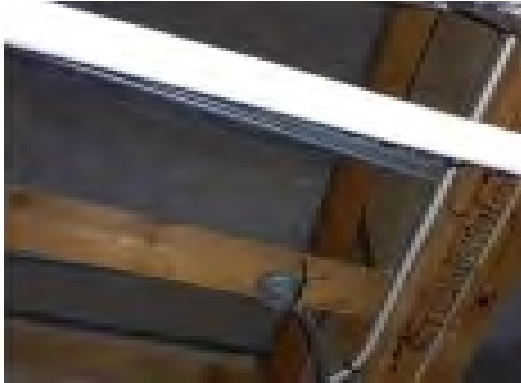
Item 230 Ref: As PK000700

The bitumen drip walls and roof structure in Office 38 (G/032) does not contain asbestos.

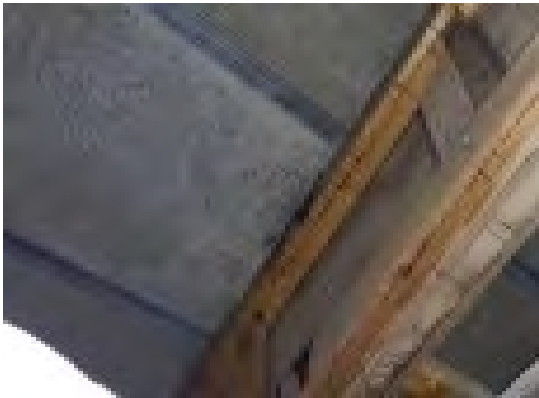
Item 231 Ref: As PK000700

The bitumen drip walls and roof structure in Office 38a (G/033) does not contain asbestos.

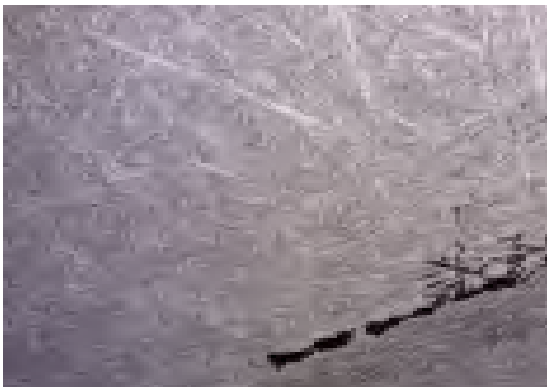
Item 232 Ref: As PK000700

The bitumen drip walls and roof structure in Office 34 (G/034) does not contain asbestos.

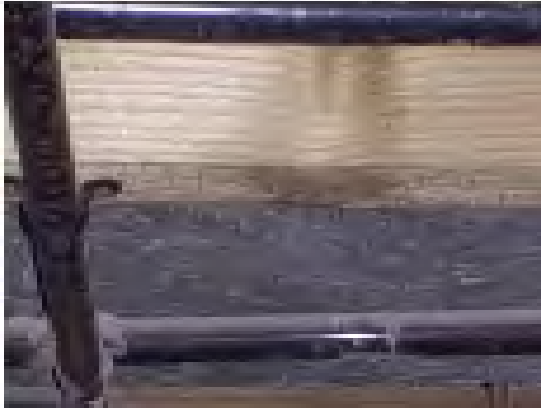
Item 233 Ref: As PK000700

The bitumen drip walls and roof structure in Office 33 (G/035) does not contain asbestos.

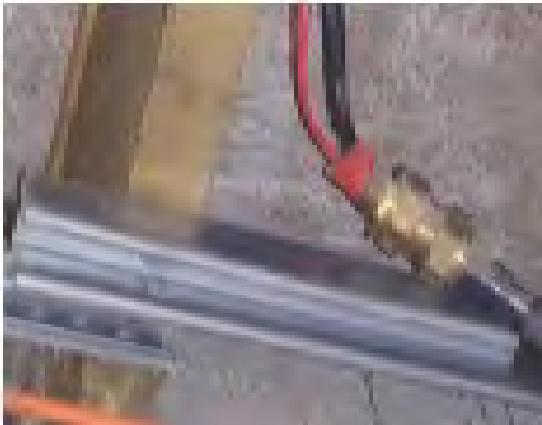
Item 234 Ref: As PK000700

The bitumen drip walls and roof structure in the Sub Main intake off reception 37 (G/036) does not contain asbestos.

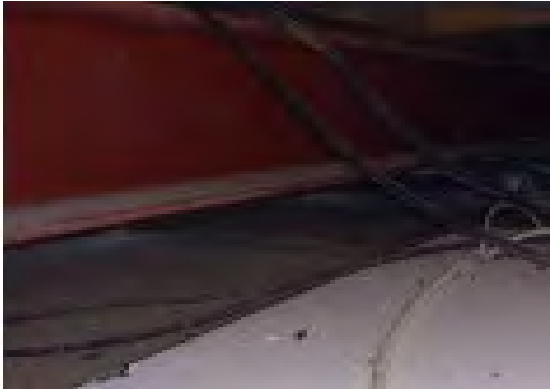
Item 236 Ref: As PK000709

The textured coating debris – top of ceiling tiles and light fittings in Office 36 (G/037) does not contain asbestos.

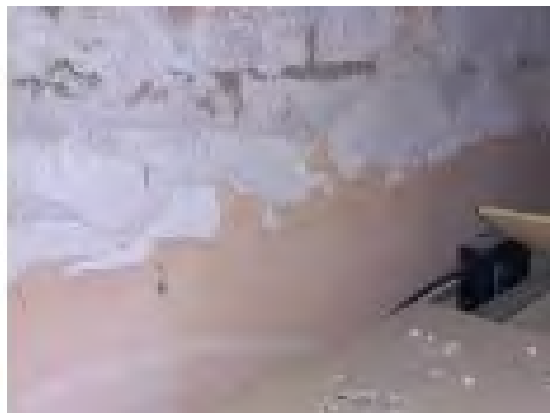
Item 237 Ref: As PK000709

The textured coating debris – top of ceiling tiles and light fittings in Store cupboard 32 (G/038) does not contain asbestos.

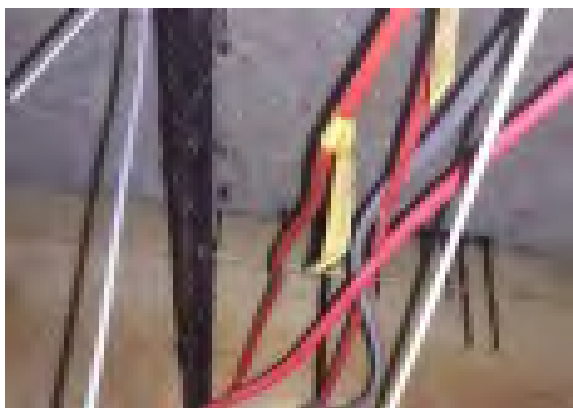
Item 238 Ref: As PK000700

The bitumen drip walls and roof structure in Former reception (G/041) does not contain asbestos.

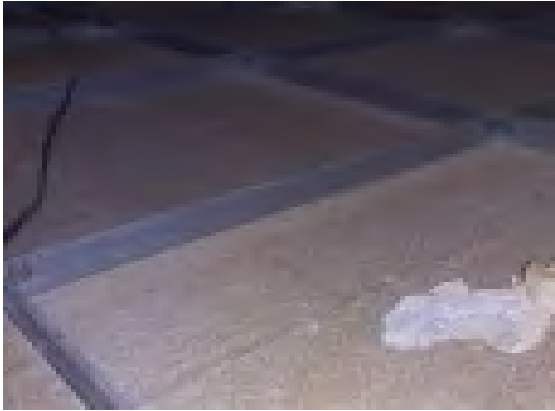
Item 239 Ref: PK000709

The textured coating debris – top of ceiling tiles and light fittings in Canteen area (G/042) does not contain asbestos.

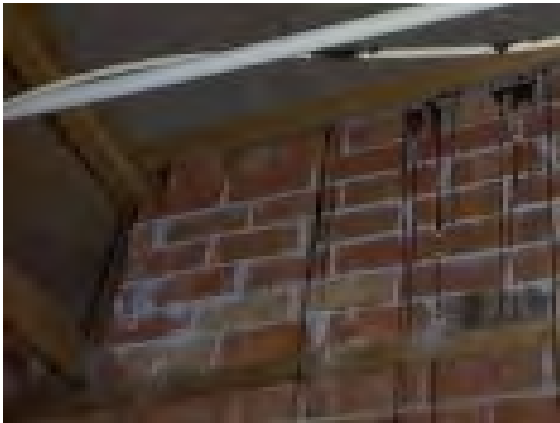
Item 240 Ref: As PK000700

The bitumen drip walls and roof structure in Main canteen kitchen (G/043) does not contain asbestos.

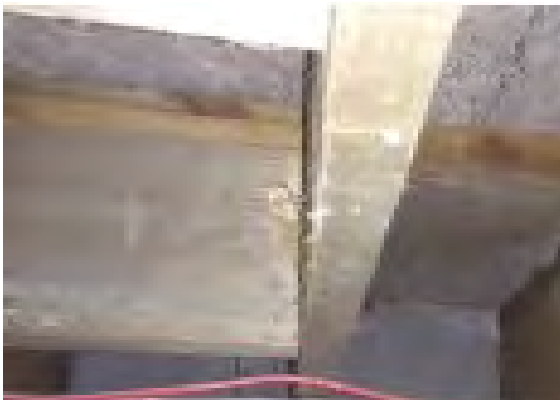
Item 241 Ref: As PK000700

The bitumen drip walls and roof structure in Main front reception (G/044) does not contain asbestos.

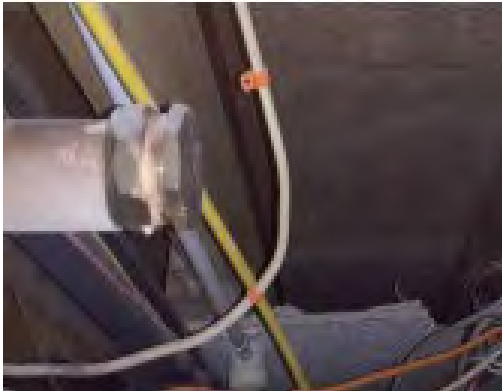
Item 242 Ref: PK000707

The textured coating remnants - upper ceiling above suspended tiles in the Corridor (G/049) does contain asbestos.

Any change in appearance should be reported to Property Services.

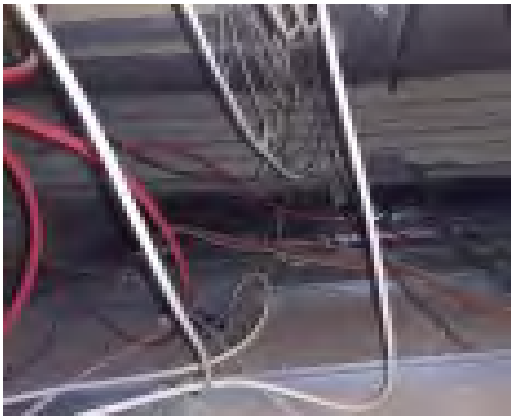
Item 243 Ref: As PK000709

The textured coating debris – top of ceiling tiles and light fittings in the Corridor (G/049) does not contain asbestos.

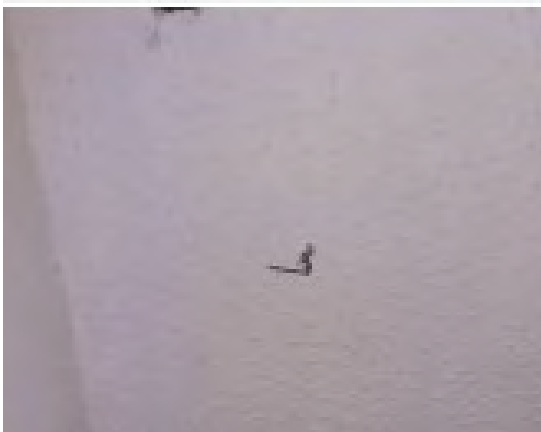
Item 244 Ref: As PK000707

The textured coating remnants - upper ceiling above suspended tiles in the Cupboard 28 (G/050) does contain asbestos.

Any change in appearance should be reported to Property Services.

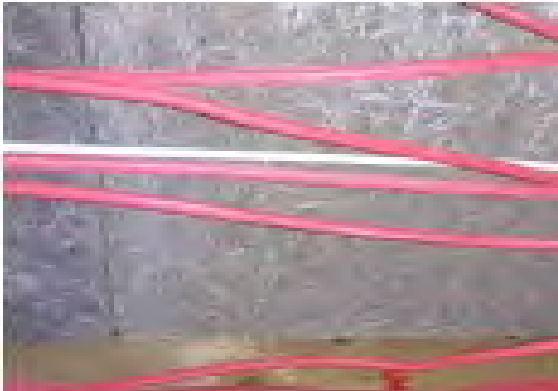
Item 245 Ref: As PK000700

The bitumen drip walls and roof structure in the Corridor (G/051) does not contain asbestos.

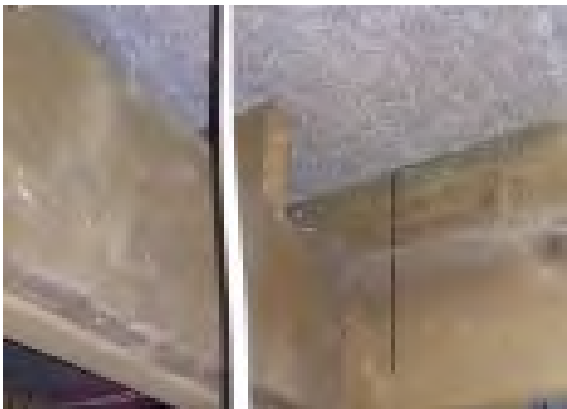
Item 246 Ref: As PK000700

The bitumen drip walls and roof structure in the Corridor (G/052) does not contain asbestos.

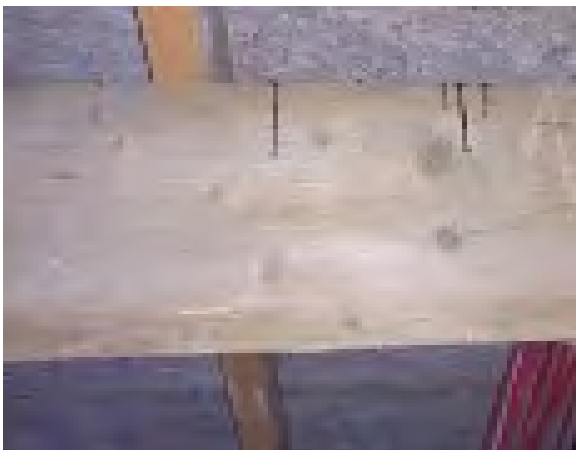
Item 247 Ref: As PK000700

The bitumen drip walls and roof structure in the Corridor (G/053) does not contain asbestos.

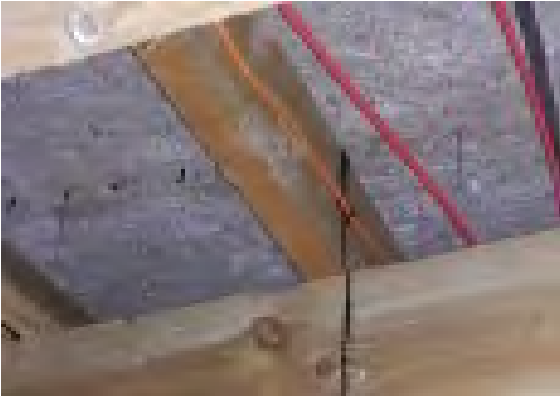
Item 248 Ref: As PK000700

The bitumen drip walls and roof structure in the Corridor (G/054) does not contain asbestos.

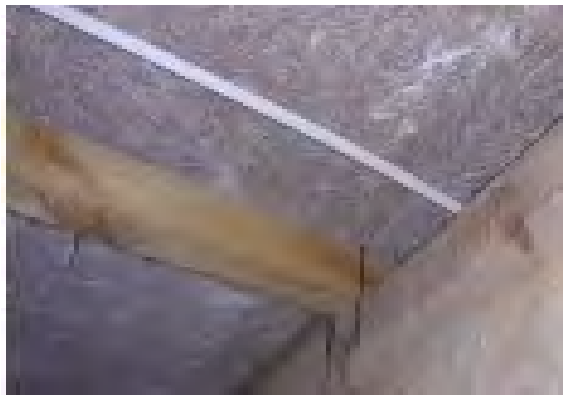
Item 249 Ref: As PK000700

The bitumen drip walls and roof structure in the Main reception lobby (G/055) does not contain asbestos.

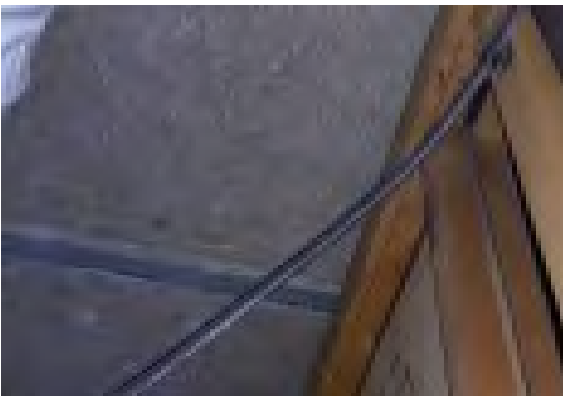
Item 250 Ref: As PK000700

The bitumen drip walls and roof structure in the Seminar Room (G/056) does not contain asbestos.

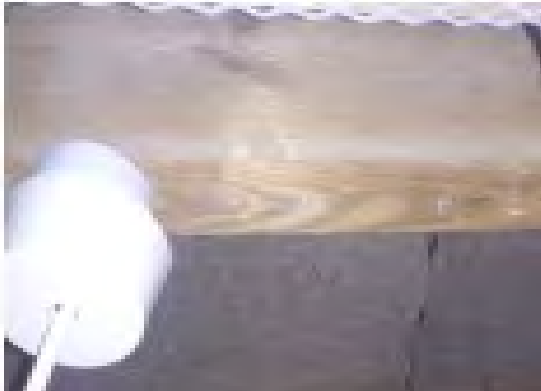
Item 251 Ref: As PK000700

The bitumen drip walls and roof structure in the Male Toilets (G/057) does not contain asbestos.

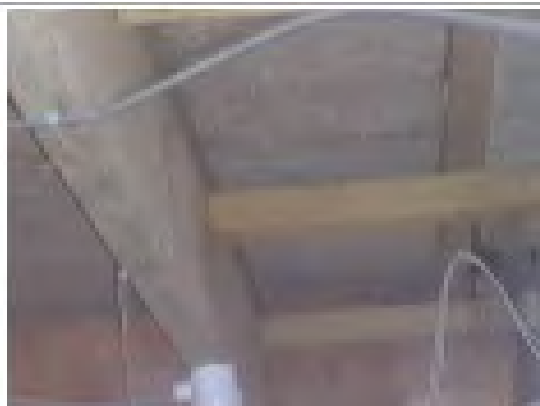
Item 252 Ref: As PK000700

The bitumen drip walls and roof structure in the Female Toilets (G/058) does not contain asbestos.

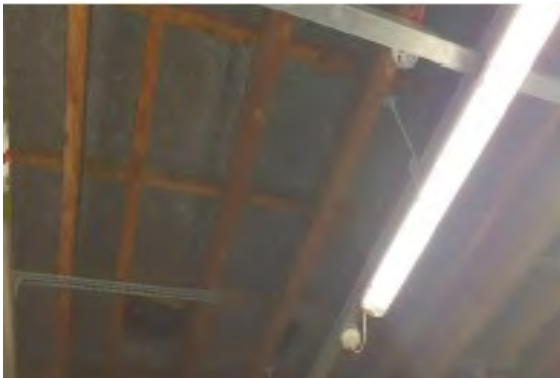
Item 253 Ref: OU001831

The strawboard ceiling in the Boiler Room (G/41) does not contain asbestos.

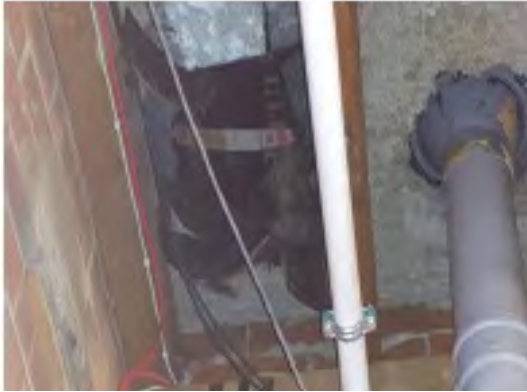
Item 254 Ref: OU001832

The bitumen above strawboard and metal ceiling in the Boiler Room (G/41) does not contain asbestos.

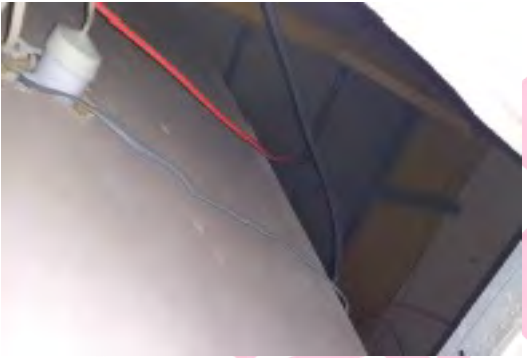
Item 255 Ref: OU001833

The strawboard ceiling in Corridor 7 (G/44) does not contain asbestos.

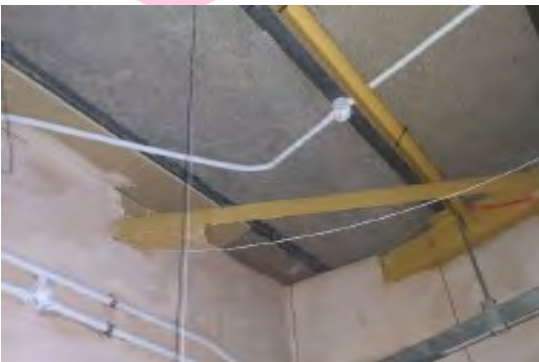
Item 256 Ref: As OU001833

The strawboard ceiling in Office 4 (G/45) does not contain asbestos.

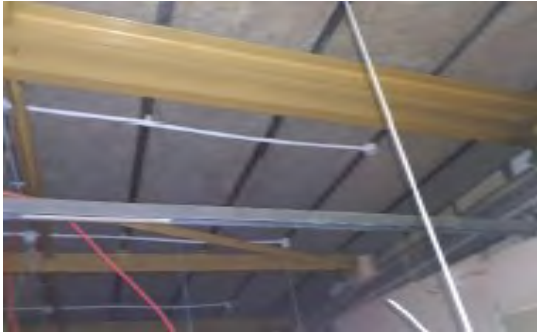
Item 257 Ref: As OU001833

The strawboard ceiling in Business Support Admin/Stores (G/46) does not contain asbestos.

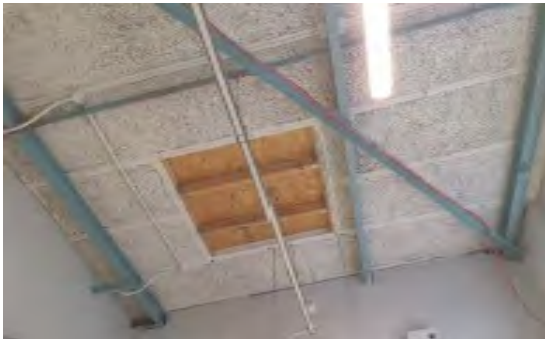
Item 258 Ref: As OU001833

The strawboard ceiling in the Team Leaders Office (G/47) does not contain asbestos.

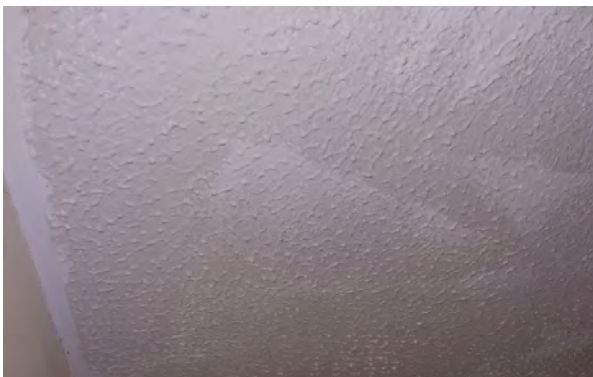
Item 259 Ref: PK003096

The textured coating – plasterboard upper ceiling above suspended ceiling tiles in the Drop In Room B (G/02) does contain asbestos.

Any change in appearance should be reported to Property Services.
