ASBESTOS SURVEY REPORT FOR LEECHMERE TRAINING CENTRE (INCLUDING TELECARE HOUSE), SUNDERLAND

Asbestos Register for LEECHMERE CENTRE, SUNDERLAND

Premises Manager / Samo: - Tenant Date: 16 January 2025

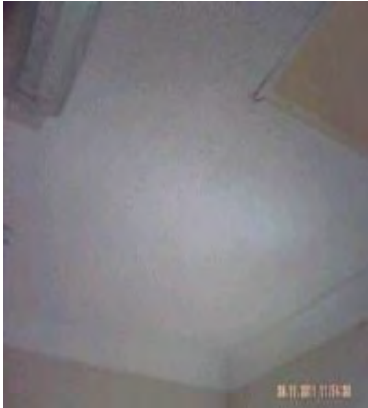
Item 11 Ref: AY001950

The textured coating to the ceiling in the hallway (Room 1) contains asbestos.

Any change in its appearance should be recorded and passed to Property Services.

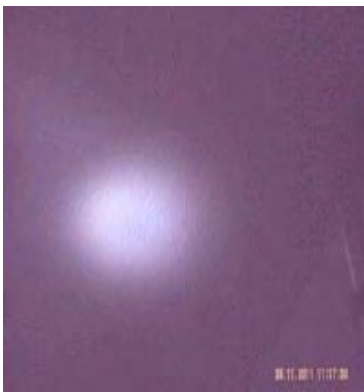
Item 12 - Ref: AY001951

The textured coating to the ceiling in the cupboard (Room 2) contains asbestos.

Any change in its appearance should be recorded and passed to Property Services.

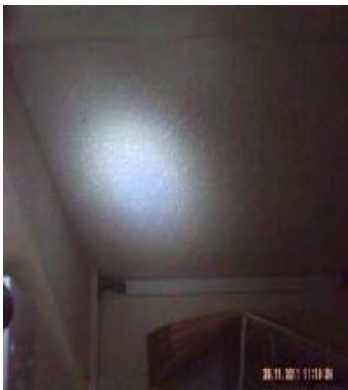
Item 13 – As AY001951

The textured coating to the ceiling in the cupboard (Room 3) contains asbestos.

Any change in its appearance should be recorded and passed to Property Services.

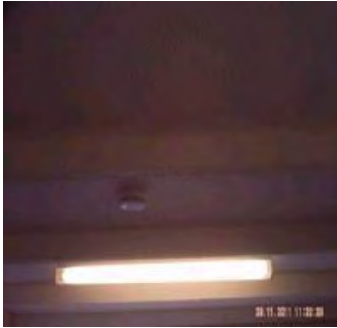
Item 14 – As AY001951

The textured coating to the ceiling in the living room (Staff Room) (Room 4) contains asbestos.

Removed 2023

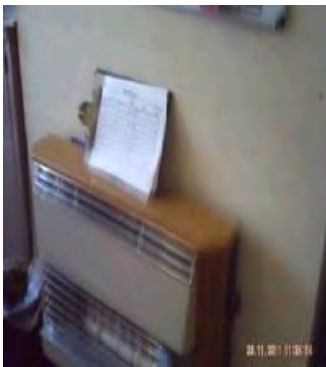
There was no access gained behind the gas fire in the living room therefore it must be presumed to contain asbestos.

Prior to any works on this fire. Sampling must be carried out.

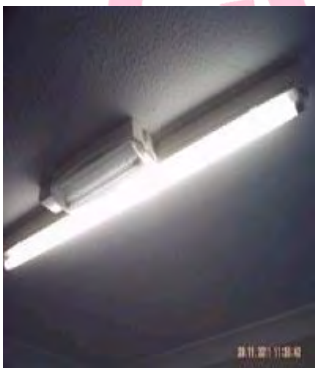
Item 15 - Ref: As AY001951

The textured coating to the ceiling in the kitchen (Room 5) contains asbestos.

Removed 2023

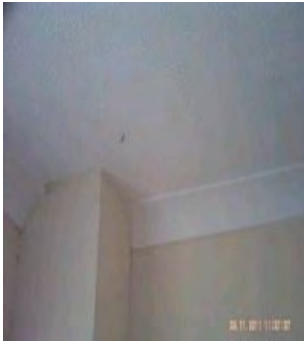
Item 16 – As AY001951

The textured coating to the ceiling in the ground floor WC (Room 6) contains asbestos.

Removed 2023

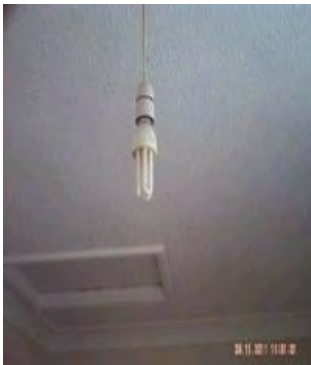
Item 17 – Ref: AY001948

The textured coating to the ceiling on the first floor landing (Rm 1/1) contains asbestos.

Removed 2023

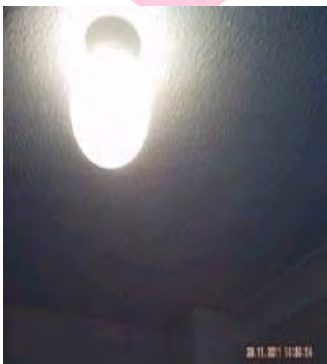
Item 18 - Ref: As AY001949

The textured coating to the ceiling in the bathroom (Rm 1/2) contains asbestos.

Removed 2023

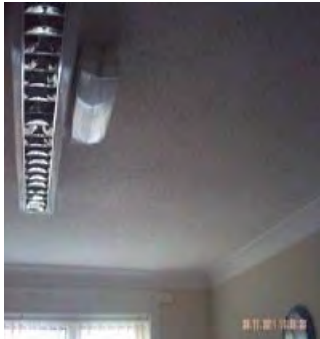
Item 19 – As AY001949

The textured coating to the ceiling in bedroom 1 (Rm 1/3) contains asbestos.

Removed 2023

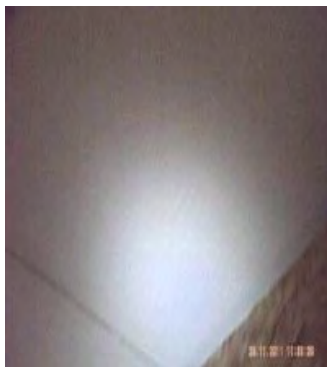
Item 20 – As AY001949

The textured coating to the ceiling in bedroom 1 cupboard (Rm 1/4) contains asbestos.

Removed 2023

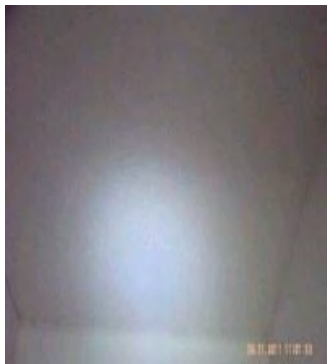
Item 21 – As AY001949

The textured coating to the ceiling in cupboard on the landing (Rm 1/5) contains asbestos.

Removed 2023

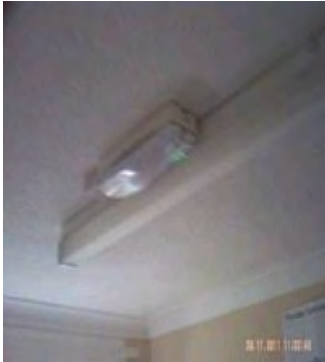
Item 22 – As AY001948

The textured coating to the ceiling in bedroom 2 (Rm 1/6) contains asbestos.

Removed 2023

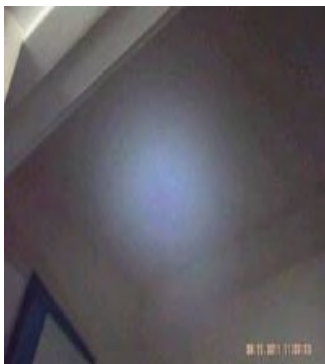
Item 23 – As AY001948

The textured coating to the ceiling in bedroom 2 cupboard (Rm 1/7) contains asbestos.

Removed 2023

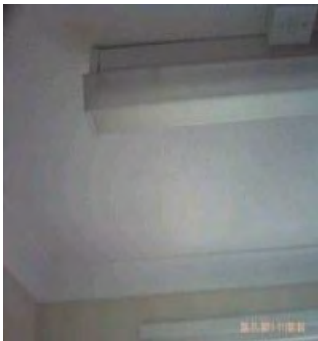
Item 24 – As AY001949

The textured coating to the ceiling in bedroom 3 cupboard (Rm 1/8) contains asbestos.

Removed 2023

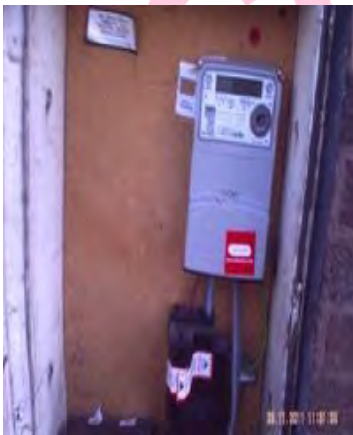
The electrics to the external could not be accessed.

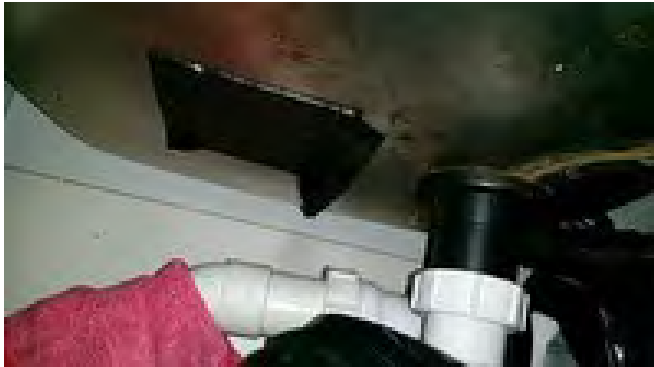
Item 147 - Ref: Presumed

The sink pads in Kitchen (Rm 0/002) are presumed to contain asbestos.

Any change in its appearance should be recorded and passed to Property Services.

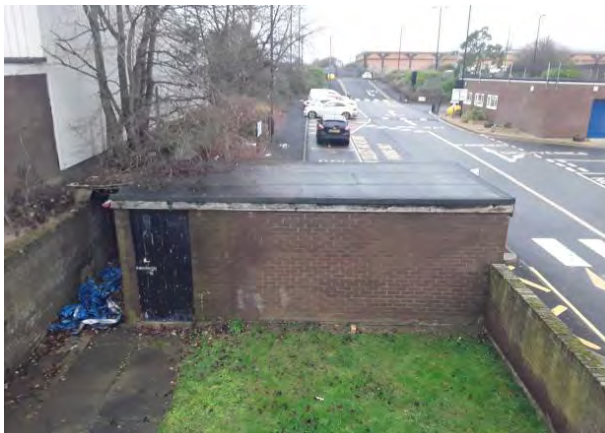
Item 193 - Ref: 22-55417-10

The roof felt to garage (External) does not contain asbestos.

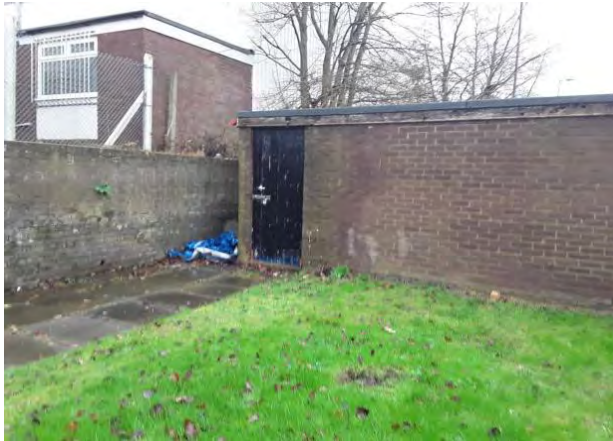
Item 194 - Ref: 22-55417-11

The frame sealant to wood door frame to garage (Area 17) contains asbestos.

Removed 2023

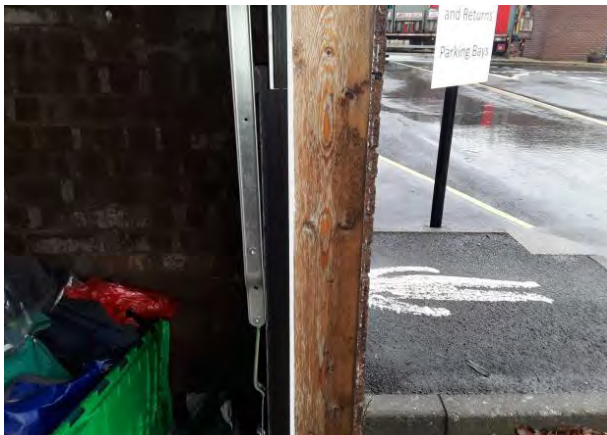
Item 195 - Ref: 22-55417-12

The frame sealant to brickwork to metal door to garage (Area 17) contains asbestos.

Removed 2023

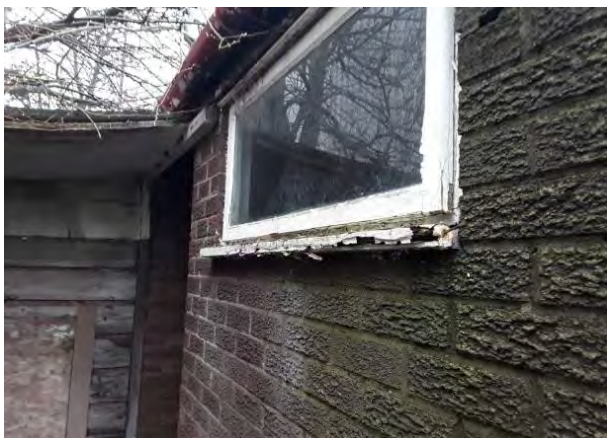
Item 196 - Ref: 22-55417-13

The window putty to garage (Area 17) does not contain asbestos.

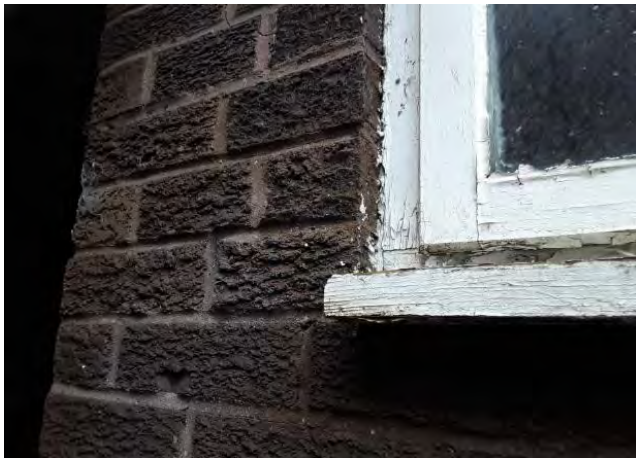
Item 197 - Ref: 22-55417-14

The frame sealant to window to garage (Area 17) contains asbestos.
