ASBESTOS SURVEY REPORT FOR LEECHMERE TRAINING CENTRE (INCLUDING TELECARE HOUSE), SUNDERLAND

Asbestos Register for LEECHMERE CENTRE, SUNDERLAND

Date: 16 January 2025

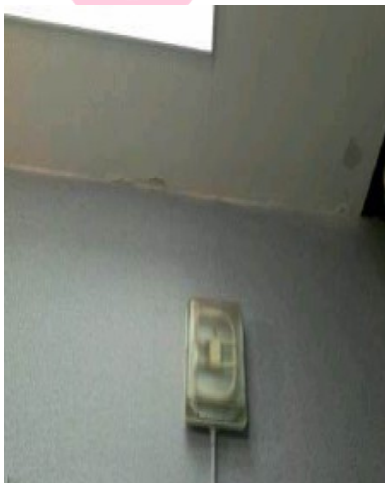
Item 6 - Ref: CB000915

CB000915 – Textured coating (Stores Male WC) (Item 6) - Low Risk

The textured coating to the ceiling in the Stores male wc contains asbestos.

Any change in its appearance should be recorded and passed to Property Services.

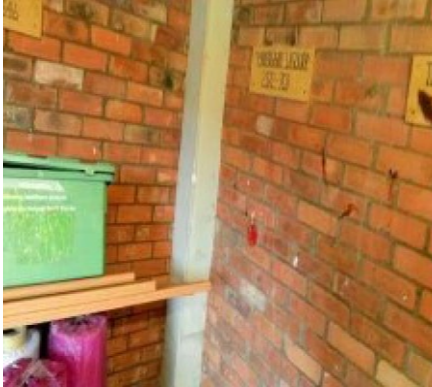
Item 7 - Ref: DJC04/1429

CB000913 – Insulating board boxing (Stores External Cupbd) (Item 7) –Low Risk

The insulating board boxing to the stores external cupboard contains asbestos.

Any change in its appearance should be recorded and passed to Property Services.

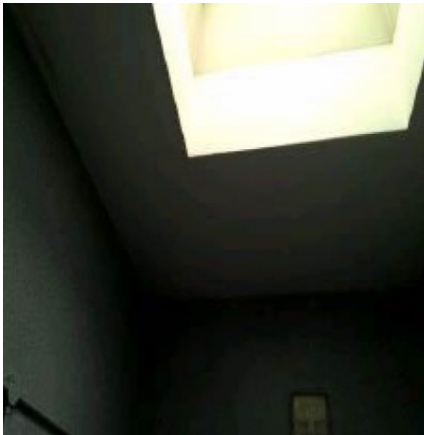
Item 8 - Ref: CB000915

As CB000915 – Textured coating (Stores Female WC) (Item 8) – Removed Nov 2016

The textured coating to the ceiling in the Stores Female WC contains asbestos.

**This was removed
November 2016.**

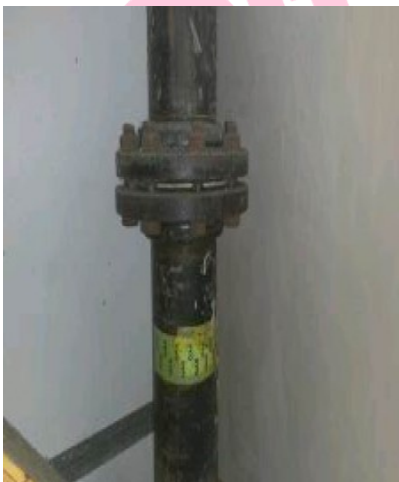
Item 9 - Ref: CB000918

CB000918 – Gasket (Gas Store) (Item 9) – Very Low Risk

The gasket to the gas store contains asbestos.

Any change in its appearance should be recorded and passed to Property Services.

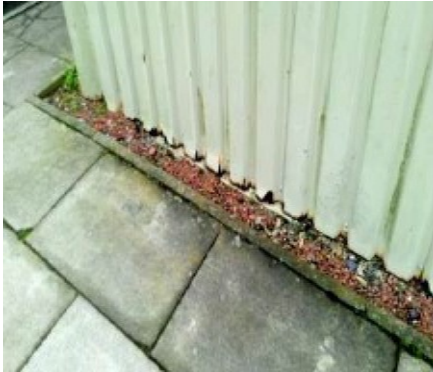
Item 10 - Ref: 170761-1

170761-1 - Corrugated wall cladding (External) (Item 10) – Very Low Risk

The corrugated wall cladding to the external is presumed to contain asbestos.

Any change in its appearance should be recorded and passed to Property Services.

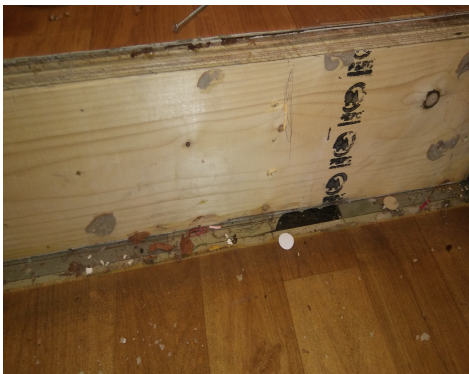
Item 25 - Ref: 315020-1

315020-1 – Floor covering (Seminar Room) (Item 25) – Very low Risk

The floor covering below the wood skirting and stage in the Seminar Room contains asbestos.

Any change in its appearance should be recorded and passed to Property Services.

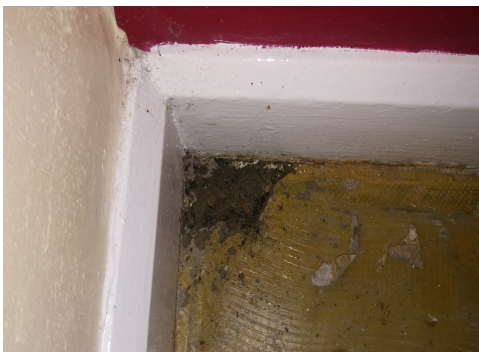
Item 26 - Ref: 315202-2

315202-2 – Remnant bitumen adhesive (Seminar Room) (Item 26) – Very Low Risk

The remnant bitumen adhesive below modern linoleum and modern screed in the Seminar Room contains asbestos.

Any change in its appearance should be recorded and passed to Property Services.

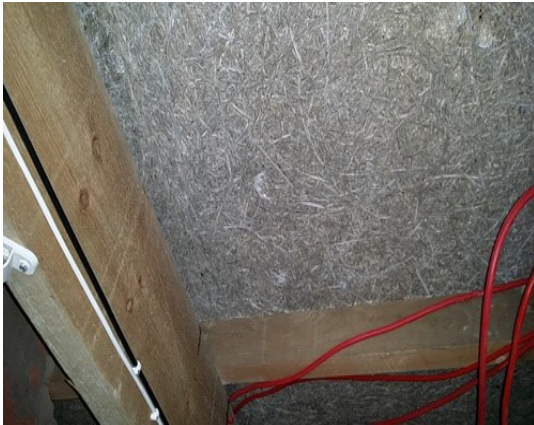
Item 27 - Ref: 70826-1

70826-1 – Underside of Roof (ILC entrance-void above 0/001) (Item 27) – No risk

The underside of roof in ILC entrance ceiling void (Rm 0/001) does not contain asbestos.

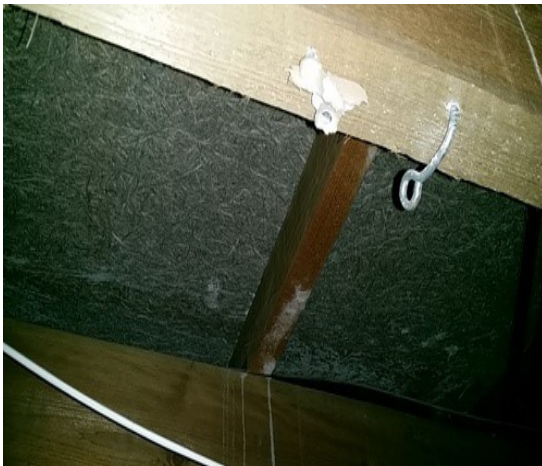
Item 28 - Ref: As 70826-3

As 70826-3 – Debris to nail in beams (ILC entrance-void above 0/001) (Item 28) – Low Risk

The debris to nails in wood beams in ILC entrance ceiling void (Rm 0/001) contains asbestos.

Any change in its appearance should be recorded and passed to Property Services.

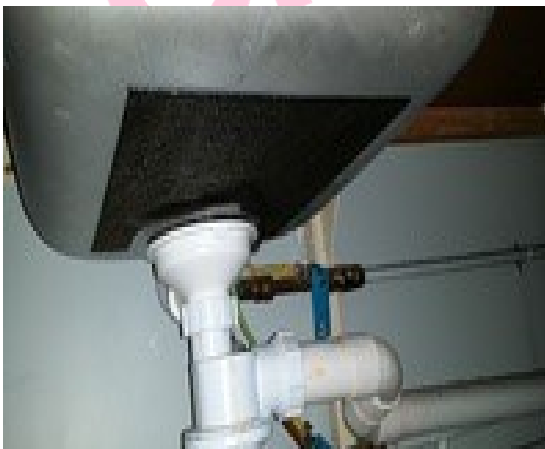
Item 29 - Ref: Presumed

Presumed – Sink Pad (Kitchen 0/010) (Item 29) – Very low Risk

The sink pad in kitchen (Rm 0/010) is presumed to contain asbestos.

Any change in its appearance should be recorded and passed to Property Services.

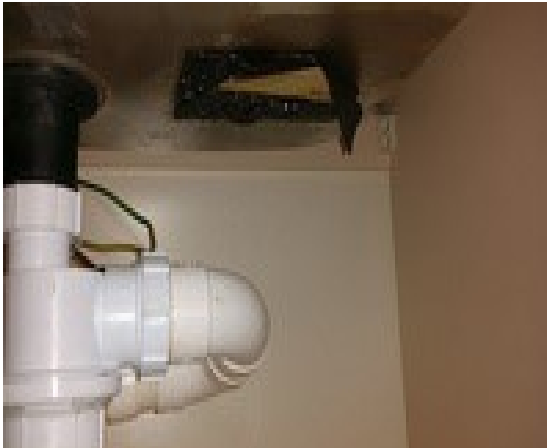
Item 30 - Ref: Presumed

Presumed – Sink Pad (Kitchen 0/035) (Item 30) – Very low Risk

The sink pad in kitchen (Rm 0/035) is presumed to contain asbestos.

Any change in its appearance should be recorded and passed to Property Services.

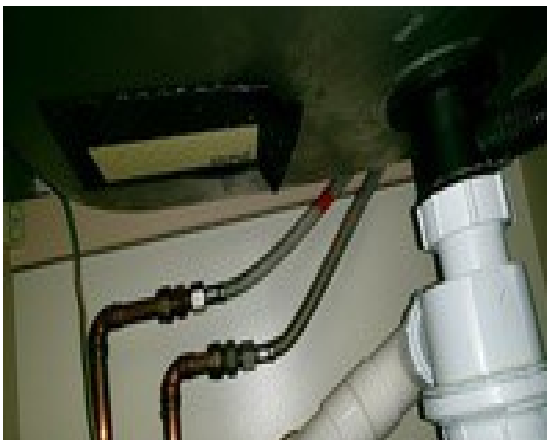
Item 31 - Ref: Presumed

Presumed – Sink Pad (Kitchen 0/049) (Item 31) – Very low Risk

The sink pad in kitchen (Rm 0/049) is presumed to contain asbestos.

Any change in its appearance should be recorded and passed to Property Services.

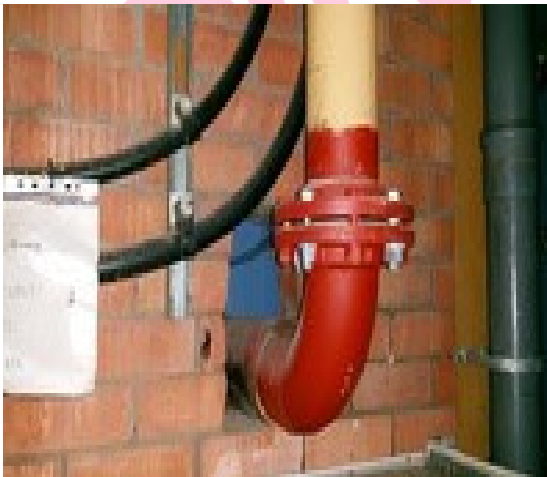
Item 32 - Ref: Presumed

Presumed – Flange Gasket (Main Electrics intake rm-void above 0/062) (Item 32) – Very Low Risk

The flange gasket to gas pipe the electricians intake room – void above (Rm 0/062) is presumed to contain asbestos.

Any change in its appearance should be recorded and passed to Property Services.

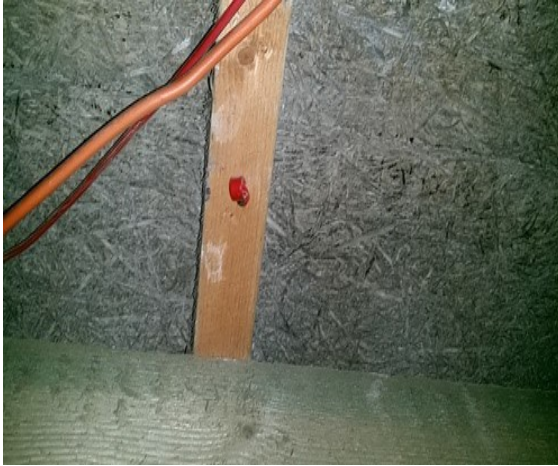
Item 33 - Ref: As 70826-1

As 70826-1 – Underside of Roof (ILC reception office-void above 0/066) (Item 33) – No Risk

The underside of roof in ILC reception office ceiling void (Rm 0/066) does not contain asbestos.

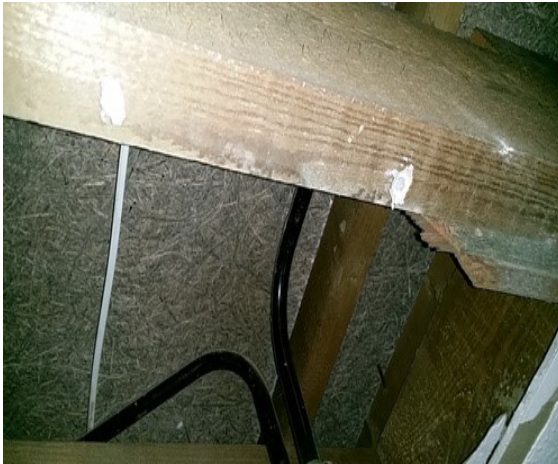
Item 34 - Ref: 70826-3

70826-3 – Debris to nail in beams (ILC reception office-void above 0/066) (Item 34) – Removed November 2019

The debris to nails in wood beams in ILC reception office ceiling void (Rm 0/066) contains asbestos.

Removed November 2019

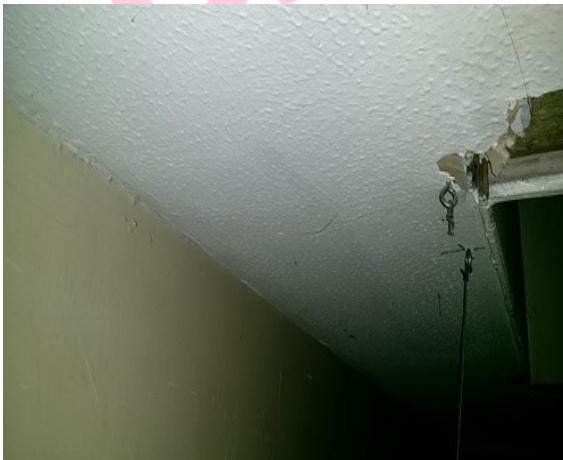
Item 35 - Ref: 70826-2

70826-2 – Textured Coating to ceiling (ILC reception office-void above 0/066) (Item 35) – Very Low Risk

The textured coating to former plasterboard ceiling in ILC reception office ceiling void (Rm 0/066) contains asbestos.

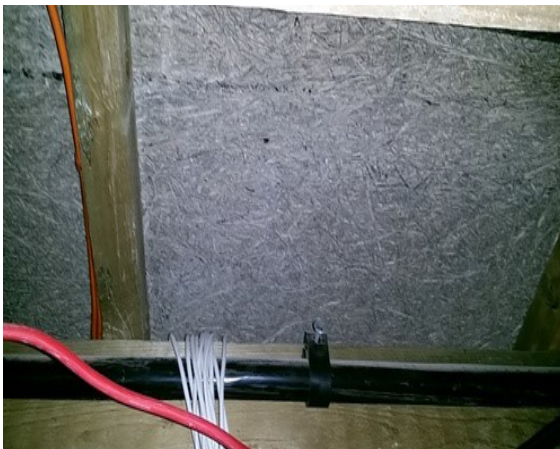
Item 37 - Ref: As 70826-1

As 70826-1 – Underside of Roof (Sub main electrics intake room-void above 0/067) (Item 37) – No Risk

The underside of roof in Sub main electric intake room ceiling void (Rm 0/067) does not contain asbestos.

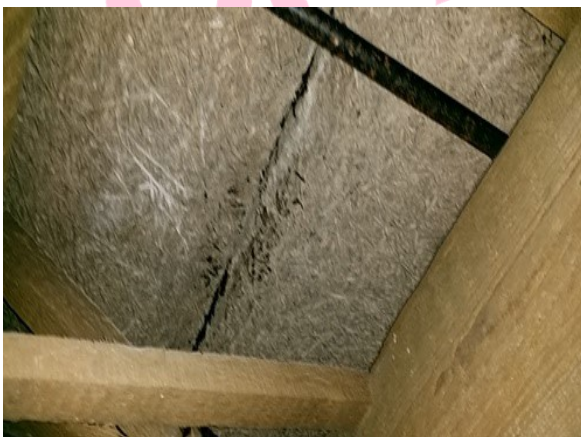
Item 41 - Ref: As 70826-1

As 70826-1 – Underside of Roof (Female Toilets & Lobby-void above 0/070) (Item 41) – No Risk

The underside of roof in Female Toilets & Lobby ceiling void (Rm 0/070) does not contain asbestos.

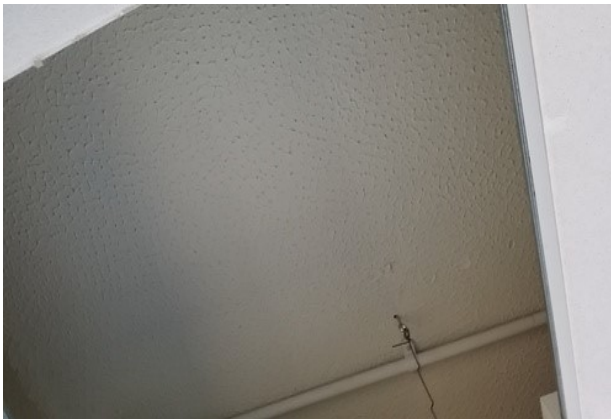
Item 67 - Ref: As 70826-5

The textured coating to plasterboard ceiling in Operations Managers Office ceiling void (Rm 0/085) contains asbestos.

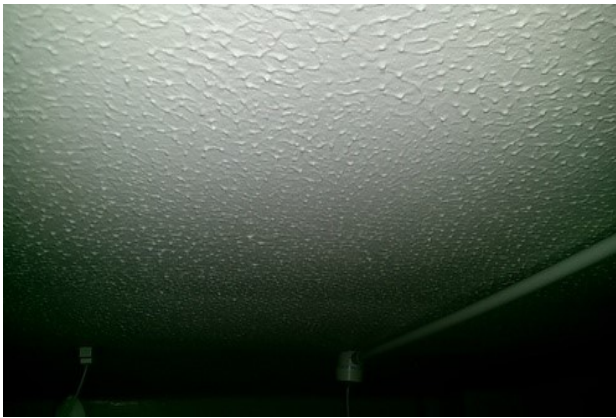
Item 69 - Ref: As 70826-5

The textured coating to ceiling in Operations Managers Office ceiling void (Rm 0/087) contains asbestos.

Any change in its appearance should be recorded and passed to Property Services.

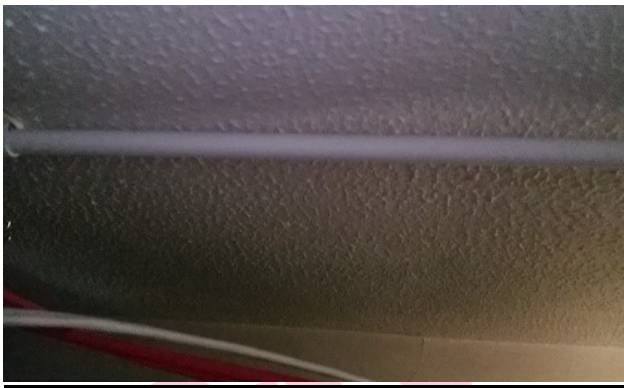
Item 70 - Ref: As 70826-5

The textured coating to ceiling in Operations Managers Office ceiling void (Rm 0/088) contains asbestos.

Any change in its appearance should be recorded and passed to Property Services.

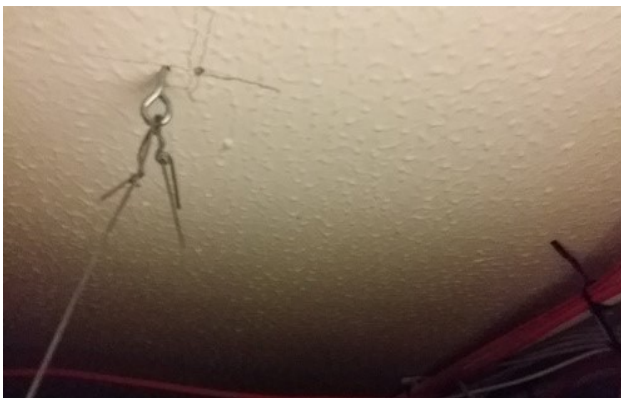
Item 71 - Ref: As 70826-5

The textured coating to ceiling in Fire Exit void above (Rm 0/089) contains asbestos.

Any change in its appearance should be recorded and passed to Property Services.

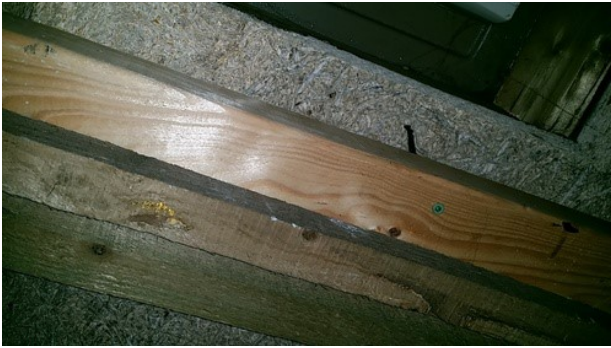
Item 72 - Ref: As 70826-6

The Underside of Roof in Office-void above (Rm 0/090) does not contain asbestos.

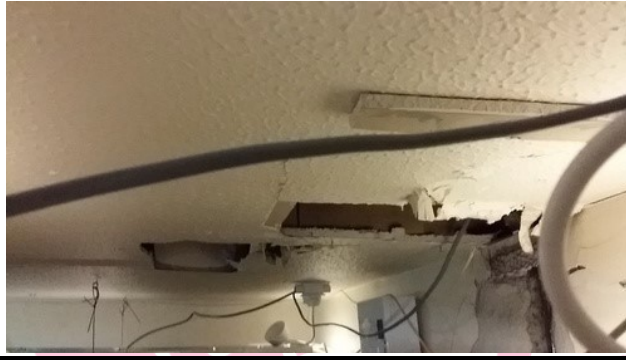
Item 73 - Ref: 70826-8

The textured coating to ceiling in Office-void above (Rm 0/090) contains asbestos.

Any change in its appearance should be recorded and passed to Property Services.

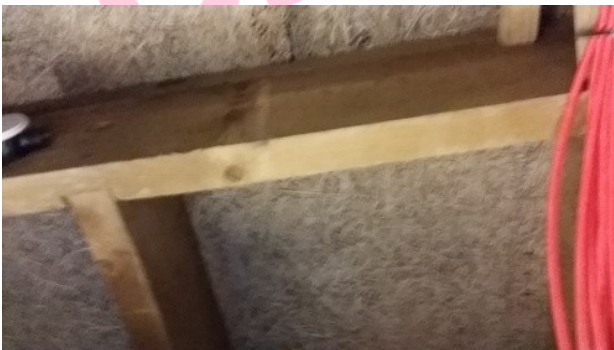
Item 74 - Ref: As 70826-6

The Underside of Roof in Office-void above (Rm 0/091) does not contain asbestos.

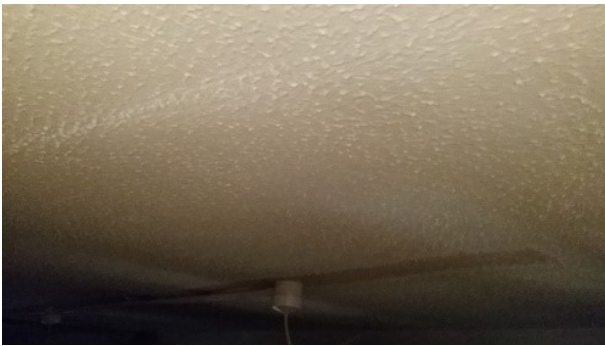
Item 75 - Ref: 70826-9

The textured coating to ceiling in Chief operating Officer-void above (Rm 0/092) contains asbestos.

Any change in its appearance should be recorded and passed to Property Services.

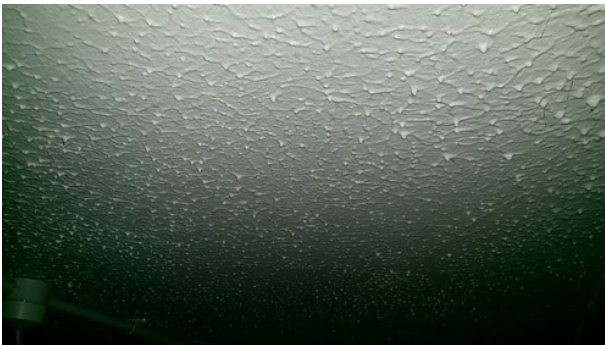
Item 76 - Ref: As 70826-9

The textured coating to ceiling in Office-void above (Rm 0/093) contains asbestos.

Any change in its appearance should be recorded and passed to Property Services.

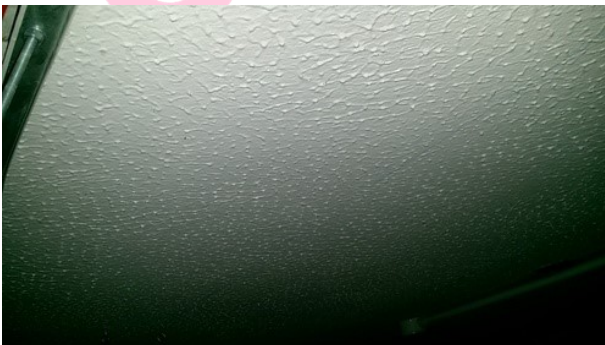
Item 77 - Ref: As 70826-9

The textured coating to ceiling in Human resource office-void above (Rm 0/094) contains asbestos.

Any change in its appearance should be recorded and passed to Property Services.

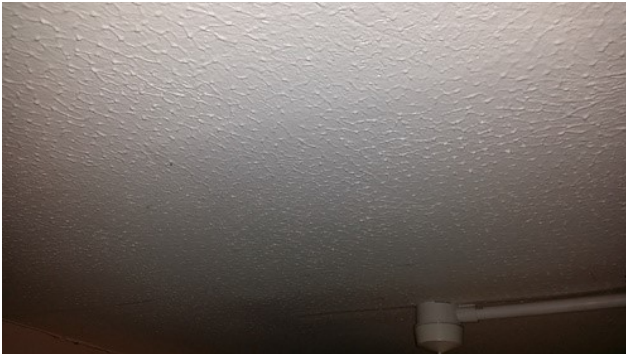
Item 78 - Ref: As 70826-9

The textured coating to ceiling in Operational Managers office-void above (Rm 0/095) contains asbestos.

Any change in its appearance should be recorded and passed to Property Services.

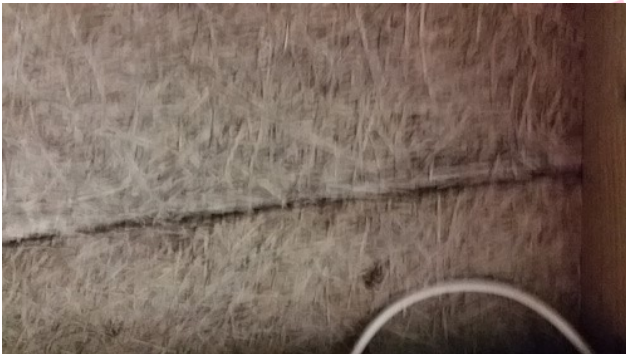
Item 79 - Ref: As 70826-1

The Underside of Roof Leechmere Reception Office-void above (Rm 0/096) does not contain asbestos.

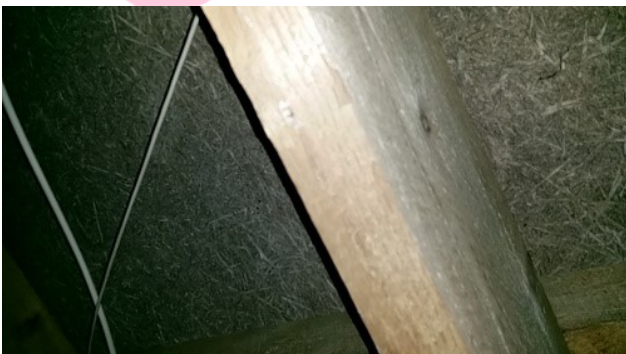
Item 80 - Ref: 70826-10

The debris to nail holes in beams in Leechmere Reception Office-void above (Rm 0/096) contains asbestos.

Removed as per reinspection survey Sept 2019

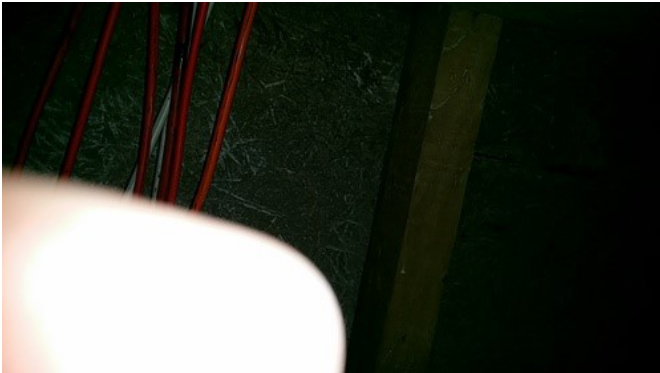
Item 81 - Ref: As 70826-1

The underside of roof in Leechmere Reception Area-void above (Rm 0/097) does not contain asbestos.

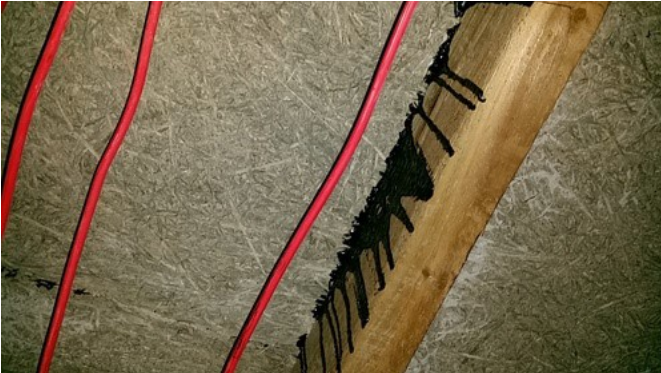
Item 82 - Ref: As 70826-6

The underside of roof in Corridor-void above (Rm 0/098) does not contain asbestos.

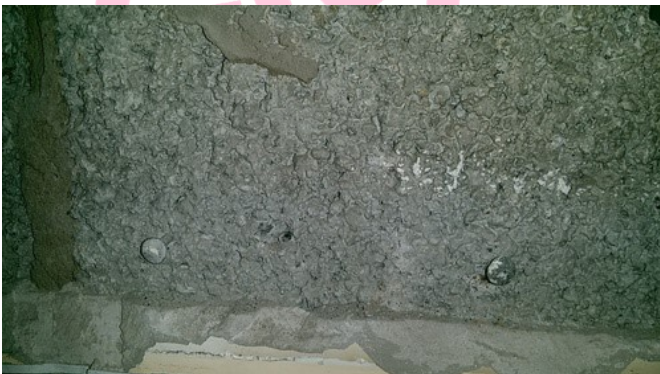
Item 83 - Ref: 70826-11

The debris to nails in wall at former ceiling in Corridor-void above (Rm 0/098) contains asbestos.

Removed as per reinspection survey Sept 2019

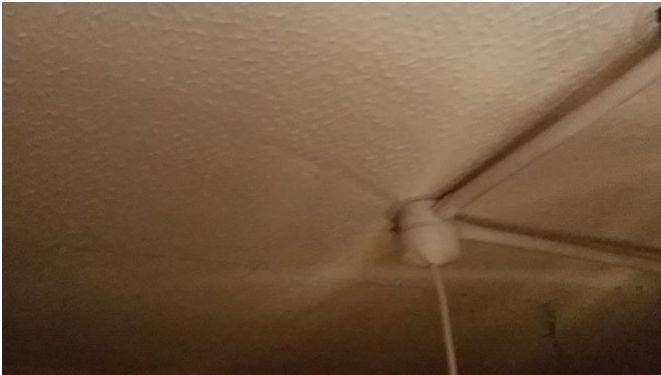
Item 84 - Ref: As 70826-9

The textured coating to ceiling in Female Toilets-void above (Rm 0/099) contains asbestos.

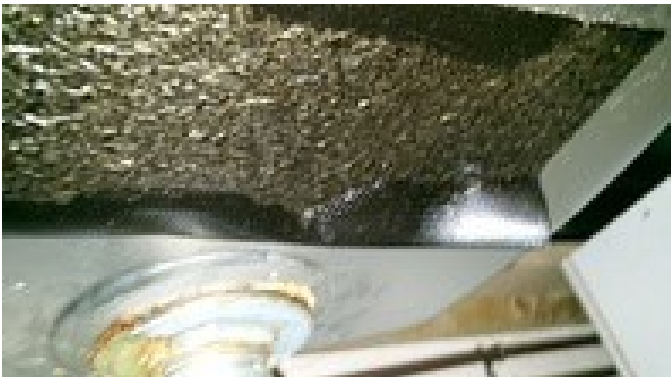
Item 86 - Ref: Presumed

The sink pads in Kitchen (Rm 0/101) are presumed to contain asbestos.

Any change in its appearance should be recorded and passed to Property Services.

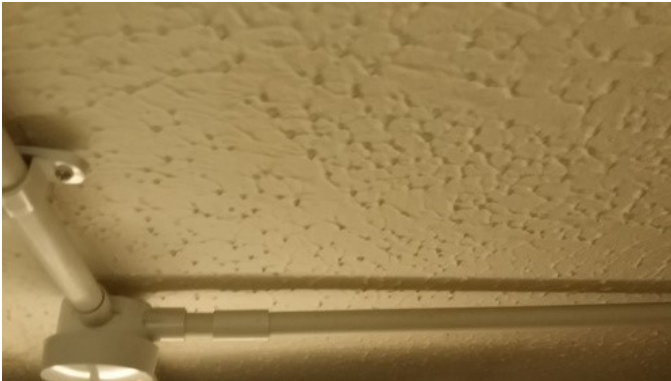
Item 87 - Ref: As 70826-9

The textured coating to ceiling in Kitchen-void above (Rm 0/101) contains asbestos.

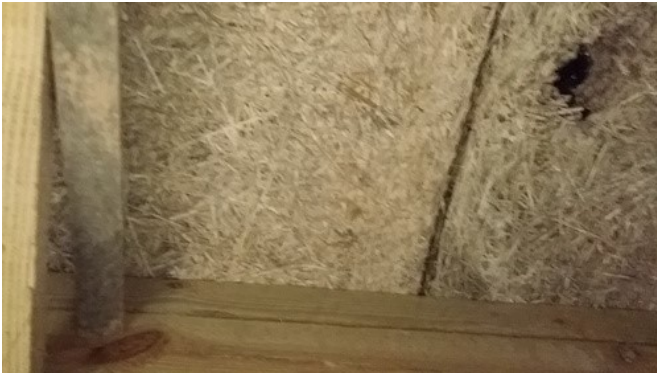
Item 90 - Ref: 70826-12

The underside of roof in Disabled Toilet-void above (Rm 0/104) does not contain asbestos.

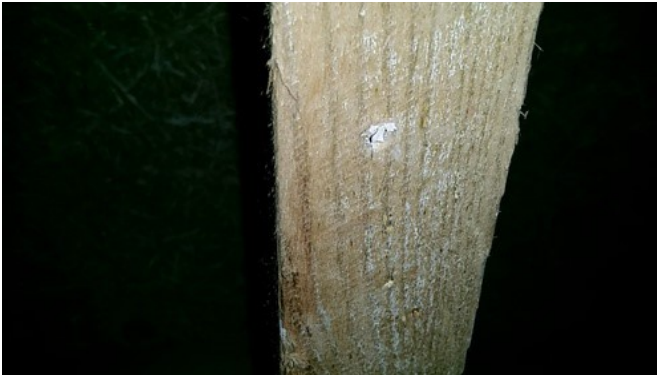
Item 91 - Ref: 70826-13

The debris to beams in Disabled Toilet-void above (Rm 0/104) does not contain asbestos.

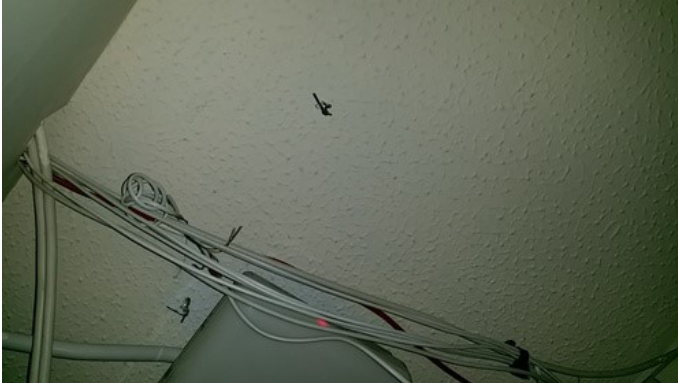
Item 96 - Ref: As 70826-14

The textured coating to ceiling in Electrics Cupboard -void above (Rm 0/107a) contains asbestos.

Any change in its appearance should be recorded and passed to Property Services.

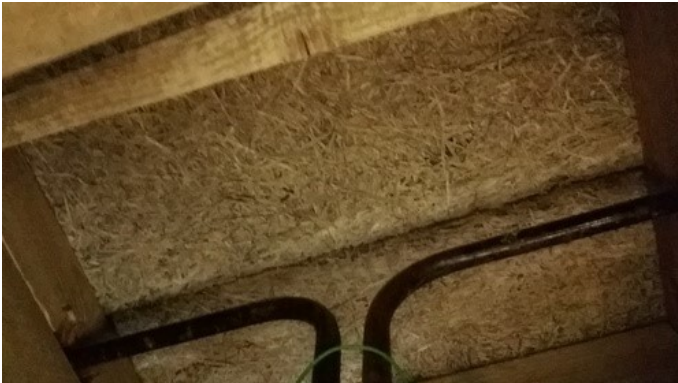
Item 97 - Ref: As 70826-12

The underside of roof in Male Toilet -void above (Rm 0/108) does not contain asbestos.

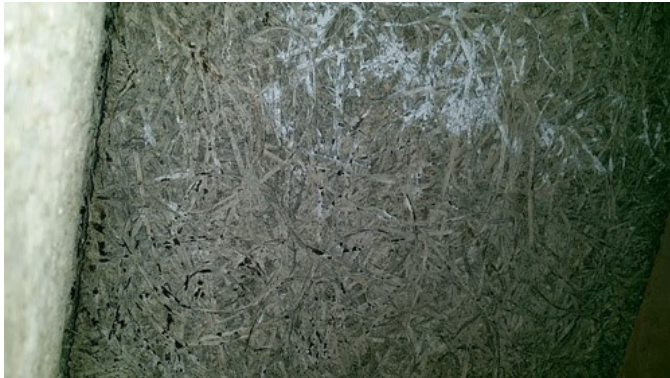
Item 99 - Ref: As 70826-12

The underside of roof in Female Toilet -void above (Rm 0/109) does not contain asbestos.

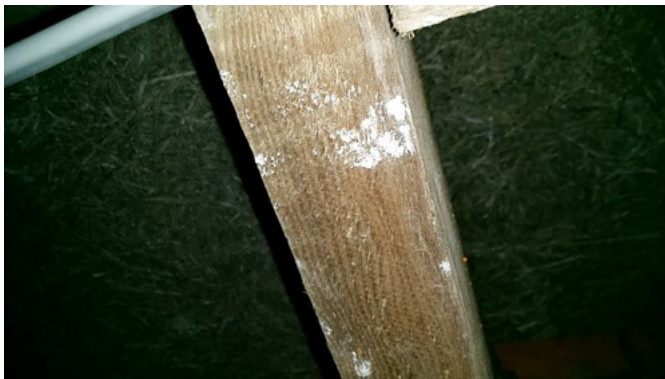
Item 100 - Ref: As 70826-13

The debris to beams in Female Toilet -void above (Rm 0/109) does not contain asbestos.

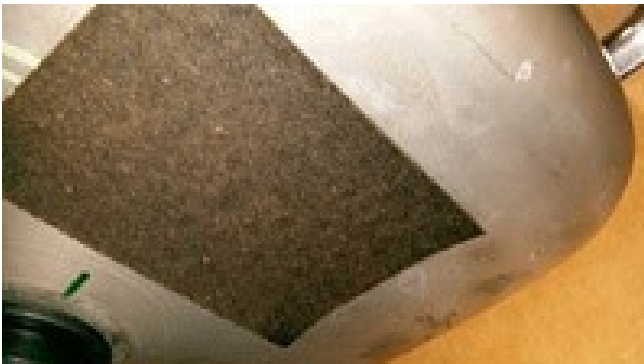
Item 102 - Ref: Presumed

The sink pads in Bar Area (Rm 0/111) are presumed to contain asbestos.

Any change in its appearance should be recorded and passed to Property Services.

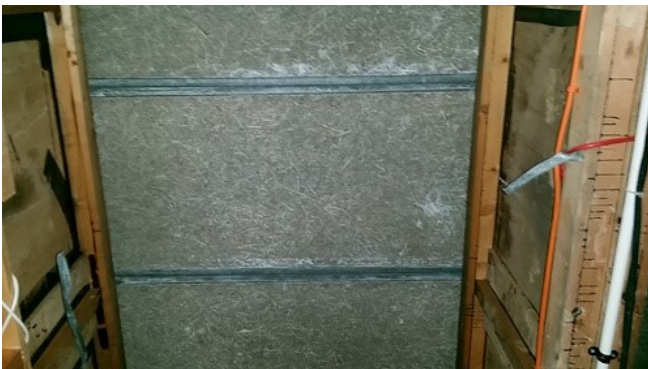
Item 103 - Ref: As 70826-12

The underside of roof in Bar Area -void above (Rm 0/111) does not contain asbestos.

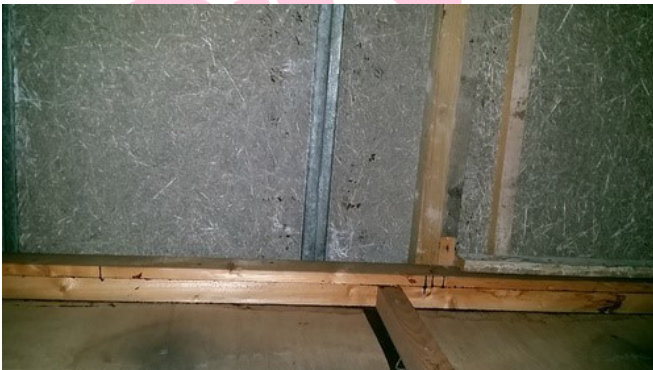
Item 104 - Ref: As 70826-12

The underside of roof in Store -void above (Rm 0/112) does not contain asbestos.

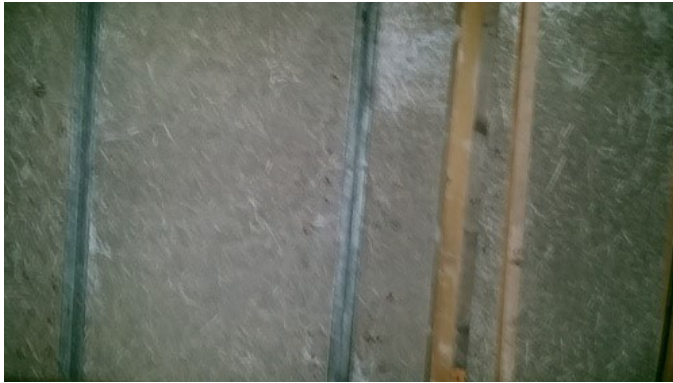
Item 105 - Ref: As 70826-12

The underside of roof in Barrel Store -void above (Rm 0/113) does not contain asbestos.

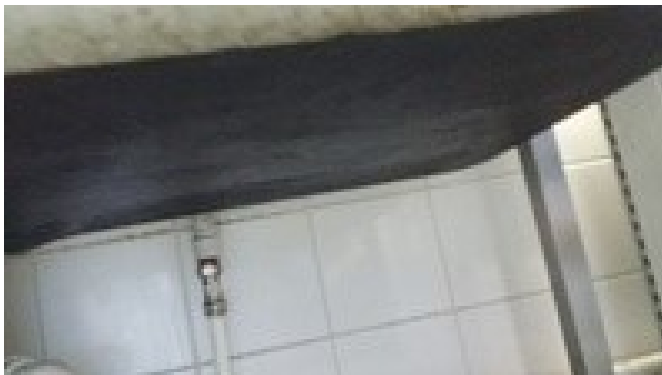
Item 106 - Ref: Presumed

The paint to underside of sink pads in Kitchen (Rm 0/114) are presumed to contain asbestos.

Any change in its appearance should be recorded and passed to Property Services.

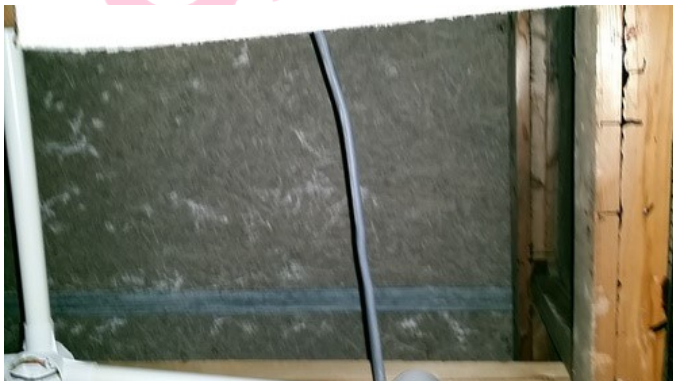
Item 107 - Ref: As 70826-12

The underside of roof in Kitchen -void above (Rm 0/114) does not contain asbestos.

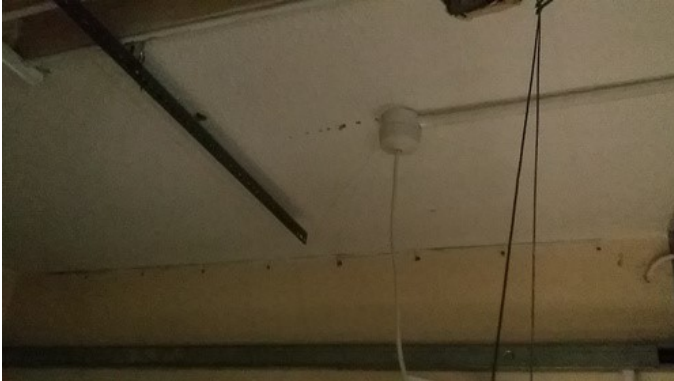
Item 108 - Ref: As 70826-14

The textured coating to ceiling in Kitchen -void above (Rm 0/114) contains asbestos.

Any change in its appearance should be recorded and passed to Property Services.

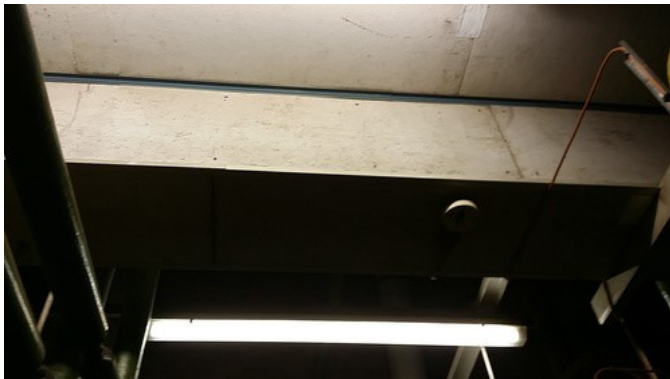
Item 111 - Ref: 70826-22

The boxing to beam in Boiler Room (Rm 0/116) contains asbestos.

Removed Oct '20

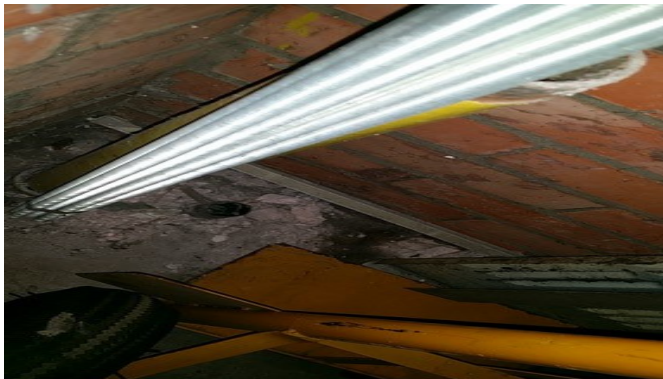
Item 112 - Ref: 70826-25

The debris to floor in Boiler Room (Rm 0/116) does not contain asbestos.

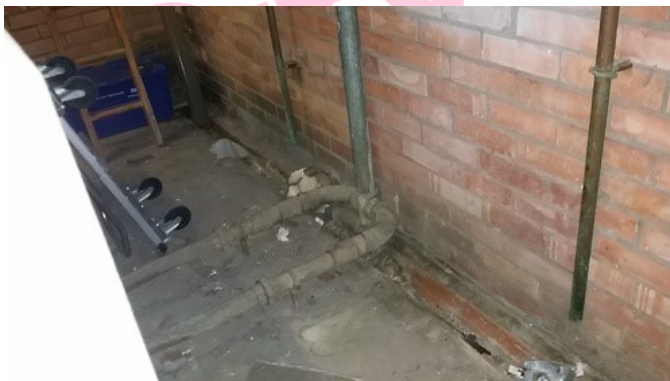
Item 113 - Ref: 70826-26

The general debris to floor in Boiler Room (Rm 0/116) contains asbestos.

**Removed as per
reinspection survey Sept
2019**

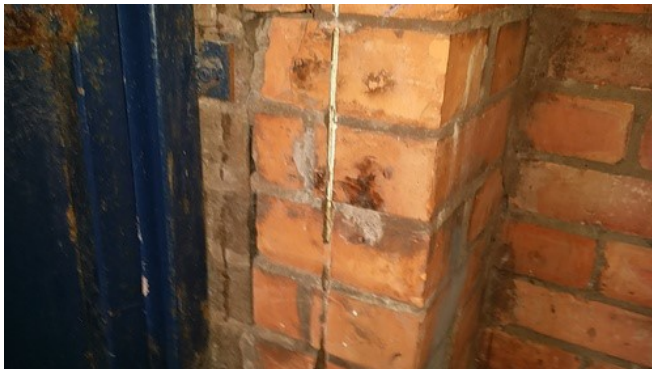
Item 114 - Ref: 70826-27

The remnant mastic to door frame in Boiler Room (Rm 0/116) contains asbestos.

Removed Oct '20

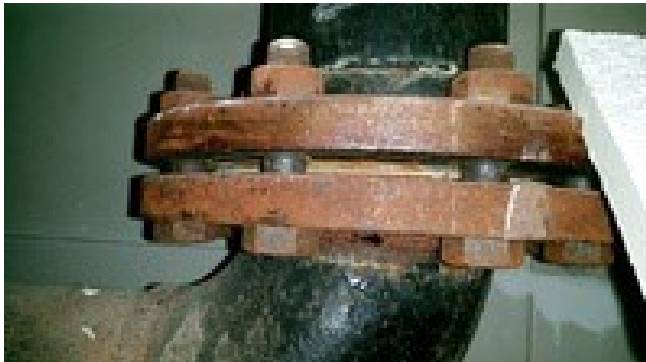
Item 115 - Ref: Presumed

The flange gaskets in Caretakers Office (Rm 0/117) are presumed to contain asbestos.

Any change in its appearance should be recorded and passed to Property Services.

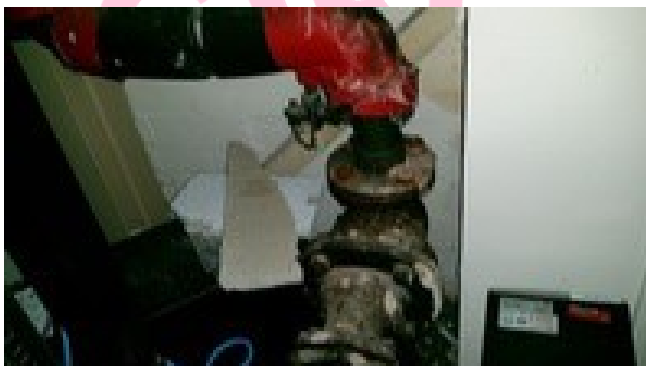
Item 116 - Ref: Presumed

The flange gaskets in Server Room (Rm 0/118) are presumed to contain asbestos.

Any change in its appearance should be recorded and passed to Property Services.

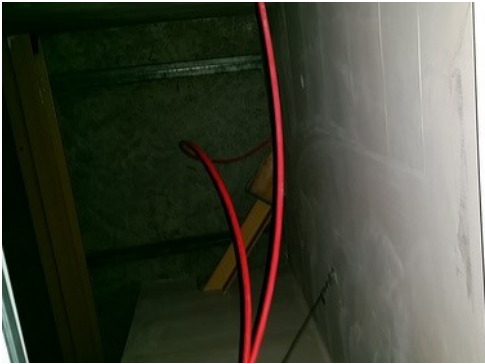
Item 117 - Ref: As 70826-12

The underside of roof in Server Room -void above (Rm 0/118) does not contain asbestos.

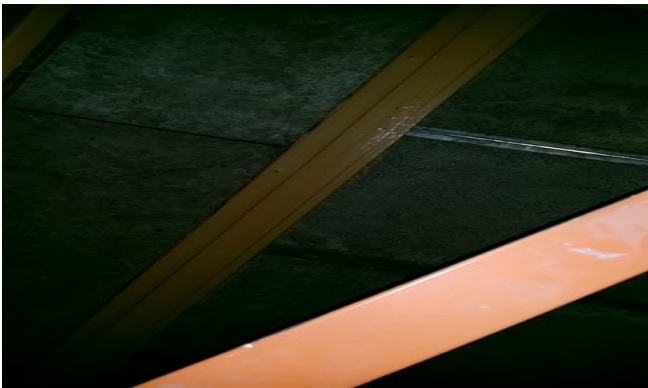
Item 118 - Ref: As 70826-12

The underside of roof in Corridor -void above (Rm 0/119) does not contain asbestos.

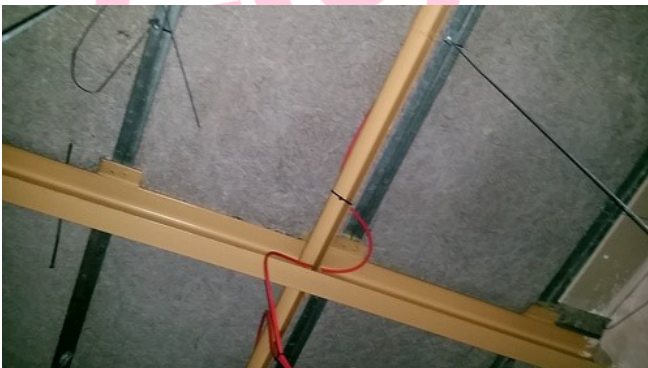
Item 119 - Ref: As 70826-12

The underside of roof in Office -void above (Rm 0/120) does not contain asbestos.

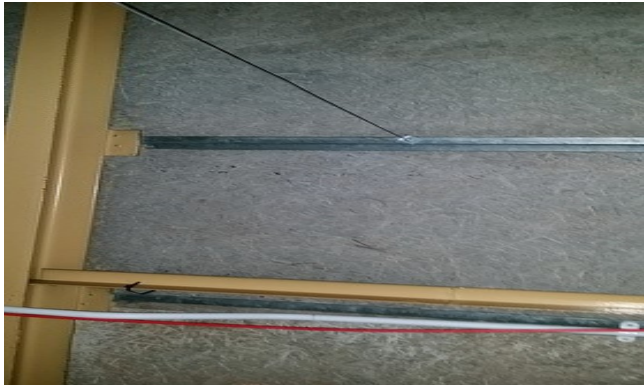
Item 120 - Ref: As 70826-12

The underside of roof in General Office -void above (Rm 0/121) does not contain asbestos.

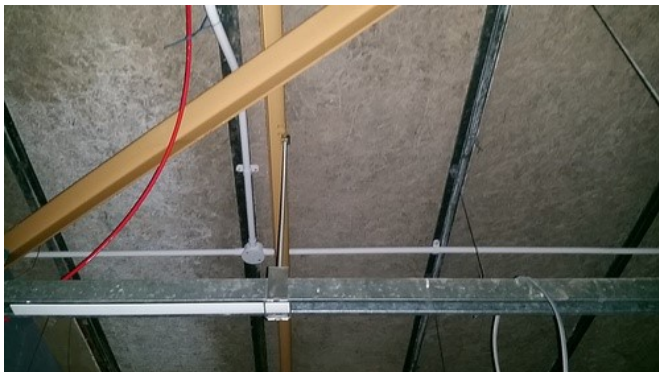
Item 121 - Ref: As 70826-12

The underside of roof in Managers Office -void above (Rm 0/122) does not contain asbestos.

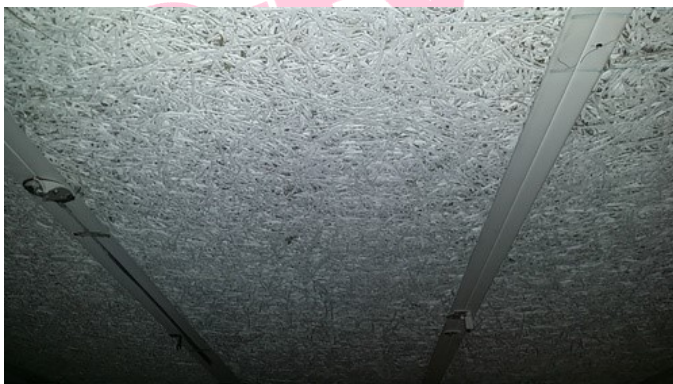
Item 122 - Ref: 70826-28

The underside of roof in Refurb Warehouse -void above (Rm 0/123) does not contain asbestos.

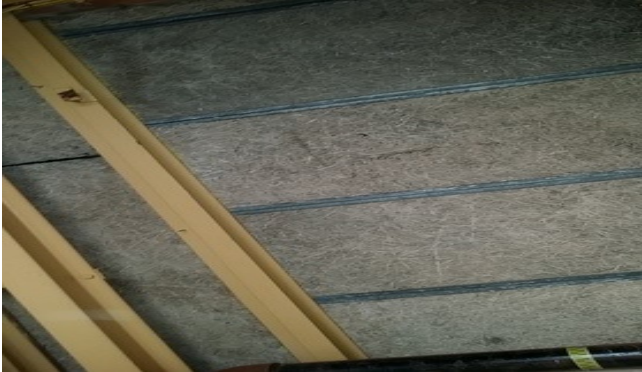
Item 123 - Ref: As 70826-28

The underside of roof in Gas Store -void above (Rm 0/124) does not contain asbestos.

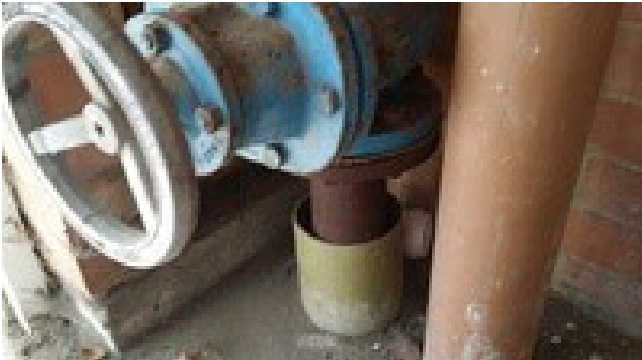
Item 124 - Ref: Presumed

The flange gaskets in Gas Store (Rm 0/124) are presumed to contain asbestos.

Any change in its appearance should be recorded and passed to Property Services.

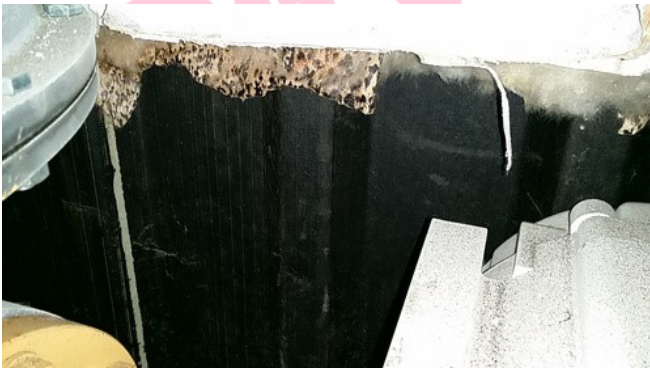
Item 125 - Ref: 70826-29

The coating to external wall in Gas Store (Rm 0/124) contains asbestos.

Any change in its appearance should be recorded and passed to Property Services.

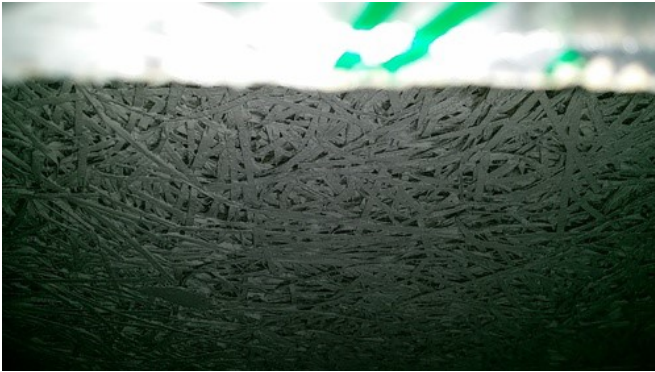
Item 126 - Ref: As 70826-28

The underside of roof in Spares Workshop -void above (Rm 0/127) does not contain asbestos.

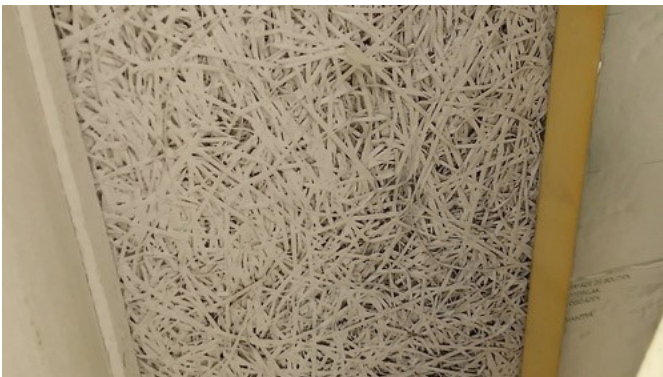
Item 127 - Ref: As 70826-28

The underside of roof in Machine Wash Area -void above (Rm 0/128) does not contain asbestos.

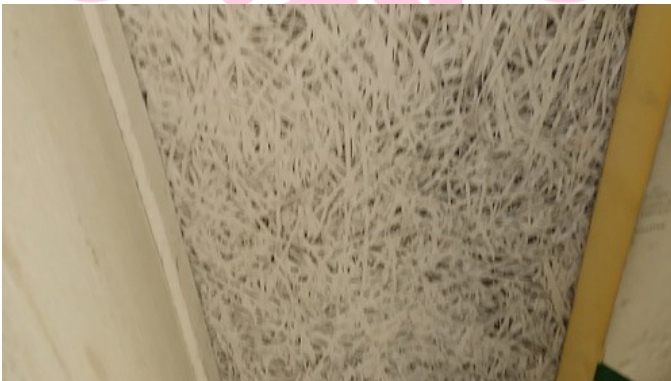
Item 128 - Ref: As 70826-28

The underside of roof in Office -void above (Rm 0/129) does not contain asbestos.

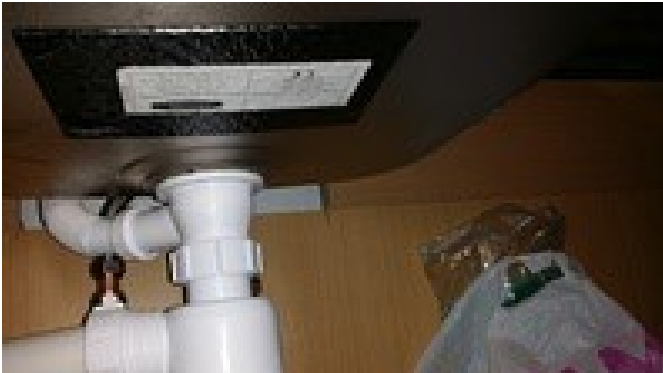
Item 129 - Ref: Presumed

The sink pads in Hand Wash Area (Rm 0/130) are presumed to contain asbestos.

Any change in its appearance should be recorded and passed to Property Services.

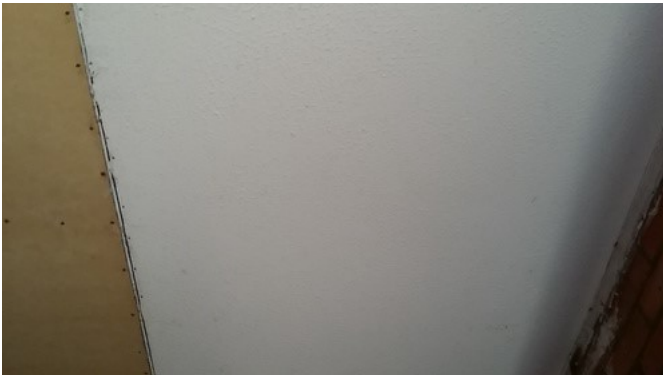
Item 130 - Ref: As 70826-31

The coating to plasterboard ceiling in Gas Cylinder Store (Rm 0/133) contains asbestos.

Any change in its appearance should be recorded and passed to Property Services.

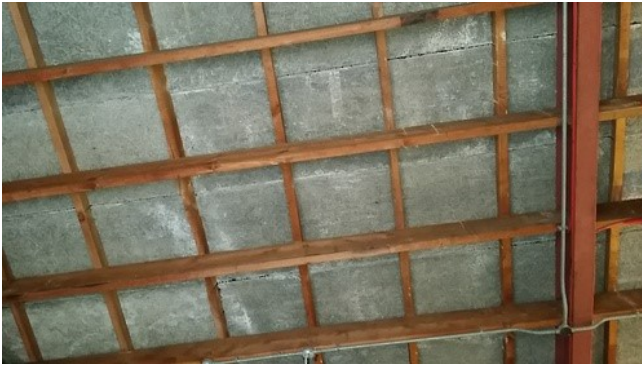
Item 132 - Ref: As 70826-28

The underside of roof in Former compressor room (Rm 0/134) does not contain asbestos.

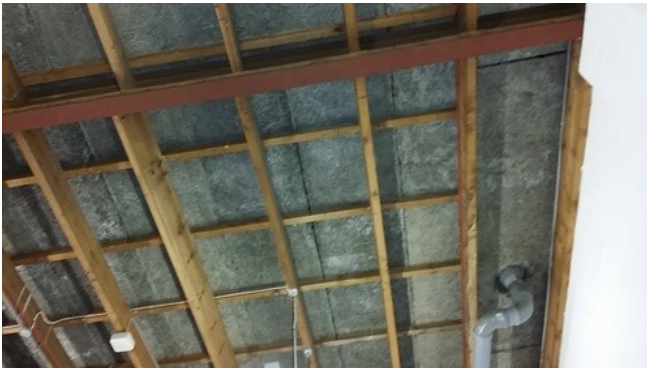
Item 133 - Ref: As 70826-28

The underside of roof in Equipment Store (Rm 0/135) does not contain asbestos.

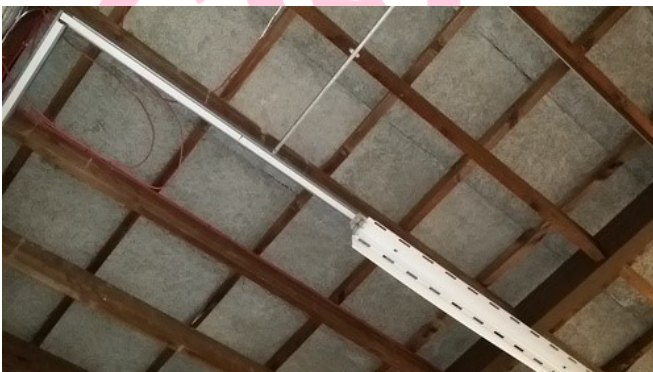
Item 134 - Ref: As 70826-28

The underside of roof in Document Store (Rm 0/136) does not contain asbestos.

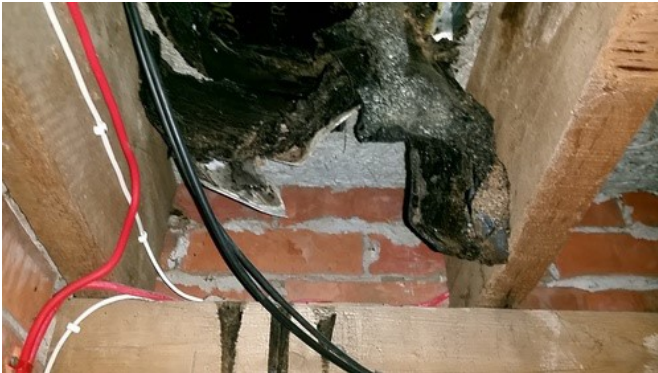
Item 135 - Ref: 70826-34

The underside of roof above stramit in Boiler Room (Rm 0/137) does not contain asbestos.

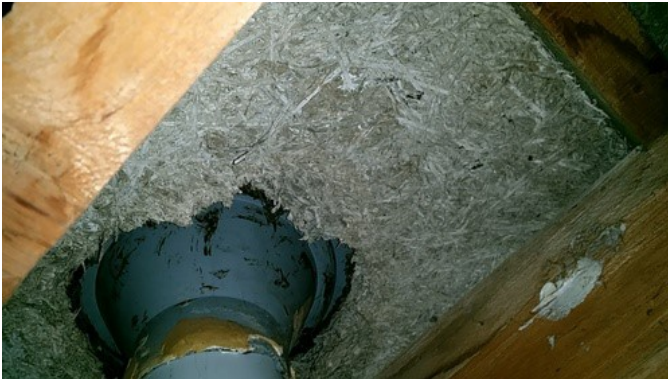
Item 136 - Ref: 70826-35

The underside of roof in Boiler Room (Rm 0/137) does not contain asbestos.

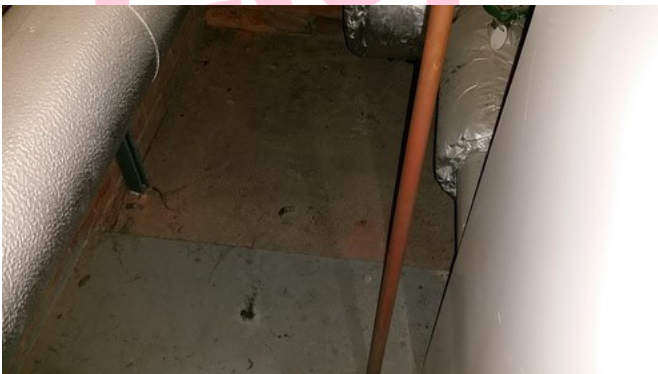
Item 137 - Ref: 70826-37

The general debris to floor in Boiler Room (Rm 0/137) does not contain asbestos.

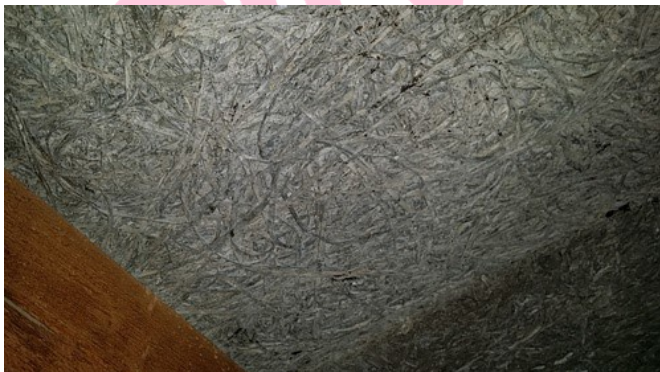
Item 140 - Ref: 70826-15

The underside of roof in Tank Room (Rm 1/001) does not contain asbestos.

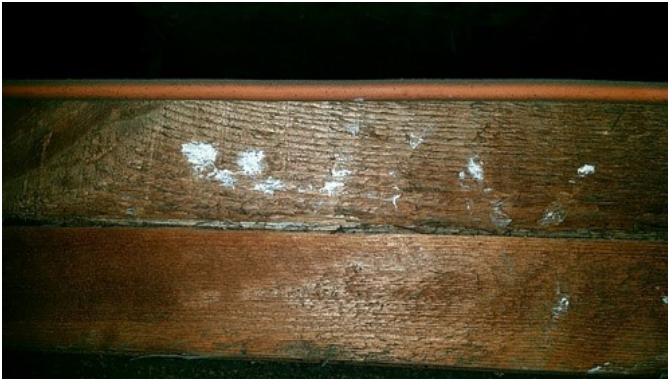
Item 141 - Ref: 70826-16

The debris to beams in Tank Room (Rm 1/001) does not contain asbestos.

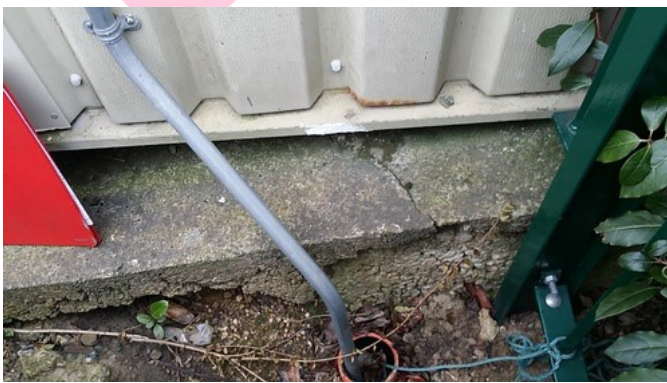
Item 146 - Ref: 70826-39

The coating to metal wall cladding (External) contains asbestos.

Any change in its appearance should be recorded and passed to Property Services.

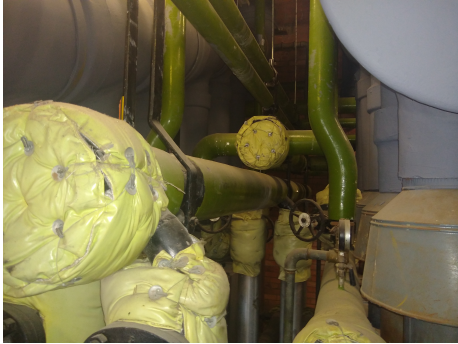
Item 149 Ref: 421249-5

The large bore pipework feeding 12 x bank of boilers in Boiler Room 0/001 does not contain asbestos.

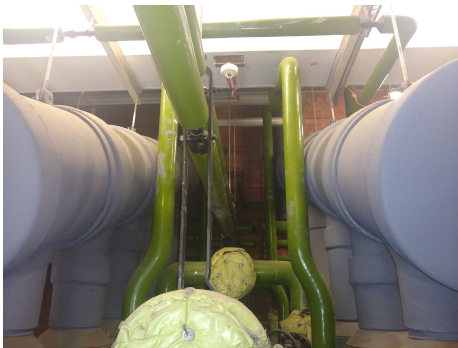
Item 150 Ref: 421249-6

The small bore pipework feeding 12 x bank of boilers in Boiler Room 0/001 does not contain asbestos.

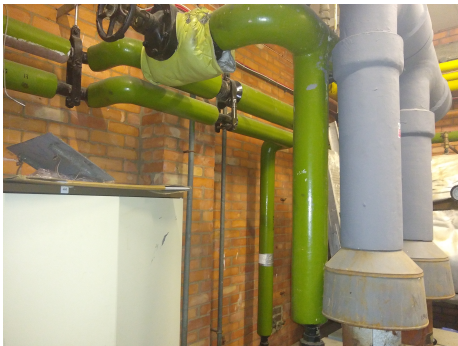
Item 151 Ref: 421249-7

The lagging to pipework feeding 2 x boilers in Boiler Room 0/001 does not contain asbestos.
