ASBESTOS SURVEY REPORT FOR LEECHMERE TRAINING CENTRE (INCLUDING TELECARE HOUSE), SUNDERLAND

Asbestos Register for LEECHMERE CENTRE, SUNDERLAND

Date: 16 January 2025

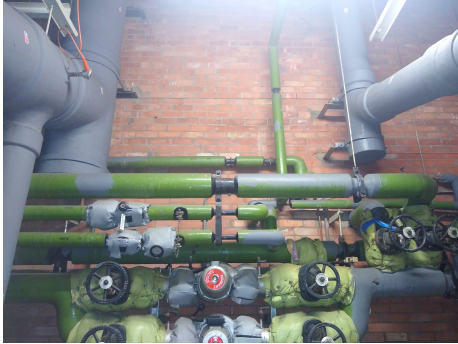
Item 152 Ref: 421249-8

The large bore pipework lagging to rear wall in Boiler Room 0/001 does not contain asbestos.

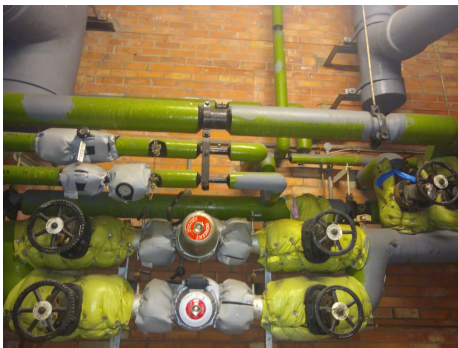
Item 153 Ref: 421249-9

The small bore lagging to rear wall in Boiler Room 0/001 does not contain asbestos.

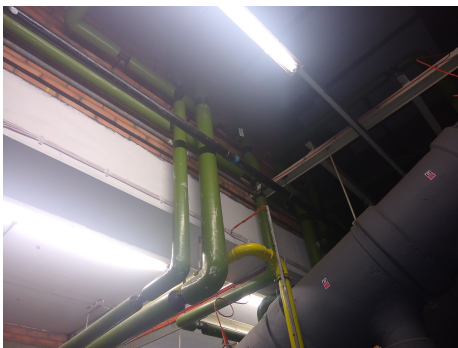
Item 154 Ref: 421249-10

The lagging to high level pipework above boilers in Boiler Room 0/001 does not contain asbestos.

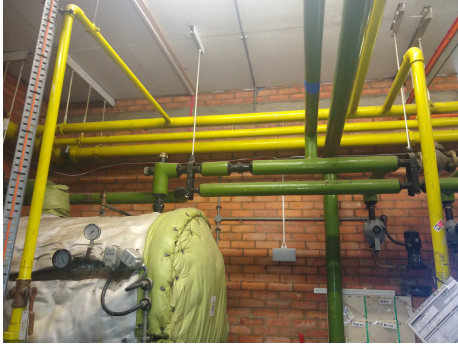
Item 155 Ref: 421249-11

The lagging to pipework feeding water tank in Boiler Room 0/001 does not contain asbestos.

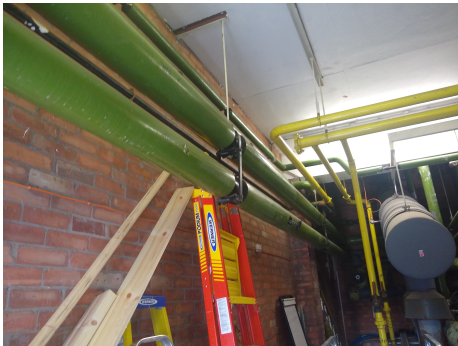
Item 156 Ref: 421249-12

The large bore pipework lagging adjacent door in Boiler Room 0/001 does not contain asbestos.

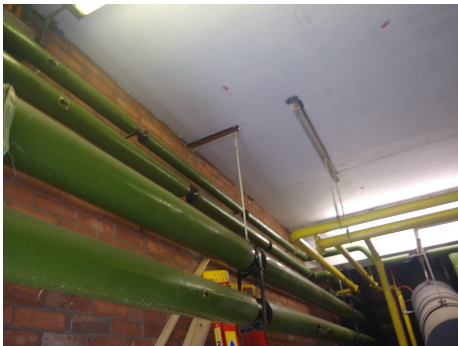
Item 157 Ref: 421249-13

The small bore lagging adjacent door in Boiler Room 0/001 does not contain asbestos.

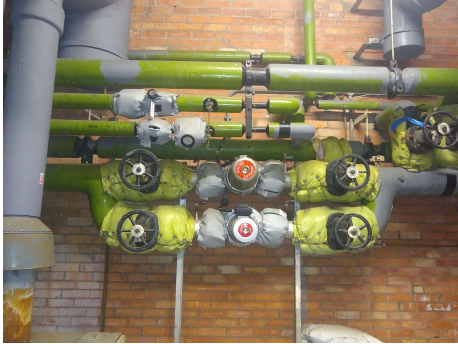
Item 158 Ref: 421249-14

The gaskets to pumps flanges in Boiler Room 0/001 do not contain asbestos.

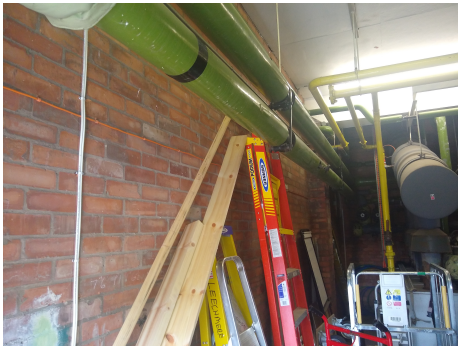
Item 159 Ref: 421249-15

The debris to wall adjacent door in Boiler Room 0/001 does not contain asbestos.

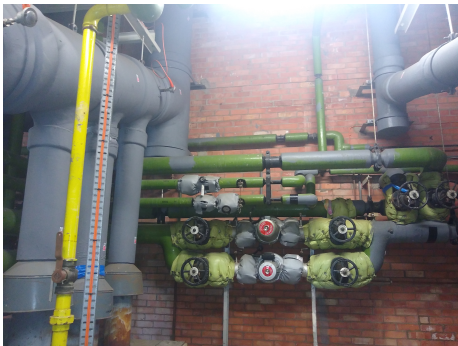
Item 160 Ref: 421249-16

The debris to rear wall in Boiler Room 0/001 does not contain asbestos.

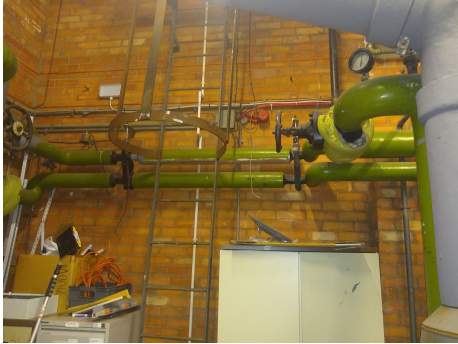
Item 161 Ref: 421249-17

The debris to tank room ladder wall in Boiler Room 0/001 does not contain asbestos.

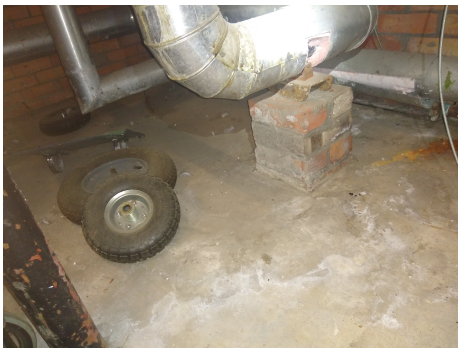
Item 162 Ref: 421249-24

The debris to floor below tank in Boiler Room 0/001 does not contain asbestos.

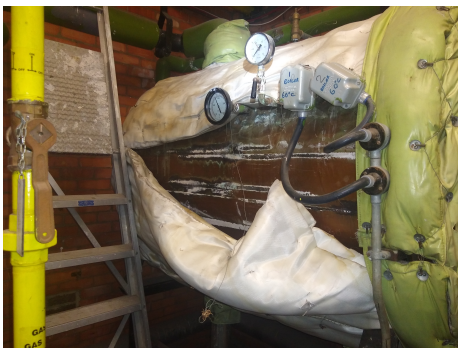
Item 163 Ref: 421249-25

The debris to water tank in Boiler Room 0/001 does not contain asbestos.

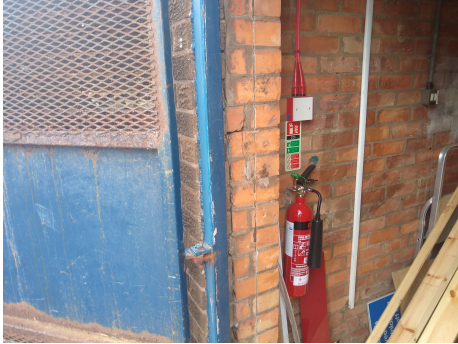
Item 164 Ref: 421249-26

The mastic to old entrance door line in Boiler Room 0/001 contains asbestos.

Removed Oct '20

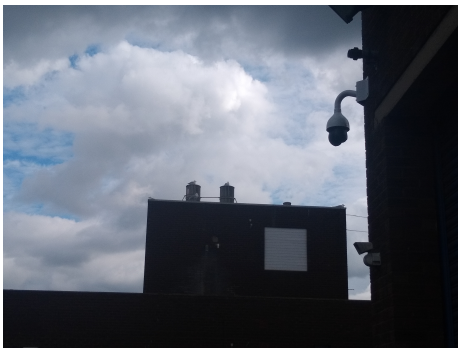
Item 165 Ref: As 421249-3

The high level flue cowls in Boiler Room 0/001 contains asbestos.

Removed Oct 2020

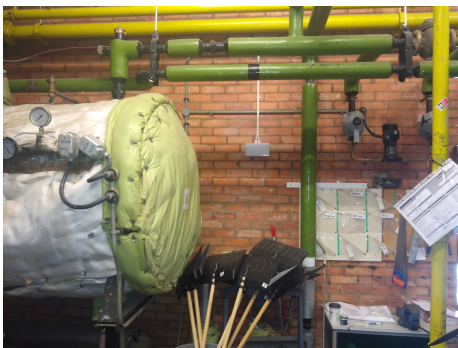
Item 166 Ref: 421249-18

The debris to water tank wall in Boiler Room 0/001 does not contain asbestos.

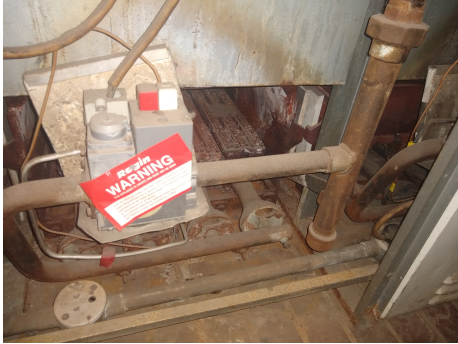
Item 167 Ref: 421249-19

The boards to front and sides of boilers in Boiler Room 0/001 do not contain asbestos.

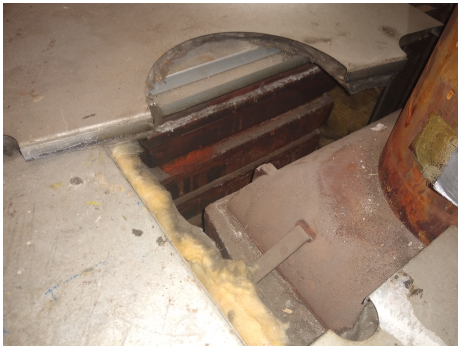
Item 168 Ref: 421249-20

The rope to boiler sections in Boiler Room 0/001 contains asbestos.

Removed Oct '20

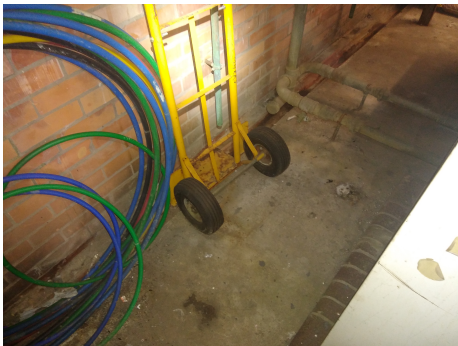
Item 169 Ref: 421249-21

The debris to floor behind boilers in Boiler Room 0/001 does not contain asbestos.

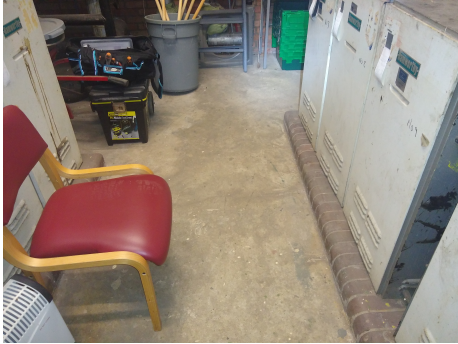
Item 170 Ref: 421249-22

The debris to floor between boilers in Boiler Room 0/001 does not contain asbestos.

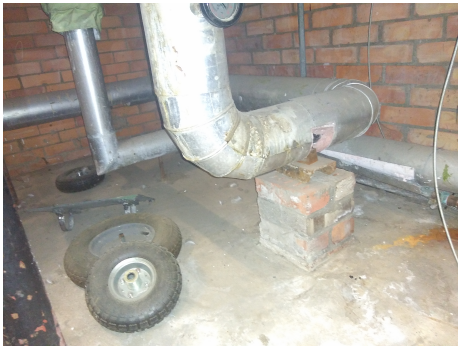
Item 171 Ref: 421249-23

The lagging to clad pipework below tank in Boiler Room 0/001 does not contain asbestos.

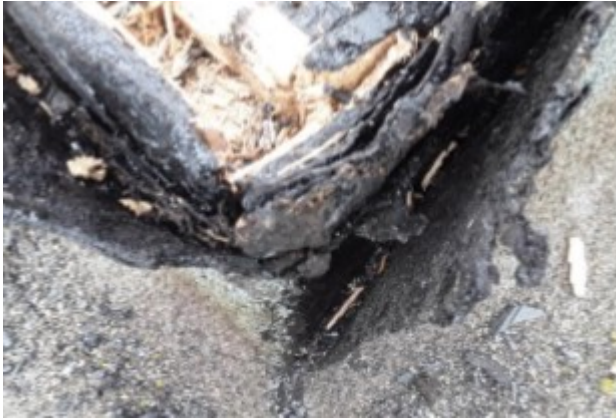
Item 173 Ref: 20-28782-1

The felt to the upstanding original roof (External/Roof 1) does contain asbestos.

Any change in appearance should be reported to Property Services.

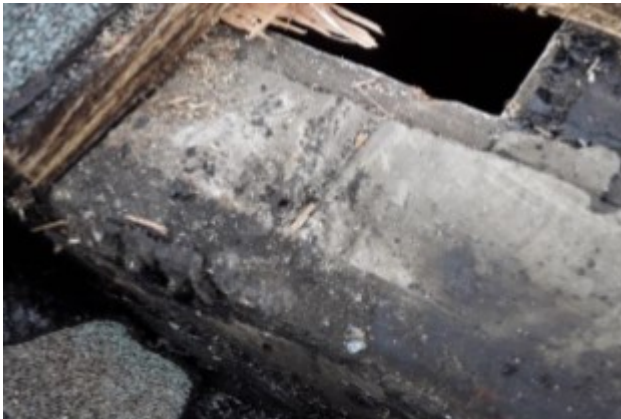
Item 174 Ref: 20-28782-1

The felt under the new bitumen (External/Roof 1) does contain asbestos.

Any change in appearance should be reported to Property Services.

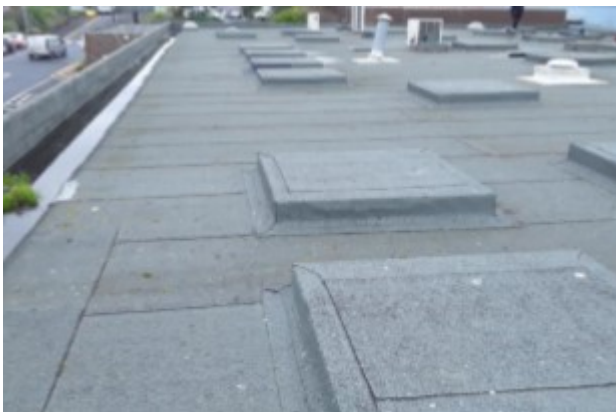
Item 175 Ref: 20-28782-2

The roof felt (External/Roof 1) does not contain asbestos.

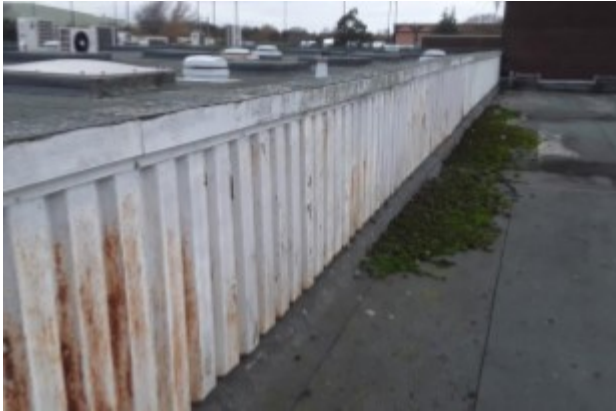
Item 176 Ref: 20-28782-3

The paint to the metal fascia (External/Roof 2) does contain asbestos.

Any change in appearance should be reported to Property Services.

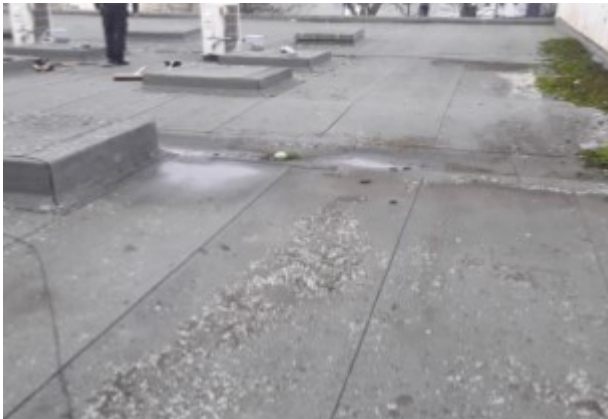
Item 177 Ref: 20-28782-4

The roof felt (External/Roof 2) does not contain asbestos.

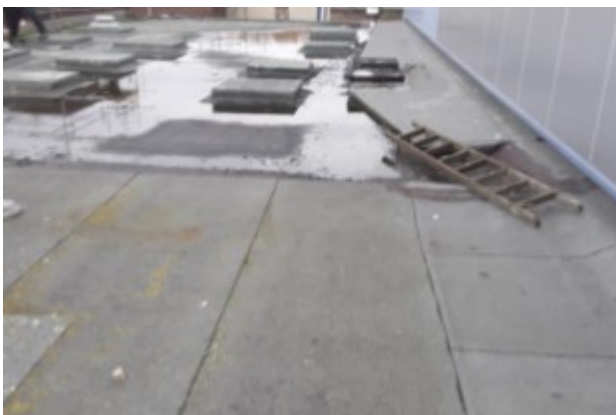
Item 178 Ref: 20-28782-5

The roof felt (External/Roof 5) does not contain asbestos.

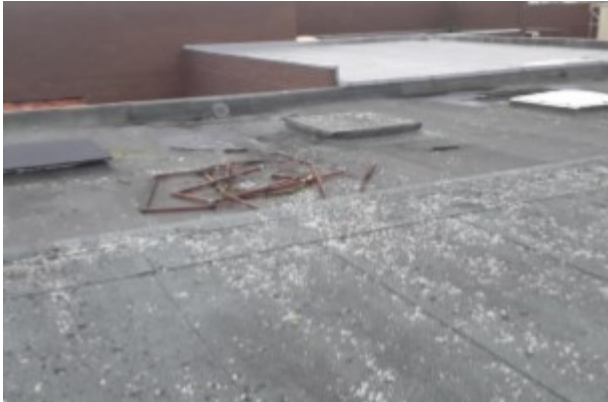
Item 179 Ref: 20-28782-6

The roof felt (External/Roof 8, 10, 11 and Workshops and Stores) does not contain asbestos.

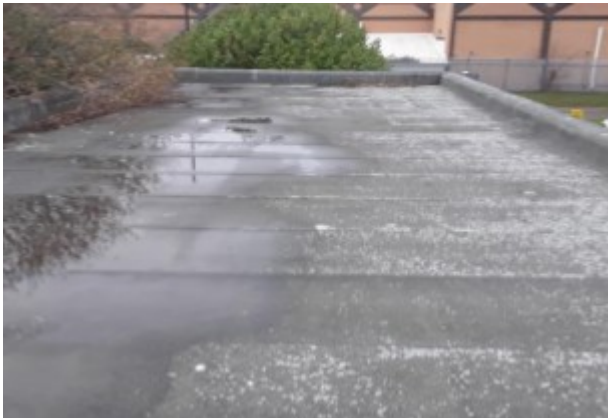
Item 180 Ref: 20-28782-7

The roof felt (External/Roof 12 to archives) does not contain asbestos.

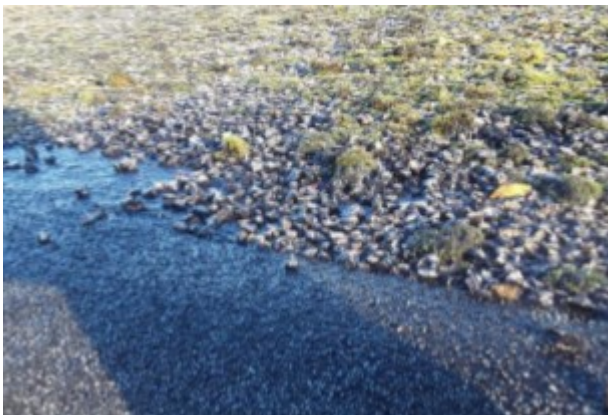
Item 181 Ref: 20-28782-8

The roof felt (External/Roof 4 to archives) does not contain asbestos.

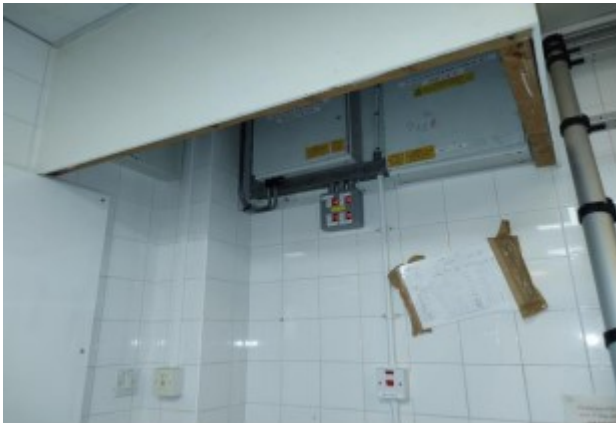
Item 183 Ref: 21-31963-2

The adhesive to the ceramic tiles to the wall in the Kitchen does not contain asbestos.

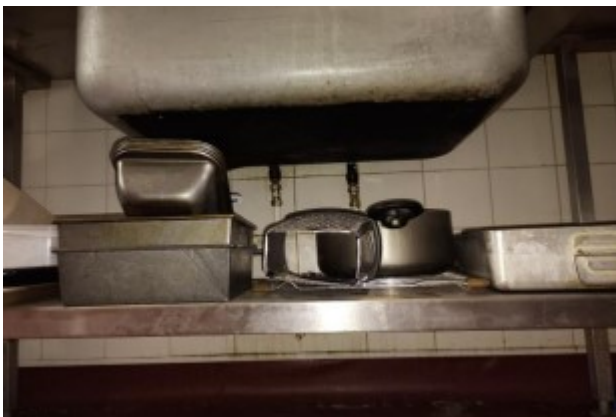
Item 184 Ref: 21-31963-3

The sink pad in the Kitchen does not contain asbestos.

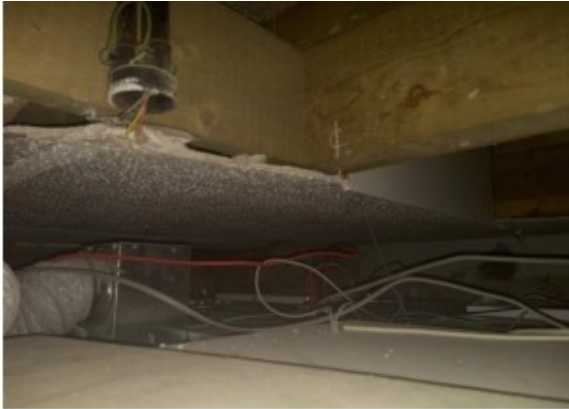
Item 185 Ref: 21-32786-1

The textured coating ceiling in the ceiling void in the office (Area 1) does contain asbestos.

Any change in appearance should be reported to Property Services.

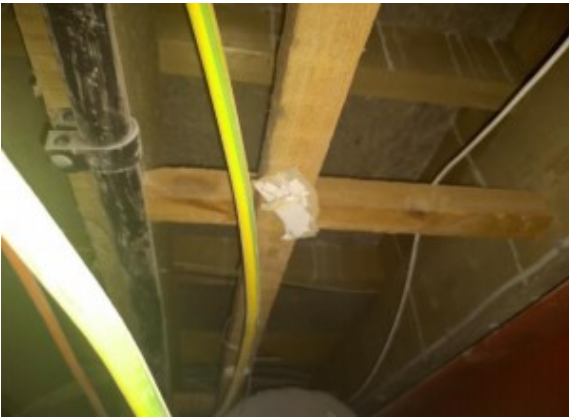
Item 186 Ref: 21-32786-2

The residual plasterboard sections to the wood beams in the office ceiling void (Area 1) does contain asbestos.

Any change in appearance should be reported to Property Services.

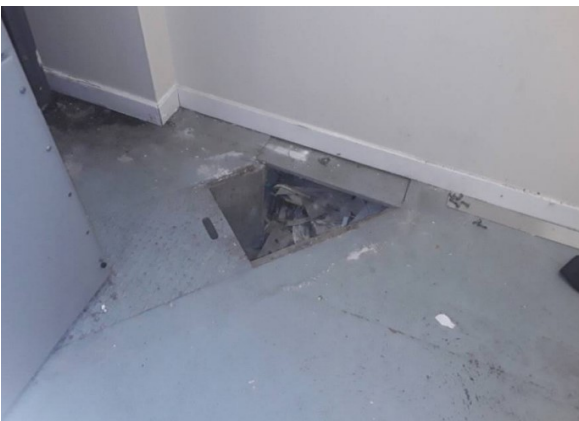
Item 198 Ref: NZ000796

The debris/residue within floor void duct in the ground floor electrical cupboard (Room G/001) does not contain asbestos.

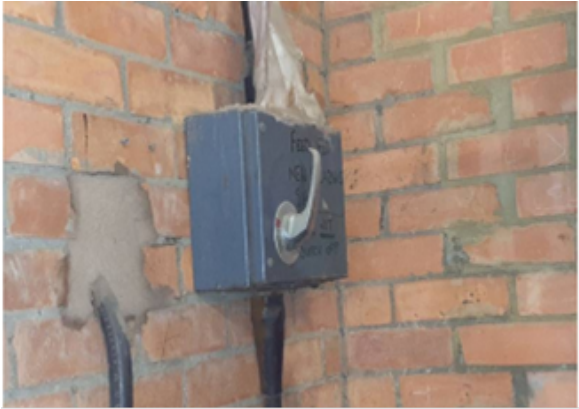
Item 200 Ref: Presumed

The fuses in electrical fuse box (Boiler room G/001) is presumed to contain asbestos.

Any change in appearance should be reported to Property Services.

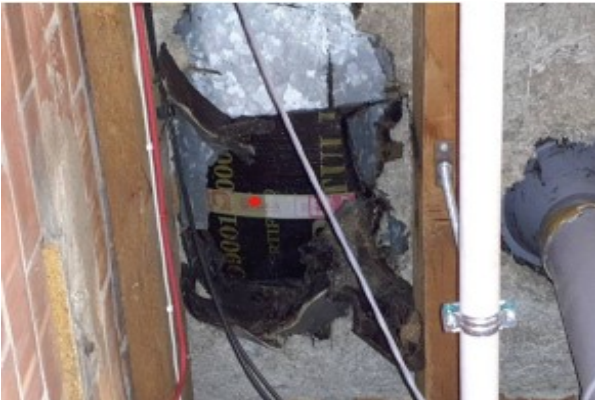
Item 201 Ref: PK000396

The roof felt in the Boier Room (Room G/001) does contain asbestos.

Any change in appearance should be reported to Property Services.

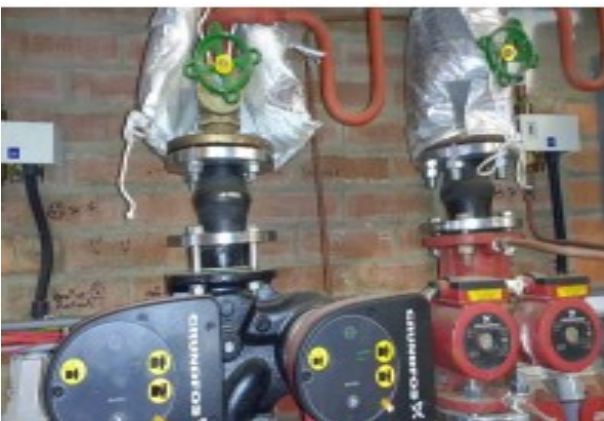
Item 202 Ref: PK000394

The green gasket pipework in the Boiler Room (Room G/001) does not contain asbestos.

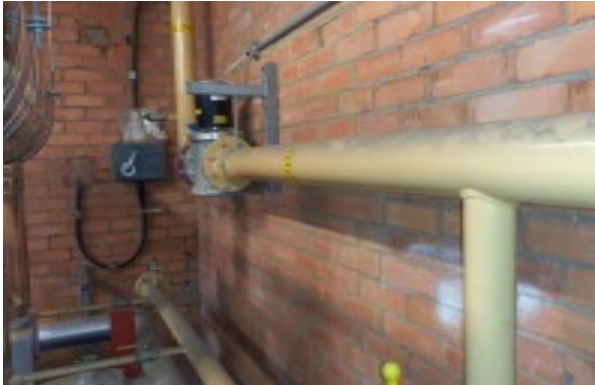
Item 203 Ref: PK000395

The gasket gas pipe in the Boiler Room (Room G/001) does not contain asbestos.

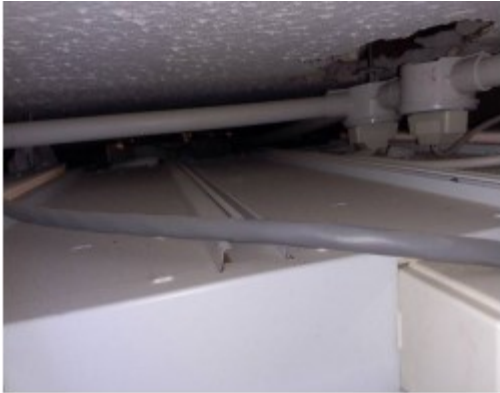
Item 206 Ref: PK000708

The textured coating debris – top of ceiling tiles and light fittings in Meeting Room 2 (G/01) does contain asbestos.

Any change in appearance should be reported to Property Services.

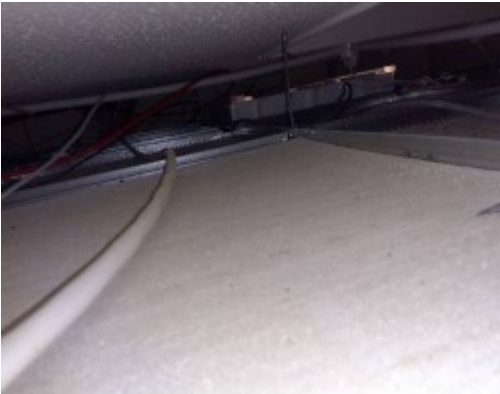
Item 207 Ref: As PK000708

The textured coating debris – top of ceiling tiles and light fittings in Meeting Room 1 (G/02) does contain asbestos.

Any change in appearance should be reported to Property Services.

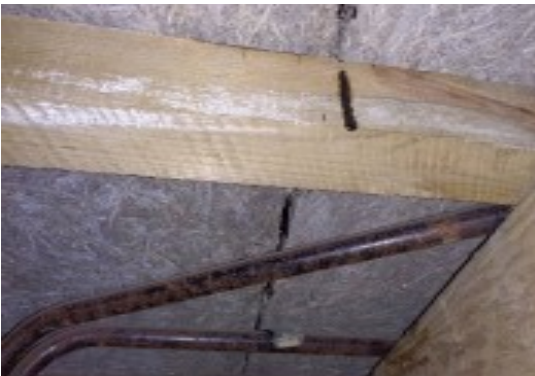
Item 208 Ref: PK000700

The bitumen drip walls and roof structure in IT suite touchdown space 22 (G/03) does not contain asbestos.

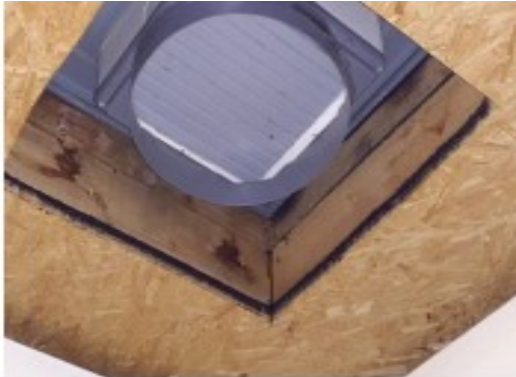
Item 209 Ref: As PK000700

The bitumen drip skylight roof cover in the Drop-in room A (G/05) does not contain asbestos.

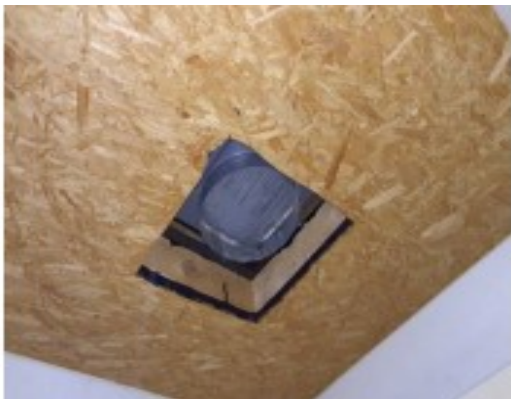
Item 210 Ref: As PK000700

The bitumen drip skylight roof cover in the Drop-in room B (G/06) does not contain asbestos.

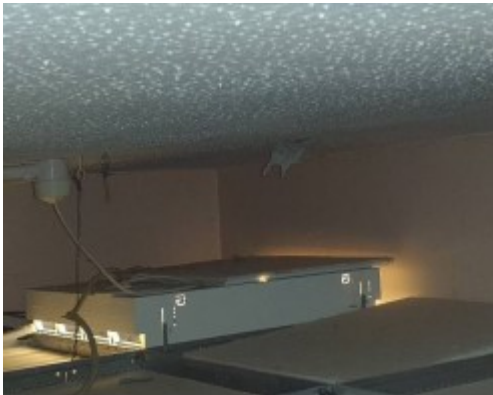
Item 212 Ref: As PK000708

The textured coating debris – top of ceiling tiles and light fittings in Office 19 (G/07) does contain asbestos.

Any change in appearance should be reported to Property Services.

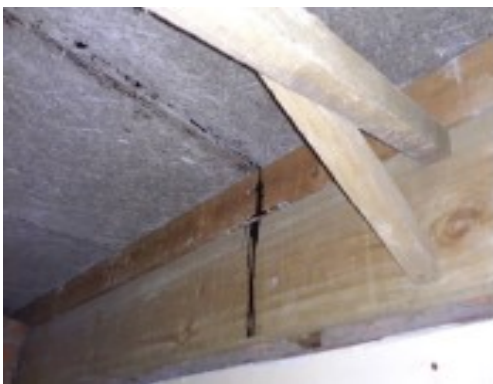
Item 213 Ref: As PK000700

The bitumen drip walls and roof structure in the Washroom (G/08) does not contain asbestos.

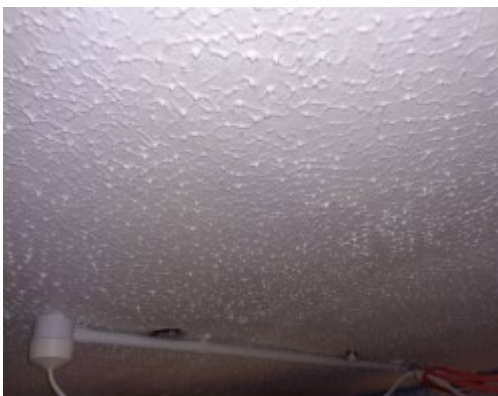
Item 214 Ref: PK000702

The textured coating upper ceiling above suspended tiles in the Office 16a (G/09) does contain asbestos.

Any change in appearance should be reported to Property Services.

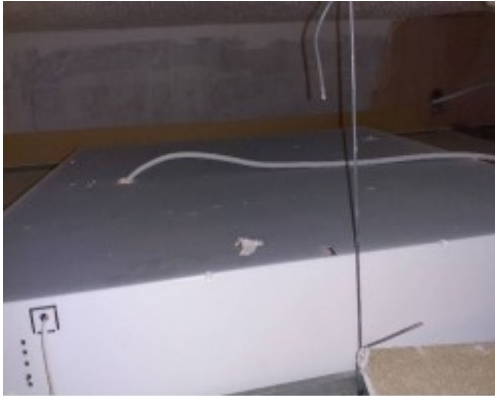
Item 215 Ref: As PK000708

The textured coating debris – top of ceiling tiles and light fittings in Office 16a (G/09) does contain asbestos.

Any change in appearance should be reported to Property Services.

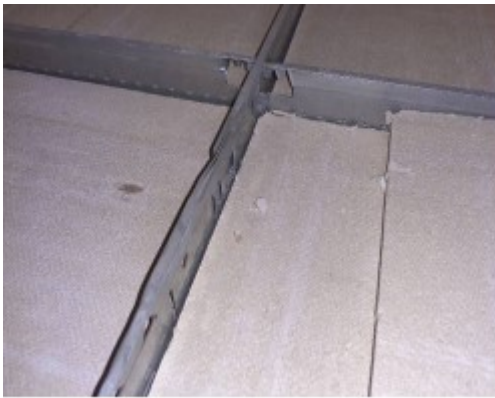
Item 216 Ref: As PK000708

The textured coating debris – top of ceiling tiles and light fittings in Office 16 (G/010) does contain asbestos.

Any change in appearance should be reported to Property Services.

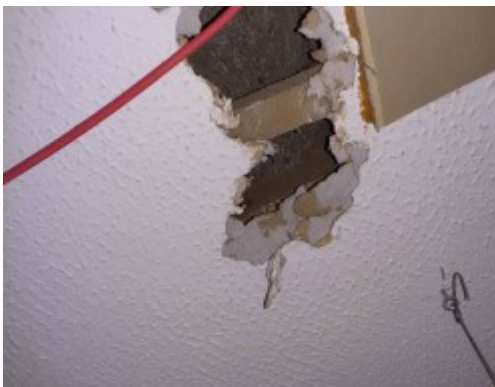
Item 217 Ref: As PK000708

The textured coating debris – top of ceiling tiles and light fittings in Office 15 (G/012) does contain asbestos.

Any change in appearance should be reported to Property Services.

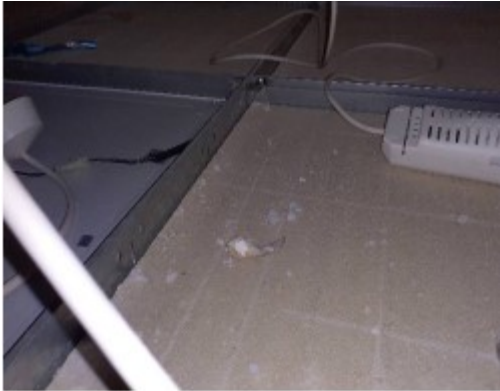
Item 218 Ref: As PK000708

The textured coating debris – top of ceiling tiles and light fittings in Female Toilets (G/014) does contain asbestos.

Any change in appearance should be reported to Property Services.

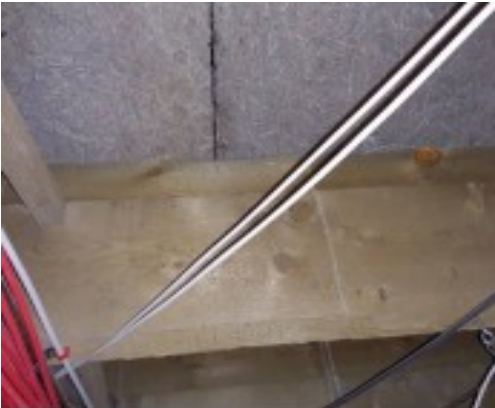
Item 219 Ref: As PK000700

The bitumen drip walls and roof structure in Office 12 (G/015) does not contain asbestos.

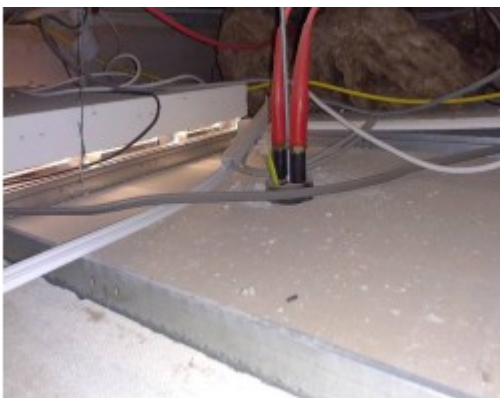
Item 220 Ref: As PK000708

The textured coating debris – top of ceiling tiles and light fittings in Office 9 (G/016) does contain asbestos.

Any change in appearance should be reported to Property Services.

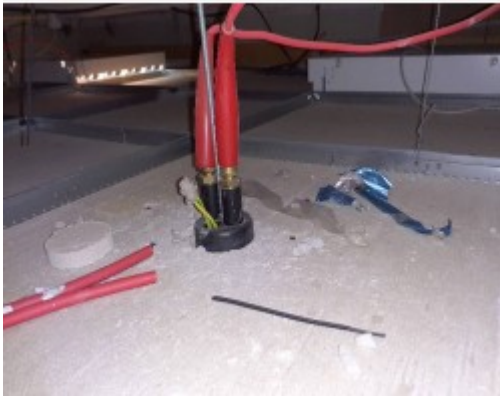
Item 221 Ref: As PK000708

The textured coating debris – top of ceiling tiles and light fittings in Office 10 (G/017) does contain asbestos.

Any change in appearance should be reported to Property Services.

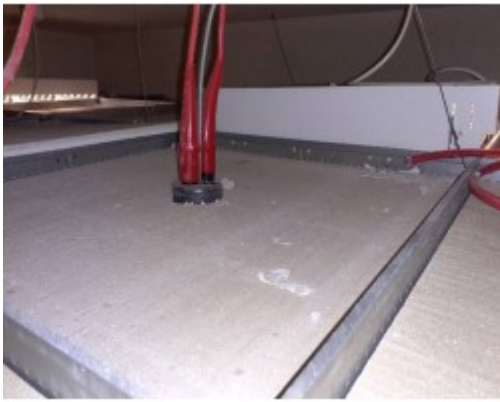
Item 222 Ref: As PK000708

The textured coating debris – top of ceiling tiles and light fittings in Office 6 (G/021) does contain asbestos.

Any change in appearance should be reported to Property Services.

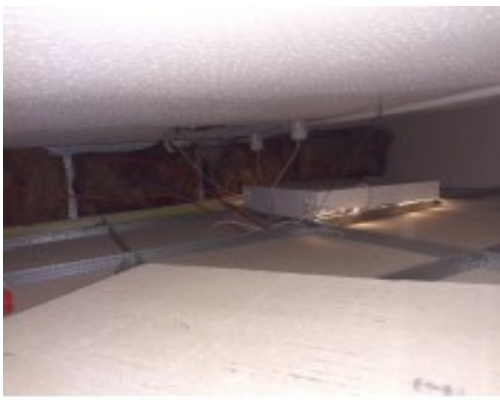
Item 223 Ref: As PK000709

The textured coating debris – top of ceiling tiles and light fittings in Office 4 (G/022) does not contain asbestos.

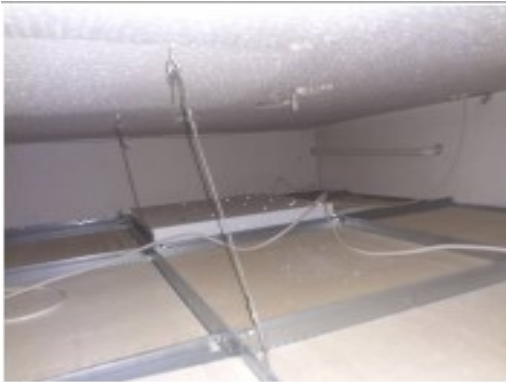
Item 224 Ref: As PK000709

The textured coating debris – top of ceiling tiles and light fittings in Office 2 (G/024) does not contain asbestos.

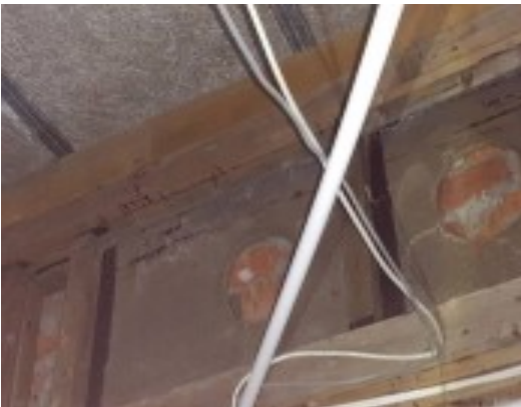
Item 225 Ref: As PK000700

The bitumen drip walls and roof structure in the Store cupboard 1 (G/025) does not contain asbestos.

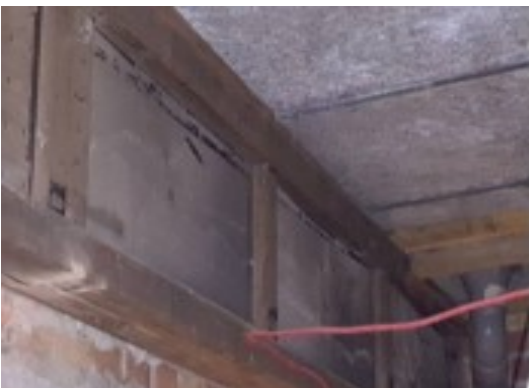
Item 226 Ref: As PK000700

The bitumen drip walls and roof structure in the Caretakers office (G/026) does not contain asbestos.

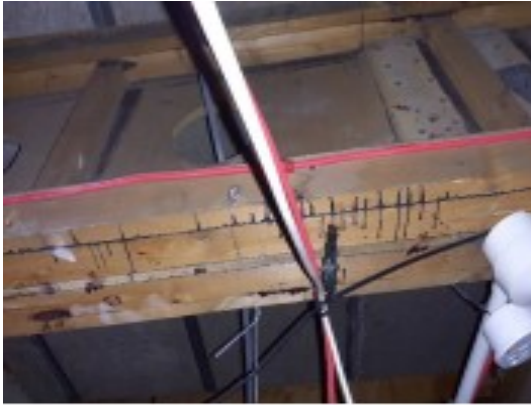
Item 227 Ref: As PK000700

The bitumen drip walls and roof structure in the Main kitchen (G/027) does not contain asbestos.

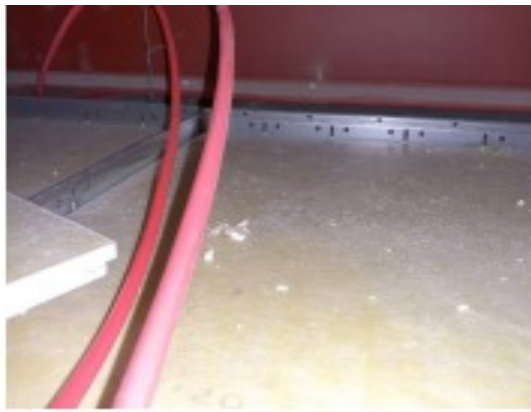
Item 228 Ref: As PK000709

The textured coating debris – top of ceiling tiles and light fittings in Training Room 30 (G/030) does not contain asbestos.

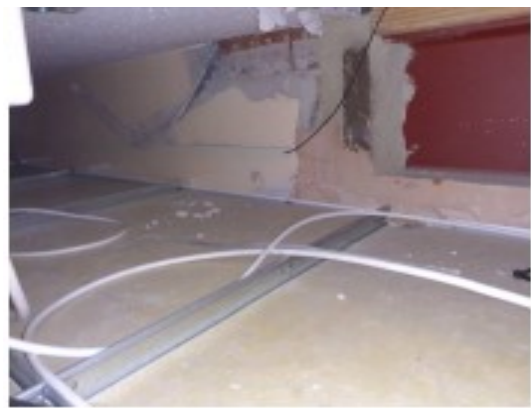
Item 229 Ref: As PK000709

The textured coating debris – top of ceiling tiles and light fittings in Training Room 39a (G/031) does not contain asbestos.

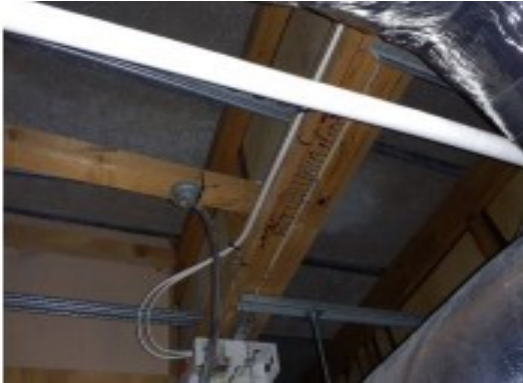
Item 230 Ref: As PK000700

The bitumen drip walls and roof structure in Office 38 (G/032) does not contain asbestos.

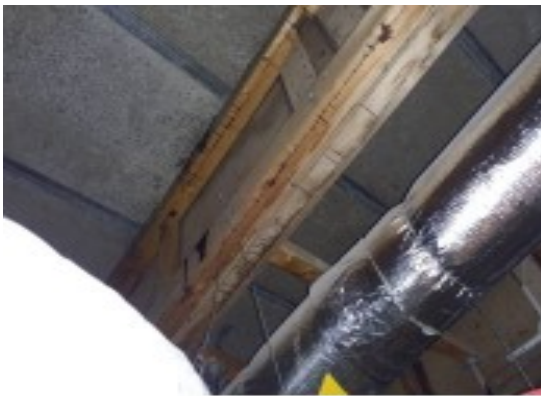
Item 231 Ref: As PK000700

The bitumen drip walls and roof structure in Office 38a (G/033) does not contain asbestos.

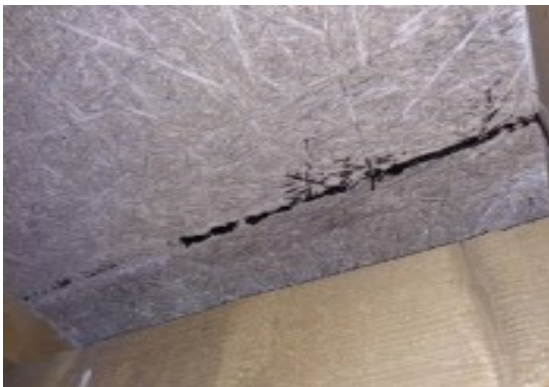
Item 232 Ref: As PK000700

The bitumen drip walls and roof structure in Office 34 (G/034) does not contain asbestos.

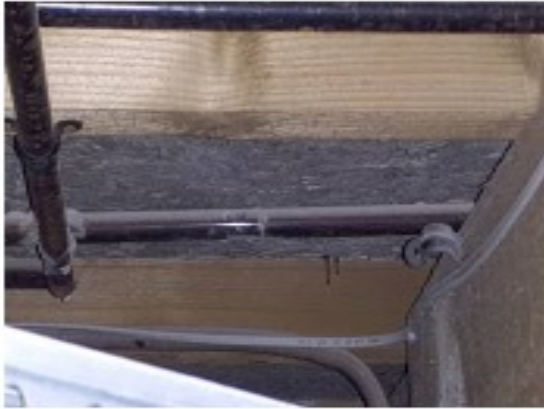
Item 233 Ref: As PK000700

The bitumen drip walls and roof structure in Office 33 (G/035) does not contain asbestos.

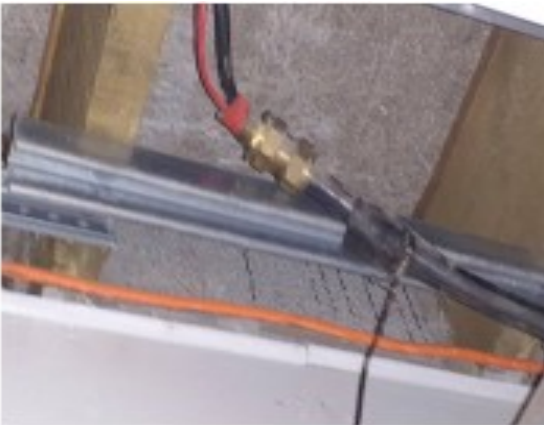
Item 234 Ref: As PK000700

The bitumen drip walls and roof structure in the Sub Main intake off reception 37 (G/036) does not contain asbestos.

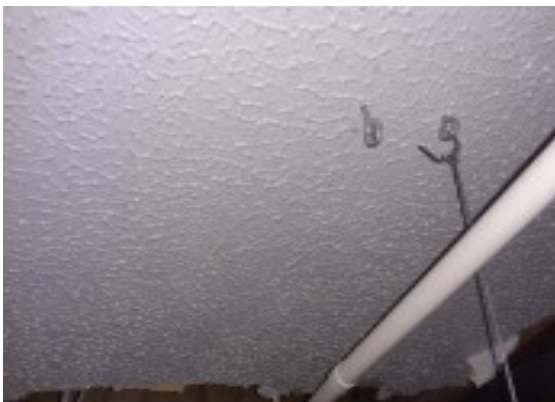
Item 235 Ref: PK000705

The textured coating upper ceiling above suspended tiles in Office 36 (G/037) does not contain asbestos.

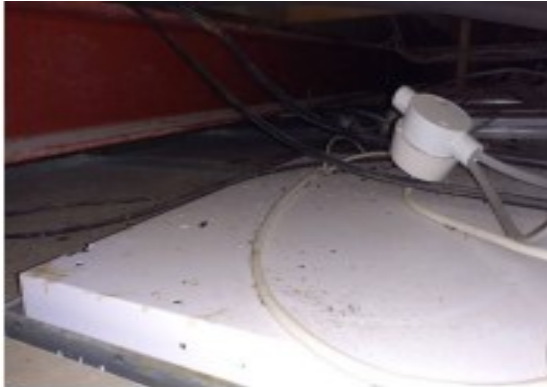
Item 236 Ref: As PK000709

The textured coating debris – top of ceiling tiles and light fittings in Office 36 (G/037) does not contain asbestos.

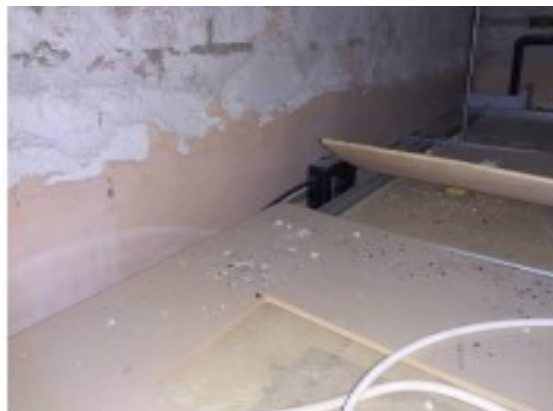
Item 237 Ref: As PK000709

The textured coating debris – top of ceiling tiles and light fittings in Store cupboard 32 (G/038) does not contain asbestos.

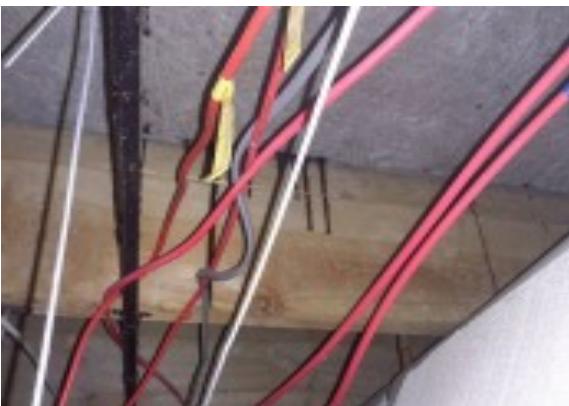
Item 238 Ref: As PK000700

The bitumen drip walls and roof structure in Former reception (G/041) does not contain asbestos.

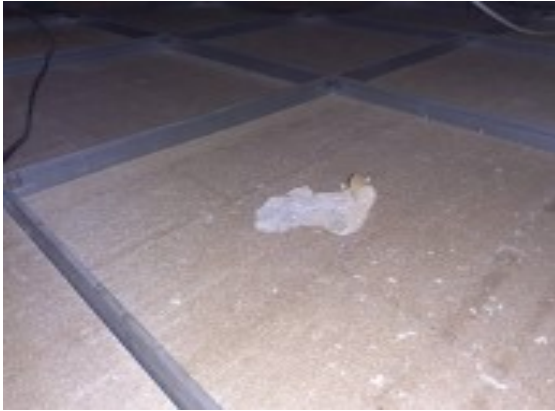
Item 239 Ref: PK000709

The textured coating debris – top of ceiling tiles and light fittings in Canteen area (G/042) does not contain asbestos.

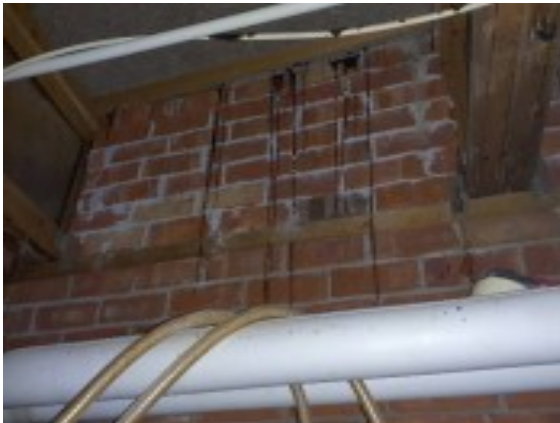
Item 240 Ref: As PK000700

The bitumen drip walls and roof structure in Main canteen kitchen (G/043) does not contain asbestos.

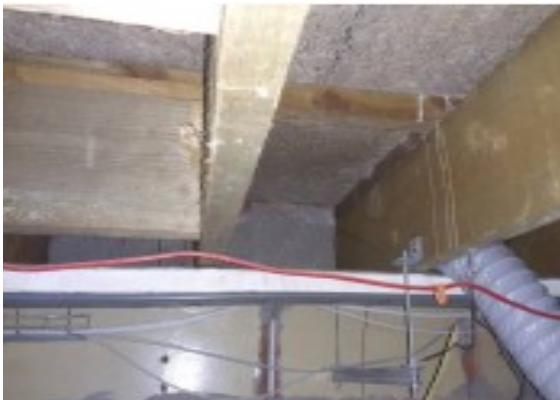
Item 241 Ref: As PK000700

The bitumen drip walls and roof structure in Main front reception (G/044) does not contain asbestos.

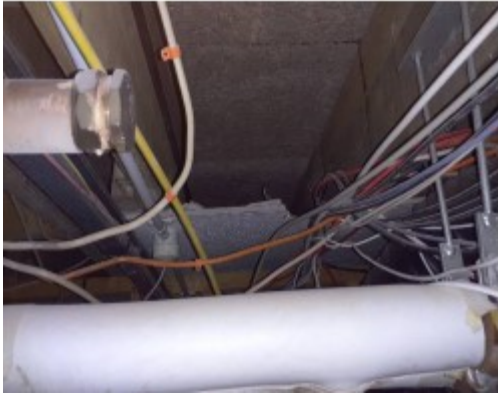
Item 242 Ref: PK000707

The textured coating remnants - upper ceiling above suspended tiles in the Corridor (G/049) does contain asbestos.

Any change in appearance should be reported to Property Services.

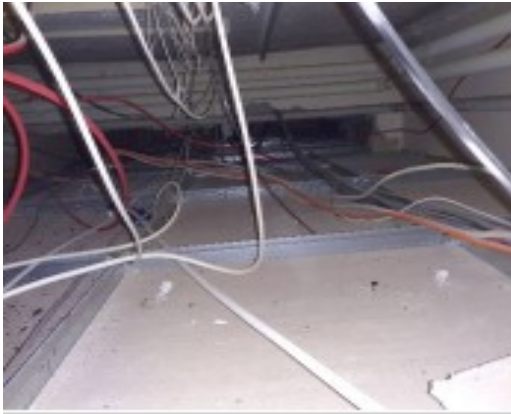
Item 243 Ref: As PK000709

The textured coating debris – top of ceiling tiles and light fittings in the Corridor (G/049) does not contain asbestos.

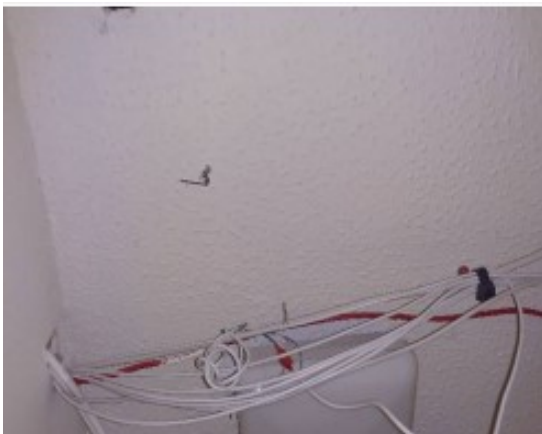
Item 244 Ref: As PK000707

The textured coating remnants - upper ceiling above suspended tiles in the Cupboard 28 (G/050) does contain asbestos.

Any change in appearance should be reported to Property Services.

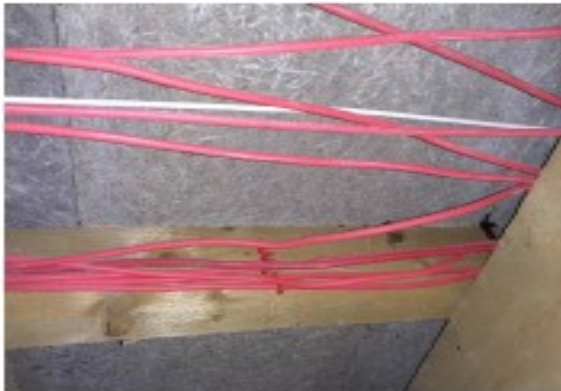
Item 245 Ref: As PK000700

The bitumen drip walls and roof structure in the Corridor (G/051) does not contain asbestos.

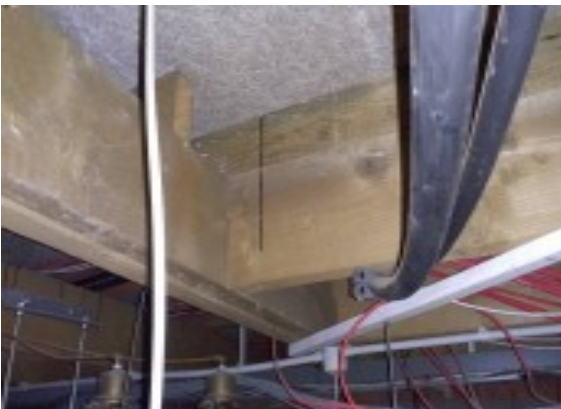
Item 246 Ref: As PK000700

The bitumen drip walls and roof structure in the Corridor (G/052) does not contain asbestos.

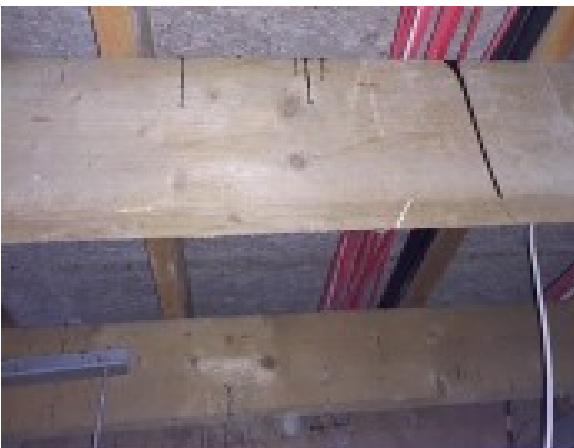
Item 247 Ref: As PK000700

The bitumen drip walls and roof structure in the Corridor (G/053) does not contain asbestos.

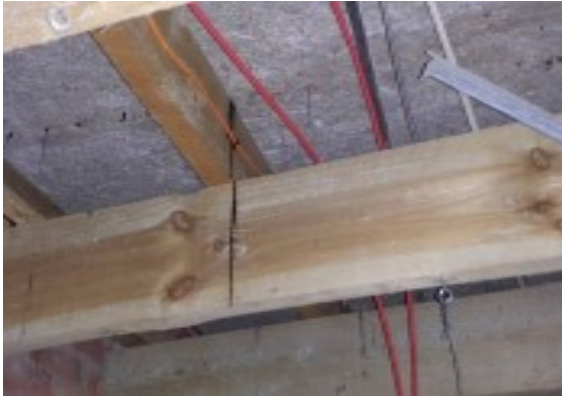
Item 248 Ref: As PK000700

The bitumen drip walls and roof structure in the Corridor (G/054) does not contain asbestos.

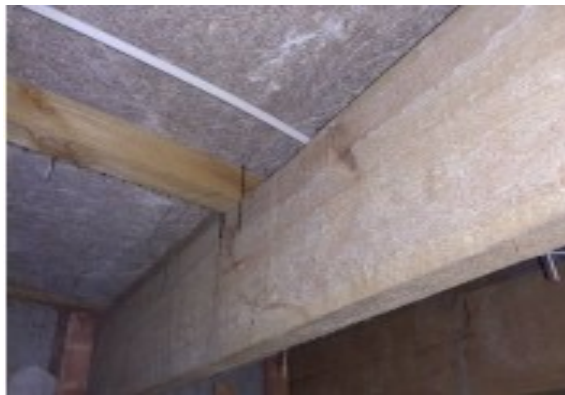
Item 249 Ref: As PK000700

The bitumen drip walls and roof structure in the Main reception lobby (G/055) does not contain asbestos.

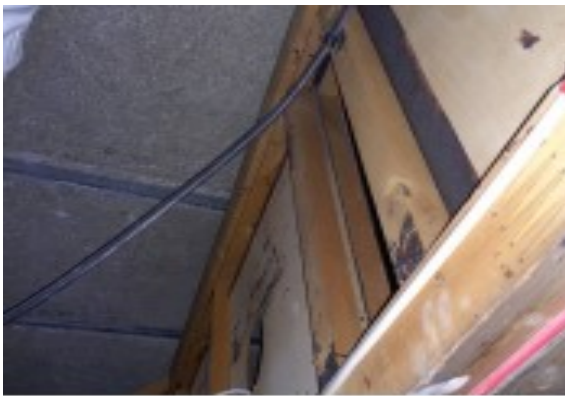
Item 250 Ref: As PK000700

The bitumen drip walls and roof structure in the Seminar Room (G/056) does not contain asbestos.

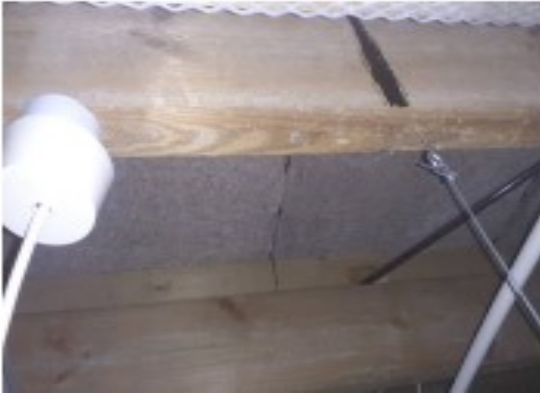
Item 251 Ref: As PK000700

The bitumen drip walls and roof structure in the Male Toilets (G/057) does not contain asbestos.

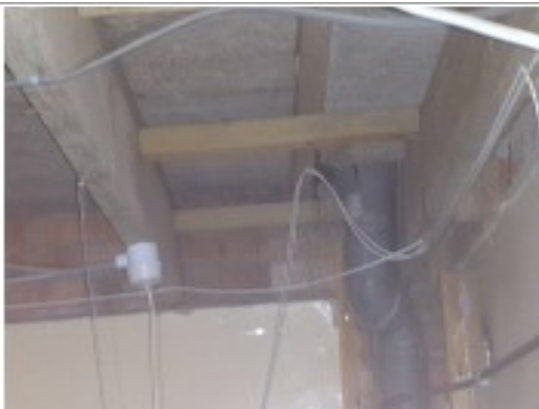
Item 252 Ref: As PK000700

The bitumen drip walls and roof structure in the Female Toilets (G/058) does not contain asbestos.

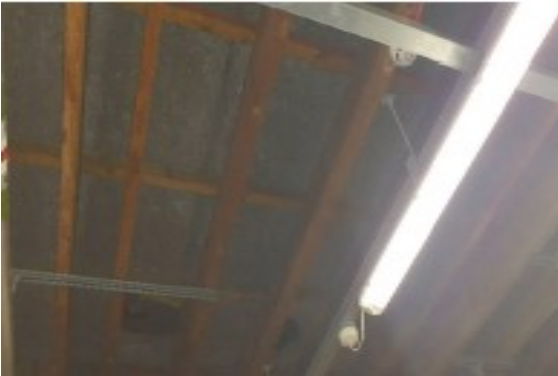
Item 253 Ref: OU001831

The strawboard ceiling in the Boiler Room (G/41) does not contain asbestos.

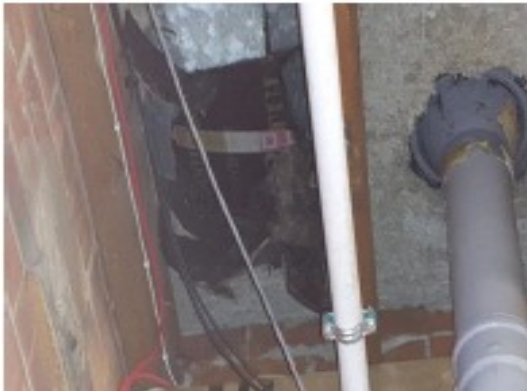
Item 254 Ref: OU001832

The bitumen above strawboard and metal ceiling in the Boiler Room (G/41) does not contain asbestos.

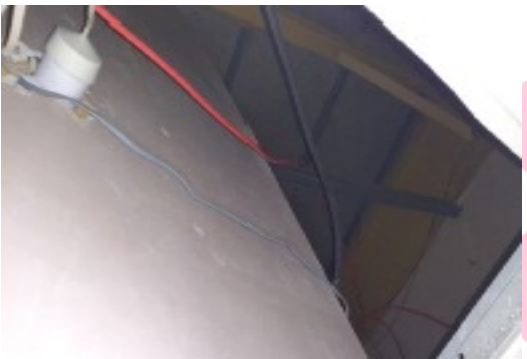
Item 255 Ref: OU001833

The strawboard ceiling in Corridor 7 (G/44) does not contain asbestos.

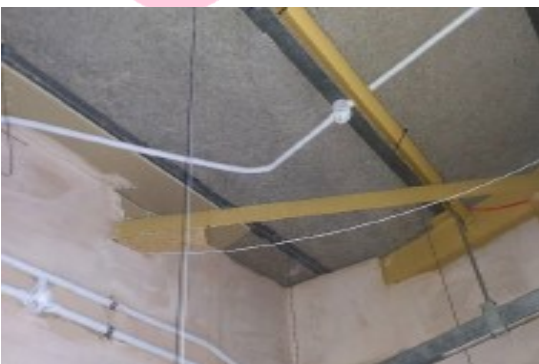
Item 256 Ref: As OU001833

The strawboard ceiling in Office 4 (G/45) does not contain asbestos.

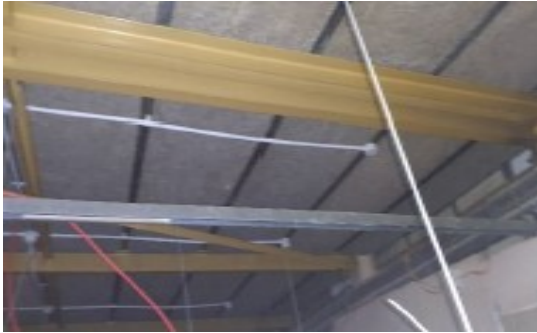
Item 257 Ref: As OU001833

The strawboard ceiling in Business Support Admin/Stores (G/46) does not contain asbestos.

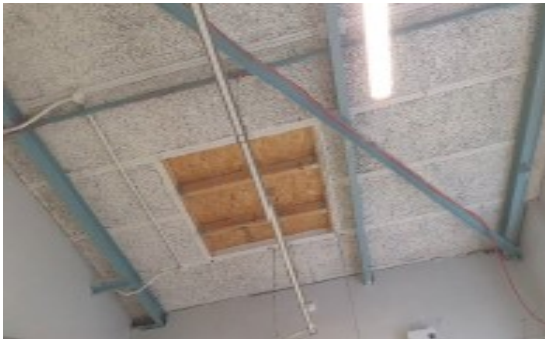
Item 258 Ref: As OU001833

The strawboard ceiling in the Team Leaders Office (G/47) does not contain asbestos.

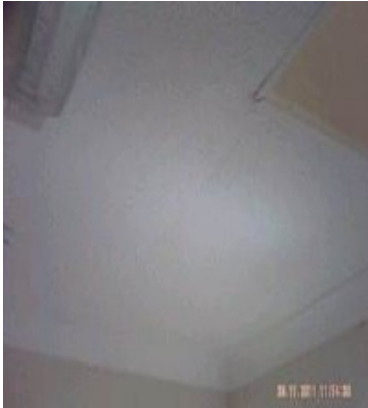
Item 11 Ref: AY001950

The textured coating to the ceiling in the hallway (Room 1) contains asbestos.

Any change in its appearance should be recorded and passed to Property Services.

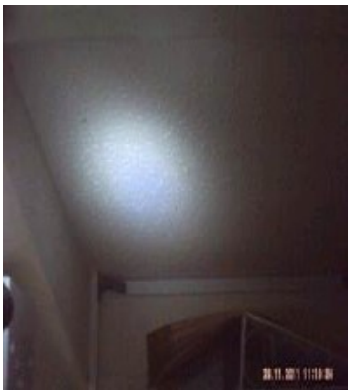
Item 13 – As AY001951

The textured coating to the ceiling in the cupboard (Room 3) contains asbestos.

Any change in its appearance should be recorded and passed to Property Services.

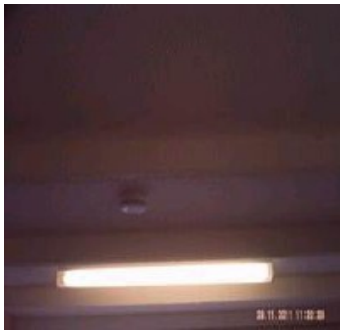
Item 14 – As AY001951

The textured coating to the ceiling in the living room (Staff Room) (Room 4) contains asbestos.

Removed 2023

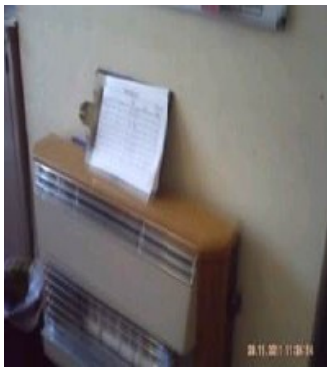
There was no access gained behind the gas fire in the living room therefore it must be presumed to contain asbestos.

Prior to any works on this fire. Sampling must be carried out.

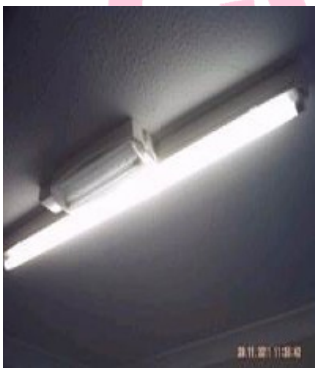
Item 15 - Ref: As AY001951

The textured coating to the ceiling in the kitchen (Room 5) contains asbestos.

Removed 2023

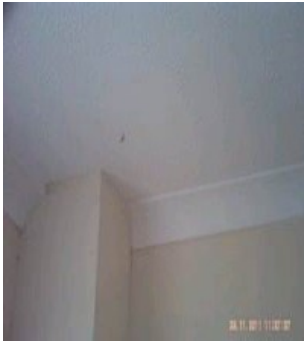
Item 16 – As AY001951

The textured coating to the ceiling in the ground floor WC (Room 6) contains asbestos.

Removed 2023
