ASBESTOS SURVEY REPORT FOR LEECHMERE TRAINING CENTRE (INCLUDING TELECARE HOUSE), SUNDERLAND

Asbestos Register for LEECHMERE CENTRE, SUNDERLAND

Date: 16 January 2025

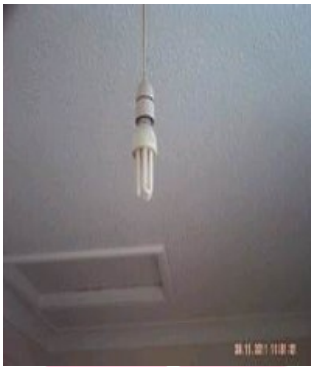
Item 17 – Ref: AY001948

The textured coating to the ceiling on the first floor landing (Rm 1/1) contains asbestos.

Removed 2023

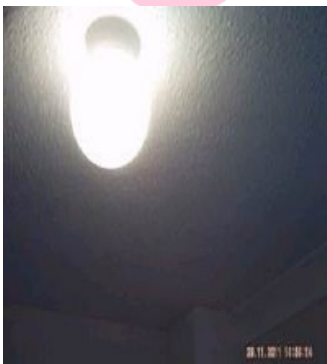
Item 18 - Ref: As AY001949

The textured coating to the ceiling in the bathroom (Rm 1/2) contains asbestos.

Removed 2023

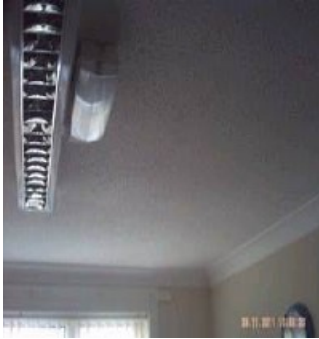
Item 19 – As AY001949

The textured coating to the ceiling in bedroom 1 (Rm 1/3) contains asbestos.

Removed 2023

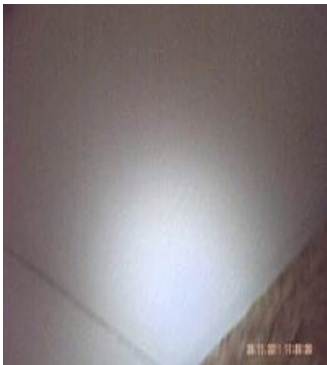
Item 20 – As AY001949

The textured coating to the ceiling in bedroom 1 cupboard (Rm 1/4) contains asbestos.

Removed 2023

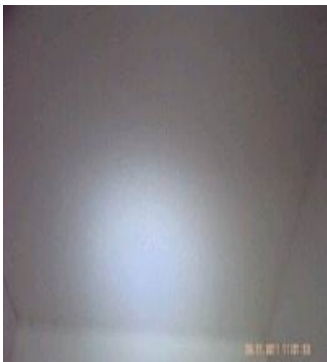
Item 21 – As AY001949

The textured coating to the ceiling in cupboard on the landing (Rm 1/5) contains asbestos.

Removed 2023

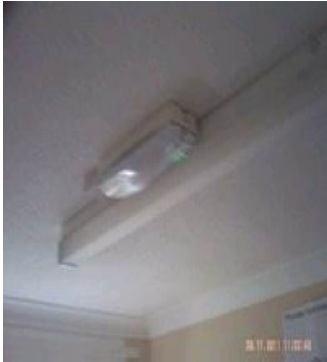
Item 22 – As AY001948

The textured coating to the ceiling in bedroom 2 (Rm 1/6) contains asbestos.

Removed 2023

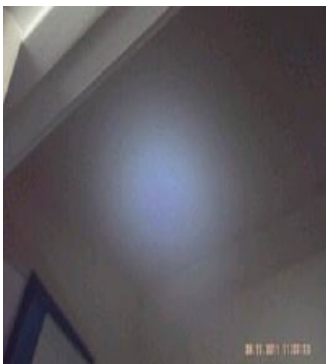
Item 23 – As AY001948

The textured coating to the ceiling in bedroom 2 cupboard (Rm 1/7) contains asbestos.

Removed 2023

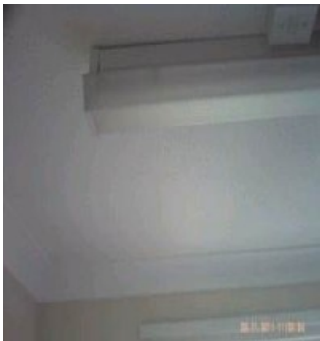
Item 24 – As AY001949

The textured coating to the ceiling in bedroom 3 cupboard (Rm 1/8) contains asbestos.

Removed 2023

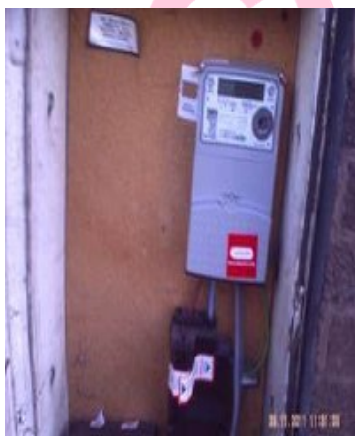
The electrics to the external could not be accessed.

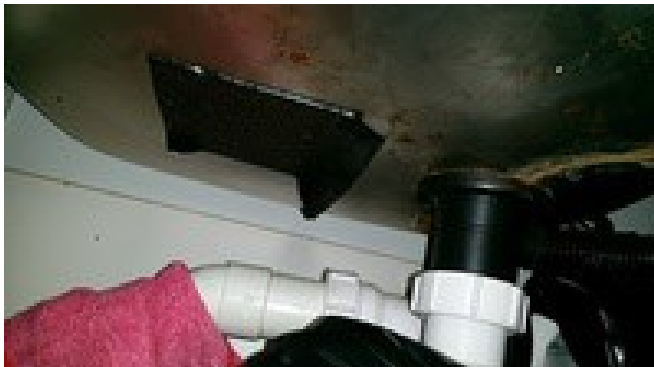
Item 147 - Ref: Presumed

The sink pads in Kitchen (Rm 0/002) are presumed to contain asbestos.

Any change in its appearance should be recorded and passed to Property Services.

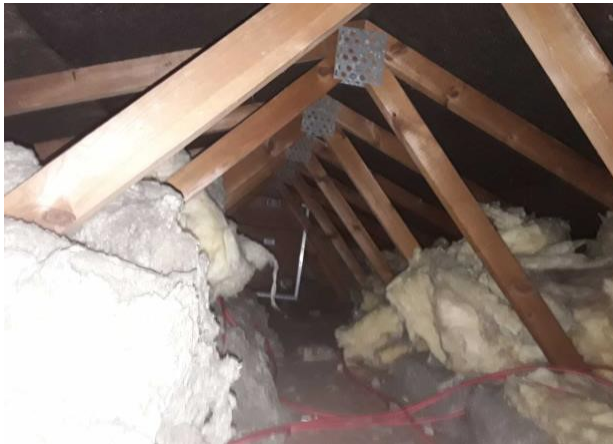
Item 192 - Ref: Presumed

The pipes/gasket to redundant elson tank in the loft (Area 16) is presumed to contain asbestos.

Any change in appearance should be recorded and passed to Property Services.

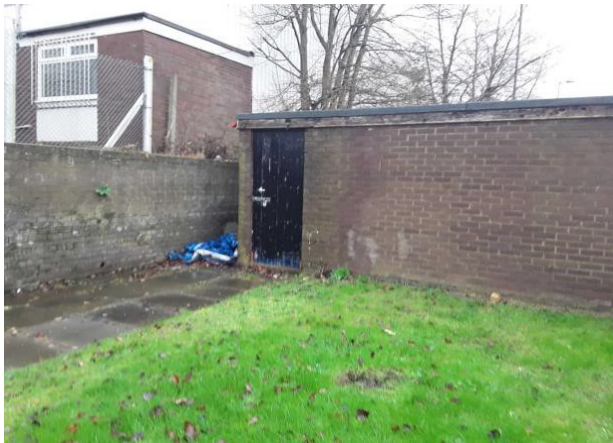
Item 194 - Ref: 22-55417-11

The frame sealant to wood door frame to garage (Area 17) contains asbestos.

Removed 2023

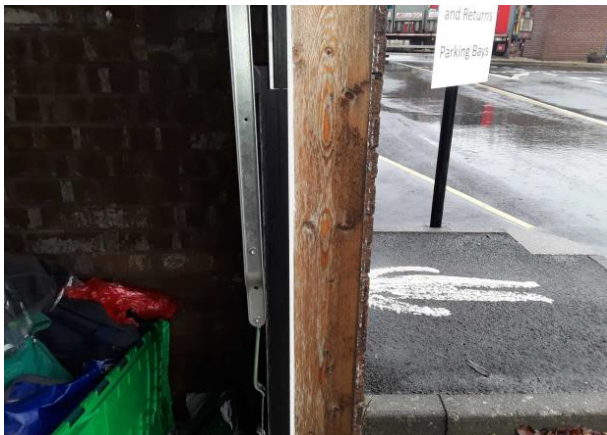
Item 195 - Ref: 22-55417-12

The frame sealant to brickwork to metal door to garage (Area 17) contains asbestos.

Removed 2023

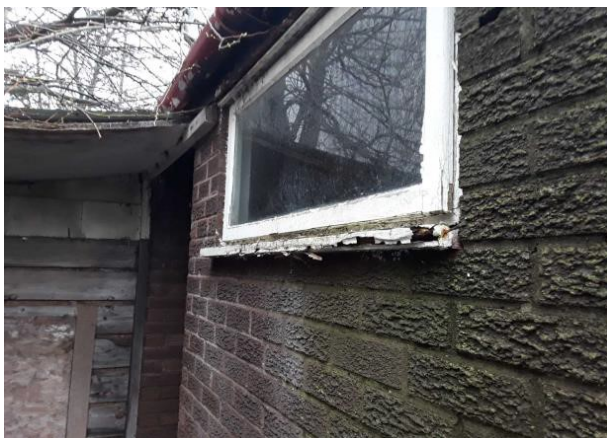
Item 196 - Ref: 22-55417-13

The window putty to garage (Area 17) does not contain asbestos.

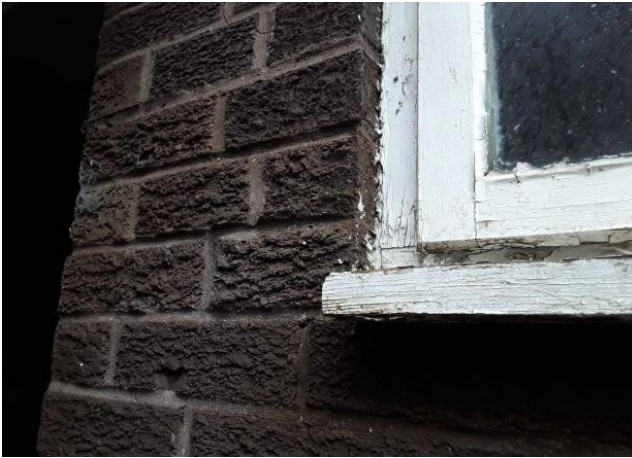
Item 197 - Ref: 22-55417-14

The frame sealant to window to garage (Area 17) contains asbestos.
