### ASBESTOS SURVEY REPORT FOR ARTS CENTRE WASHINGTON, FATFIELD, WASHINGTON

*Control of Asbestos  
Regulations 2012*

**ARTS CENTRE WASHINGTON,  
FATFIELD, WASHINGTON**

**Date: 16 March 2026**

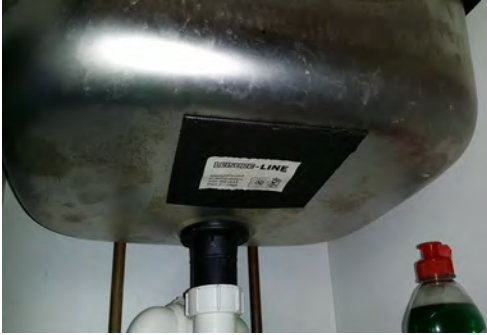
### **Item 1 Ref: 106990-5**

The sink pad to the kitchen in the main building (Room 005) does not contain asbestos.

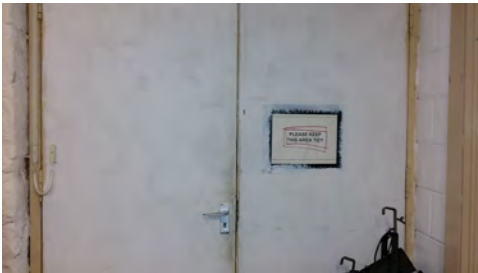
### **Item 2 Ref: 106990-6**

The panels to the back of the doors in the store to the main building (Room 006) (Room 007) do not contain asbestos.

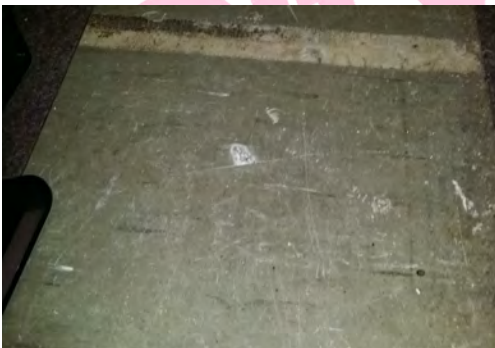
### **Item 3 Ref: 106990-7**

The vinyl floor tiles to the store in the main building (Room 007) do not contain asbestos.

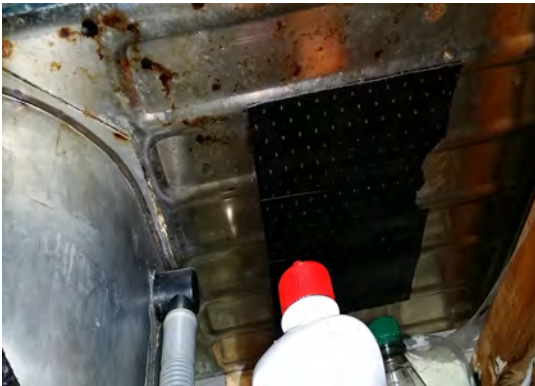
### **Item 4 Ref: 106990-14**

The sink pad to the bar to the main building (Room 008a) contains asbestos.

Any change in its appearance should be recorded and passed to Property Services.

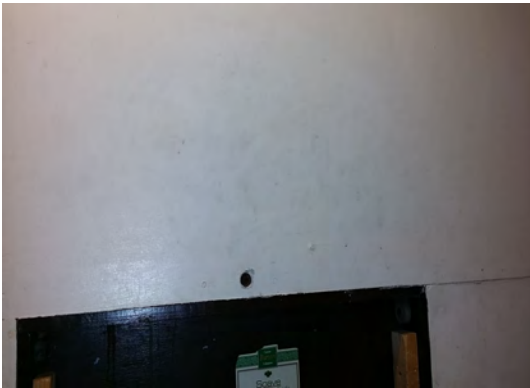
### **Item 5 Ref: 106990-13**

The panel above the dumb waiter in the store in the main building (Room 018) do not contain asbestos.

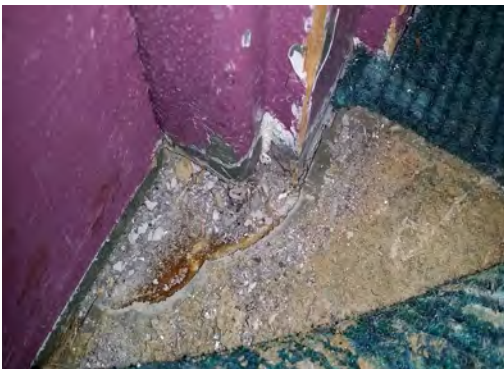
### **Item 6 Ref: 106990-8**

The vinyl flooring to the office in the main building (Room 019) does not contain asbestos.

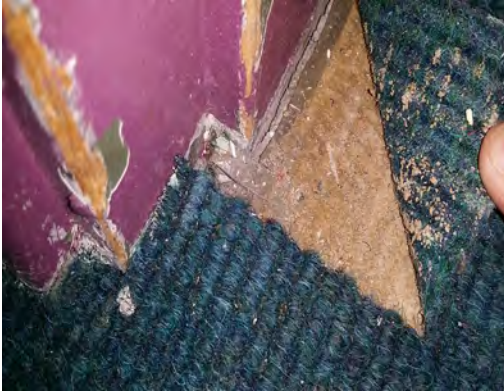
### **Item 7 As: 106990-8**

The vinyl floor covering to the office in the main building (Room 020) does not contain asbestos.

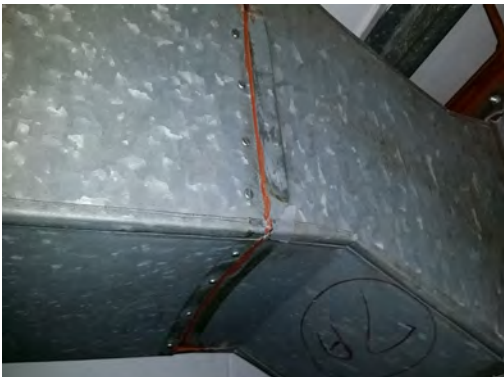
### **Item 8 Ref: 106990-9**

The mastic to the joints of the air handling unit in the plant room of the main building (Room 021) does not contain asbestos.

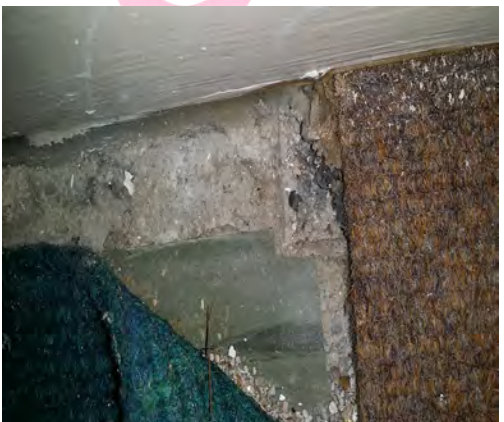
### **Item 9 As: 106990-8**

The vinyl flooring to the corridor in the main building (Room 023) does not contain asbestos.

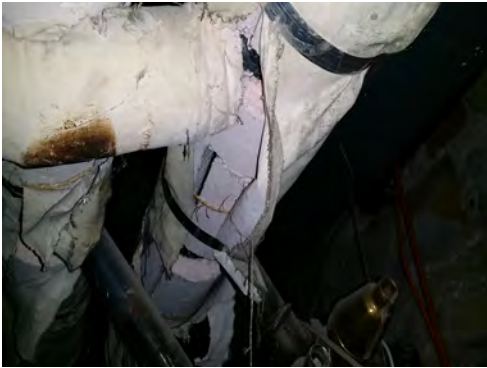
### **Item 10 Ref: 106990-10**

The pipe lagging in the ceiling void of the lobby in the main building (Room 027) does not contain asbestos.

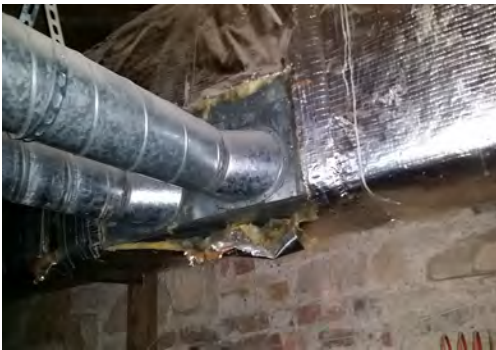
### **Item 11 Ref: 106990-11**

The sealant to the ducts of the air handling duct work to the ceiling void above the male WC (Room 030) does not contain asbestos.

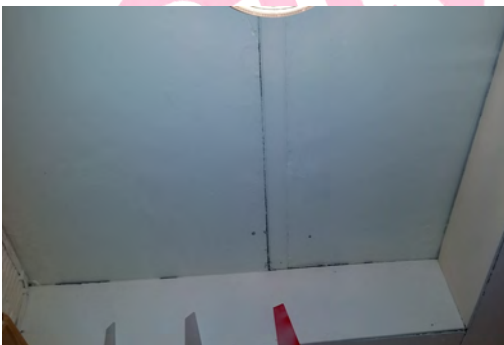
### **Item 12 Ref: 106990-3**

The ceiling to the lobby in the main building (Room 054) contains asbestos.

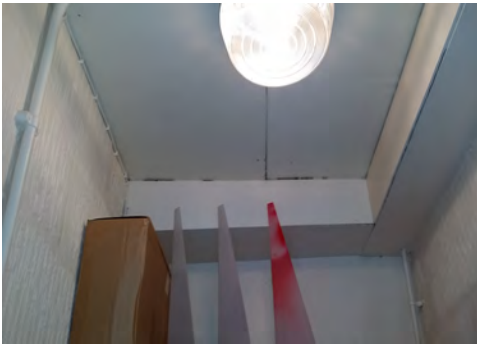
### **Item 13 As: 106990-3**

The ceiling to the WC in the main building (Room 055) contains asbestos.

Any change in its appearance should be recorded and passed to Property Services.

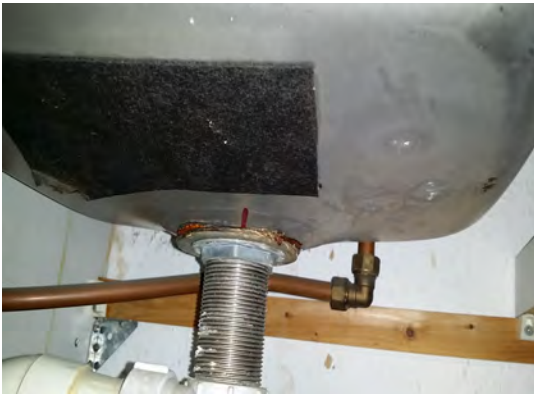
### **Item 14 Ref:106990-2**

The sink pad in Studio 1 of main building (Room 058) does not contain asbestos.

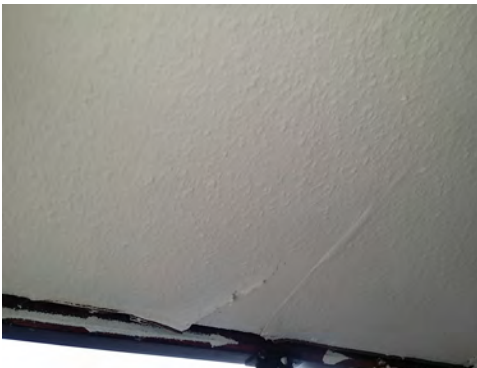
### **Item 15 Ref: 106990-1**

The textured coating to the ceiling in the lobby to the main building (Room 060) does not contain asbestos.

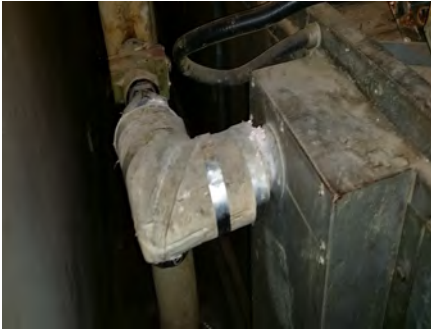
### **Item 16 Ref: 106990-12**

The pipe lagging to the plant room in the main building (Room 005) does not contain asbestos.

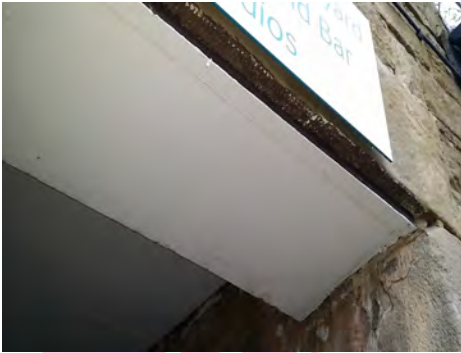
### **Item 17 Ref: 106990-15**

The boxing above the walkway between the sub-station and studio 10 to the external contain asbestos.

Any change in its appearance should be recorded and passed to Property Services.

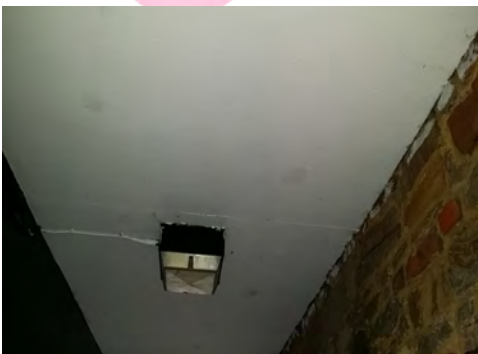
### **Item 18 Ref: 106990-16**

The soffit above the walkway between the sub-station and studio 10 to the external contain asbestos.

***Removed January 2020***

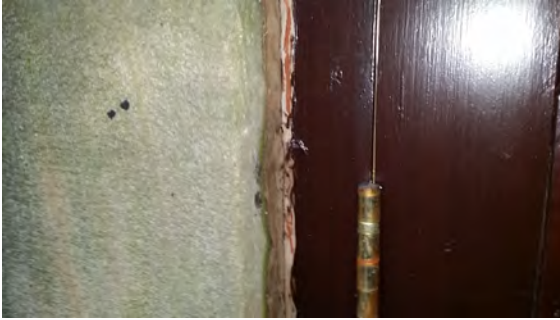
### **Item 19 Ref: 106990-17**

The sealant to the door frame and windows to the external of the main building contains asbestos.

Any change in its appearance should be recorded and passed to Property Services.

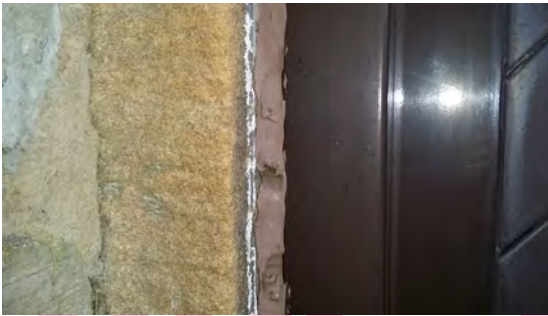
### **Item 20 Ref: 106990-18**

The sealant to the door frame and windows to the external of the studios does not contain asbestos.

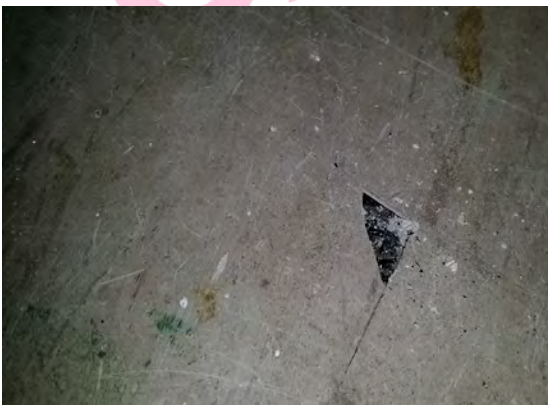
### **Item 21 Ref: 106990-4**

The floor tiles to the store in unit 6 Studio (Room 003) contain asbestos.

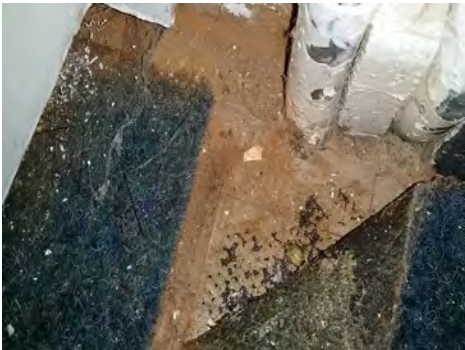
### **Item 22 As: 106990-4**

The floor tiles and adhesive to the floor in the Corridor in Unit 6 Studio (Room 004) contains asbestos.

***Removed October 2020***

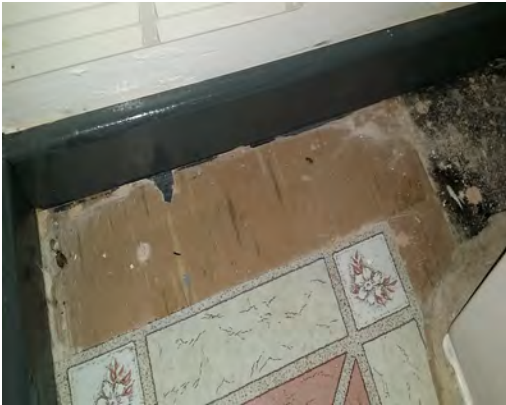
### **Item 23 As: 106990-4**

The floor tiles and adhesive to the floor in the wc in Unit 6 (Room 5) Studio contains asbestos.

***Removed October 2020***

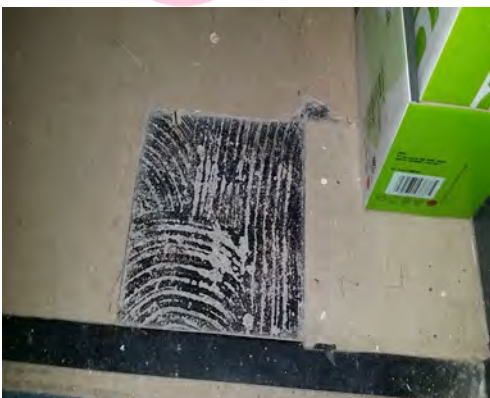
### **Item 24 As: 106990-4**

The floor tiles and adhesive to the floor in the lobby in Unit 6 (Room 6) Studio contains asbestos.

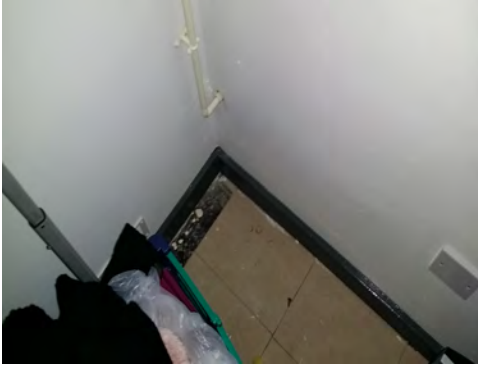
### **Item 25 As: 106990-4**

The floor tiles and adhesive to the floor in the store in Unit 6 Studio (Room 007) contains asbestos.

Any change in its appearance should be recorded and passed to Property Services.

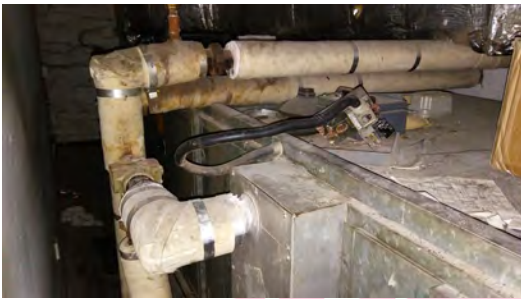
### **Item 26: 234441-1**

The pipe lagging in the plant room (Room 001) does not contain asbestos.

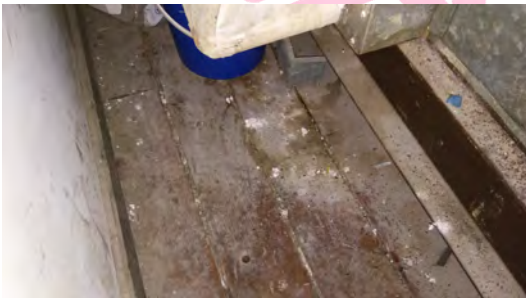
### **Item 27: 234441-2**

The pipe lagging debris to the floor adjacent to entrance in the plant room (Room 001) does not contain asbestos.

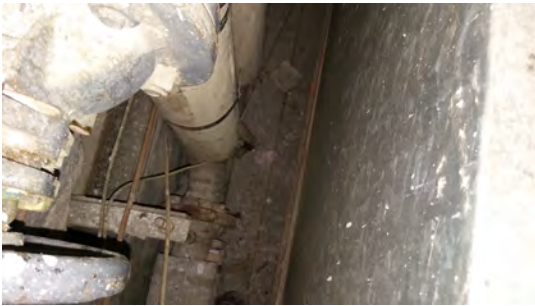
### **Item 28: 234441-3**

The pipe lagging debris to the floor and horizontal surfaces near LHS elevation in the plant room (Room 001) does not contain asbestos.

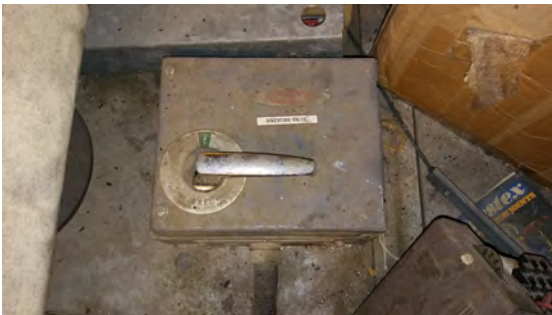
### **Item 29: Presumed**

The electrics in the plant room (Room 001) are presumed to contain asbestos.

Item 27	No asbestos	Is present		
Item 28	No asbestos	Is present		
Item 29	Electrics - Room 001	Presumed	6 monthly	Noted as removed – No WCN paperwork received

**Removed May 2024 but no WCN received**

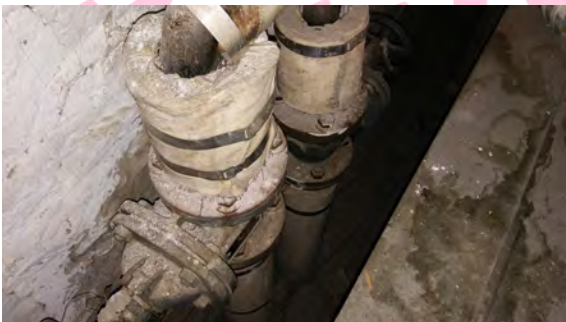
### **Item 30: Presumed**

The pipework flange gasket adjacent to rear wall in the plant room (Room 001) are presumed to contain asbestos.

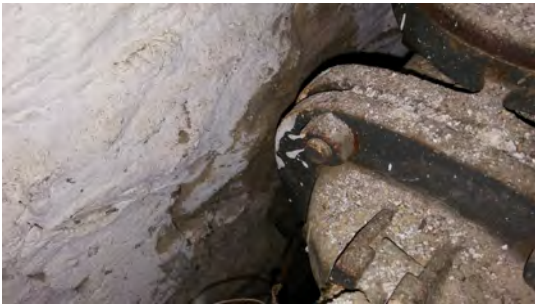
**Item 31: 234441-4**

The pipe lagging debris to the walls in the plant room (Room 001) does not contain asbestos.

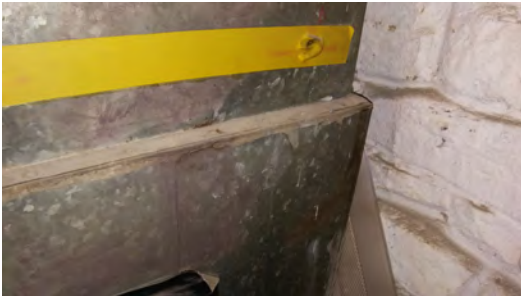
**Item 32: 234441-5**

The sealant in the air handling duct work joints in the plant room (Room 001) contains asbestos.

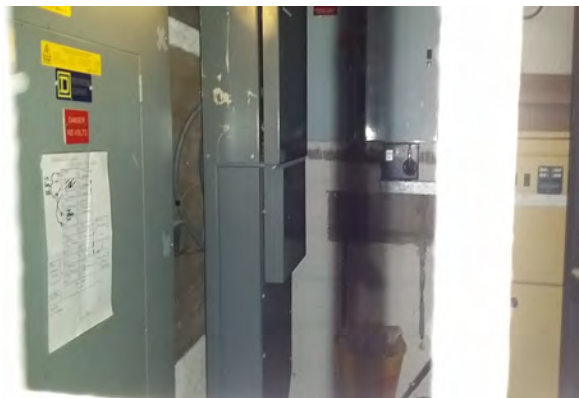
### **Item 38: Presumed (106990)**

The electrics back stage (Room 043) is presumed to contain asbestos.

***Removed June 2020***

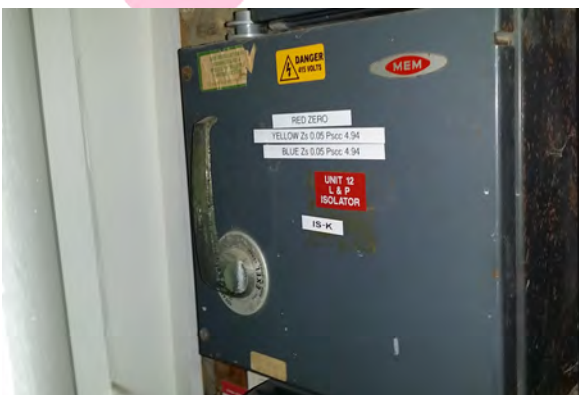
### **Item 39: Presumed (106990)**

The electrics in the workshop (Room 053) is presumed to contain asbestos.

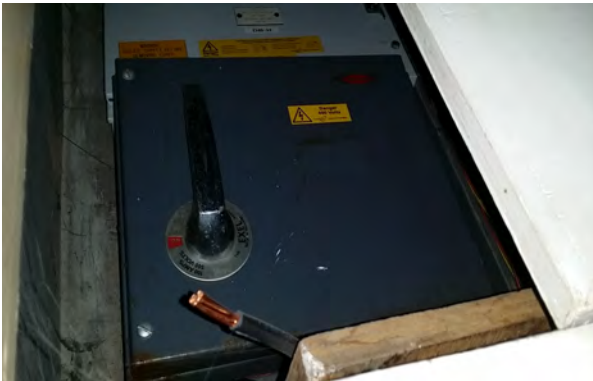
### **Item 40: Presumed (106990)**

The electrics in the WC (Room 059) is presumed to contain asbestos.

Any change in its appearance should be recorded and passed to Property Services.

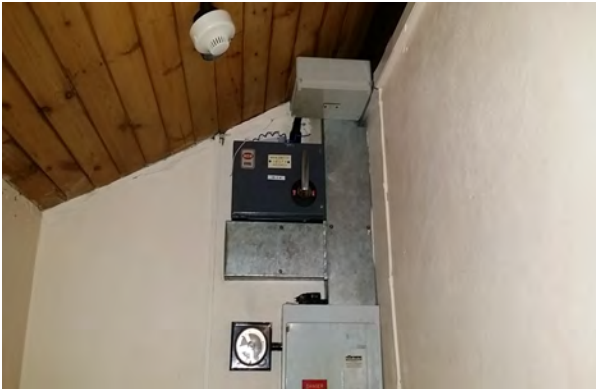
### **Item 41: Presumed (106990)**

The electrics in the fire exit stairs (Room 004) is presumed to contain asbestos.

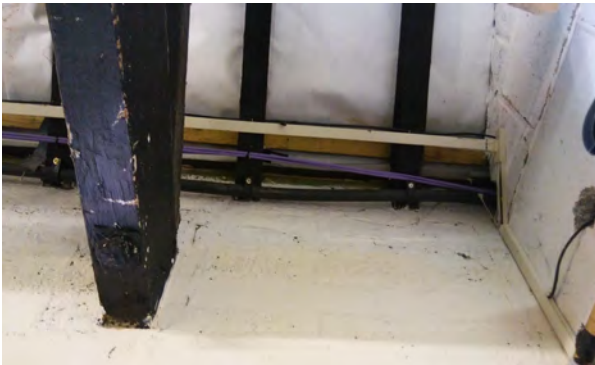
### **Item 43 Ref: As 349632-2**

The felt to roof line along cable route in the Store (Room 006) does not contain asbestos.

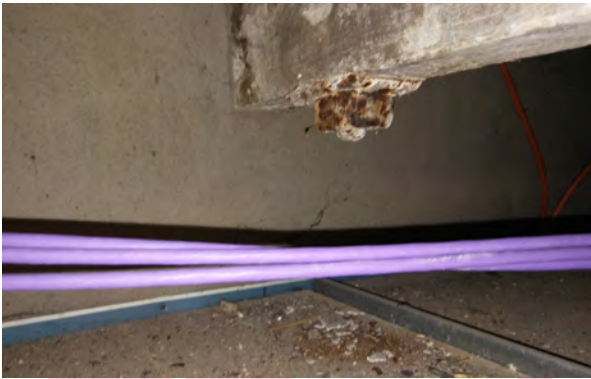
### **Item 44 Ref: As 349632-1**

The debris to beams and void in the ceiling void above the store (Room 007) does not contain asbestos.

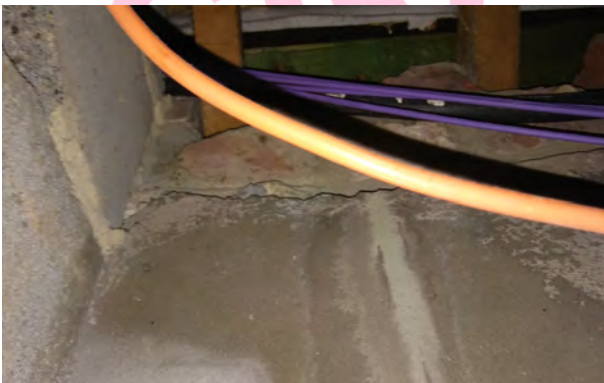
### **Item 45 Ref: As 349632-32**

The felt to wall top along cable route in the ceiling void above the store (Room 007) does not contain asbestos.

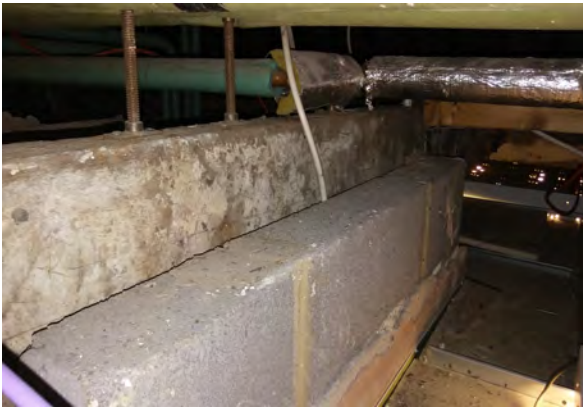
### **Item 46 Ref: As 349632-1**

The debris to the ceiling void and beams in the void above the Male WC (Room 011) does not contain asbestos.

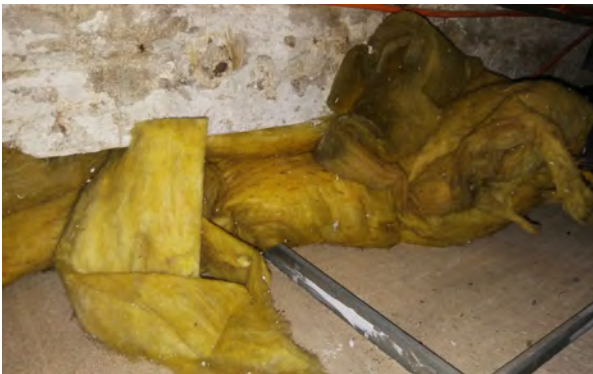
### **Item 47 Ref: 349632-1**

The debris to ceiling void and beams in the ceiling void above the fire exit corridor (Room 012) does not contain asbestos.

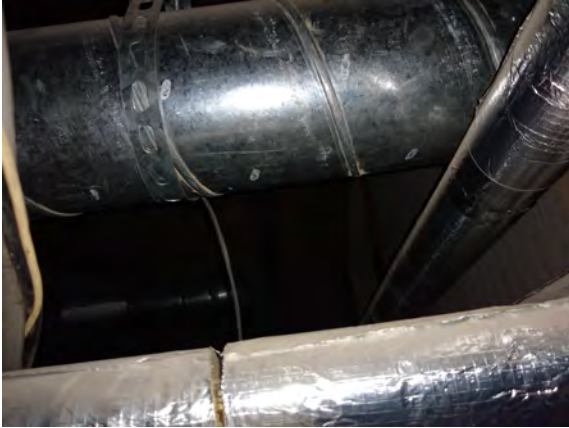
**Item 55 Ref: 76353-2**

The mastic to ductwork (Rm 003/Female WC void above) does not contain asbestos.

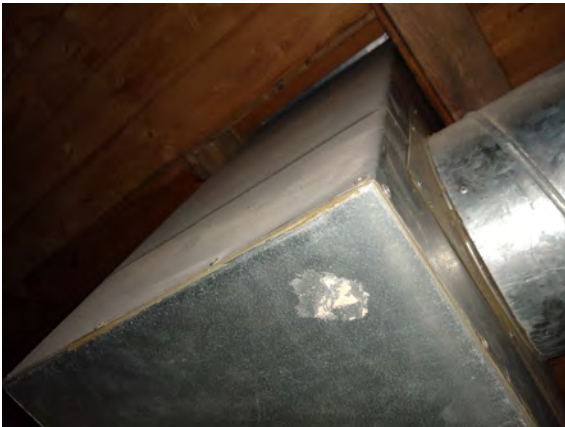
**Item 56 Ref: As 76353-2**

The mastic to ductwork (Rm 004/Male WC void above) does not contain asbestos.

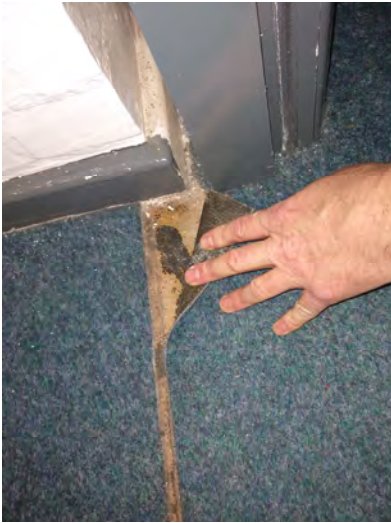
### **Item 83 Ref: 371873-9**

The floor covering (Rm 067/ukulele music room) does contain asbestos.

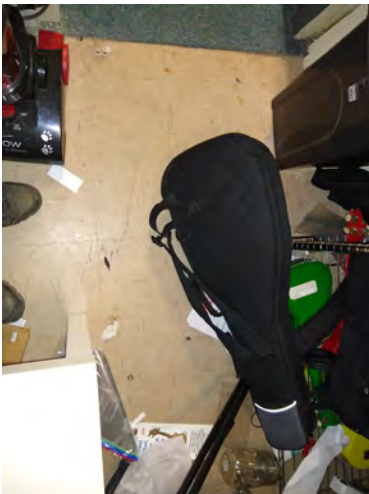
### **Item 88 Ref: As 371873-9**

The floor covering (Rm 071/ukulele music room store) does contain asbestos.

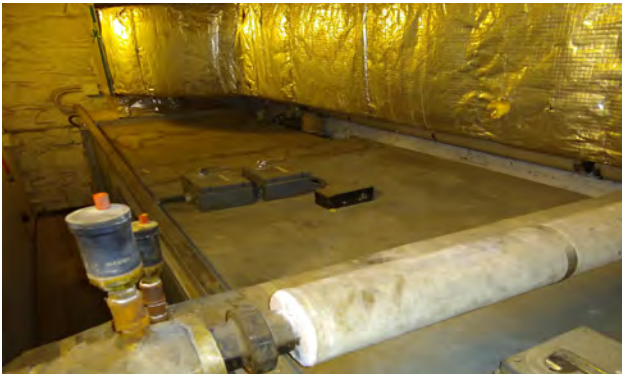
**Item 99 Ref: As 322744-3**

The debris to topside of ductwork (Rm 1/001 Plant Room) does not contain asbestos.

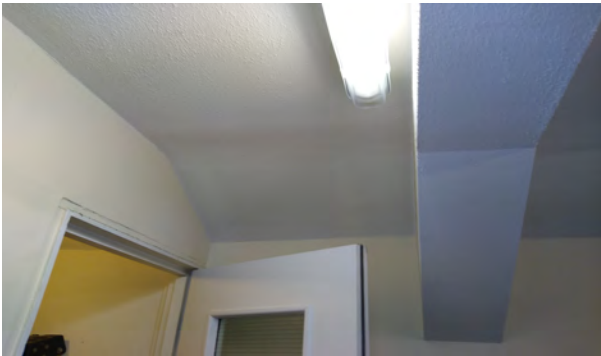
### **Item 101 Ref: 371873-14**

The ceiling in the kitchen (Rm 1/017) does not contain asbestos.

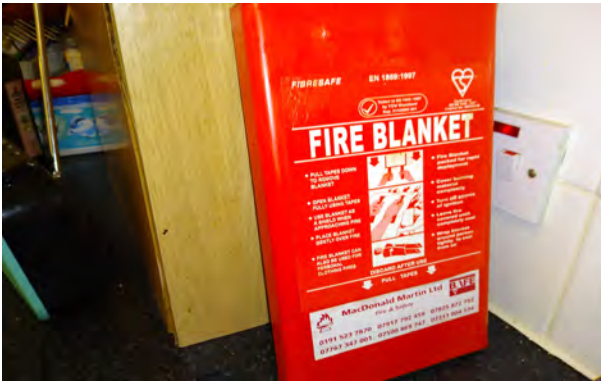
### **Item 102 Ref: Presumed**

The fire blanket in the kitchen (Rm 1/017) does contain asbestos.

Removed May 2022

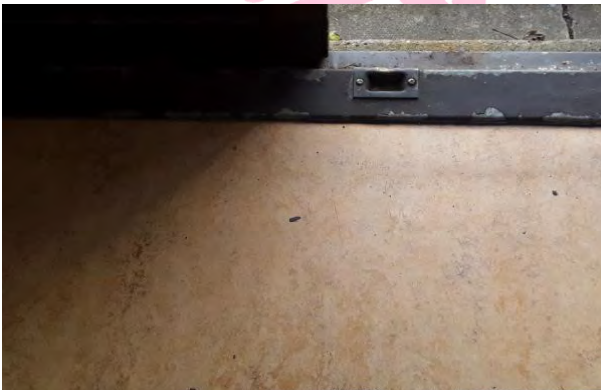
### **Item 103 Ref: 20-27852-2**

The vinyl flooring in the rear – side fire exit doorway does not contain asbestos.

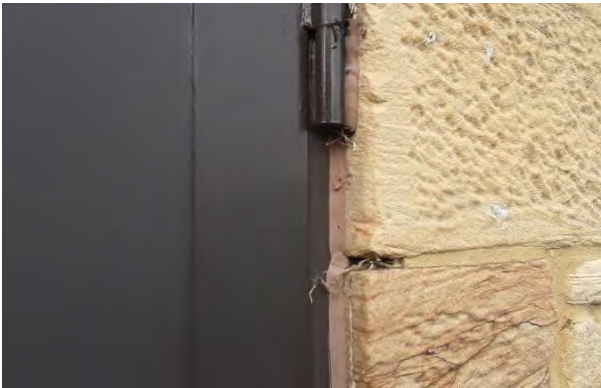
**Item 104 Ref: 20-27852-3**

The door frame sealant to rear – side fire exit doorway does not contain asbestos.

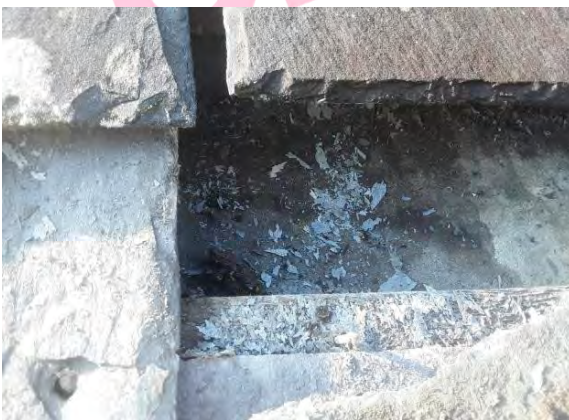
**Item 109 Ref: 21-378903-4**

The roof sarking felt (Bitumen) (Area 2/Roof Area 2) does not contain asbestos.

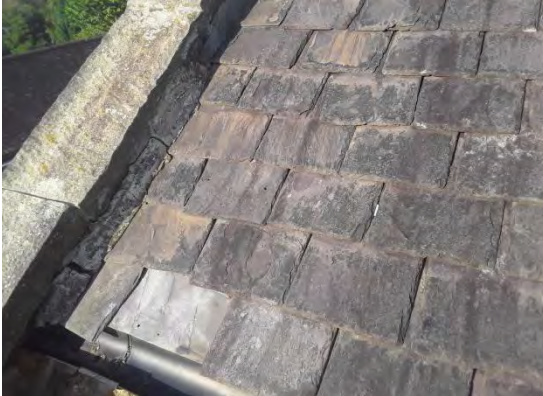
**Item 110 Ref: 21-378903-5**

The roof sarking felt (Bitumen) (Area 3/Roof Area 3) does not contain asbestos.

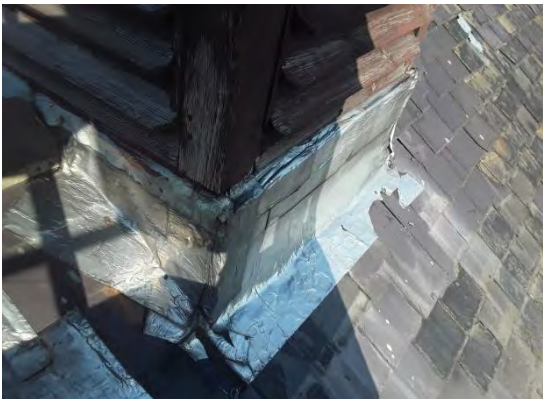
**Item 111 Ref: 21-378903-6**

The flashing to roof vents (Bitumen) (Area 3/Roof Area 3) does not contain asbestos.

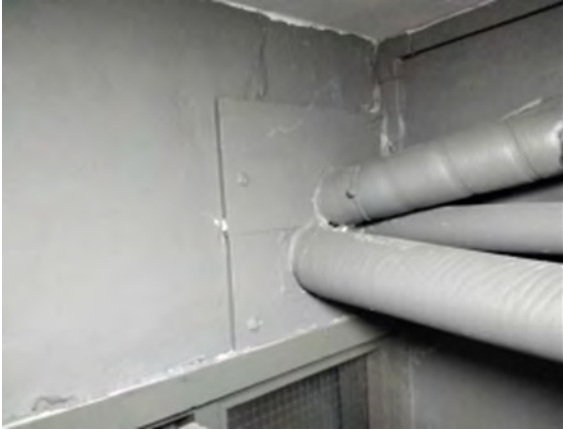
**Item 113 Ref: KX001131**

The pipe penetration panel above inner door in the Corridor (Room 29) does not contain asbestos.

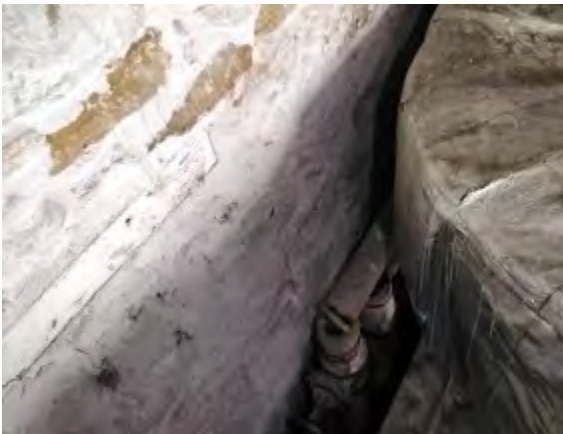
**Item 118 Ref: SC004282**

The wall – Plug/Packing in Plant Room does not contain asbestos.

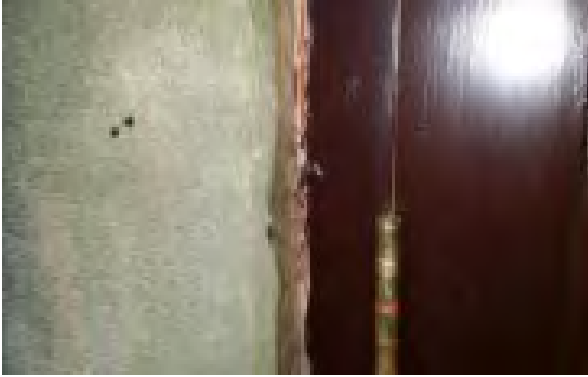
**Item 119 Ref: 106990-17**

The sealant to door frame and windows in Plant Room does contain asbestos.

**Duplicated item – see item 19**

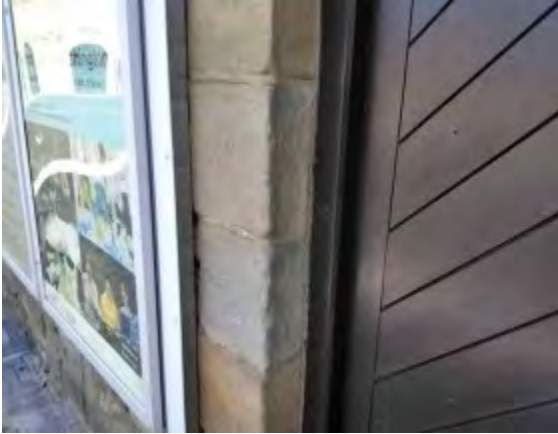
**Item 128 Ref: AW005891**

The brown door frame sealant External to Studio Building does not contain asbestos.

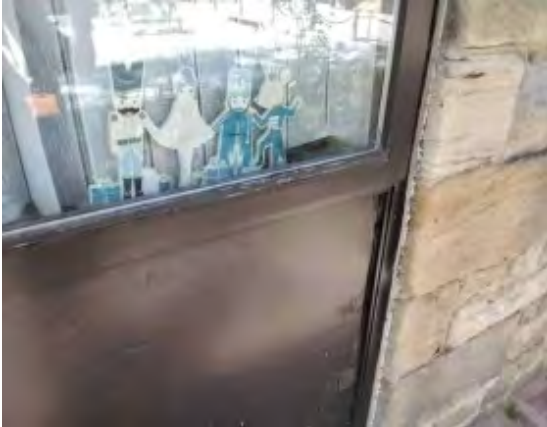
**Item 131 Ref: AW005894**

The window remains of old sealant External to Main Building does not contain asbestos.

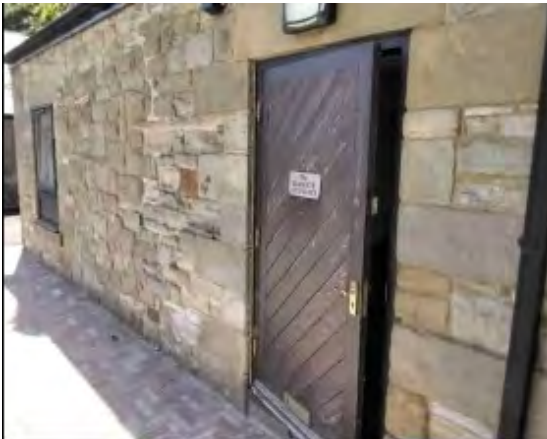
**Item 132 Ref: AW005895**

The brown door frame sealant External to Main Building does not contain asbestos.

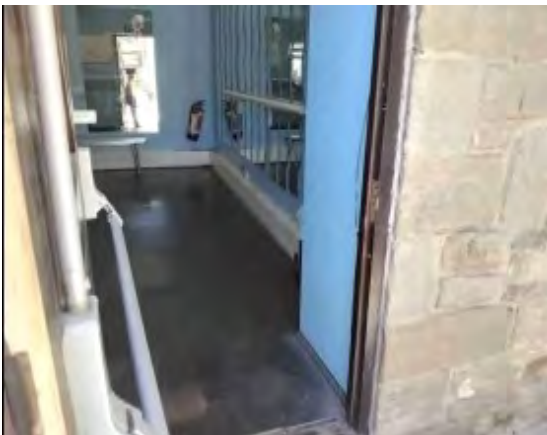
**Item 133 Ref: AW005896**

The door remains of old door frame sealant External to Main Building does not contain asbestos.

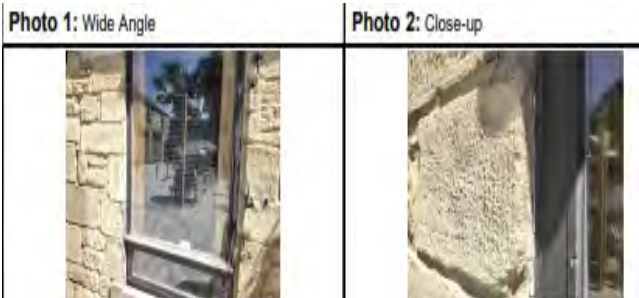
**Item 136 Ref: AW005899**

The window remains of old  
sealant External to Main  
Building does contain  
asbestos.

Any change in appearance  
should be reported to  
Property Services.

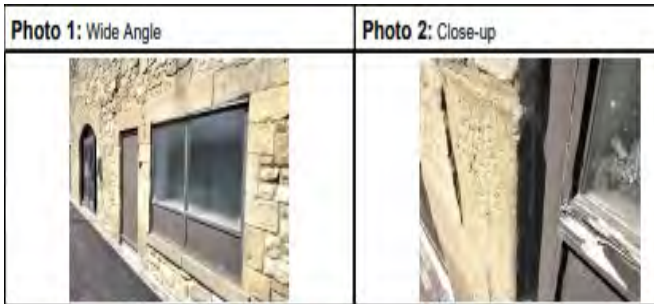
**Item 138 Ref: AW005901**

The window remains of old sealant External to Main Building does contain asbestos.

Item 137	No asbestos	Is present		
<b>Item 138</b>	<b>Window remains of old sealant (External Main Building E/002)</b>	<b>Medium</b>	<b>3 monthly</b>	Noted as removed – No WCN paperwork received

Any change in appearance should be reported to Property Services.

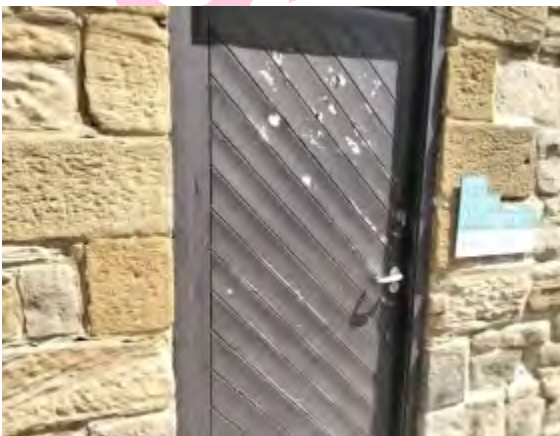
**Item 139 Ref: AW005902**

The door remains of old sealant External to Main Building does not contain asbestos.

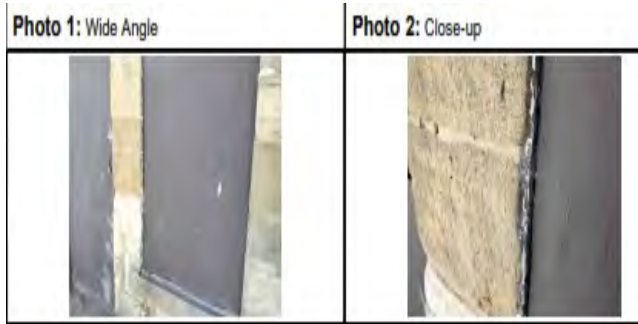
**Item 140 Ref: AW005903**

The door remains of old sealant External to Main Building does contain asbestos.
