### ASBESTOS SURVEY REPORT FOR NOOK LODGE, NOOKSIDE, SUNDERLAND

**NOOK LODGE, NOOKSIDE, SUNDERLAND**

**Date: 17<sup>th</sup> January 2025**

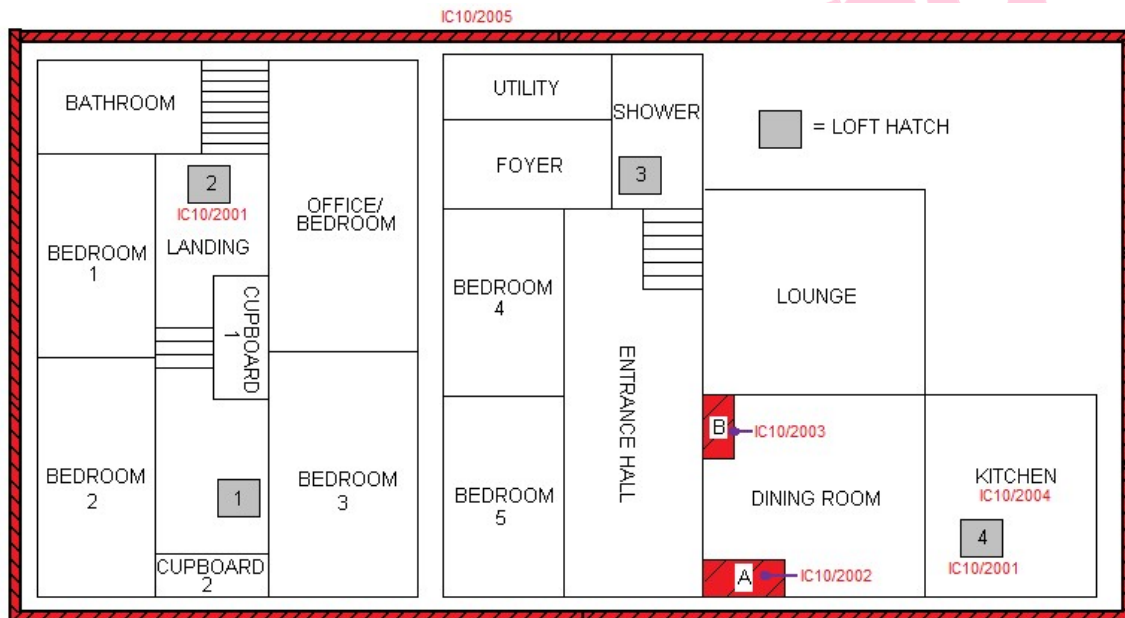
385803-9 – Damp proof course to original building (External) (Item 12) No Risk

KN001533 – Roof felt flashing (External) (Item 13) No Risk

= Areas Where Asbestos Containing Materials Have Been Found
