ASBESTOS SURVEY REPORT FOR CROWTREE LEISURE CENTRE,
CROWTREE ROAD, SUNDERLAND, SR1 3EL.

Asbestos Register for

Crowtree Leisure Centre, Crowtree Road, Sunderland

Date: 07 January 2026

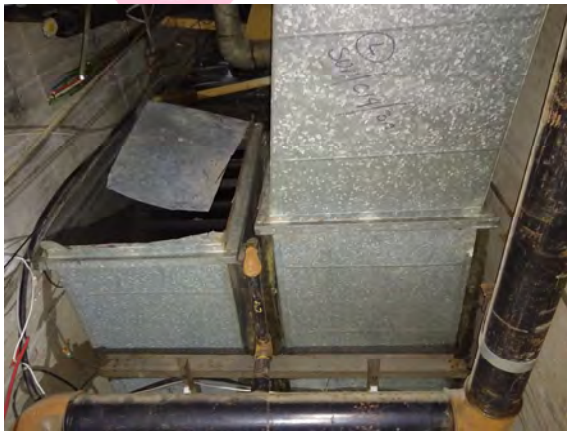
Item 9 Ref: 20277-104

- (Item 8) Ref: 20277-111 – Panels to rise door (Riser adjacent lift/Rm 0/049) – No Risk
- (Item 9) Ref: 20277-104 – Sealant to joints (Riser adjacent lift/Rm 0/049) – Very Low Risk

The Sealant to joints (Riser adjacent lift/Rm 0/049) contains asbestos.

Whilst this cannot be inspected, any change in appearance should be reported to Property Services.

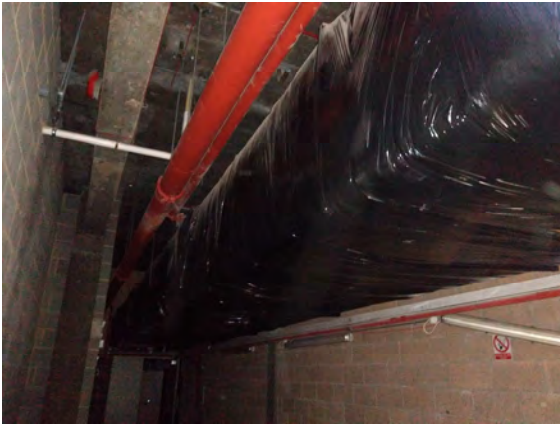
Item 10 Ref: As 20277-104

- (Item 10) Ref: As 20277-104 – Sealant to joints (Service Corridor/Rm 0/051) – Very Low Risk
- (Item 11) Ref: 20277-54 – Sealant to flanged type and round section ductwork (Service Corridor/Rm 0/051) – No Risk

The Sealant to joints (Service Corridor/Rm 0/051) contains asbestos.

Whilst this cannot be inspected, any change in appearance should be reported to Property Services.

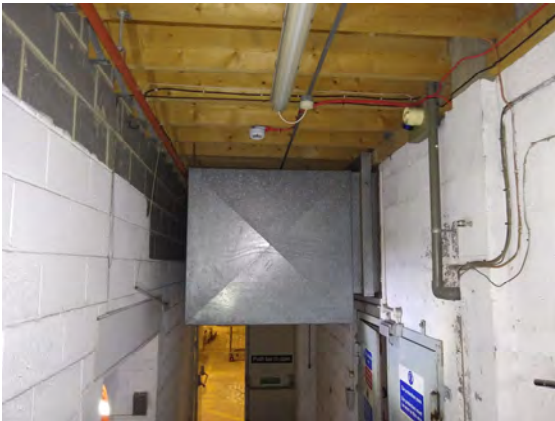
Item 11 Ref: 20277-54

The Sealant to flanged type and round section ductwork (Service Corridor/Rm 0/051) does not contain asbestos.

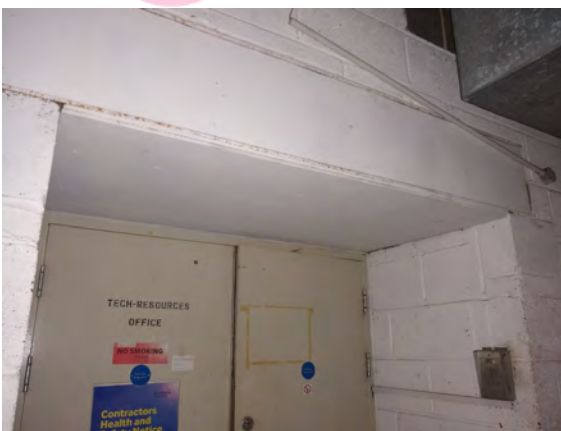
Item 12 Ref: 20277-171

The Soffit to doorway at foot of steps (Service Corridor/Rm 0/051) does not contain asbestos.

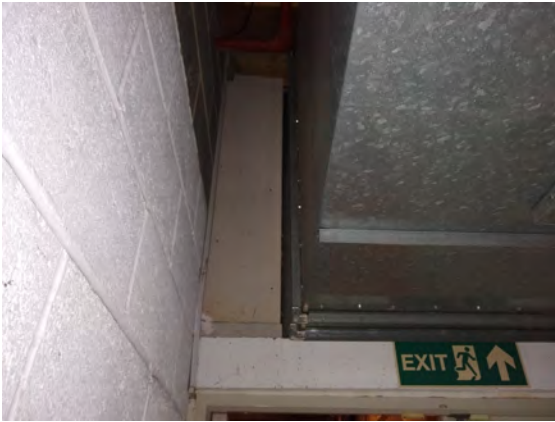
Item 13 Ref: As 20277-171

The Panel to side duct exit to garage (Service Corridor/Rm 0/051) does not contain asbestos.

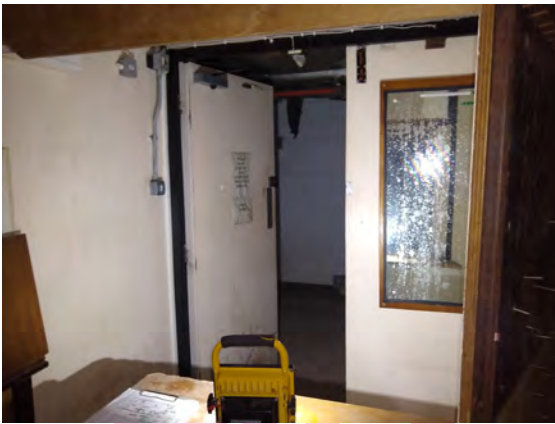
Item 14 Ref: 20277-172

The Panels within fire door (Stores/Rm 0/052) does not contain asbestos.

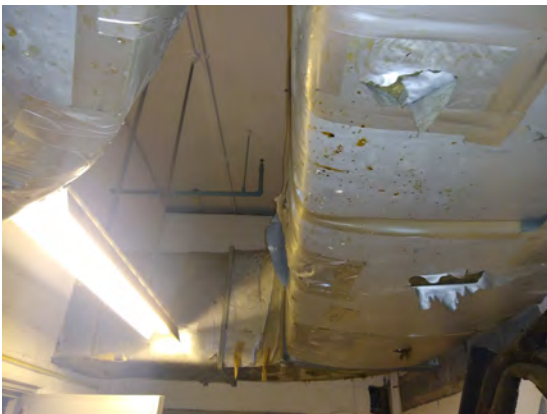
Item 15 Ref: As 20277-104

The Sealant to joints (Cellar Rooms/Rm 0/053) contains asbestos.

Whilst this cannot be inspected, any change in appearance should be reported to Property Services.

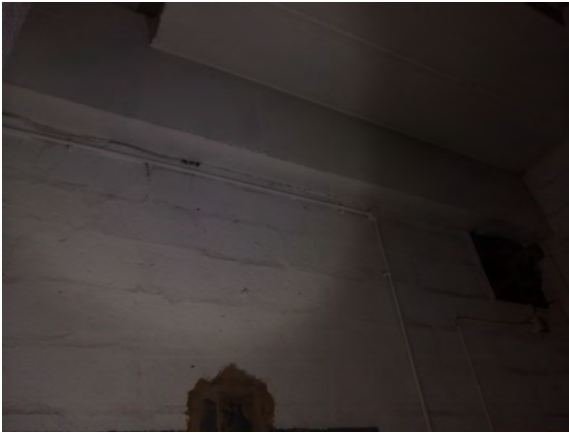
Item 16 Ref: 20277-173

- (Item 16) Ref: 20277-173 – Rope packing (Cellar Rooms/Rm 0/053) – Low Risk
- (Item 17) Ref: 20277-174 – Sink pad (Staff Room and lockers/Rm 0/055) – No Risk

The Rope packing (Cellar Rooms/Rm 0/053) contains asbestos.

Any change in appearance should be reported to Property Services

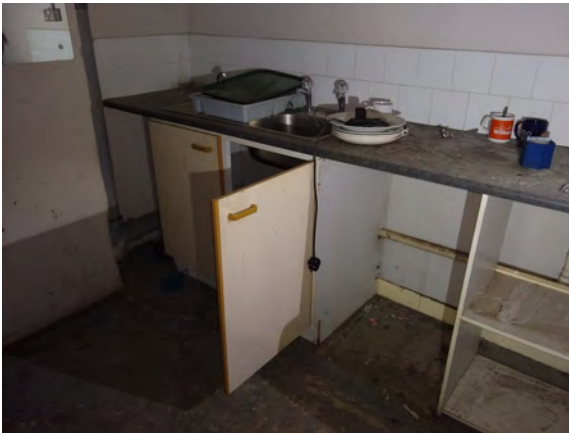
Item 17 Ref: 20277-174

The Sink pad (Staff Room and lockers/Rm 0/055) does not contain asbestos.

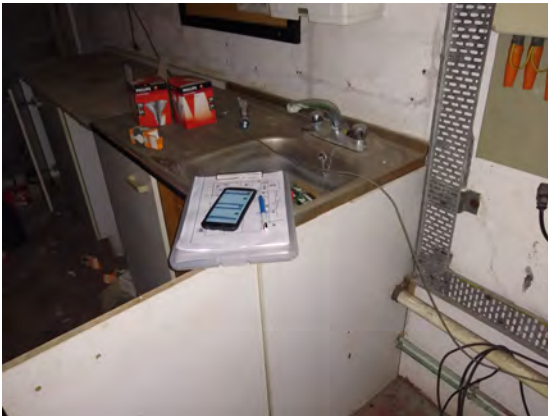
Item 20 Ref: 20277-177

The Sink pad (Laboratory/Rm
0/060) does not contain
asbestos.

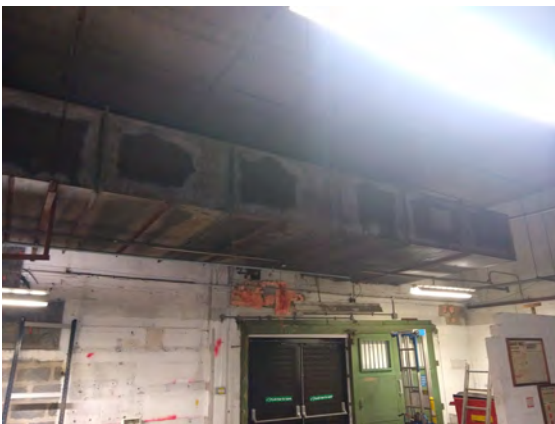
Item 23 Ref: As 20277-173

- (Item 22) Ref: 20277-73 – Sealant to joints in ductwork (Main plant room/Rm 0/062) – Very Low Risk
- (Item 23) Ref: As 220277-173 – Rope packing (Main plant room/Rm 0/062) – Low Risk

The Rope packing (Main plant room/Rm 0/062) contains asbestos.

Whilst this cannot be inspected, any change in appearance should be reported to Property Services.

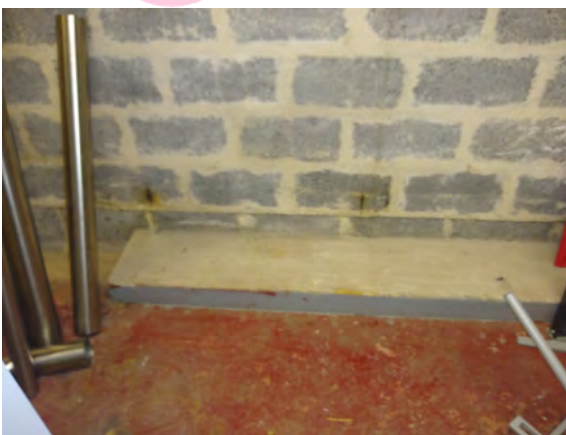
Item 24 Ref: 20277-181

- (Item 24) Ref: 20277-181 – Damp proof course (Main plant room/Rm 0/062) – Very Low Risk
- (Item 25) Ref: 20277-185 – Gasket to diesel engine (Main plant room/Rm 0/062) – Very Low Risk

The Damp proof course (Main plant room/Rm 0/062) contains asbestos.

Any change in appearance should be reported to Property Services.

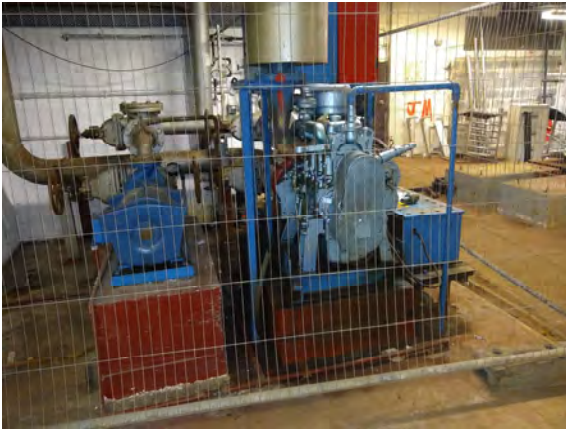
Item 25 Ref: 20277-185

The Gasket to diesel engine (Main plant room/Rm 0/062) contains asbestos.

Any change in appearance should be reported to Property Services.

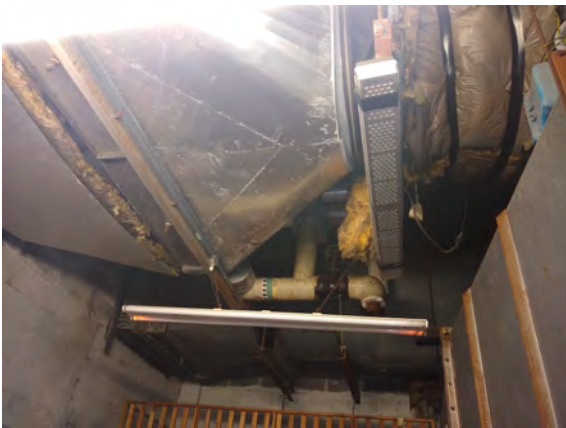
Item 26 Ref: As 20277-73

- (Item 26) Ref: As 20277-73 – Sealant to joints (Entrance and public address stores/Rm 0/063) – Very Low Risk
- (Item 27) Ref: As 20277-73 – Sealant to joints (Electrical workshop/Rm 0/064) – Very Low Risk

The Sealant to joints (Entrance and public address stores/Rm 0/063) contains asbestos.

Whilst this cannot be inspected, any change in appearance should be reported to Property Services.

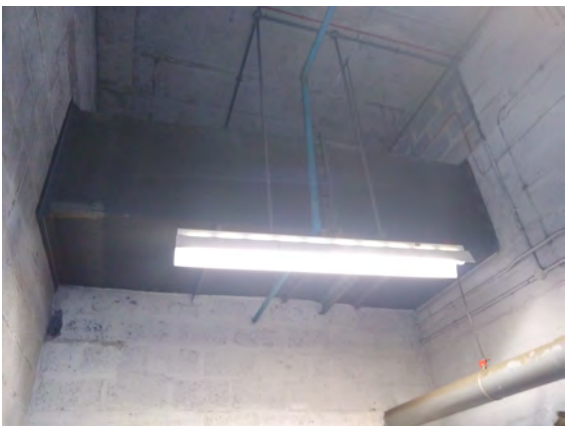
Item 27 Ref: As 20277-73

The Sealant to joints (Electrical workshop/Rm 0/064) contains asbestos.

Whilst this cannot be inspected, any change in appearance should be reported to Property Services.

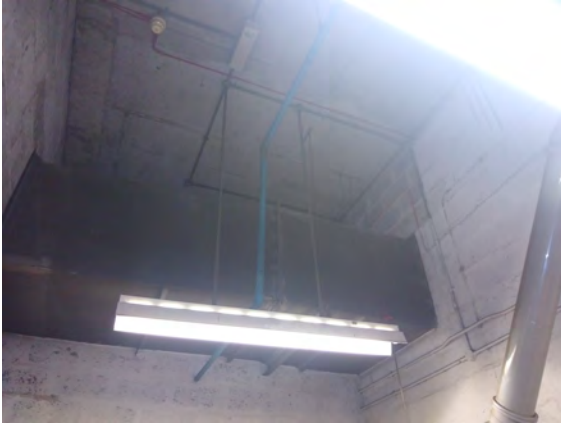
Item 28 Ref: As 20277-173

- (Item 28) Ref: As 20277-173 – Rope packing (Electrical workshop/Rm 0/064) – Low Risk

The Rope packing (Electrical workshop/Rm 0/064) contains asbestos.

Whilst this cannot be inspected, any change in appearance should be reported to Property Services.

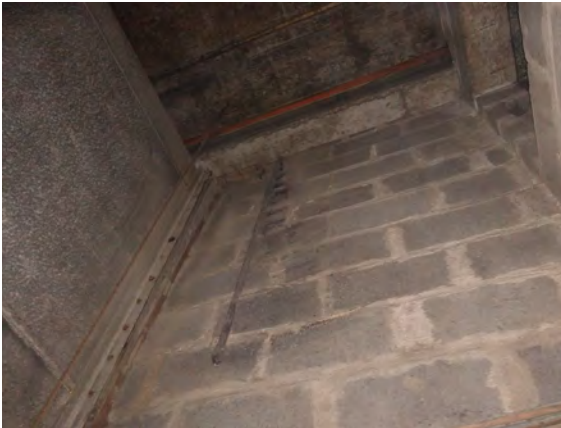
Item 29 Ref: As 20277-173

- (Item 29) Ref: As 20277-173 – Rope packing (Plenum Room/Rm 0/065) – Low Risk
- (Item 30) Ref: As 20277-181 – Damp proof course (Plenum Room/Rm 0/065) – Very Low Risk

The Rope packing (Plenum Room/Rm 0/065) contains asbestos.

Whilst this cannot be inspected, any change in appearance should be reported to Property Services.

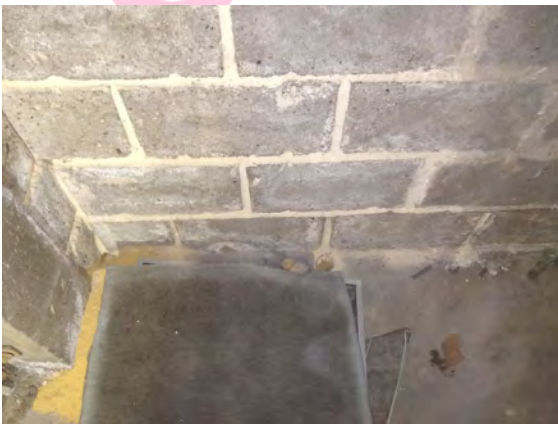
Item 30 Ref: As 20277-181

The Damp proof course (Plenum Room/Rm 0/065) contains asbestos.

Any change in appearance should be reported to Property Services.

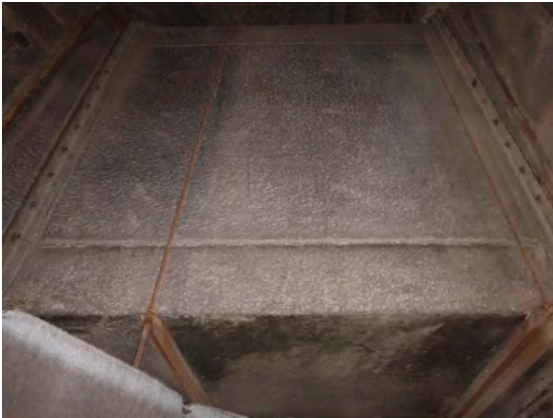
Item 31 Ref: As 20277-73

- (Item 31) Ref: As 20277-73 – Sealant to joints (Plenum Room/Rm 0/065) – Very Low Risk
- (Item 32) Ref: As 20277-173 – Rope packing (Generator Room/Rm 0/067) – Low Risk

The Sealant to joints (Plenum Room/Rm 0/065) contains asbestos.

Whilst this cannot be inspected, any change in appearance should be reported to Property Services.

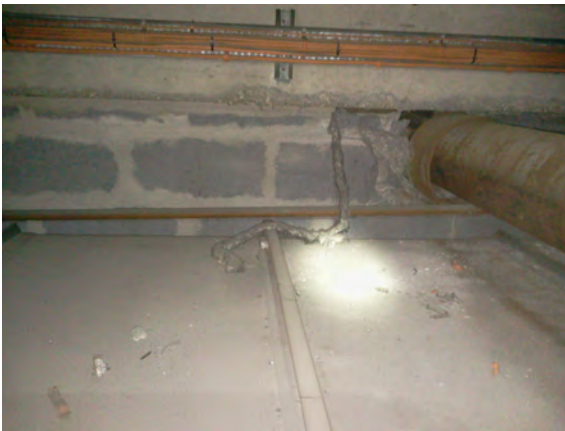
Item 32 Ref: As 20277-173

The Rope packing (Generator Room/Rm 0/067) contains asbestos.

Whilst this cannot be inspected, any change in appearance should be reported to Property Services.

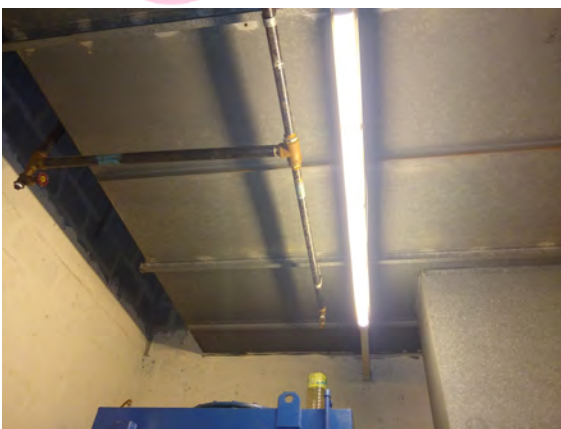
Item 33 Ref: As 20277-73

The Sealant to joints (Generator Room/Rm 0/067) contains asbestos.

Whilst this cannot be inspected, any change in appearance should be reported to Property Services.

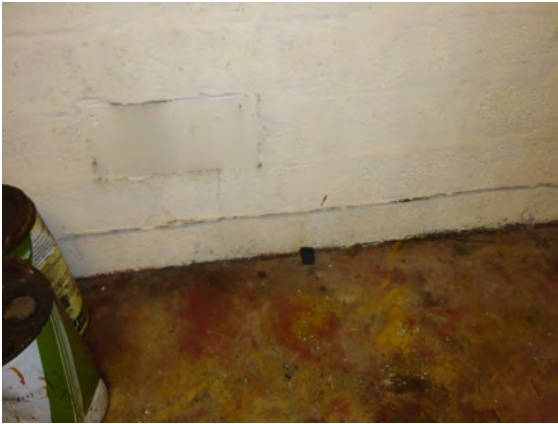
Item 34 Ref: As 20277-181

The Damp proof course (Generator Room/Rm 0/067) contains asbestos.

Any change in appearance should be reported to Property Services.

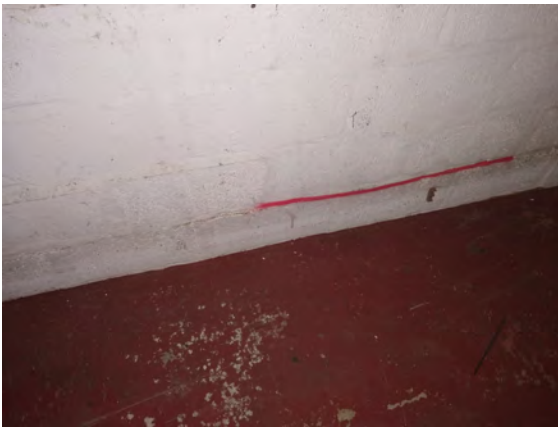
Item 35 Ref: As 20277-181

The Damp proof course (Woodworking shop/Rm 0/068) contains asbestos.

Any change in appearance should be reported to Property Services.

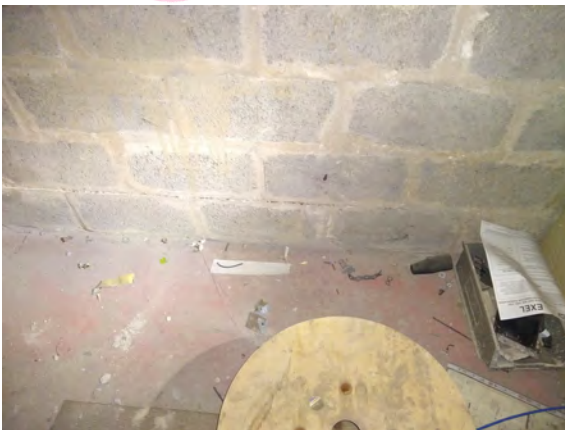
Item 36 Ref: As 20277-181

The Damp proof course (LV switchroom/Rm 0/069) contains asbestos.

Any change in appearance should be reported to Property Services.

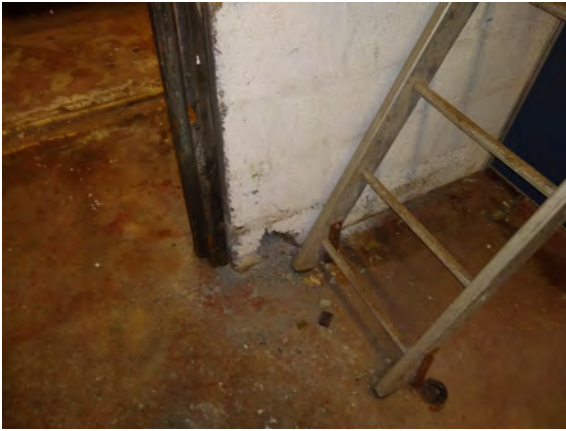
Item 37 Ref: As 20277-181

- (Item 37) Ref: As 20277-181 – Damp proof course (Store/Rm 0/070) – Very Low Risk
- (Item 38) Ref: 20277-182 – Loose lying gaskets (Gas meter house/Rm 0/071) – Very Low Risk

The Damp proof course (Store/Rm 0/070) contains asbestos.

Item 37	Damp proof course (Store/Rm 0/070)	Very Low Risk	12 monthly	05/12/2026
Item 38	Loose lying gaskets (Gas meter house/Rm 0/071)	Very Low Risk	12 monthly	05/12/2026

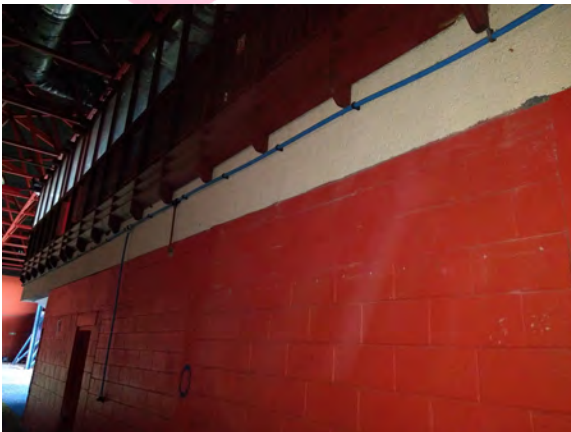
Item 45 Ref: 20277-80

The Rope Packing (Ice rink/Rm 1/003) contains asbestos.

Whilst this cannot be inspected, any change in appearance should be reported to Property Services.

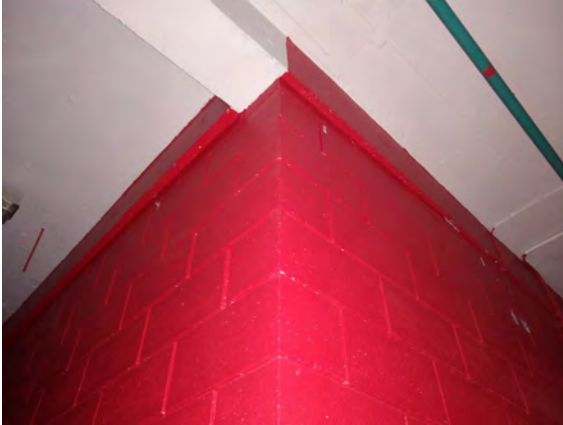
Item 46 Ref: As 20277-56

The Rope packing (Changing Room/Rm 1/004) contains asbestos.

Whilst this cannot be inspected, any change in appearance should be reported to Property Services.

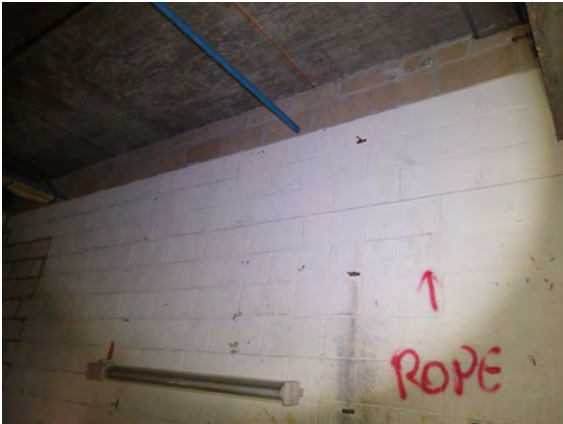
Item 49 Ref: 20277-95

The Rope packing (Garage to ice grooming machine/Rm 1/005) contains asbestos.

Whilst this cannot be inspected, any change in appearance should be reported to Property Services.

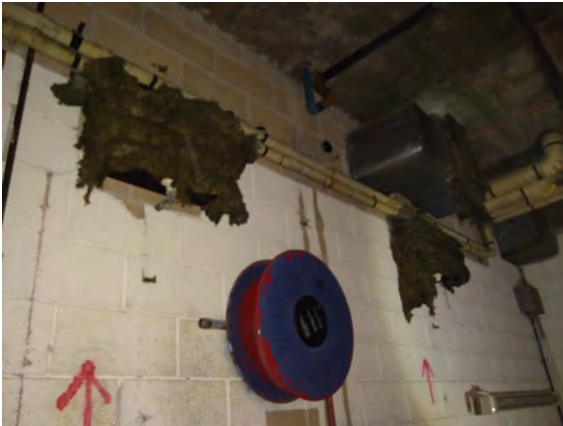
Item 50 Ref: 20277-96

The Urinal cistern (Garage to ice grooming machine/Rm 1/005) contains asbestos.

Any change in appearance should be reported to Property Services.

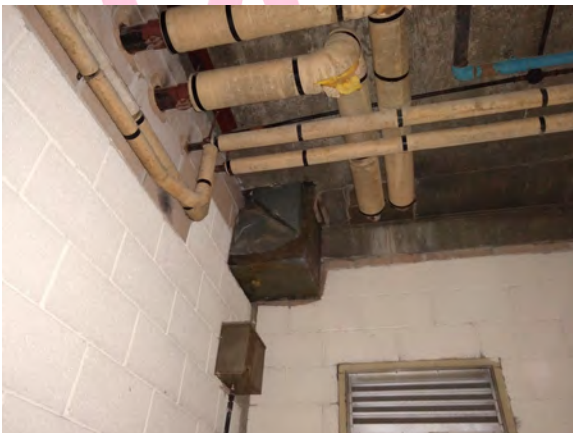
Item 51 Ref: 20277-97

The Sealant to joints (Garage to ice grooming machine/Rm 1/005) contains asbestos.

Whilst this cannot be inspected, any change in appearance should be reported to Property Services.

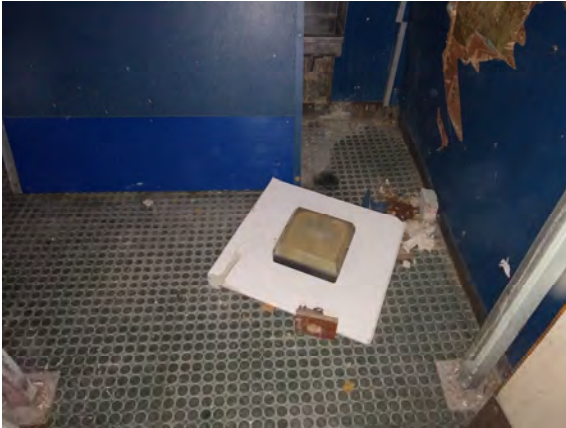
Item 52 Ref: 20277-77

The Floor covering (Male WC/Rm 1/006) does not contain asbestos.

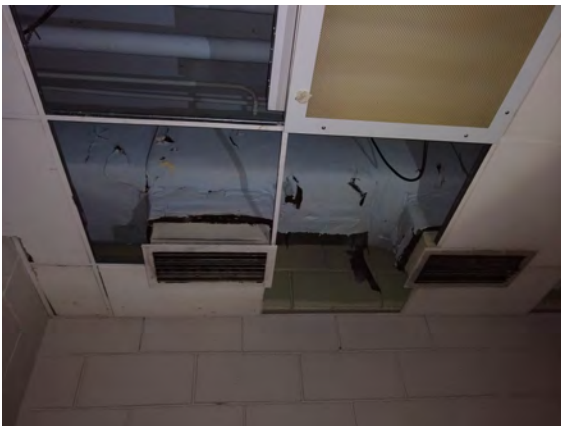
Item 53 Ref: As 20277-97

The Sealant to square section ductwork (Male WC/Rm 1/006) contains asbestos.

Whilst this cannot be inspected, any change in appearance should be reported to Property Services.

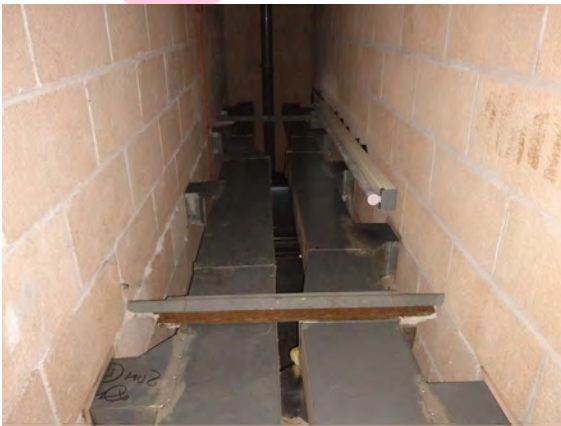
Item 54 Ref: As 20277-97

The Sealant to square section ductwork (Cistern void/Rm 1/007) contains asbestos.

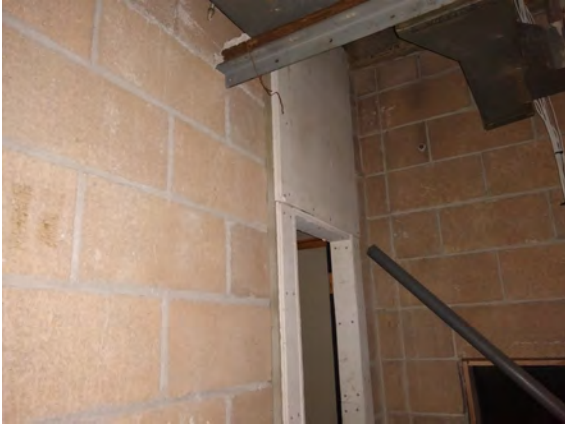
Item 55 Ref: 20277-98

- (Item 55) Ref: 20277-98 – Boards to door and door frame (Cistern void/Rm 1/007) – No Risk
- (Item 56) Ref: 20277-99 – Loose lying panels (Cistern void/Rm 1/007) – No Risk

The Boards to door and door frame (Cistern void/Rm 1/007) do not contain asbestos.

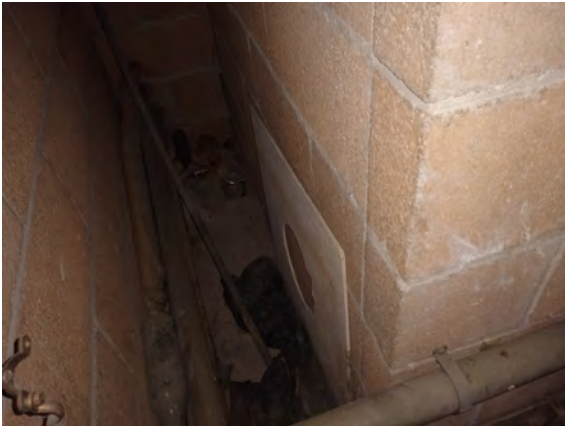
Item 56 Ref: 20277-99

The Loose lying panels (Cistern void/Rm 1/007) does not contain asbestos.

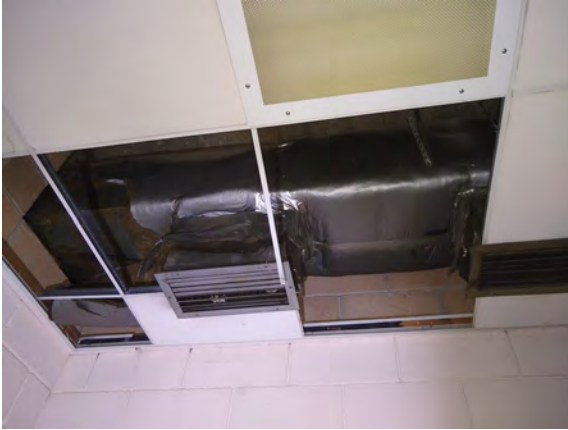
Item 58 Ref: As 20277-97

The Sealant to square section ductwork (Female WC/Rm 1/008) contains asbestos.

Whilst this cannot be inspected, any change in appearance should be reported to Property Services.

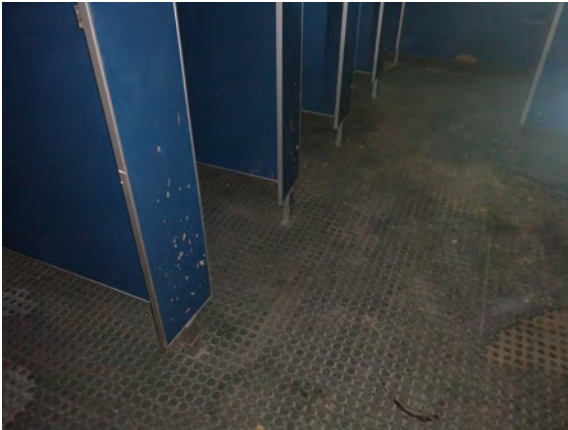
Item 59 Ref: As 20277-77

The Floor covering (Female WC/Rm 1/008) does not contain asbestos.

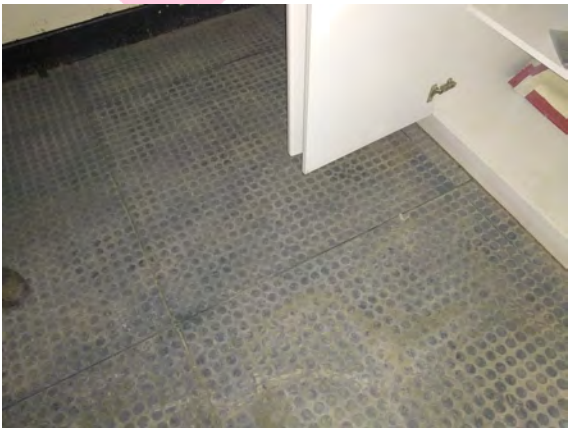
Item 60 Ref: As 20277-77

The Floor covering (First Aid/Rm 1/009) does not contain asbestos.

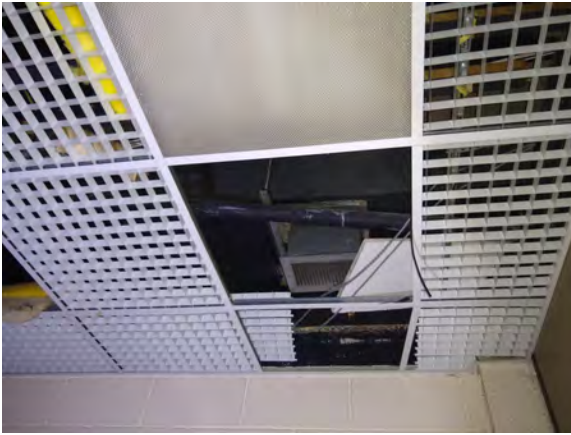
Item 61 Ref: As 20277-97

The Sealant to square section ductwork (First Aid/Rm 1/009) contains asbestos.

Whilst this cannot be inspected, any change in appearance should be reported to Property Services.

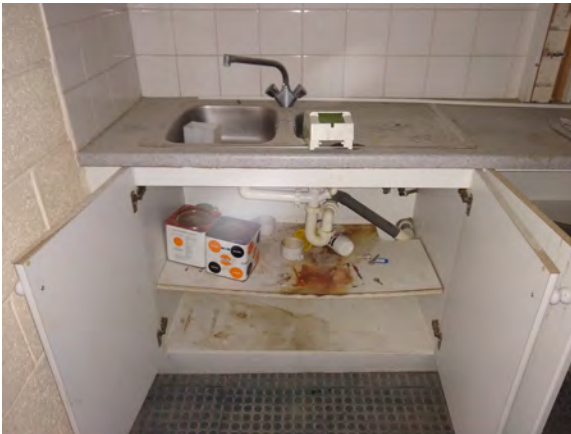
Item 62 Ref: 20277-100

The Sink pad (First Aid/Rm 1/009) does not contain asbestos.

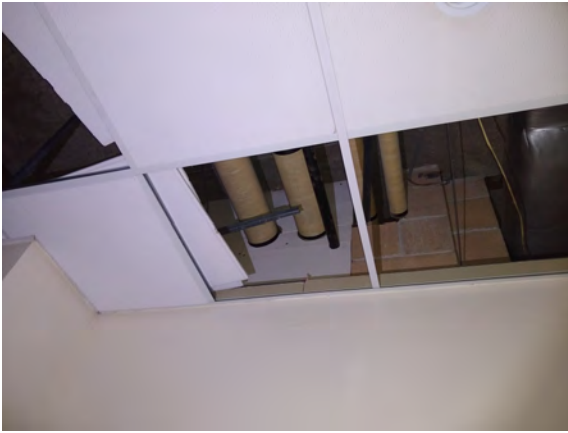
Item 64 Ref: 20277-101

The Firebreak panels (Shop/Rm 1/010) does not contain asbestos.

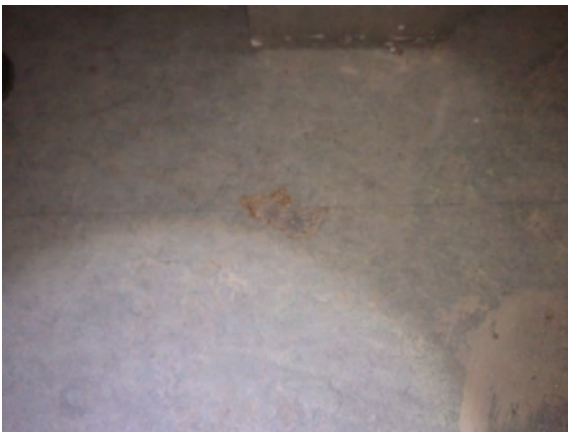
Item 65 Ref: As 20277-77

The Floor covering (Shop/Rm 1/010) does not contain asbestos.

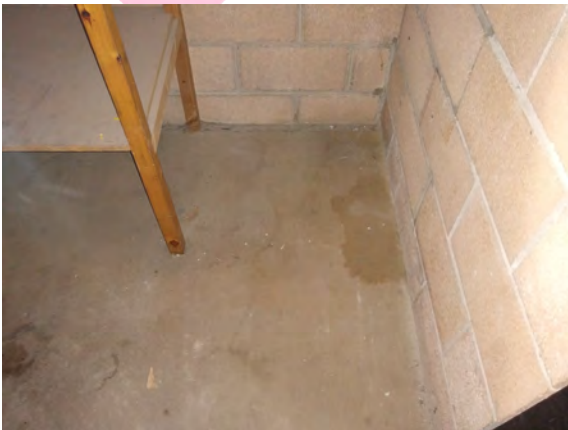
Item 66 Ref: 20277-103

The Floor covering (Store/Rm 1/011) does not contain asbestos.

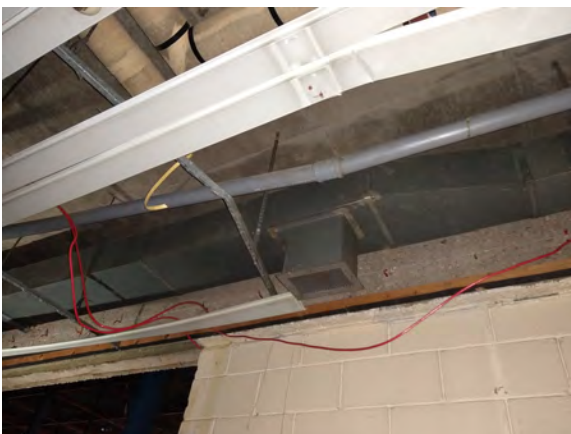
Item 69 Ref: As 20277-104

The Sealant to square section ductwork (Skate store/Rm 1/012) contains asbestos.

Whilst this cannot be inspected, any change in appearance should be reported to Property Services.

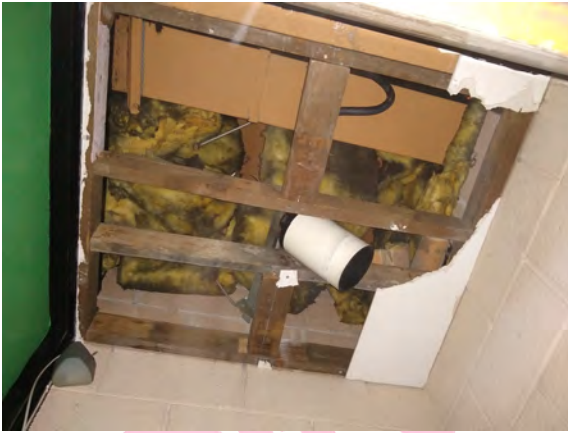
Item 71 Ref: 20277-107

The Fixed ceiling (Lobby to stairwell/Rm 1/013) does not contain asbestos.

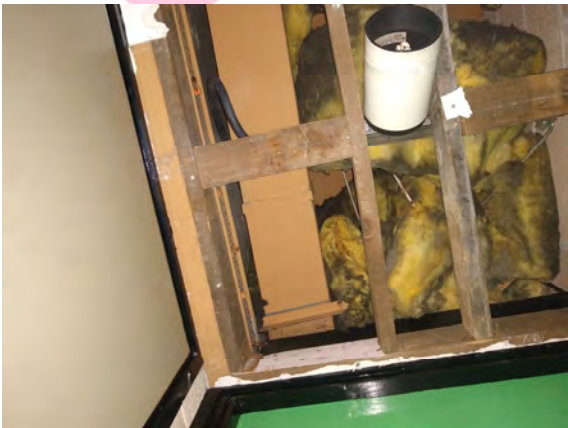
Item 72 Ref: As 20277-104

The Sealant to square section ductwork (lobby to stairwell/Rm 1/013) contains asbestos.

Whilst this cannot be inspected, any change in appearance should be reported to Property Services.

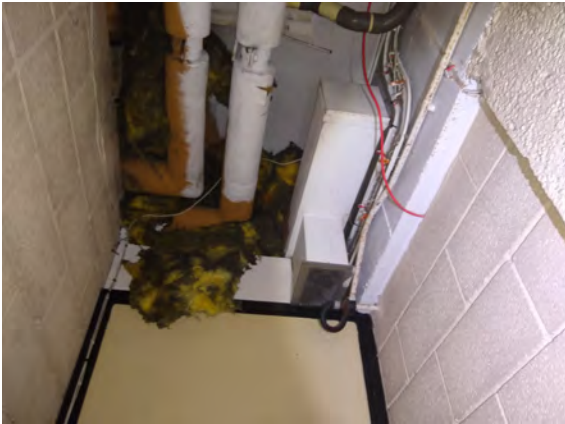
Item 73 Ref: As 20277-104

The Sealant to square section ductwork (Stairwell/Rm 1/014) contains asbestos.

Whilst this cannot be inspected, any change in appearance should be reported to Property Services.

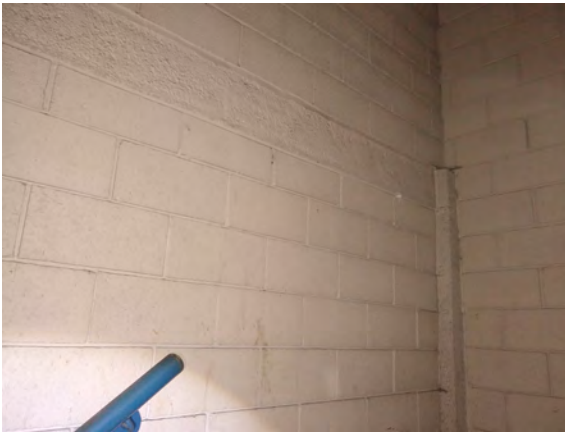
Item 74 Ref: 20277-108

The Rope packing (Stairwell/Rm 1/014) contains asbestos.

Whilst this cannot be inspected, any change in appearance should be reported to Property Services.

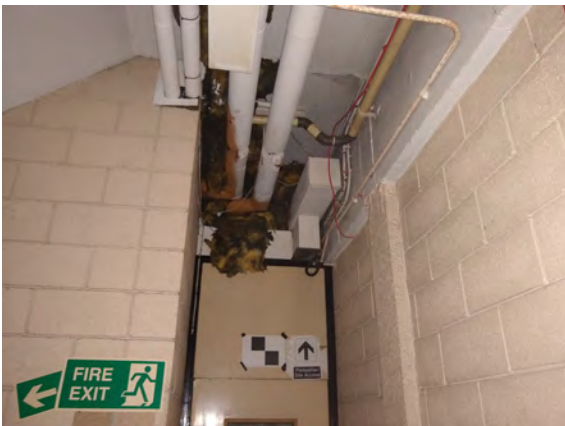
Item 75 Ref: As 20277-107

The Ceiling panel (Stairwell/Rm 1/014) does not contain asbestos.

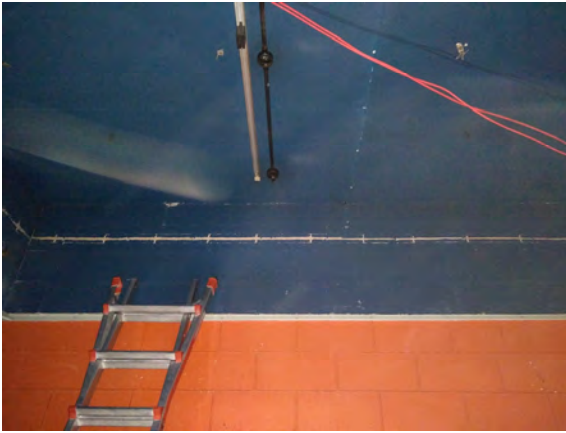
Item 76 Ref: As 20277-108

The Rope packing (Lobby to ice rink/Rm 1/015) contains asbestos.

Whilst this cannot be inspected, any change in appearance should be reported to Property Services.

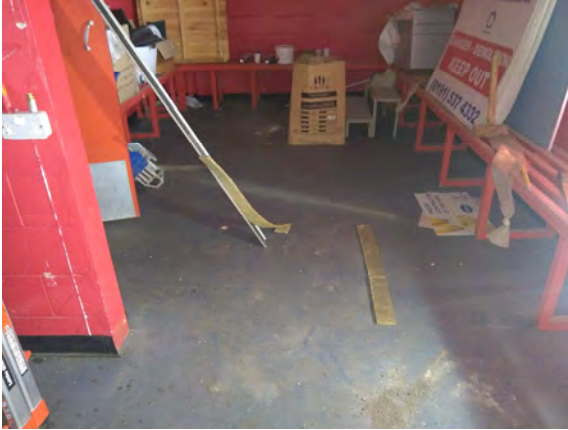
Item 79 Ref: As 20277-77

The Floor covering (Changing Rooms/Rm 1/021) does not contain asbestos.

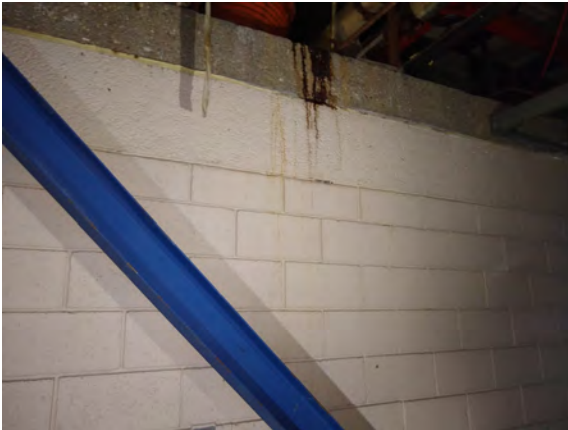
Item 80 Ref: As 20277-56

The Rope packing (Lobby Area/Rm 2/010) contains asbestos.

Whilst this cannot be inspected, any change in appearance should be reported to Property Services.

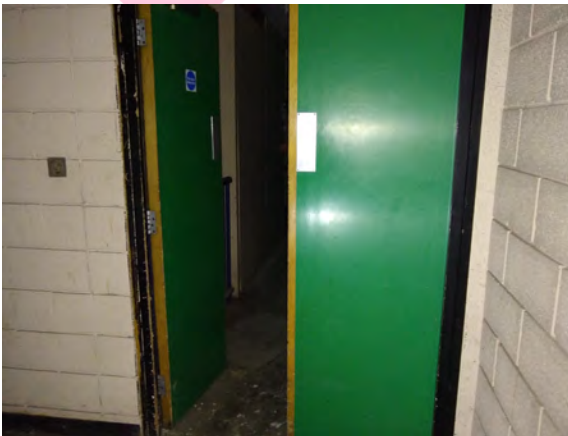
Item 81 Ref: 20277-19

The Fire strips in fire doors (Lobby Area/Rm 2/010) does not contain asbestos.

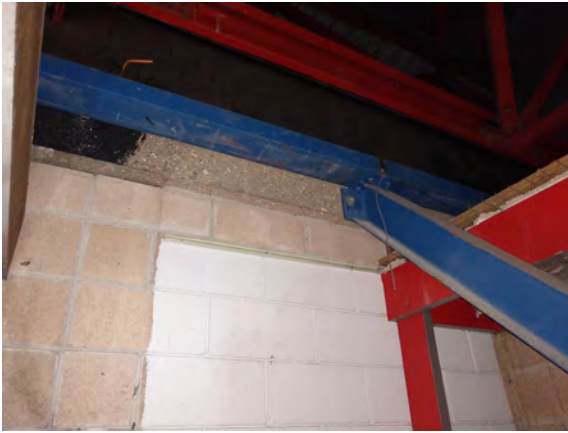
Item 82 Ref: As 20277-56

The Rope packing (Bar Server/Rm 2/011) contains asbestos.

Whilst this cannot be inspected, any change in appearance should be reported to Property Services.

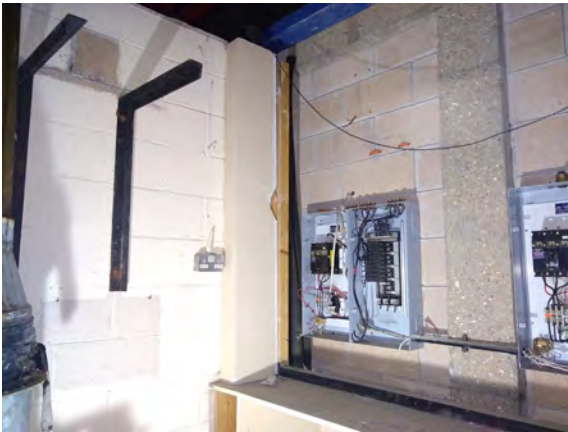
Item 83 Ref: 20277-30

The Boxing around distribution boards (Switchroom/Rm 2/012) does not contain asbestos.

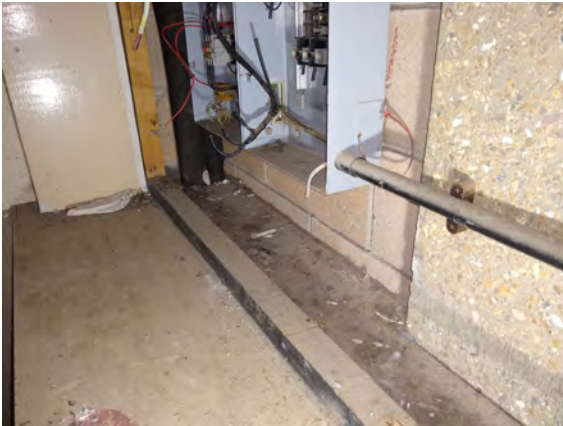
Item 86 Ref: 374099-1

The Debris to bench top
(Switchroom/Rm 2/012)
contains asbestos.

Any change in appearance
should be reported to Property
Services.

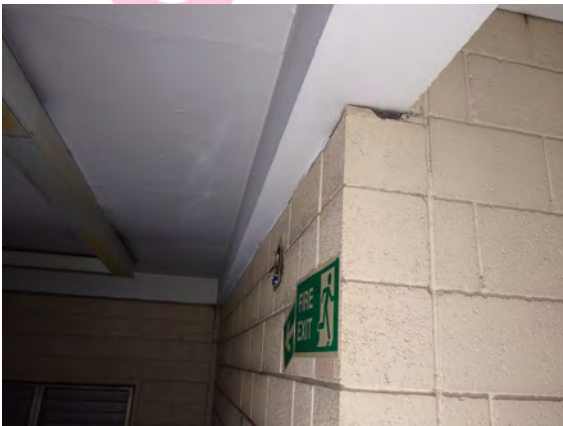
Item 87 Ref: 20277-52

The Rope packing
(Stairwell/Rm 2/014) contains
asbestos.

Whilst this cannot be
inspected, any change in
appearance should be
reported to Property Services.

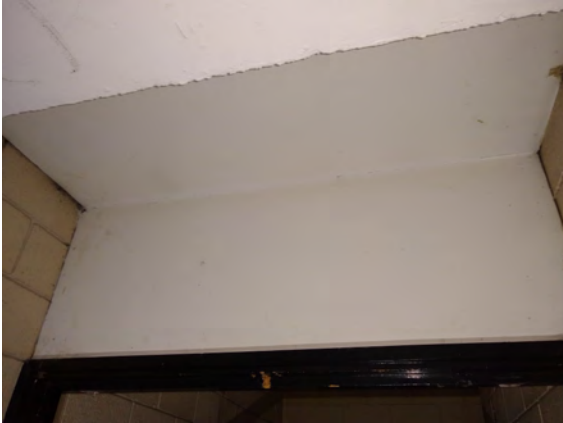
Item 88 Ref: 20277-40

The Ceiling panel
(Stairwell/Rm 2/014) does not
contain asbestos.

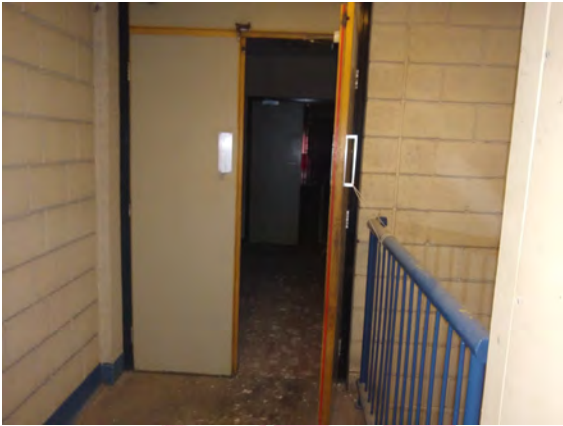
Item 89 Ref: As 20277-19

The Fire strips in fire doors
(Stairwell/Rm 2/014) does not
contain asbestos.

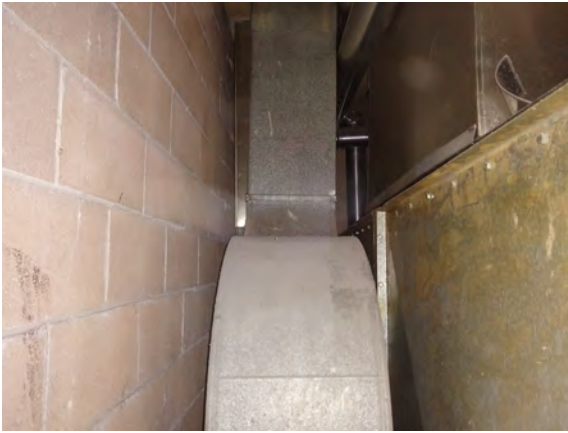
Item 103 Ref: As 20277-43

The Sealant to joints (Air handling plant unit/Rm 2/028) contains asbestos.

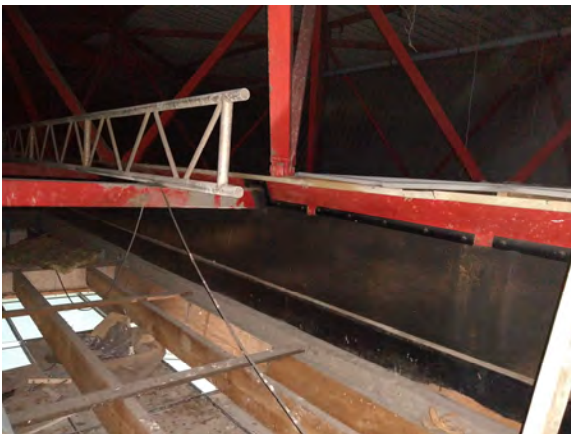
Item 116 Ref: 20277-62

The Sealant to steelwork at penetration (High level area above ice rink/Rm 3/002) does not contain asbestos.

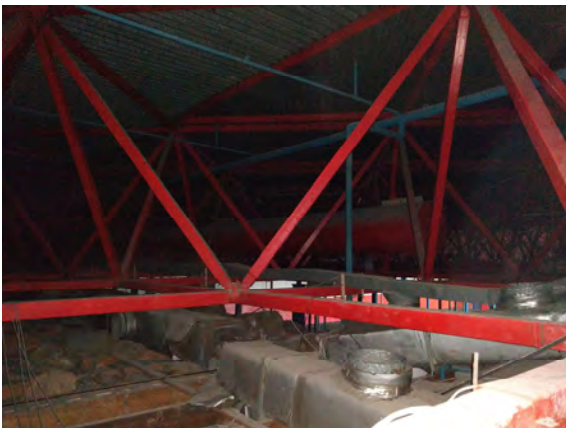
Item 117 Ref: 20277-59

The Sealant to round section ductwork (High level area above ice rink/Rm 3/002) contains asbestos.

Whilst this cannot be inspected, any change in appearance should be reported to Property Services.

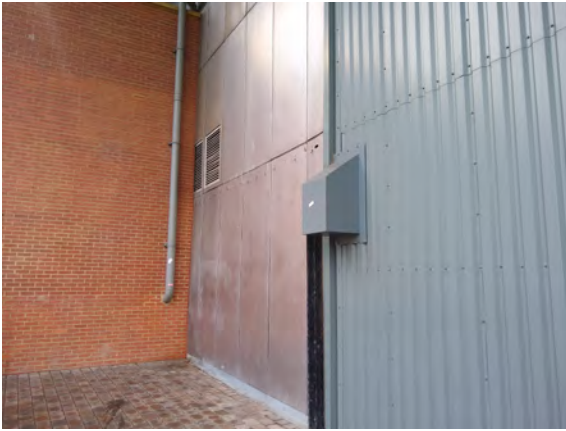
Item 118 Ref: 20277-146

The Inside leaf of silver cladding panels (External) contains asbestos.

Whilst this cannot be inspected, any change in appearance should be reported to Property Services.

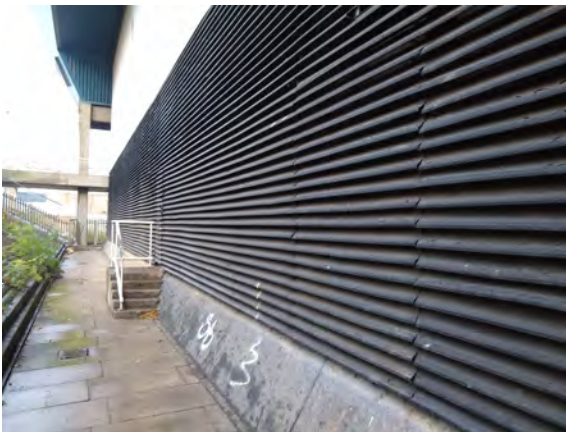
Item 119 Ref: 20277-147

The Coating to louvered panels around plant area (External) does not contain asbestos.

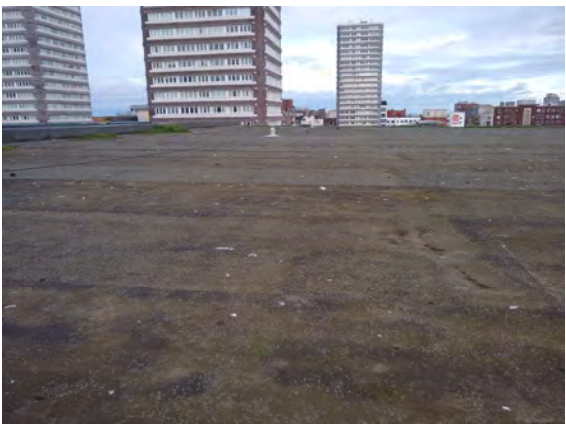
Item 120 Ref: 20277-151

The Roof covering (External/Main roof area) contains asbestos.

Any change in appearance should be reported to Property Services.

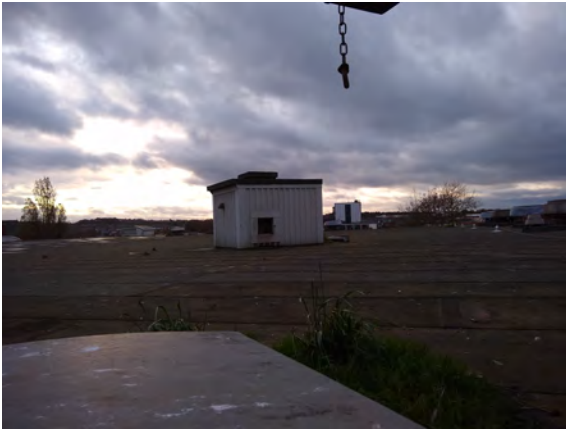
Item 121 Ref: 20277-153

The Sealant to breather pipe externally (Main roof area/tank room) contains asbestos.

Any change in appearance should be reported to Property Services.

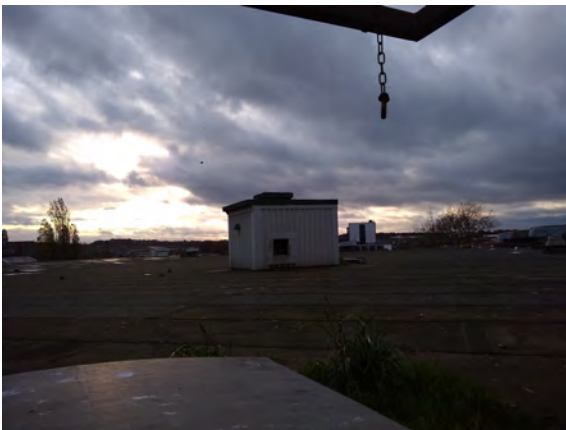
Item 122 Ref: 20277-154

The Promenade tile debris to floor in tank room (Main roof area/tank room) contains asbestos.

Any change in appearance should be reported to Property Services.

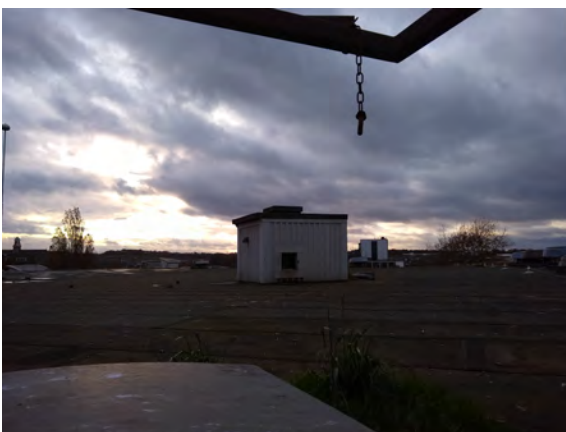
Item 123 Ref: 20277-152

The Gasket to immersion heater element (Main roof area/tank room) contains asbestos.

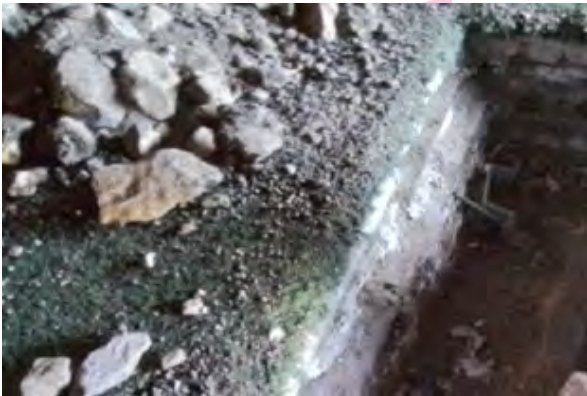
Item 125 Ref: PZ000394

The floor above pipework, under polystyrene insulation in the Sports Hall G/001 does not contain asbestos.

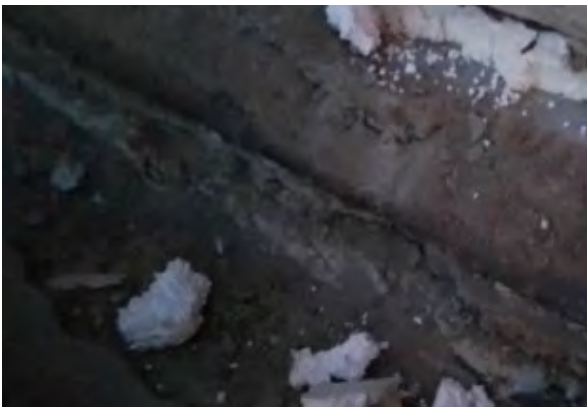
Item 126 Ref: PZ000395

The floor adhesive to blue foam insulation in the Sports Hall G/001 does not contain asbestos.

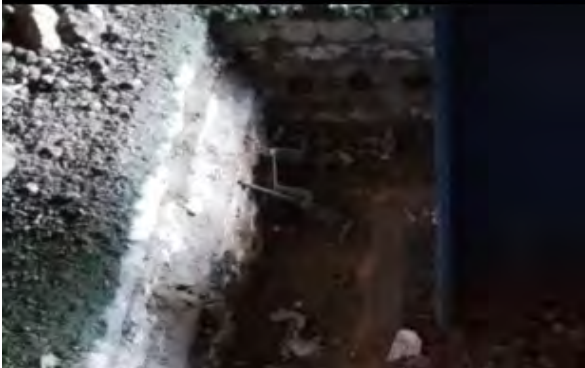
Item 127 Ref: PZ000396

The damp proof course under columns in the Sports Hall G/001 does not contain asbestos.

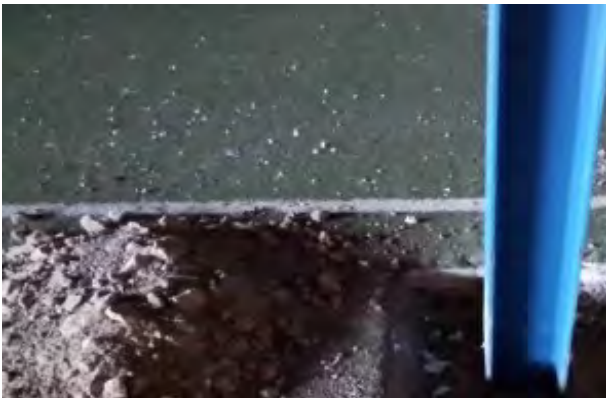
Item 128 Ref: PZ000397

The floor in the Sports Hall G/001 does not contain asbestos.

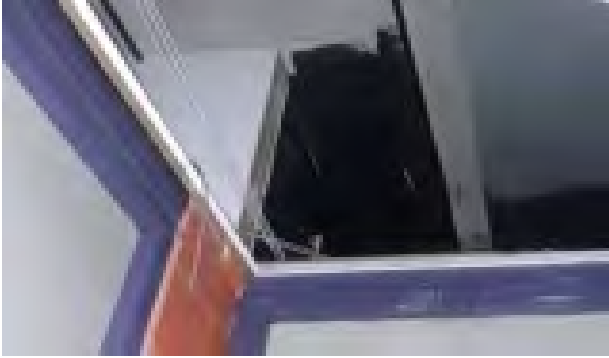
Item 130 Ref: NZ001774

The ceiling void wall in the medical/first aid room (1/006) does not contain asbestos.

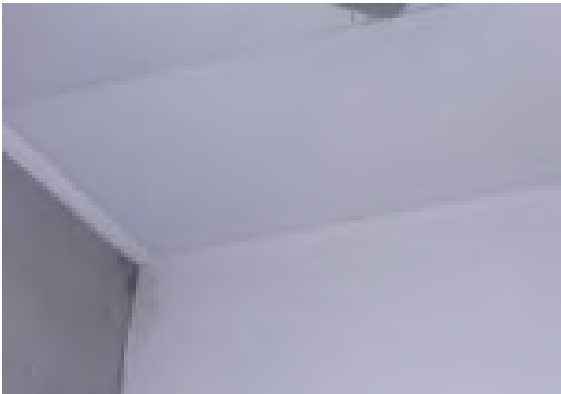
Item 134 Ref: As NZ001776

The door header panel to left hand side of staircase (Corridor 2/005) does not contain asbestos.

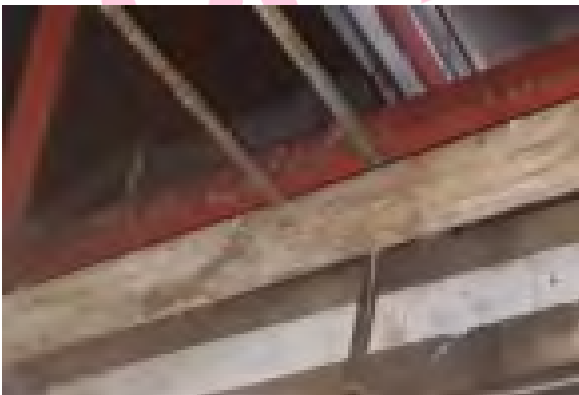
Item 135 Ref: As NZ001776

The door header panel to left hand side of staircase (Plant Room 2/011) does not contain asbestos.

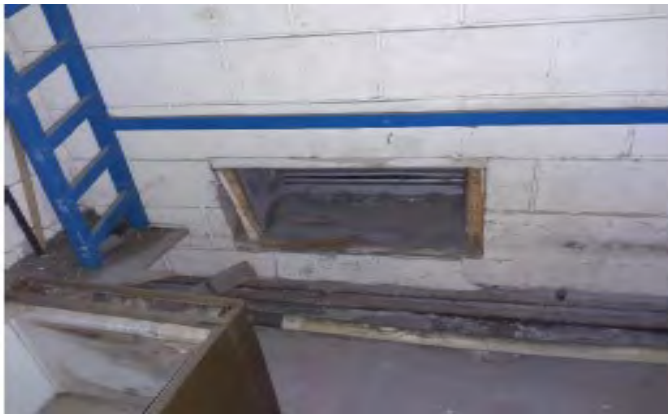
Item 145 Ref: PK002592

The cement panels to metal wall vents in the Garage (1/02) does contain asbestos.

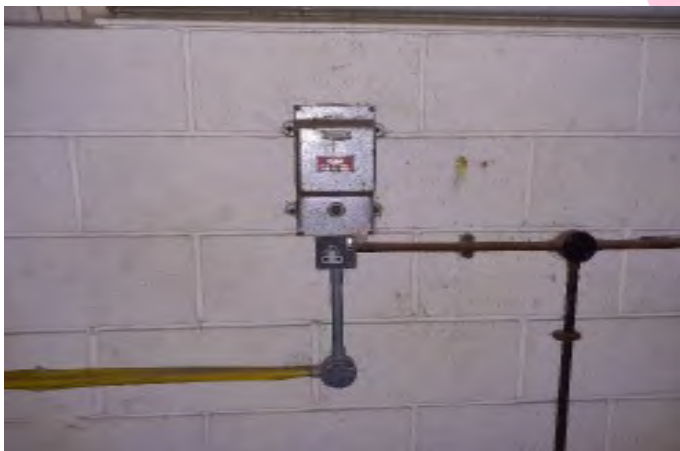
Item 146 Ref: As PK002608

The sleeve type flashguards and screw cap to fuse Walsall electrics in the Garage (1/02) does contain asbestos.

Any change in appearance should be reported to Property Services.

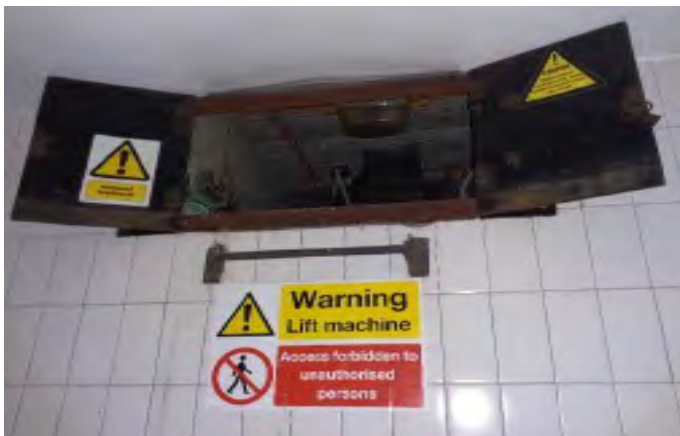
Item 148 Ref: Presumed

The brake pads to the lift motor in the Lift motor room (2/18) are presumed to contain asbestos.

Any change in appearance should be reported to Property Services.
