ASBESTOS SURVEY REPORT FOR CROWTREE LEISURE CENTRE,
CROWTREE ROAD, SUNDERLAND, SR1 3EL.

Asbestos Register for

Crowtree Leisure Centre, Crowtree Road, Sunderland

Date: 07 January 2026

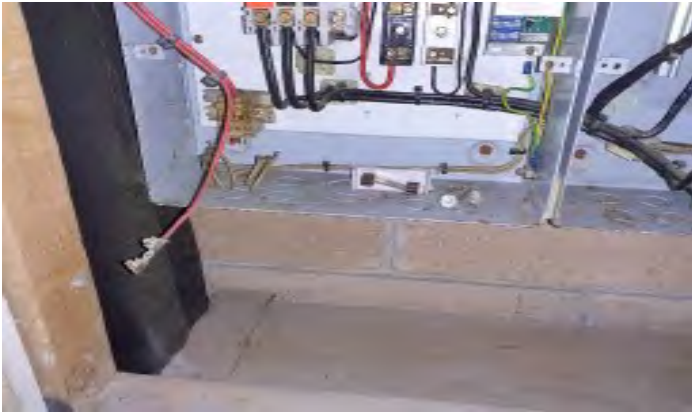
Item 149 Ref: PK002604

The flash guard fuses dated 1967 in the Switch Room (2/05) does contain asbestos.
