ASBESTOS SURVEY REPORT FOR ENDURANCE WAREHOUSE, NORTH MOOR STREET, SUNDERLAND, SR1 2BQ

**ENDURANCE HOUSE AND WAREHOUSE, NORTH  
MOOR STREET,  
SUNDERLAND, SR1 2BQ**

**Date: 25 September 2025**

Endurance House - Last updated 25/09/2025 – Version 2

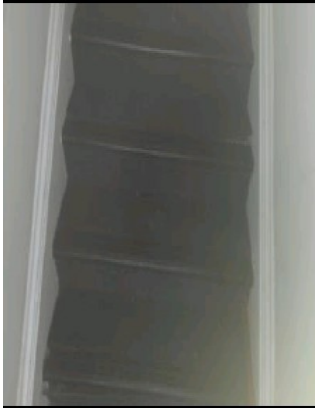
### **Item 1 Ref: EA001484**

The stair nosing to the entrance lobby (Room 1) does not contain asbestos.

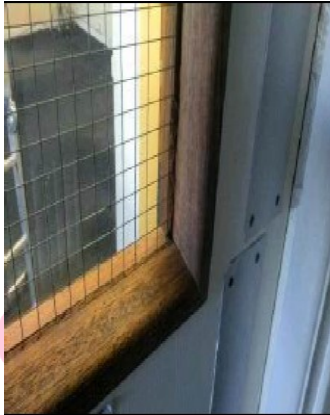
### **Item 2 - Ref: EA001485**

The window putty to door glass in the entrance lobby (Room 1) does not contain asbestos.

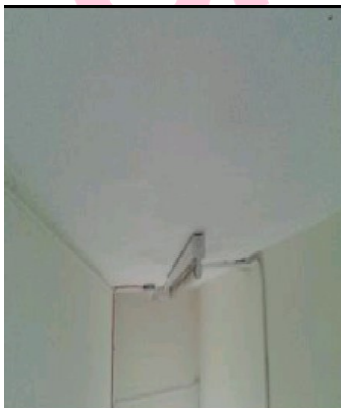
### **Item 3 - Ref: EA001486**

The textured coating to ceiling (Entrance Lobby) (Room 1) does not contain asbestos.

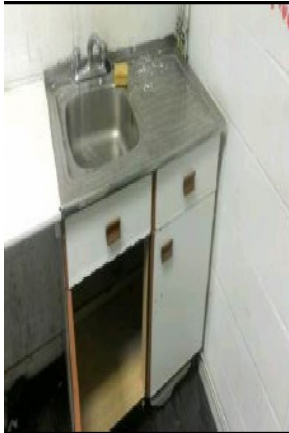
### **Item 31 - Ref: EA001499**

The Bitumen pads to the underside of the sink and drainer to the kitchen (Room 11) do not contain asbestos.

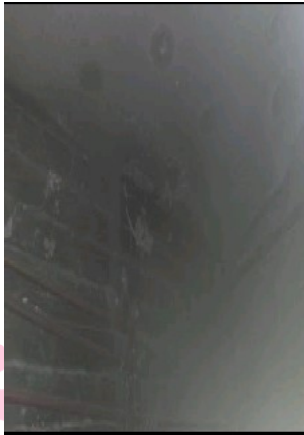
### **Item 32 - Ref: As EA001495**

The paper lined fibreboard ceiling panels to the kitchen (Room 11) contain asbestos.

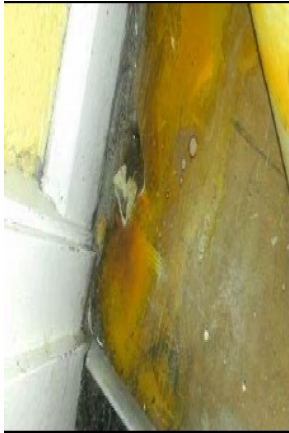
### **Item 34 - Ref: EA001501**

The old lino beneath modern flooring in cubicles to the toilets (Room 12) does not contain asbestos.

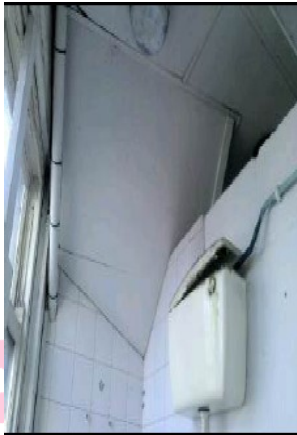
### **Item 35 - Ref: As EA001488**

The cladding to the underside of the stairs in the toilets (Room 12) does not contain asbestos.

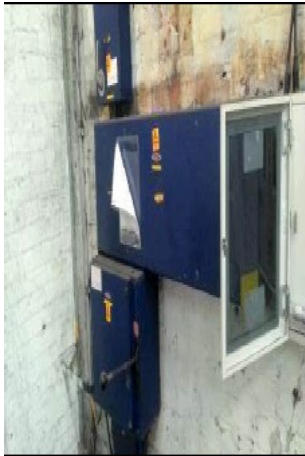
### **Item 37 - Presumed**

It was presumed asbestos was present in the flash guards within fuse box in warehouse 1 (Ground Floor) (Room 14).

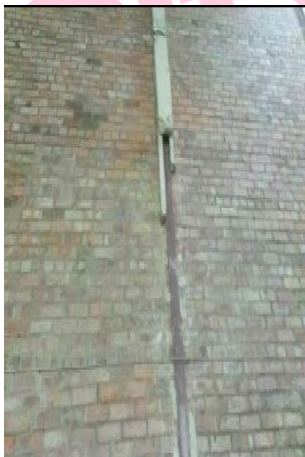
### **Item 39 - Ref: EA001510**

The vermiculite cladding to steel columns top warehouse 4 (Room 16) does not contain asbestos.

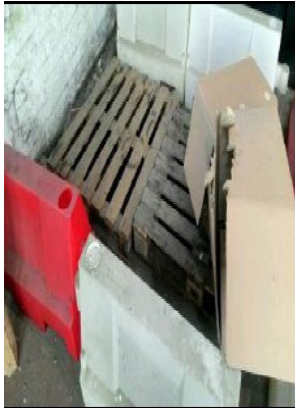
No access within underground pit to warehouse 1. (Room 14). Further investigation required.

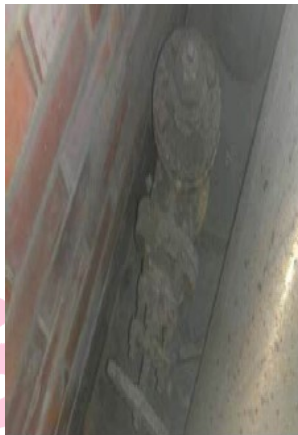
### **Item 48 - Ref: As EA001515**

The gasket to the pipe flange in boiler room 2 (Room 18) does contain asbestos.

Any change in its appearance should be recorded, and passed to Property Services.

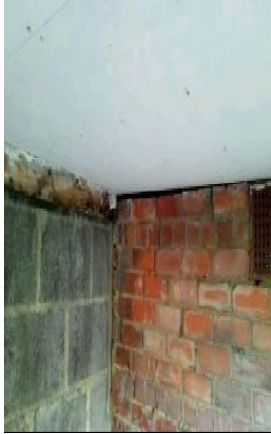
### **Item 50 - Ref: EA001529**

The ceiling boards to the Gas intake room (Room 20) contain asbestos.

Any change in its appearance should be recorded, and passed to Property Services.

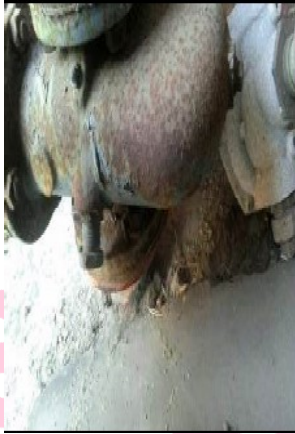
### **Item 51 - Ref: EA001523**

The gasket to pipework flanges to the Gas intake room (Room 20) does not contain asbestos.

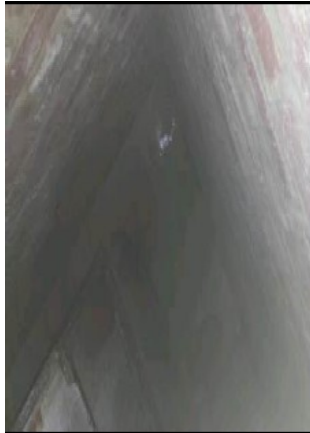
### **Item 53 - Ref: As EA001513**

The ceiling boards to boiler room 3 (Room 21) does contain asbestos.

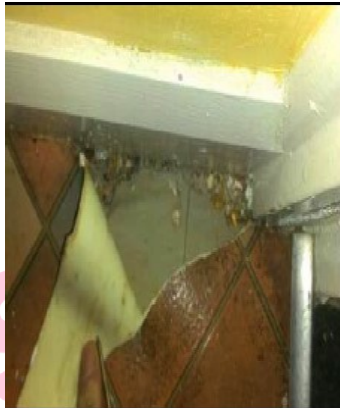
**Item 63 - Ref: As EA001502**

The red screed to the WC lobby (First floor - Room 7) does not contain asbestos.

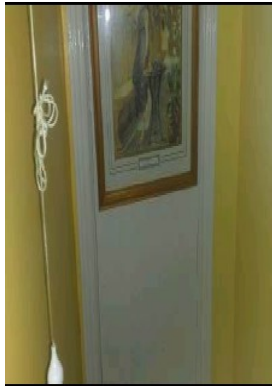
**Item 65 - Ref: EA001506**

The panel to the window in the female wc (First Floor Room 8) does not contain asbestos.

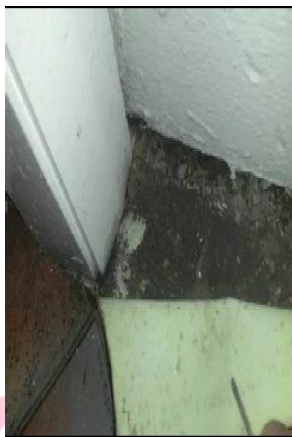
**Item 66 - Ref: As EA001502**

The red floor screed to floor of the male wc (First floor Room 9) does not contain asbestos.

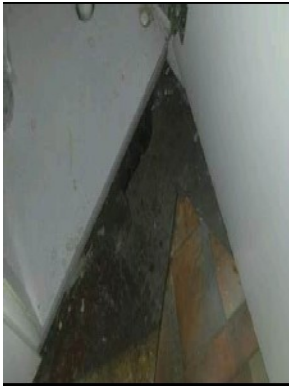
### **Item 68 - Ref: As EA001502**

The red screed to floor of the male wc (First floor Room 9) does not contain asbestos.

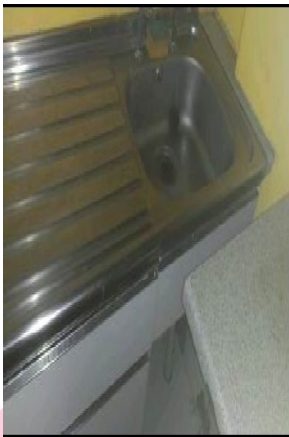
### **Item 69 - Ref: EA001507**

The bitumen pads to the underside of sink drainers in the kitchen (First Floor Room 10) do not contain asbestos.

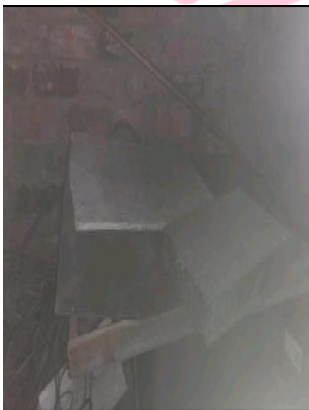
### **Item 70 - Ref: EA001527**

The panel on top of the water tank (Roof Void) (Room 1) does not contain asbestos.

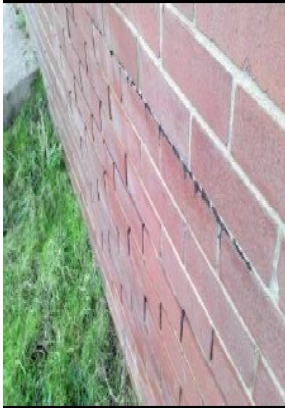
### **Item 76 - Ref: EA001521**

The damp proof course to Warehouse 4 (External) contains asbestos.

Any change in its appearance should be recorded and passed to Property Services.

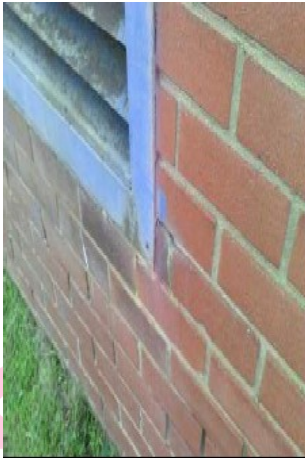
### **Item 77 - Ref: EA001522**

The mastic to vent frills on boiler room walls (External) does not contain asbestos.

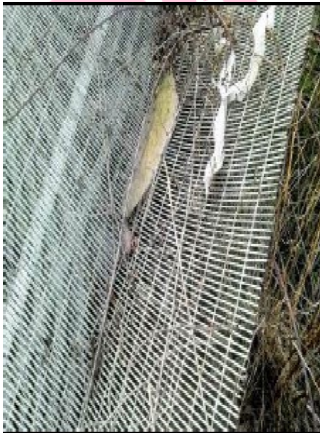
### **Item 78 - Ref: EA001525**

The cement debris to the ground (External) contains asbestos.

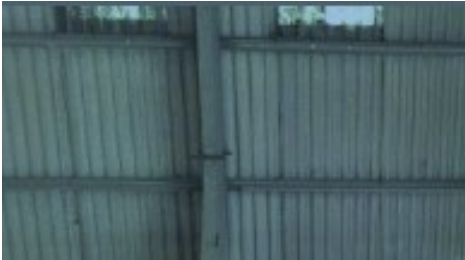
**Item 79 - Ref: EC001129**

The cement ceiling panels to Room 1 Warehouse 2 contain asbestos.

Any change in its appearance should be recorded and passed to Property Services.

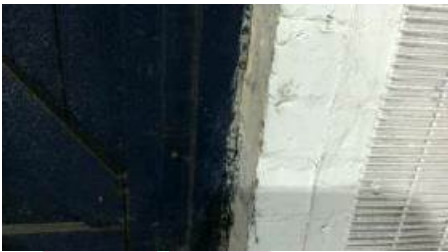
**Item 80 - Ref: EC001130**

The mastic to the door in room 1 to warehouse 2 does not contain asbestos.

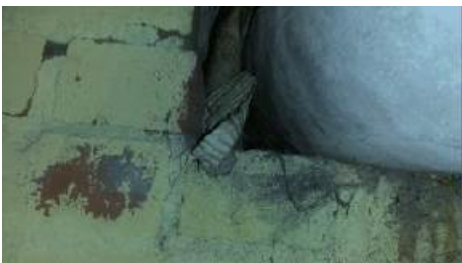
**Item 81 - Ref: EC001131**

The flue penetration to room 1 in warehouse 2 does not contain asbestos.

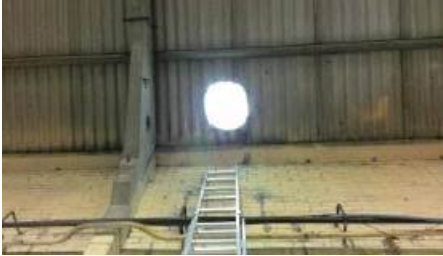
**Item 82 - Ref: EC001132**

The cement ceiling panels to Room 1 Warehouse 2 contain asbestos.

Any change in its appearance should be recorded and passed to Property Services.

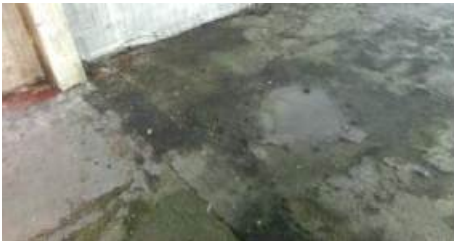
**Item 83 - Ref: EC001133**

The random debris to the floor in room 1, Warehouse 2 does not contain asbestos.

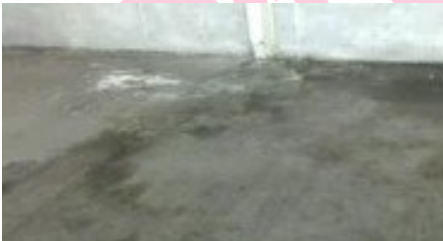
**Item 84 - Ref: EC001134**

The random debris to the floor in room 1, Warehouse 2 does not contain asbestos.

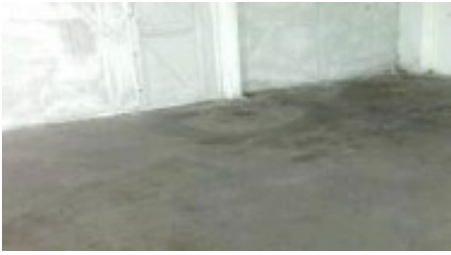
### **Item 85 - Ref: EC001135**

The random debris to the floor in room 1, Warehouse 2 does not contain asbestos.

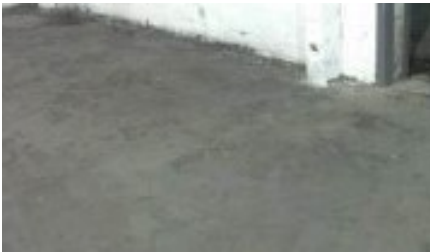
### **Item 86 - Ref: EC001136**

The random debris to the floor in room 1, Warehouse 2 does not contain asbestos.

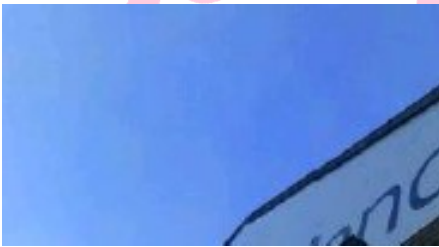
### **Item 87 - Ref: EC001147**

The external cement fascia to the external of warehouse 2 contains asbestos.

Any change in its appearance should be noted and passed to Property Services.

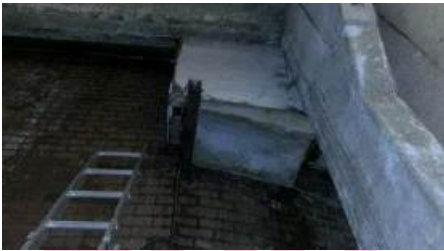
### **Item 89 - Ref: EC001138**

The boxing to room 1 in Warehouse 3 contains asbestos.

Any change in its appearance should be recorded and passed to Property Services.

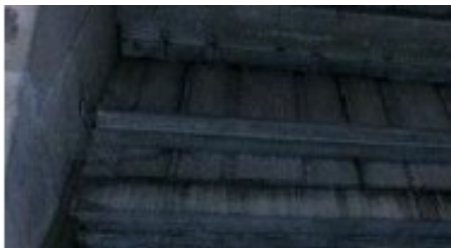
### **Item 90 - Ref: EC001139**

The cement wall panels to room 1 of Warehouse 3 contain asbestos.

Any change in its appearance should be recorded and passed to Property Services.

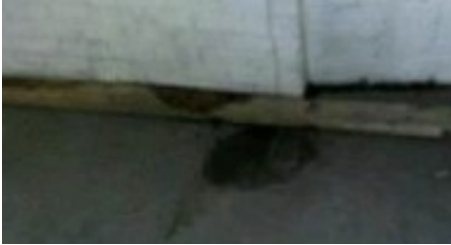
**Item 91 - Ref: EC001140**

The floor debris to room 1 of warehouse 3 does not contain asbestos.

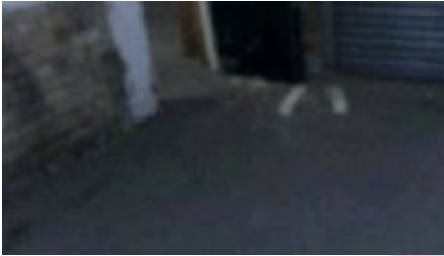
**Item 92 - Ref: EC001141**

The debris to the floor in room 1 in Warehouse 3 does not contain asbestos.

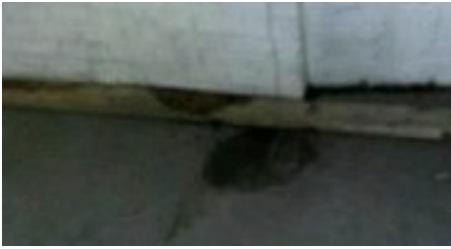
**Item 94 - Ref: EC001146**

The floor debris to room 1 of warehouse 3 does not contain asbestos.

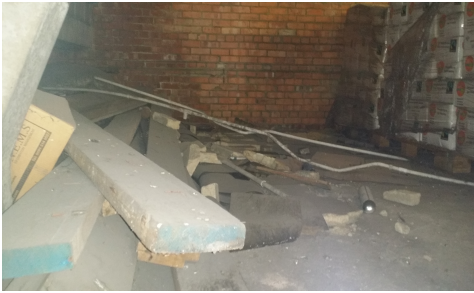
### **Item 99 - Ref: 279740-2**

The remnant boxing to columns north in Warehouse 3 (Room 001) does not contain asbestos.

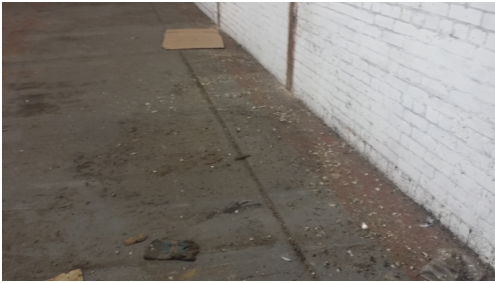
### **Item 103 - Ref: As 279740-1**

The expansion joint filler to floor in Warehouse 4 (Room 002) does not contain asbestos.
