ASBESTOS SURVEY REPORT FOR CONTAINER PARK OFFICES Gr FI 1 EAST SIDE COMMUNITY BLOCK, PORT OF SUNDERLAND

Asbestos Register for

**CONTAINER PARK OFFICES, Gr FI1, EAST SIDE
HUDSON DOCK, PORT OF SUNDERLAND**

Date: 3rd July 2025

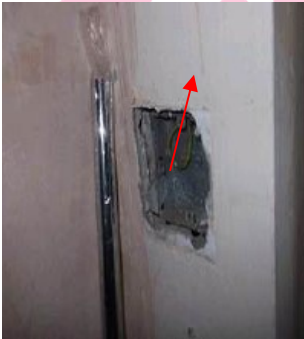
The boxing to the columns in the canteen (Room 3) room does not contain asbestos.

Similar boxing is located in rooms 5, 9, 10, 11, 12, 14, 17 and 18.
