ASBESTOS SURVEY REPORT FOR ASHLEY PRIMARY ACADEMY, TEMPLE PARK ROAD, SOUTH SHIELDS, NE33 0QA

Asbestos Register for

ASHLEY PRIMARY ACADEMY, TEMPLE PARK ROAD

Date: 13 March 2026

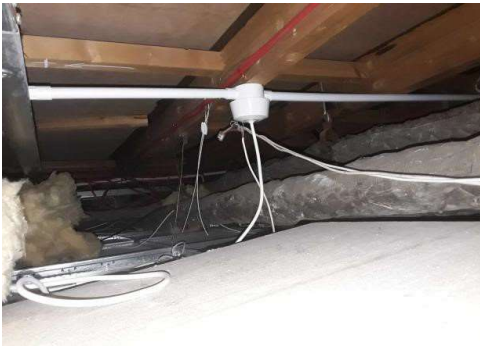
Item 1 Ref: 22-53098-1

The pipes – string to mmmf lagged metal pipes - Ground Floor, Room 1, Entrance Hall - do not contain asbestos

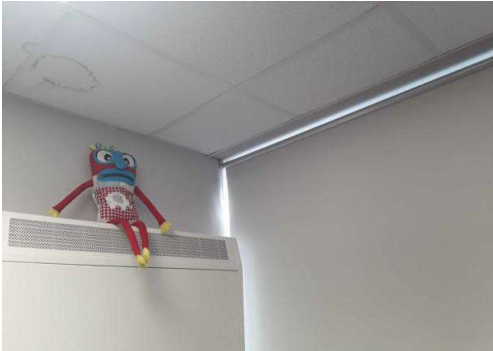
Item 37 Ref: Presumed

The walls – lining inside clasp columns - Ground Floor, Room 17, Corridor Store Cupboard – are presumed to contain asbestos.

Any change in its appearance should be recorded and passed to Property Services.

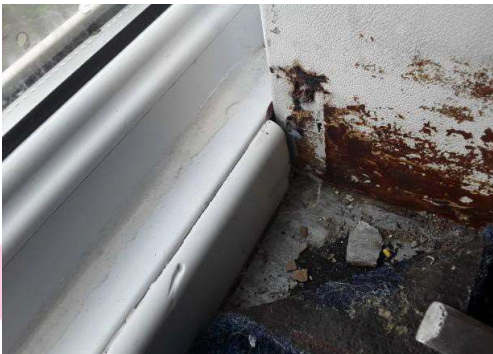
Item 38 Ref: 22-53098-3

The floor – residual adhesive beneath floor screed - Ground Floor, Room 17, Corridor Store Cupboard - contains asbestos.

Any change in its appearance should be recorded and passed to Property Services.

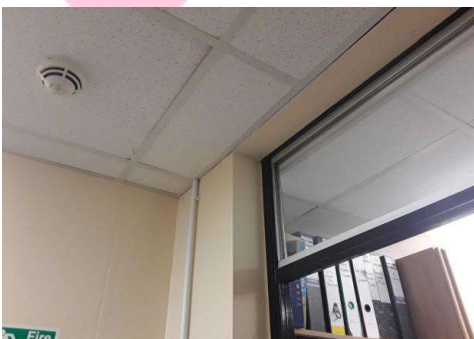
Item 39 Ref: Presumed

The walls – lining inside clasp columns - Ground Floor, Room 18, Deputy Head teachers office – are presumed to contain asbestos.

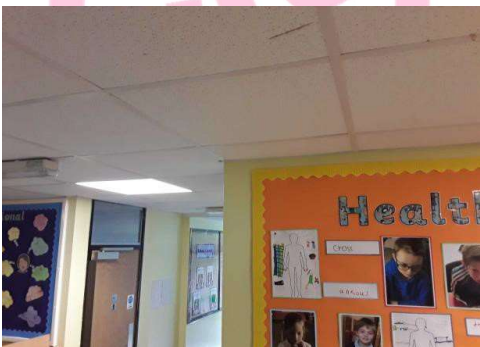
Item 42 Ref: Presumed

The walls – lining inside clasp columns - Ground Floor, Room 19, Fire exit hallway and cloak rooms – are presumed to contain asbestos.

Any change in its appearance should be recorded and passed to Property Services.

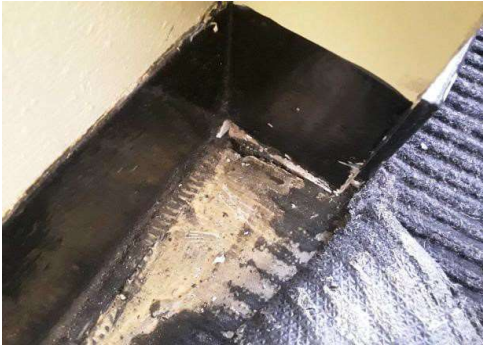
Item 43 Ref: 22-53098-3

The floor – residual adhesive beneath floor screed - Ground Floor, Room 19, Fire exit hallway and cloak rooms - contains asbestos.

Any change in its appearance should be recorded and passed to Property Services.

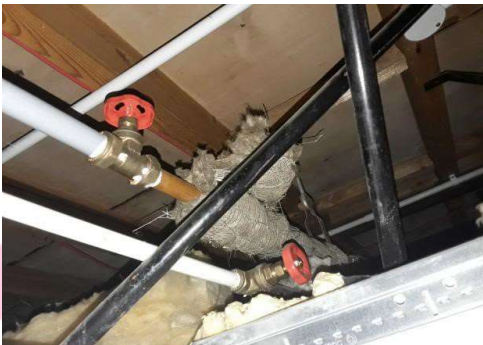
Item 44 Ref: 22-53098-1

The pipes – string to mmmf lagged metal pipes - Ground Floor, Room 20, Boys Toilet - do not contain asbestos

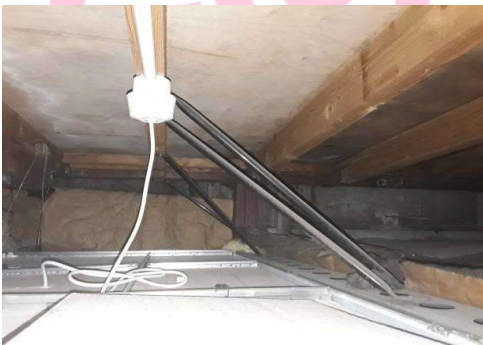
Item 45 Ref: Presumed

The walls – lining inside clasp columns - Ground Floor, Room 20, Boys Toilet – are presumed to contain asbestos.

Any change in its appearance should be recorded and passed to Property Services.

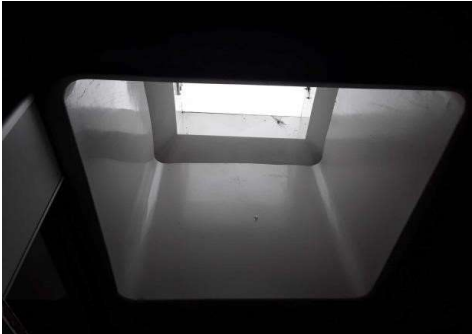
Item 46 Ref: Presumed

The ceiling – textile rope seal to fibreglass skylight - Ground Floor, Room 20, Boys Toilet – is presumed to contain asbestos.

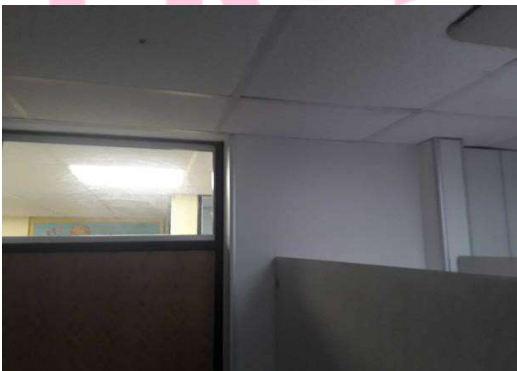
Item 48 Ref: Presumed

The walls – lining inside clasp columns - Ground Floor, Room 21, Girls Toilet – are presumed to contain asbestos.

Any change in its appearance should be recorded and passed to Property Services.

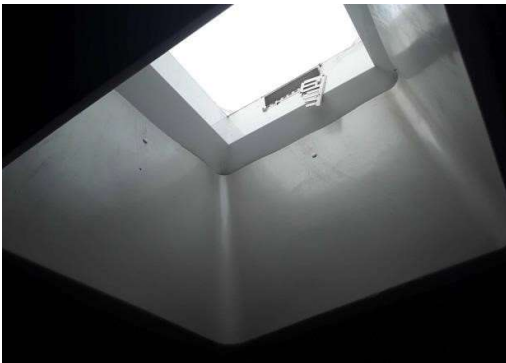
Item 49 Ref: Presumed

The ceiling – textile rope seal to fibreglass skylight - Ground Floor, Room 21, Girls Toilet – is presumed to contain asbestos.

Any change in its appearance should be recorded and passed to Property Services.

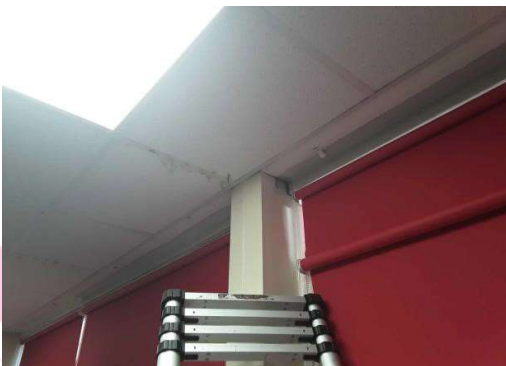
Item 50 Ref: Presumed

The walls – lining inside clasp columns - Ground Floor, Room 22, Classroom – are presumed to contain asbestos.

Any change in its appearance should be recorded and passed to Property Services.

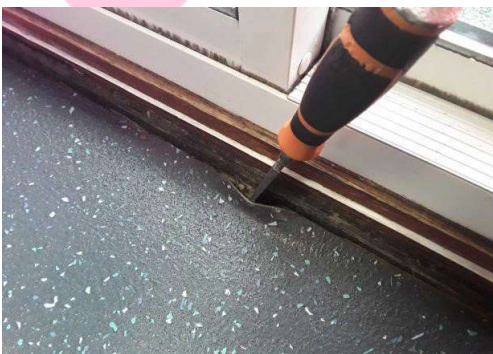
Item 51 Ref: 22-53098-3

The floor – residual adhesive beneath floor screed - Ground Floor, Room 22, Classroom - contains asbestos.

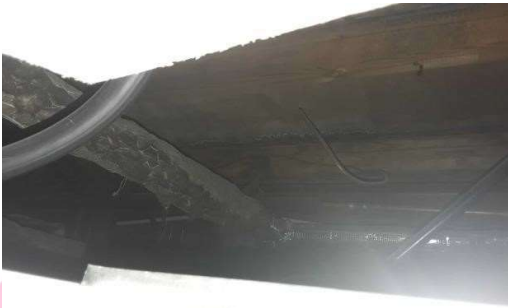
Item 53 Ref: 22-53098-1

The pipes – string to mmmf lagged metal pipes - Ground Floor, Room 25, Classroom store cupboard - do not contain asbestos

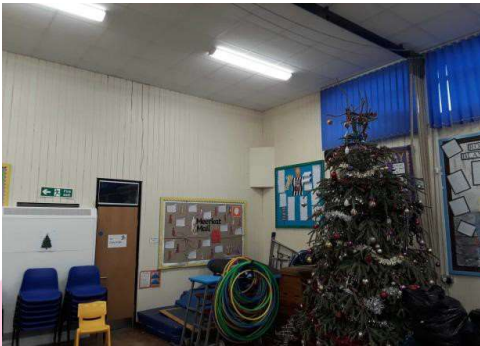
Item 59 Ref: Presumed

The walls – firebreak behind
wood cladding between hall
and boiler room - Ground
Floor, Room 28, Main School
Hall – are presumed to
contain asbestos.

Any change in its appearance
should be recorded and
passed to Property Services.

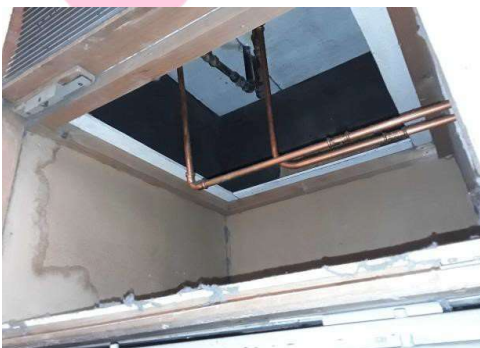
Item 60 Ref: 22-53098-29

The vessels – lining inside
area of old heating unit -
Ground Floor, Room 28, Main
School Hall – does not contain
asbestos.

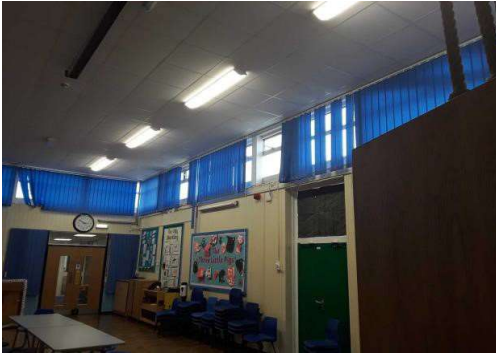
Item 61 Ref: Presumed

The walls – lining inside clasp columns - Ground Floor, Room 28, Main School Hall – are presumed to contain asbestos.

Any change in its appearance should be recorded and passed to Property Services.

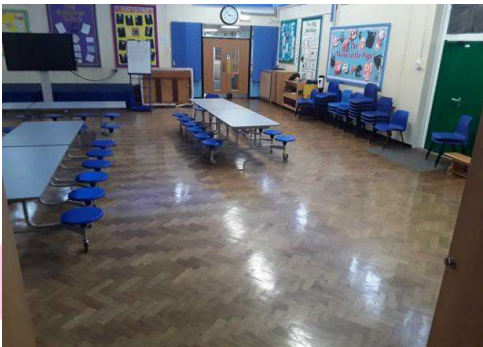
Item 62 Ref: Presumed

The floor -adhesive beneath parquet flooring - Ground Floor, Room 28, Main School Hall – is presumed to contain asbestos.

Any change in its appearance should be recorded and passed to Property Services.

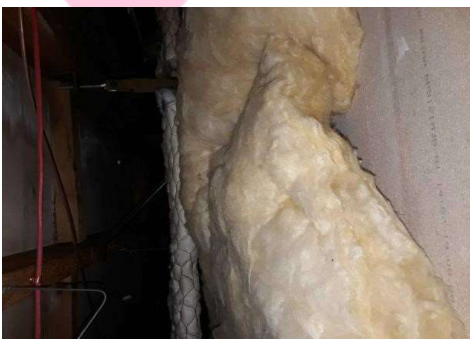
Item 63 Ref: 22-53098-1

The pipes – string to mmf lagged metal pipes - Ground Floor, Room 29, Hall Store Room - do not contain asbestos

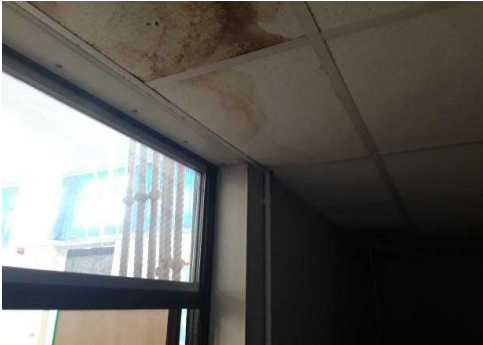
Item 64 Ref: Presumed

The walls – lining inside clasp columns - Ground Floor, Room 29, Hall Store Room – are presumed to contain asbestos.

Any change in its appearance should be recorded and passed to Property Services.

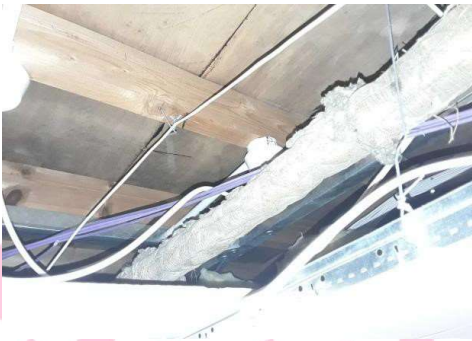
Item 65 Ref: 22-53098-1

The pipes – string to mmmf lagged metal pipes - Ground Floor, Room 30, Corridor and Study Areas - do not contain asbestos

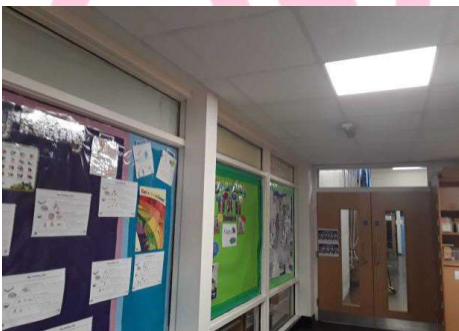
Item 66 Ref: Presumed

The walls – lining inside clasp columns - Ground Floor, Room 30, Corridor and Study Areas – are presumed to contain asbestos.

Any change in its appearance should be recorded and passed to Property Services.

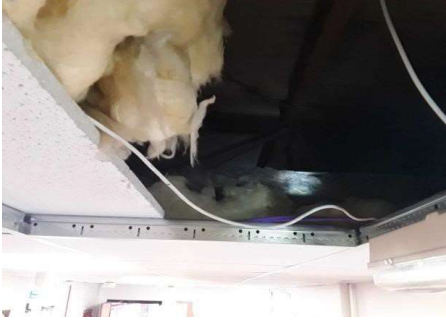
Item 67 Ref: 22-53098-1

The pipes – string to mmmf lagged metal pipes - Ground Floor, Room 31, Cloakroom, classroom - do not contain asbestos

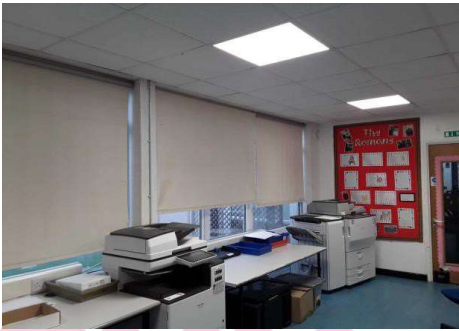
Item 68 Ref: Presumed

The walls – lining inside clasp columns - Ground Floor, Room 31, Cloakroom, classroom – are presumed to contain asbestos.

Any change in its appearance should be recorded and passed to Property Services.

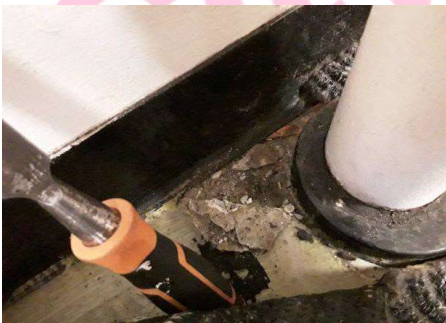
Item 69 Ref: 22-53098-7

The floor – residual adhesive beneath floor screed - Ground Floor, Room 31, Cloakroom, classroom - contains asbestos.

Any change in its appearance should be recorded and passed to Property Services.

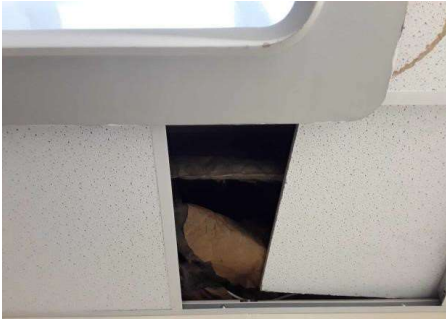
Item 70 Ref: 22-53098-1

The pipes – string to mmmf lagged metal pipes - Ground Floor, Room 32, Girl's toilet - do not contain asbestos

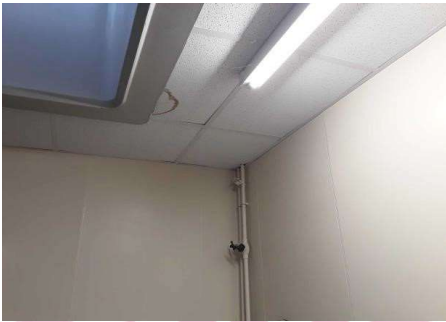
Item 71 Ref: Presumed

The walls – lining inside clasp columns - Ground Floor, Room 32, Girl's toilet – are presumed to contain asbestos.

Any change in its appearance should be recorded and passed to Property Services.

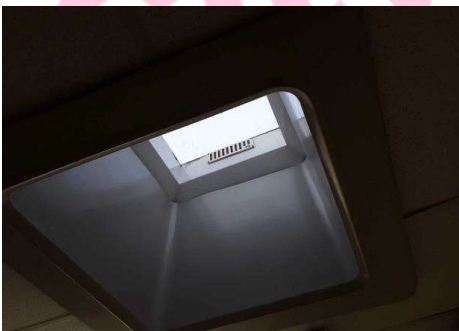
Item 72 Ref: Presumed

The ceiling – textile rope seal to fibreglass skylight - Ground Floor, Room 32, Girl's toilet – is presumed to contain asbestos.

Any change in its appearance should be recorded and passed to Property Services.

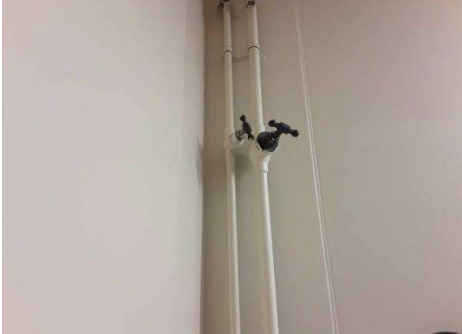
Item 73 Ref: Presumed

The pipes – stop taps (gaskets) – Ground Floor, Room 32, Girl's toilet - are presumed to contain asbestos.

Any change in its appearance should be recorded and passed to Property Services.

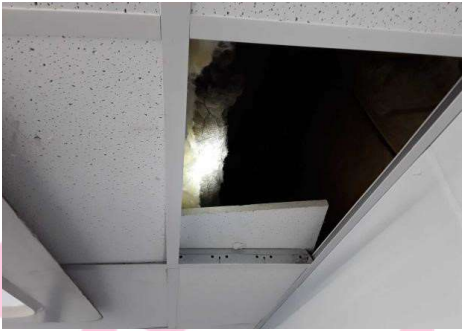
Item 74 Ref: 22-53098-1

The pipes – string to mmmf lagged metal pipes - Ground Floor, Room 33, Boy's toilet - do not contain asbestos

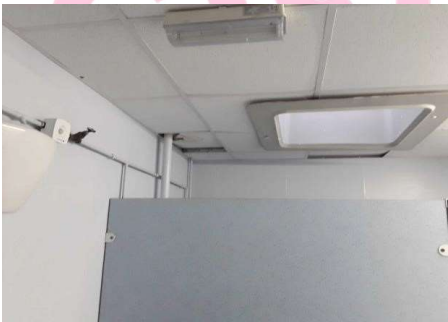
Item 75 Ref: Presumed

The walls – lining inside clasp columns - Ground Floor, Room 33, Boy's toilet – are presumed to contain asbestos.

Any change in its appearance should be recorded and passed to Property Services.

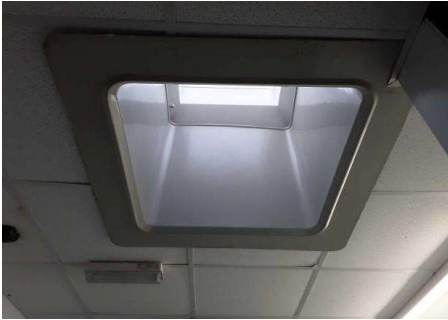
Item 76 Ref: Presumed

The ceiling – textile rope seal to fibreglass skylight - Ground Floor, Room 33, Boy's toilet – is presumed to contain asbestos.

Any change in its appearance should be recorded and passed to Property Services.

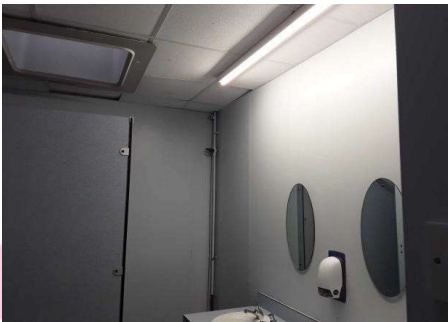
Item 77 Ref: Presumed

The pipes – stop taps (gaskets) – Ground Floor, Room 33, Boy's toilet - are presumed to contain asbestos.

Any change in its appearance should be recorded and passed to Property Services.

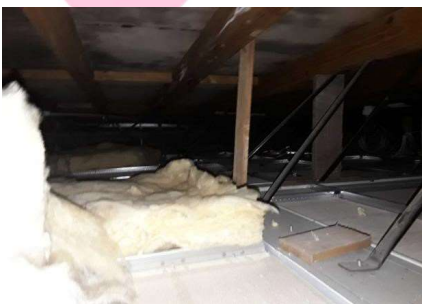
Item 78 Ref: 22-53098-1

The pipes – string to mmmf lagged metal pipes - Ground Floor, Room 34, Classroom - do not contain asbestos

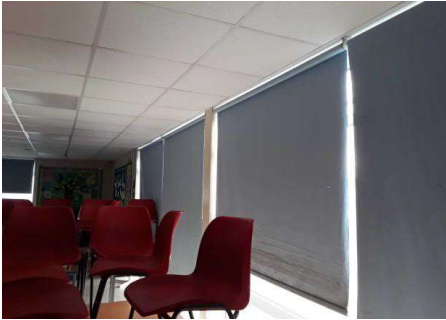
Item 79 Ref: Presumed

The walls – lining inside clasp columns - Ground Floor, Room 34, Classroom – are presumed to contain asbestos.

Any change in its appearance should be recorded and passed to Property Services.

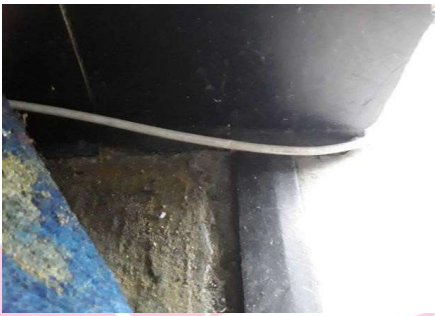
Item 80 Ref: 22-53098-7

The floor – residual adhesive beneath floor screed - Ground Floor, Room 34, Classroom - contains asbestos.

Any change in its appearance should be recorded and passed to Property Services.

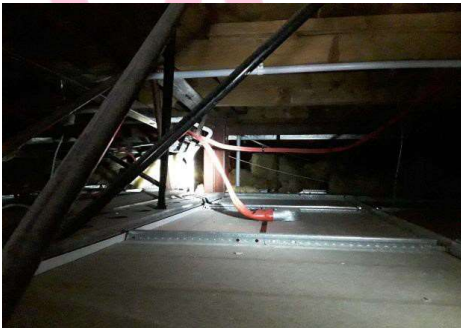
Item 81 Ref: Presumed

The walls – lining inside clasp columns - Ground Floor, Room 35 Hallway between Classrooms – are presumed to contain asbestos.

Any change in its appearance should be recorded and passed to Property Services.

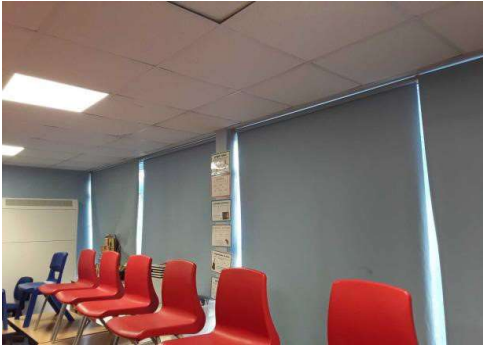
Item 82 Ref: Presumed

The walls – lining inside clasp columns - Ground Floor, Room 36, Classroom – are presumed to contain asbestos.

Any change in its appearance should be recorded and passed to Property Services.

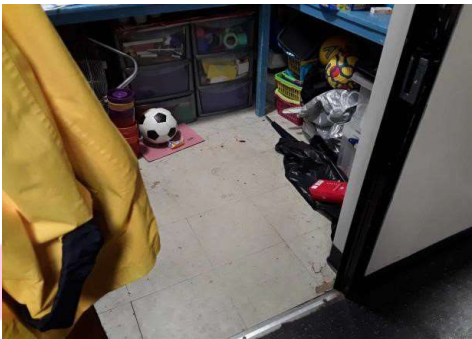
Item 83 Ref: 22-53098-10

The floor – tiles and adhesive - Ground Floor, Room 37, Classroom cupboard - contains asbestos.

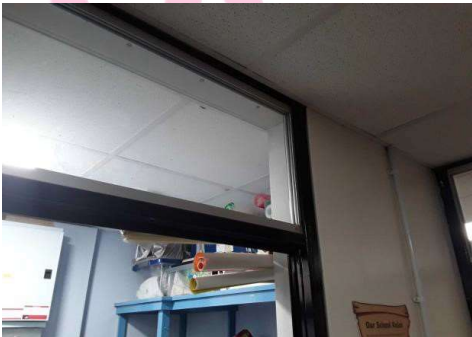
Item 84 Ref: Presumed

The walls – lining inside clasp columns - Ground Floor, Room 37, Classroom cupboard – are presumed to contain asbestos.

Any change in its appearance should be recorded and passed to Property Services.

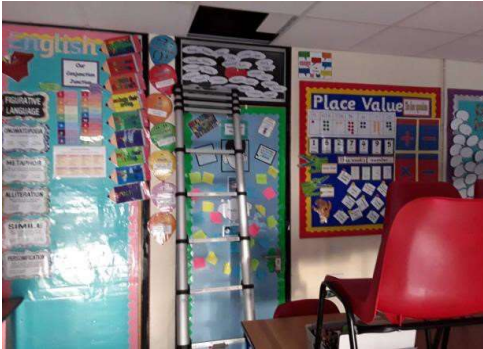
Item 85 Ref: Presumed

The walls – lining inside clasp columns - Ground Floor, Room 37, Classroom cupboard – are presumed to contain asbestos.

Any change in its appearance should be recorded and passed to Property Services.

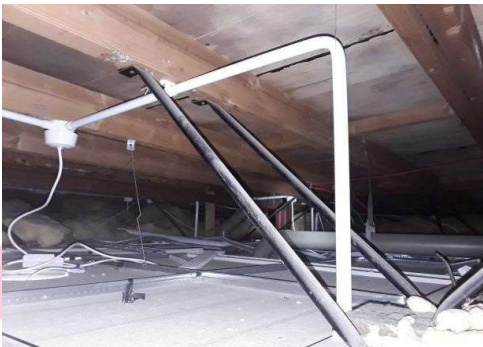
Item 86 Ref: Presumed

The walls – lining inside clasp columns - Ground Floor, Room 38, Classroom cupboard – are presumed to contain asbestos.

Any change in its appearance should be recorded and passed to Property Services.

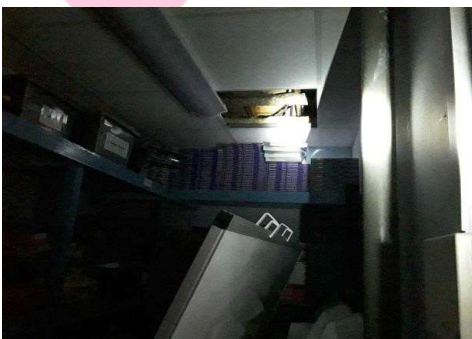
Item 87 Ref: 22-53098-1

The pipes – string to mmf lagged metal pipes - Ground Floor, Room 39, Store Cupboard - do not contain asbestos

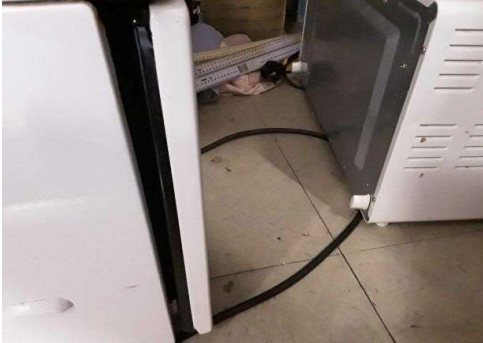
Item 88 Ref: 22-53098-10

The floor – tiles and adhesive
- Ground Floor, Room 39,
Store Cupboard - contains
asbestos.

Any change in its appearance
should be recorded and
passed to Property Services.

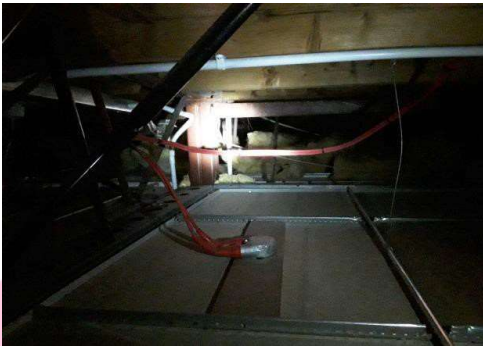
Item 89 Ref: Presumed

The walls – lining inside clasp
columns - Ground Floor,
Room 39, Store Cupboard –
are presumed to contain
asbestos.

Any change in its appearance
should be recorded and
passed to Property Services.

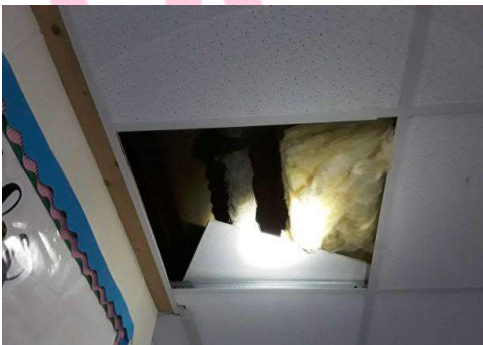
Item 90 Ref: 22-53098-1

The pipes – string to mmmf
lagged metal pipes - Ground
Floor, Room 40, Classroom -
do not contain asbestos

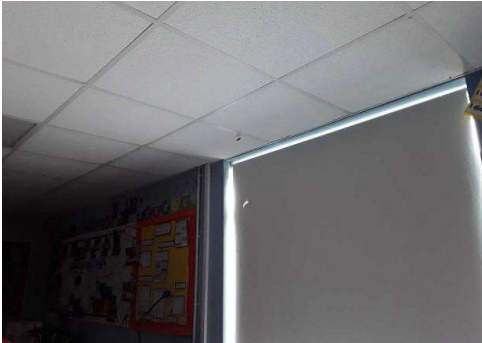
Item 91 Ref: Presumed

The walls – lining inside clasp columns - Ground Floor, Room 40, Classroom – are presumed to contain asbestos.

Any change in its appearance should be recorded and passed to Property Services.

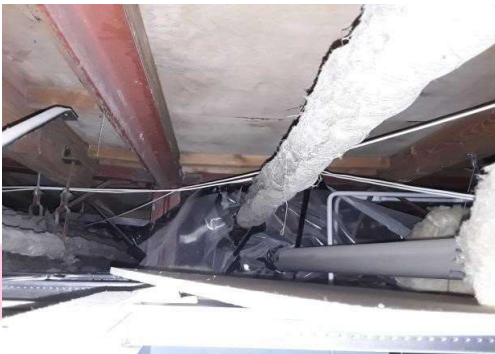
Item 92 Ref: 22-53098-1

The pipes – string to mmmf lagged metal pipes - Ground Floor, Room 41, Classroom Cupboard - do not contain asbestos

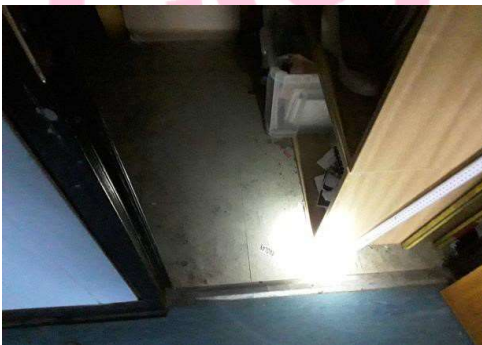
Item 93 Ref: 22-53098-10

The floor – tiles and adhesive - Ground Floor, Room 41, Classroom Cupboard - contains asbestos.

Any change in its appearance should be recorded and passed to Property Services.

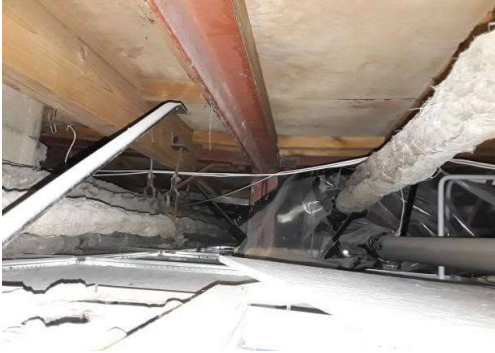
Item 94 Ref: Presumed

The walls – lining inside clasp columns - Ground Floor, Room 41, Classroom Cupboard – are presumed to contain asbestos.

Any change in its appearance should be recorded and passed to Property Services.

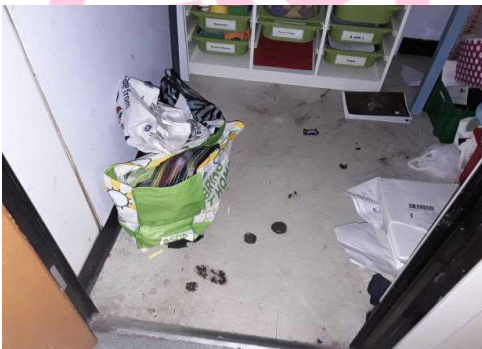
Item 96 Ref: 22-53098-10

The floor – tiles and adhesive - Ground Floor, Room 42, Classroom Cupboard - contains asbestos.

Any change in its appearance should be recorded and passed to Property Services.

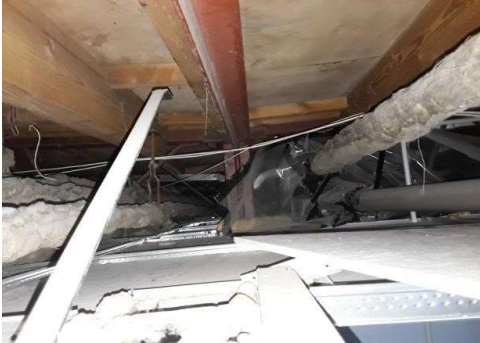
Item 97 Ref: Presumed

The walls – lining inside clasp columns - Ground Floor, Room 42, Classroom Cupboard – are presumed to contain asbestos.

Any change in its appearance should be recorded and passed to Property Services.

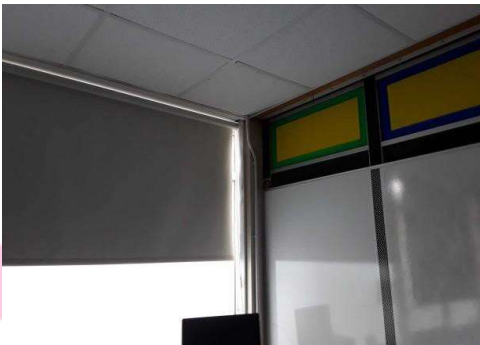
Item 98 Ref: Presumed

The walls – lining inside clasp columns - Ground Floor, Room 43, Classroom between two classrooms – are presumed to contain asbestos.

Any change in its appearance should be recorded and passed to Property Services.

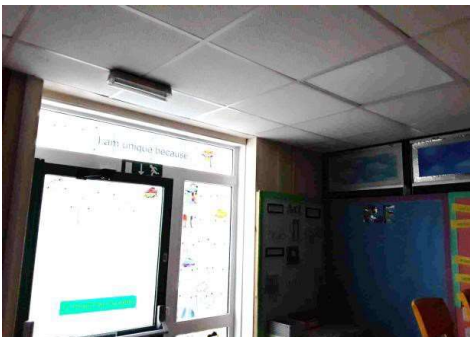
Item 99 Ref: Presumed

The walls – lining inside clasp columns - Ground Floor, Room 44, Classroom – are presumed to contain asbestos.

Any change in its appearance should be recorded and passed to Property Services.

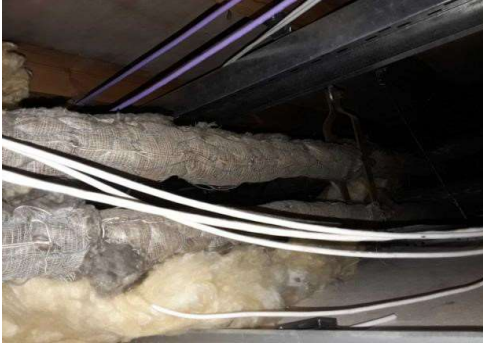
Item 100 Ref: 22-53098-1

The pipes – string to mmf lagged metal pipes - Ground Floor, Room 45, Classroom - do not contain asbestos

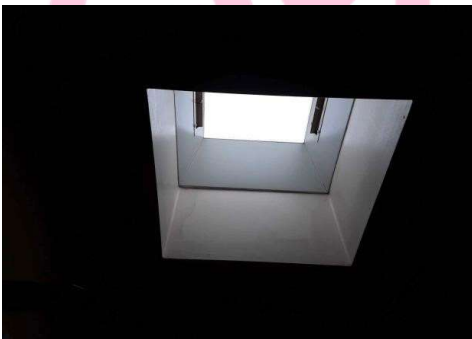
Item 102 Ref: Presumed

The ceiling – textile rope seal to fibreglass skylight - Ground Floor, Room 45, Cloakroom & Computer Room – is presumed to contain asbestos.

Any change in its appearance should be recorded and passed to Property Services.

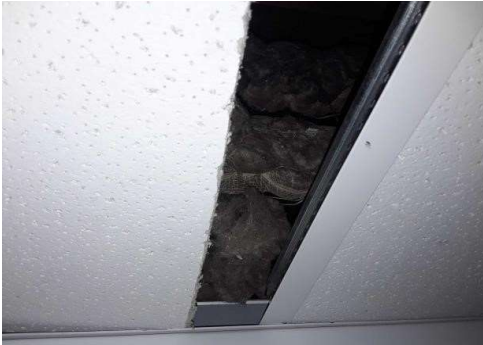
Item 103 Ref: 22-53098-1

The pipes – string to mmmf lagged metal pipes - Ground Floor, Room 46, Girls Toilet - do not contain asbestos

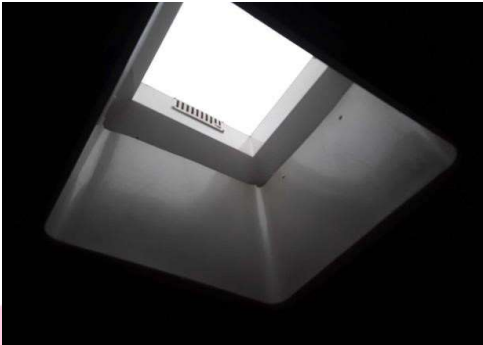
Item 104 Ref: Presumed

The ceiling – textile rope seal to fibreglass skylight - Ground Floor, Room 46, Girls Toilet – is presumed to contain asbestos.

Any change in its appearance should be recorded and passed to Property Services.

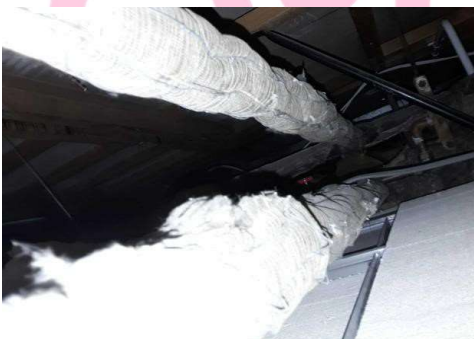
Item 105 Ref: Presumed

The pipes – string to mmmf lagged metal pipes - Ground Floor, Room 47 Boys Toilet - do not contain asbestos

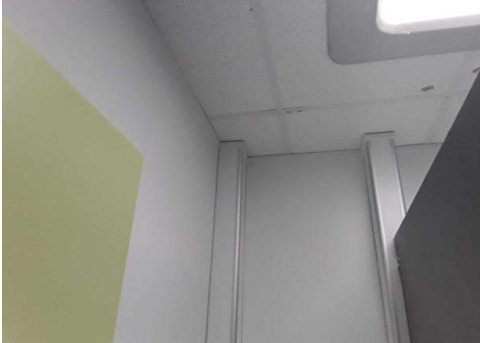
Item 106 Ref: Presumed

The walls – lining inside clasp columns - Ground Floor, Room 47 Boys Toilet – are presumed to contain asbestos.

Any change in its appearance should be recorded and passed to Property Services.

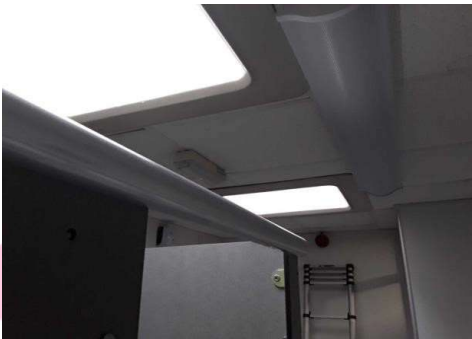
Item 107 Ref: Presumed

The ceiling – textile rope seal to fibreglass skylight - Ground Floor, Room 47 Boy's Toilet – is presumed to contain asbestos.

Any change in its appearance should be recorded and passed to Property Services.

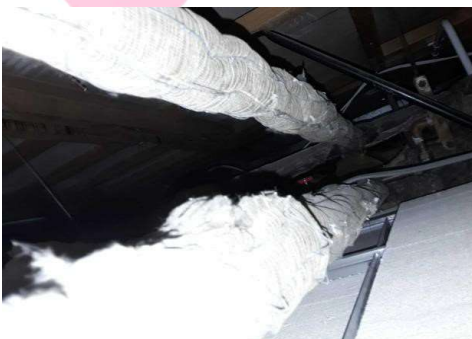
Item 108 Ref: 22-53098-1

The pipes – string to mmmf lagged metal pipes - Ground Floor, Room 51 Classroom - do not contain asbestos

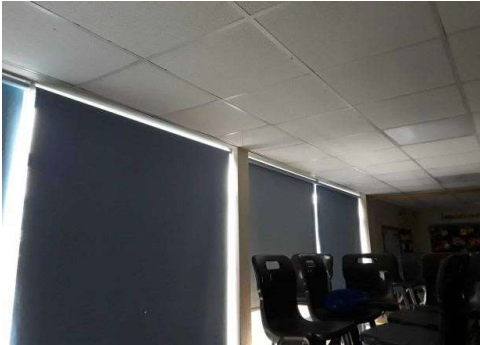
Item 109 Ref: Presumed

The walls – lining inside clasp columns - Ground Floor, Room 51 Classroom – are presumed to contain asbestos.

Any change in its appearance should be recorded and passed to Property Services.

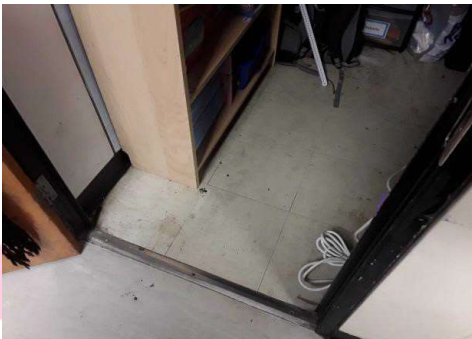
Item 110 Ref: 22-53098-10

The floor – tiles and adhesive - Ground Floor, Room 52, Classroom Cupboard - contains asbestos.

Any change in its appearance should be recorded and passed to Property Services.

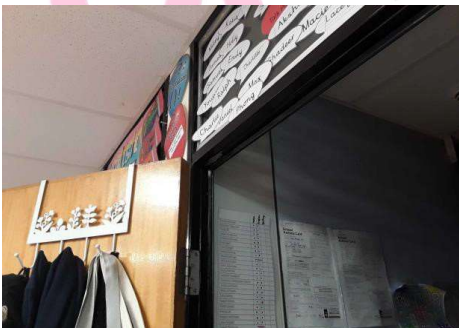
Item 111 Ref: Presumed

The walls – lining inside clasp columns - Ground Floor, Room 52 Classroom – are presumed to contain asbestos.

Any change in its appearance should be recorded and passed to Property Services.

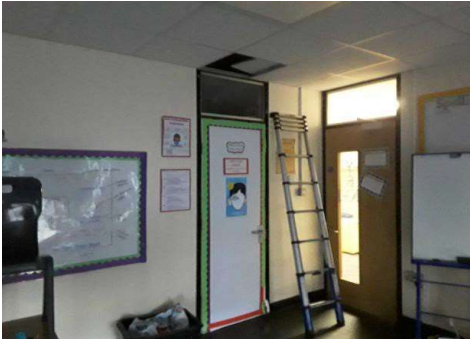
Item 112 Ref: Presumed

The walls – lining inside clasp columns - Ground Floor, Room 52 Classroom cupboard – are presumed to contain asbestos.

Any change in its appearance should be recorded and passed to Property Services.

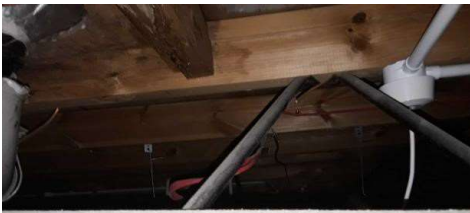
Item 113 Ref: 22-53098-1

The pipes – string to mmmf lagged metal pipes - Ground Floor, Room 53 Classroom - do not contain asbestos

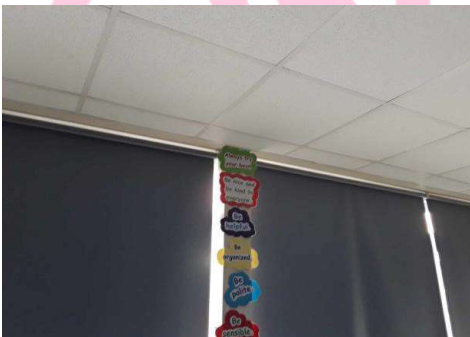
Item 114 Ref: Presumed

The walls – lining inside clasp columns - Ground Floor, Room 53 Classroom – are presumed to contain asbestos.

Any change in its appearance should be recorded and passed to Property Services.

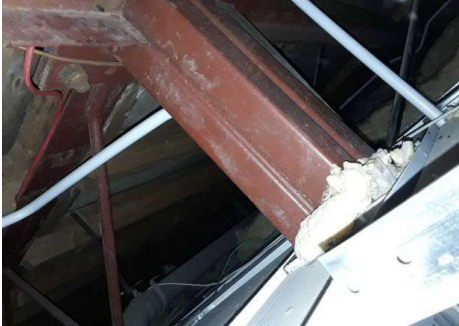
Item 115 Ref: Presumed

The walls – lining inside clasp columns - Ground Floor, Room 54 Classroom cupboard – are presumed to contain asbestos.

Any change in its appearance should be recorded and passed to Property Services.

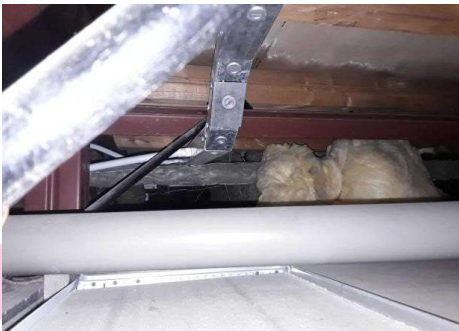
Item 116 Ref: 22-53098-1

The pipes – string to mmmf lagged metal pipes - Ground Floor, Room 55 Classroom - do not contain asbestos

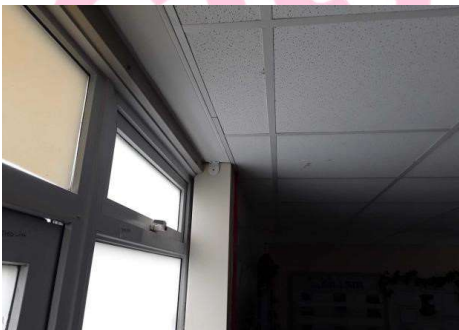
Item 117 Ref: Presumed

The walls – lining inside clasp columns - Ground Floor, Room 55 Classroom – are presumed to contain asbestos.

Any change in its appearance should be recorded and passed to Property Services.

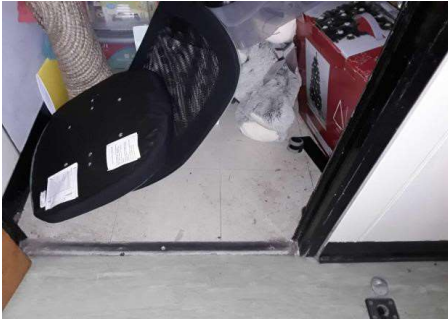
Item 118 Ref: 22-53098-10

The floor – tiles and adhesive
- Ground Floor, Room 56,
Classroom Cupboard -
contains asbestos.

Any change in its appearance
should be recorded and
passed to Property Services.

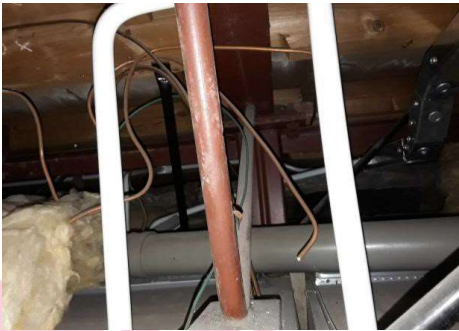
Item 119 Ref: Presumed

The walls – lining inside clasp
columns - Ground Floor,
Room 56, Classroom
Cupboard – are presumed to
contain asbestos.

Any change in its appearance
should be recorded and
passed to Property Services.

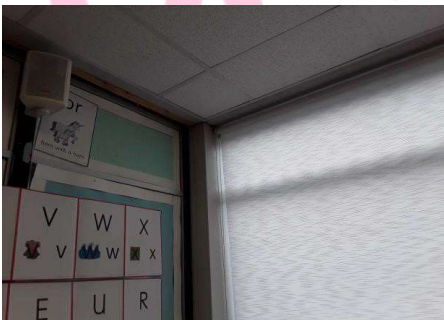
Item 120 Ref: Presumed

The walls – lining inside clasp
columns - Ground Floor,
Room 57, Classroom
between
Classroom – are presumed to
contain asbestos.

Any change in its appearance
should be recorded and
passed to Property Services.

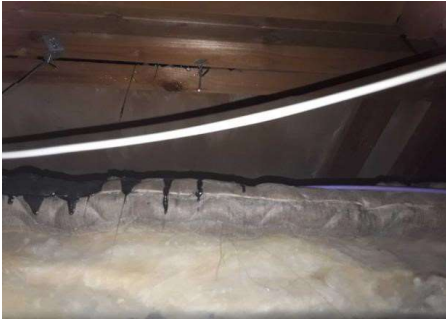
Item 121 Ref: 22-53098-1

The pipes – string to mmmf lagged metal pipes - Ground Floor, Room 58 Classroom - do not contain asbestos

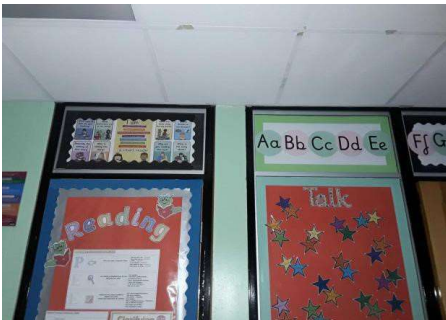
Item 122 Ref: Presumed

The walls – lining inside clasp columns - Ground Floor, Room 58 Classroom – are presumed to contain asbestos.

Any change in its appearance should be recorded and passed to Property Services.

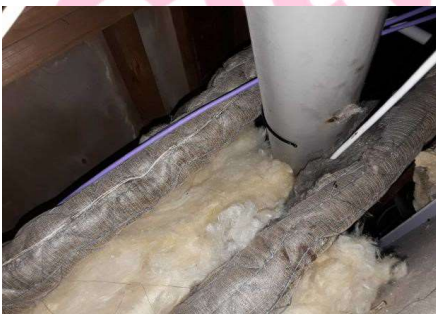
Item 123 Ref: 22-53098-1

The pipes – string to mmmf lagged metal pipes - Ground Floor, Room 59 Classroom cupboard - do not contain asbestos

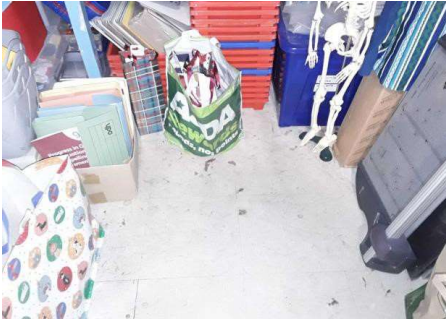
Item 124 Ref: 22-53098-10

The floor – tiles and adhesive
- Ground Floor, Room 59,
Classroom Cupboard -
contains asbestos.

Any change in its appearance
should be recorded and
passed to Property Services.

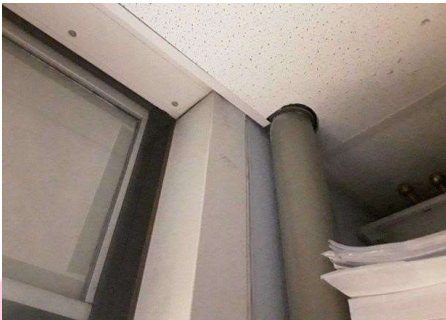
Item 125 Ref: Presumed

The walls – lining inside clasp
columns - Ground Floor,
Room 59 Classroom cupboard
– are presumed to contain
asbestos.

Any change in its appearance
should be recorded and
passed to Property Services.

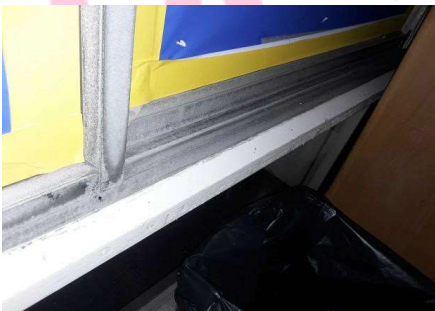
Item 126 Ref: 22-53098-11

The window – internal wood
windows - Ground Floor,
Room 60 Library - does not
contain asbestos

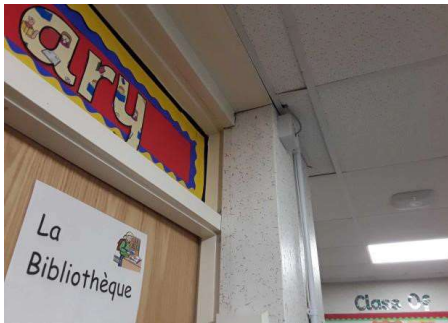
Item 127 Ref: Presumed

The walls – lining inside clasp columns - Ground Floor, Room 60 Library – are presumed to contain asbestos.

Any change in its appearance should be recorded and passed to Property Services.

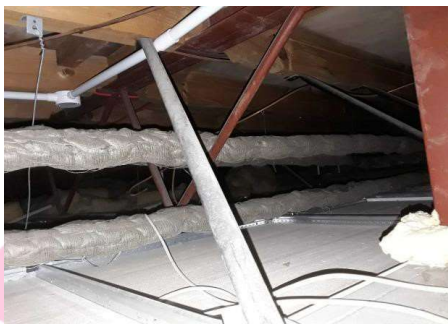
Item 128 Ref: 22-53098-1

The pipes – string to mmmf lagged metal pipes - Ground Floor, Room 61 Computer Room and store cupboard - do not contain asbestos

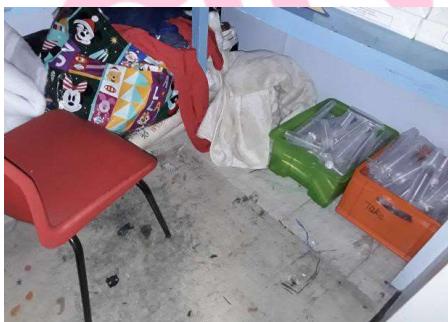
Item 129 Ref: 22-53098-12

The floor – tiles and adhesive - Ground Floor, Room 61 Computer Room and store cupboard - contains asbestos.

Any change in its appearance should be recorded and passed to Property Services.

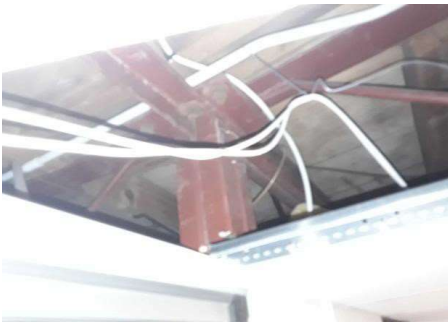
Item 130 Ref: Presumed

The walls – lining inside clasp columns - Ground Floor, Room 61 Computer Room and store cupboard – are presumed to contain asbestos.

Any change in its appearance should be recorded and passed to Property Services.

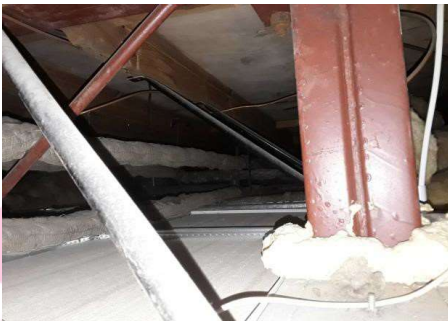
Item 131 Ref: 22-53098-1

The pipes – string to mmmf lagged metal pipes - Ground Floor, Room 62 Paper store cupboard - do not contain asbestos

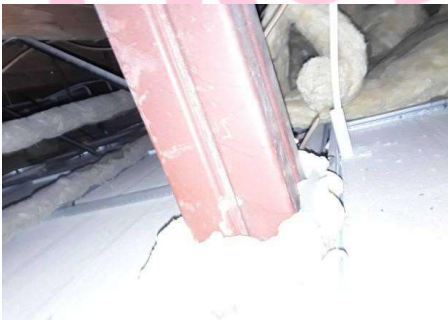
Item 132 Ref: Presumed

The walls – lining inside clasp columns - Ground Floor, Room 62 Paper store cupboard – are presumed to contain asbestos.

Any change in its appearance should be recorded and passed to Property Services.

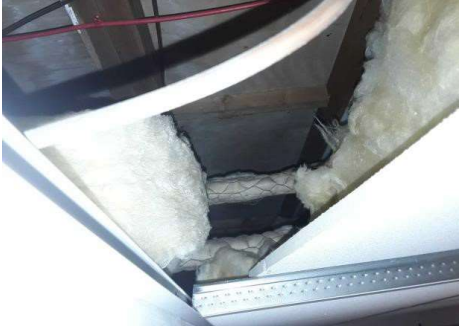
Item 133 Ref: 22-53098-1

The pipes – string to mmmf lagged metal pipes - Ground Floor, Room 63 Main School hall store cupboard - do not contain asbestos

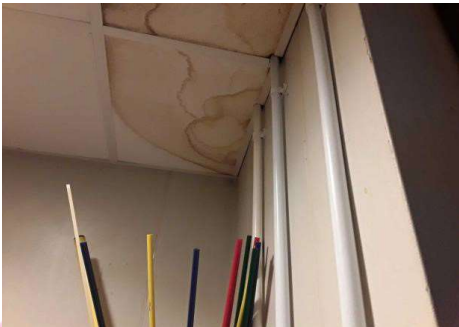
Item 134 Ref: Presumed

The walls – lining inside clasp columns - Ground Floor, Room 63 Main School hall store cupboard – are presumed to contain asbestos.

Any change in its appearance should be recorded and passed to Property Services.

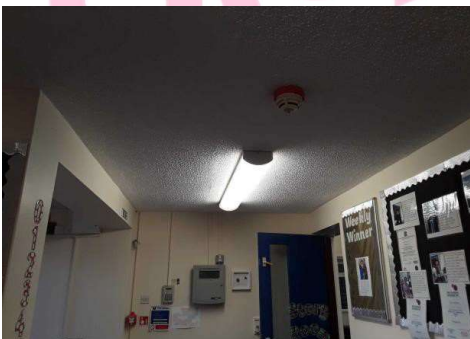
Item 135 Ref: 22-53098-13

The ceiling – textured coating - Ground Floor, Room 64, Entrance hall, Nursery - contains asbestos.

Any change in its appearance should be recorded and passed to Property Services.

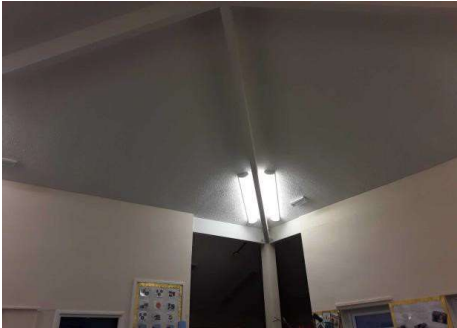
Item 136 Ref: 22-53098-13

The ceiling – textured coating
- Ground Floor, Room 65,
Main Nursery Area 1 -
contains asbestos.

Any change in its appearance
should be recorded and
passed to Property Services.

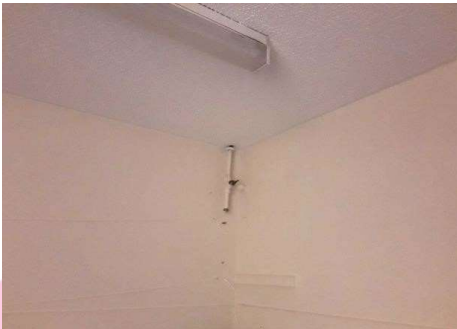
Item 137 Ref: Presumed

The pipes – stop taps
(Gaskets) – Ground Floor,
Room 65, Main Nursery Area
1 - are presumed to contain
asbestos.

Any change in its appearance
should be recorded and
passed to Property Services.

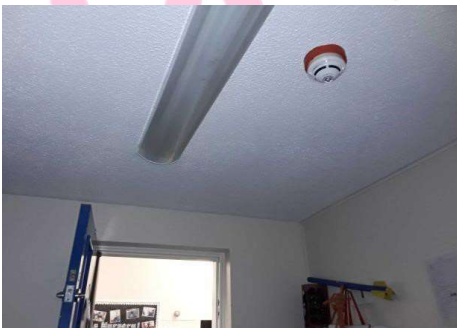
Item 138 Ref: 22-53098-13

The ceiling – textured coating
- Ground Floor, Room 66
Office, Nursery - contains
asbestos.

Any change in its appearance
should be recorded and
passed to Property Services.

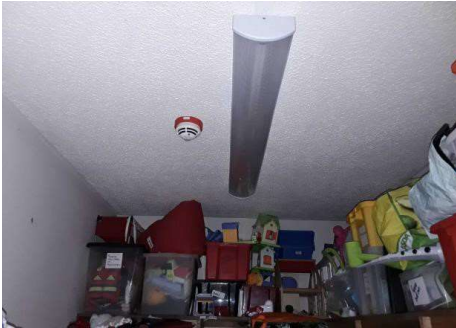
Item 139 Ref: 22-53098-13

The ceiling – textured coating
- Ground Floor, Room 67
Store Cupboard, nursery -
contains asbestos.

Any change in its appearance
should be recorded and
passed to Property Services.

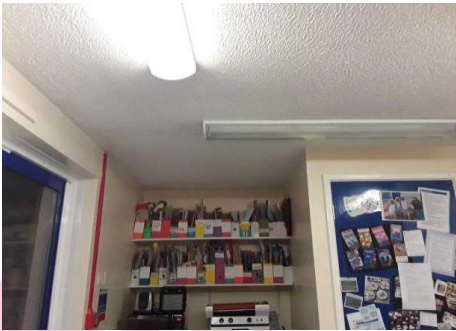
Item 140 Ref: 22-53098-13

The ceiling – textured coating
- Ground Floor, Room 68,
Kitchen, Nursery - contains
asbestos.

Any change in its appearance
should be recorded and
passed to Property Services.

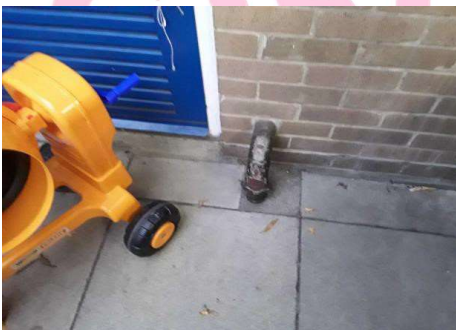
Item 141 Ref: 22-53098-14

The floor - intake pipe -
Ground Floor, Room 69,
External store area, Nursery -
does not contain asbestos.

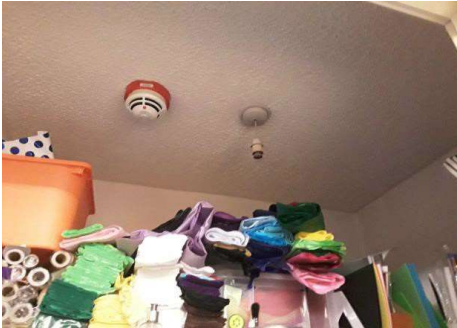
Item 142 Ref: 22-53098-13

The ceiling – textured coating
- Ground Floor, Room 71,
Kitchen Store Cupboard,
Nursery - contains asbestos.

Any change in its appearance
should be recorded and
passed to Property Services.

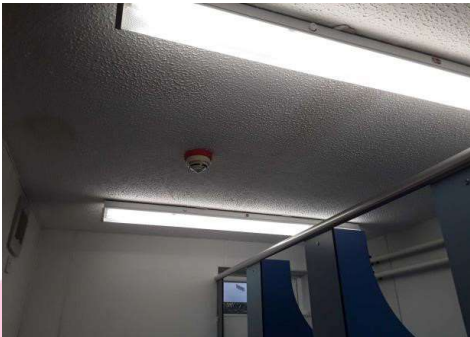
Item 143 Ref: 22-53098-13

The ceiling – textured coating
- Ground Floor, Room 72,
Nursery Toilets - contains
asbestos.

Any change in its appearance
should be recorded and
passed to Property Services.

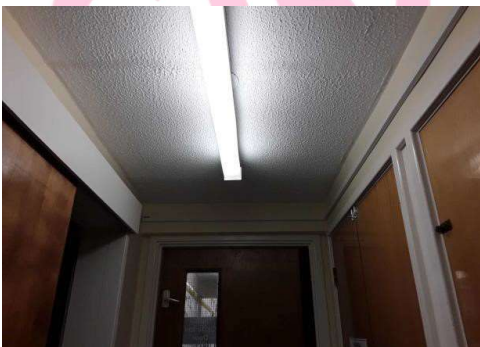
Item 144 Ref: 22-53098-13

The ceiling – textured coating
- Ground Floor, Room 73,
Corridor Nursery - contains
asbestos.

Any change in its appearance
should be recorded and
passed to Property Services.

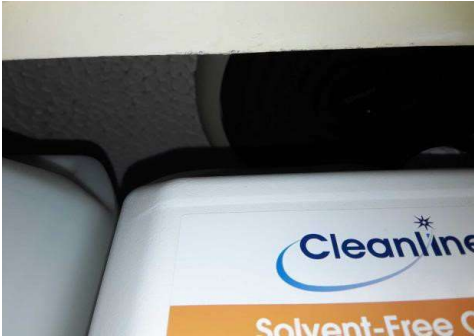
Item 145 Ref: 22-53098-13

The ceiling – textured coating
- Ground Floor, Room 74,
Cleaners Cupboard, Nursery -
contains asbestos.

Any change in its appearance
should be recorded and
passed to Property Services.

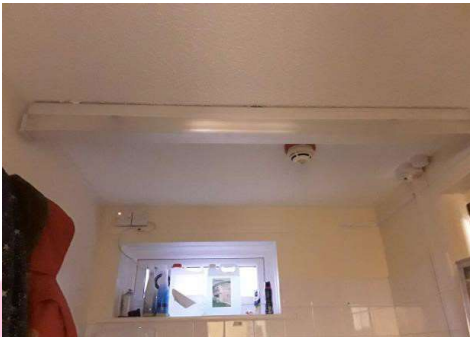
Item 146 Ref: 22-53098-13

The ceiling – textured coating
- Ground Floor, Room 76,
Cleaners Store Cupboard,
Nursery - contains asbestos.

Any change in its appearance
should be recorded and
passed to Property Services.

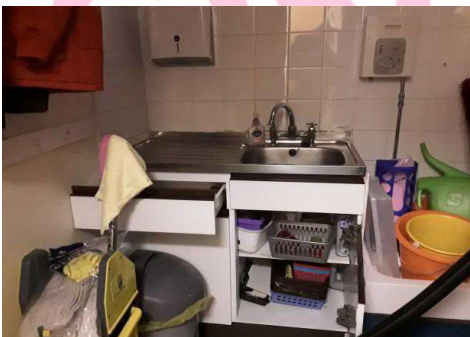
Item 147 Ref: 22-53098-16

The sink pad - Ground Floor,
Room 76, Cleaners Store
Cupboard, Nursery – does not
contain asbestos.

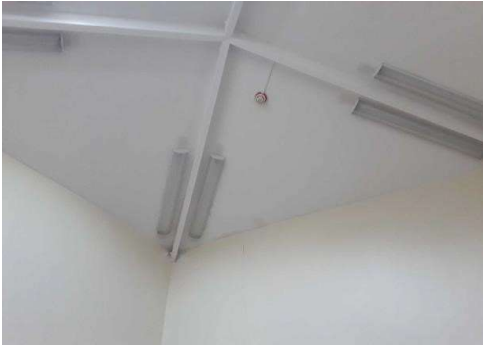
Item 148 Ref: 22-53098-13

The ceiling – textured coating
- Ground Floor, Room 77
Nursery area 2 - contains
asbestos.

Any change in its appearance
should be recorded and
passed to Property Services.

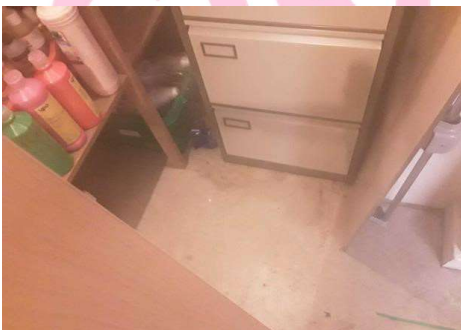
Item 150 Ref: 22-53098-20

The floor – tiles and adhesive
- Ground Floor, Room 78
Nursery area 2 store cupboard
- contains asbestos.

Any change in its appearance
should be recorded and
passed to Property Services.

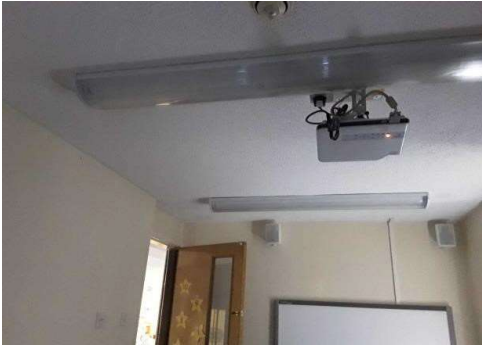
Item 151 Ref: 22-53098-13

The ceiling – textured coating
- Ground Floor, Room 79
Classroom Nursery - contains
asbestos.

Any change in its appearance
should be recorded and
passed to Property Services.

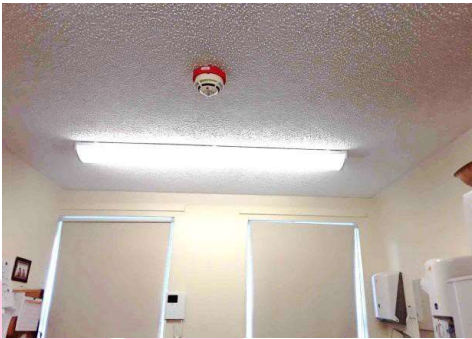
Item 152 Ref: 22-53098-13

The ceiling – textured coating
- Ground Floor, Room 80 Staff
Room Nursery - contains
asbestos.

Any change in its appearance
should be recorded and
passed to Property Services.

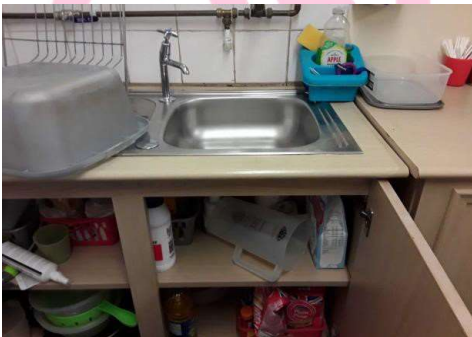
Item 153 Ref: 22-53098-17

The sink pad - Ground Floor,
Room 80 Staff Room Nursery
– does not contain asbestos.

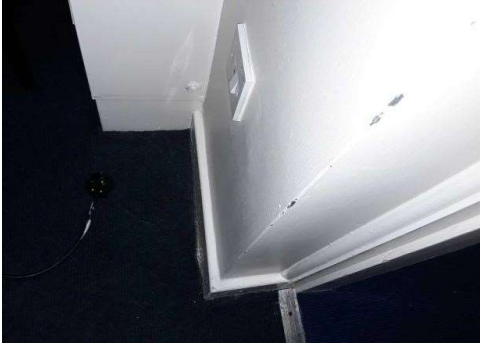
Item 154 Ref: 22-53098-18

The floor – tiles and adhesive
- Ground Floor, Room 80 Staff
Room Nursery - contains
asbestos.

Removed Jan 2025

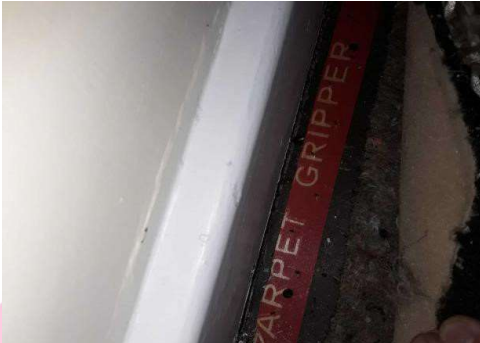
Item 155 Ref: 22-53098-19

The floor – tiles and adhesive
- Ground Floor, Room 81
Reading Room Nursery -
contains asbestos.

Removed Jan 2025
