ASBESTOS SURVEY REPORT FOR ASHLEY PRIMARY ACADEMY, TEMPLE PARK ROAD, SOUTH SHIELDS, NE33 0QA

Asbestos Register for

ASHLEY PRIMARY ACADEMY, TEMPLE PARK ROAD

Date: 13 March 2026

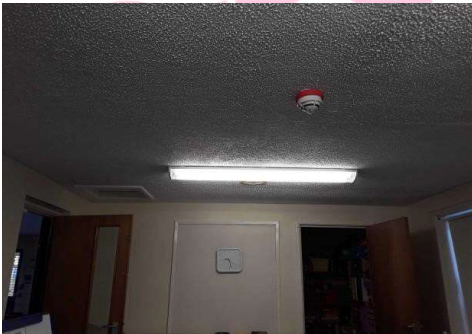
Item 156 Ref: 22-53098-13

The ceiling – textured coating
- Ground Floor, Room 82
Classroom Nursery - contains
asbestos.

Removed Jan 2025

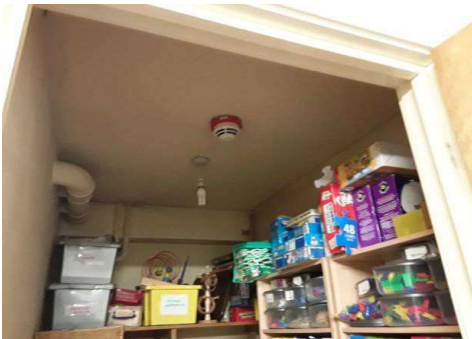
Item 157 Ref: 22-53098-13

The ceiling – textured coating
- Ground Floor, Room 83
Store Room Nursery -
contains asbestos.

Any change in its appearance
should be recorded and
passed to Property Services.

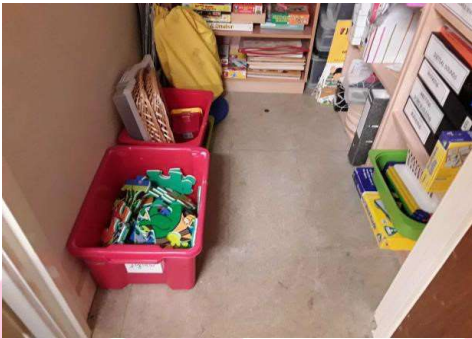
Item 158 Ref: 22-53098-20

The floor – tiles and adhesive
- Ground Floor, Room 83
Store Room Nursery -
contains asbestos.

Any change in its appearance
should be recorded and
passed to Property Services.

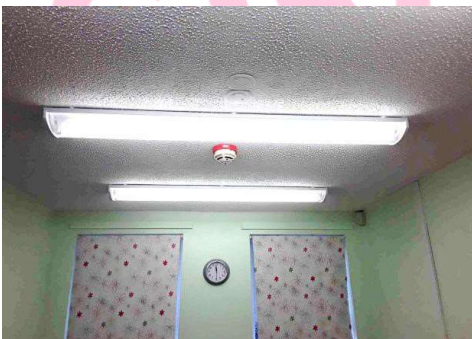
Item 159 Ref: 22-53098-13

The ceiling – textured coating
- Ground Floor, Room 84
Office Nursery - contains
asbestos.

Any change in its appearance
should be recorded and
passed to Property Services.

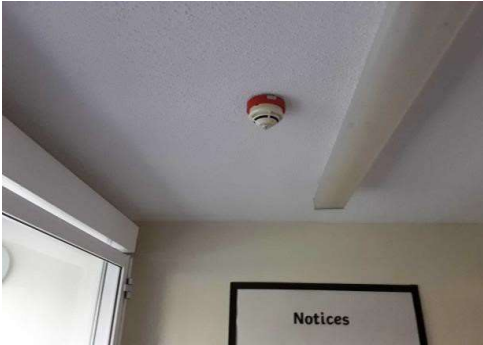
Item 160 Ref: 22-53098-13

The ceiling – textured coating
- Ground Floor, Room 85 Rear
Entrance Hall Nursery -
contains asbestos.

Any change in its appearance
should be recorded and
passed to Property Services.

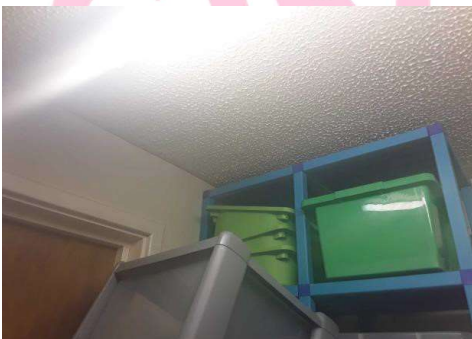
Item 162 Ref: 22-53098-13

The ceiling – textured coating
- Ground Floor, Room 89
Nursery area 2 Store
cupboard 1- contains
asbestos.

Any change in its appearance
should be recorded and
passed to Property Services.

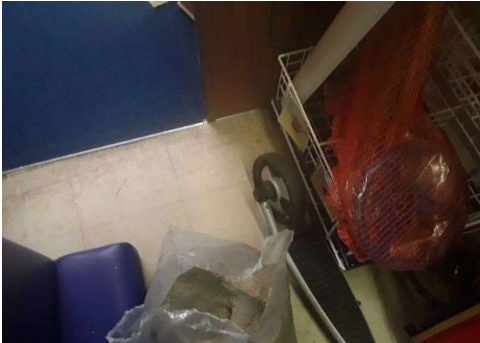
Item 163 Ref: 22-53098-20

The floor – tiles and adhesive
- Ground Floor, Room 89
Nursery area 2 Store
cupboard 1- contains
asbestos.

Any change in its appearance
should be recorded and
passed to Property Services.

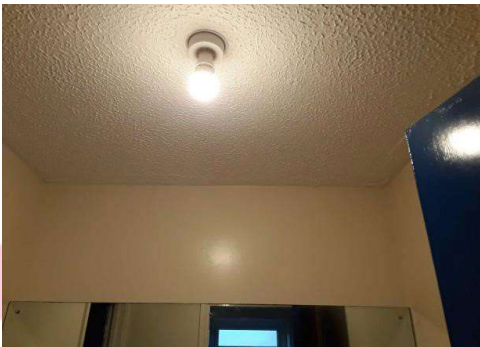
Item 164 Ref: 22-53098-13

The ceiling – textured coating
- Ground Floor, Room 90 Staff
Toilets Nursery - contains
asbestos.

Any change in its appearance
should be recorded and
passed to Property Services.

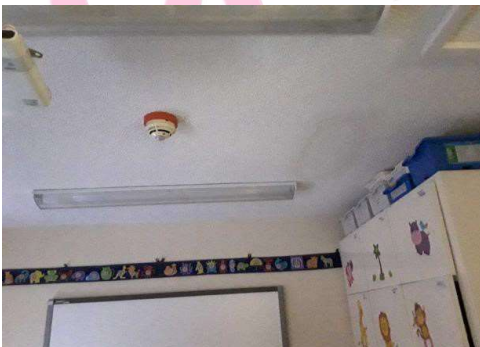
Item 165 Ref: 22-53098-13

The ceiling – textured coating
- Ground Floor, Room 91
Interview Room Nursery -
contains asbestos.

Any change in its appearance
should be recorded and
passed to Property Services.

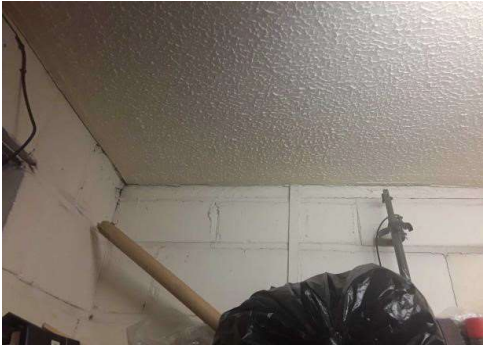
Item 166 Ref: 22-53098-13

The ceiling – textured coating
- Ground Floor, Room 93
External Store Nursery -
contains asbestos.

Any change in its appearance
should be recorded and
passed to Property Services.

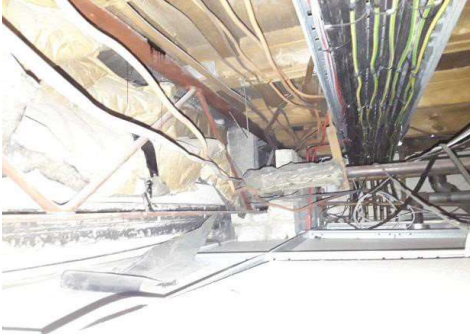
Item 169 Ref: 22-53098-1

The pipes – string to mmmf lagged metal pipes - Ground Floor, Room 98 Boiler Room - do not contain asbestos

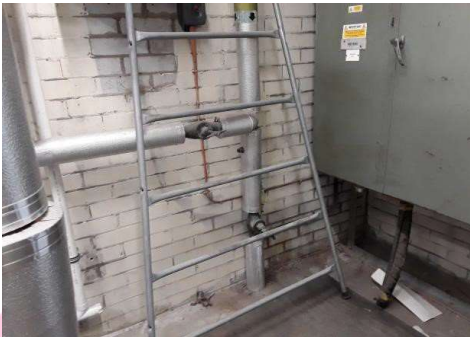
Item 170 Ref: Presumed

The pipes – Stop taps (Gaskets) - Ground Floor, Room 98 Boiler Room – are presumed to contain asbestos.

Any change in its appearance should be recorded and passed to Property Services.

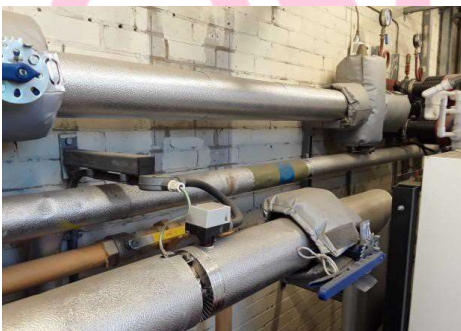
Item 171 Ref: 22-53098-24

The walls – residual insulation to walls - Ground Floor, Room 98 Boiler Room - do not contain asbestos

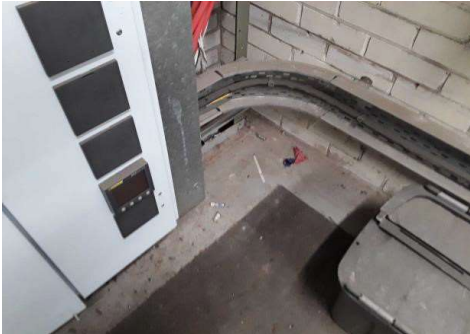
Item 172 Ref: 22-53098-25

The floor – redundant barrel fuses - Ground Floor, Room 98 Boiler Room - do not contain asbestos

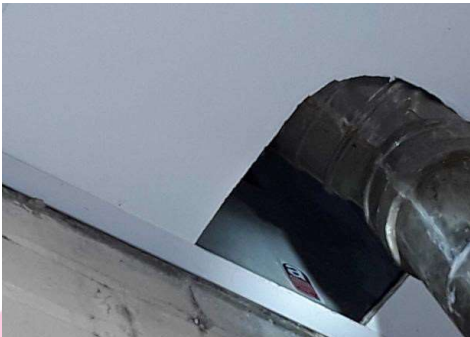
Item 173 Ref: Presumed

The walls – firebreak above suspended ceiling tiles between boiler room and kitchen and hall area of school – Ground Floor, Room 98 Boiler Room - are presumed to contain asbestos.

Any change in its appearance should be recorded and passed to Property Services.

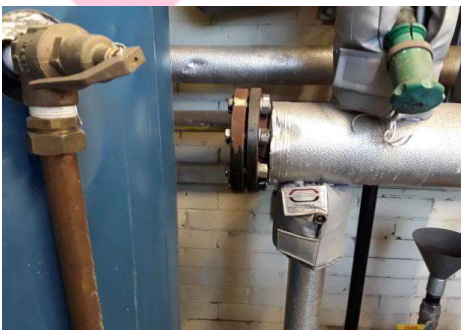
Item 174 Ref: 22-53098-27

The pipes – flange (Gaskets) - Ground Floor, Room 98 Boiler Room - do not contain asbestos

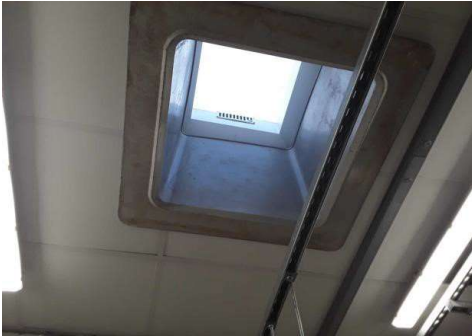
Item 175 Ref: Presumed

The ceiling – textured coating - Ground Floor, Room 98
Boiler Room – are presumed to contain asbestos.

Any change in its appearance should be recorded and passed to Property Services.

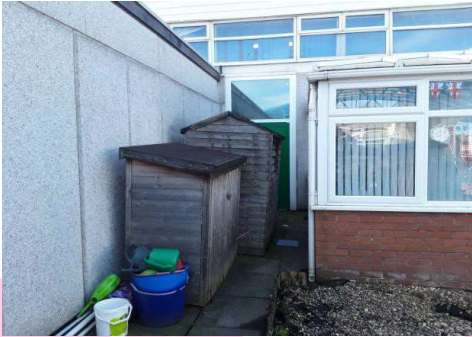
Item 176 Ref: 22-53098-28

The roof – shed roof felts - Ground Floor, Room 101,
Sheds in school courtyard – does not contain asbestos.

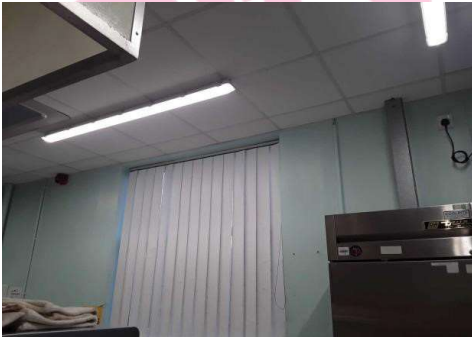
Item 177 Ref: Presumed

The walls – lining inside clasp columns - Ground Floor,
Room 104 Kitchen - are presumed to contain asbestos.

Any change in its appearance should be recorded and passed to Property Services.

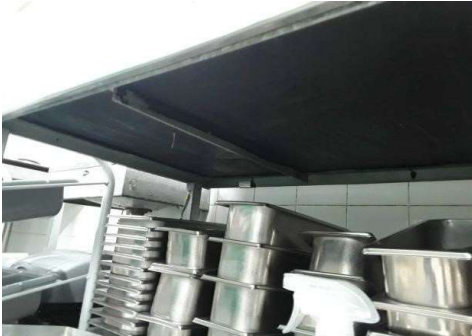
Item 178 Ref: 22-53098-30

The sink pad – coating to underside of drainers – Ground Floor, Room 104 Kitchen - does not contain asbestos.

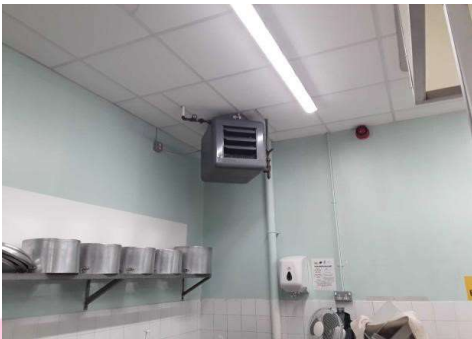
Item 179 Ref: Presumed

The vessels – lining inside ceiling heater - Ground Floor, Room 104 Kitchen - are presumed to contain asbestos.

Any change in its appearance should be recorded and passed to Property Services.

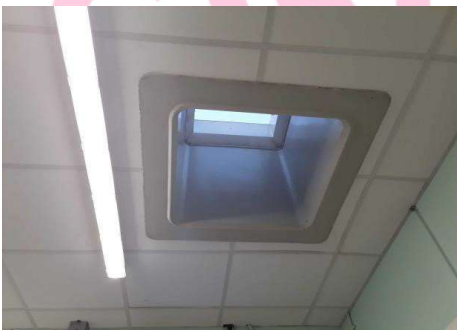
Item 180 Ref: Presumed

The ceiling – textile rope seal to fibreglass skylight - Ground Floor, Room 104 Kitchen - is presumed to contain asbestos.

Any change in its appearance should be recorded and passed to Property Services.

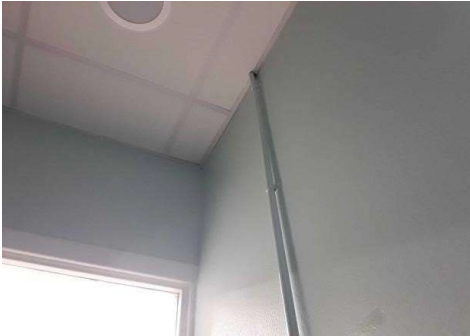
Item 181 Ref: Presumed

The walls – lining inside clasp columns - Ground Floor, Room 105 Kitchen Office - are presumed to contain asbestos.

Any change in its appearance should be recorded and passed to Property Services.

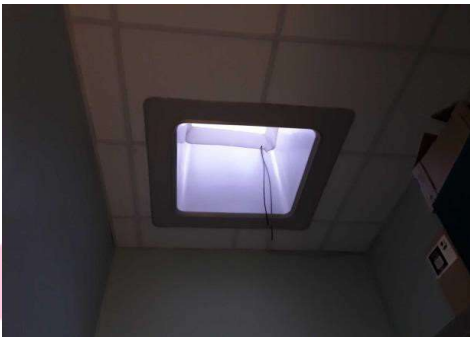
Item 182 Ref: Presumed

The ceiling – textile rope seal to fibreglass skylight - Ground Floor, Room 105 Kitchen Office - is presumed to contain asbestos.

Any change in its appearance should be recorded and passed to Property Services.

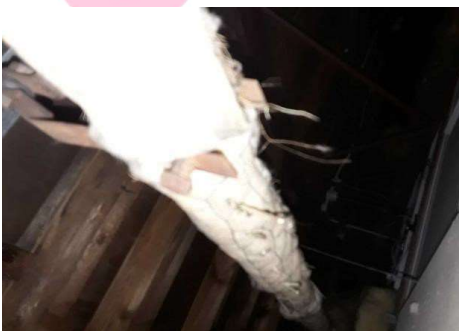
Item 183 Ref: 22-53098-1

The pipes – string to mmmf lagged metal pipes - Ground Floor, Room 106 Kitchen Pantry - do not contain asbestos

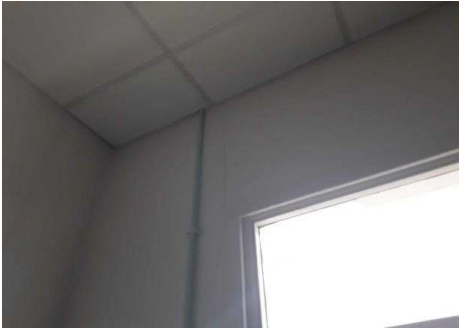
Item 184 Ref: Presumed

The walls – lining inside clasp columns - Ground Floor, Room 106 Kitchen Pantry - are presumed to contain asbestos.

Any change in its appearance should be recorded and passed to Property Services.

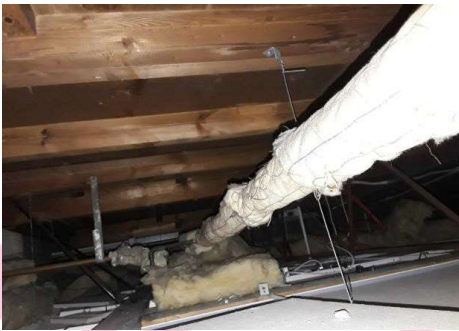
Item 185 Ref: 22-53098-1

The pipes – string to mmmf lagged metal pipes - Ground Floor, Room 107 Kitchen Store Cupboard - do not contain asbestos

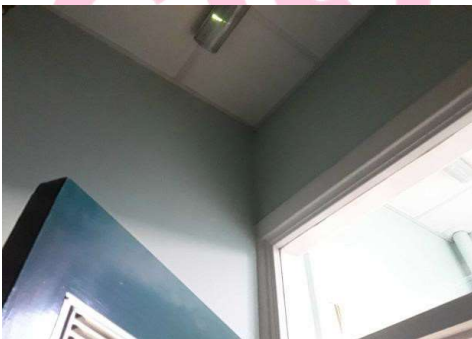
Item 186 Ref: Presumed

The walls – lining inside clasp columns - Ground Floor, Room 107 Kitchen Store Cupboard - are presumed to contain asbestos.

Any change in its appearance should be recorded and passed to Property Services.

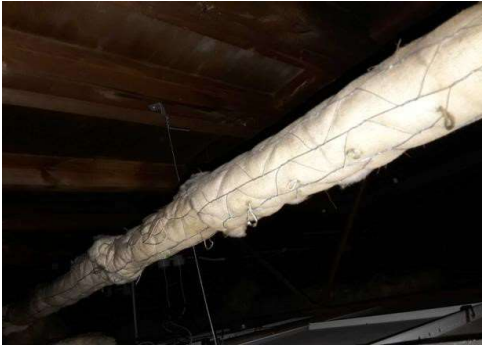
Item 187 Ref: 22-53098-1

The pipes – string to mmmf lagged metal pipes - Ground Floor, Room 108 Kitchen Fire Exit Hallway - do not contain asbestos

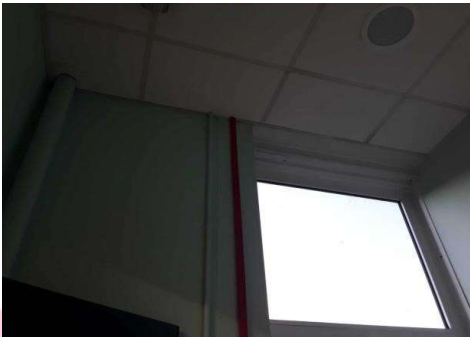
Item 188 Ref: Presumed

The walls – lining inside clasp columns - Ground Floor, Room 108 Kitchen Fire Exit Hallway - are presumed to contain asbestos.

Any change in its appearance should be recorded and passed to Property Services.

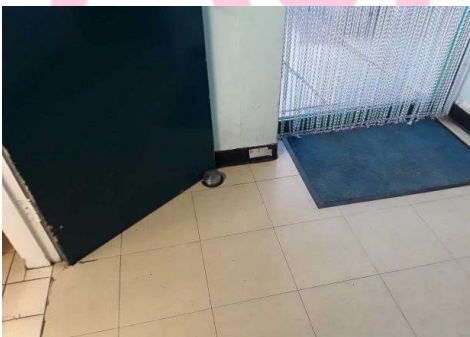
Item 189 Ref: 22-53098-31

The floor – tiles and adhesive - Ground Floor, Room 108 Kitchen Fire Exit Hallway - contains asbestos.

Any change in its appearance should be recorded and passed to Property Services.

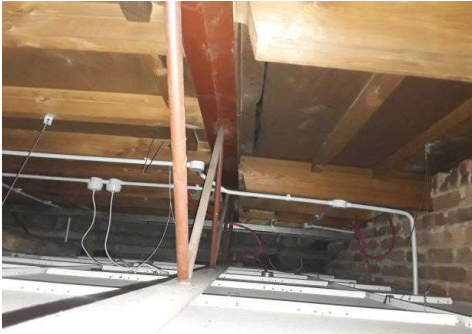
Item 190 Ref: 22-53098-1

The pipes – string to mmmf lagged metal pipes - Ground Floor, Room 109 Kitchen Staff Cloakroom - do not contain asbestos

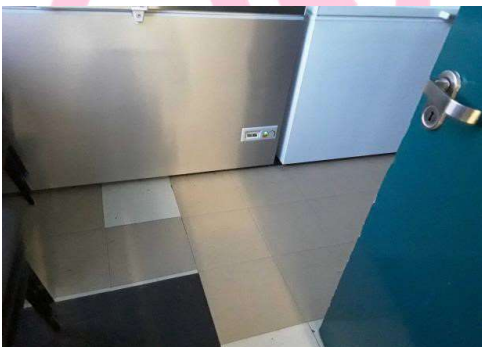
Item 192 Ref: 22-53098-31

The floor – tiles and adhesive - Ground Floor, Room 109 Kitchen Staff Cloakroom - contains asbestos.

Any change in its appearance should be recorded and passed to Property Services.

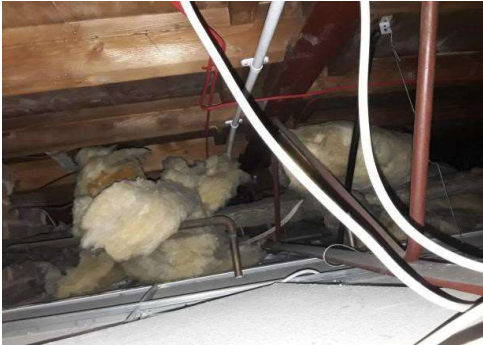
Item 193 Ref: 22-53098-1

The pipes – string to mmmf lagged metal pipes - Ground Floor, Room 110 Kitchen Staff Toilet - do not contain asbestos

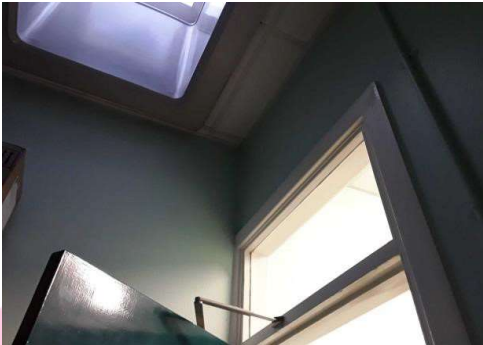
Item 194 Ref: Presumed

The walls – lining inside clasp columns - Ground Floor, Room 110 Kitchen Staff Toilet - are presumed to contain asbestos.

Any change in its appearance should be recorded and passed to Property Services.

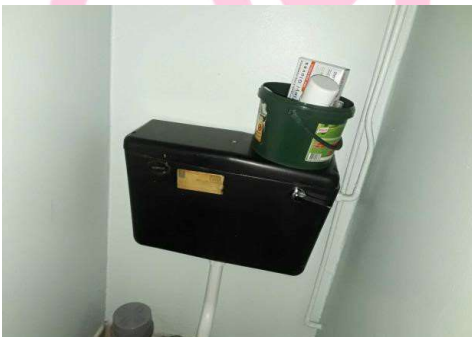
Item 195 Ref: 22-53098-32

The toilet cistern – Ground Floor, Room 110 Kitchen Staff Toilet - contains asbestos.

Any change in its appearance should be recorded and passed to Property Services.

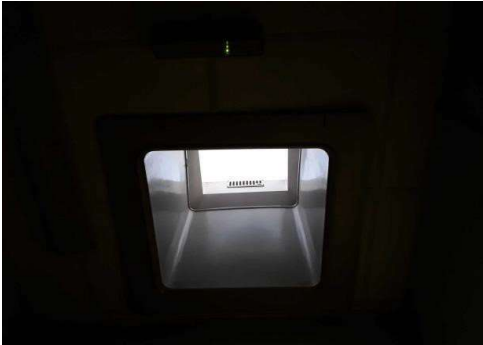
Item 196 Ref: Presumed

The ceiling – textile rope seal to fibreglass skylight - Ground Floor, Room 110 Kitchen Staff Toilet - is presumed to contain asbestos.

Any change in its appearance should be recorded and passed to Property Services.

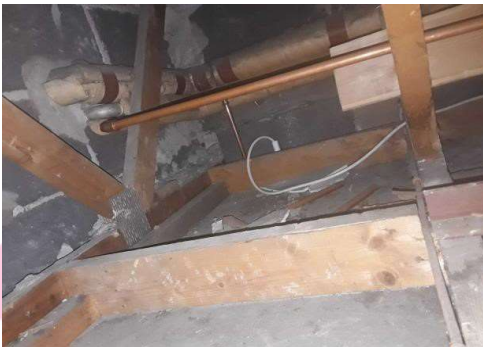
Item 197 Ref: 22-53098-34

The floor - 1st Floor, Room 111 Loft above boiler room in nursery – does not contain asbestos.

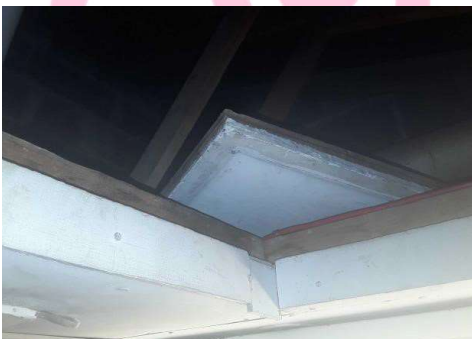
Item 198 Ref: 22-53098-35

The door hatch - 1st Floor, Room 111 Loft above boiler room in nursery – does not contain asbestos.

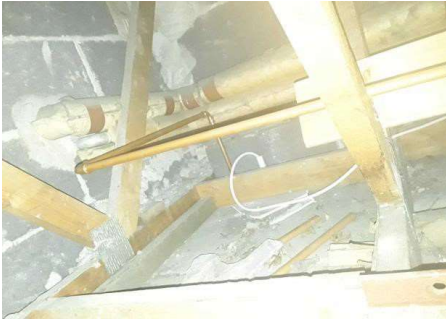
Item 199 Ref: 22-53098-36

The floor – debris to floor - 1st Floor, Room 111 Loft above boiler room in nursery – does not contain asbestos.

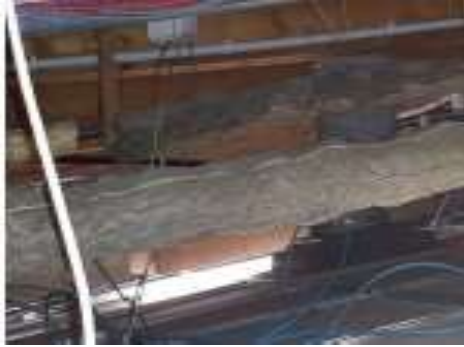
Item 208 Ref: OU002710

The string around the hessian covered pipework in Staff Room 3 (G/01) does not contain asbestos.

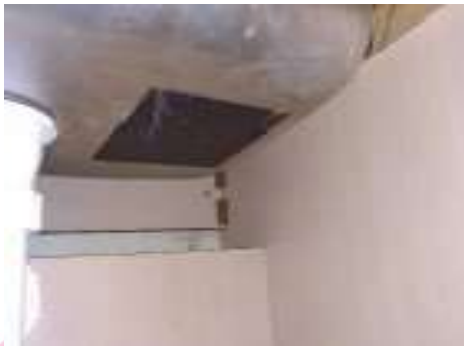
Item 209 Ref: OU002711

The bitumen sink pad in Staff Room 3 (G/01) does not contain asbestos.
