ASBESTOS SURVEY REPORT FOR JOPLING HOUSE, JOHN STREET,
SUNDERLAND, SR1 1DP.

Jopling House, John Street, Sunderland

Date: 27 June 2025

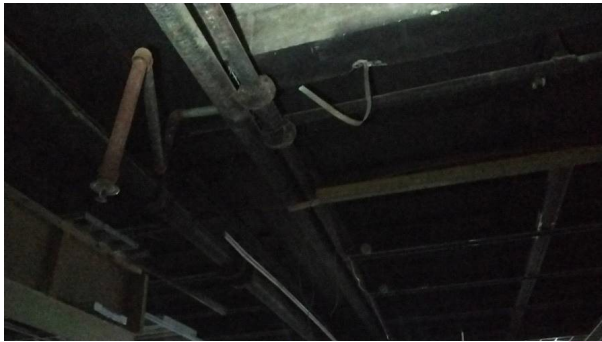
4.	Presumed	Pipework Gaskets to deeply recessed to sample	Z-Sub level 1 Shop Floor (Room Z1/001)	Presumed to contain asbestos - Any change in its appearance should be recorded and passed to Property Services.

3.	NO000253	Pipework Gaskets	Z-Sub level 1 Shop Floor (Room Z1/001)	No Risk
4.	Presumed	Pipework Gaskets to deeply recessed to sample	Z-Sub level 1 Shop Floor (Room Z1/001)	This item is classed as very low risk and should be inspected every 12 months

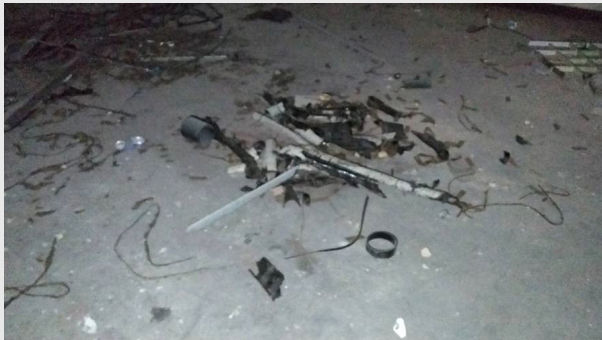
5.	NO000254	Cable braiding insulation	Z-Sub level 1 Shop Floor (Room Z1/001)	Does not contain asbestos.

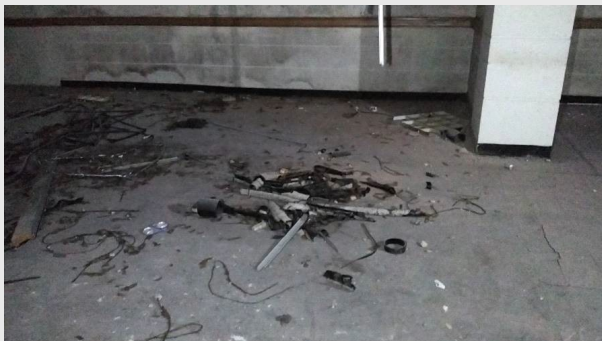
6.	NO000255	Cable braiding insulation	Z-Sub level 1 Shop Floor (Room Z1/001)	Does not contain asbestos.

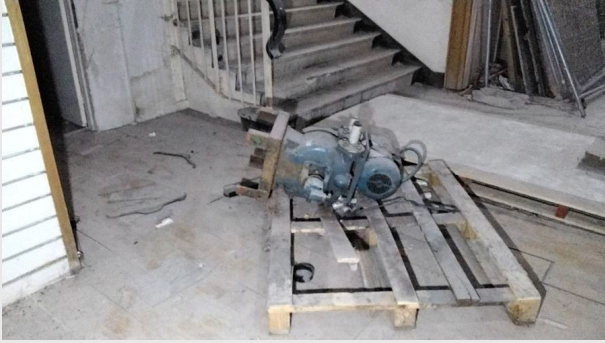
10.	NO000259	Debris/Residue to redundant pump	Z-Sub level 1 Shop Floor (Room Z1/001)	Does not contain asbestos.

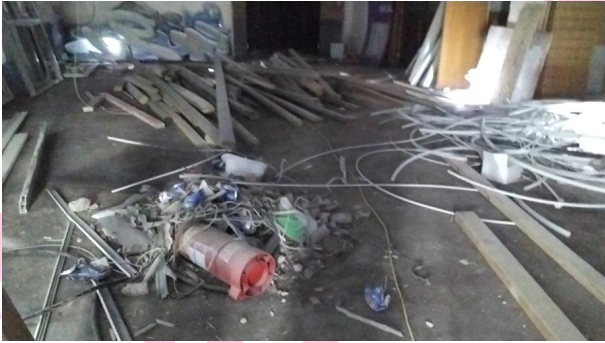
11.	NO000264	Debris/Residue to floor adjacent stairwell	Z-Sub level 1 Shop Floor (Room Z1/001)	Removed Sept 2023

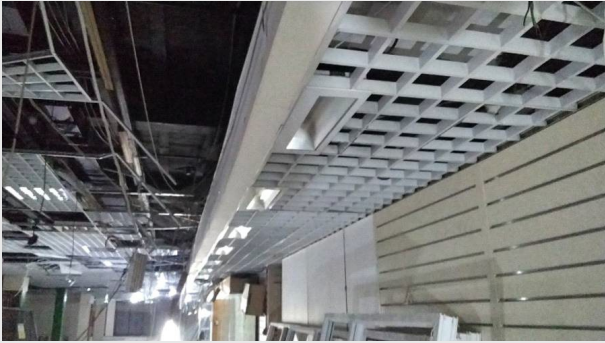
12.	NO000266	Ceiling tile behind metal grid tiles	Z-Sub level 1 Shop Floor (Room Z1/001)	Does not contain asbestos.

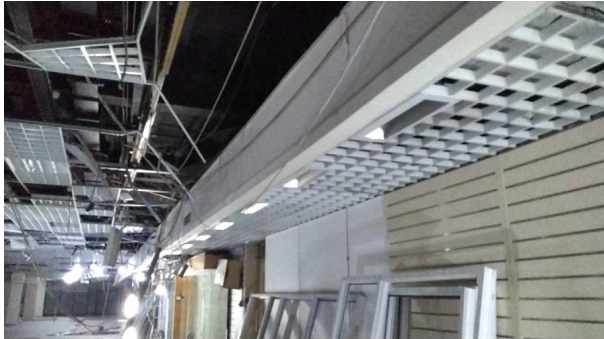
13.	NO000267	Ductwork joints	Z-Sub level 1 Shop Floor (Room Z1/001)	Contains asbestos - Any change in its appearance should be recorded and passed to Property Services.

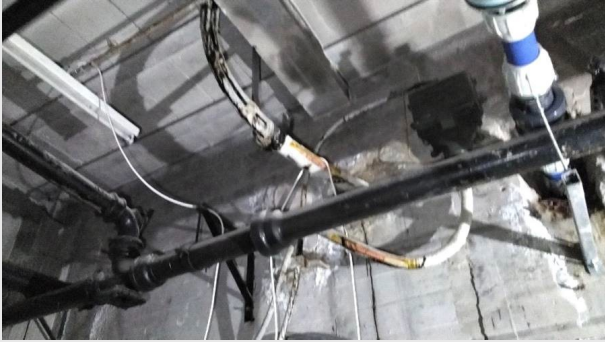
16.	As NO000254	Cable braiding insulation	Z-Sub level 1 Switch Room (Room Z1/007)	Does not contain asbestos.

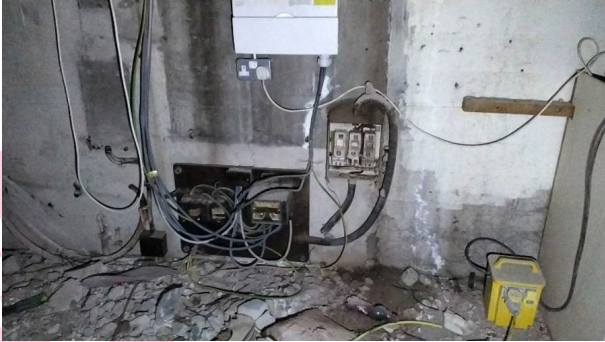
17.	NO000256	Fuses flashguards	Z-Sub level 1 Switch Room (Room Z1/007)	Contains asbestos - Any change in its appearance should be recorded and passed to Property Services.

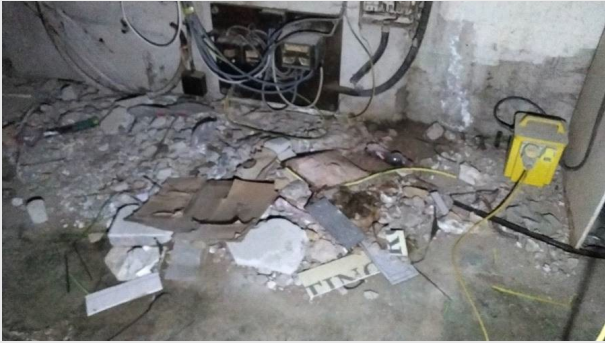
18.	NO000302	Door seal/gasket discarded on floor	Z-Sub level 1 Switch Room (Room Z1/007)	Does not contain asbestos.

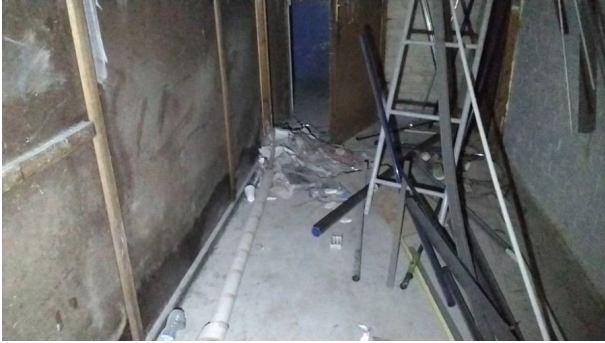
19.	NO000262	Debris/residue to floor	Z-Sub level 1 Plant Room (Room Z1/008)	Removed Sept 2023

19.	NO000262	Debris/residue to	Z-Sub level 1 Plant	Removed Sept 2023

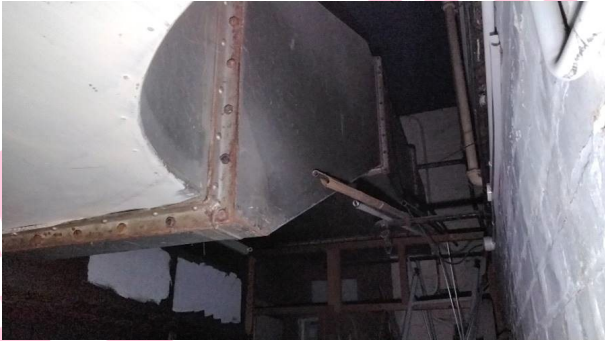
20.	NO000263	Ductwork joints	Z-Sub level 1 Plant Room (Room Z1/008)	Contains asbestos - Any change in its appearance should be recorded and passed to Property Services.

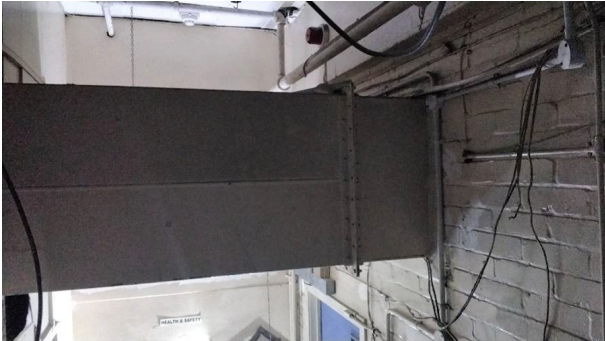
21.	As NO000263	Ductwork joints	Z-Sub level 1 Staircase/Stairwell (Room Z1/009)	Presumed to contain asbestos - Any change in its appearance should be recorded and passed to Property Services.

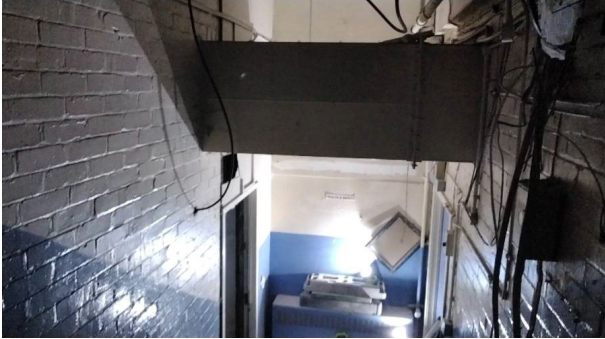
22.	NO000265	Wall	Z-Sub level 1 Staircase/Stairwell (Room Z1/009)	Contains asbestos - Any change in its appearance should be recorded and passed to Property Services.

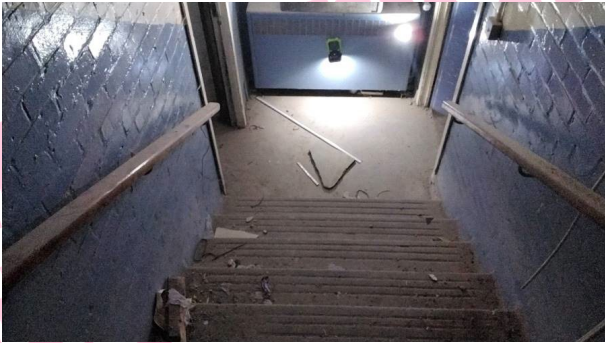
23.	As NO000265	Debris/Residue foot of stairwell and adjacent areas	Z-Sub level 1 Staircase/Stairwell (Room Z1/009)	Removed Sept 2023

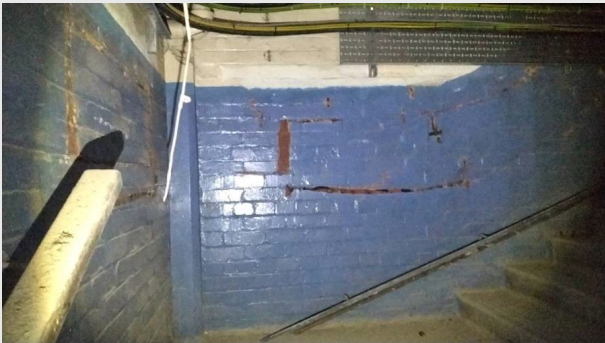
24.	NO000301	Cable braiding insulation remnants to wall	Z-Sub level 1 Staircase/Stairwell (Room Z1/009)	Does not contain asbestos.

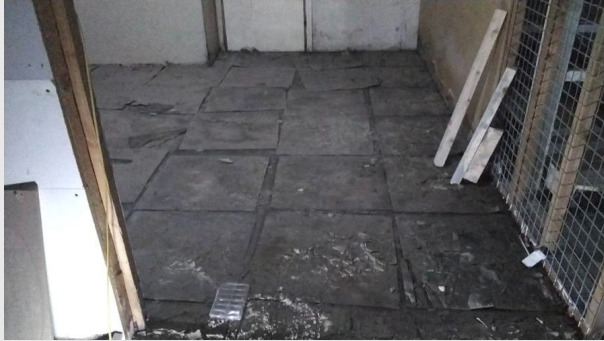
25.	NO000268	Floor tile	Z-Sub level 1 Store Room (Room Z1/010)	Does not contain asbestos.

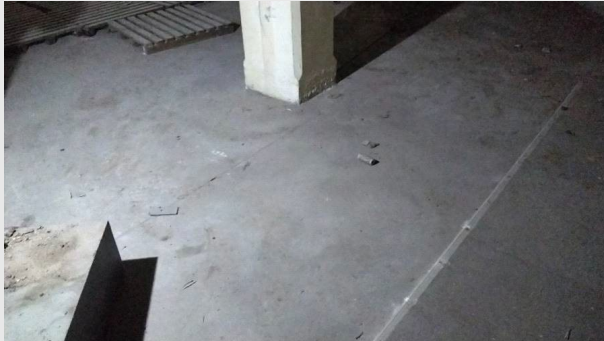
26.	NO000269	Floor jointing compound	Z-Sub level 1 Store Room (Room Z1/014)	Does not contain asbestos.

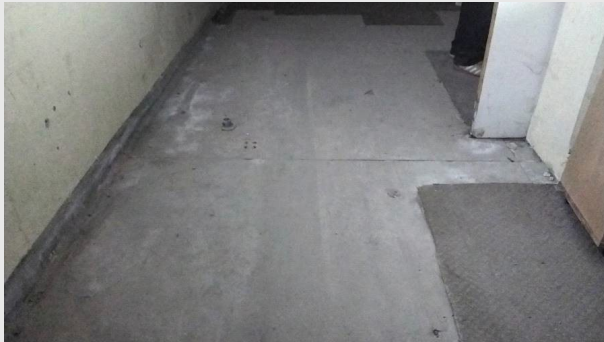
27.	As NO000269	Floor jointing compound	Z-Sub level 1 Store Room (Room Z1/017)	Does not contain asbestos.

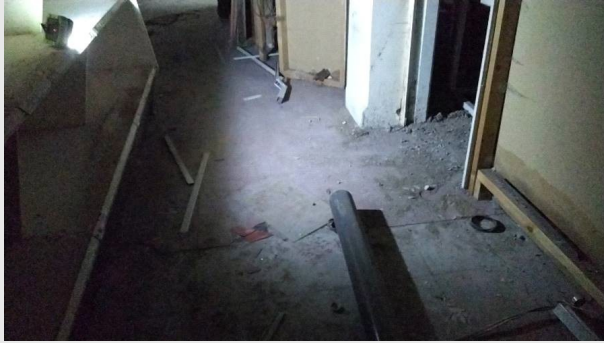
28.	NO000270	Floor tile red	Z-Sub level 1 Store Room (Room Z1/017)	Does not contain asbestos.

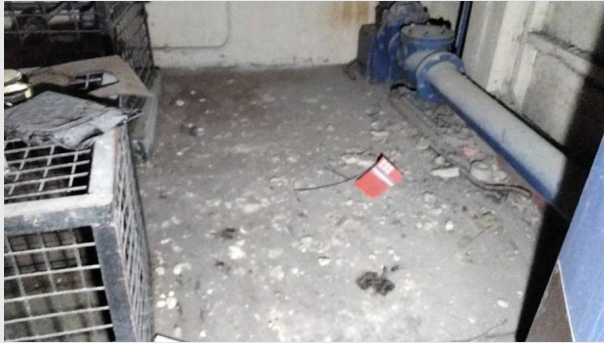
29.	As NO000269	Floor jointing compound	Z-Sub level 1 Tank Room (Room Z1/018)	Does not contain asbestos.

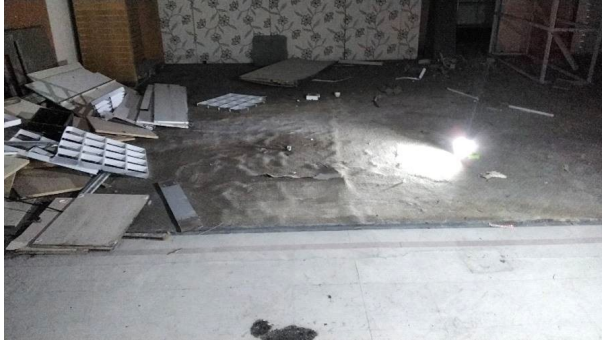
37.	As NO000257	Debris/Residue	Z-Sub level 1 Shop Floor (Room Z1/019)	Removed Sept 2023

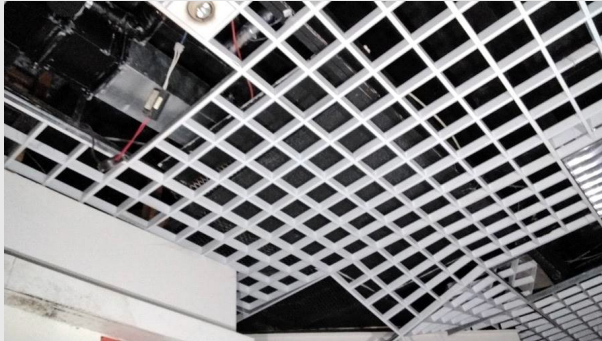
38.	As NO000266	Ceiling tile behind metal grid tiles	Z-Sub level 1 Shop Floor (Room Z1/019)	Does not contain asbestos.

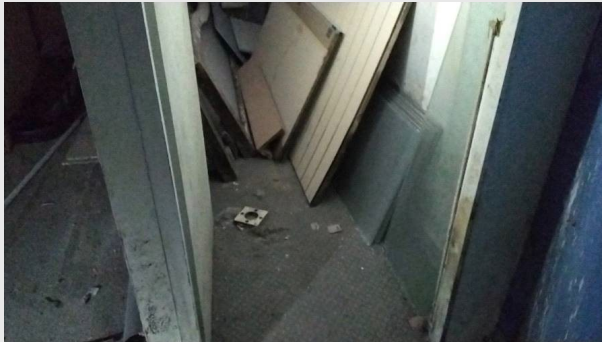
39.	As NO000272	Floor tile cream	Z-Sub level 1 Shop Floor (Room Z1/019)	Does not contain asbestos.

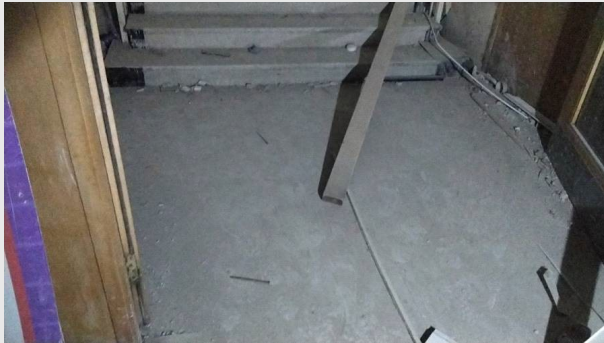
41.	As NO000251	Floor tile pink/grey	Z-Sub level 1 Staircase/Stairwell (Room Z1/020)	Does not contain asbestos.

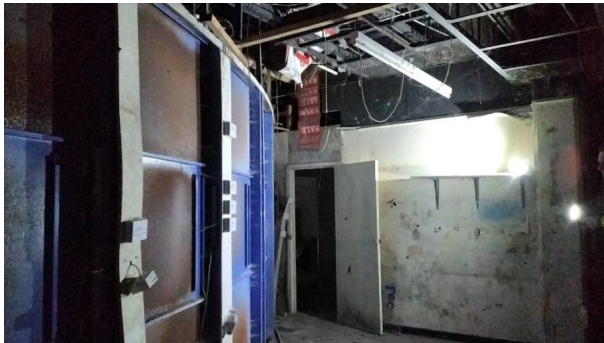
42.	As NO000273	Debris/Residue to ceiling void and floor below	Z-Sub level 1 Store Room (Room Z1/021)	Removed Sept 2023

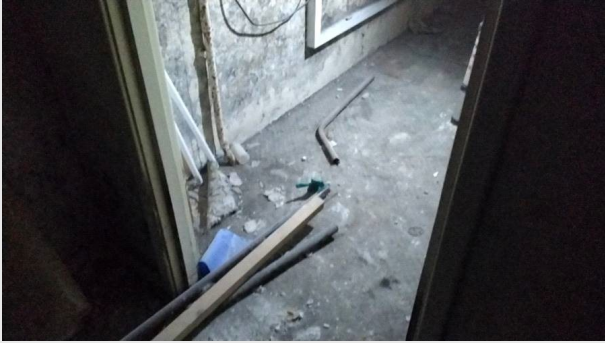
46.	As NO000268	Floor tile	Z-Sub level 1 Store Room (Room Z1/023)	Does not contain asbestos.

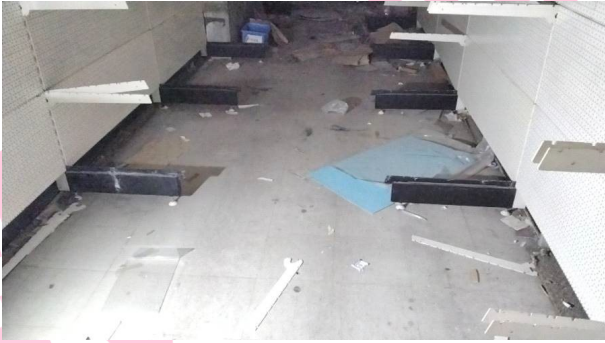
47.	NO000275	Floor tile grey	Z-Sub level 1 Store Room (Room Z1/026)	Contains asbestos - Any change in its appearance should be recorded and passed to Property Services.

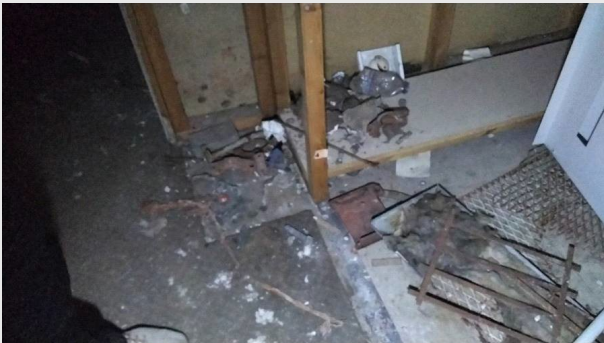
51.	NO000277	Fuses/flashguards inside fuses discarded throughout	Z-Sub level 1 Store Room (Room Z1/027)	Does not contain asbestos.

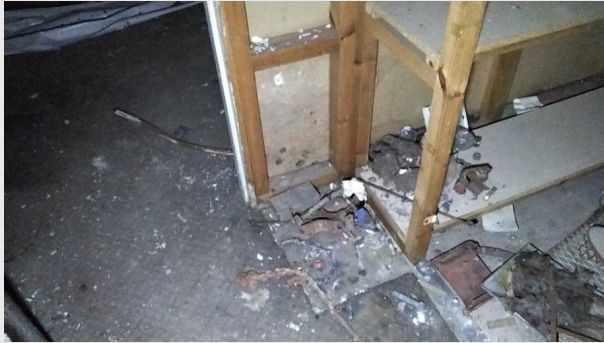
52.	NO000278	Debris/residue to floor	Z-Sub level 1 Store Room (Room Z1/027)	Does not contain asbestos.

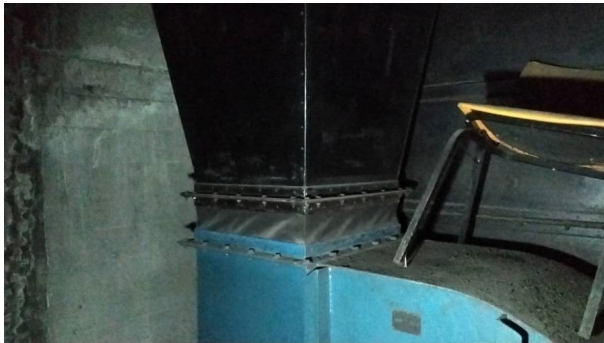
54.	As NO000267	Ductwork joints	Z-Sub level 1 Plant Room (Room Z1/028)	Presumed to contain asbestos - Any change in its appearance should be recorded and passed to Property Services.

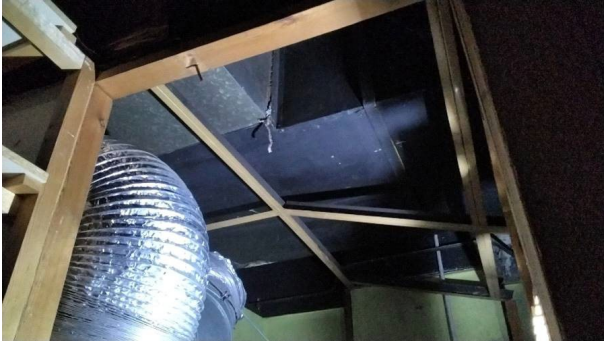
55.	NO000280	Ductwork joints	Z-Sub level 1 Store Room (Room Z1/029)	Contains asbestos - Any change in its appearance should be recorded and passed to Property Services.

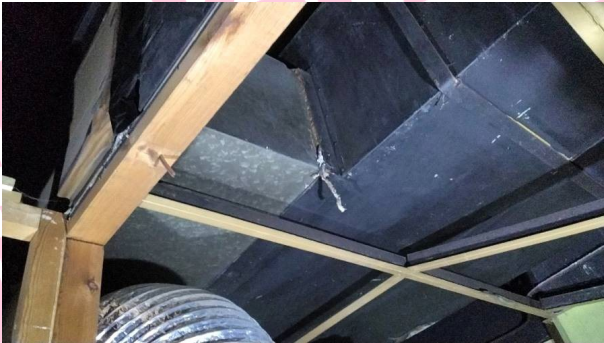
56.	NO000281	Ductwork joints red/brown mastic	Z-Sub level 1 Store Room (Room Z1/029)	Contains asbestos - Any change in its appearance should be recorded and passed to Property Services.

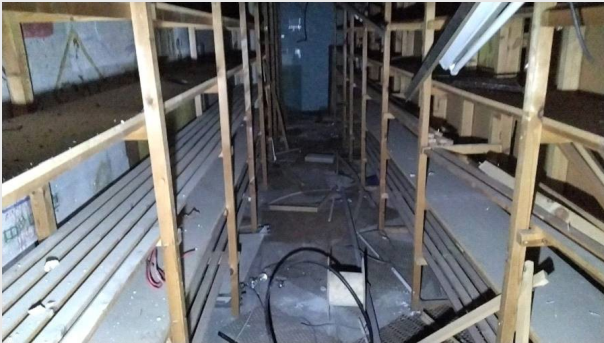
57.	As NO000268	Floor tile	Z-Sub level 1 Store Room (Room Z1/029)	Does not contain asbestos.

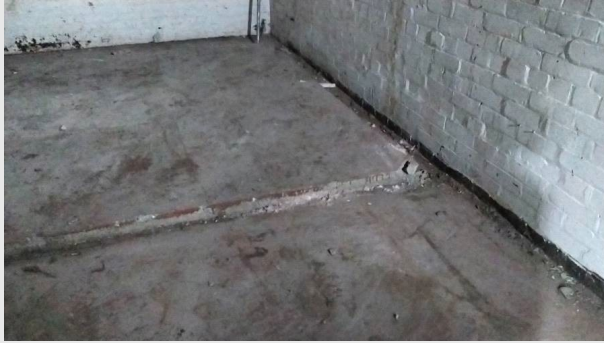
64.	NO000288	Debris/Residue to floor	Z-Sub level 1 Boiler Room (Room Z1/030)	Does not contain asbestos.

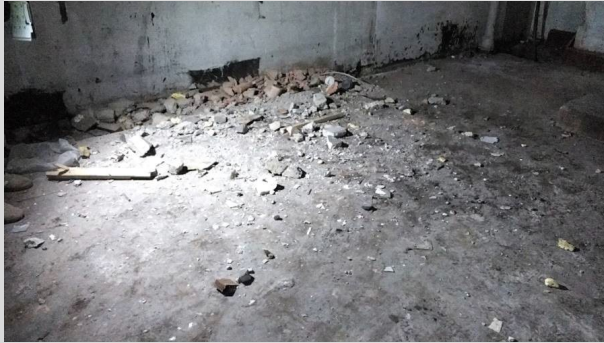
65.	NO000289	Floor tile	Z-Sub level 1 Boiler Room (Room Z1/030)	Removed confirmed on survey J12535

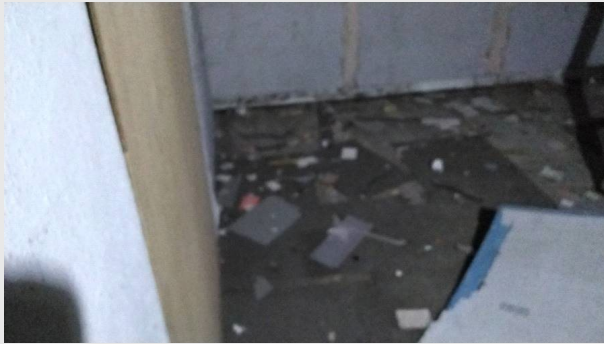
66.	As NO000268	Floor tile	Z-Sub level 1 Store Room (Room Z1/032)	Does not contain asbestos.

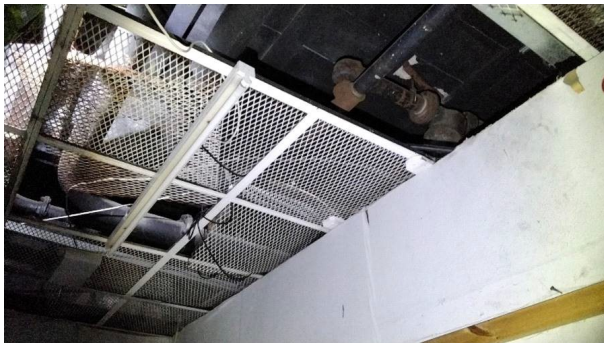
67.	As NO000271	Pipework gasket	Z-Sub level 1 Store Room (Room Z1/032)	Presumed to contain asbestos - Any change in its appearance should be recorded and passed to Property Services.

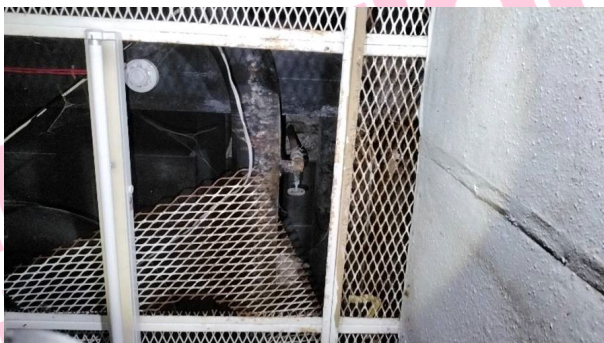
68.	NO000290	Pipework wrap to pipe penetrations in ceiling	Z-Sub level 1 Store Room (Room Z1/032)	Contains asbestos - Any change in its appearance should be recorded and passed to Property Services.

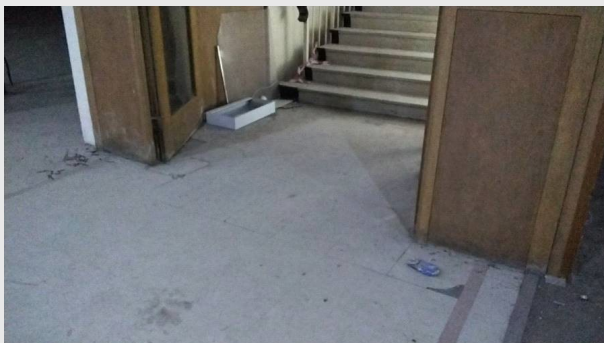
69.	As NO000251	Floor tile pink/grey including debris up the stairs	Z-Sub level 1 Stairwell Staircase (Room Z1/034)	Does not contain asbestos.

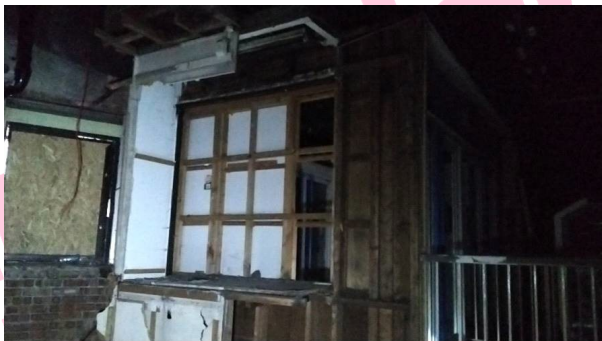
74.	NO000295	Debris/Residue to entrance porch, on top and to sides, including beneath shelf and framework	Ground Floor Shop Floor Unit 1 (Room G/001)	Contains asbestos - Any change in its appearance should be recorded and passed to Property Services.

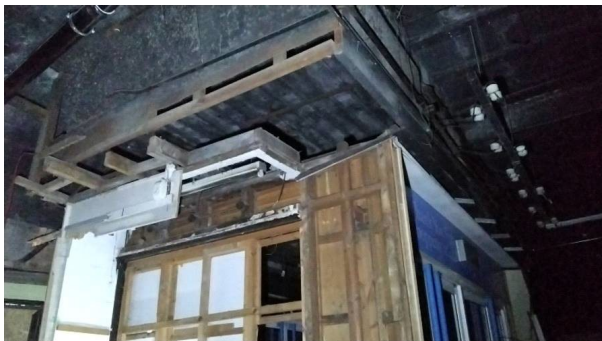
75.	NO000296	Debris/Residue to top of ceiling at entrance porch	Ground Floor Shop Floor Unit 1 (Room G/001)	Removed Sept 2023

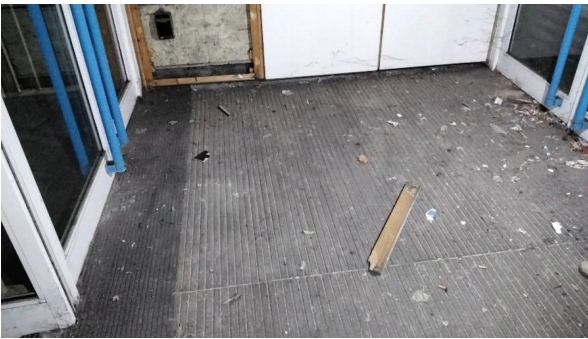
82.	As NO000295	Debris/Residue to floor	Ground Floor Porch Unit 1 (Room G/002)	Removed Sept 2023

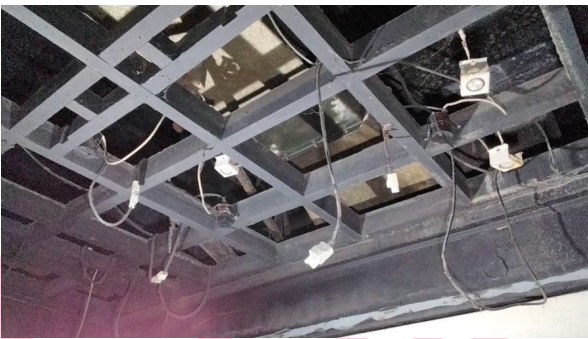
83.	As NO000280	Ductwork joints	Ground Floor Porch Unit 1 (Room G/002)	Presumed to contain asbestos - Any change in its appearance should be recorded and passed to Property Services.

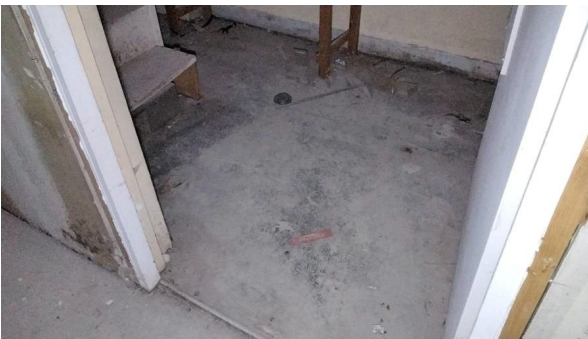
84.	As NO000293	Floor adhesive remnants	Ground Floor Store Room Unit 1 (Room G/003)	Presumed to contain asbestos - Any change in its appearance should be recorded and passed to Property Services.

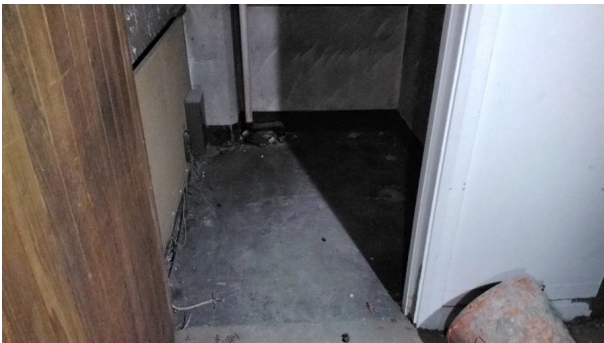
85.	As NO000293	Floor adhesive remnants	Ground Floor Store Room Unit 1 (Room G/004)	Presumed to contain asbestos - Any change in its appearance should be recorded and passed to Property Services.

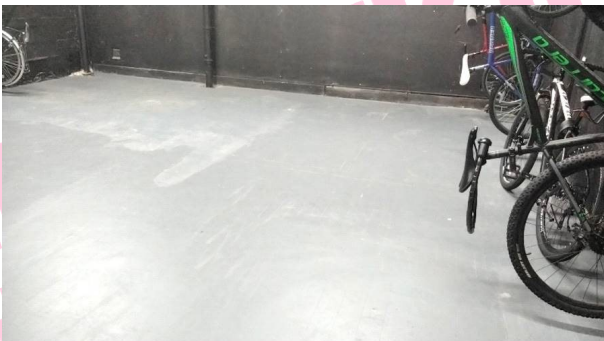
86.	NO000303	Floor tile grey/beige beneath modern lino	Ground Floor Store Room Bike Store (Room G/005)	Contains asbestos - Any change in its appearance should be recorded and passed to Property Services.

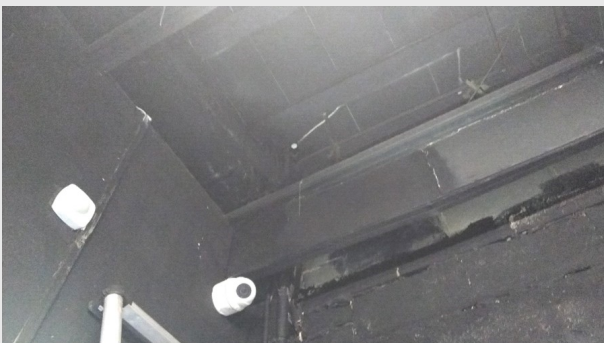
87.	NO000304	Ceiling shuttering	Ground Floor Store Room Bike Store (Room G/005)	Does not contain asbestos.

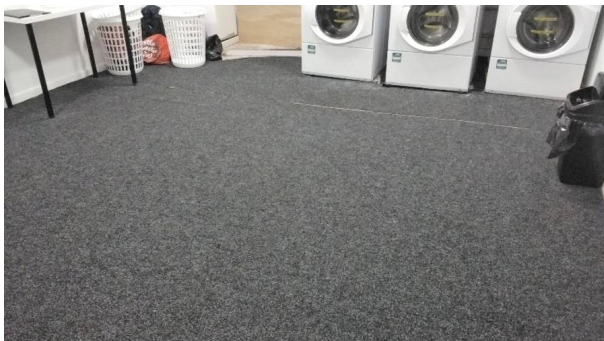
88.	As NO000303	Tile grey/beige beneath carpet	Ground Floor Laboratory (Room G/007)	Presumed to contain asbestos - Any change in its appearance should be recorded and passed to Property Services.

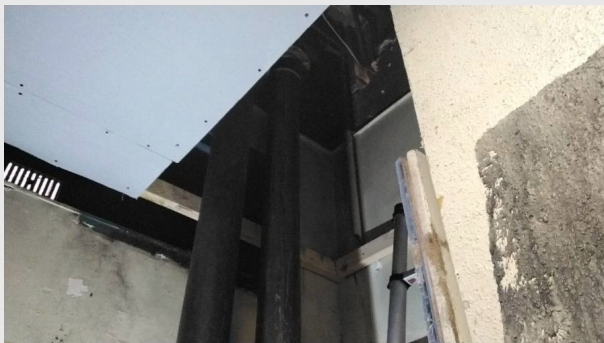
90.	NO000305	Pipework Gasket	Ground Floor Hallway/passageway Switch Room (Room G/008)	Does not contain asbestos.

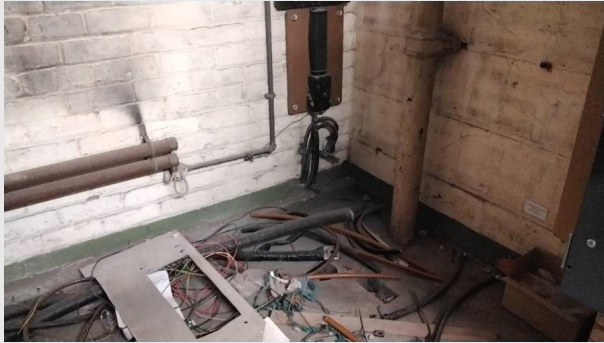
91.	As NO000254	Cable braiding insulation	Ground Floor Switch Room behind lifts (Room G/009)	Does not contain asbestos.

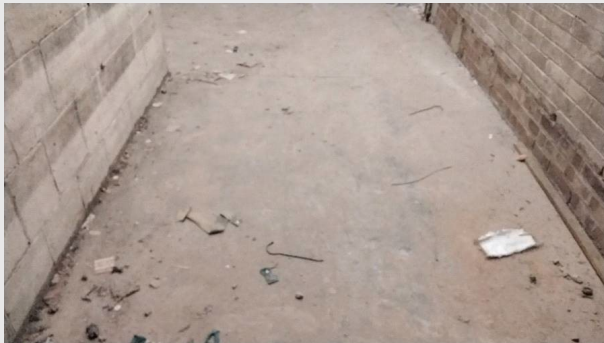
92.	NO000306	Floor jointing compound	Ground Floor Switch Room behind lifts (Room G/009)	Does not contain asbestos.

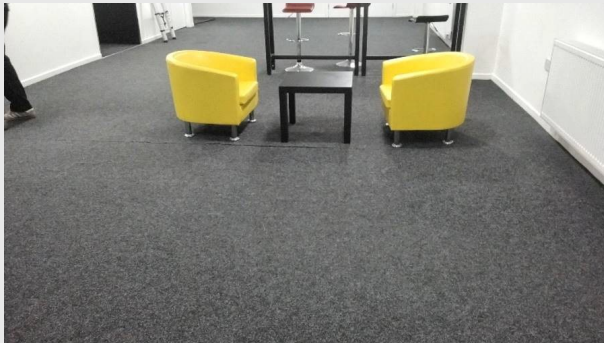
93.	NO000307	Floor adhesive remnants beneath carpet	Ground Floor Hallway/passageway lift lobby (Room G/010)	Does not contain asbestos.

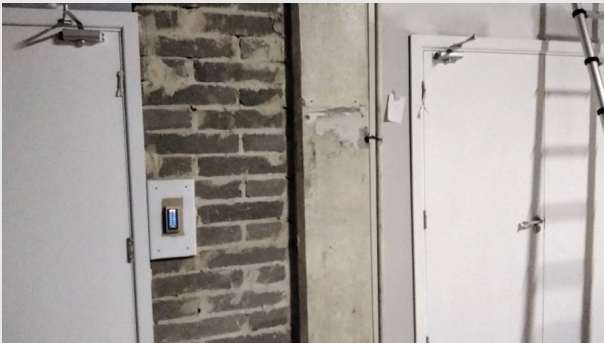
103.	NO000311	Wall to nail/screw heads, various points on column	Ground Floor Store Room (Room G/017)	Does not contain asbestos.

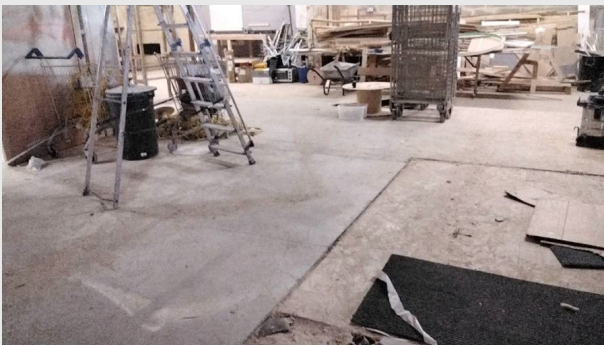
104.	As NO000306	Floor jointing compound	Ground Floor Store Room unit 4 (Room G/018)	Does not contain asbestos.

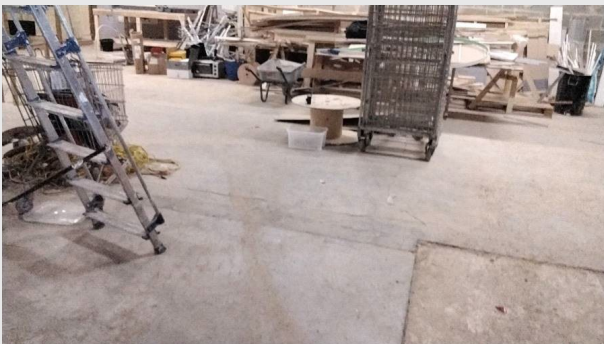
105.	As NO000307	Floor adhesive remnants	Ground Floor Store Room unit 4 (Room G/018)	Does not contain asbestos.

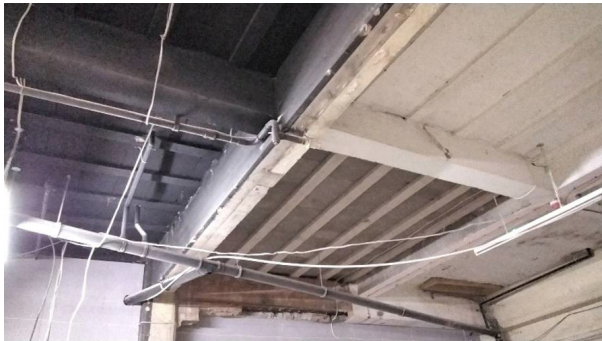
106.	NO000312	Pipework insulation packing to former wall penetration	Ground Floor Store Room unit 4 (Room G/018)	Contains asbestos - Any change in its appearance should be recorded and passed to Property Services.

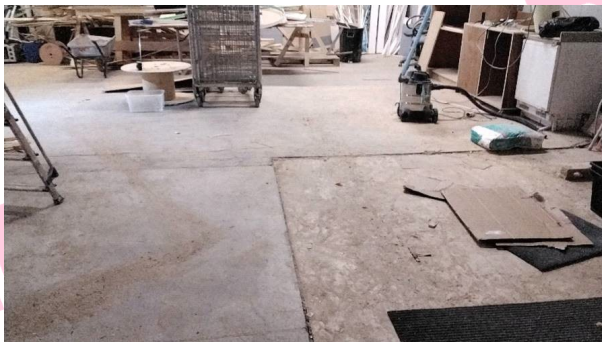
107.	NO000313	Residue/Debris to floor	Ground Floor Store Room unit 4 (Room G/018)	Removed Sept 2023

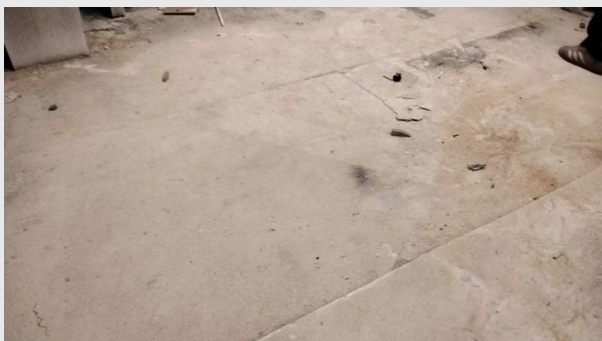
108.	As NO000306	Floor jointing compound	Ground Floor Store Room (Room G/020)	Does not contain asbestos.

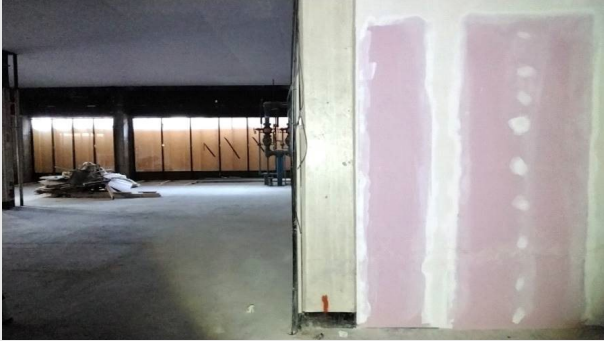
112.	As NO000311	Wall to nail/screw heads various points on column	Ground Floor Unit 3 (café) limited inspection to ceiling (Room G/022)	Does not contain asbestos.

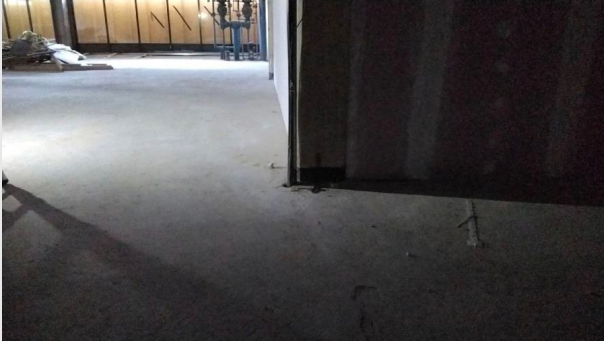
113.	As NO000307	Floor adhesive remnants	Ground Floor Unit 3 (café) limited inspection to ceiling (Room G/022)	Does not contain asbestos.

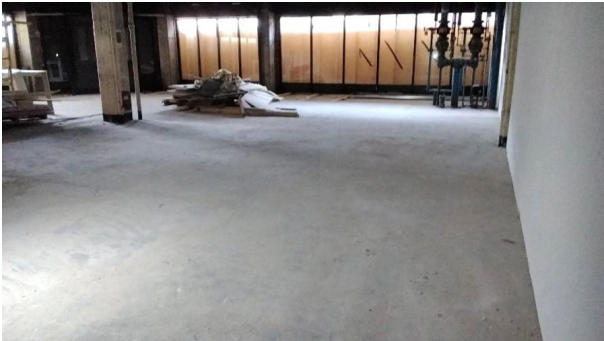
114.	As NO000303	Floor tile remnants	Ground Floor Unit 3 (café) limited inspection to ceiling (Room G/022)	Presumed to contain asbestos - Any change in its appearance should be recorded and passed to Property Services.

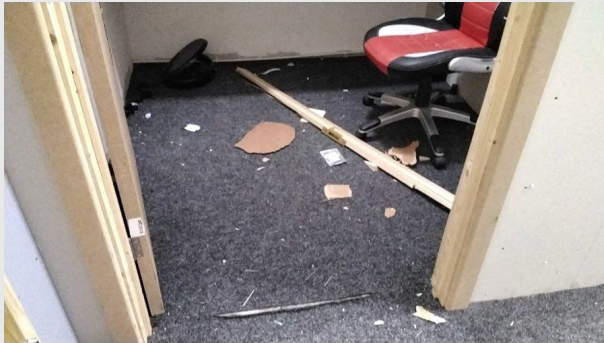
118.	As NO000307	Floor adhesive remnants	Ground Floor Office (Room G/026)	Does not contain asbestos.

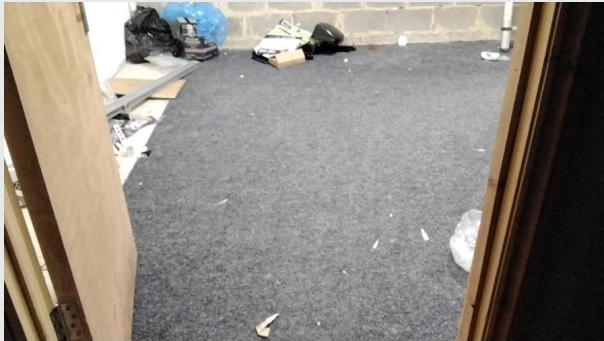
119.	As NO000307	Floor adhesive remnants	Ground Floor Hallway/passageway (Room G/027)	Does not contain asbestos.

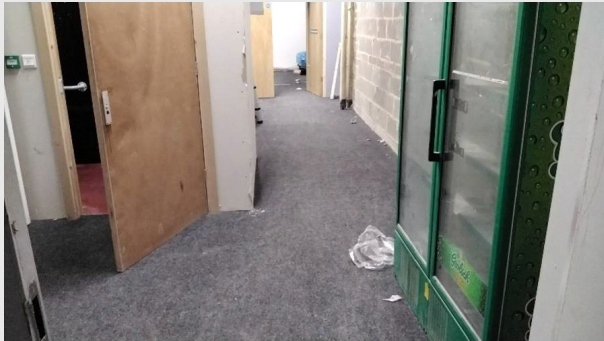
120.	As NO000307	Floor adhesive remnants	Ground Floor Hallway/passageway (Room G/028)	Does not contain asbestos.

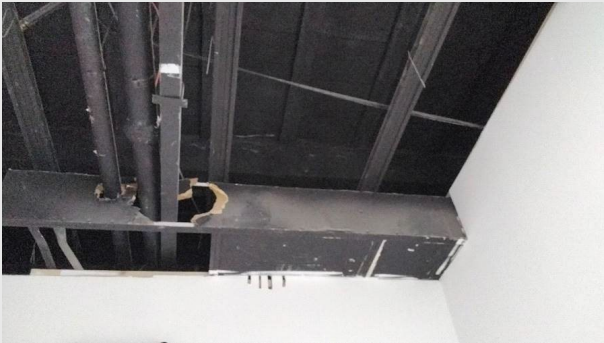
121.	NO000315	Ceiling tiles	Ground Floor Bin store (Room G/031)	Does not contain asbestos.

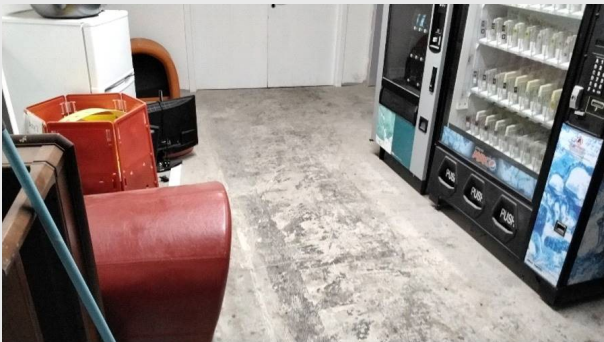
122.	As NO000307	Floor adhesive remnants	Ground Floor Bin store (Room G/031)	Does not contain asbestos.

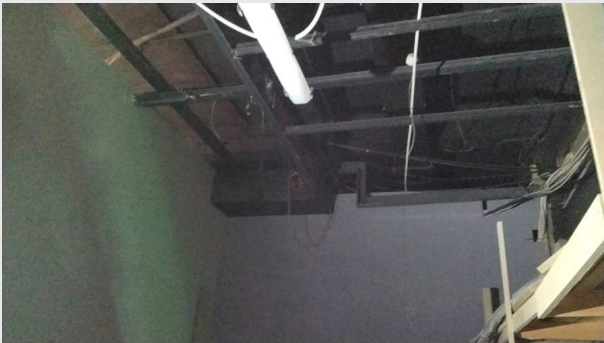
123.	As NO000315	Ceiling tiles	Ground Floor Store Room (Room G/032)	Does not contain asbestos.

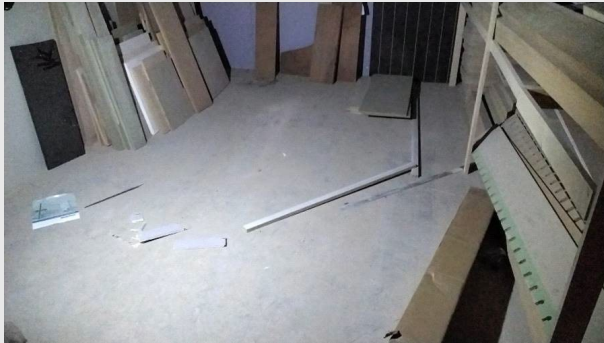
124.	As NO000307	Floor adhesive remnants	Ground Floor Store Room (Room G/032)	Does not contain asbestos.

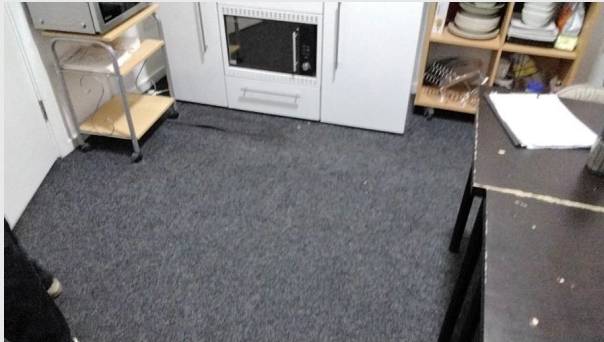
125.	As NO000307	Floor adhesive remnants	Ground Floor Staff Room (Room G/035)	Does not contain asbestos.

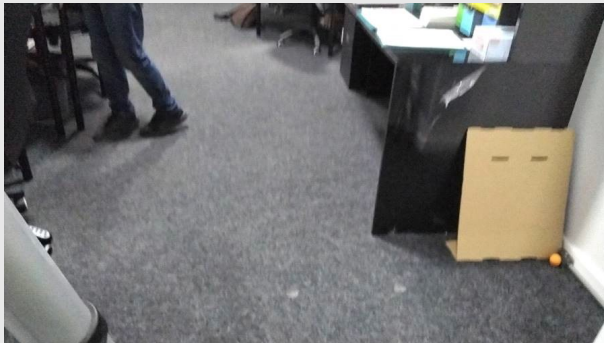
126.	As NO000307	Floor adhesive remnants	Ground Floor Office (Room G/036)	Does not contain asbestos.

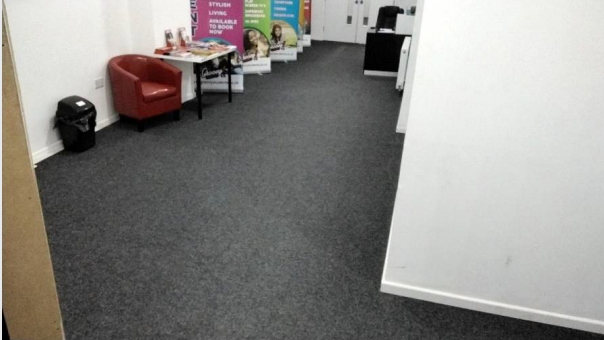
127.	As NO000307	Floor adhesive remnants	Ground Floor Entrance Hall/Foyer/Lobby (Room G/037)	Does not contain asbestos.

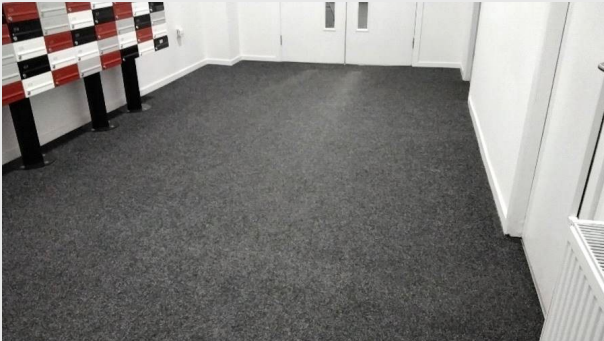
128.	As NO000307	Floor adhesive remnants	Ground Floor Hallway/Passageway (Room G/038)	Does not contain asbestos.

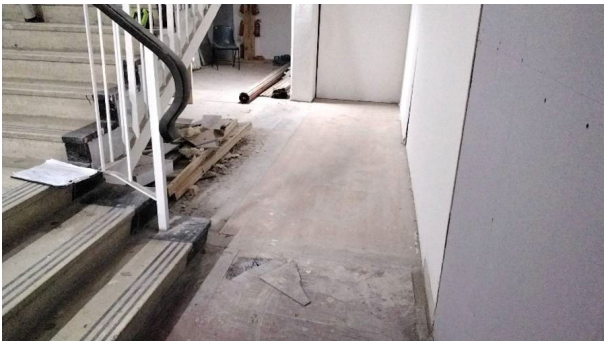
129.	NO000317	Floor tile to former shop floor and understairs area	Ground Floor Staircase/Stairwell (Room G/039)	Contains asbestos - Any change in its appearance should be recorded and passed to Property Services.

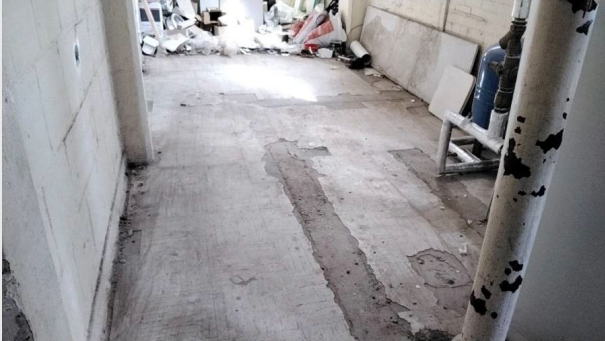
133.	NO000320	Floor tile	First Floor Plant Room (Room 1/005)	Does not contain asbestos.

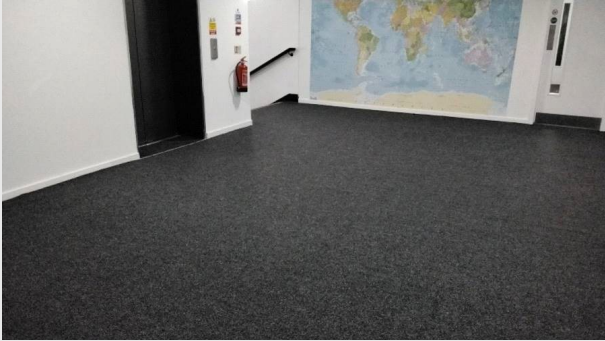
134.	NO000321	Floor tile beneath carpet	Second Floor Landing including stairs up (Room 2/001)	Does not contain asbestos.

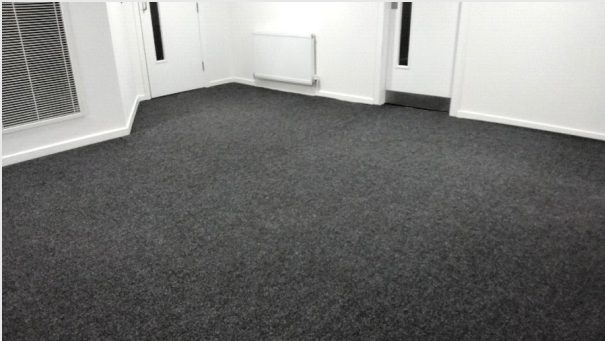
135.	NO000321	Floor tile beneath carpet	Second Floor Landing (Room 2/003)	Does not contain asbestos.

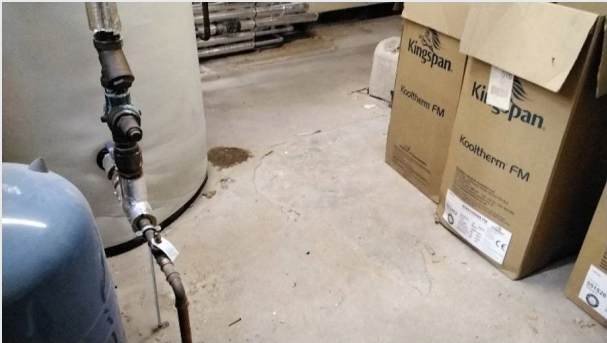
136.	As NO000320	Floor tile	Second Floor Plant Room (Room 2/004)	Does not contain asbestos.

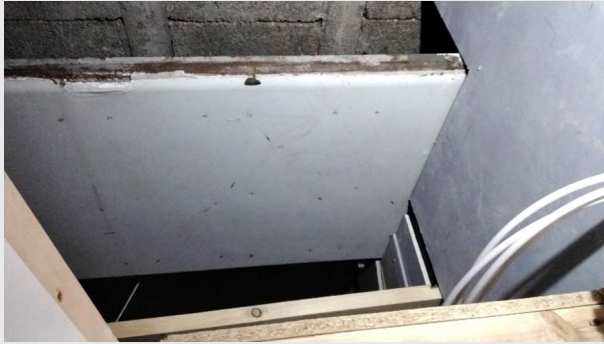
139.	NO000324	Ceiling void insulation top Of ceiling heater	Second Floor Hallway/passageway (Room 2/010)	Does not contain asbestos.

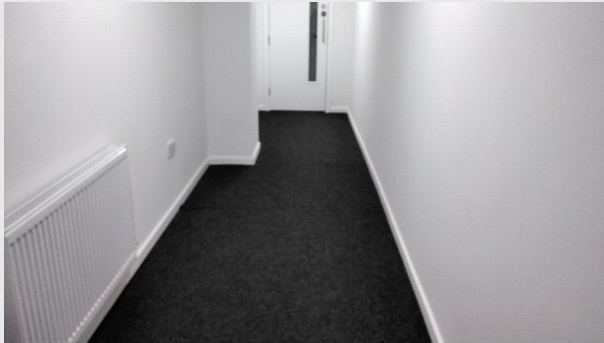
141.	NO000325	Debris/Residue to stairs	Second Floor Fire escape (Room 2/015)	Removed Sept 2023

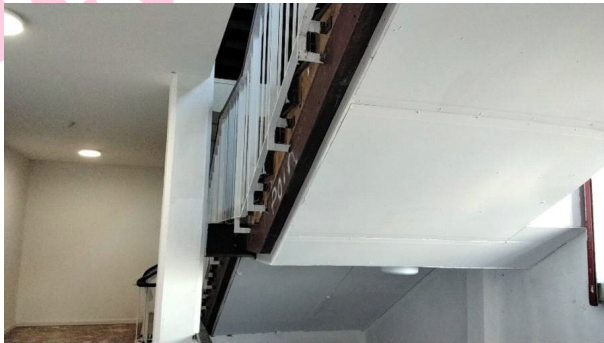
142.	NO000326	Debris/Residue to side stairs (external wall) including sloping runner	Second Floor Fire escape (Room 2/015)	Removed Sept 2023

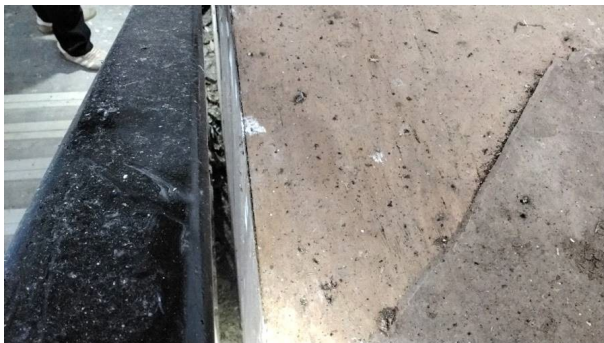
143.	NO000327	Floor nosing to stairs	Second Floor Fire escape (Room 2/015)	Contains asbestos - Any change in its appearance should be recorded and passed to Property Services.

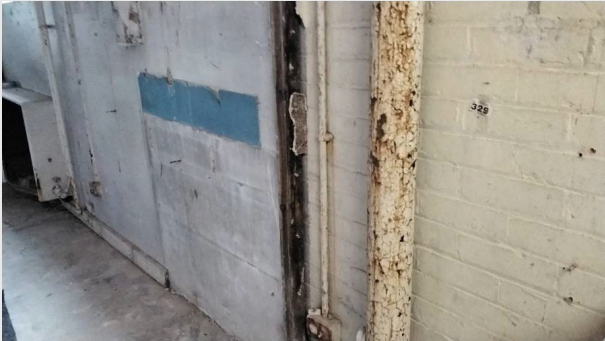
153.	NO000333	Debris/Residue to stairs	Third Floor Fire Escape (Room 3/016)	Contains asbestos - Any change in its appearance should be recorded and passed to Property Services.

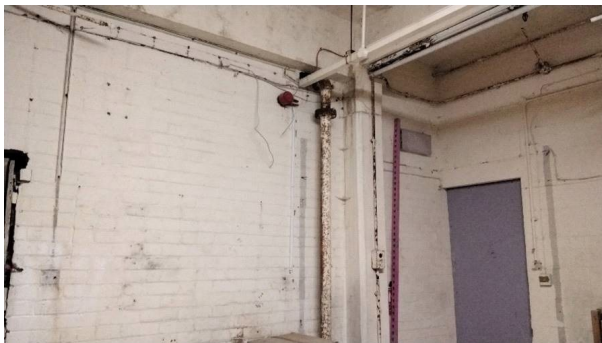
158.	As NO000335	Beam cladding suspected continuation from electric cupboard	Fourth Floor Landing (Room 4/001)	Presumed to contain asbestos - Any change in its appearance should be recorded and passed to Property Services.

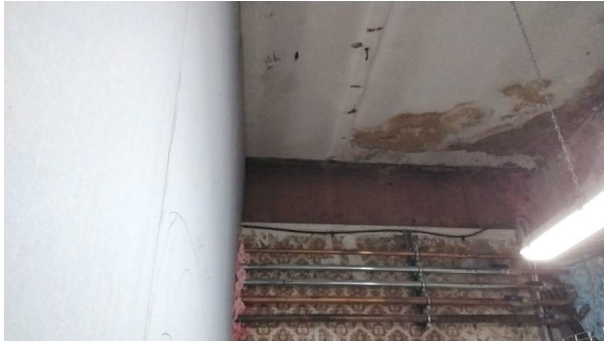
161.	NO000337	Debris/Residue to steel girder	Fourth Floor Hub/Network Room (Room 4/006)	Removed Sept 2023

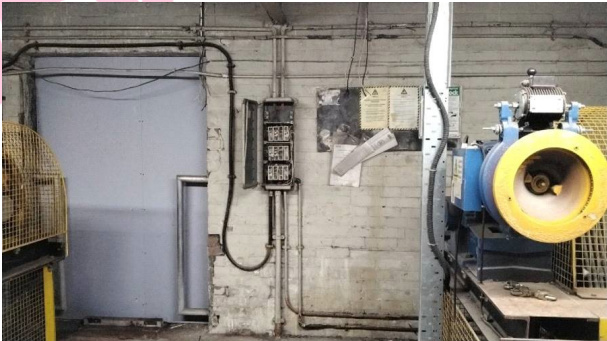
168.	NO000341	Fuses/flashguards	Fourth Floor Lift Machinery Room (Room 4/008)	Contains asbestos - Any change in its appearance should be recorded and passed to Property Services.

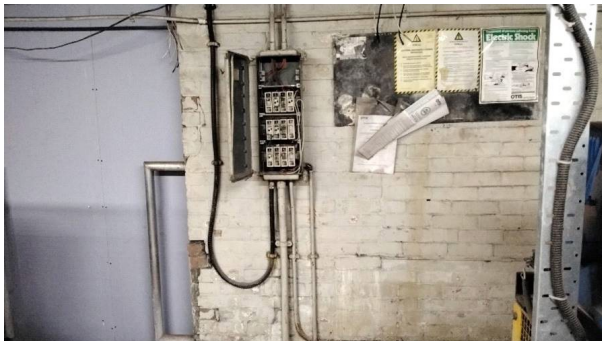
169.	NO000342	Fuses/flashguards isolation strips	Fourth Floor Lift Machinery Room (Room 4/008)	Contains asbestos - Any change in its appearance should be recorded and passed to Property Services.

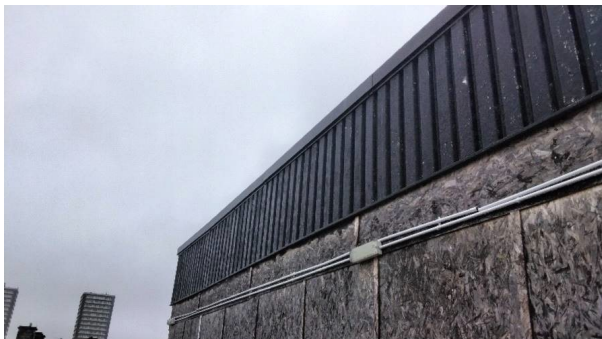
171.	NO000374	Wall coating to upper metal cladding	Fourth Floor External roof area (Room 4/059)	Contains asbestos - Any change in its appearance should be recorded and passed to Property Services.

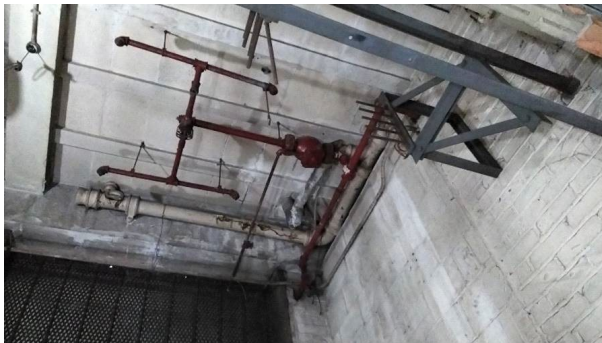
172.	Presumed	Pipework gaskets to sprinkler system	Mezzanine Switch Room midway between basement and ground floor	Presumed to contain asbestos - Any change in its appearance should be recorded and passed to Property Services.

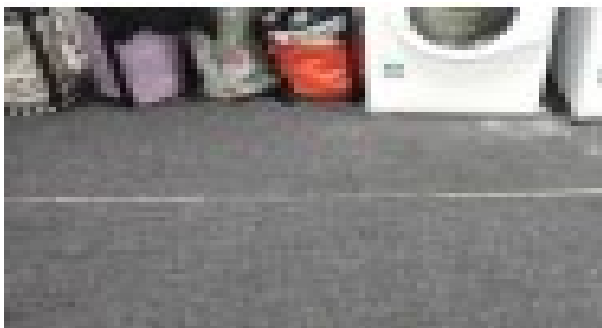
174.	NG001612	Floor tile (with adhesive) grey beneath carpet	Ground Floor, Laundry (Room G/001)	Contains asbestos - Any change in its appearance should be recorded and passed to Property Services.

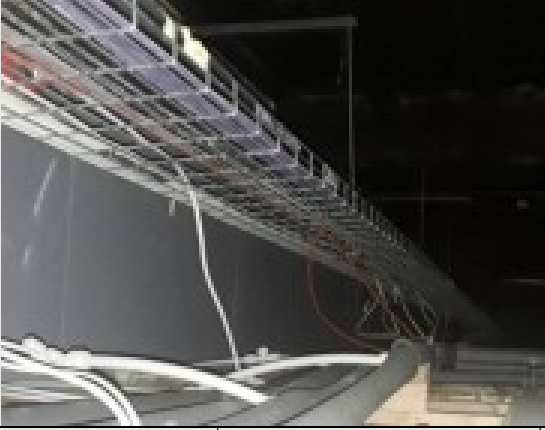
230.	As NZ001416	Debris/Residue to ceiling floor below	Loft space within corridors to flats 120-125 (Room 1/006)	Does not contain asbestos.

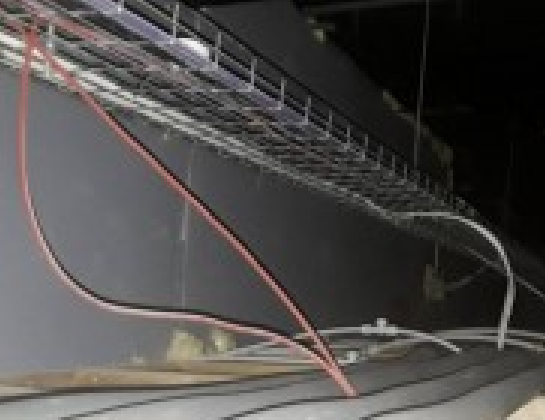
231.	NZ001417	Debris/Residue to ceiling floor below	Loft space within corridors to flats 126-130 (Room 1/007)	Does not contain asbestos.

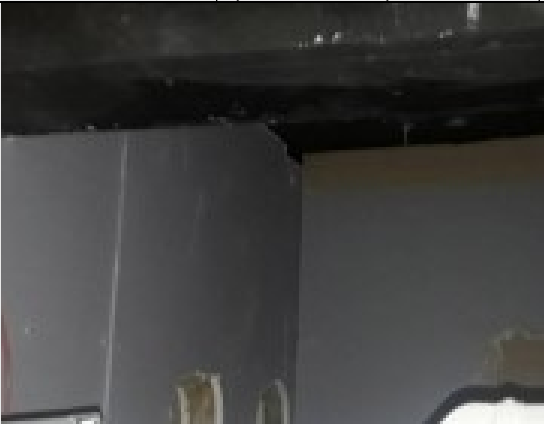
232.	As NZ001417	Debris/Residue to ceiling floor below	Loft space within corridor adjacent flat 130 (Room 1/008)	Does not contain asbestos.
