ASBESTOS SURVEY REPORT FOR JOPLING HOUSE, JOHN STREET,
SUNDERLAND, SR1 1DP.

Jopling House, John Street, Sunderland

Date: 27 June 2025

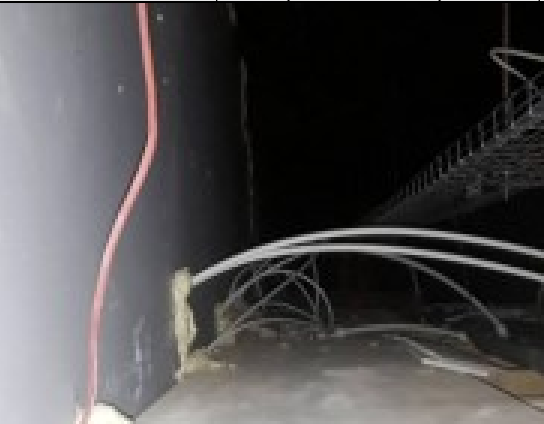
233.	NZ001418	Debris/Residue to ceiling floor below	Loft space within corridors to flats 101- 103 (Room 1/009)	Does not contain asbestos.

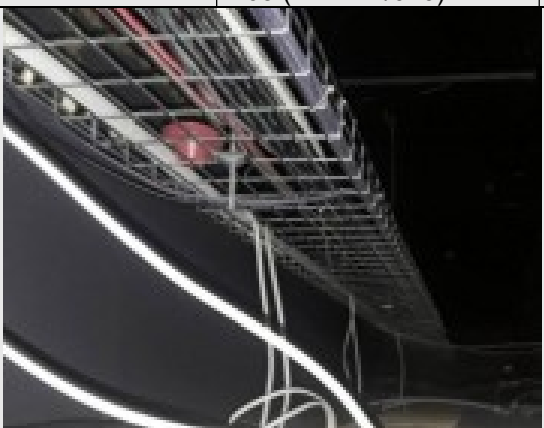
234.	As NZ001418	Debris/Residue to ceiling floor below	Loft space within corridors to flats 104- 105 (Room 1/010)	Does not contain asbestos.

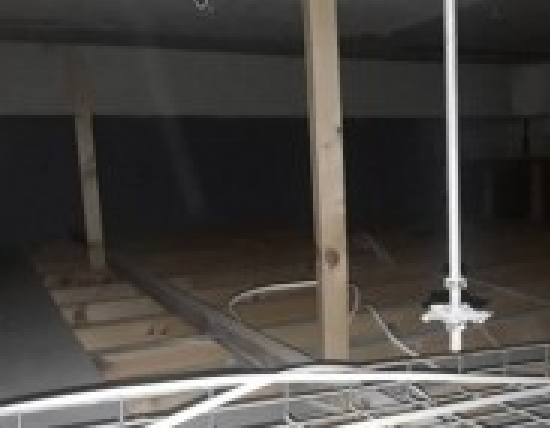
235.	NZ001408	Debris/Residue to ceiling floor below	Loft space within lift lobby (Room 2/001)	Does not contain asbestos.

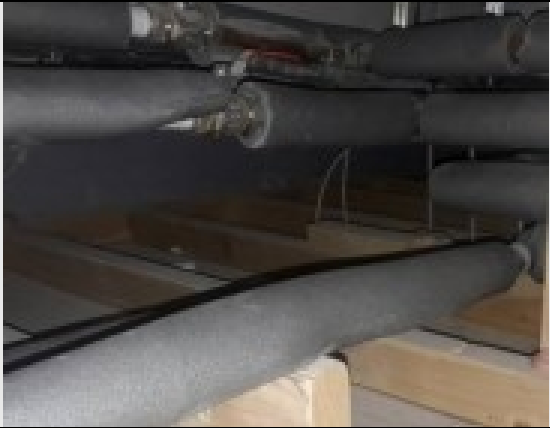
236.	As NZ001408	Debris/Residue to ceiling floor below	Loft space within gaming room lobby (Room 2/002)	Does not contain asbestos.

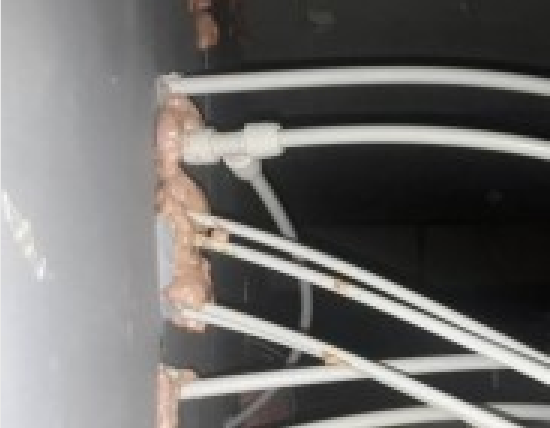
237.	NZ001409	Debris/Residue to ceiling floor below	Loft space within corridor to flats 207-208 (Room 2/003)	Does not contain asbestos.

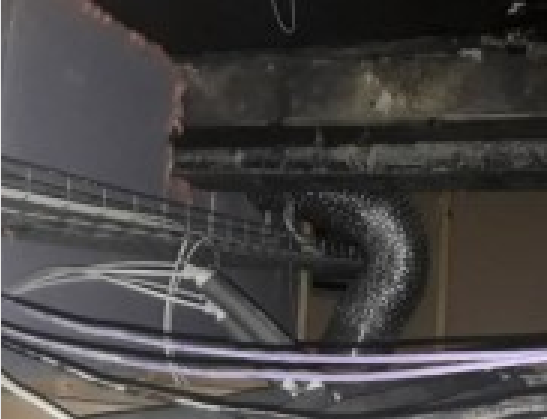
238.	As NZ001409	Debris/Residue to ceiling floor below	Loft space within corridor to flats 209-211 (Room 2/004)	Does not contain asbestos.

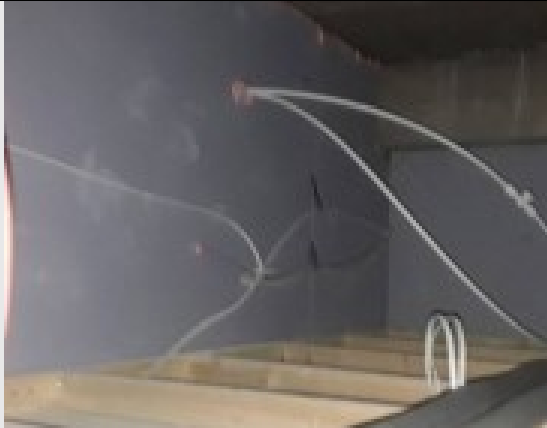
239.	NZ001410	Debris/Residue to ceiling floor below	Loft space within corridor adjacent flat 210 (Room 2/005)	Does not contain asbestos.

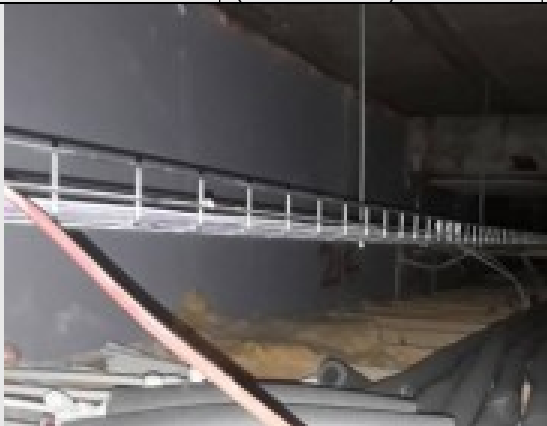
240.	As NZ001410	Debris/Residue to ceiling floor below	Loft space within corridor to flats 212-219 (Room 2/006)	Does not contain asbestos.

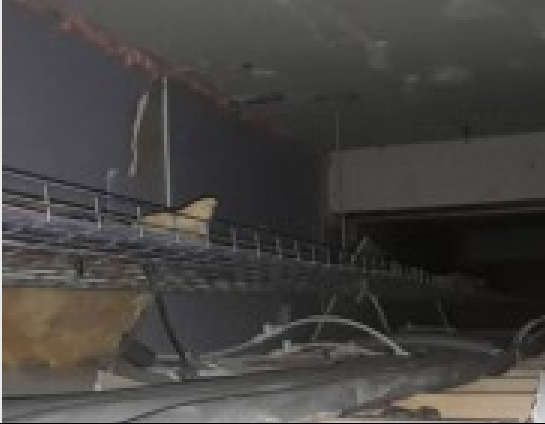
241.	NZ001411	Debris/Residue to ceiling floor below	Loft space within corridor to flats 220-225 (Room 2/007)	Does not contain asbestos.

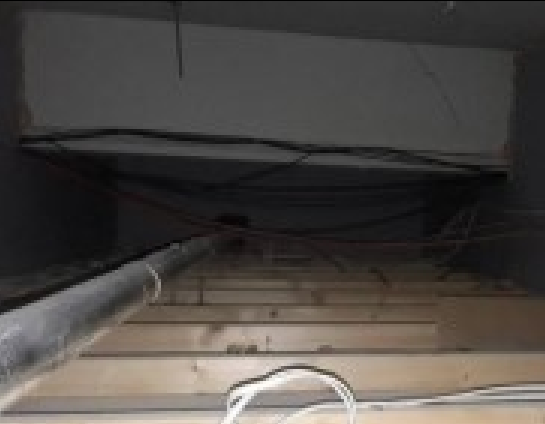
242.	As NZ001411	Debris/Residue to ceiling floor below	Loft space within corridor adjacent lift lobby (Room 2/008)	Does not contain asbestos.

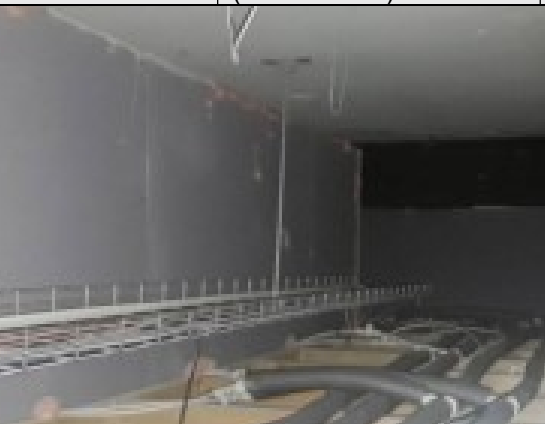
243.	NZ001412	Debris/Residue to ceiling floor below	Loft space within corridor to flats 226-230 (Room 2/009)	Does not contain asbestos.

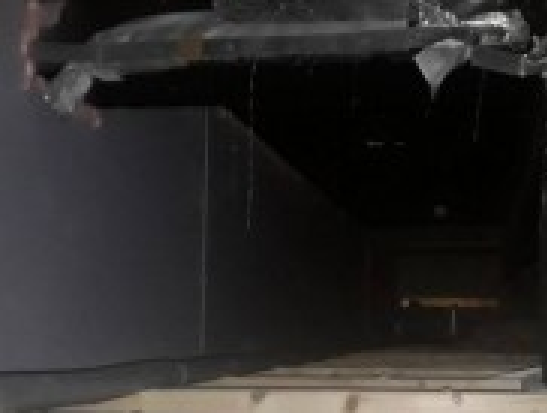
244.	As NZ001412	Debris/Residue to ceiling floor below	Loft space within corridor adjacent flat 230 (Room 2/010)	Does not contain asbestos.

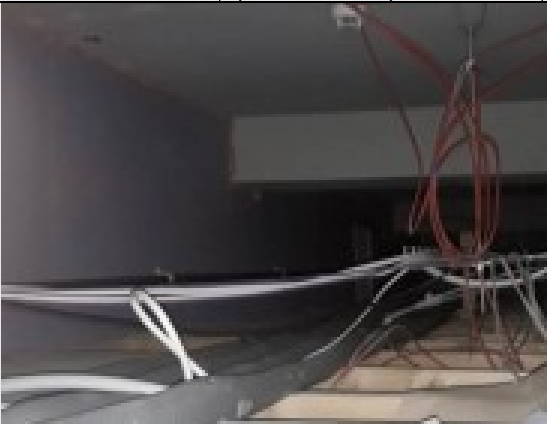
245.	NZ001413	Debris/Residue to ceiling floor below	Loft space within corridor to flats 201-203 (Room 2/011)	Does not contain asbestos.

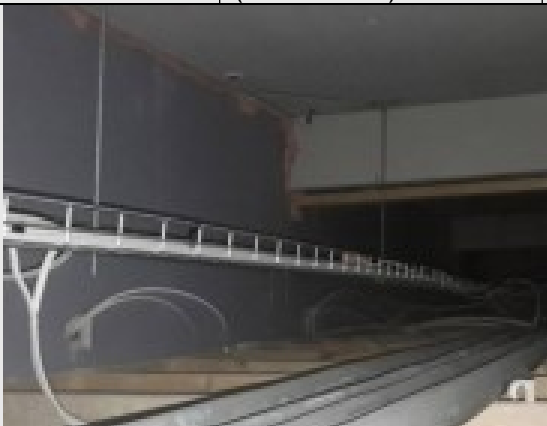
246.	As NZ001413	Debris/Residue to ceiling floor below	Loft space within corridor to flats 204-205 (Room 2/012)	Does not contain asbestos.

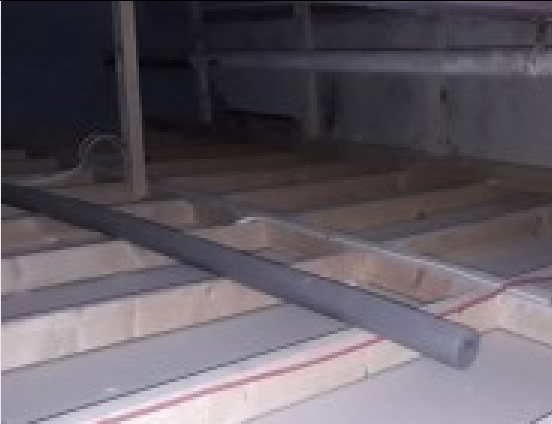
247.	NZ001403	Debris/Residue to ceiling floor below	Loft space within lobby (Room 3/001)	Does not contain asbestos.

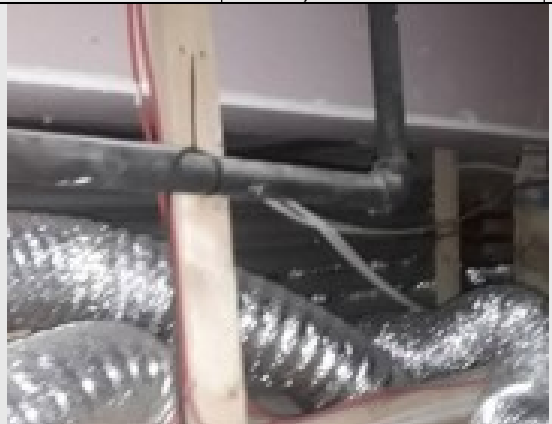
248.	As NZ001403	Debris/Residue to ceiling floor below	Loft space within football pool room lobby (Room 3/002)	Does not contain asbestos.

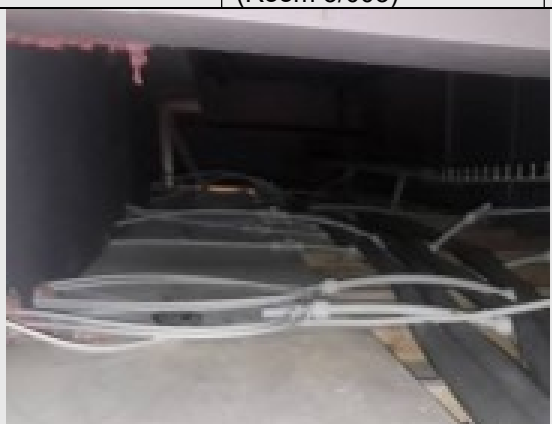
249.	NZ001404	Debris/Residue to ceiling floor below	Loft space within corridor to flats 306-311 (Room 3/003)	Does not contain asbestos.

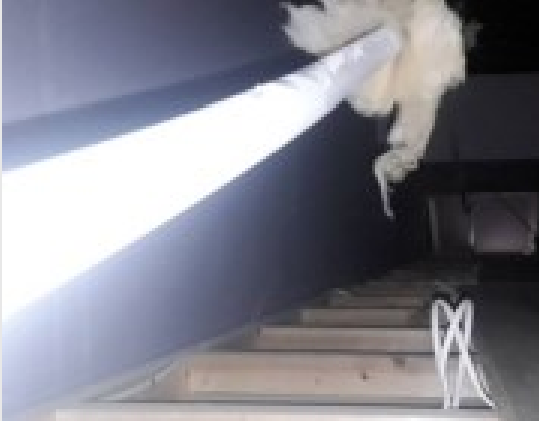
250.	As NZ001404	Debris/Residue to ceiling floor below	Loft space within corridor adjacent Flat 311 (Room 3/004)	Does not contain asbestos.

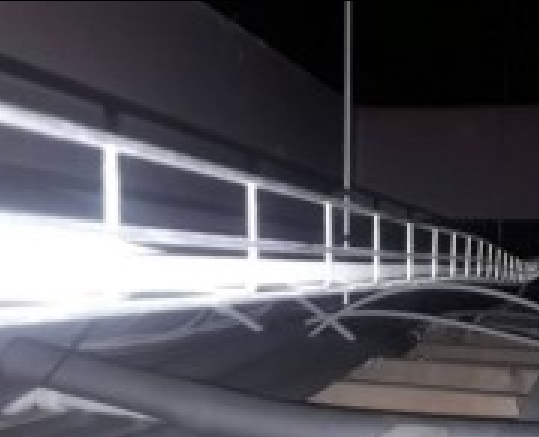
251.	NZ001405	Debris/Residue to ceiling floor below	Loft space within corridor to flats 312-319 (Room 3/005)	Does not contain asbestos.

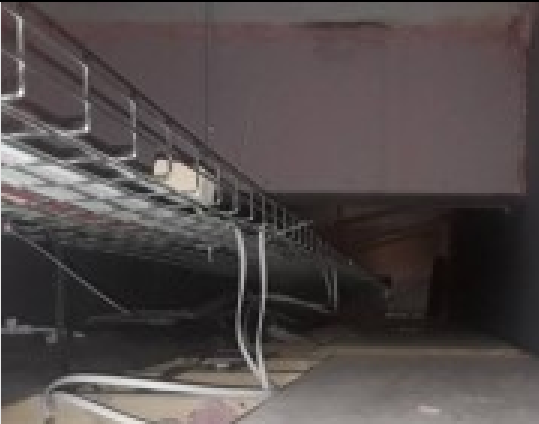
252.	As NZ001405	Debris/Residue to ceiling floor below	Loft space within corridor to flats 320-325 (Room 3/006)	Does not contain asbestos.

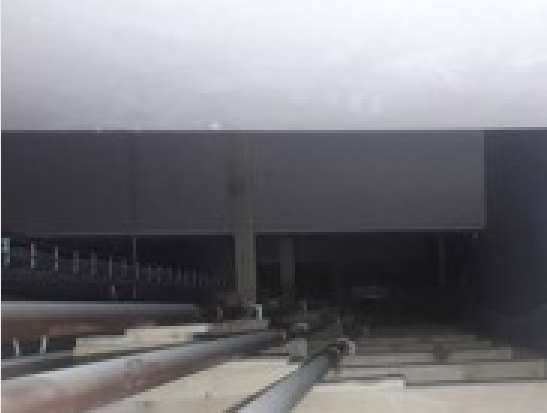
253.	As NZ001404	Debris/Residue to ceiling floor below	Loft space within corridor adjacent Flat 321 (Room 3/007)	Does not contain asbestos.

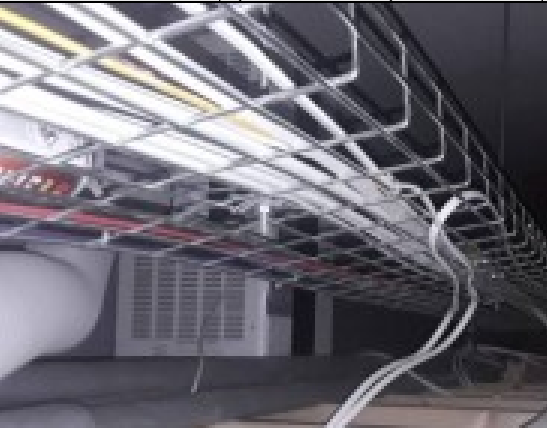
254.	NZ001406	Debris/Residue to ceiling floor below	Loft space within corridor to flats 326-330 (Room 3/008)	Does not contain asbestos.

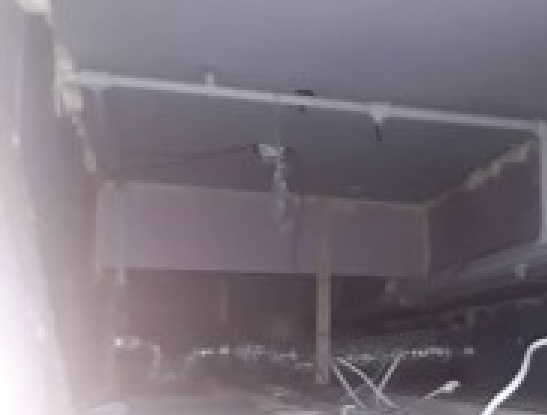
255.	As NZ001406	Debris/Residue to ceiling floor below	Loft space within corridor adjacent flat 330 (Room 3/009)	Does not contain asbestos.

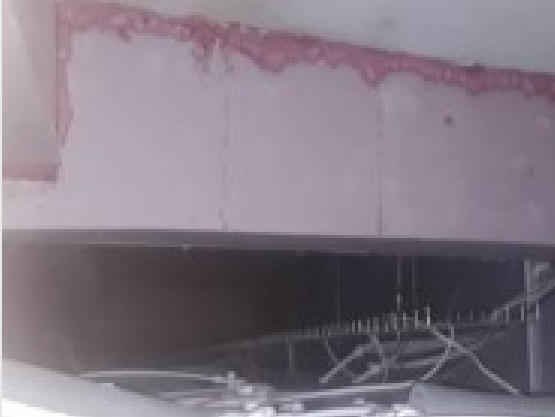
256.	NZ001407	Debris/Residue to ceiling floor below	Loft space within corridor to flats 301-304 (Room 3/010)	Does not contain asbestos.

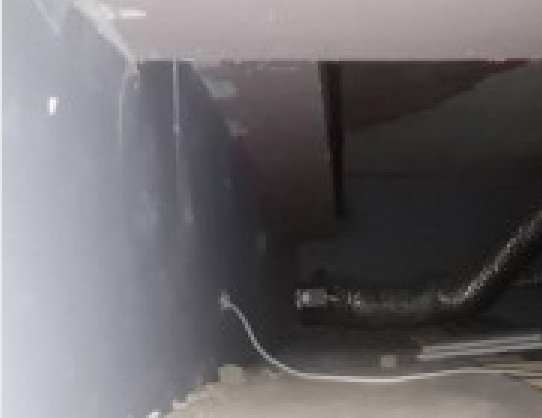
257.	As NZ001407	Debris/Residue to ceiling floor below	Loft space within corridor to flats 301-304 (Room 3/011)	Does not contain asbestos.

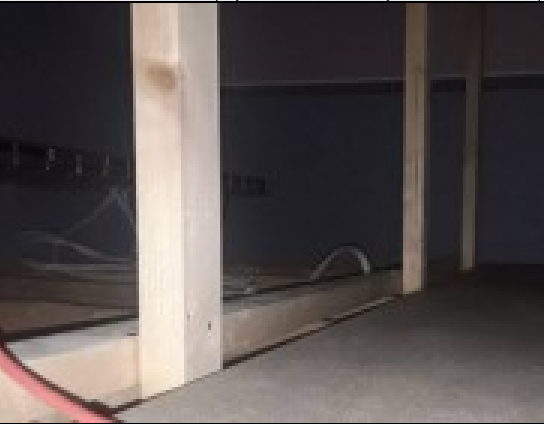
260.	NZ001402	Debris/Residue to ceiling floor below	Loft space within corridor to flats 415-416 (Room 4/003)	Does not contain asbestos.

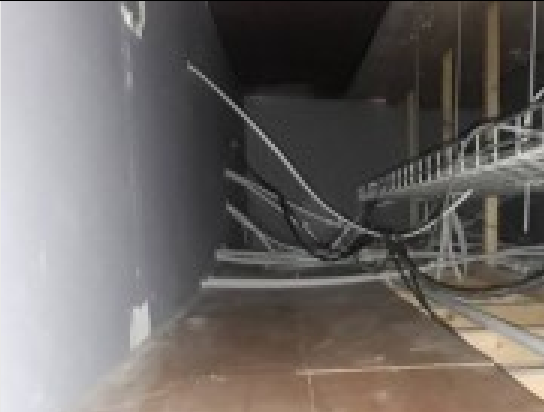
261.	As NZ001402	Debris/Residue to ceiling floor below	Loft space within corridor to flats 403-407 (Room 4/004)	No Risk
262.	EV005969	Textured coated wall & debris to ceiling loft space where the wall had been damaged to ducting installation	Loft space/Ceiling void (R/01)	No Risk

261.	As NZ001402	Debris/Residue to ceiling floor below	Loft space within corridor to flats 403-407 (Room 4/004)	Does not contain asbestos.
