ASBESTOS SURVEY REPORT FOR JOPLING HOUSE, JOHN STREET,
SUNDERLAND, SR1 1DP.

Asbestos Register for

Jopling House, John Street, Sunderland

Date: 14 May 2026

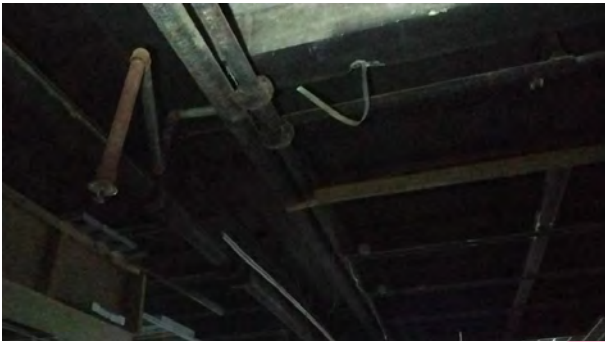
4.	Presumed	Pipework Gaskets to deeply recessed to sample	Z-Sub level 1 Shop Floor (Room Z1/001)	Presumed to contain asbestos - Any change in its appearance should be recorded and passed to Property Services.

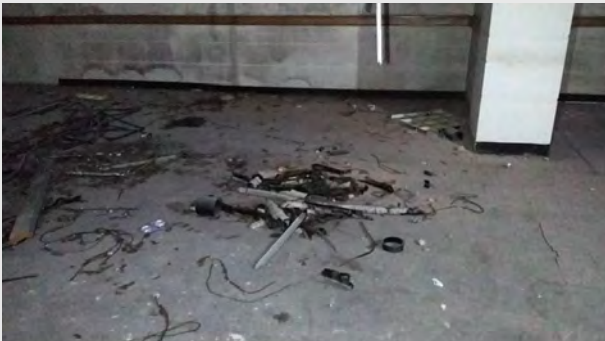
5.	NO000254	Cable braiding insulation	Z-Sub level 1 Shop Floor (Room Z1/001)	Does not contain asbestos.

6.	NO000255	Cable braiding insulation	Z-Sub level 1 Shop Floor (Room Z1/001)	Does not contain asbestos.

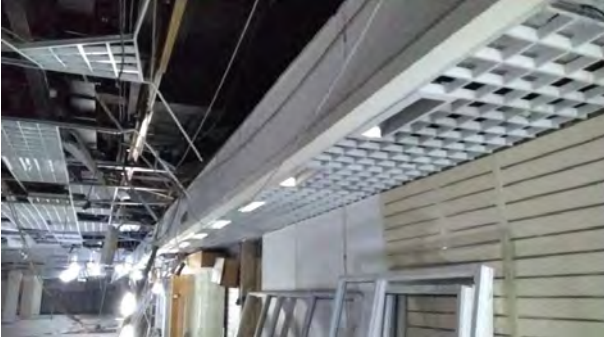
13.	NO000267	Ductwork joints	Z-Sub level 1 Shop Floor (Room Z1/001)	This item is classed as low risk and should be inspected every 6 months
14.	NO000260	Floor tile on shelving	Z-Sub level 1 Store Room (Room Z1/006)	No Risk

13.	NO000267	Ductwork joints	Z-Sub level 1 Shop Floor (Room Z1/001)	Contains asbestos - Any change in its appearance should be recorded and passed to Property Services.

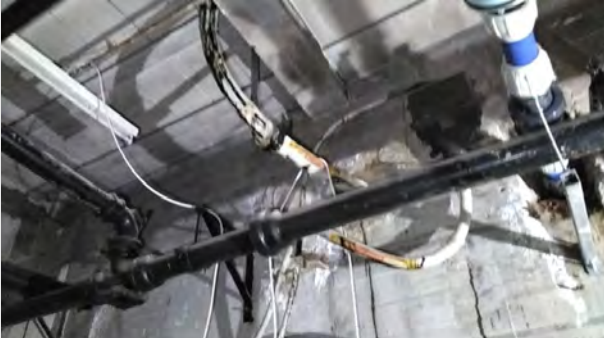
16.	As NO000254	Cable braiding insulation	Z-Sub level 1 Switch Room (Room Z1/007)	Does not contain asbestos.

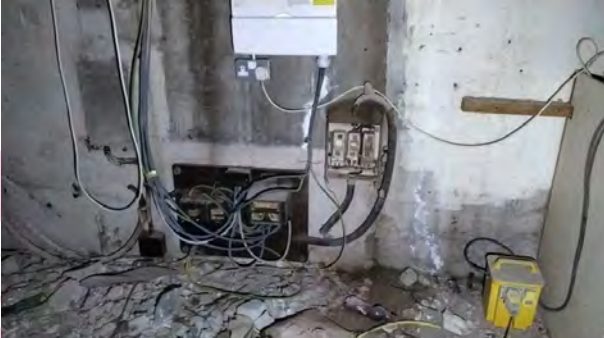
17.	NO000256	Fuses flashguards	Z-Sub level 1 Switch Room (Room Z1/007)	This item is classed as very low risk and should be inspected every 12 months
18.	NO000302	Door seal/gasket discarded on floor	Z-Sub level 1 Switch Room (Room Z1/007)	No Risk

17.	NO000256	Fuses flashguards	Z-Sub level 1 Switch Room (Room Z1/007)	Contains asbestos - Any change in its appearance should be recorded and passed to Property Services.

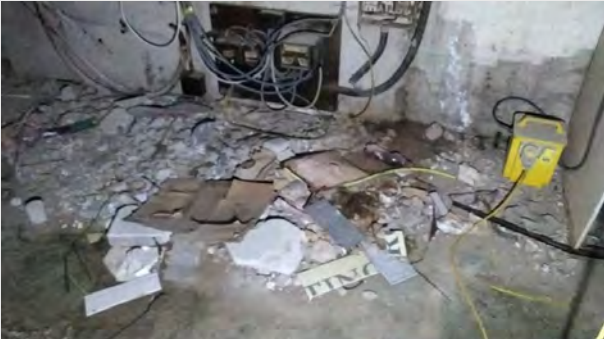
18.	NO000302	Door seal/gasket discarded on floor	Z-Sub level 1 Switch Room (Room Z1/007)	Does not contain asbestos.

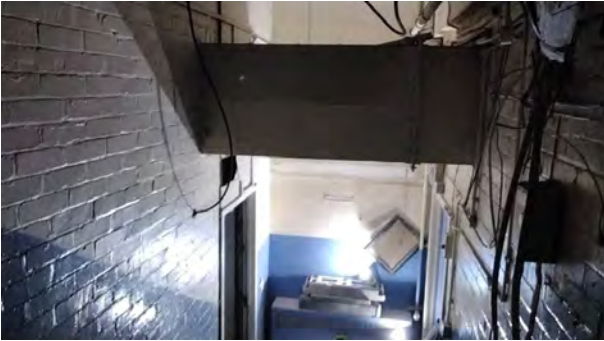
22.	NO000265	Wall	Z-Sub level 1 Staircase/Stairwell (Room Z1/009)	Contains asbestos - Any change in its appearance should be recorded and passed to Property Services.

22.	NO000265	Wall	Z-Sub level 1 Staircase/Stairwell (Room Z1/009)	This item should be removed by a licensed contractor asap
23.	As NO000265	<i>Debris/Residue foot of stairwell and adjacent areas</i>	<i>Z-Sub level 1 Staircase/Stairwell (Room Z1/009)</i>	<i>Removed Sept 2023</i>

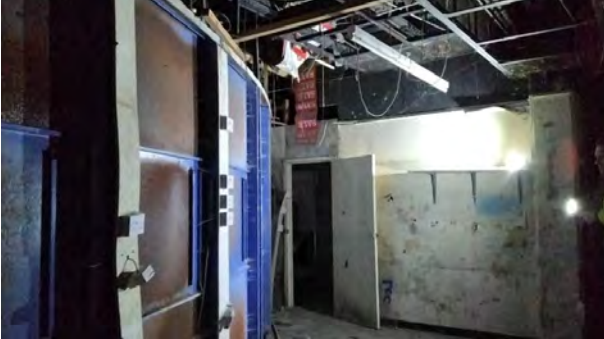
42.	As NO000273	<i>Debris/Residue to ceiling void and floor below</i>	Z-Sub level 1 Store Room (Room Z1/021)	<i>Removed Sept 2023</i>

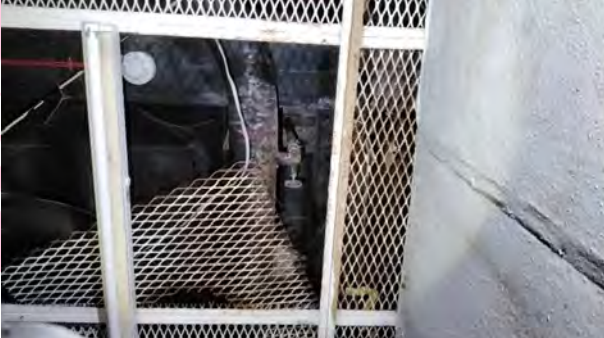
68.	NO000290	Pipework wrap to pipe penetrations in ceiling	Z-Sub level 1 Store Room (Room Z1/032)	Contains asbestos - Any change in its appearance should be recorded and passed to Property Services.

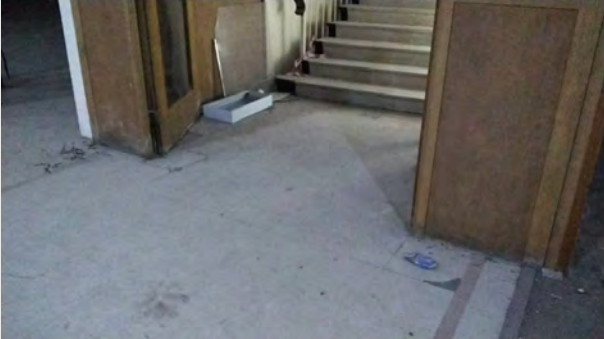
69.	As NO000251	Floor tile pink/grey including debris up the stairs	Z-Sub level 1 Stairwell Staircase (Room Z1/034)	Does not contain asbestos.

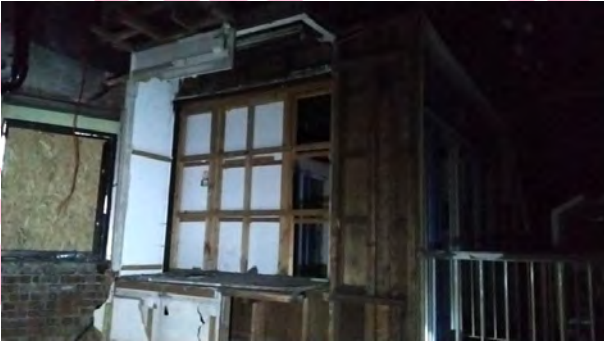
74.	NO000295	Debris/Residue to entrance porch, on top and to sides, including beneath shelf and framework	Ground Floor Shop Floor Unit 1 (Room G/001)	Removed Feb 2026

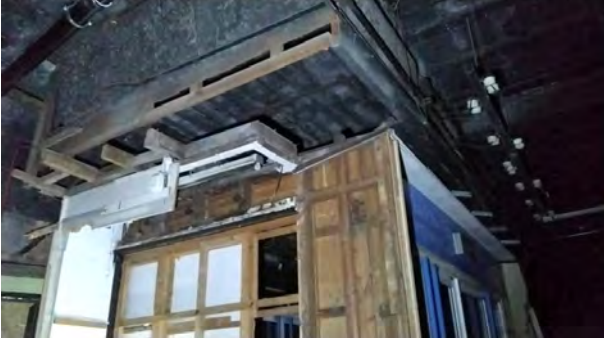
75.	NO000296	Debris/Residue to top of ceiling at entrance porch	Ground Floor Shop Floor Unit 1 (Room G/001)	Removed Sept 2023

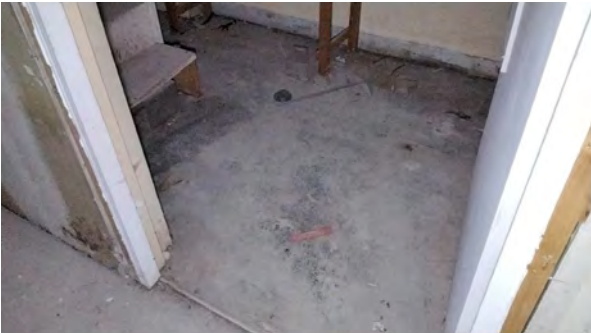
84.	As NO000293	Floor adhesive remnants	Ground Floor Store Room Unit 1 (Room G/003)	Presumed to contain asbestos - Any change in its appearance should be recorded and passed to Property Services.

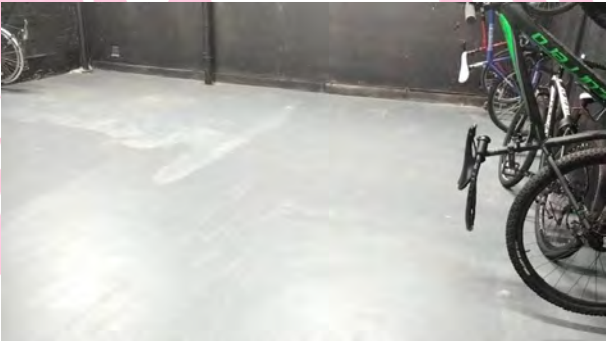
86.	NO000303	Floor tile grey/beige beneath modern lino	Ground Floor Store Room Bike Store (Room G/005)	Contains asbestos - Any change in its appearance should be recorded and passed to Property Services.

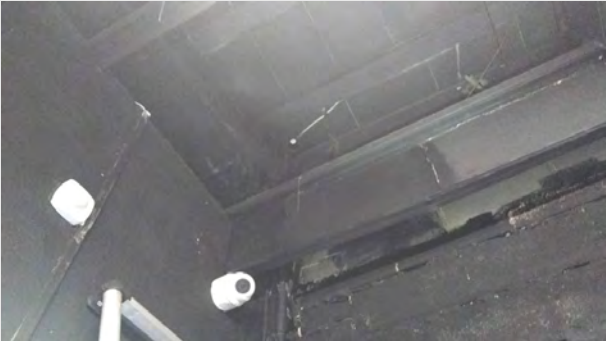
87.	NO000304	Ceiling shuttering	Ground Floor Store Room Bike Store (Room G/005)	Does not contain asbestos.

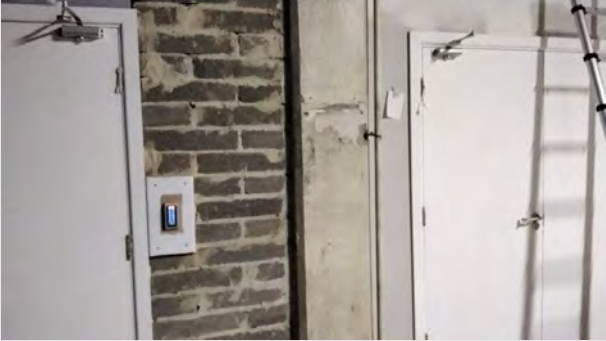
103.	NO000311	Wall to nail/screw heads, various points on column	Ground Floor Store Room (Room G/017)	Does not contain asbestos.

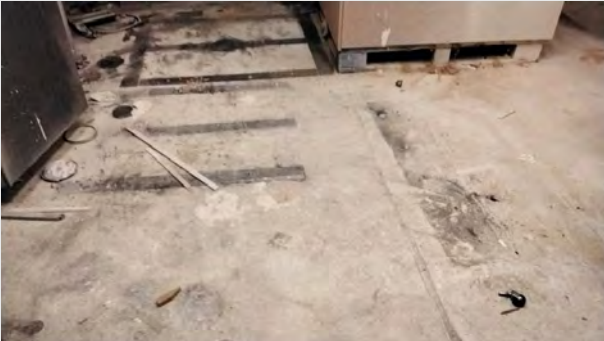
109.	As NO000307	Floor adhesive remnants	Ground Floor Store Room (Room G/020)	Does not contain asbestos.

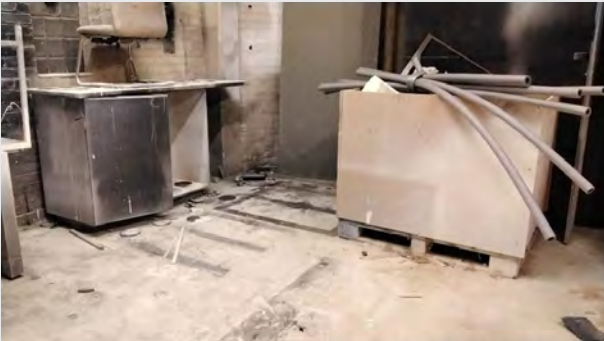
110.	As NO000301	Cabling braiding insulation	Ground Floor Store Room (Room G/020)	Does not contain asbestos.

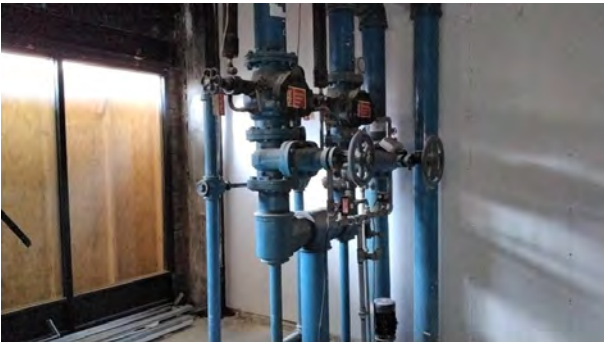
111.	Presumed	Pipework gasket too deeply recessed to sample	Ground Floor Unit 3 (café) limited inspection to ceiling (Room G/022)	Presumed to contain asbestos - Any change in its appearance should be recorded and passed to Property Services.

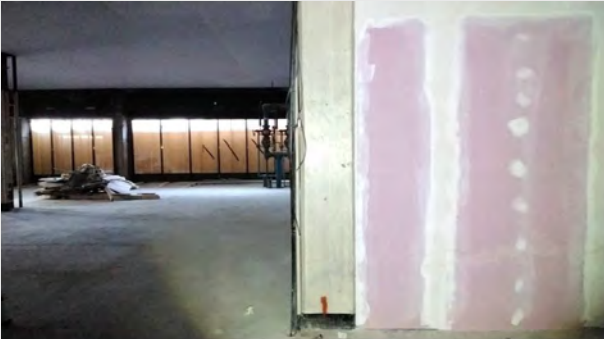
112.	As NO000311	Wall to nail/screw heads various points on column	Ground Floor Unit 3 (café) limited inspection to ceiling (Room G/022)	Does not contain asbestos.

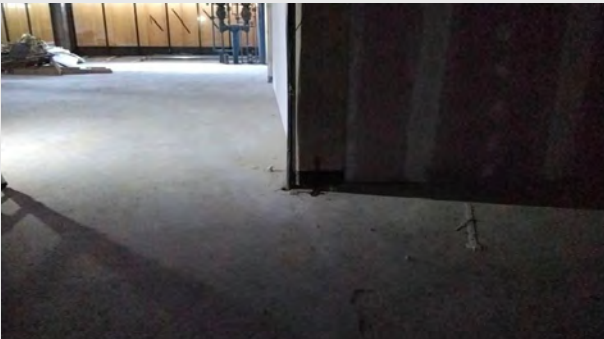
113.	As NO000307	Floor adhesive remnants	Ground Floor Unit 3 (café) limited inspection to ceiling (Room G/022)	Does not contain asbestos.

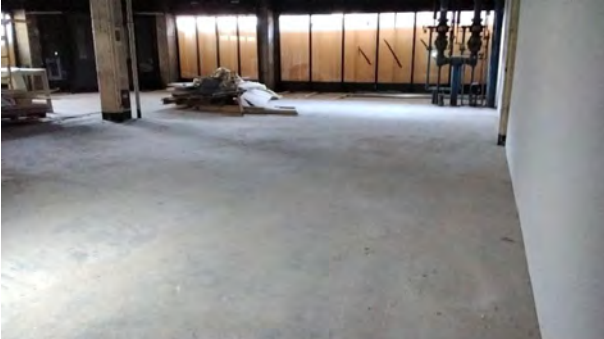
114.	As NO000303	Floor tile remnants	Ground Floor Unit 3 (café) limited inspection to ceiling (Room G/022)	Presumed to contain asbestos - Any change in its appearance should be recorded and passed to Property Services.

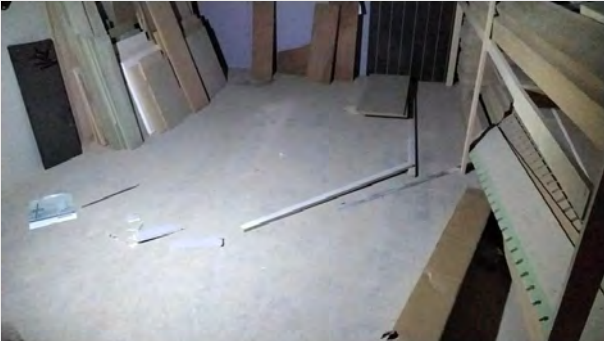
124.	As NO000307	Floor adhesive remnants	Ground Floor Store Room (Room G/032)	Does not contain asbestos.

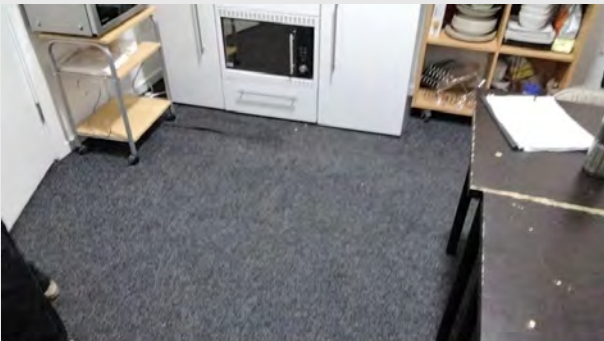
125.	As NO000307	Floor adhesive remnants	Ground Floor Staff Room (Room G/035)	Does not contain asbestos.

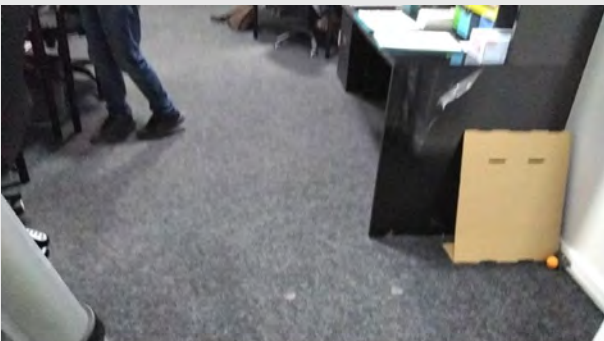
126.	As NO000307	Floor adhesive remnants	Ground Floor Office (Room G/036)	Does not contain asbestos.

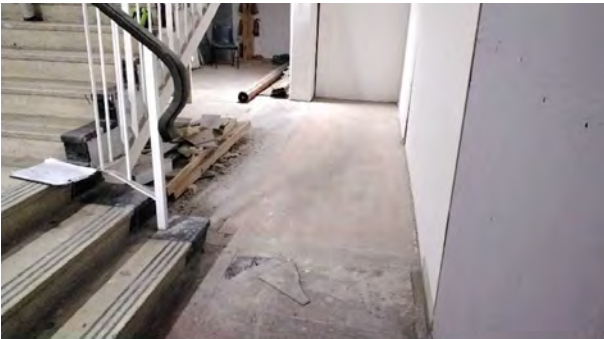
129.	NO000317	Floor tile to former shop floor and understairs area	Ground Floor Staircase/Stairwell (Room G/039)	Contains asbestos - Any change in its appearance should be recorded and passed to Property Services.

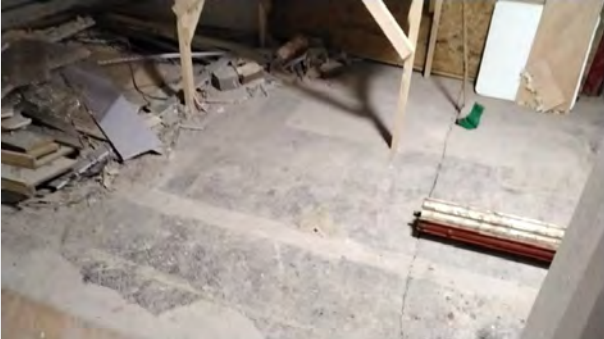
130.	As NO000307	Floor adhesive remnants	Ground Floor Staircase/Stairwell (Room G/039)	Does not contain asbestos.

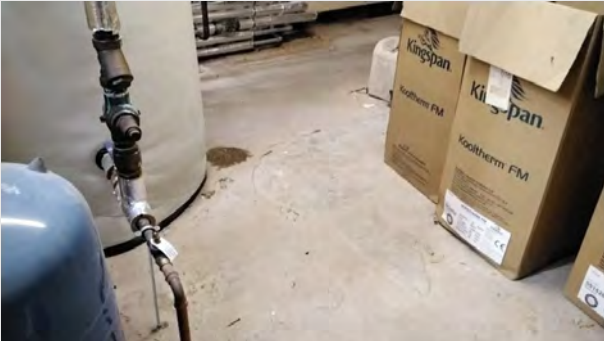
136.	As NO000320	Floor tile	Second Floor Plant Room (Room 2/004)	Does not contain asbestos.

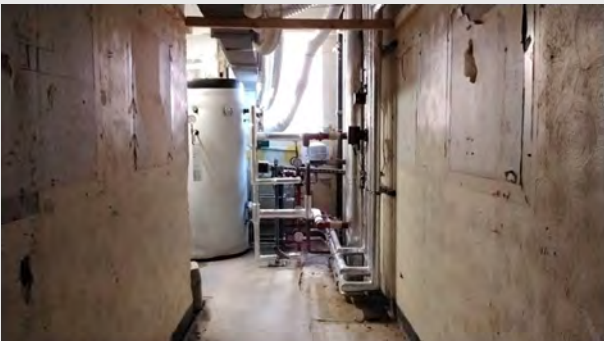
137.	NO000322	Wall Coating	Second Floor Plant Room (Room 2/004)	Does not contain asbestos.

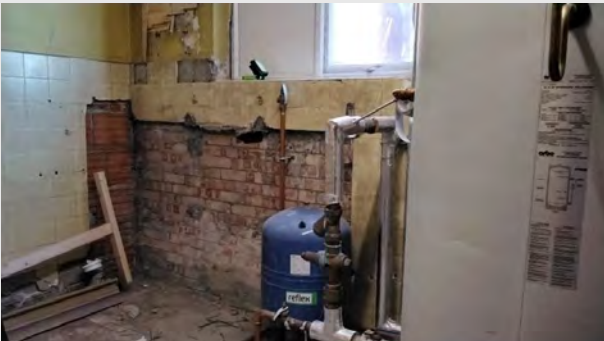
138.	NO000323	Wall void cavity	Second Floor Plant Room (Room 2/004)	Does not contain asbestos.

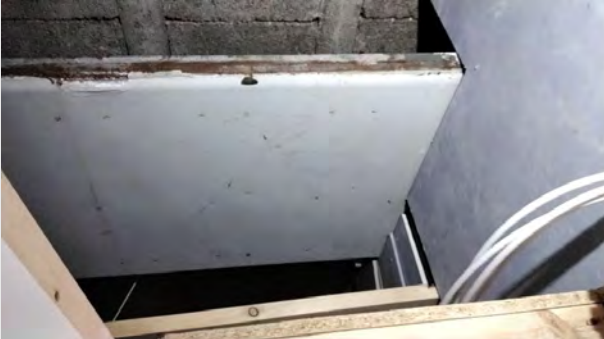
139.	NO000324	Ceiling void insulation top Of ceiling heater	Second Floor Hallway/passageway (Room 2/010)	Does not contain asbestos.

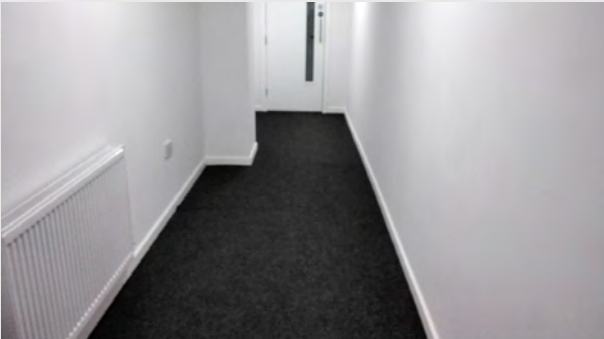
140.	As NO000321	Floor tile beneath carpet	Second Floor Hallway/passageway (Room 2/013)	Does not contain asbestos.

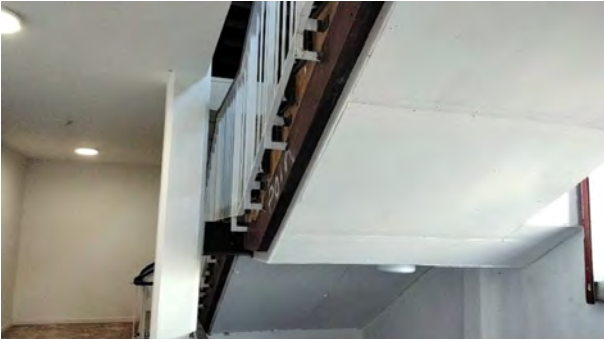
141.	NO000325	Debris/Residue to stairs	Second Floor Fire escape (Room 2/015)	Removed Sept 2023

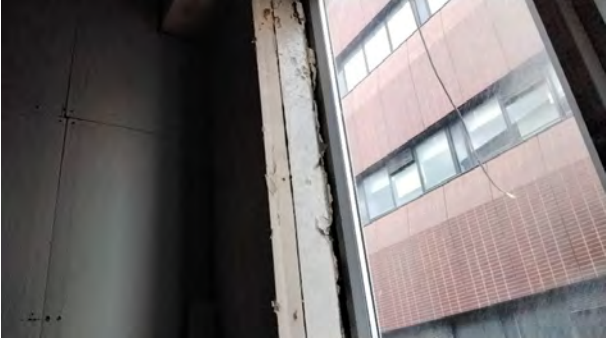
148.	NO000330	Window/putty seal from removed window	Second Floor Store Room (Room 2/018)	Contains asbestos - Any change in its appearance should be recorded and passed to Property Services.

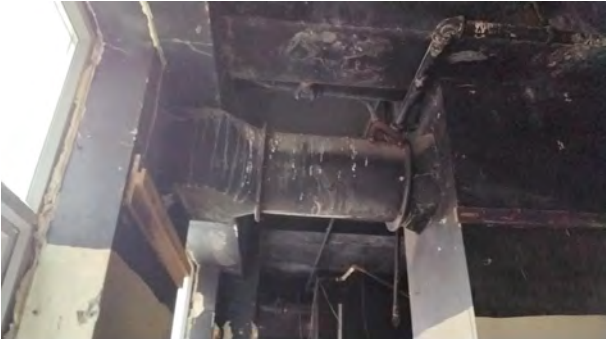
150.	NO000329	Ductwork	Second Floor Store Room Former toilets (Room 2/019)	Contains asbestos - Any change in its appearance should be recorded and passed to Property Services.

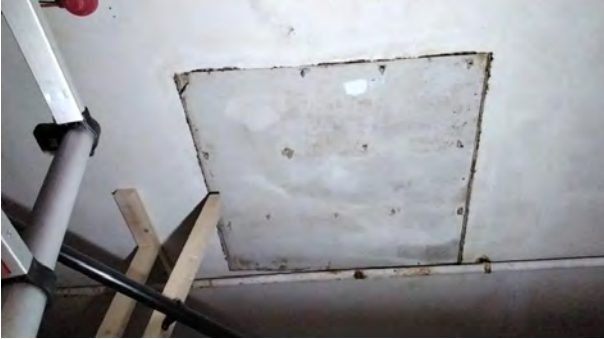
151.	NO000331	Ceiling void ceiling above panel	Third Floor Landing (Room 3/001)	Contains asbestos - Any change in its appearance should be recorded and passed to Property Services.

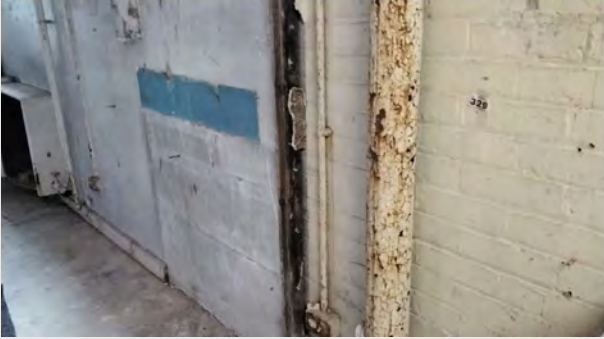
152.	NO000332	Wall tile	Third Floor Plant Room (Room 3/004)	Does not contain asbestos.

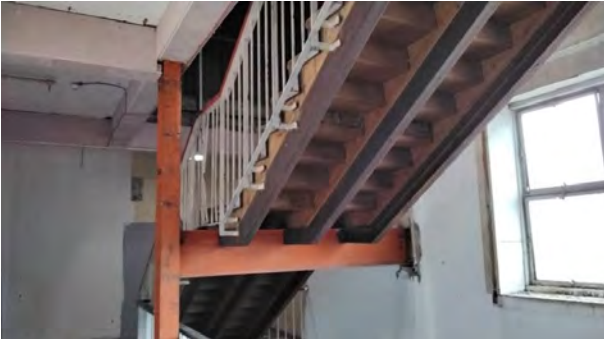
153.	NO000333	Debris/Residue to stairs	Third Floor Fire Escape (Room 3/016)	Contains asbestos - Any change in its appearance should be recorded and passed to Property Services.

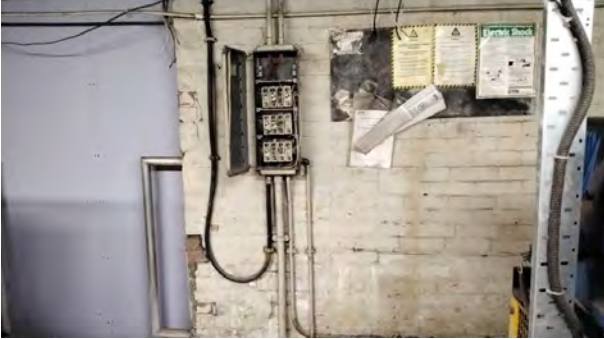
169.	NO000342	Fuses/flashguards isolation strips	Fourth Floor Lift Machinery Room (Room 4/008)	Contains asbestos - Any change in its appearance should be recorded and passed to Property Services.

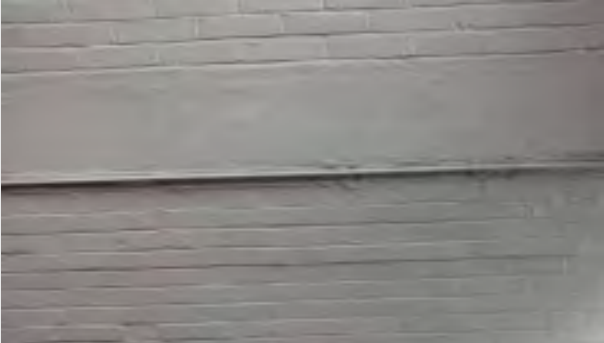
216.	NG001589	Wall panel	Entrance Hall/Foyer/Lobby (Room 4/001)	Does not contain asbestos.

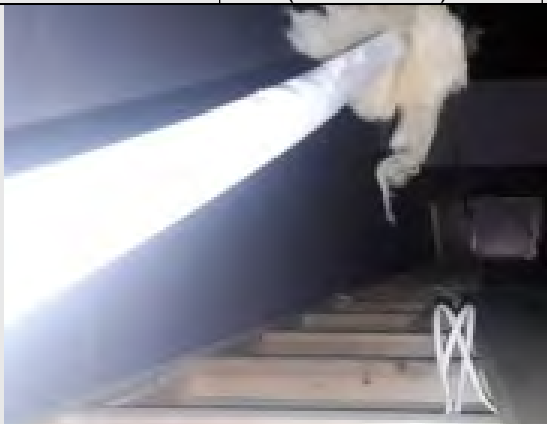
251.	NZ001405	Debris/Residue to ceiling floor below	Loft space within corridor to flats 312-319 (Room 3/005)	Does not contain asbestos.

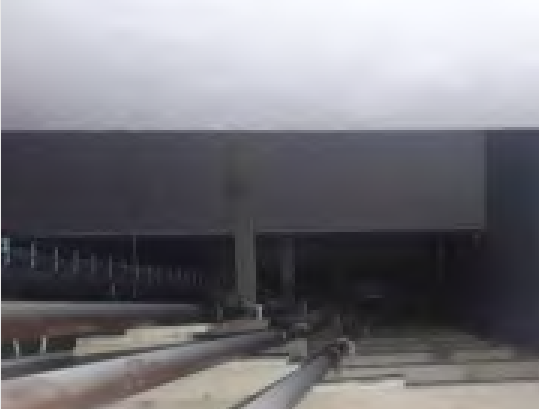
254.	NZ001406	Debris/Residue to ceiling floor below	Loft space within corridor to flats 326-330 (Room 3/008)	Does not contain asbestos.

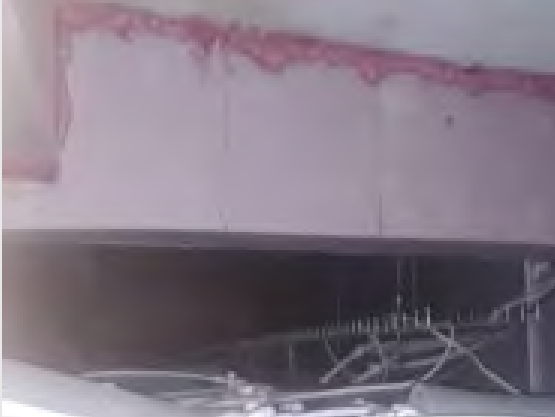
257.	As NZ001407	Debris/Residue to ceiling floor below	Loft space within corridor to flats 301-304 (Room 3/011)	Does not contain asbestos.
