ASBESTOS SURVEY REPORT FOR ROSSMERE ACADEMY, CATCOTE ROAD, HARTLEPOOL, TS25 3JL.

Asbestos Register for

Rossmere Academy, Hartlepool

Date: 07 July 2025

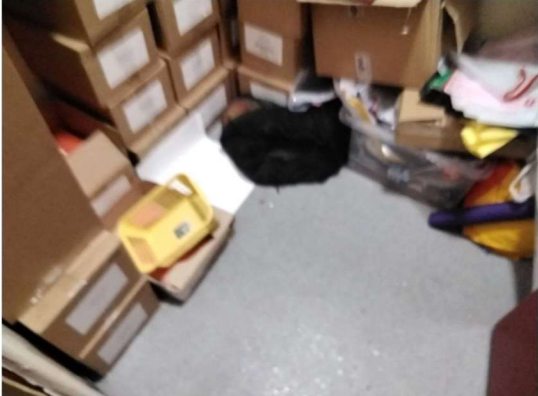
| 6 | As KX001572 | Floor screed under lino and modern screed layer | Block A Ground Floor Cupboard Store (Room 003a) | Does not contain asbestos. |

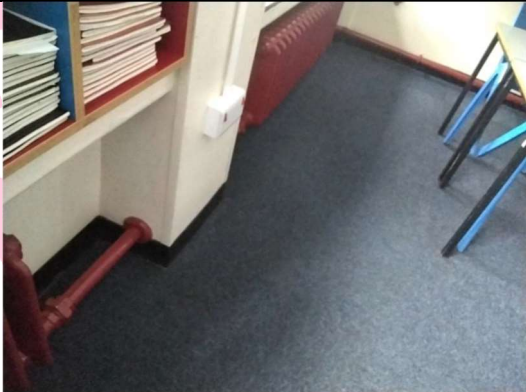
| 14 | As KX001577 | Wall Skirting | Block A Ground Floor Classroom (Room 008) | Contains asbestos - Any change in appearance should be recorded and passed to Property Services. |

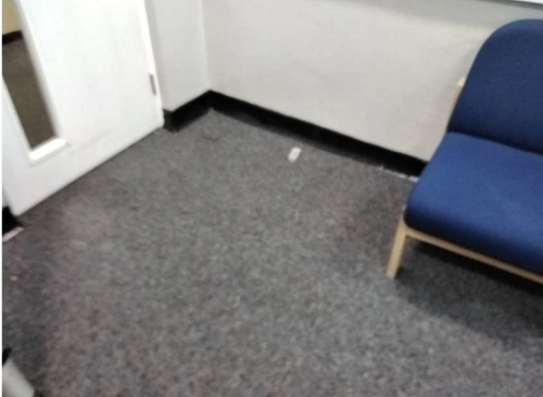
| 15 | As KX001572 | Floor screed under lino and modern screed layer | Block A Ground Floor Office (Room 010) | Does not contain asbestos. |

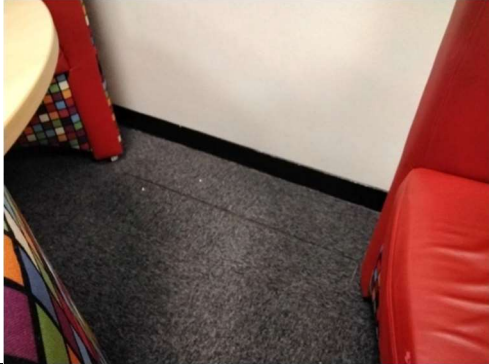
| 19 | As KX001580 | Wall Skirting | Block A Ground Floor Hallway/Passageway (Room 020) | Contains asbestos - Any change in appearance should be recorded and passed to Property Services. |

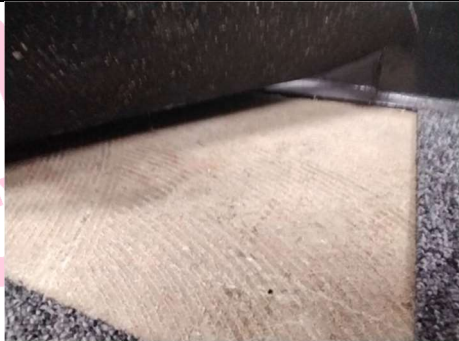
| 20 | KX001581 | Floor adhesive residue under carpet and screed | Block A Ground Floor Hallway/Passageway (Room 020) | Contains asbestos - Any change in appearance should be recorded and passed to Property Services. |

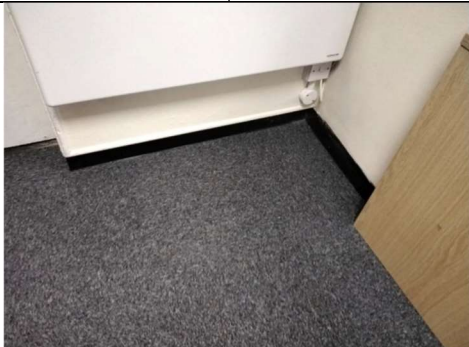
| 21 | As KX001580 | Wall Skirting | Block A Ground Floor Reception (Room 020 b & c) | Contains asbestos - Any change in appearance should be recorded and passed to Property Services. |

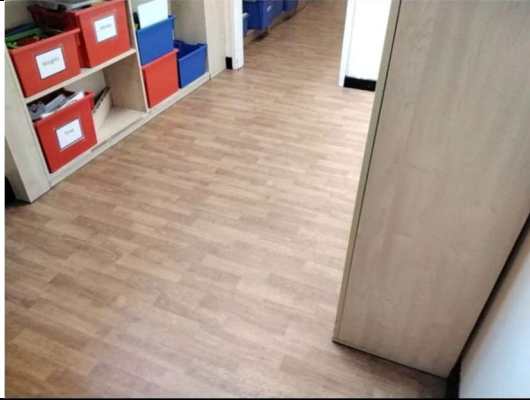
| 52 | As KX001590 | Floor adhesive residue | Block A Ground Floor Corridor (Room 041a) | Contains asbestos - Any change in appearance should be recorded and passed to Property Services. |

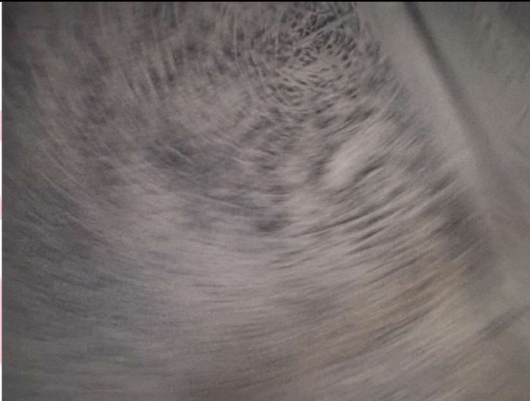
| 53 | As KX001584 | Ceiling void above ceiling | Block A Ground Floor Staff Room (Room 041) | Does not contain asbestos. |

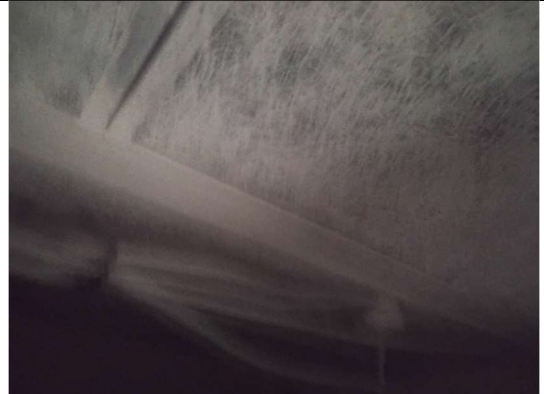
| 63 | As KX001591 | Ceiling void ceiling above | Block A Ground Floor Office (Room 059) | Does not contain asbestos. |

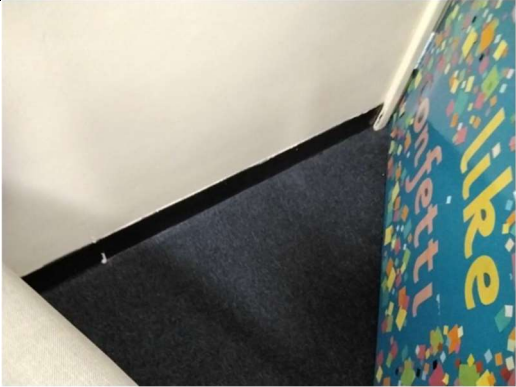
| 64 | As KX001592 | Wall skirting | Block A Ground Floor Office (Room 59) | Contains asbestos - Any change in appearance should be recorded and passed to Property Services. |

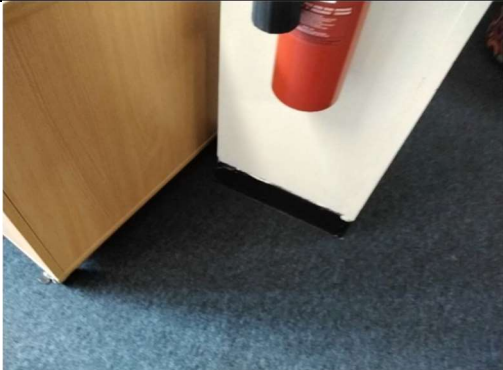
| 66 | As KX001592 | Wall skirting | Block A Ground Floor Corridor (Room 61) | Contains asbestos - Any change in appearance should be recorded and passed to Property Services. |

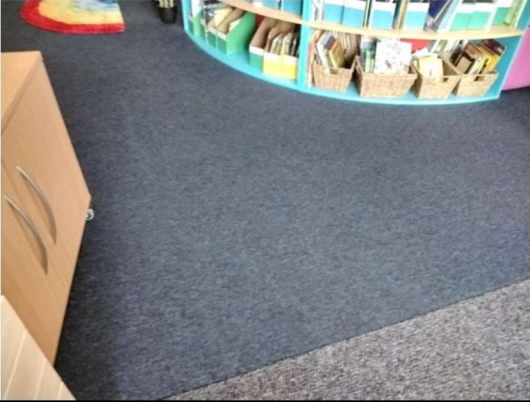
| 67 | As KX001593 | Floor tile (under floor covering) grey under screed | Block A Ground Floor Corridor (Room 61) | Contains asbestos - Any change in appearance should be recorded and passed to Property Services. |

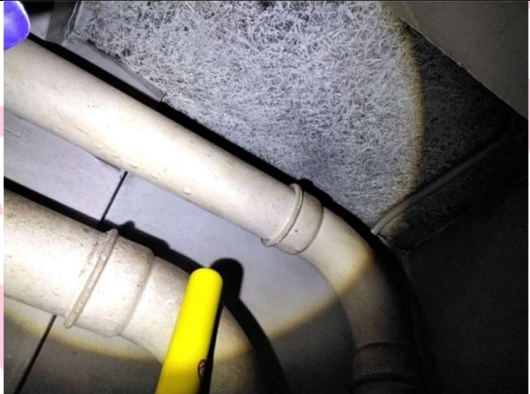
| 68 | As KX001591 | Ceiling | Block A Ground Floor Cleaners Cupboard (Room 035) | Does not contain asbestos. |

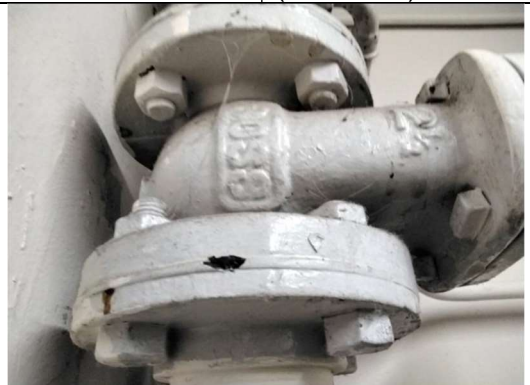
| 69 | As KX001595 | Pipework Gaskets | Block A Ground Floor Cleaners Cupboard (Room 035) | Do not contain asbestos. |

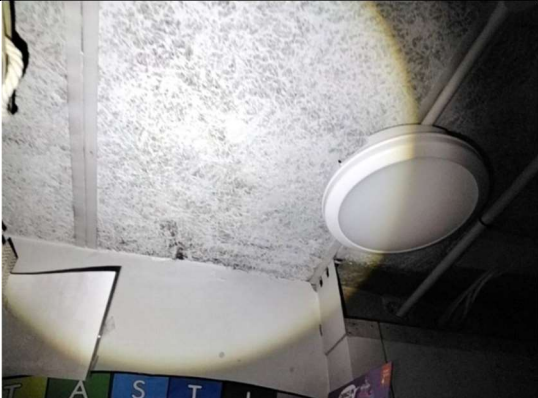
| 72 | As KX001591 | Ceiling void ceiling above | Block A Ground Floor Cupboard (Room 064) | Does not contain asbestos. |

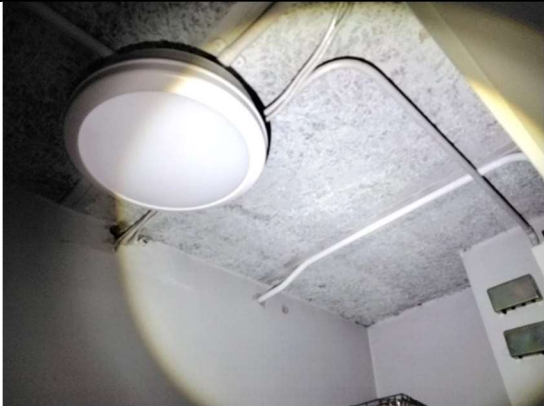
| 76 | As KX001591 | Ceiling void ceiling above | Block A Ground Floor Cupboard (Room 068) | Does not contain asbestos. |

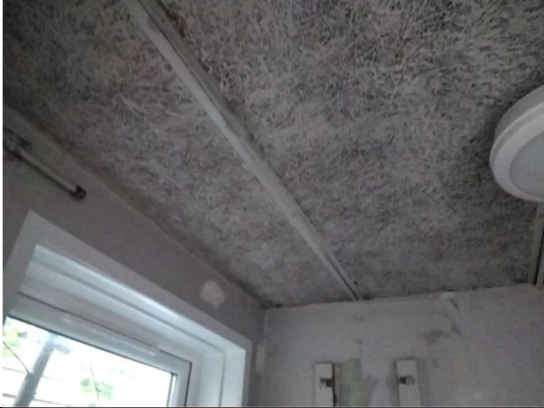
| 82 | As KX001591 | Ceiling void ceiling above | Block A Ground Floor Cupboard (Room 070) | Does not contain asbestos. |

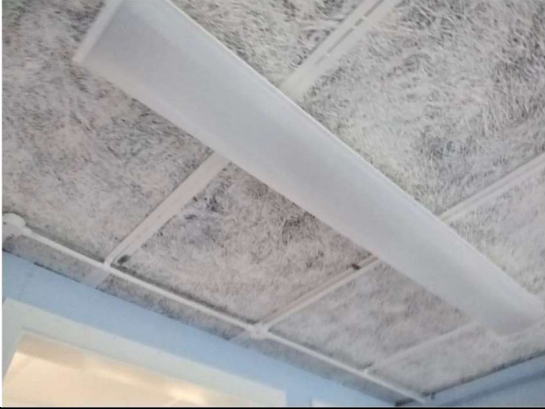
| 91 | As KX001591 | Ceiling | Block A Ground Floor Classroom (Room 078b) | Does not contain asbestos. |

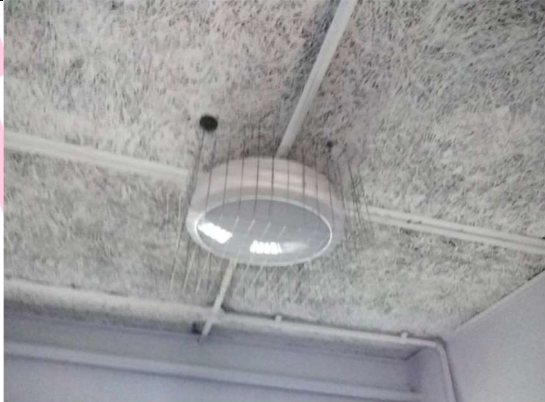
| 93 | As KX001591 | Ceiling | Block A Ground Floor Cupboard (Room 078a) | Does not contain asbestos. |

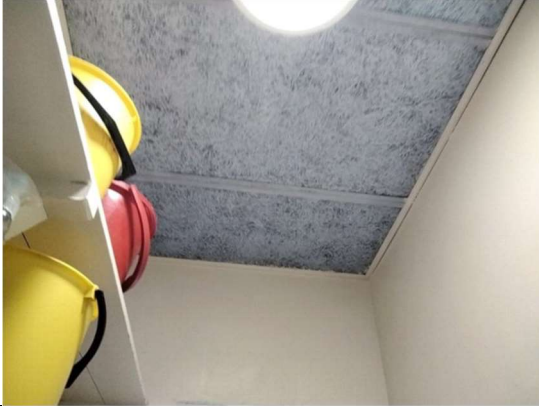
| 97 | As KX001591 | Ceiling | Block A Ground Floor Cleaners Cupboard (Room 052) | Does not contain asbestos. |

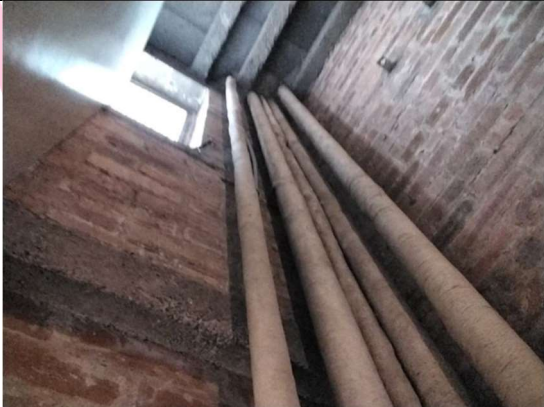
| 117 | As KX001585 | Pipework insulation string binding to fibreglass | Block A First Floor Storage (Room 018) | Contains asbestos - Any change in appearance should be recorded and passed to Property Services. |

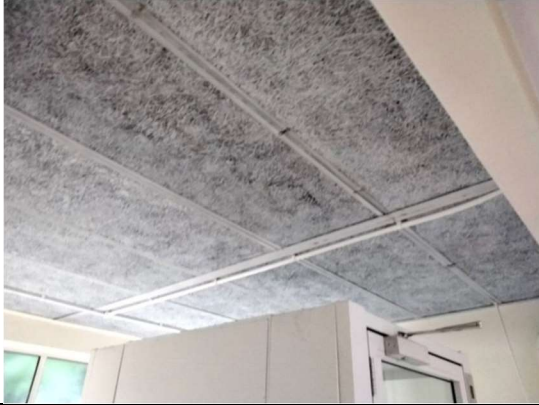
| 118 | As KX001591 | Ceiling | Block A First Floor Staircase Stairwell (Room 107) | Does not contain asbestos. |

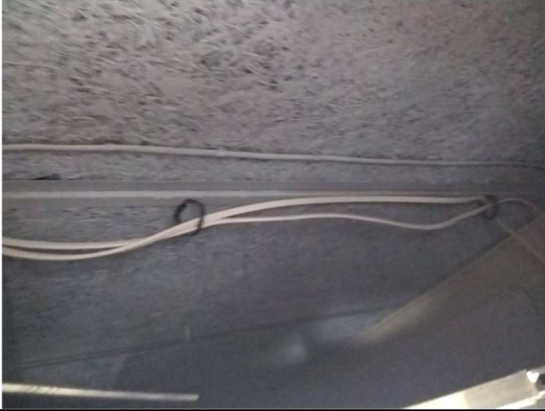
| 121 | As KX001591 | Ceiling void ceiling above | Block A First Floor Cloakroom (Room 105) | Does not contain asbestos. |

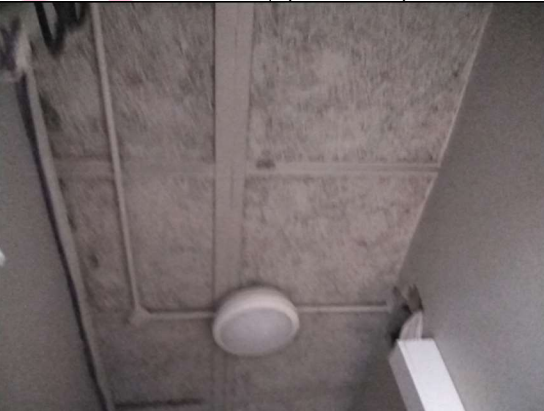
| 129 | As KX001591 | Ceiling | Block A First Floor Cleaners Cupboard (Room 96) | Does not contain asbestos. |

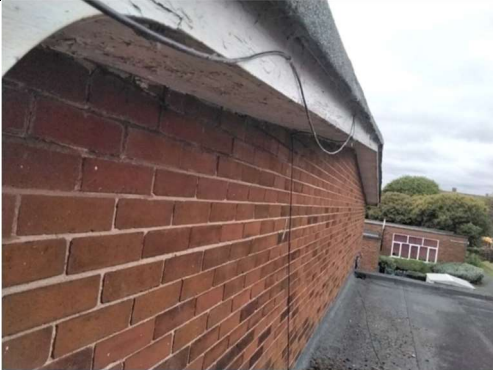
| 139 | KX001607 | Soffits Gable ends | Block A External | Contains asbestos - Any change in appearance should be recorded and passed to Property Services. |

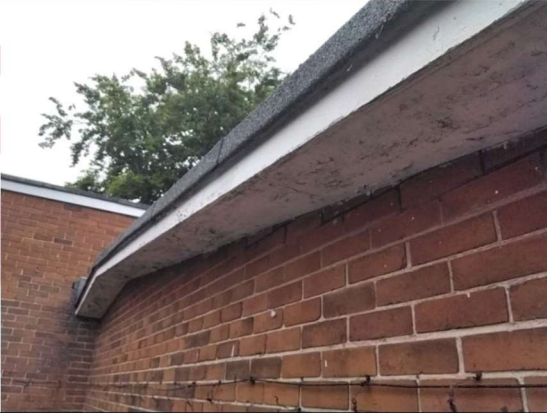
| 140 | KX001608 | Soffits Gable ends | Block A External | Contains asbestos - Any change in appearance should be recorded and passed to Property Services. |

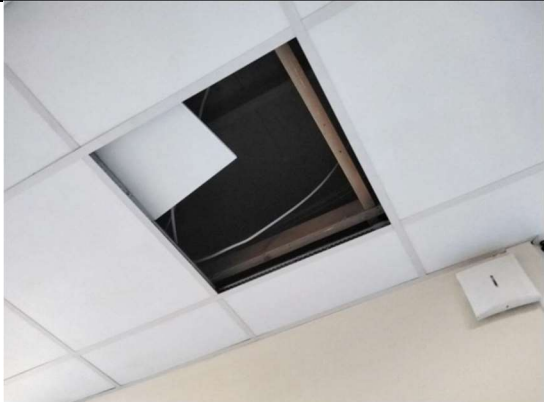
| 148 | KX001619 | Ceiling void debris to wooden framework and within nail holes - encapsulated | Block B Ground Floor Kitchen (Room 109) | Medium Risk |

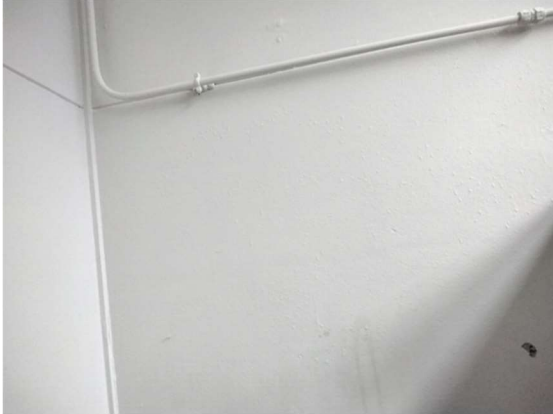
| 163 | As KX001625 | Wall coating fire flex paint | Block B Ground Floor Toilets (Room 129) | Does not contain asbestos. |

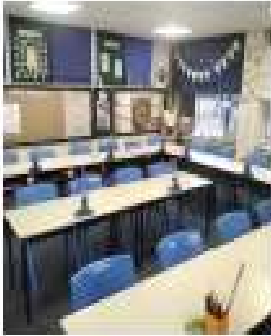
| 178 | CF010792 | Floor tile below screed | Ground Floor Classroom (Room 008) | Low Risk |

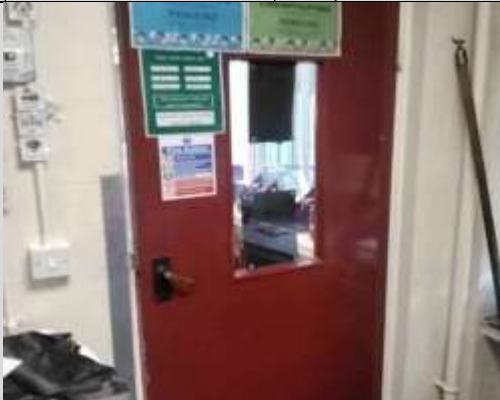
| 179 | CF010791 | Mastic to beading within door | Ground Floor Classroom (Room 008) | No Risk |

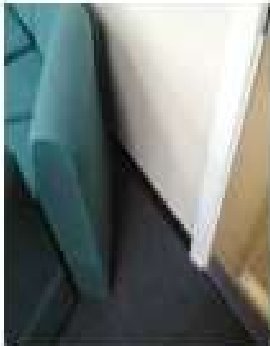
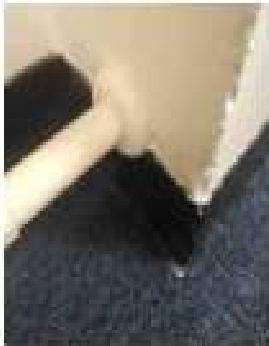
| 180 | CF010789 | Floor tile | Ground Floor Staff Room (Room 041) | Low Risk |

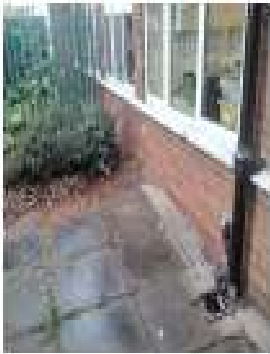
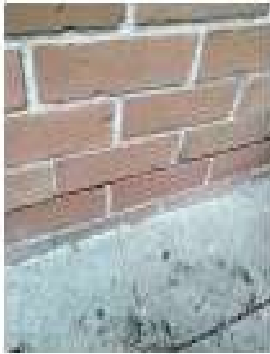
| 181 | CF010794 | Damp proof course | External to staff room (E/001) | Low Risk |

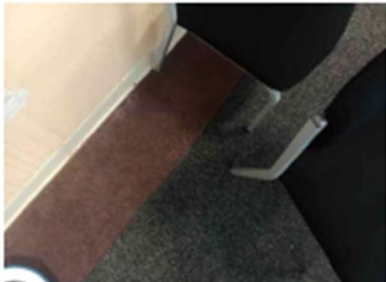
| 182 | TL001053 | Floor – covering beneath screed | Ground floor Office rm 2 (Heads Office) (G/001) | Low Risk |

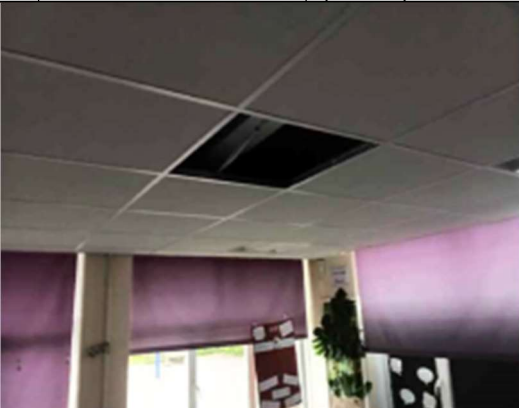
| 183 | TL001254 | Ceiling Cladding | Classroom Iguanas (G/001) | No Risk |

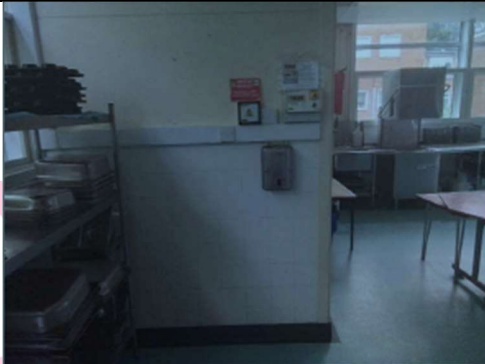
| 188 | Presumed | Old Electrical equipment to wall | Kitchen (Survey J081624) | Low Risk |
