### ASBESTOS SURVEY REPORT FOR PETER SMITH ANTIQUES, 12 – 14 BOROUGH ROAD

## Asbestos Register for

**12 – 14 Borough Road, Sunderland**

**Date: 17 February 2026**

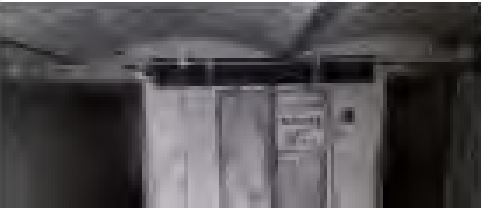
1	NZ001349	Wall (Insulating Board)	Large Room Z1/001	Removed – inspection survey J140747 Dec 2025
<b>Photo 1: Wide Angle</b>		<b>Photo 2: Close</b>

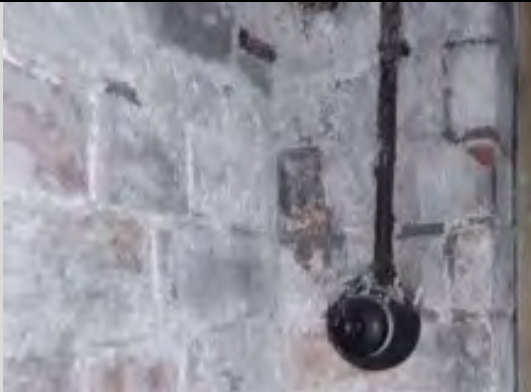
4	As NZ001333	Electrical Services Light switch (Composite Resinous/Reinforced Plastics)	Storage Z1/002	No Risk – N/A

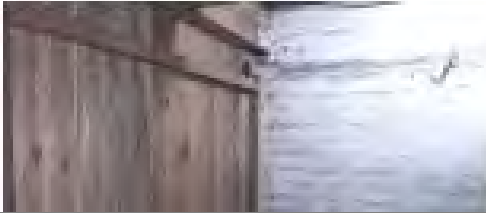
7	NZ001351	<i>Debris/Residue To Timber wall adjacent stairwell (Thermal Insulation Lagging)</i>	Storage Area Z1/004	Removed Aug/Sept 24
<b>Photo 1: Wide Angle</b>		<b>Photo 2: Close</b>

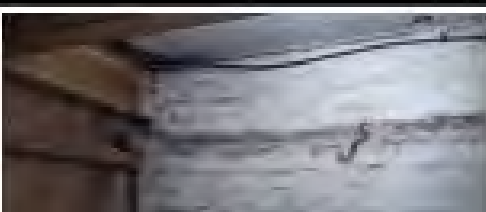
8	NZ001352	<i>Debris/Residue To brick wall and pipework hangers adjacent stairwell (Thermal Insulation Lagging)</i>	Storage Area Z1/004	Removed – inspection survey J140747 Dec 2025
<b>Photo 1: Wide Angle</b>		<b>Photo 2: Close</b>

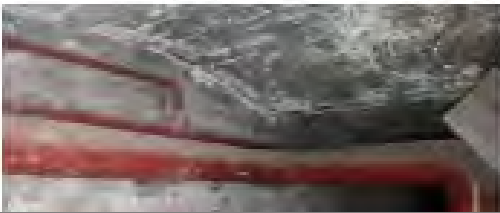
16	NZ001360	<i>Pipework - Insulation To pipework L/H side of room (Thermal Insulation Lagging)</i>	<i>Boiler Room (Restricted access due to contamination issues and storage) Z1/006</i>	<i>Removed Aug/Sept 24</i>
		<b>Photo 1: Wide Angle</b>	<b>Photo 2: Clos</b>

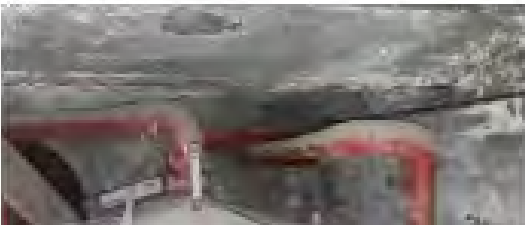
17	NZ001361	<i>Pipework - Insulation To R/H side pipework (Thermal Insulation Lagging)</i>	<i>Boiler Room (Restricted access due to contamination issues and storage) Z1/006</i>	<i>Removed Aug/Sept 24</i>
		<b>Photo 1: Wide Angle</b>	<b>Photo 2: Clos</b>

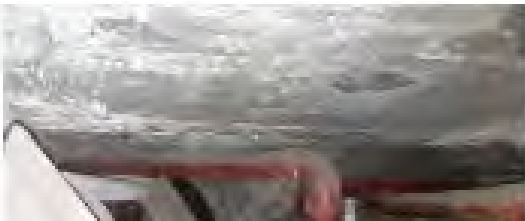
18	NZ001362	<i>Pipework - Insulation To central pipework from boiler (Thermal Insulation Lagging)</i>	<i>Boiler Room (Restricted access due to contamination issues and storage) Z1/006</i>	<i>Removed Aug/Sept 24</i>
		<b>Photo 1: Wide Angle</b>	<b>Photo 2: Clos</b>

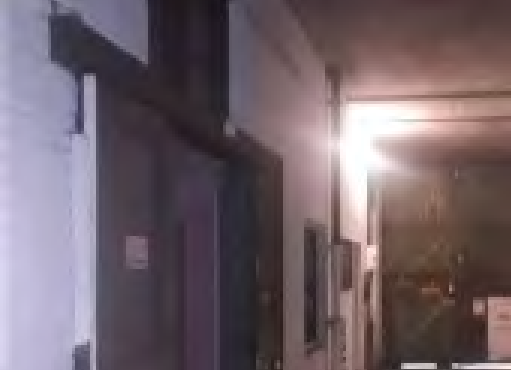
20	NZ001320	Window Putty/seal to glass windows and doors	Entrance Hall/Foyer/Lobby G/001	No Risk – N/A

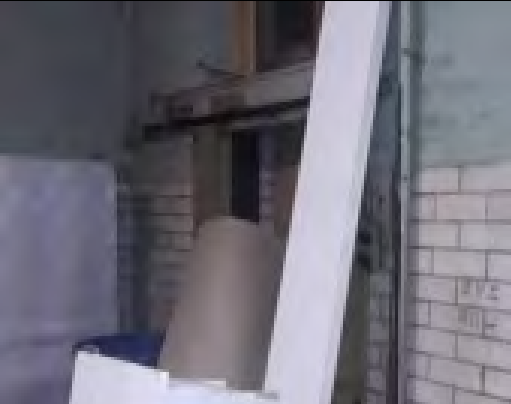
21	As NZ001333	Electrical Services Light switch (Composite Resinous/Reinforced Plastics)	Room G/006	No Risk – N/A

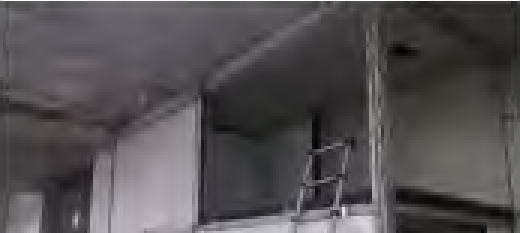
25	NZ001323	Debris/Residue To top of lift lobby (Insulating Board)	Room – Large G/010	Removed – inspection survey J140747 Dec 2025
<b>Photo 1: Wide Angle</b>		<b>Photo 2: Close</b>

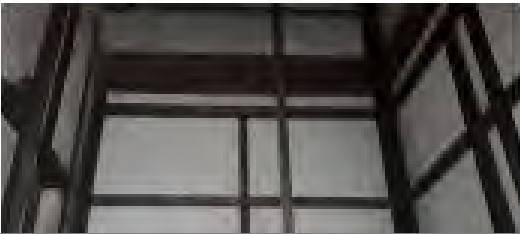
26	As NZ001321	Wall To lift shaft and lift lobby walls (Insulating Board)	Lift (Restricted access due to contamination issues) G/011	Removed – inspection survey J140747 Dec 2025
<b>Photo 1: Wide Angle</b>		<b>Photo 2: Close</b>

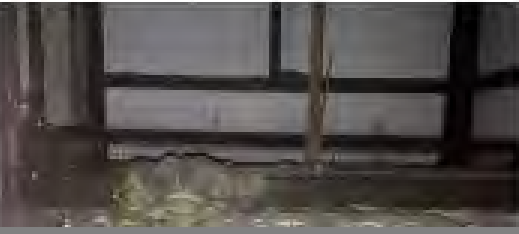
27	As NZ001322	Debris/Residue To floor, top of lift and around frame (Insulating Board)	Lift (Restricted access due to contamination issues) G/011	Removed – inspection survey J140747 Dec 2025
<b>Photo 1: Wide Angle</b>		<b>Photo 2: Close</b>

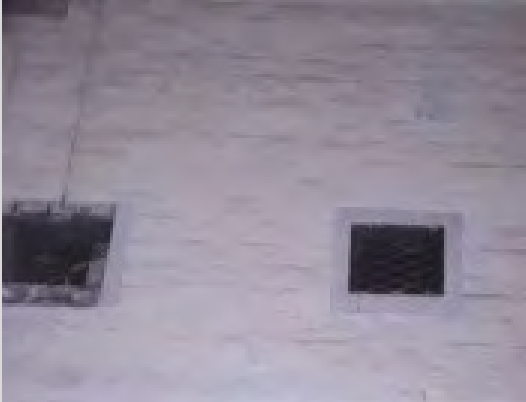
33	NZ001326	Wall - Vent Lining Panels to mesh (Cement)	Plant Room G/014	No Risk – N/A

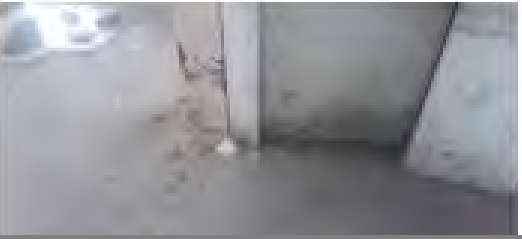
50	As NZ001336	Debris/Residue To floor next to door (Insulating Board)	Lift Lobby 1/002	Removed Aug/Sept 24
<b>Photo 1: Wide Angle</b>		<b>Photo 2: Close</b>

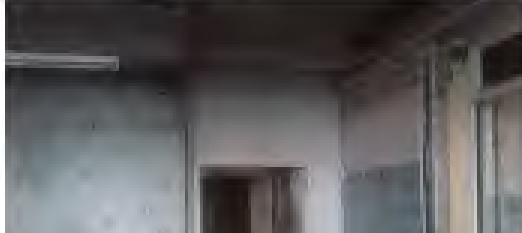
59	As NZ001335	Wall To doors to stairwell and side panels (Insulating Board)	Room – Large 1/005	Removed – inspection survey J140747 Dec 2025
<b>Photo 1: Wide Angle</b>		<b>Photo 2: Close</b>

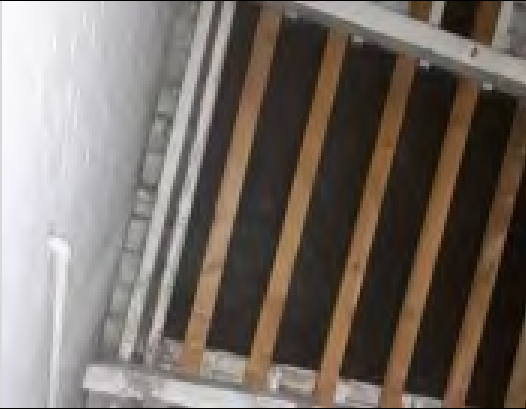
70	As NZ001346	Roof – Lining (Composite Bitumen)	Landing Including staircase 2/001	No Risk – N/A

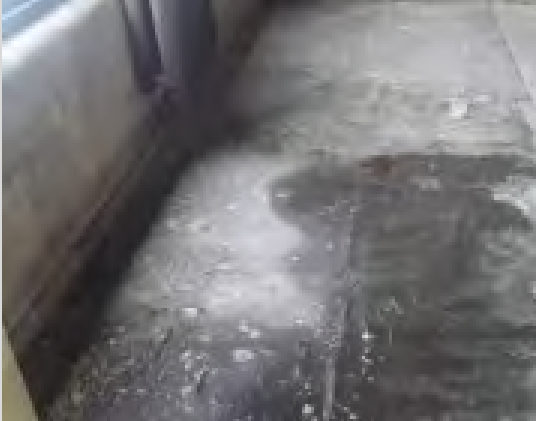
76	NZ001344	Floor – Covering (Composite Vinyl Tile, Vinyl/Lino with adhesive)	Room – Large 2/003	No Risk – N/A

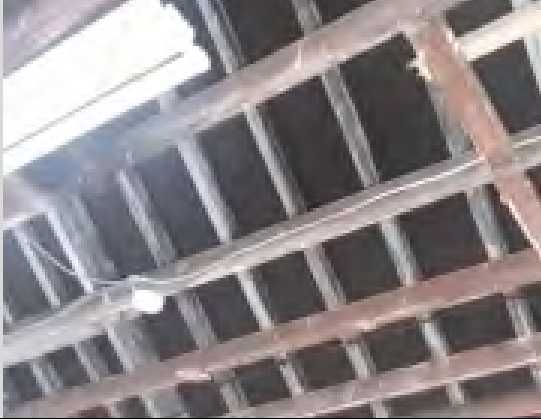
79	NZ001346	Roof – Lining (Composite Bitumen)	Workshop 2/005	No Risk – N/A

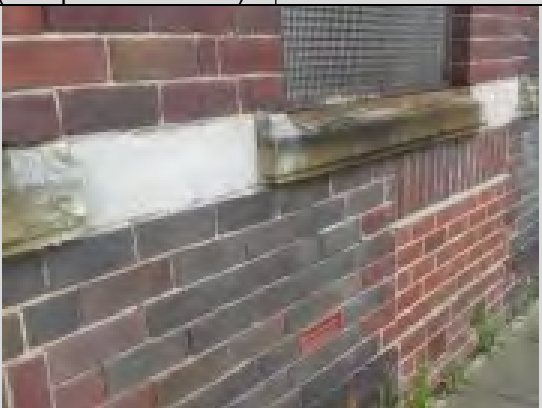
90	NZ001364	Damp Proof Course (Composite Bitumen)	External E/001	No Risk – N/A

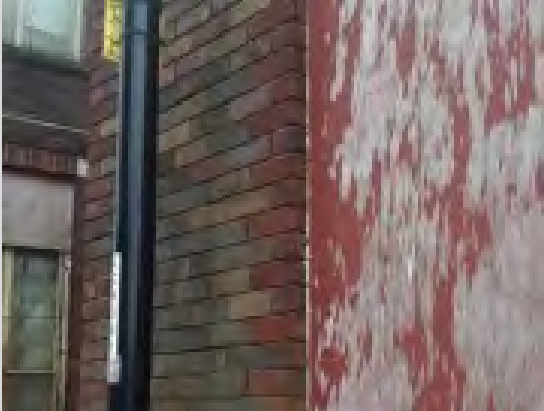
91	NZ001365	Window Putty/seal To Timber infill panels to windows	External E/001	No Risk – N/A

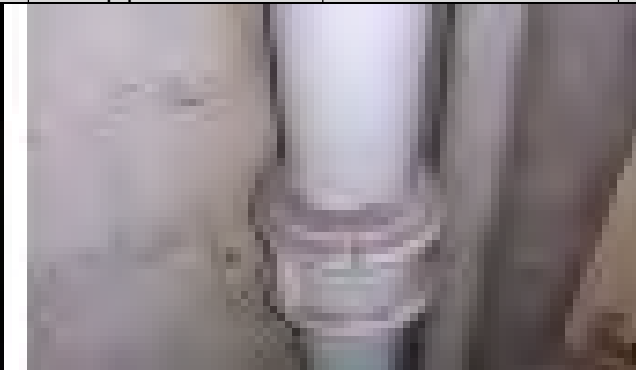
131	As PK002345	Insulation metal downpipe collars	Stairs/Landing 01 1/001	No Risk
