ASBESTOS SURVEY REPORT FOR WHITBURN VILLAGE PRIMARY SCHOOL, CLEADON LANE, WHITBURN, SUNDERLAND, TYNE AND WEAR, SR6 7NS

Asbestos Register for

**Whitburn Village Primary School, Cleadon Lane, Whitburn,
Sunderland, Tyne and Wear, SR6 7NS**

Date: 27 March 2026

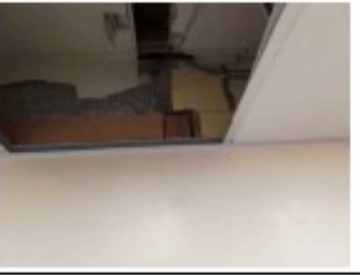
2	As OQ002218	Column Cladding - suspected behind wooden cladding	Ground Floor G/003 Hallway/passageway	Low Risk – Check every 6 months
Photo 1: Wide Angle		Photo 2: Close-up
