ASBESTOS SURVEY REPORT FOR ST HELEN'S PRIMARY SCHOOL,
DURHAM ST, HARTLEPOOL, TS24 0HR

**St Helen's Primary School, Durham St,
Hartlepool, TS24 0HR**

Date: 30 March 2026

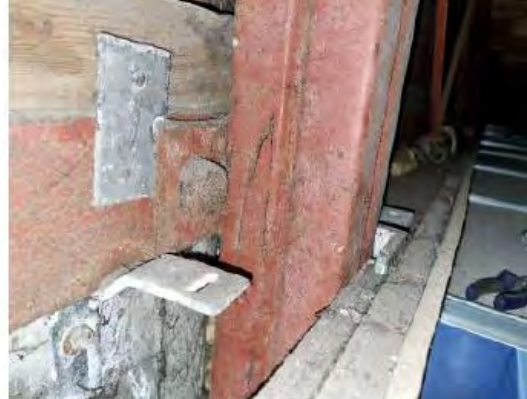
6	RT000604	Packers - to columns - Presumed to run to all columns	KS2 Building - 3, 003 Dining Room, G/03	Low Risk – To be checked on a 6 monthly basis

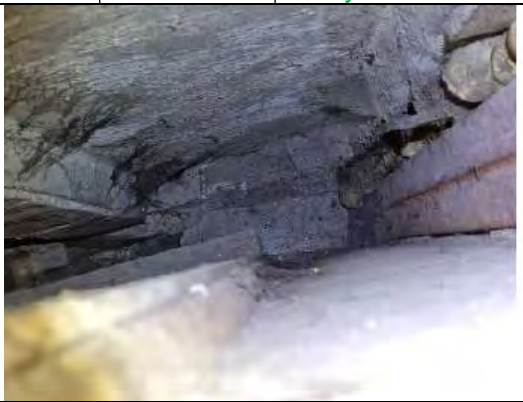
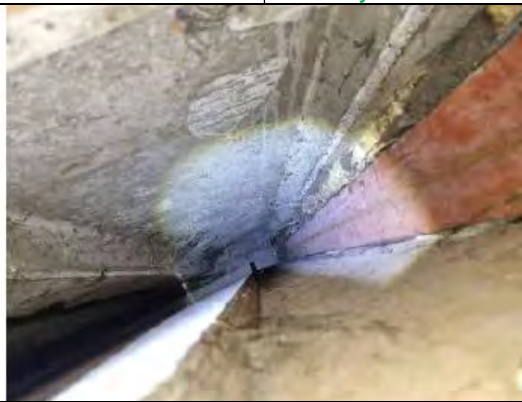
7	As RT000604	Insulating board debris - to foot of cavity	KS2 Building - 3, 003 Dining Room, G/03	Medium Risk – To be checked on a 3 monthly basis

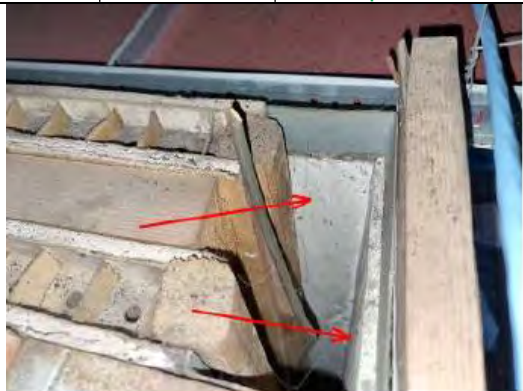
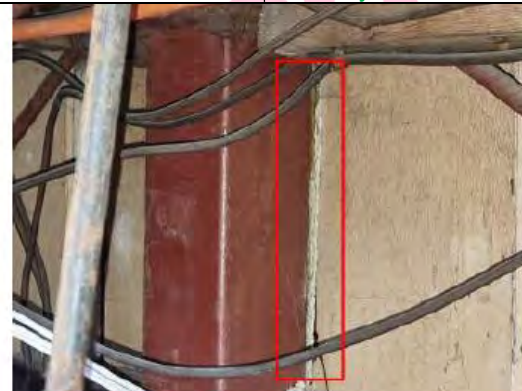
8	RT000605	Insulating board - to columns and wall end caps	KS2 Building - 4, 002 Kitchen, G/04	Medium Risk – To be checked on a 3 monthly basis

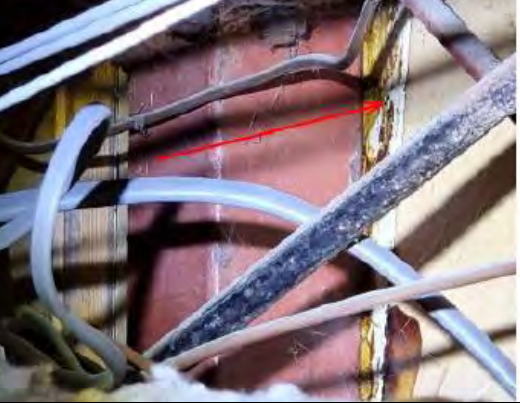
13	As RT000605	Insulating board - to column – 1 column visible	KS2 Building - 8, 022 Thrive Room, G/08	Medium Risk – To be checked on a 3 monthly basis

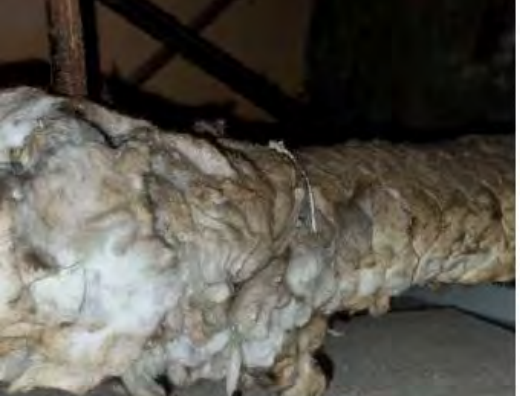
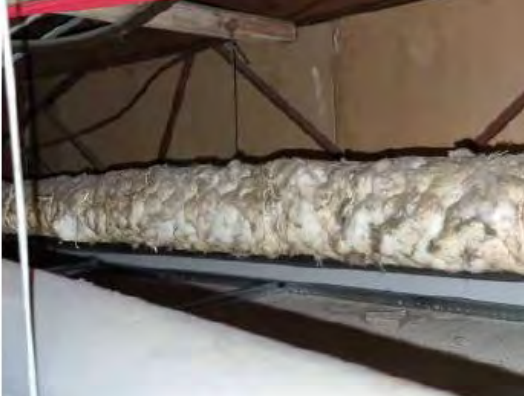
14	As RT000602	String - to pipework - Within ceiling void	KS2 Building - 8, 022 Thrive Room, G/08	Low Risk – To be checked on a 6 monthly basis

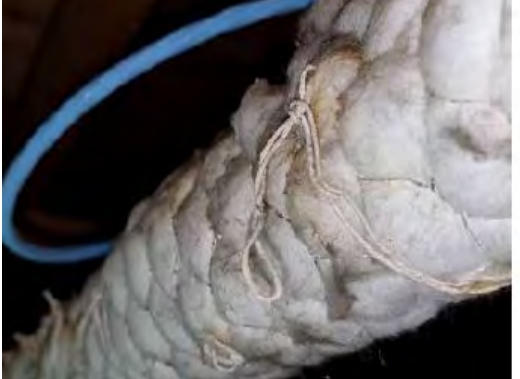
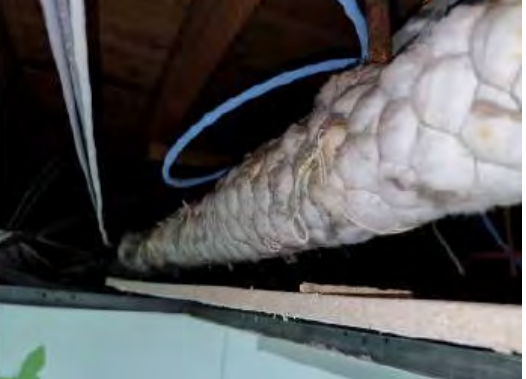
15	RT000607	String - to pipework - Within ceiling void	KS2 Building - 9, 005b Office, G/09	Low Risk – To be checked on a 6 monthly basis

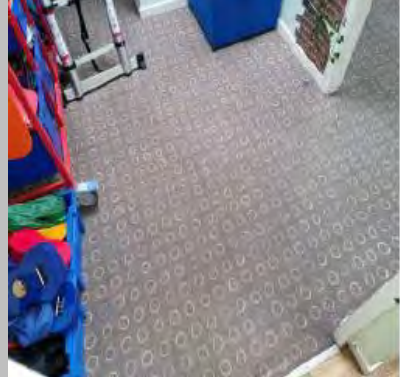
18	As RT000608	Beige vinyl tiles and adhesive - to floor below carpet	KS2 Building - 005a Circulation G/10	No Risk

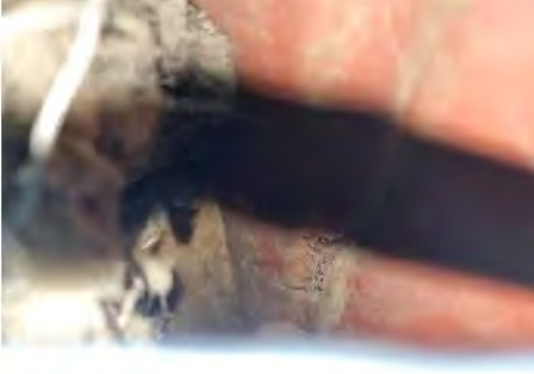
37	As RT000610	Insulating board - to columns and wall end caps	KS2 Building - 19, 012 Circulation, G/19	Low Risk – To be checked on a 6 monthly basis

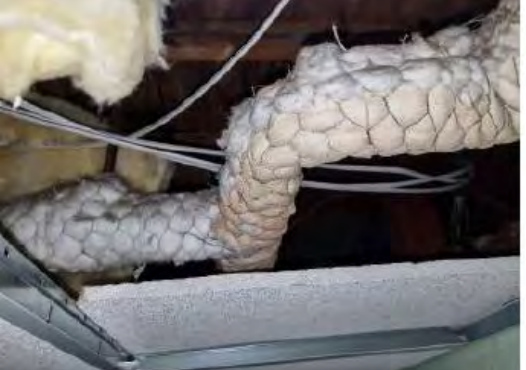
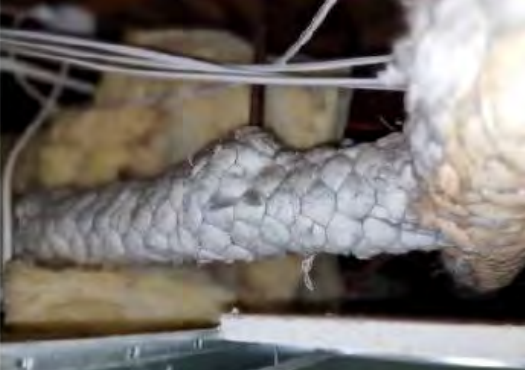
41	As RT000611	String - to pipework - Within ceiling void	KS2 Building - 21, 018 Print Room, G/21	Low Risk – To be checked on a 6 monthly basis

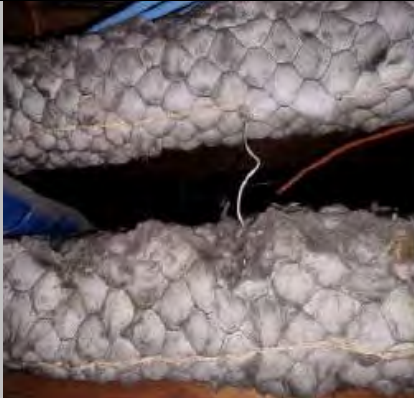
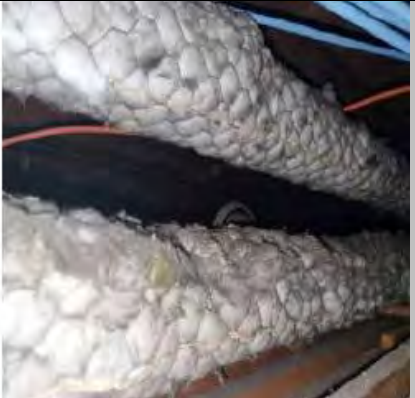
103	RT000619	String - to pipework	KS1 Building - 001 Entrance Lobby G/01	No Risk

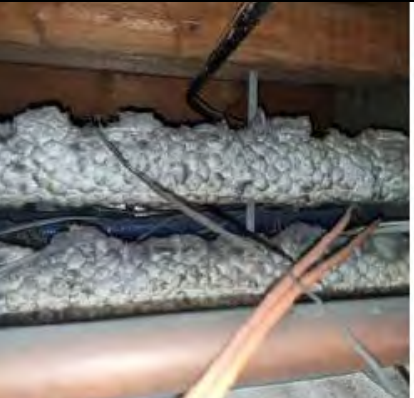
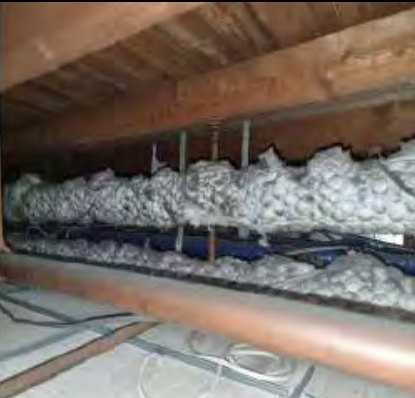
104	As RT000619	String - to pipework	KS1 Building - 036 Office G/02	No Risk

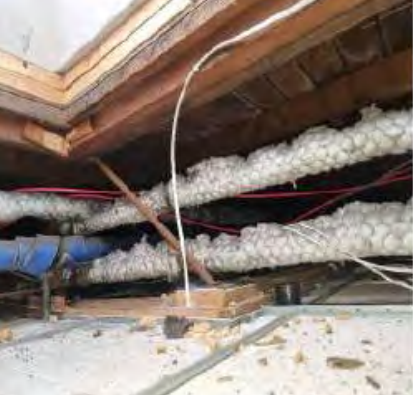
140	As RT000624	String - to pipework	KS1 Building - 006 Cloaks G/41	No Risk

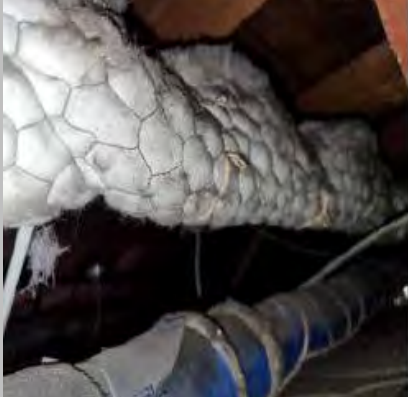
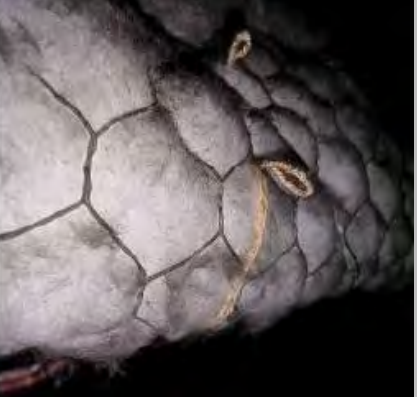
141	As RT000624	String - to pipework	KS1 Building - 007 Store G/42	No Risk

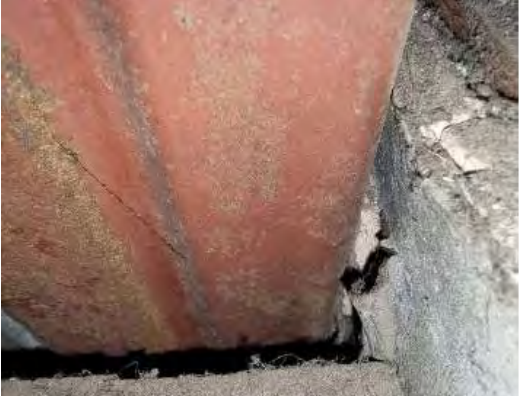
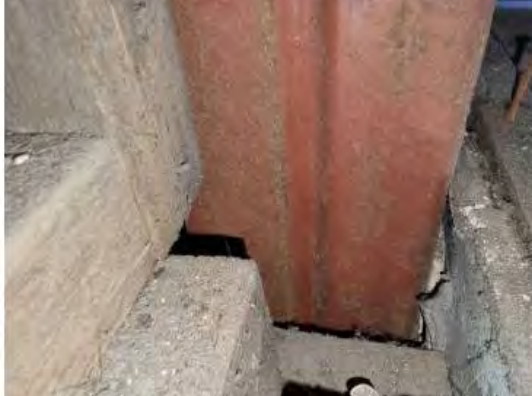
142	As RT000623	Insulating board - to columns	KS1 Building - 43, 008 Teaching Space, G/43	Low Risk – To be checked on a 6 monthly basis

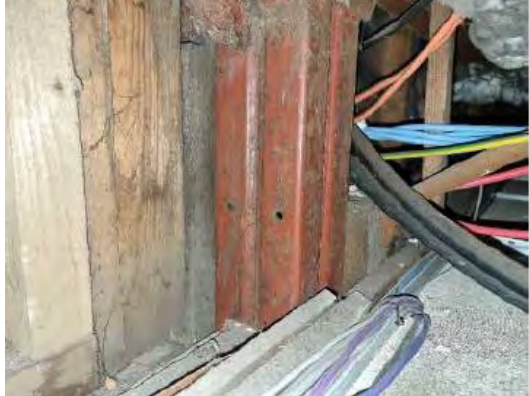
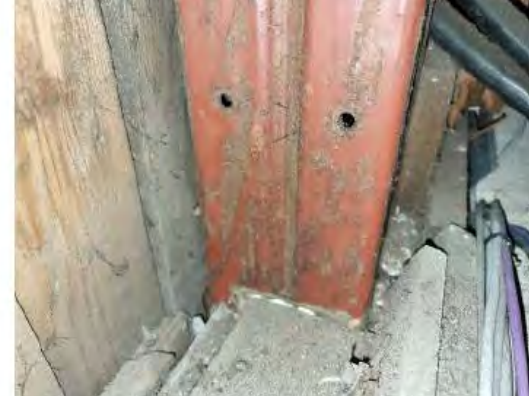
143	As RT000623	Insulating board - to columns	KS1 Building - 44, 011 Circulation, G/44	Low Risk – To be checked on a 6 monthly basis

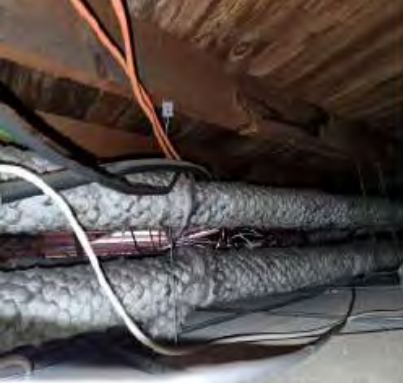
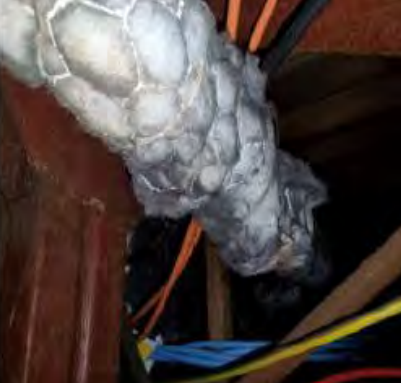
144	As RT000624	String - to pipework	KS1 Building - 011 Circulation G/44	No Risk

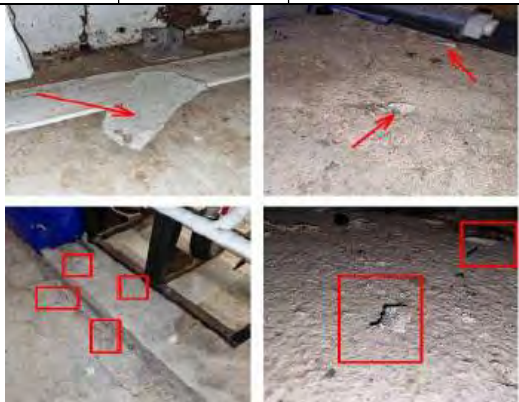
151	RT000632	Cement debris - to floor	KS1 Building - 47, 044 KS1 Boiler Room, G/47	Medium Risk – To be checked on a 3 monthly basis

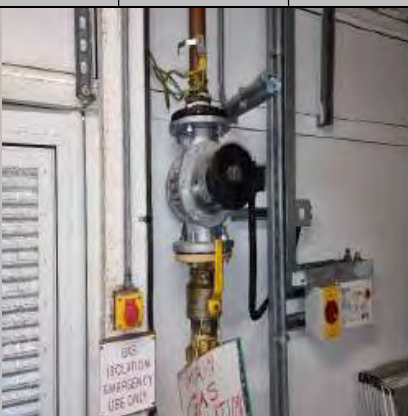
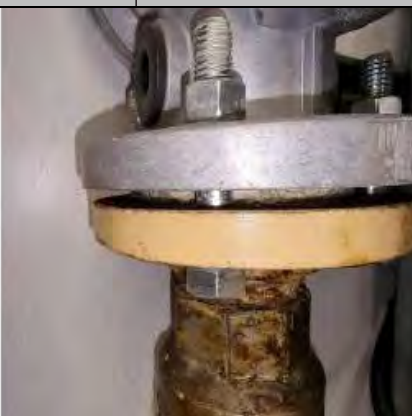
152	RT000633	Gaskets - to gas pipe	KS1 Building - 044 KS1 Boiler Room G/47	No Risk

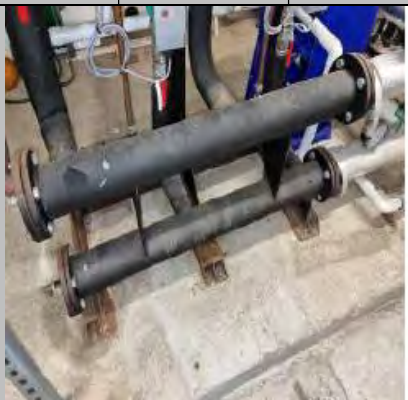
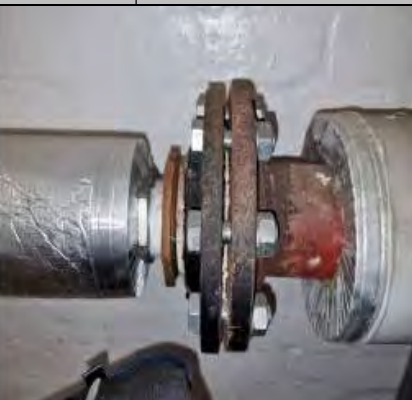
153	RT000634	Gaskets - to pipework	KS1 Building - 044 KS1 Boiler Room G/47	No Risk
