ASBESTOS SURVEY REPORT FOR RAINBOW FAMILY CENTRE, SUNDERLAND

Asbestos Register for RAINBOW FAMILY CENTRE, SUNDERLAND

UPRN: - 218304

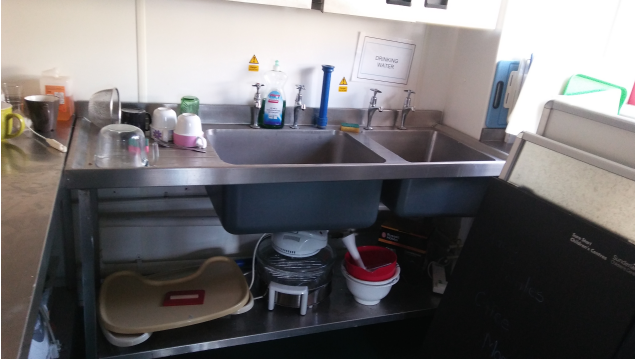
Item 1 Ref: 218304-1

218304-1 – Sink Paint (Rm 0/33/Kitchen) (Item 1) – No Risk

The sink paint in the kitchen (Rm 0/33) does not contain asbestos.

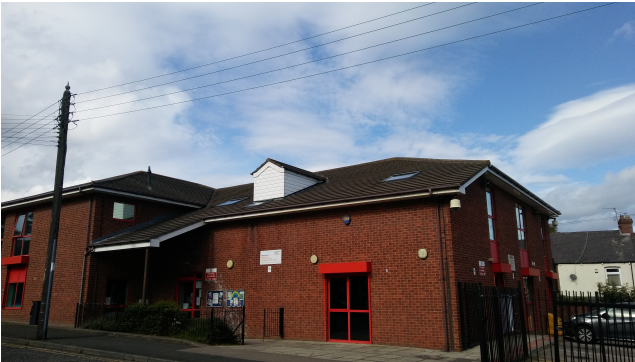
Item 2 - Ref: 218304-2

218304-2 – Roof Undercloaks Cement (999-Externals) (Item 2) – No Risk

The roof undercloakes (external) does not contain asbestos.
