ASBESTOS SURVEY REPORT FOR 2 BONEMILL LANE, WASHINGTON.  
NE38 8AJ

**Asbestos Register for  
2 BONEMILL LANE, WASHINGTON**

**UPRN: - 299514**

**Date:- 12 February 2026**

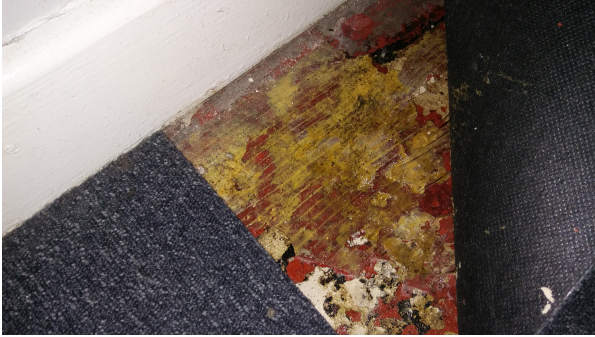
### **Item 1 - Ref: 299514-1**

- (Item 1) 299514-1 – Remnant Bitumen Adhesive (02/Call Centre) – Very Low Risk
- (Item 2) 299514-2 – Damp Proof Course (999/Externals) – No Risk

The remnant bitumen adhesive beneath carpet (call centre) contains asbestos.

Any changes should be reported to Property Services.

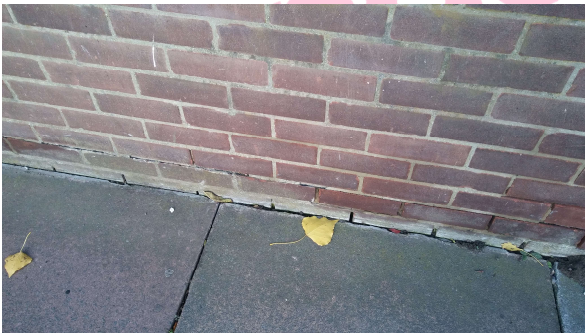
### **Item 2 - Ref: 299514-2**

The damp proof course (external) does not contain asbestos.
