ASBESTOS SURVEY REPORT FOR HOLLEY PARK ACADEMY – CARETAKERS HOUSE, SUNDERLAND

Holley Park Academy – Caretakers House

Plan of Building and Samples Location – Caretakers House

Photographs of Areas Sampled

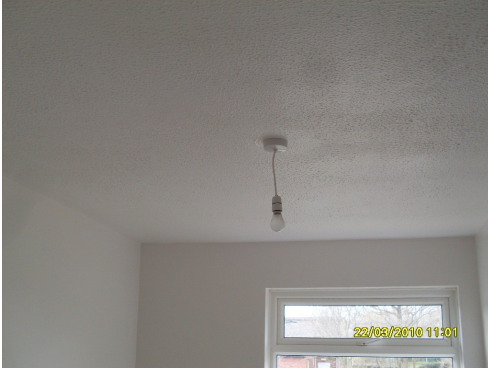
Item 1 Ref: ME1359/10

The textured coating to Bedroom 1 (Rm 0/02) does not contain asbestos.

Similar textured coating is in rooms 0/03 and 0/04.

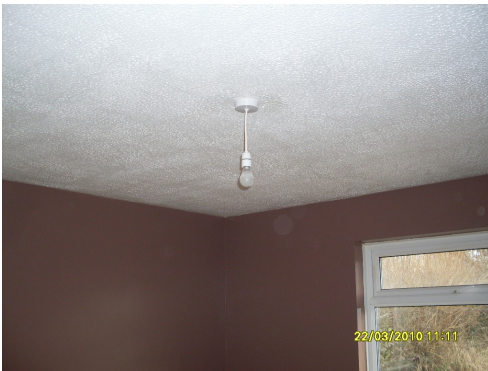
Item 4 Ref: ME1360/10

The textured coating to Bedroom 3 (Rm 0/05) does not contain asbestos.

Similar textured coating is in rooms 0/06 and 0/08.

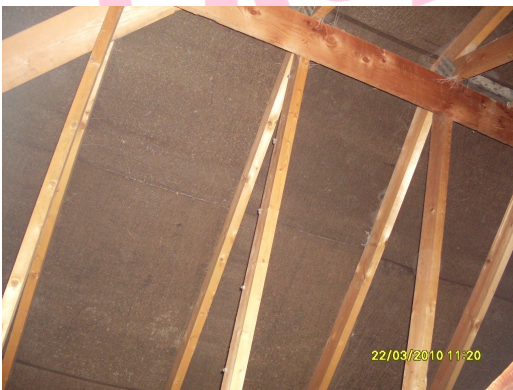
Item 7 Ref: ME1361/10

The roof lining to the loft space (Area L0/11) does not contain asbestos.

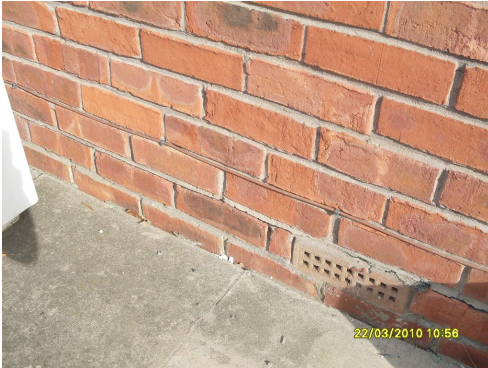
Item 8 Ref: ME1357/10

The damp proof course to the external does not contain asbestos.

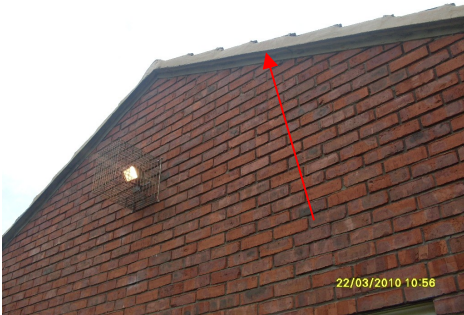
Item 9 Ref: ME1358/10

The undercloak to the external of the building contains asbestos.

Any change in its appearance should be recorded and reported to Property Services.
