ASBESTOS SURVEY REPORT FOR HOLLEY PARK ACADEMY – CARETAKERS HOUSE, SUNDERLAND

Holley Park Academy – Caretakers House

Date: 29 April 2025

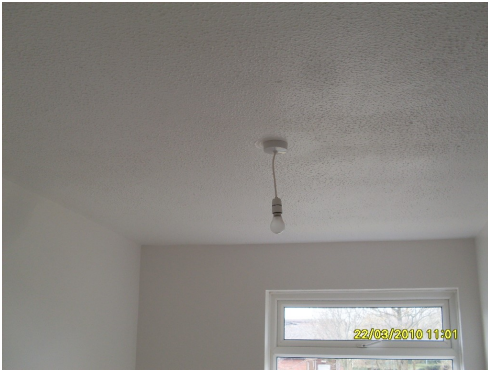
Item 1 Ref: ME1359/10

The textured coating to Bedroom 1 (Rm 0/02) does not contain asbestos.

Similar textured coating is in rooms 0/03 and 0/04.

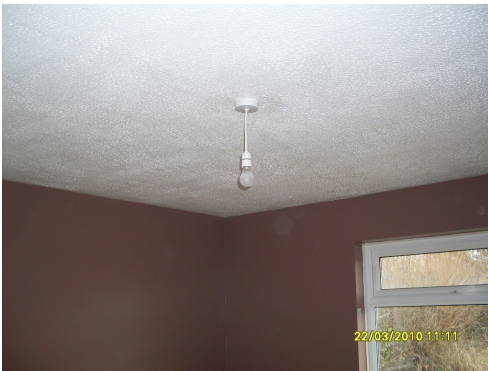
Item 4 Ref: ME1360/10

The textured coating to Bedroom 3 (Rm 0/05) does not contain asbestos.

Similar textured coating is in rooms 0/06 and 0/08.

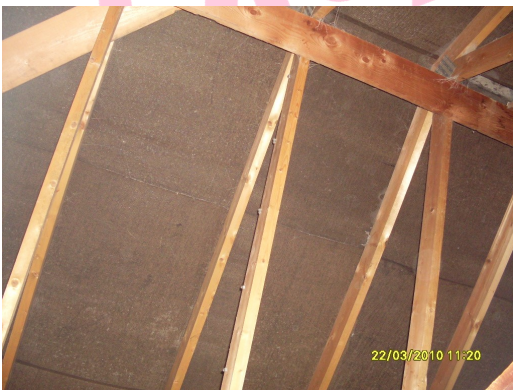
Item 7 Ref: ME1361/10

The roof lining to the loft space (Area L0/11) does not contain asbestos.

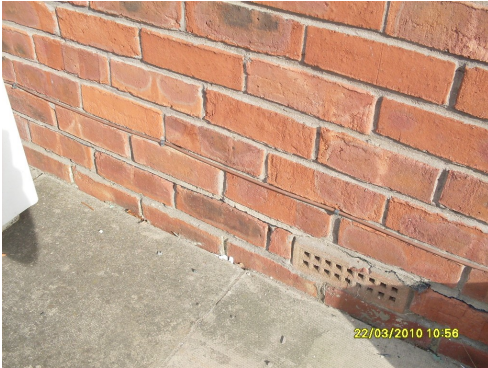
Item 8 Ref: ME1357/10

The damp proof course to the external does not contain asbestos.

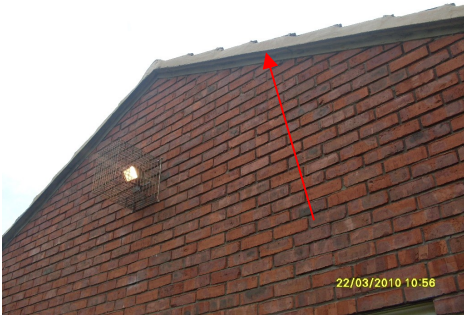
Item 9 Ref: ME1358/10

The undercloak to the external of the building contains asbestos.

Any change in its appearance should be recorded and reported to Property Services.
