# Roker Park Conservation Area

# Character Appraisal and Management Strategy

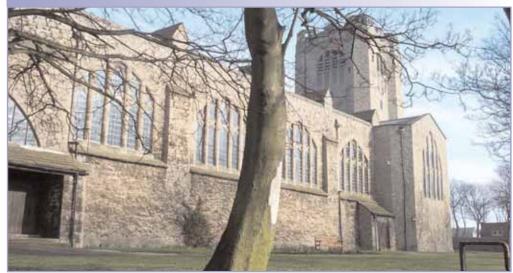
### St Andrews Church

St Andrew's Church is Grade I listed and one of Sunderland's finest buildings. The Church was built in 1906/7 and is the most distinguished of the City's modern ecclesiastical buildings. It was designed by noted architect Edward Pryor who was closely involved with William Morris' Arts and Crafts Movement. St Andrew's is said to be Pryor's finest Church and it has been described as the "Cathedral of the Arts and Crafts Movement". The style is an adaptation of Gothic, its appearance simple and its construction derived from medieval practices. Internally, the Church is quite remarkable and said to resemble an upturned ship. Furnishings are by various members of the Arts and Crafts Movement, including William Morris & Co. The Church terminates the vista along Rock Lodge Road particularly well. It's bold tower and the use of local magnesian limestone make it a readily identifiable local landmark, especially when viewed from the seafront. Local limestone was also used to construct the boundary walls to the Church.

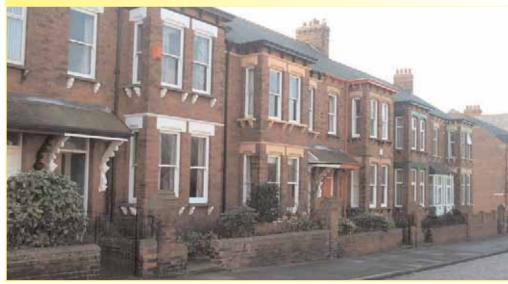
### **Park Parade**

Park Parade is a particularly notable terrace with unusual rectangular shaped brick bay windows complemented by terracotta mouldings. However, the harmony of the terrace has been spoiled by the installation of replacement uPVC windows in almost half of the properties

Bay windows in a variety of styles, many extending from the ground to eaves height, are a characteristic feature of the terraces. The rectangular shaped bays of Park Parade with their decorative terracotta mouldings, illustrated in the centre, are especially unique and add considerably to the local distinctiveness of the area. The retention of original sliding-sash window frames contributes significantly to the character of the buildings. Many of these contain delicately designed top lights featuring a variety of colourful stained glass patterns/art work. It is essential such features are retained

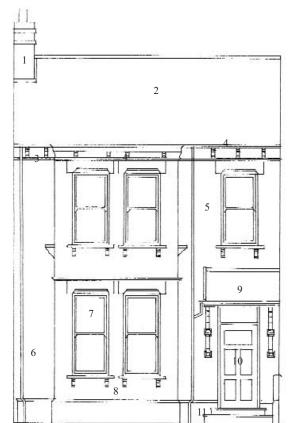
### Typical Features To Be Retained On A Terraced House In Roker

- 1. Chimney stacks and pots
- 2. Welsh roof slates
- 3. Cornice / eaves detailing
- 4. Timber guttering and brackets
- 5. External brickwork
- 6. Cast-iron downpipes
- 7. Sliding-sash windows
- 8. Bay window
- 9. Canopy / porch
- 10. Panelled door
- 11. Stone steps

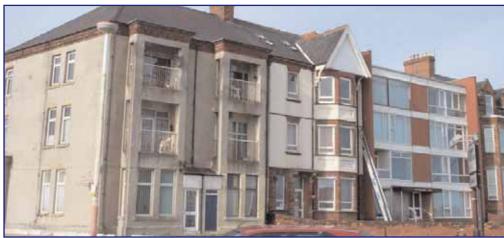
The above property, prominently located at the southern end of Roker Terrace, has been substantially altered from its original form and is in a state of disrepair. This is an unfortunate sight at the main gateway into the Conservation Area from the south and portrays a negative image of the area.

In the first instance, regular maintenance should be carried out to prevent or at least delay the need for repairs. Repairs should only be undertaken where considered strictly necessary to slow down the process of decay without damaging the character of the building. A guide on how to assess the maintenance needs of historic buildings is available from the Council's Conservation Team

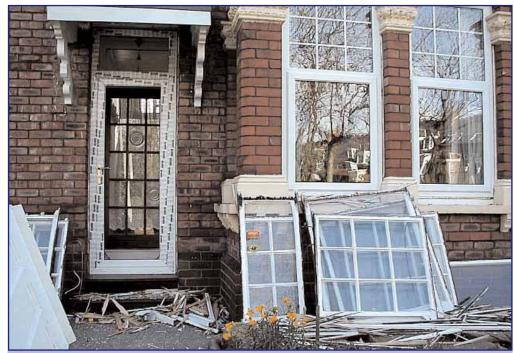
The installation of UPVC units, as illustrated above, fail to match the slender proportions and detailing of the traditional sash windows, detracting from the character of the property concerned and the terrace as a whole.

- Where repairs are considered, a traditional approach should be adopted, replacing decayed material on a like-for-like basis. In certain circumstances, the fabric may be beyond repair and the replacement of features necessary. It is imperative, however, that the unnecessary loss of historic fabric is avoided. In some cases, such as above, original windows have been replaced when they could have been more appropriately repaired. The discrete insertion of modern draught seals can greatly enhance the performance of sash windows in respect of heat retention and ease of use. There are local contractors that can undertake such work far cheaper than the cost of replacement.

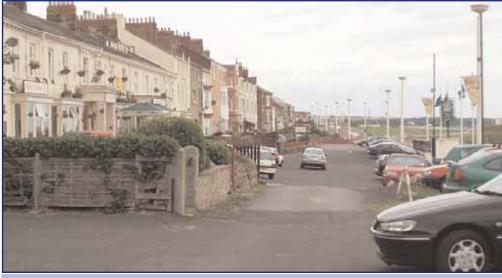
In this section of Roker Terrace almost all front gardens have been removed to accommodate car parking, detracting from the setting of these seafront properties.

- Seas of car parking to the front of properties should be avoided and alternative options considered. Parking should as far as possible be provided in the rear yards.
- Design guidance for owners to follow in repairing and reinstating traditional forms of boundary enclosures is given on page 38.

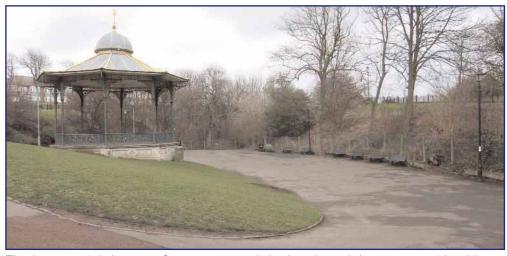
The large unsightly area of tarmac around the bandstand detracts considerably from the setting of this listed structure and the attractiveness of the Park as a whole. Originally, the bandstand was surrounded by a much more extensive area of grassed landscape with trees and shrubbery. The reinstatement of its landscape setting and original pattern of paths about the bandstand would be highly desirable. The installation of more appropriate forms of seating, as described above, would further enhance the space and its usability.

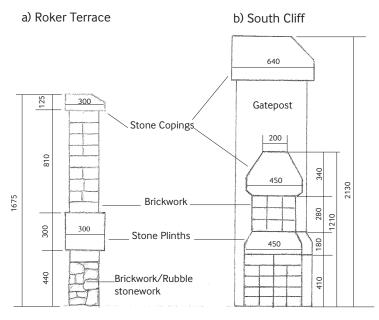
## **Boundary Wall Sections**

(All measurements in millimetres)
