Silksworth Hall Conservation Area

Character Appraisal and Management Strategy

PLANNING GUIDANCE

January 2010

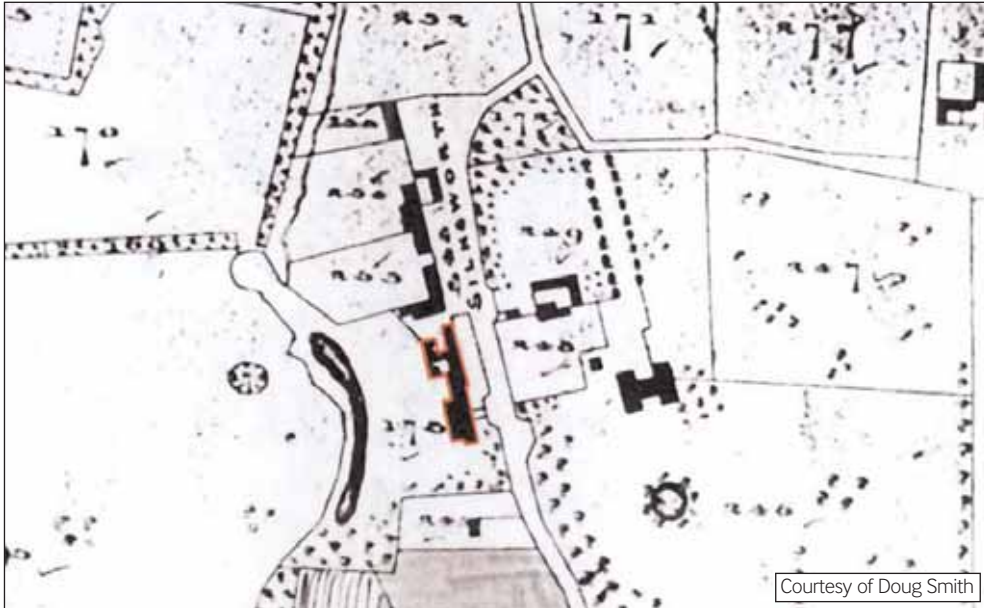
1842 tithe map

Between the drawing of the 1831 plan and an 1842 tithe (tax) map, the footprint and location of the Hall change significantly, suggesting that a replacement Hall may have been built at this time. In 1842 the Hall appears to be in an H-plan, but by the 1860 OS map it appears to have been squared off.

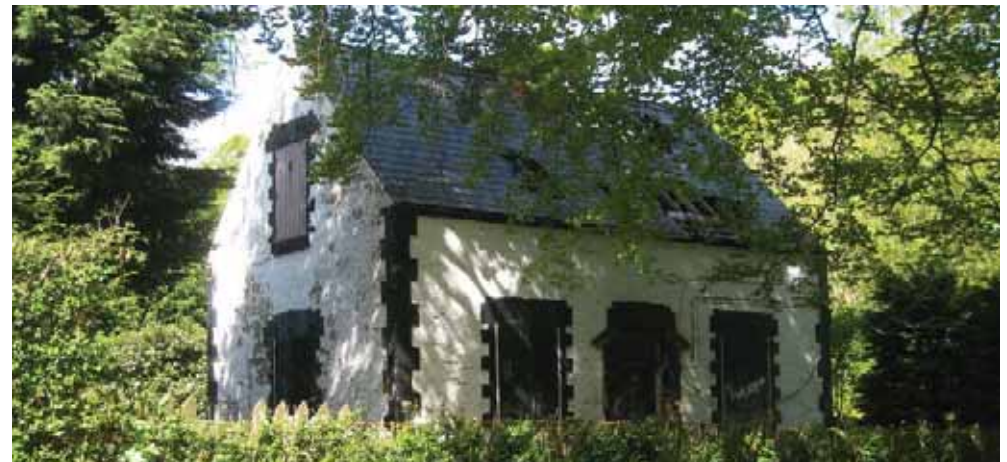
At the northern entrance to the park stand Meadow Nursery Cottage and 'The Gardens', both built as part of the Doxford estate. 'The Gardens', which is currently in extremely poor condition, could be an attractive residence or park office (see page 38). Meadow Nursery Lodge, which was derelict until fairly recently, has been renovated and is now used as offices. Elsewhere in the gardens there is an old ice house - a brick larder with the remains of iron shelves for preserving food.

'The Gardens', sadly derelict, but of considerable historic interest.

PROPOSAL 1e: The council will encourage the restoration and re-use of ancillary estate buildings within the park

The two remaining ancillary estate buildings within the park are 'The Gardens' (left) and Meadow Nursery Cottage. The Gardens, owned by the council, is currently standing derelict and has recently suffered fire damage. The council is seeking to repair the shell of the building and refurbish its interior, and is exploring potential users that would return the building into beneficial usage and

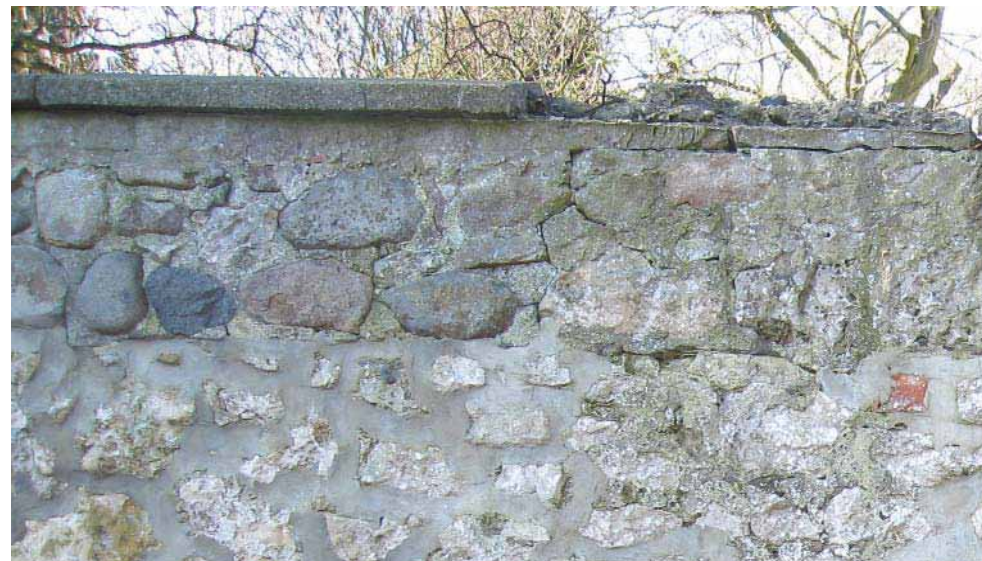
This section of wall on Warden Law Lane has had the original coping replaced, part of which is missing, and features some inappropriate cement pointing

- The random limestone walls on Warden Law Lane are a key characteristic of the Conservation Area, but are only protected from insensitive repair in certain areas, where the wall is Listed. Parts of the walls are at risk of partial or total demolition, or of being detrimentally altered, either through poor, ill-informed repair, or through a lack of maintenance. This includes the low stone boundary walls to the modern houses on Silksworth Hall Drive, which have a unifying effect within the rest of the Conservation Area.
- Other boundary treatments in the Conservation Area add little to its essential character and would benefit from replacement or improvement.

- Guidance on the sensitive repair and maintenance of limestone walls is provided on page 43 of the Management Strategy.

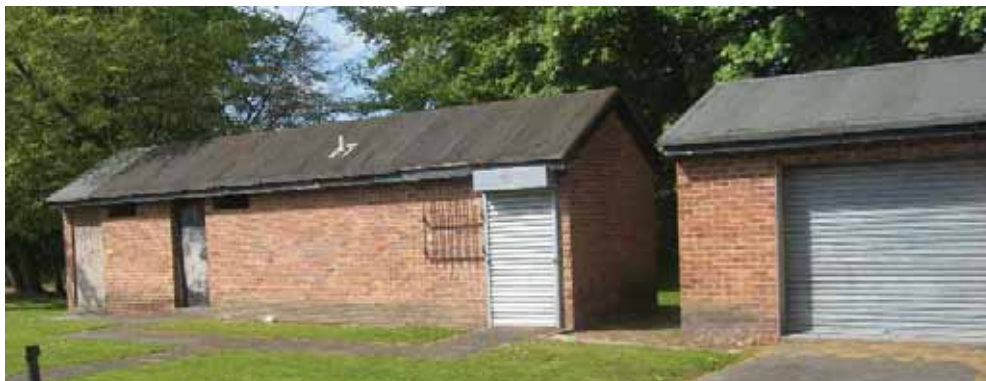
Above: the now apparently disused toilet block to the north-west of the park is of very poor appearance and detracts from the park's special interest.

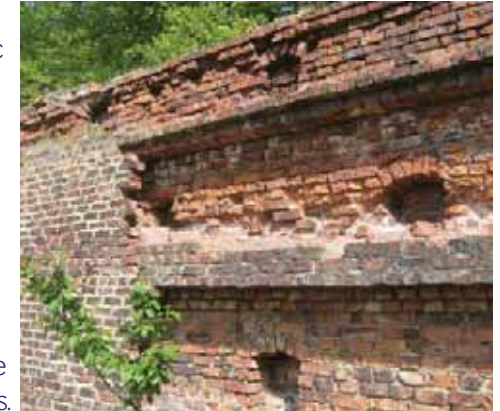
The south wall, in particular, is currently covered by a considerable amount of plant cover (including some growth in cracks in the mortar): while this gives the wall a very attractive appearance, it is likely to be causing damage to the fabric of the wall and may be undermining its structural stability. The condition of the walls should therefore be fully investigated through a structural survey to inform the preparation of a more detailed specification of repair works to ensure its sustainability into the future.

PROPOSAL 1c: The council will seek to prepare a schedule of repairs to consolidate the hot wall and kitchen garden and investigate the possibility of restoring this unique feature to its original form in the future

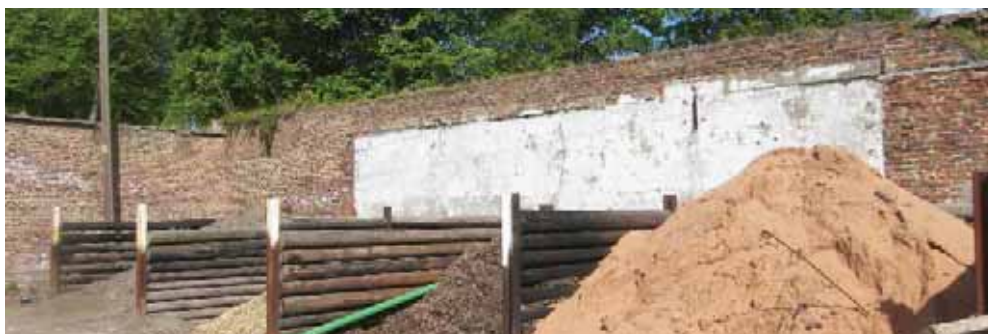
Above: the western half of the walled garden is currently used as a maintenance depot. The white section of the wall indicates the location of a structure, probably a glass house.

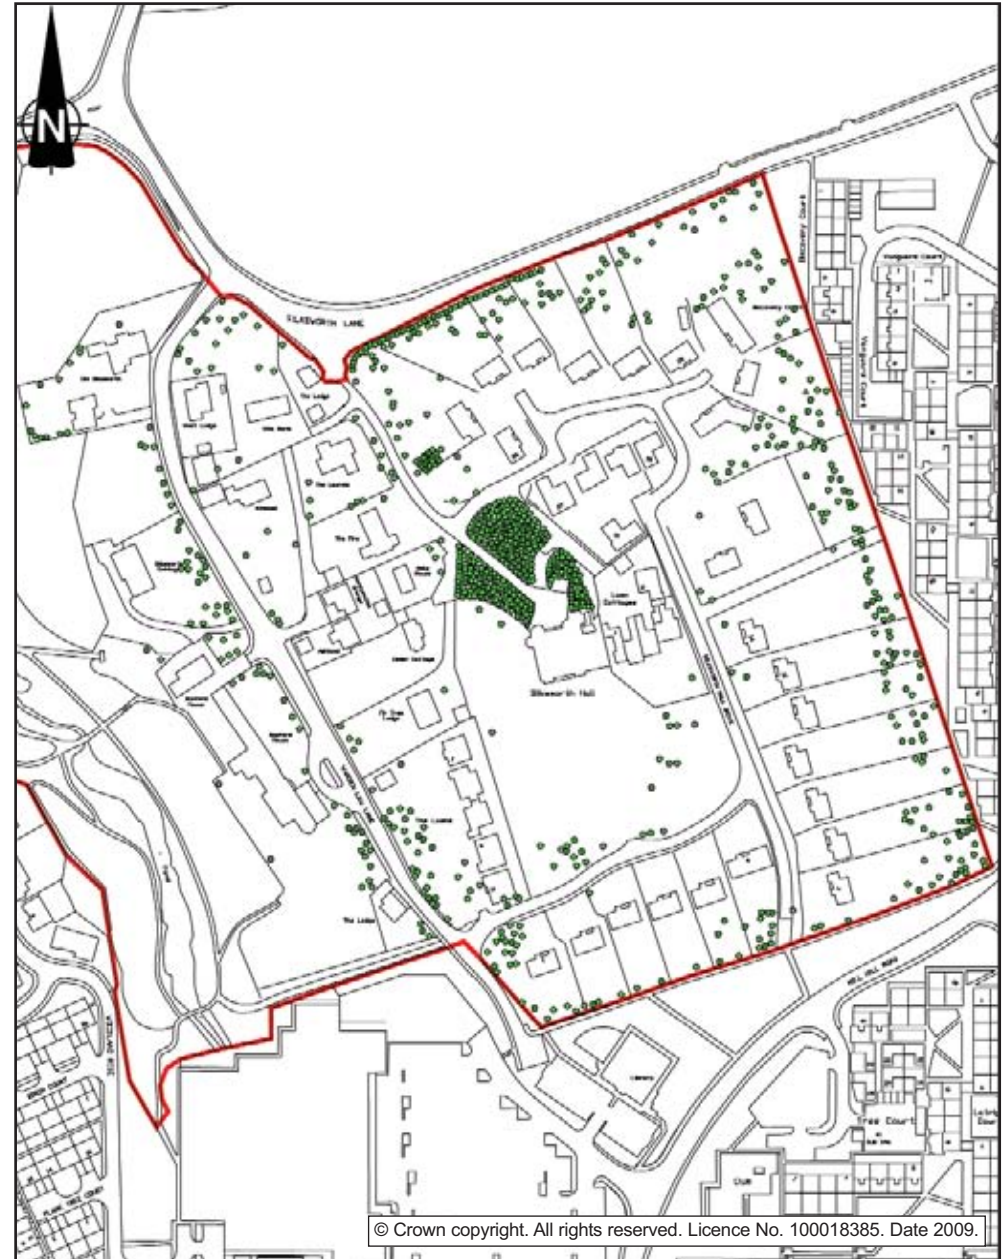
Plan illustrating the location of Tree Preservation Orders in Silksworth Hall Conservation Area - green dots are individual protected trees, green shaded areas are protected copses.

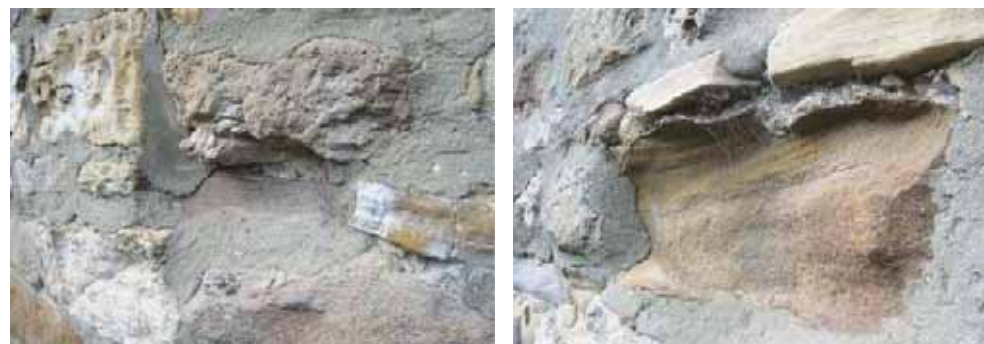
Above: the effects of using too “strong” a mortar - the stone face has eroded behind the level of the surrounding mortar joints, which are left standing proud of the stone

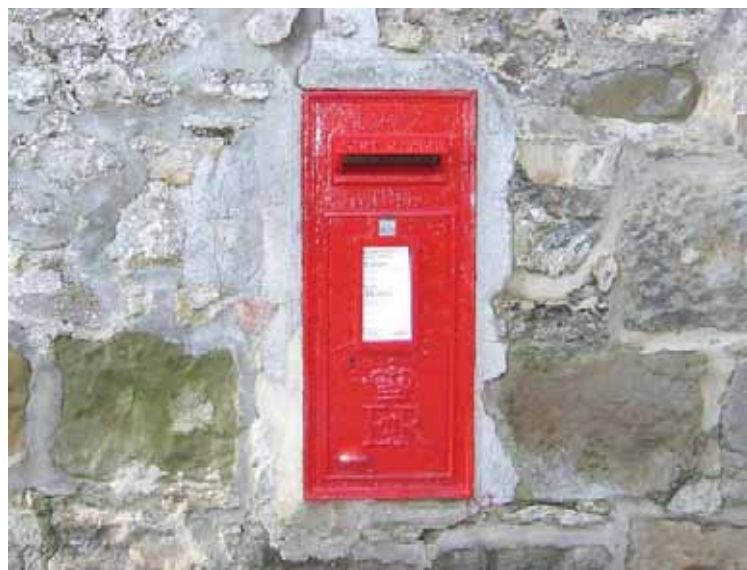
Left: although the post box is a charming and attractive feature of the wall on Warden Law Lane, the way it has been inserted into the wall has resulted in an unsightly area of poorly finished cement mortar, which may also be causing some damage to the surrounding stonework. Note the greenish discolouration on the stone to the bottom left of the post box; this is probably evidence of dampness due to water entering the stone, rather than the adjacent mortar.

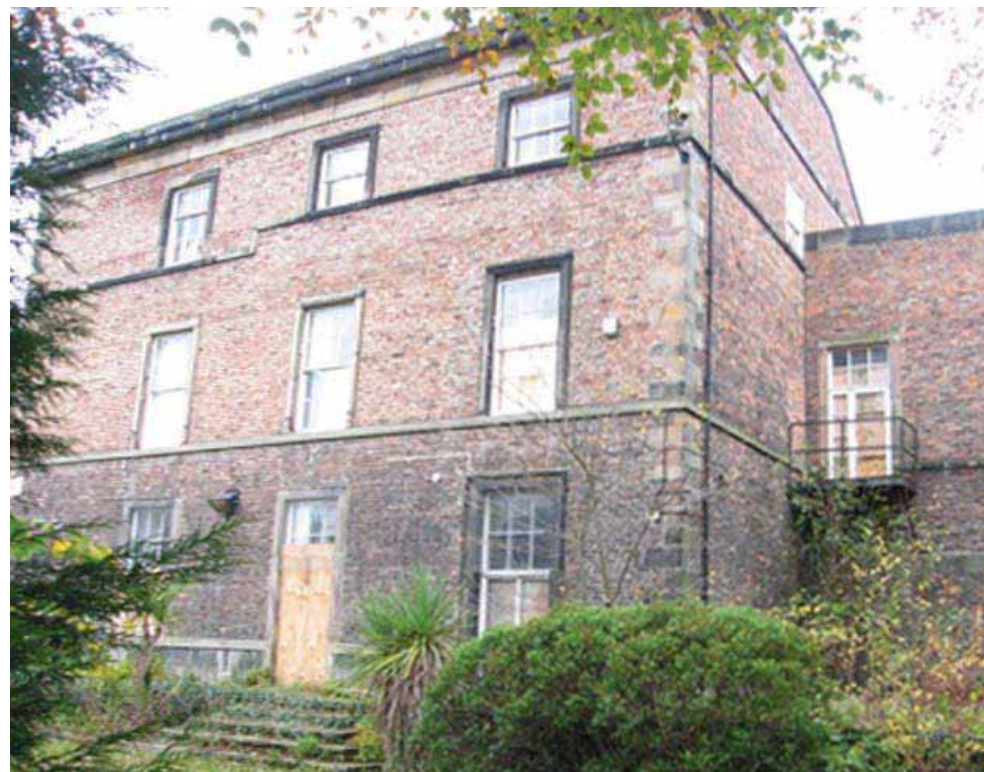
Doxford House October 2009. The building is vacant and deteriorating with doors boarded-up and window panes cracked or missing.

Doxford House is, unfortunately, on the English Heritage Buildings at Risk Register, which states that "the property is vacant and is a target for vandalism despite on-site security systems. The roof over the main house is in a poor state and the resulting leaks are causing internal damage". The House has been registered as grade C, which indicates slow decay with no solution agreed. At the time of writing the building is, however, the subject of a development proposal.
