ASBESTOS SURVEY REPORT FOR BURNSIDE ACADEMY, BURNSIDE ESTATE, HOUGHTON LE SPRING

Asbestos Register for

**BURNSIDE ACADEMY, BURNSIDE ESTATE, HOUGHTON LE
SPRING**

Burnside Academy - Last updated 22/12/2025 – Version 2

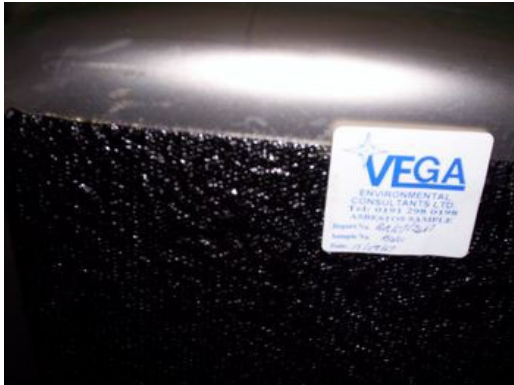
Item 1 Ref: BS/01

The sink pad to the staff room does not contain asbestos.

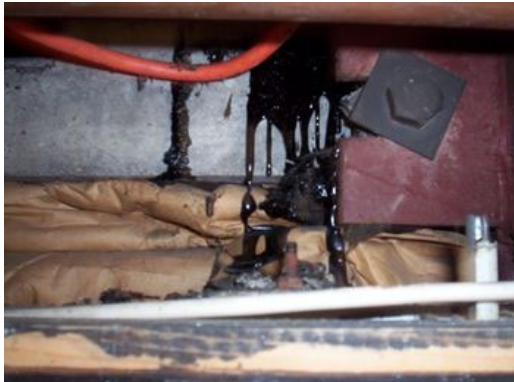
Item 2 - Ref: BS/02

The bitumen overspray to the void above the staff room does not contain asbestos.

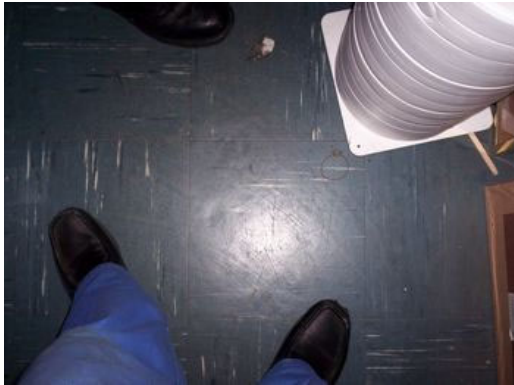
Item 4 - Ref: BS/03

The vinyl floor tile to the Stock Room 1 does not contain asbestos.

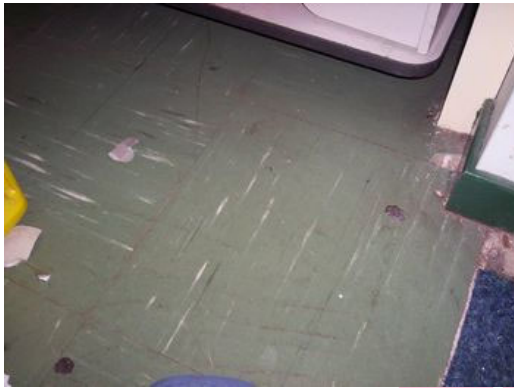
Item 7 - Ref: BS/05

The vinyl floor tiles to the floor of the store room do not contain asbestos.

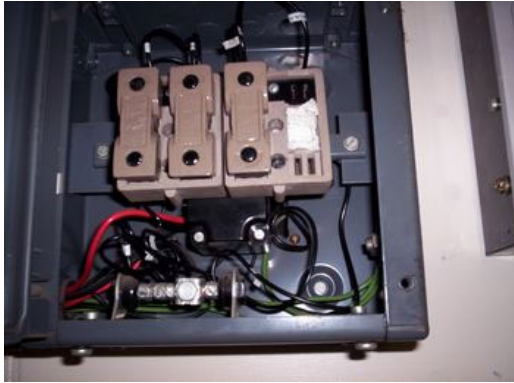
Item 12 - Ref: BS/06

The fuse flash guards to the cloakroom do not contain asbestos.

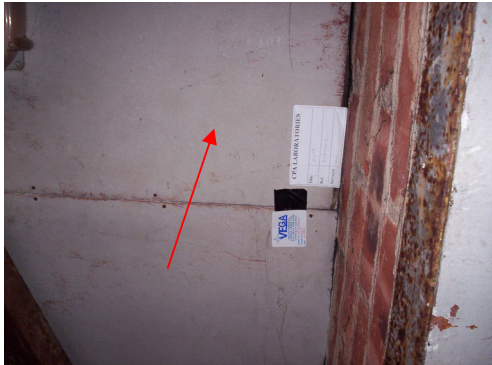
Item 18 – Ref: BS/07

The ceiling panel to the gas house contains asbestos.

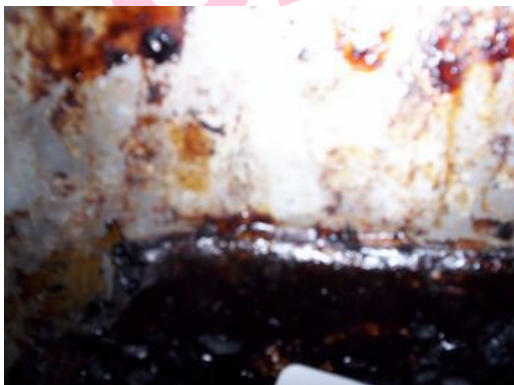
Item 20 – BS/08

The sink pad in the kitchen contains asbestos.

Any change in its appearance should be recorded and passed to Property Services.

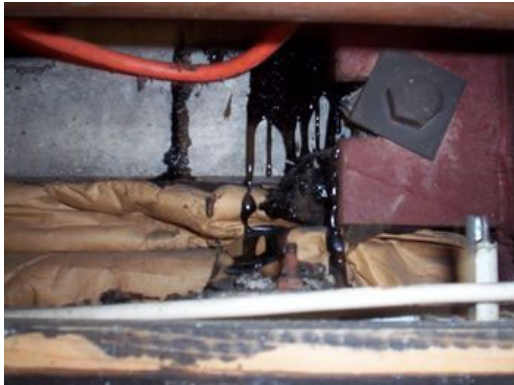
Item 21 – As BS/07

The bitumen overspray in the void above the kitchen does not contain asbestos.

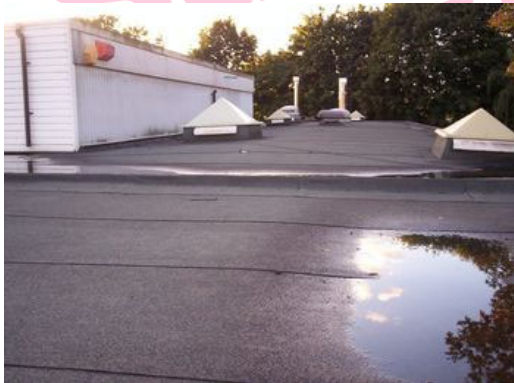
Item 23 – Ref: BS/02

The roof felt to the exterior does not contain asbestos.

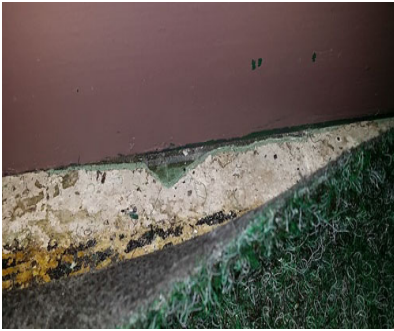
Item 24 – As 78145-1

The remnant floor covering trapped below the heater cabinet in the headteacher office contains asbestos.

Any change in its appearance should be recorded and passed to Property Services.

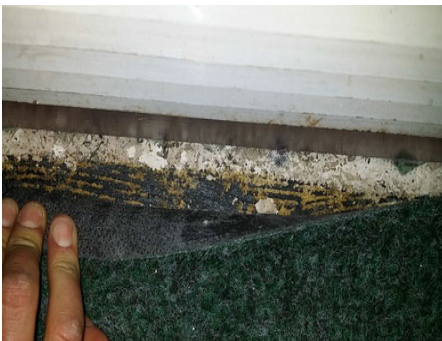
Item 25 – As 78145-2

The remnant floor adhesive to the head teachers office contains asbestos.

Any change in its appearance should be recorded and passed to Property Services.

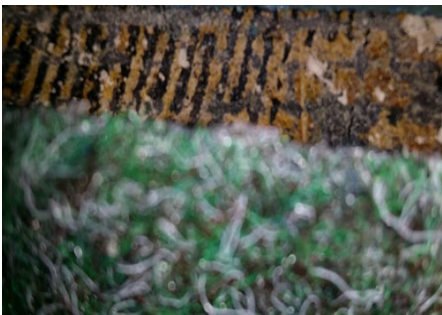
Item 26 – As 78145-2

The remnant floor adhesive in the office contains asbestos.

Any change in its appearance should be recorded and passed to Property Services.

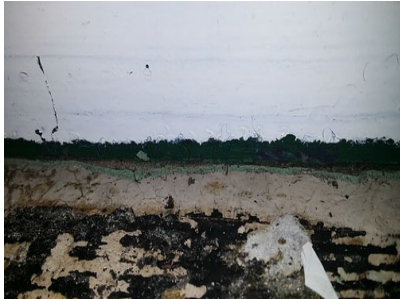
Item 27 – Ref: 78145-1

The remnant floor covering trapped below the heater cabinet in the ICT Room (previously library) contains asbestos.

Any change in its appearance should be recorded and passed to Property Services.

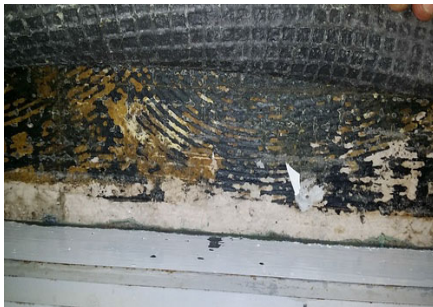
Item 28 – Ref: 78145-2

The remnant floor adhesive to the ICT Room (previously library) contains asbestos.

Any change in its appearance should be recorded and passed to Property Services.

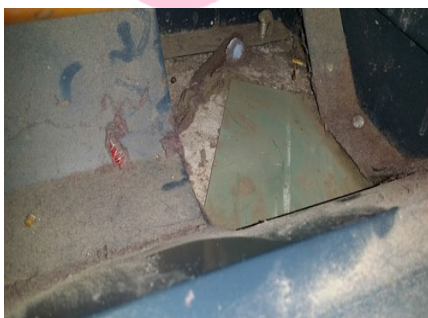
Item 29 – As 78145-1

The remnant floor covering trapped below the heater cabinet in the classroom contains asbestos.

Any change in its appearance should be recorded and passed to Property Services.

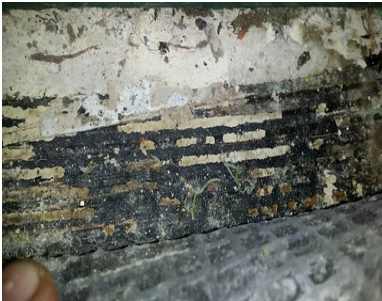
Item 30 – As 78145-2

The remnant floor adhesive to the classroom contains asbestos.

Any change in its appearance should be recorded and passed to Property Services.

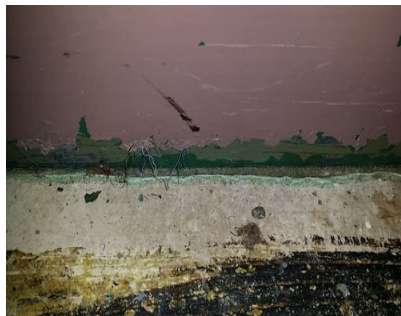
Item 31 – Ref: 78145-1

The remnant floor covering trapped below the heater cabinet in the classroom contains asbestos.

Any change in its appearance should be recorded and passed to Property Services.

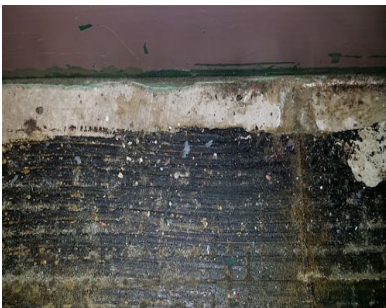
Item 32 – As 78145-2

The remnant floor adhesive to the classroom contains asbestos.

Any change in its appearance should be recorded and passed to Property Services.

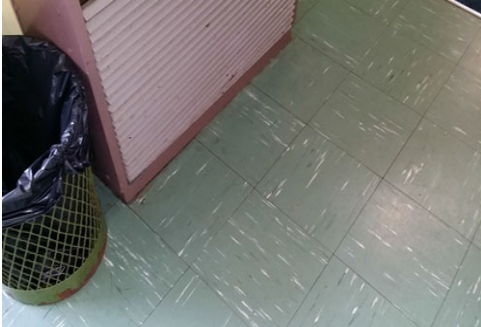
Item 33 – Ref: 78145-3

The remnant floor covering trapped below the heater cabinet in the corridor contains asbestos.

Removed March 2018.

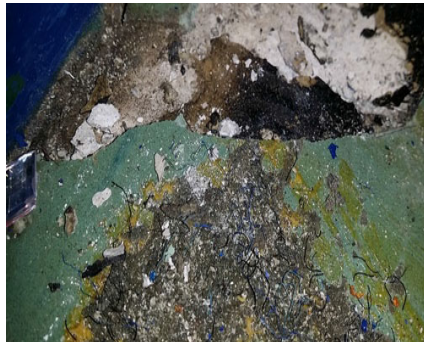
Item 34 – As 78145-2

The remnant floor adhesive to the corridor contains asbestos.

Removed March 2018.

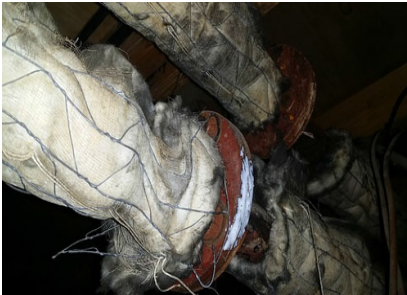
Item 37 – Ref: 78145-5

The flange gaskets to the pipework in the ceiling void to the corridor contain asbestos.

Any change in its appearance should be recorded and passed to Property Services.

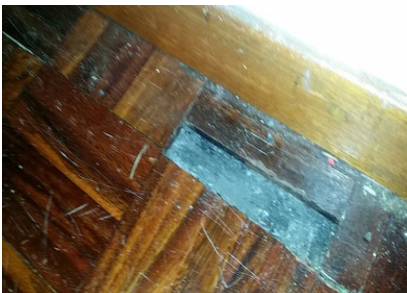
Item 38 – Ref: 78145-7

The adhesive to the wood parquet flooring in the hall does not contain asbestos.

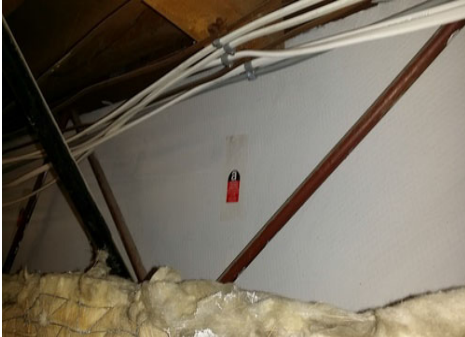
Item 39 – Ref: 78145-8

The fire break to the North West wall in the hall (ceiling void) contains asbestos.

Any change in its appearance should be recorded and passed to Property Services.

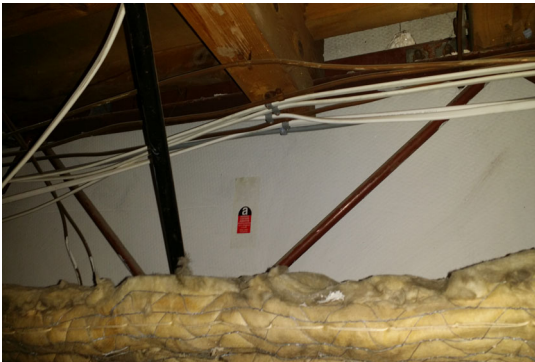
Item 40 – Ref 139157-1

The insulation to the WC ceiling void contains asbestos.

Any change in its appearance should be recorded and passed to Property Services.

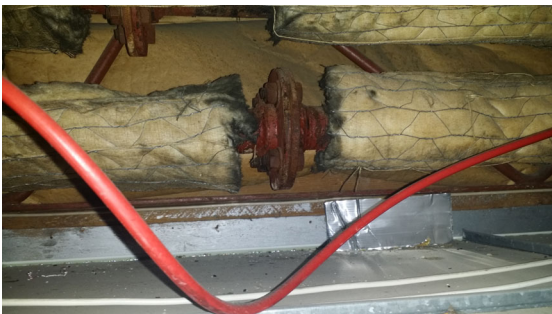
Item 41 – Ref Presumed

The gasket to the pipework in the void above the kitchen is presumed to contain asbestos.

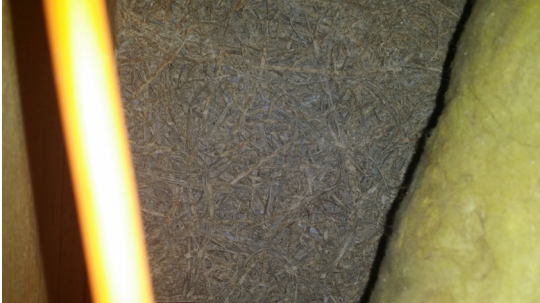
Item 42 – Ref: 139157-2

The insulation board to the void above the corridor does not contain asbestos.

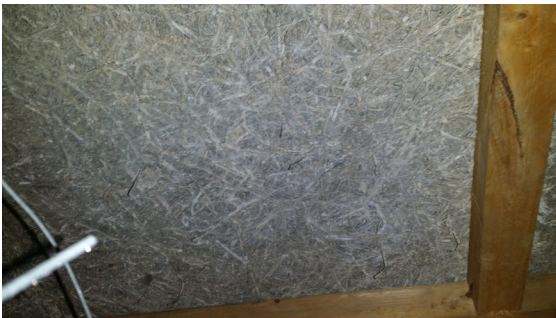
Item 43 – Ref As 139157-2

The insulation board to the void above the staff room does not contain asbestos.

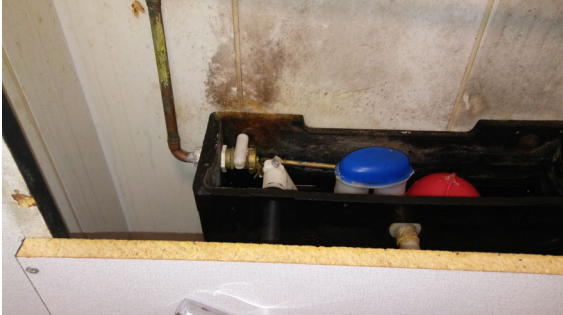
Item 45 – Ref: 271309-2

The toilet cistern in the kitchen staff toilet and cloakroom (Room 006b) contains asbestos.

Any change in its appearance should be recorded and passed to Property Services.

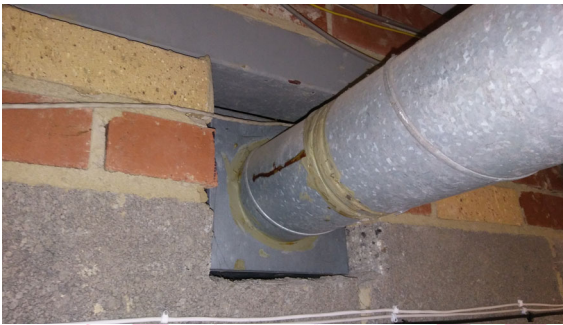
Item 46 – Ref: 303561-1

The sealant to the ductwork in the KS2 Boiler Room (Room 028) does not contain asbestos.

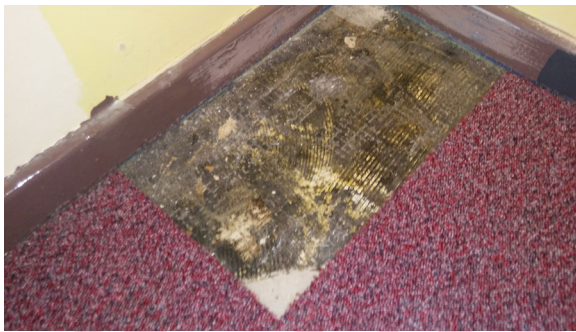
Item 49 – Ref: 345636-1

The remnant adhesive to the floor in classroom (room 020) does contain asbestos.

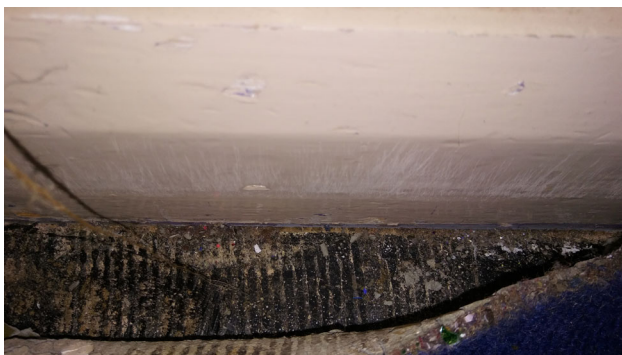
Item 53 – Ref: 345636-2

The remnant adhesive to the floor in classroom (room 029) does contain asbestos.

Any change in appearance should be reported to Property Services.

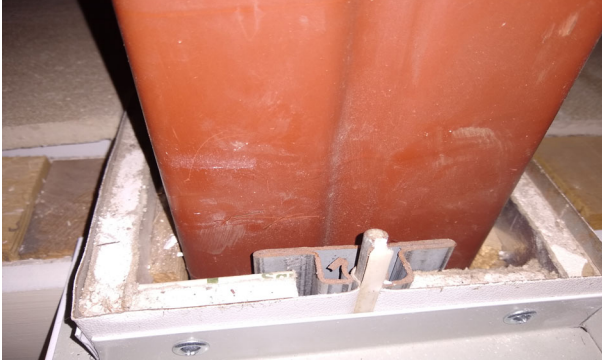
Item 54 – Ref: As 366050-2

The lining to column in classroom (Rm 020) void above suspended ceiling does not contain asbestos.

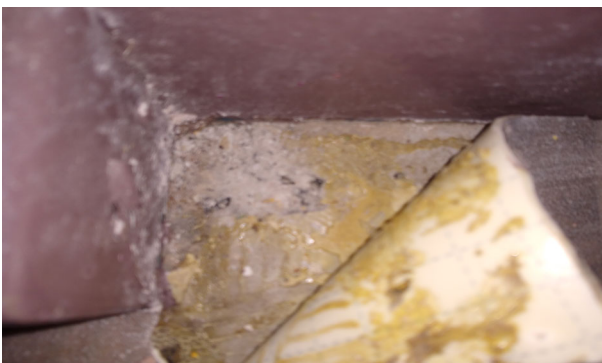
Item 56 – Ref: 366050-1

The remnant adhesive to the floor in corridor (room 021) does contain asbestos.

(Screeded over Oct 22 – But residual still in place)

Any change in appearance should be reported to Property Services.

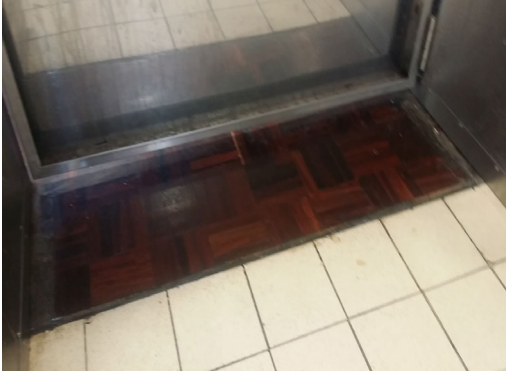
Item 60 – Ref: 209851-2

The bitumen underside of wooden parquet and concrete floor in adj hall in Kitchen (Room 001) does not contain asbestos.

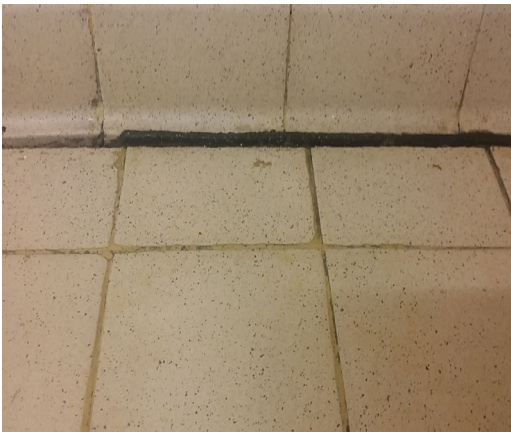
Item 61 – Ref: 209851-1

The filer to floor covering edges in the kitchen (Room 001) does not contain asbestos.

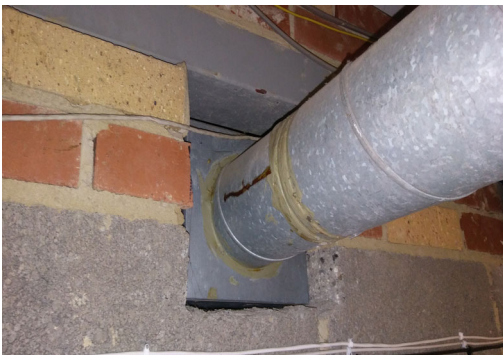
Item 62 – Ref: 303561-1

The sealant to ductwork in the KS2 boiler room (Room 028) does not contain asbestos.

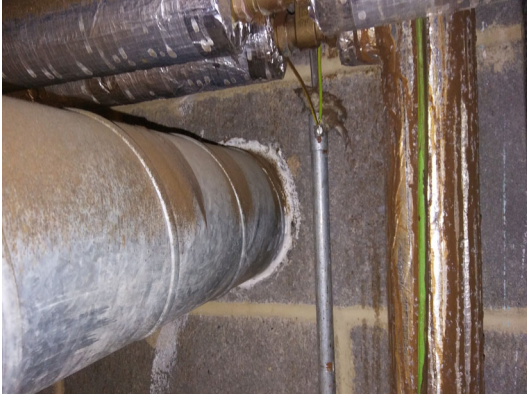
Item 63 – Ref: 303561-2

The packing to ductwork penetration to wall in the KS2 boiler house (Room 028) does not contain asbestos.

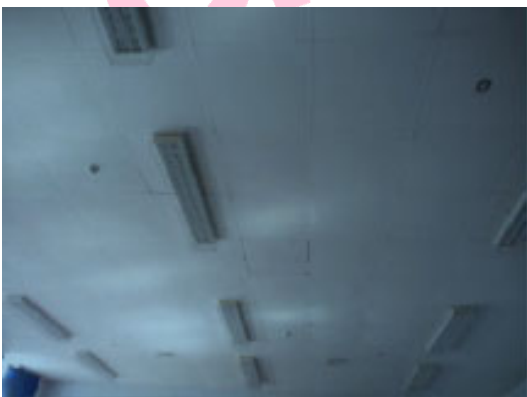
Item 65 – Ref: AS006336

The debris beyond ceiling tiles in the assembly Hall/R2 does not contain asbestos.

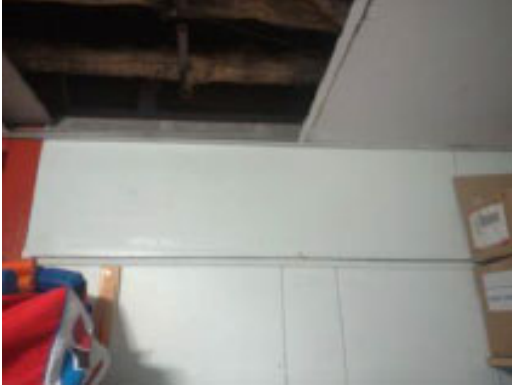
Item 66 – Ref: AS006369

The panel to the wall in the Hall Store Room/R5 does not contain asbestos.

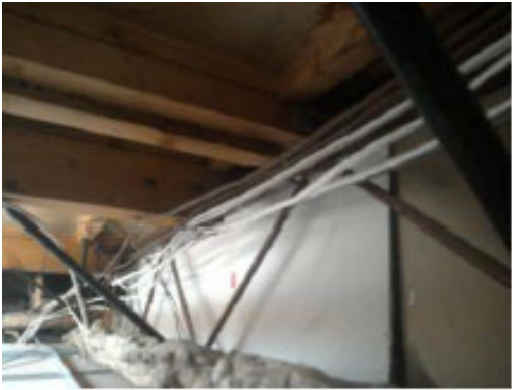
Item 67 – Ref: AS006370

The fire break within ceiling void in the Nursery Classroom/R6 does contain asbestos.

No access to this area and this must be removed if works in this area.

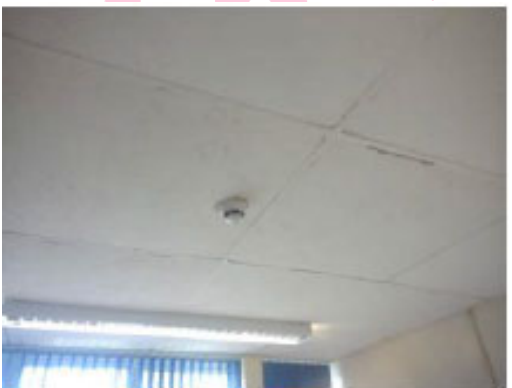
Item 68 – Ref: AS006371

The ceiling tiles in the Office/R1 does not contain asbestos.

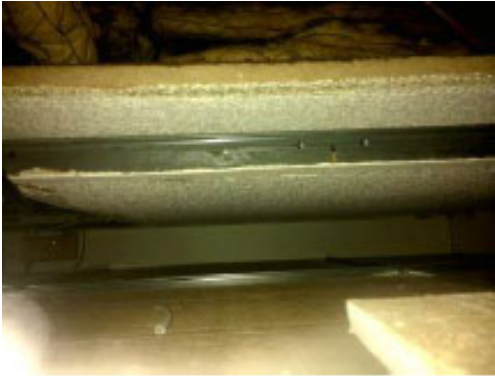
Item 69 – Ref: As AS006371

The ceiling tiles in the Corridor/R1 does not contain asbestos.

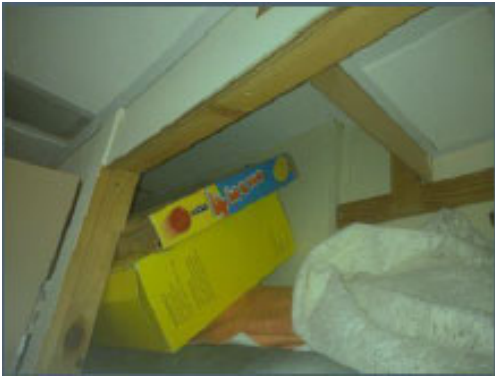
Item 70 – Ref: AS006372

The partition wall in the corridor/R1 does not contain asbestos.

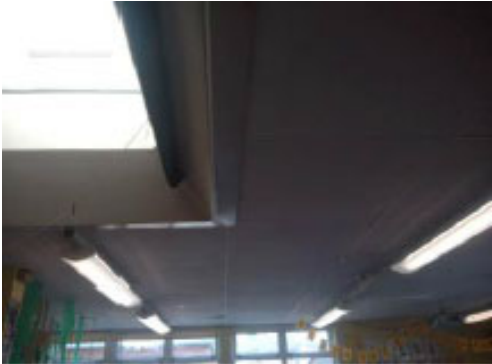
Item 72 – Ref: As AS006373

The ceiling tiles in the Classroom/R4 does not contain asbestos.

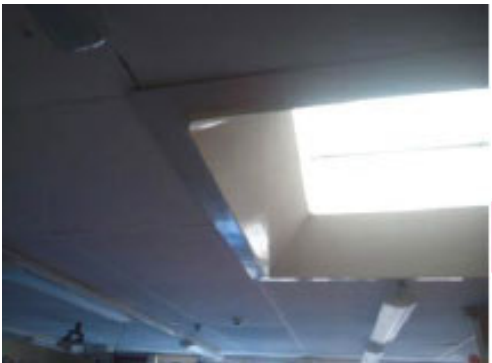
Item 73 – Ref: As AS006373

The ceiling tiles Classroom/R4 does not contain asbestos.

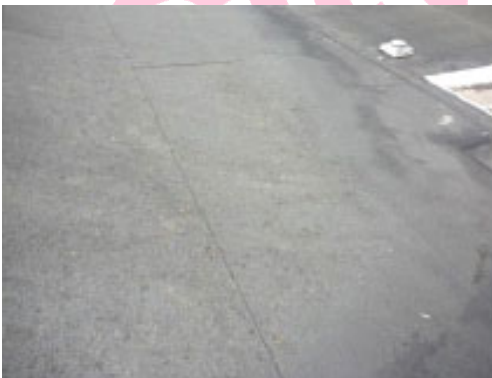
Item 74 – Ref: AS006329

The felt to flat roof (External/R2) does not contain asbestos.

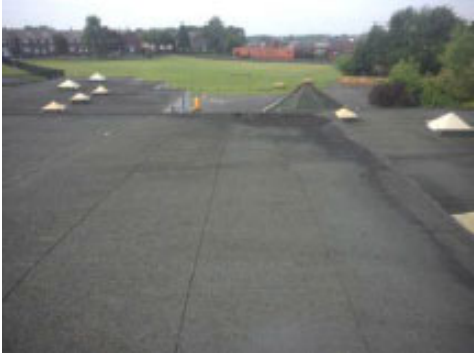
Item 75 – Ref: AS006330

The felt to flat roof (External/R2) does not contain asbestos.

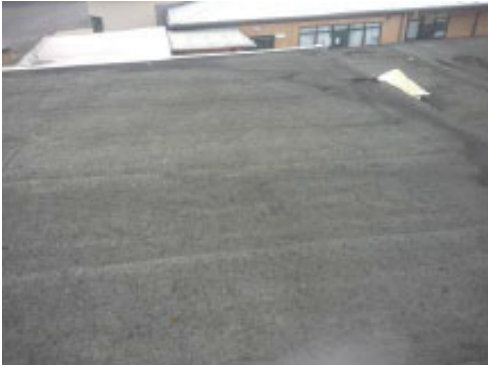
Item 76 – Ref: AS006331

The felt to flat roof (External/R2) does not contain asbestos.

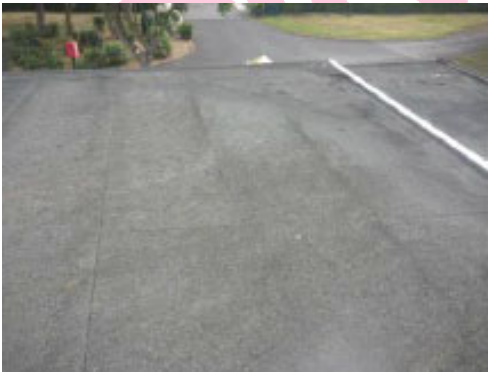
Item 77 – Ref: AS006332

The felt to flat roof (External/R2) does not contain asbestos.

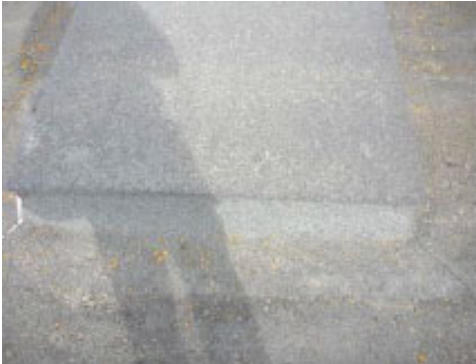
Item 78 – Ref: AS006333

The felt to flat roof hatch (External/R2) does not contain asbestos.

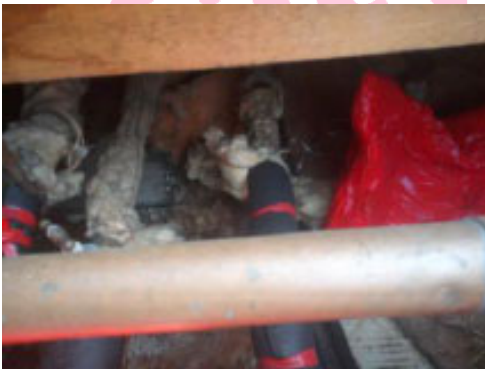
Item 80 – Ref: AS006335

The insulation to pipe run within roof hatch (External/R2) does not contain asbestos.

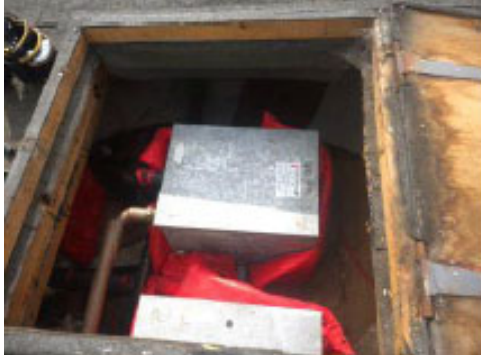
Item 81 – Ref: AS006336

The debris within roof hatch (External/R2) does not contain asbestos.

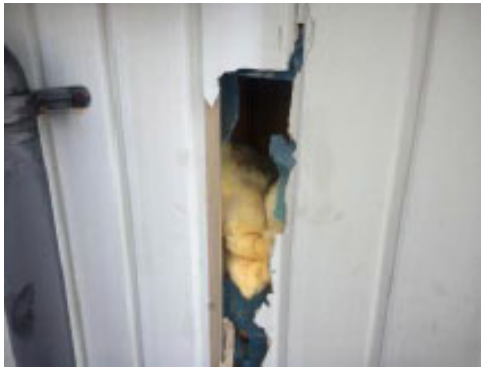
Item 82 – Ref: AS006337

The residue to timber upstand panels behind external plastic cladding (External/R2) does not contain asbestos.

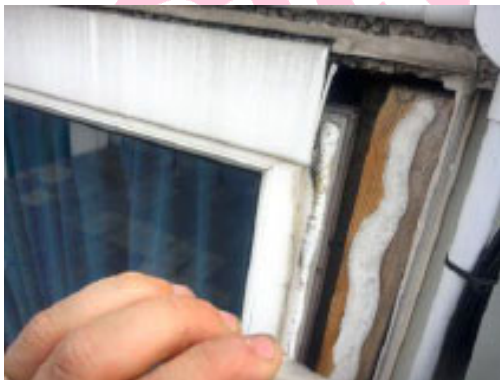
Item 83 – Ref: AS006338

The gal panels behind plastic cladding and PVCU window frames (External/R2) does not contain asbestos.

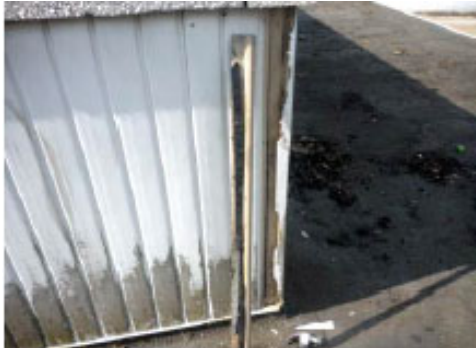
Item 84 – Ref: AS006339

The felt packer to plastic cladding corner piece (External/R2) does not contain asbestos.

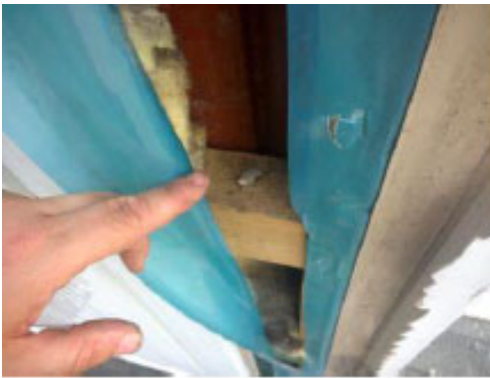
Item 85 – Ref: AS006340

The debris to timber beam behind plastic cladding (External/R2) does not contain asbestos.

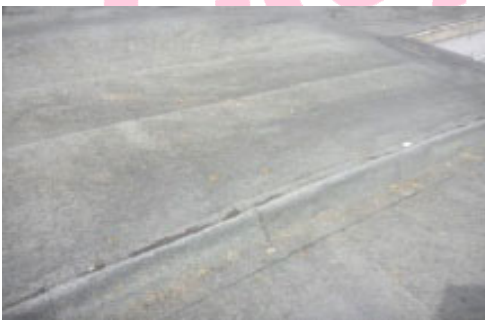
Item 86 – Ref: AS006341

The felt to flat roof (External/R4) does not contain asbestos.

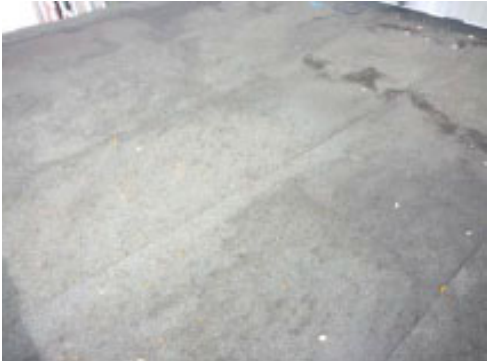
Item 87 – Ref: AS006342

The felt to flat roof (External/R4) does not contain asbestos.

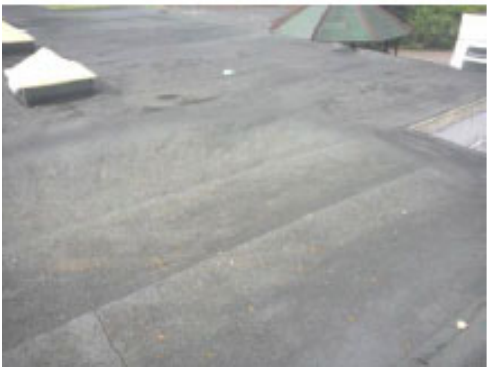
Item 88 – Ref: AS006343

The felt to flat roof (External/R4) does not contain asbestos.

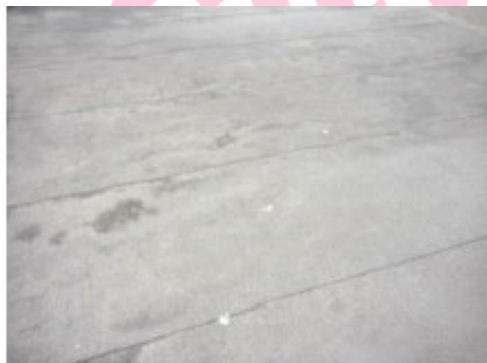
Item 89 – Ref: AS006344

The felt to flat roof (External/R4) does not contain asbestos.

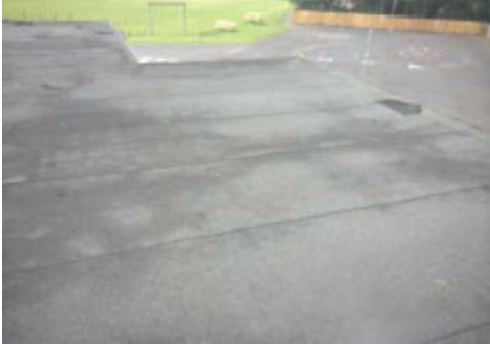
Item 90 – Ref: AS006345

The felt to flat roof
(External/R4) does not contain
asbestos.

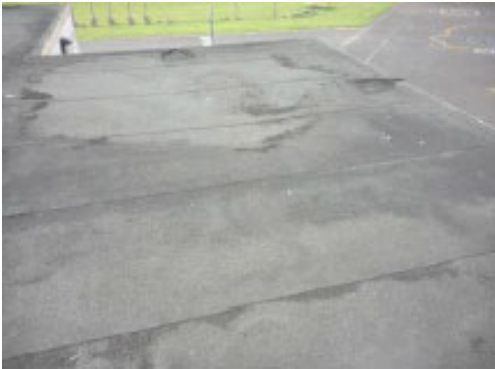
Item 91 – Ref: AS006346

The felt to flat roof
(External/R4) does not contain
asbestos.

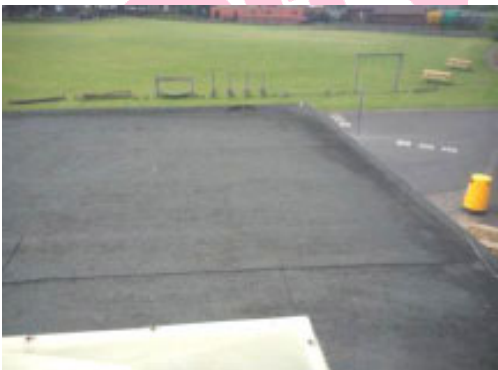
Item 92 – Ref: AS006347

The felt to flat roof
(External/R4) does not contain
asbestos.

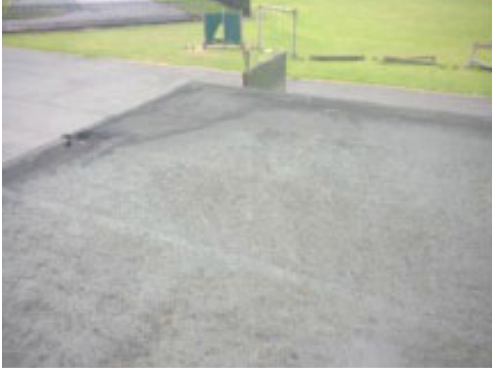
Item 93 – Ref: AS006348

The felt to flat roof
(External/R4) does not contain
asbestos.

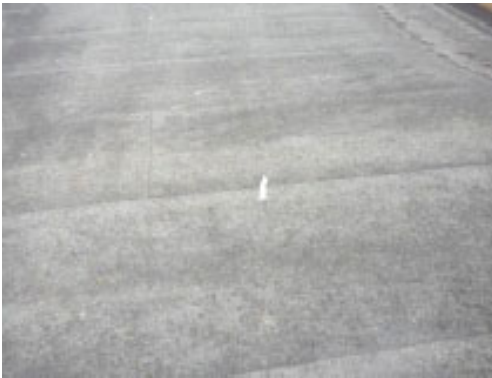
Item 94 – Ref: AS006349

The felt to flat roof
(External/R4) does not contain
asbestos.

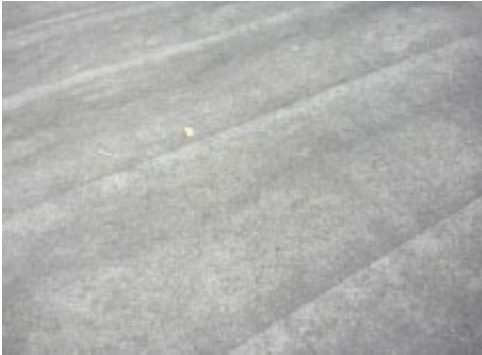
Item 96 – Ref: AS006351

The felt to flat roof (External/R4) does not contain asbestos.

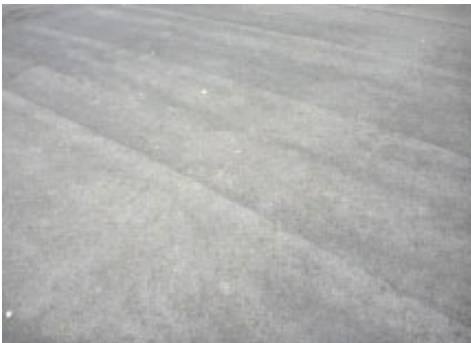
Item 97 – Ref: AS006352

The felt to flat roof (External/R4) does not contain asbestos.

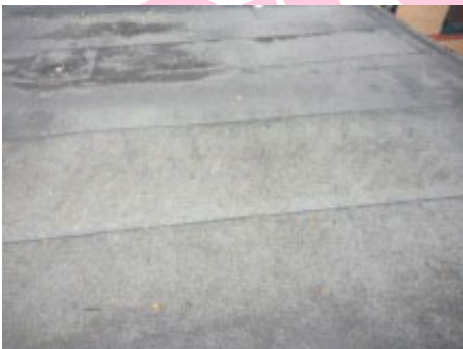
Item 98 – Ref: AS006353

The felt to flat roof (External/R4) does not contain asbestos.

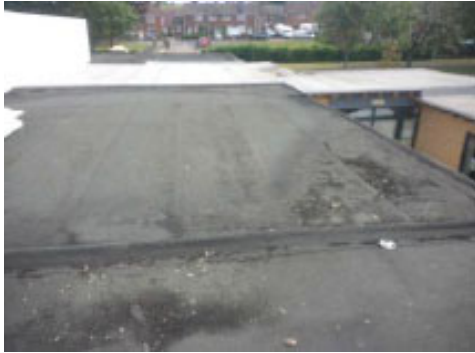
Item 99 – Ref: AS006354

The felt to flat roof (External/R4) does not contain asbestos.

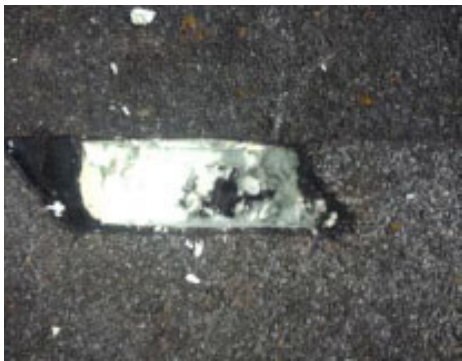
Item 100 – Ref: AS006355

The felt to flat roof (External/R4) does not contain asbestos.

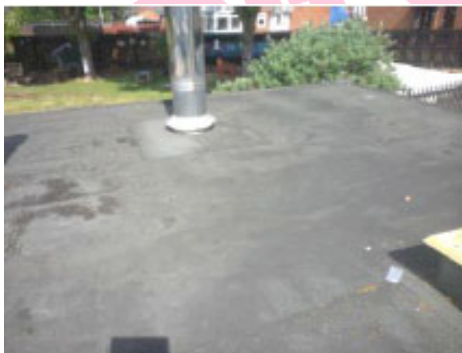
Item 101 – Ref: AS006356

The felt to flat roof (External/R1) does not contain asbestos.

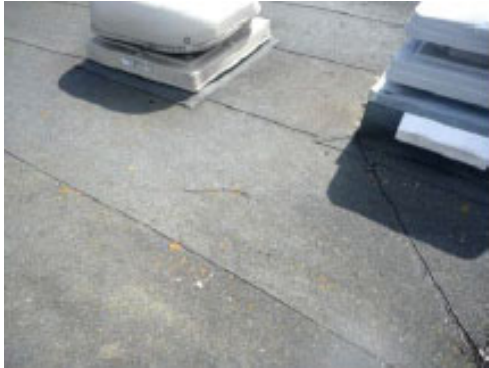
Item 102 – Ref: AS006357

The felt to flat roof
(External/R1) does not contain
asbestos.

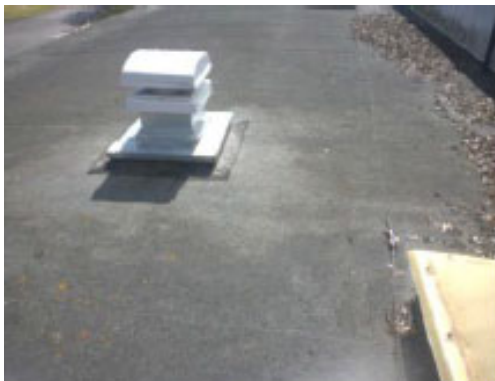
Item 103 – Ref: AS006358

The felt to flat roof
(External/R1) does not contain
asbestos.

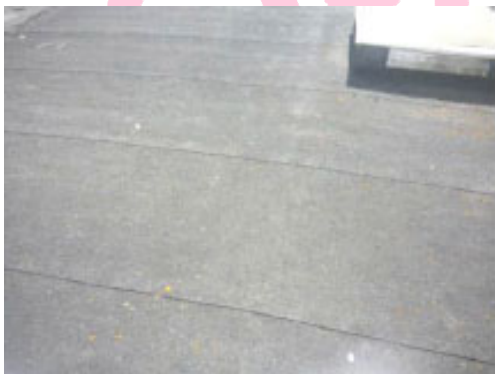
Item 104 – Ref: AS006359

The felt to flat roof
(External/R1) does not contain
asbestos.

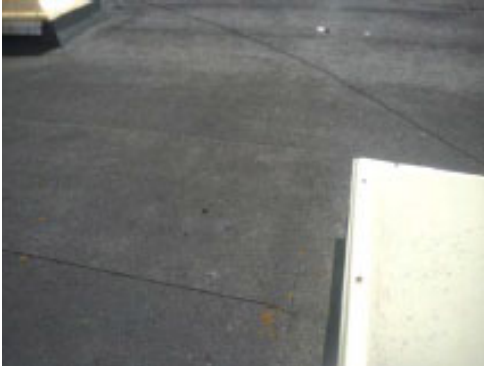
Item 105 – Ref: AS006360

The felt to flat roof (External/R1) does not contain asbestos.

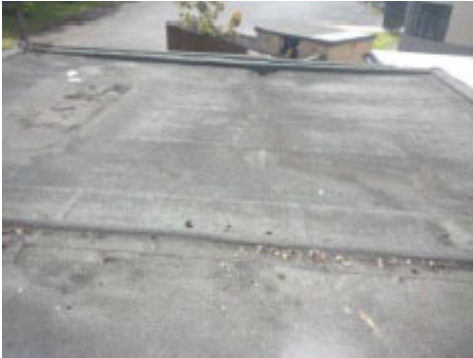
Item 106 – Ref: AS006361

The felt to flat roof (External/R1) does not contain asbestos.

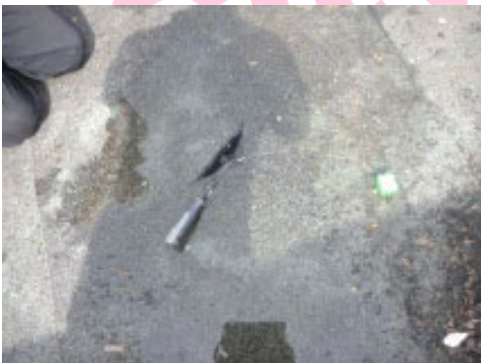
Item 107 – Ref: AS006362

The felt to flat roof (External/R5) does not contain asbestos.

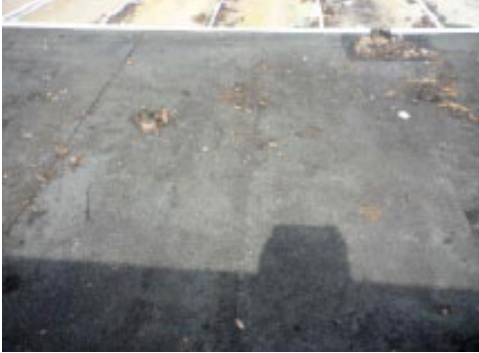
Item 108 – Ref: AS006363

The bitumen base layer between timber and foam (External/R5) does not contain asbestos.

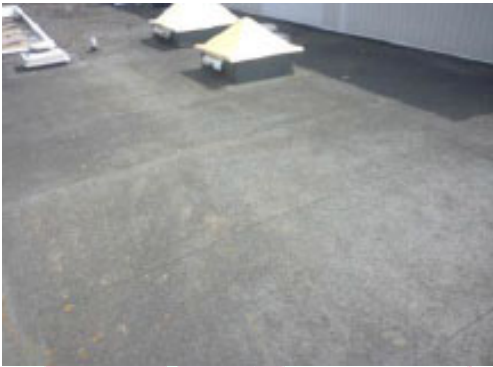
Item 109 – Ref: AS006364

The felt to flat roof (External/R6) does not contain asbestos.

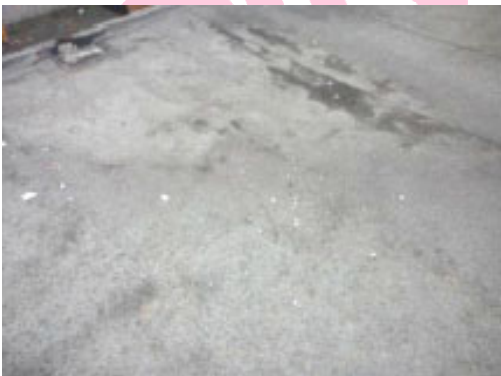
Item 110 – Ref: AS006365

The felt to flat roof (External/R6) does not contain asbestos.

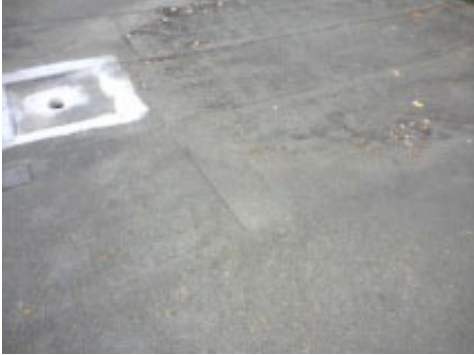
Item 111 – Ref: AS006366

The felt to flat roof (External/R6) does not contain asbestos.

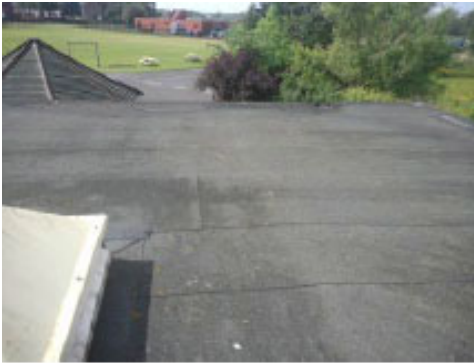
Item 112 – Ref: AS006367

The felt to flat roof (External/R6) does not contain asbestos.

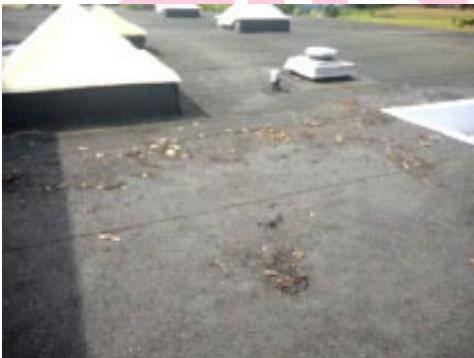
Item 113 – Ref: AS006368

The bitumen to the base layer (External/R6) does not contain asbestos.

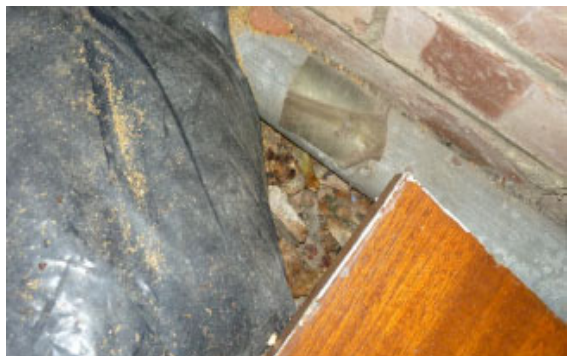
Item 117 – Ref: AW0733/11

The debris to the floor in the gas main room does contain asbestos.

This was removed July 2011.

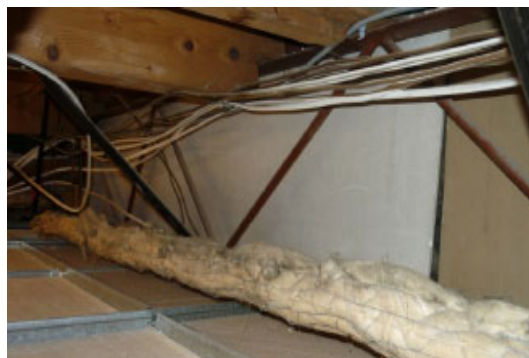
Item 122 – Ref: AW0729/11

The pipework flange gasket in the ceiling void in the office (Rm 011) is presumed to contain asbestos.

Further investigation is required before works should be carried out in this area.

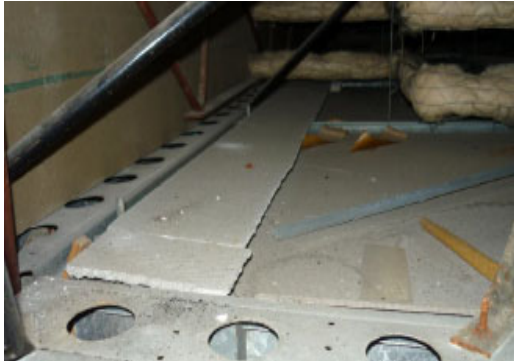
Item 123 – Ref: AW0730/11

The remains of insulation board in the classroom ceiling void (Rm 033) does contain asbestos.

This was removed July 2011.

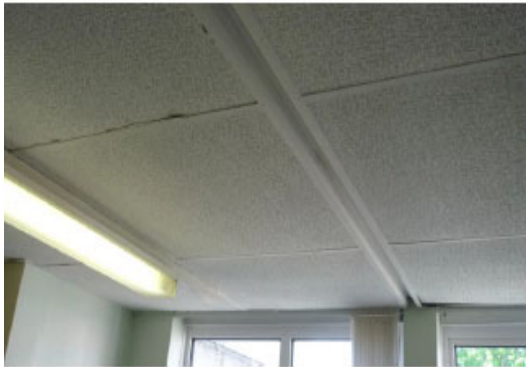
Item 124 – Ref: AW0731/11

The horizontal panel in the corridor (Rm 041) does contain asbestos.

Advised by school – removed 2018 – no WCN paperwork

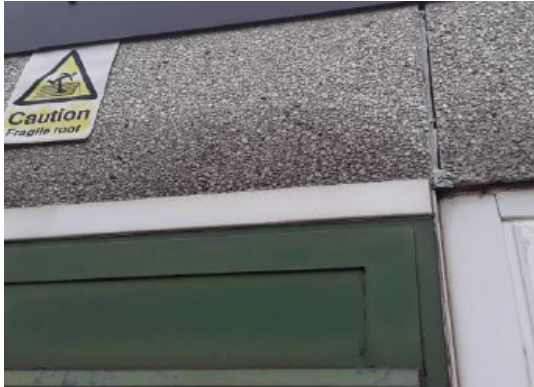
Item 126 – Ref: 21-39203-1

The mastic to concrete panel jointing compound to walls (Area 2/External) does not contain asbestos.

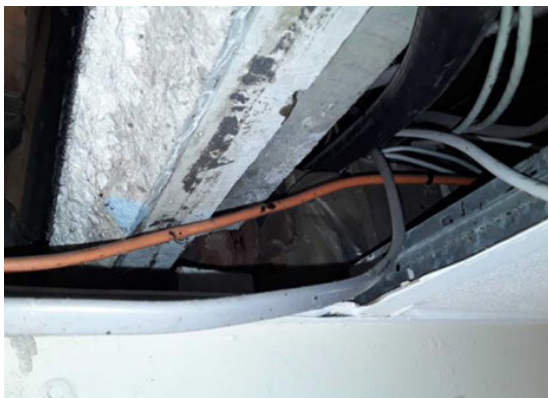
Item 127 – Ref: Presumed

The lining inside clasp columns in the fire exit hallway (Area 5) is presumed to contain asbestos.

Any change in appearance should be reported to Property Services.

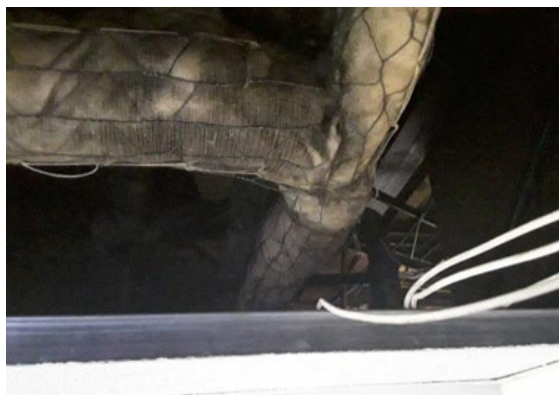
Item 146 – Ref: 22-50659-3

The string wrap to mmmf lagged pipes in the store cupboard (Area 11) does not contain asbestos.

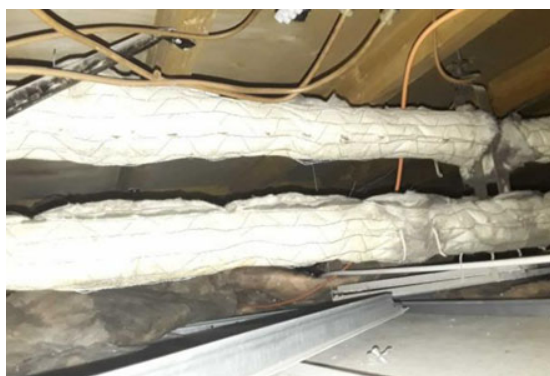
Item 155 – Ref: 22-50659-3

The string wrap to mmmf lagged pipes in the corridor (Area 13) does not contain asbestos.

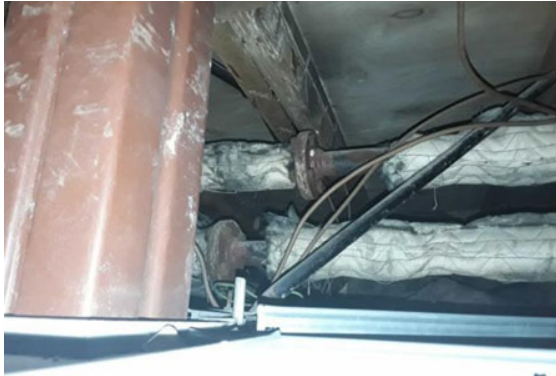
Item 156 – Ref: Presumed

The pipe flanges (gaskets) in the headteachers office (Area 14) is presumed to contain asbestos.

Any change in appearance should be reported to Property Services.

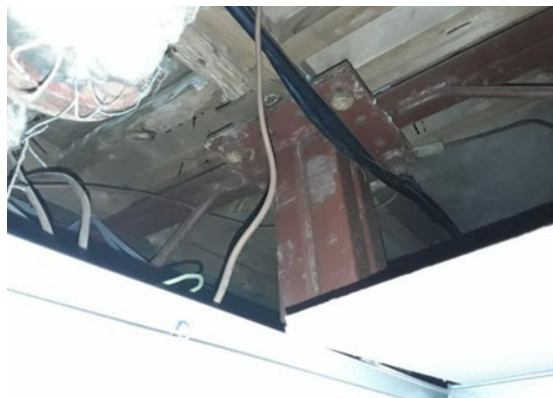
Item 157 – Ref: Presumed

The lining inside clasp columns in the headteachers store cupboard (Area 15) is presumed to contain asbestos.

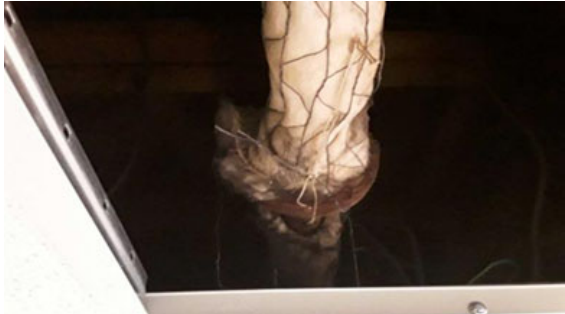
Item 159 – Ref: Presumed

The pipe flanges (gaskets) in the headteachers store (Area 15) is presumed to contain asbestos.

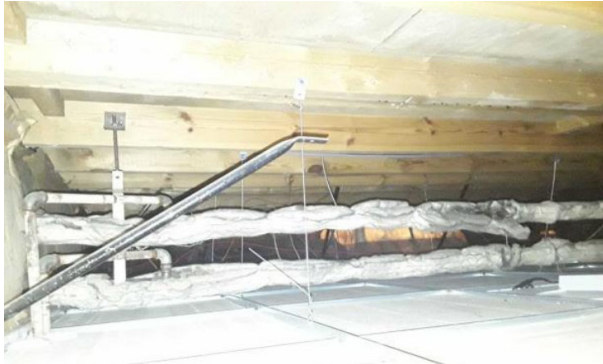
Item 168 – Ref: 22-50659-3

The string wrap to mmmf lagged pipes in the Year 2 Classroom and cupboards (Area 18) does not contain asbestos.

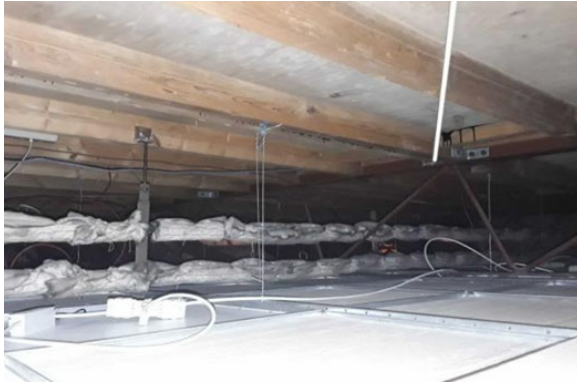
Item 171 – Ref: 22-50659-3

The string wrap to mmmf lagged pipes in the Year 2 Classroom and cupboards (Area 18) does not contain asbestos.

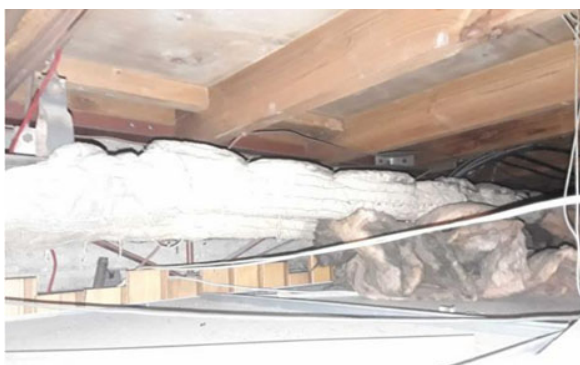
Item 188 – Ref: 22-50659-

The string wrap to mmmf lagged pipes in the hall (Area 27) does not contain asbestos.

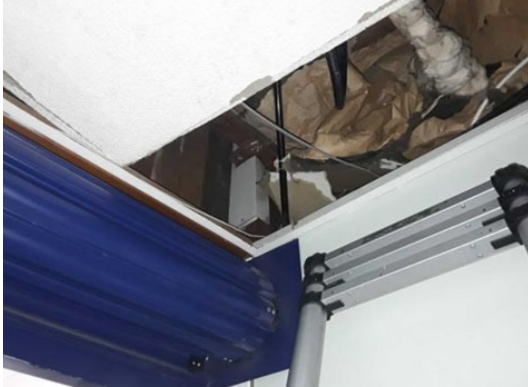
Item 189 – Ref: Presumed

The lining inside clasp columns in the hall store 1 (Area 28) is presumed to contain asbestos.

Any change in appearance should be reported to Property Services.

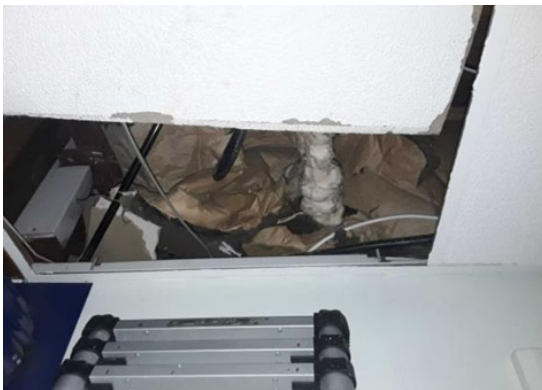
Item 190 – Ref: 22-50659-3

The string wrap to mmmf lagged pipes in the hall store 1 (Area 28) does not contain asbestos.
