### **ASBESTOS SURVEY REPORT FOR FARRINGTON ACADEMY SCHOOL, SUNDERLAND**

### **FARRINGTON ACADEMY SCHOOL, SUNDERLAND**

**Date: 05 June 2025**

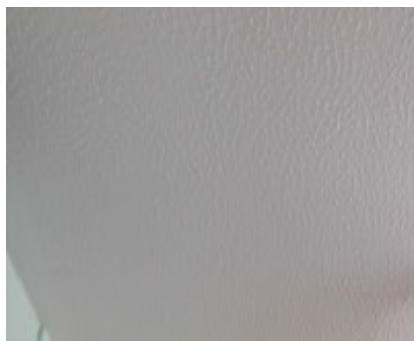
### **Item 1 Ref: 101894-1**

101894-1 – Textured coating (Rm 001) (Item 1) - Low Risk

The textured coating to the ceiling in the lobby of the behaviour unit (Rm 001) contains asbestos.

Any change in its appearance should be recorded and passed to Property Services.

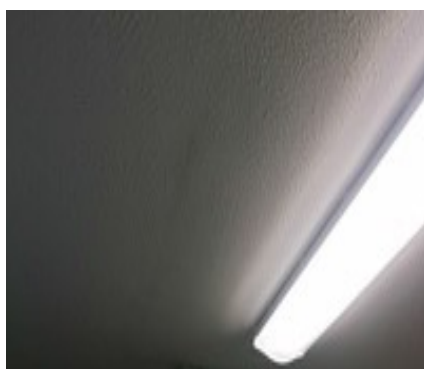
### **Item 2 – As 101894-1**

As 101894-1 – Textured coating (Rm 002) (Item 2) – Very Low Risk

The textured coating to the ceiling in the kitchen (Room 002) contains asbestos.

Any change in its appearance should be recorded and passed to Property Services.

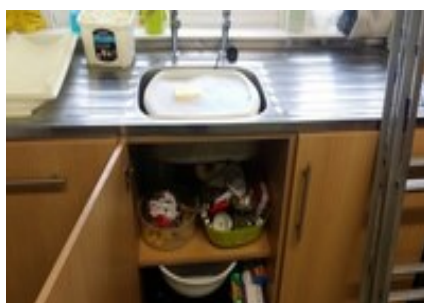
### **Item 3 Ref: 101894-2**

The sink pad to the kitchen the behaviour unit (Rm 002) does not contain asbestos.

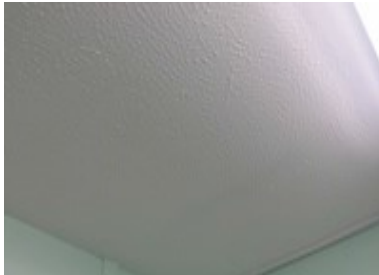
### **Item 4 As: 101894-1**

As 101894-1 – Textured coating (Rm 003) (Item 4) – Low Risk

The textured coating to the ceiling in the toilet of the behaviour unit (Rm 003) contains asbestos.

Any change in its appearance should be recorded and passed to Property Services.

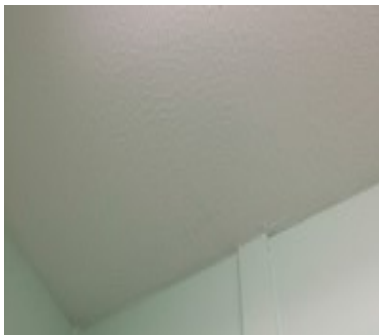
### **Item 5 As: 101894-1**

The textured coating to the ceiling in the staff toilet of the behaviour unit (Rm 004) contains asbestos.

*Removed October 2024*

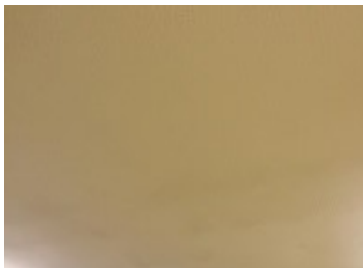
### **Item 6 As: 101894-1**

The textured coating to the ceiling in the classroom of the behaviour unit (Rm 005) contains asbestos.

*Removed October 2024*

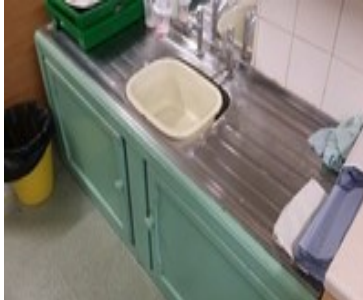
### **Item 7 As: 101894-2**

The sink pad to the classroom of the behaviour unit (Rm 005) does not contain asbestos.

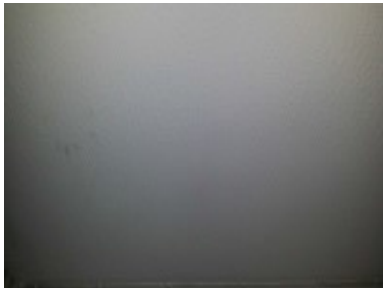
### **Item 8 As: 101894-1**

As 101894-1 – Textured coating (Rm 006) (Item 8) - Very Low Risk

The textured coating to the ceiling in the store cupboard in the behaviour unit (Rm 006) contains asbestos.

Any change in its appearance should be recorded and passed to Property Services.

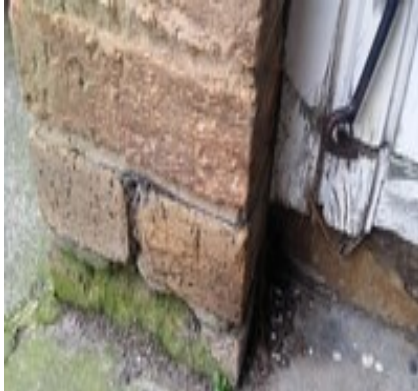
### **Item 13 Ref: 101894-5**

101894-5 – Damp proof course (External) (Item 13) - Very Low Risk

The damp proof course to the behaviour unit (External) contains asbestos.

Any change in its appearance should be recorded and passed to Property Services.

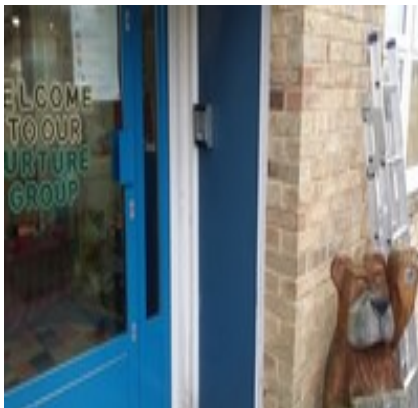
### **Item 14 Ref: 101894-6**

101894-6 – Panels to side of door (External) (Item 14) - Very Low Risk

The panels to the side of the door to the behaviour unit (External) contain asbestos.

Any change in its appearance should be recorded and passed to Property Services.

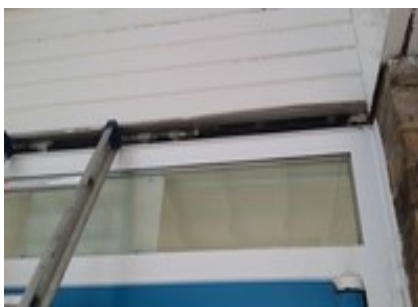
### **Item 15 Ref: 101894-7**

The membrane behind the fascia to the external of the behaviour unit does not contain asbestos.

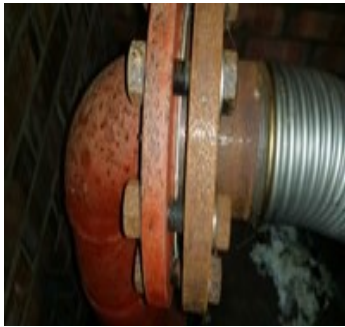
### **Item 16 Ref: 101894-8**

The flange gasket to the pipework in the gas meter house does not contain asbestos.

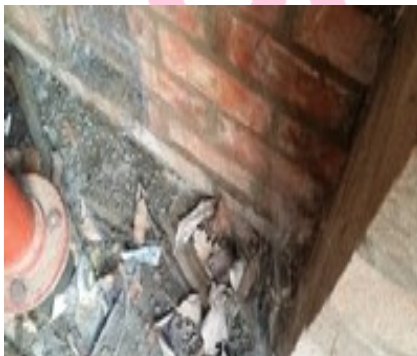
### **Item 18 Ref: 101894-10**

The damp proof course to the gas meter house does not contain asbestos.

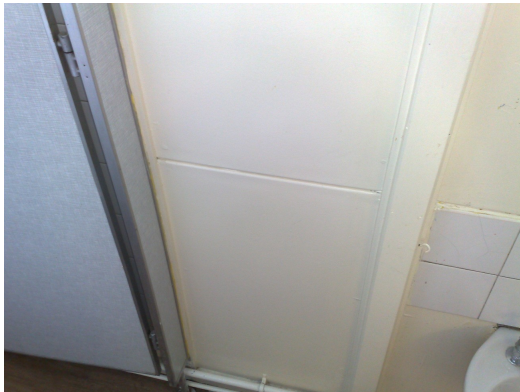
**Item 146 Ref: KR09/76**

The wall panels in the Behaviour Unit do not contain asbestos.

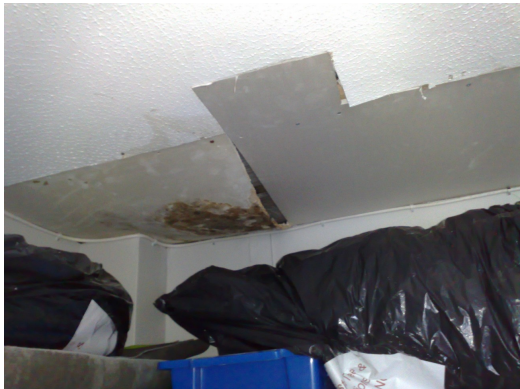
**Item 147 Ref: KR09/78**

The ceiling panels in the Behaviour Unit do not contain asbestos.

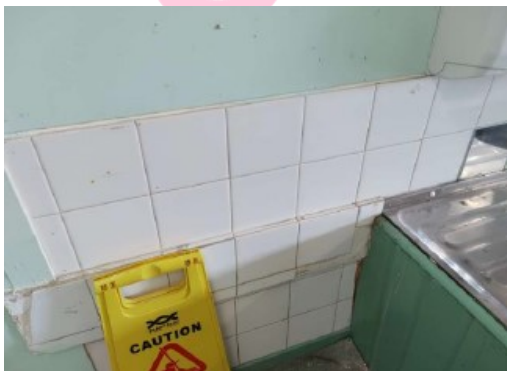
**Item 157 Ref: 21-34101-2**

The adhesive behind ceramic tiles (Area 1/Main Room) does not contain asbestos.

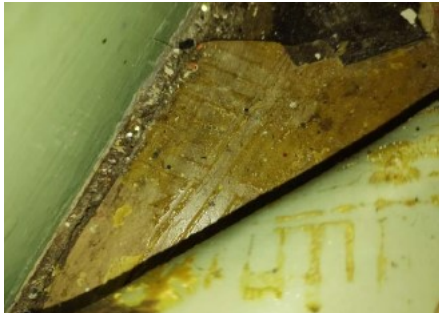
### **Item 158 Ref: 21-34101-3**

21-34101-3 – Brown vinyl floor tile (Area 1/Main Room) (Item 158) – Low Risk

The brown vinyl floor tile (Area 1/Main Room) contains asbestos.

Any change in its appearance should be recorded and passed to Property Services.

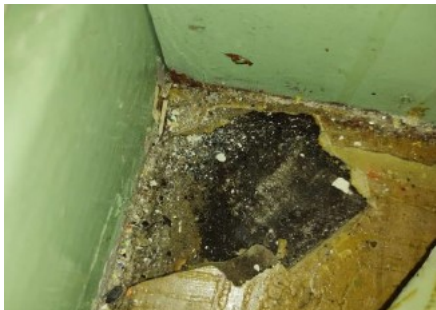
### **Item 159 Ref: 21-34101-4**

The composite floor (Area 1/Main Room) does not contain asbestos.

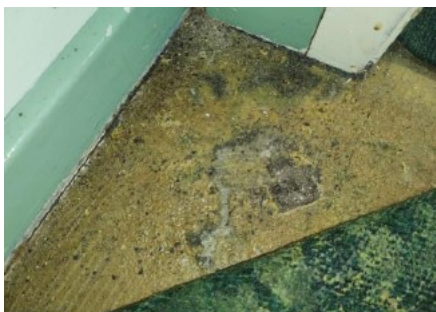
### **Item 160 Ref: 21-34101-4**

The composite floor (Area 2/Back Office) does not contain asbestos.

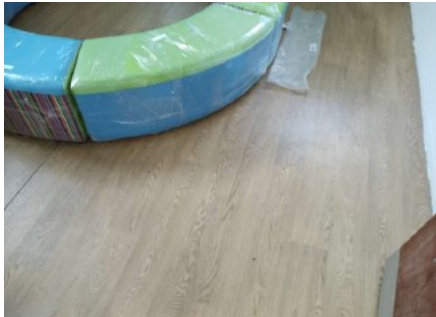
### **Item 161 Ref: 21-34101-4**

The composite floor (Area 3/Side Office) does not contain asbestos.

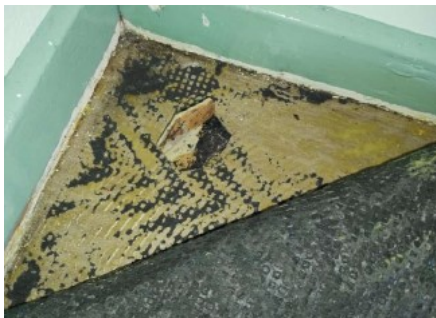
### **Item 162 Ref: 21-34101-4**

The composite floor (Area 4/Entrance Lobby) does not contain asbestos.

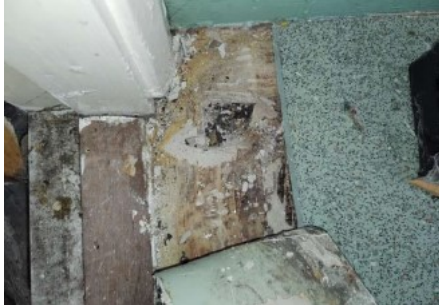
### **Item 164 Ref: 21-34101-6**

21-34101-6 - Beige vinyl floor covering (Area 5/Kitchen) (Item 164) – Low Risk

The beige vinyl floor covering (Area 5/Kitchen) contains asbestos.

Any change in its appearance should be recorded and passed to Property Services.

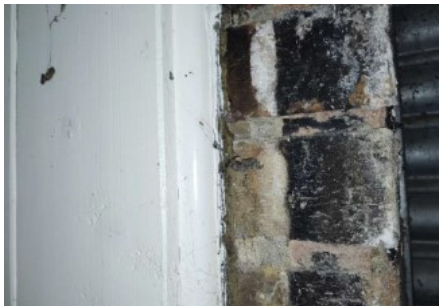
### **Item 165 Ref: 21-34101-8**

The sealant between wood cladding and brickwork (Area 6/Side Lobby) does not contain asbestos.

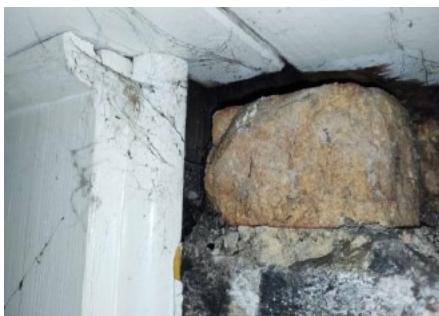
### **Item 166 Ref: 21-34101-9**

The DPC behind brickwork at doorway (Area 6/Side Lobby) does not contain asbestos.

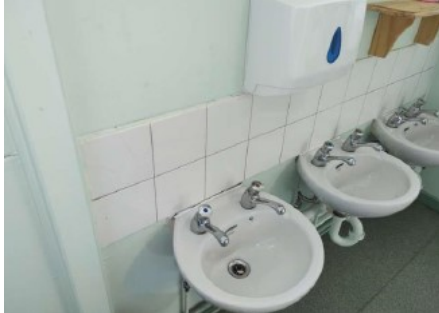
### **Item 167 Ref: 21-34101-10**

The adhesive behind ceramic tiles (Area 7/WC) does not contain asbestos.

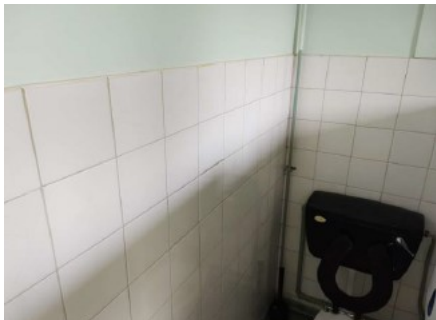
### **Item 168 Ref: 21-34101-10**

The adhesive behind ceramic tiles (Area 7/WC) does not contain asbestos.

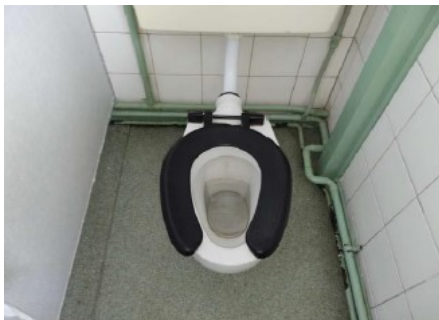
### **Item 169 Ref: 21-34101-11**

The resin toilet seats (Area 7/WC) do not contain asbestos.

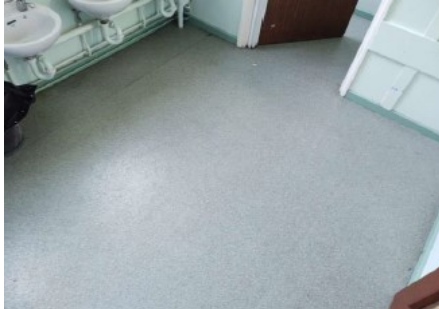
### **Item 170 Ref: 21-34101-4**

The composite floor (Area 7/WC) does not contain asbestos.

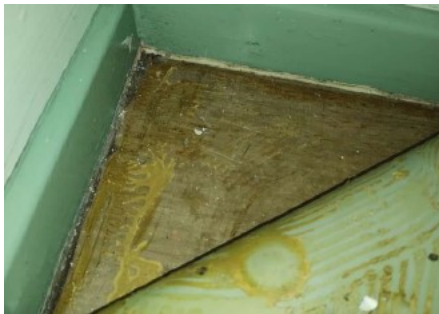
### **Item 171 Ref: 21-34101-6**

21-34101-6 - Beige vinyl floor covering (Area 7/WC) (Item 171) – Low Risk

The beige vinyl floor covering (Area 7/WC) contains asbestos.

Any change in its appearance should be recorded and passed to Property Services.

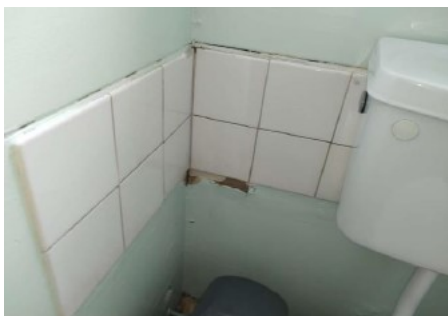
### **Item 172 Ref: 21-34101-10**

The adhesive behind ceramic tiles (Area 8/Staff WC) does not contain asbestos.

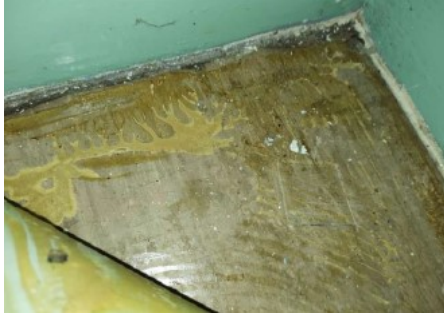
### **Item 173 Ref: 21-34101-6**

21-34101-6 - Beige vinyl floor covering (Area 8/Staff WC) (Item 173) – Low Risk

The beige vinyl floor covering (Area 8/Staff WC) contains asbestos.

Any change in its appearance should be recorded and passed to Property Services.

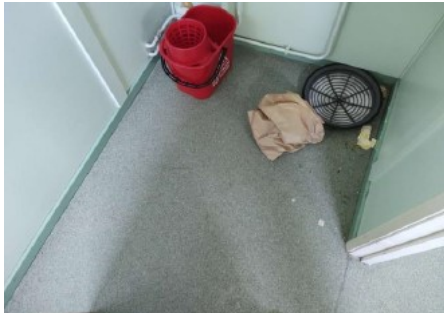
### **Item 174 Ref: 21-34101-4**

The composite floor (Area 8/Staff WC) does not contain asbestos.

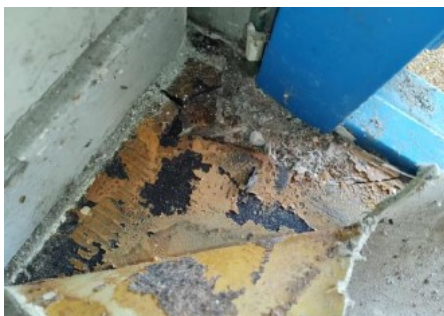
### **Item 175 Ref: 21-34101-4**

The composite floor (Area 9/Boiler Room) does not contain asbestos.

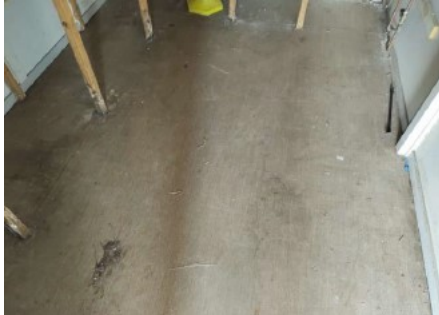
### **Item 176 Ref: 21-34101-6**

21-34101-6 - Beige vinyl floor covering (Area 9/Boiler Room) (Item 176) – Low Risk

The beige vinyl floor covering (Area 9/Boiler Room) contains asbestos.

Any change in its appearance should be recorded and passed to Property Services.

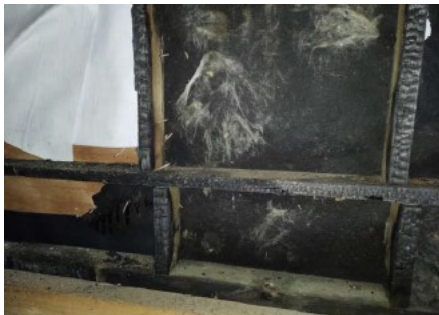
### **Item 177 Ref: 21-34101-12**

The bitumen felt lining to wood walls (Area 10/Ceiling void) does not contain asbestos.

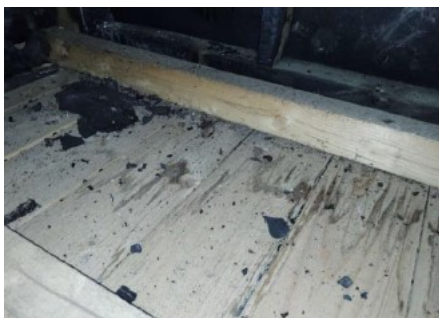
### **Item 178 Ref: 21-34101-12**

The bitumen felt lining to wood walls (Area 10/Ceiling void) does not contain asbestos.

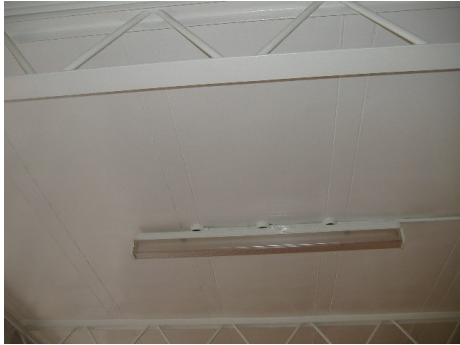
### **Item 19 - Ref: AW0435/08**

The ceiling coating to the lobby (Rm 0/01) does not contain asbestos.

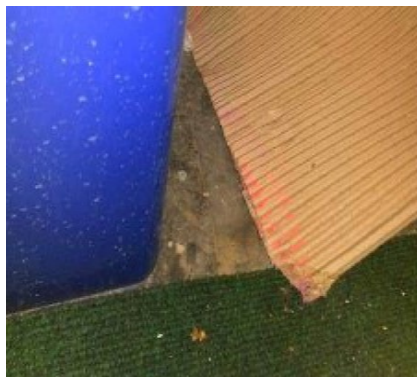
#### **Item 22 - Ref: AW0440/08**

The floor tiles to the fire hose cupboards in the corridor (Rm 0/18) contain asbestos.

Any change in its appearance should be recorded and passed to Property Services.

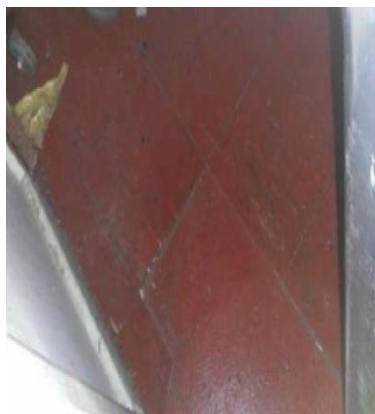
#### **Item 23 - Ref: AW0441/08**

The black floor tiles (painted red) to the store room (Rm 0/25) contain asbestos.

Any change in its appearance should be recorded and passed to Property Services.

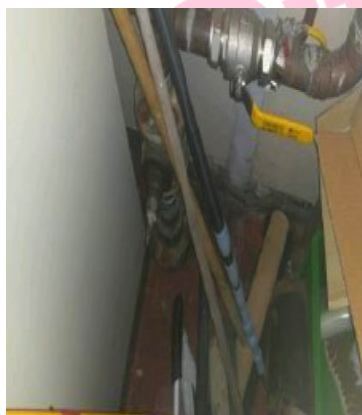
#### **Item 24 - Ref: Presumed**

The gaskets to the pipework in the store room (Rm 0/25) are presumed to contain asbestos.

Any change in its appearance should be recorded and passed to Property Services.

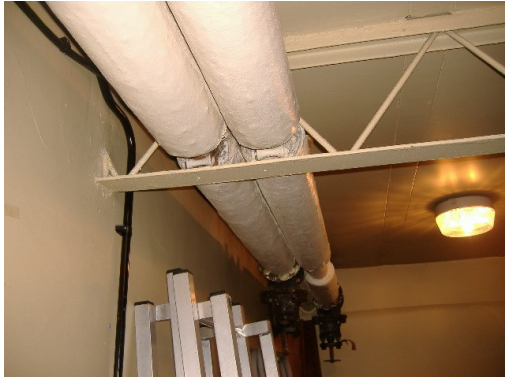
### **Various- Ref: AW0442/08**

The pipework insulation to the store room (Rm 0/43) contains asbestos.

Similar insulation is located in Rm 0/44.

Any change in its appearance should be recorded and passed to Property Services.

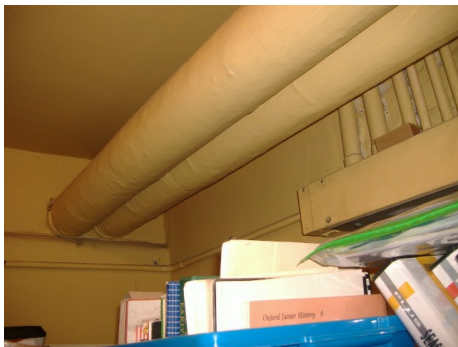
### **Item 27 - Ref: AW0443/08**

The pipework insulation to the store room (Rm 0/45) contains asbestos.

Any change in its appearance should be recorded and passed to Property Services.

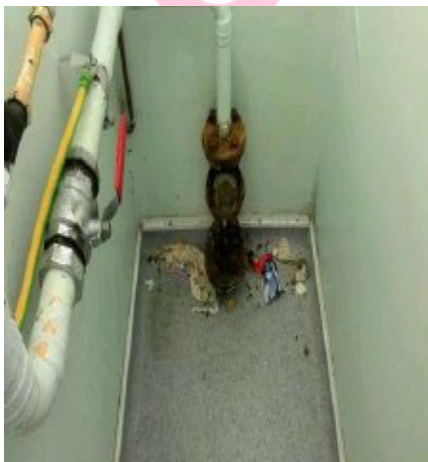
### **Item 28 - Ref: Presumed**

The gaskets to the female toilets (Rm 0/48) are presumed to contain asbestos.

Any change in its appearance should be recorded and passed to Property Services.

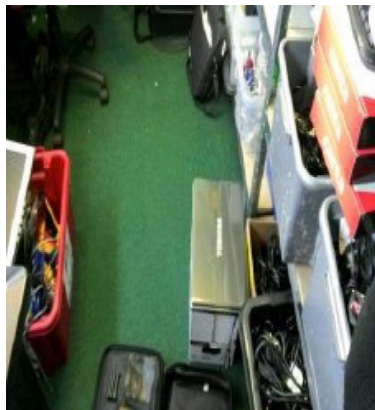
#### **Item 29- Ref: AW0444/08**

The grey floor tiles to the ICT office (Rm 0/50) contain asbestos.

Any change in its appearance should be recorded and passed to Property Services.

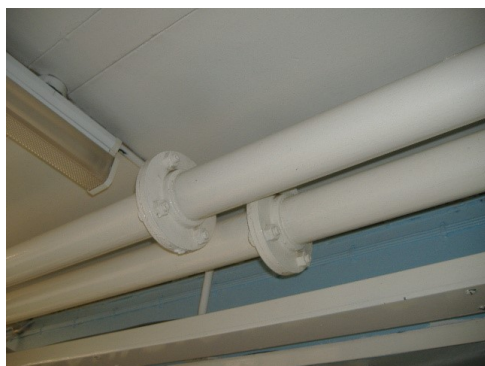
#### **Item 30 - Ref: Presumed**

The gaskets to corridor (Rm 0/59) are presumed to contain asbestos.

Any change in its appearance should be recorded and passed to Property Services.

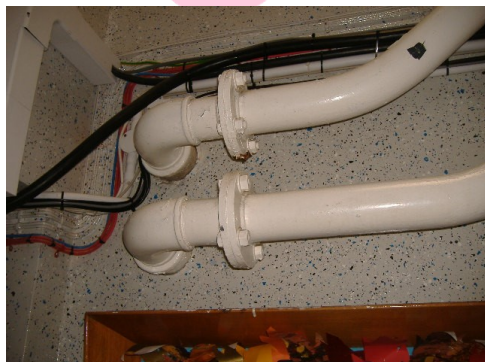
#### **Item 31 - Ref: Presumed**

The gaskets to corridor (Rm 0/83) are presumed to contain asbestos.

Any change in its appearance should be recorded and passed to Property Services.

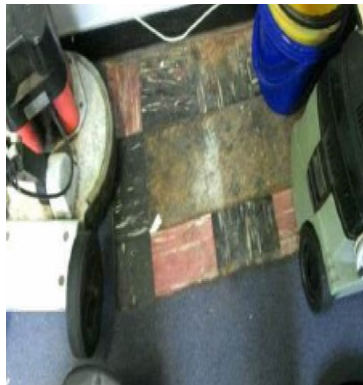
#### **Item 32 - Ref: WC0473/08**

The black/red floor tiles to the store room (Rm 0/85) contained asbestos.

***These were removed in July 2015.***

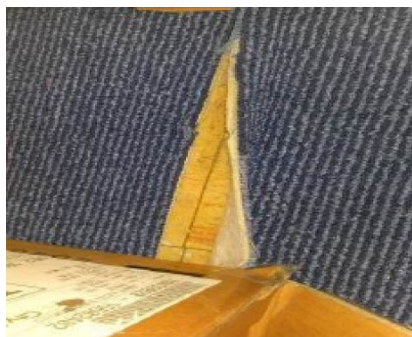
#### **Item 33 - Ref: WC0474/08**

The beige floor tiles to the office (Rm 0/86) contained asbestos.

***These were removed in May 2016.***

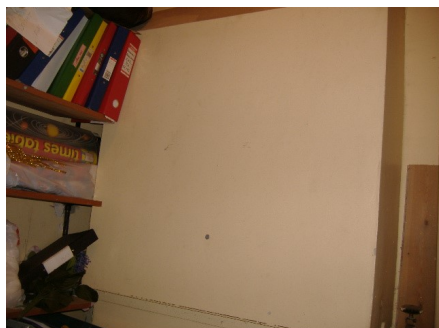
#### **Item 34 - Ref:WC0475/08**

The boxing to the rear of the heater in the store room (Rm 0/92) contains asbestos.

Any change in its appearance should be recorded and passed to Property Services.

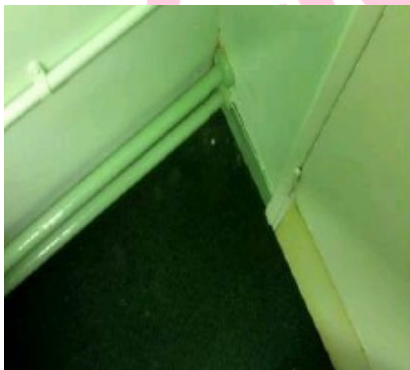
#### **Item 37 - Ref: WC0478/08**

The wall kick protection to the office (Rm 0/105) contains asbestos.

**This was removed in February 2016.**

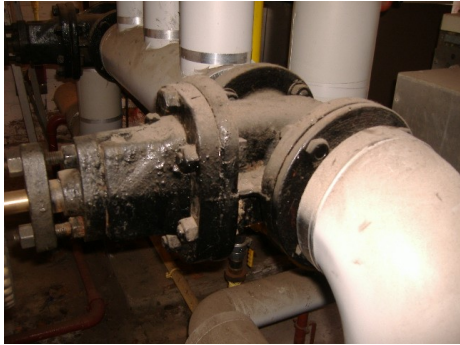
### **Item 38- Ref: Presumed**

The gaskets to the boiler room (Rm 0/109) were presumed to contain asbestos.

***These have been removed and replaced.***

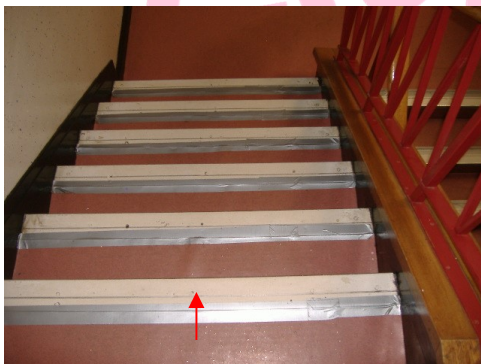
### **Item 40 - Ref:WC0480/08**

The stair nosing to the stairwell (Rm 0/111) contained asbestos.

***These were removed in November 2015.***

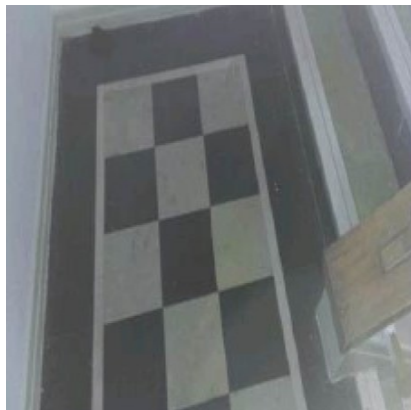
#### **Item 41- Ref: WC0482/08**

The floor tiles to stairwell (Rm 0/112) contain asbestos.

Any change in its appearance should be recorded and passed to Property Services.

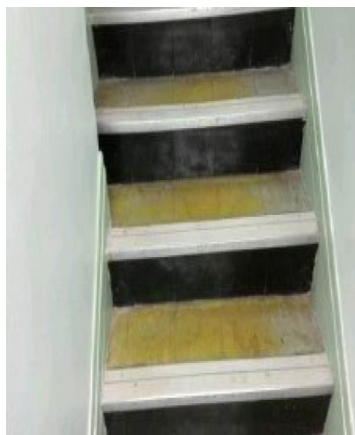
#### **Item 42 - Ref: WC0481/08**

The stair nosing to the stairwell (Rm 0/112) contains asbestos.

Any change in its appearance should be recorded and passed to Property Services.

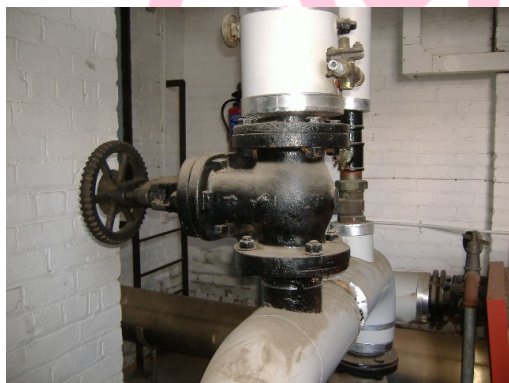
#### **Item 43 - Ref: Presumed**

The gaskets to the boiler room (Rm 0/113) were presumed to contain asbestos.

***These have been removed and replaced.***

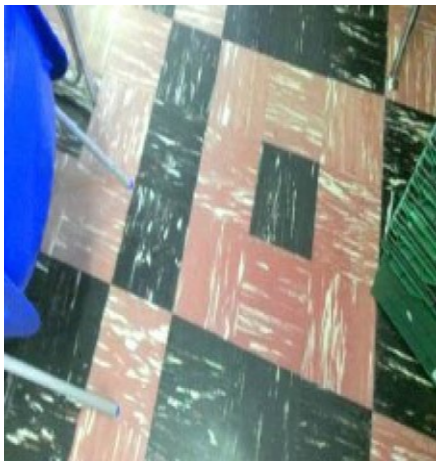
#### **Item 45 - Ref: Presumed**

The black/red floor tiles to the store room (Rm 1/06) are presumed to contain asbestos.

Any change in its appearance should be recorded and passed to Property Services.

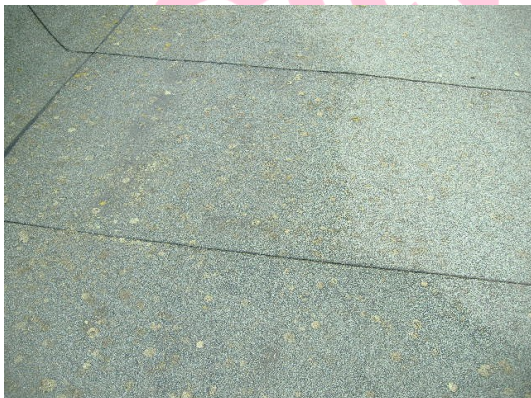
#### **Item 46- Ref: WC0484/08**

The roof felt to the exterior of the building does not contain asbestos.

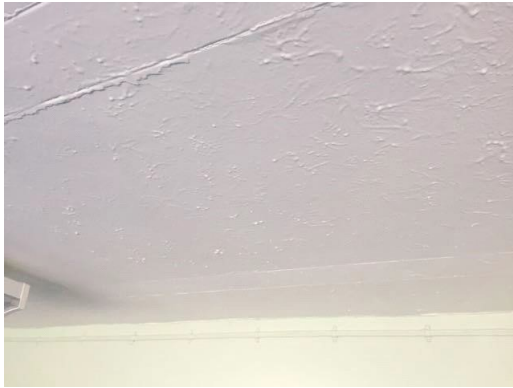
#### **Item 50 - Ref: 741267-3**

The textured coating to the stramit contains asbestos.

Any change in its appearance should be recorded and passed to Property Services.

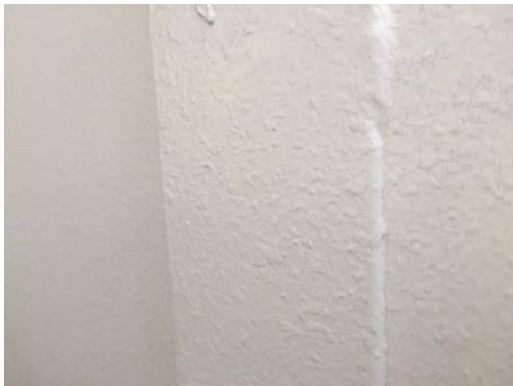
#### **Item 51 – Ref: 741269-4**

The coating to the wall in the Corridor does not contain asbestos.

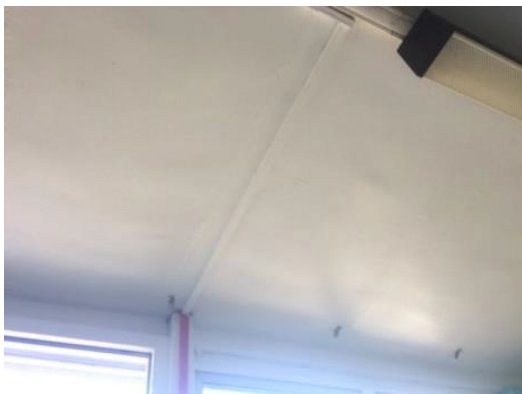
#### **Item 52 – Ref: 741270-5**

The ceiling in the Dining Hall area does not contain asbestos.

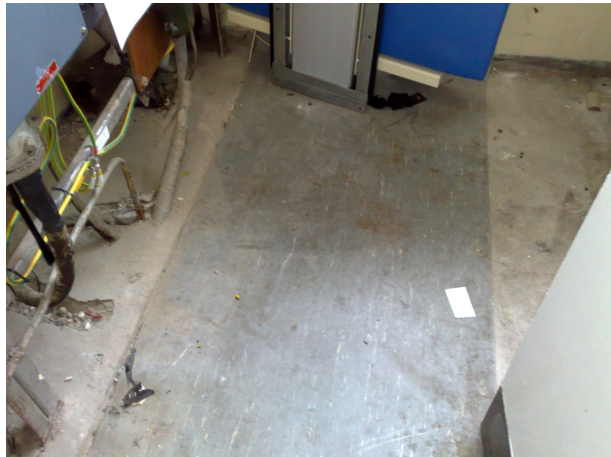
### **Item 103 - Ref: KR09/59**

The vinyl floor strip in the electrical intake 2 (Room 0/63) does not contain asbestos.

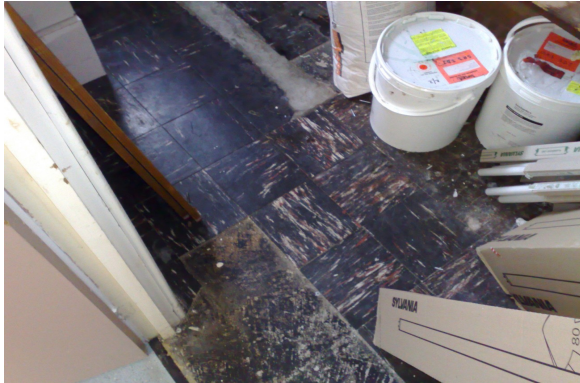
### **Item 111 - Ref: KR09/62**

The floor tiles and adhesive in Chemical Store B (Room 0/70) contains asbestos.

Any change in its appearance should be recorded and passed to Property Services.

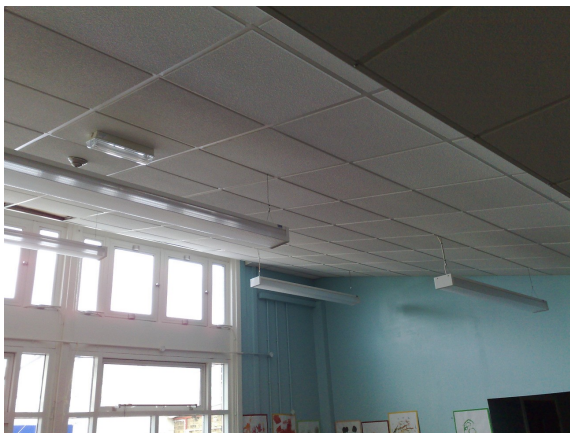
### **Item 126 - Ref: KR09/69**

The suspended ceiling tiles in the Nursery and cloakroom (Room 0/97) does not contain asbestos.

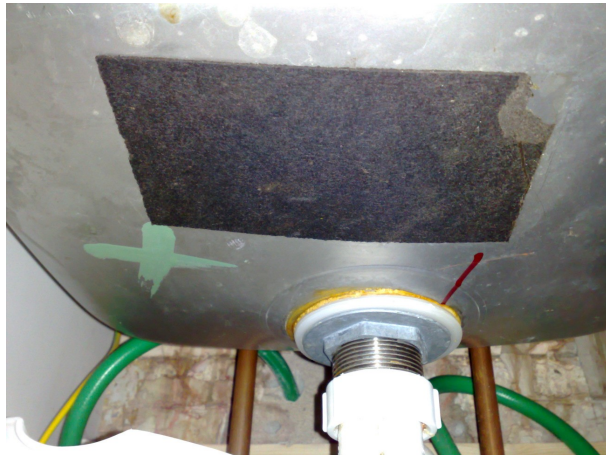
**Item 132 - Ref: KR09/61**

The sink pad in the kitchen area corridor (Room 0/69) does not contain asbestos.

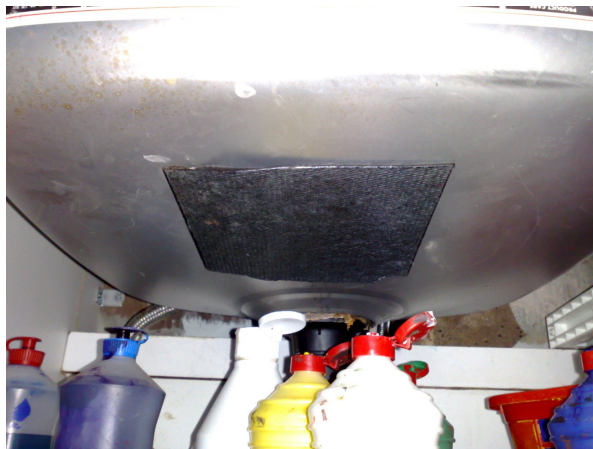
**Item 133 - Ref: KR09/64**

The sink pad in the toilet (Room 0/81) does not contain asbestos.

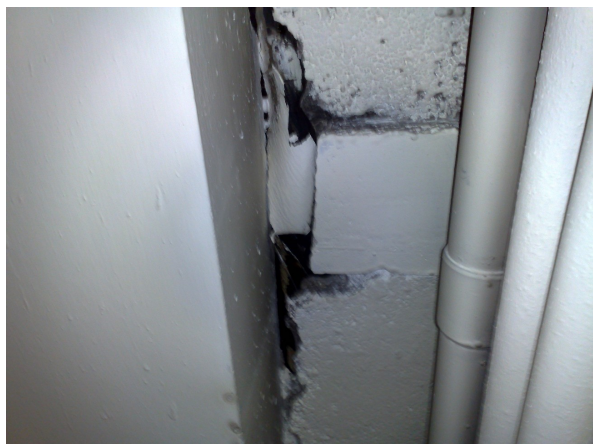
**Item 134 - Ref: KR09/66**

The bitumen material to ceiling above door in under stairs store (Room 0/83) does not contain asbestos.

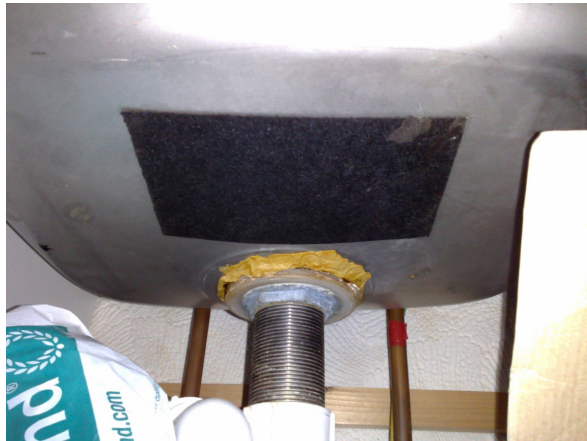
**Item 135 - Ref: KR09/67**

The sink pad in the clothes store/sink room (Room 1/085) does not contain asbestos.

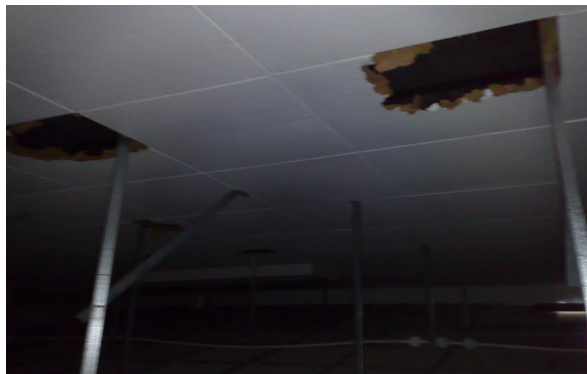
**Item 136 - Ref: KR09/70**

The ceiling tiles above suspended ceiling in the Nursery and cloakroom (Room 0/97) does not contain asbestos.

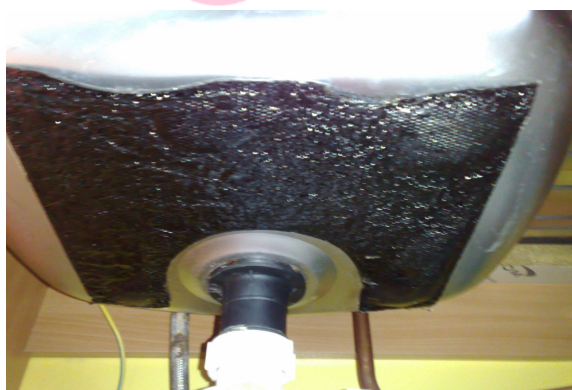
**Item 138 - Ref: KR09/71**

The sink pad in the Nursery and cloakroom (Room 0/97) does not contain asbestos.

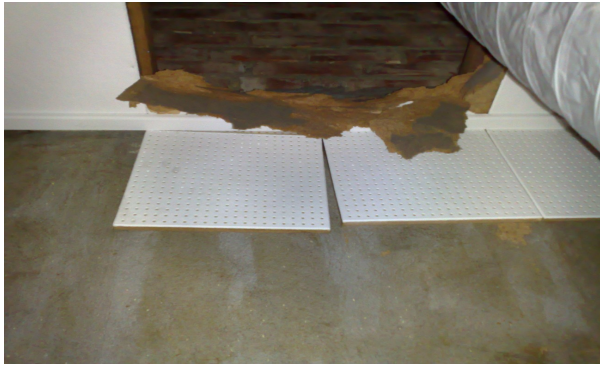
### **Item 139 - Ref: KR09/72**

The acoustic tiles in the Nursery and Cloakroom (Room 0/97) does not contain asbestos.

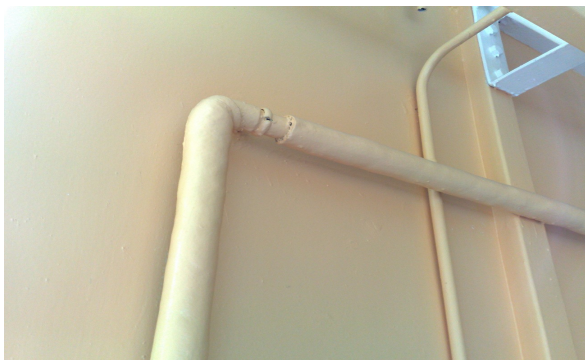
### **Item 140 - Ref: KR09/74**

The pipe insulation in the extended school kitchen club (Room 0/101) does not contain asbestos.

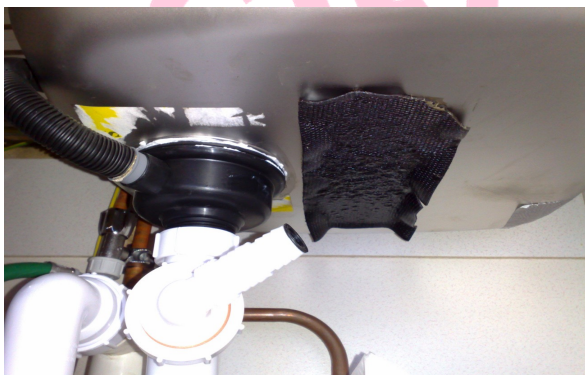
### **Item 141 - Ref: KR09/75**

The sink pad in the extended school kitchen club (Room 0/101) does not contain asbestos.

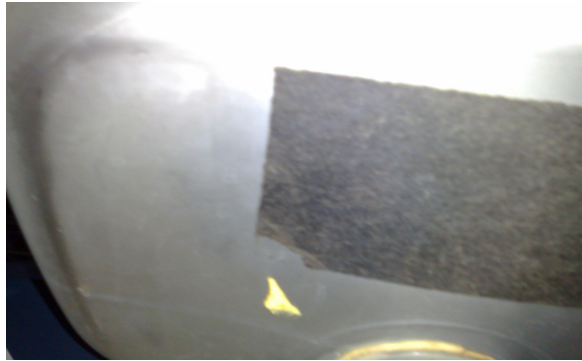
**Item 142 - Ref: KR09/48**

The sink pad in class 7 (Room 0/010) does not contain asbestos.

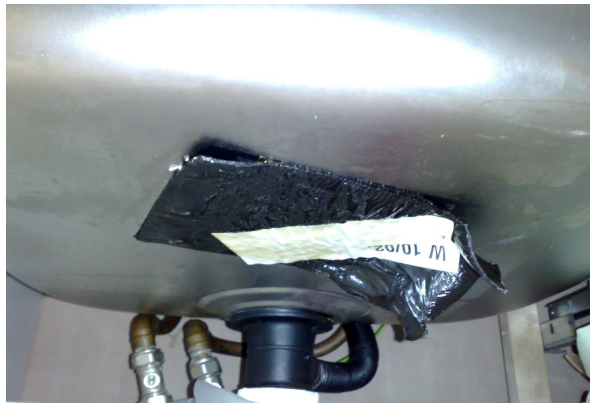
**Item 143 - Ref: KR09/51**

The sink pad in the kitchen (Room 0/021) does not contain asbestos.

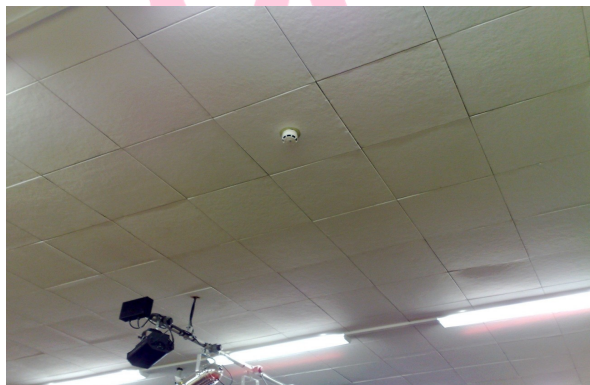
**Item 144 - Ref: KR09/52A**

The ceiling tiles in the hall (Room 0/30) does not contain asbestos.

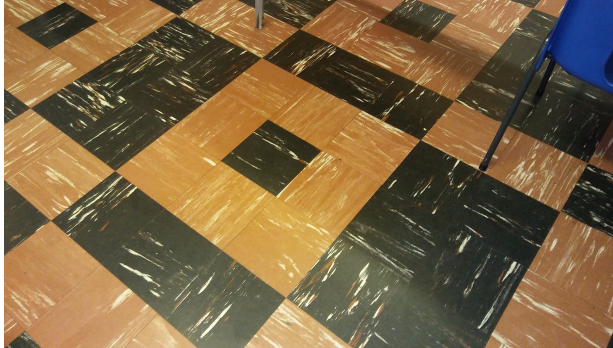
### **Item 154 - Ref: 383326-2**

The floor covering in 005/Music Room contains asbestos.

Any change in its appearance should be recorded and passed to Property Services.

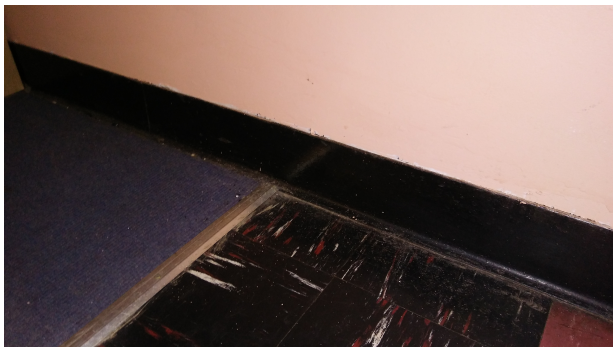
### **Item 155 - Ref: 383326-3**

The skirting board in 005/Music Room contains asbestos.

Any change in its appearance should be recorded and passed to Property Services.

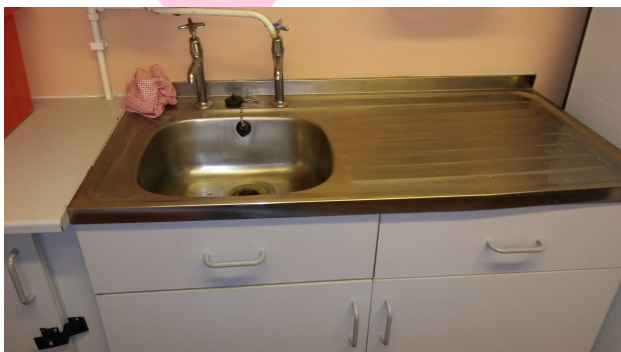
### **Item 156 - Ref: 383326-4**

The sealant to pipe beneath sink in 005/Music Room does not contain asbestos.

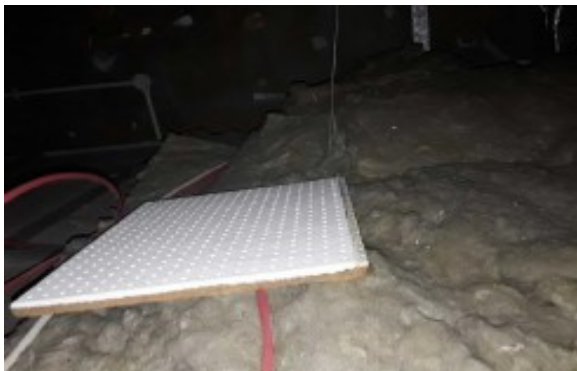
**Item 180 - Ref: 22-45169-1**

The fibreboard debris in Area 2 Classroom Reception ceiling void does not contain asbestos.

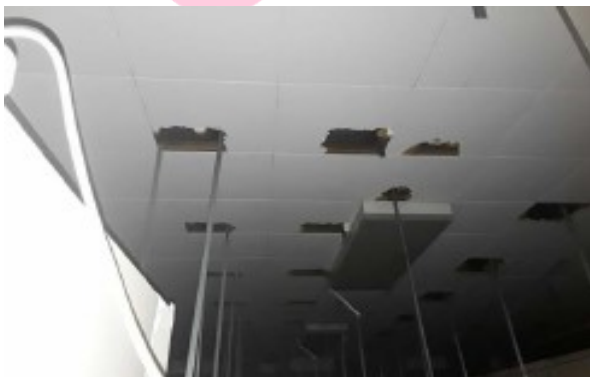
**Item 181 - Ref: 22-45169-2**

The fibreboard ceiling in Area 2 Classroom Reception ceiling void does not contain asbestos.

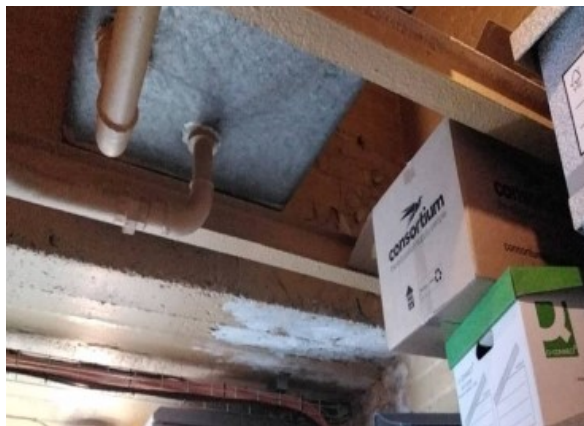
### **Item 189 - Ref: NO000640**

The wall coating in the Store Room (Rm 1/001) does not contain asbestos.

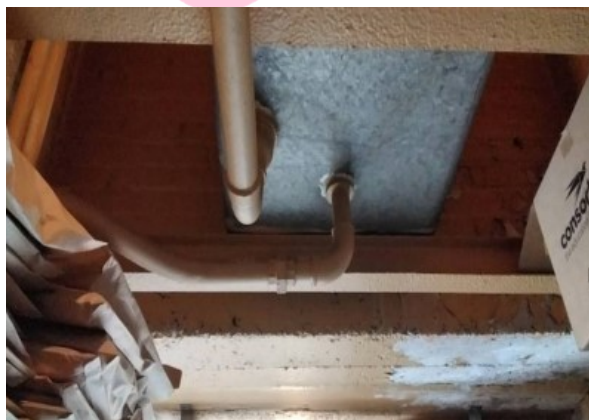
### **Item 190 - Ref: NO000641**

The wall coating to tank support girders in the Store Room (Rm 1/001) does not contain asbestos.

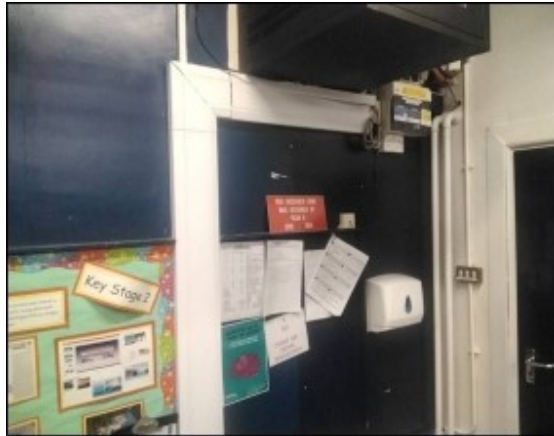
**Item 191 - Ref: NG002283**

The wall coating in the ITC Room (Rm G/001) does not contain asbestos.

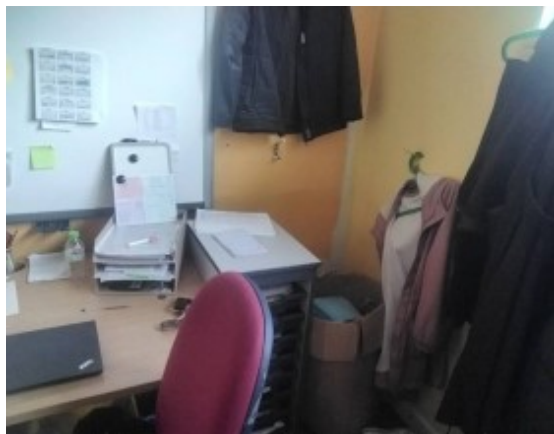
**Item 192 - Ref: NG002302**

The wall coating in the Canteen Office (Rm G/002) does not contain asbestos.

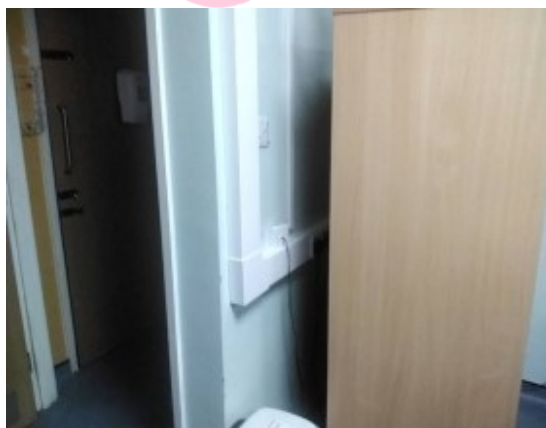
**Item 193 - Ref: NG002303**

The wall coating in the Caretakers Room (Rm G/003) does not contain asbestos.

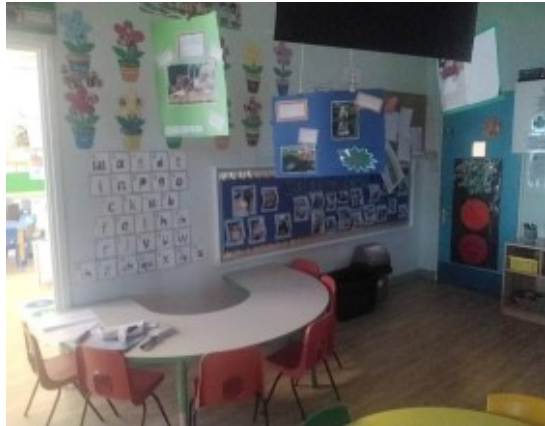
**Item 194 - Ref: NG002286**

The wall coating in Nursery 1 (Rm G/004) does not contain asbestos.

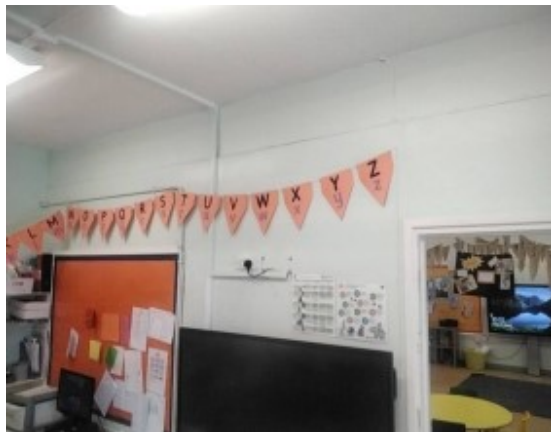
**Item 195 - Ref: NG0023287**

The wall coating in Nursery 2 (Rm G/005) does not contain asbestos.

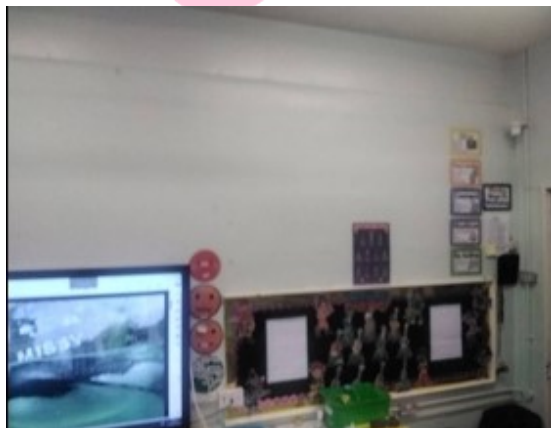
**Item 196 - Ref: NG002288**

The wall coating in the Year 3 Classroom (Rm G/006) does not contain asbestos.

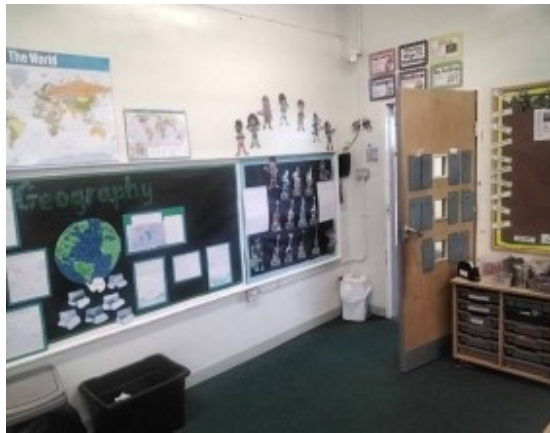
**Item 197 - Ref: NG002289**

The wall coating in the Year 3B Classroom (Rm G/007) does not contain asbestos.

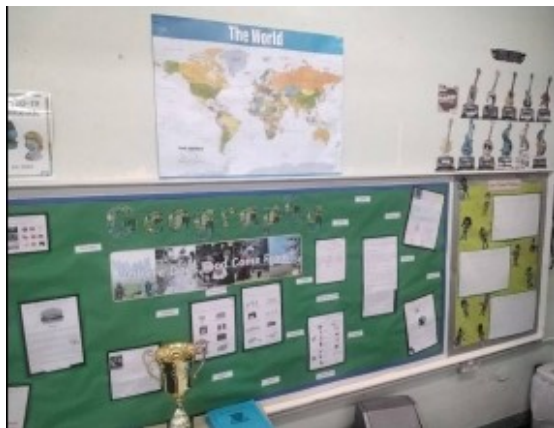
**Item 198 - Ref: NG0023290**

The wall coating in the 4A Classroom (Rm G/008) does not contain asbestos.

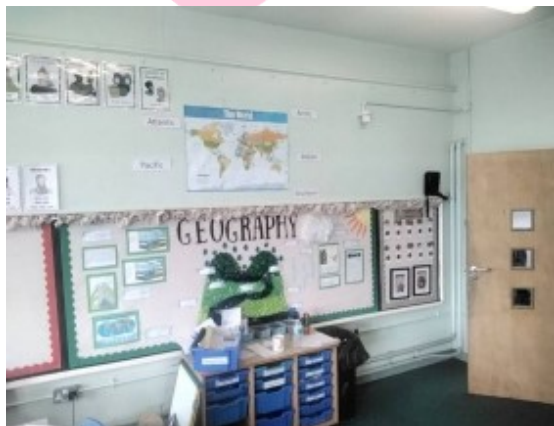
**Item 199 - Ref: NG002291**

The wall coating in the 5A Classroom (Rm G/009) does not contain asbestos.

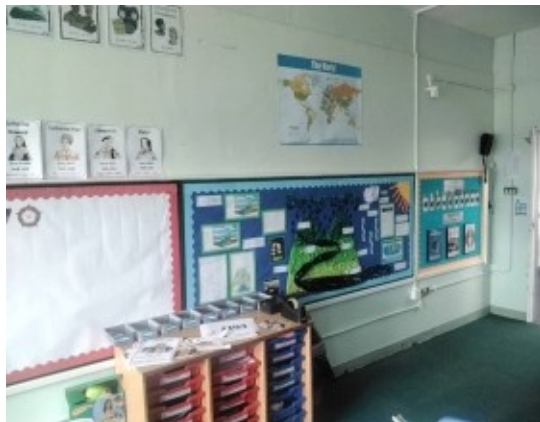
**Item 200 - Ref: NG002292**

The wall coating in the 5B Classroom (Rm G/010) does not contain asbestos.

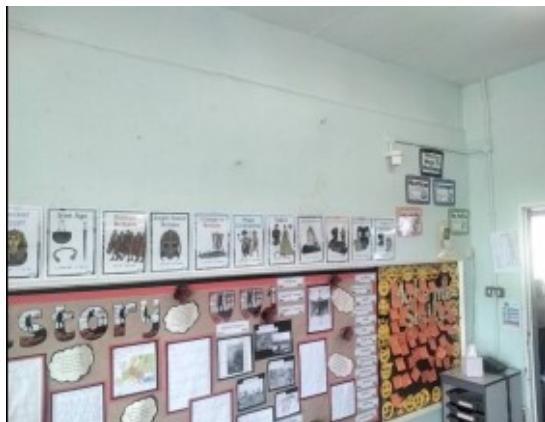
**Item 201 - Ref: NG0023293**

The wall coating in the 6A Classroom (Rm G/011) does not contain asbestos.

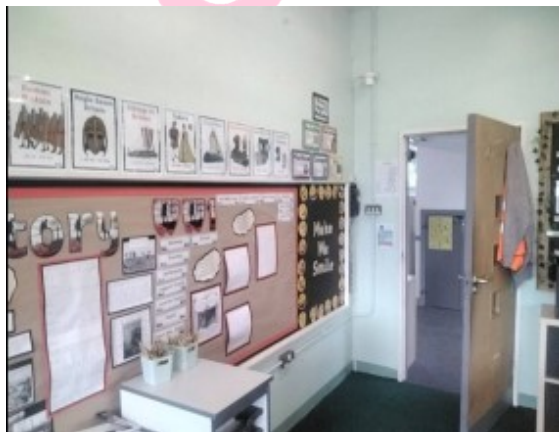
**Item 202 - Ref: NG002294**

The wall coating in the 6B Classroom (Rm G/012) does not contain asbestos.

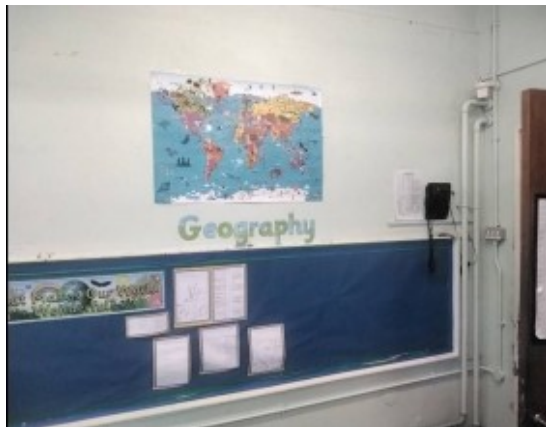
**Item 203 - Ref: NG002296**

The wall coating in the 2B Classroom (Rm G/013) does not contain asbestos.

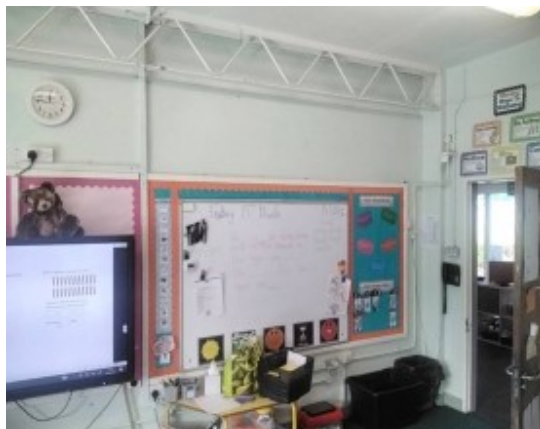
**Item 204 - Ref: NG0023297**

The wall coating in the 2A Classroom (Rm G/014) does not contain asbestos.

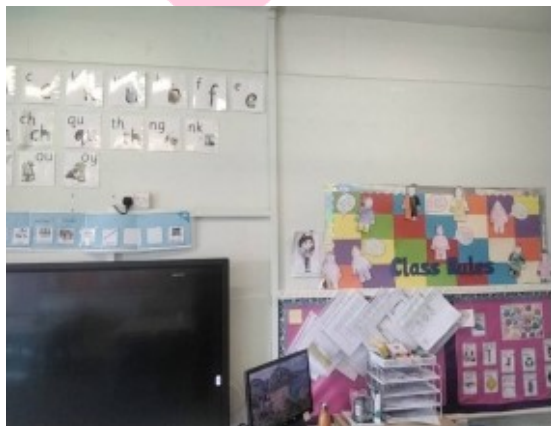
**Item 205 - Ref: NG002298**

The wall coating in the 1B Classroom (Rm G/015) does not contain asbestos.

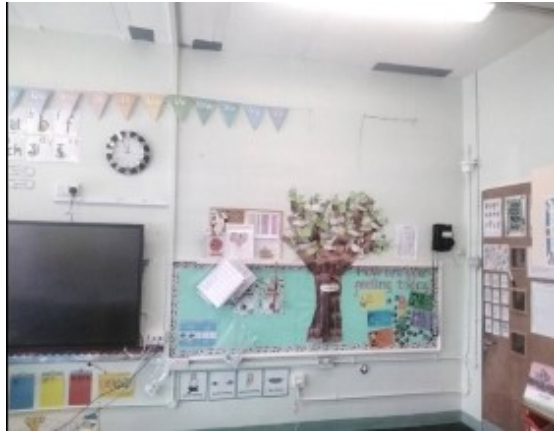
### **Item 206 - Ref: NG002299**

The wall coating in the 1A Classroom (Rm G/016) does not contain asbestos.

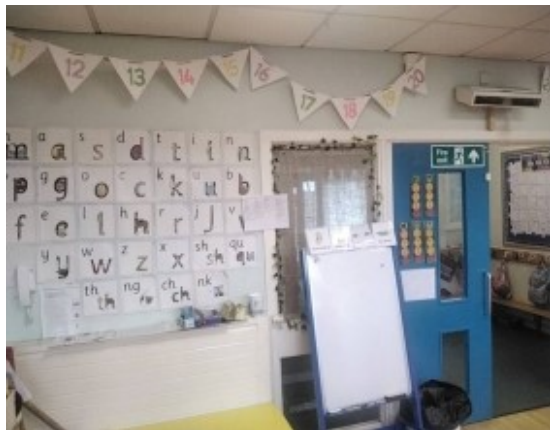
### **Item 207 - Ref: NG0023300**

The wall coating in the Reception Classroom (Rm G/017) does not contain asbestos.

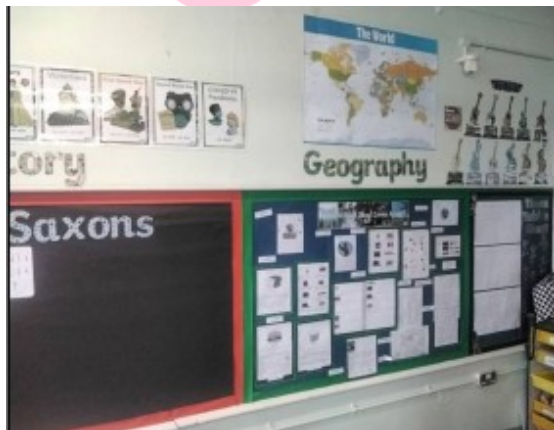
### **Item 208 - Ref: NG002304**

The wall coating in the 4B Classroom (Rm G/018) does not contain asbestos.

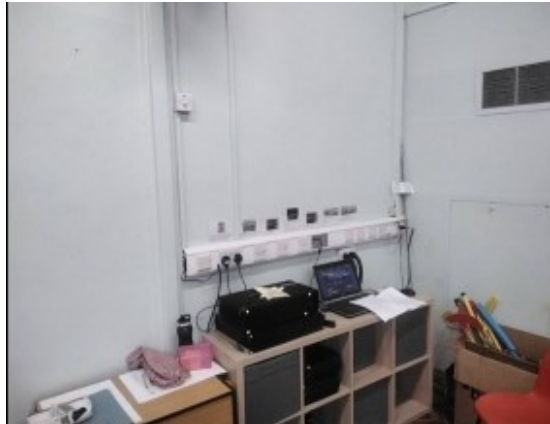
**Item 209 - Ref: NG002305**

The wall coating in the Main Hall (Rm G/019) does not contain asbestos.
