### **ASBESTOS SURVEY REPORT FOR FARRINGTON ACADEMY SCHOOL, SUNDERLAND**

### **FARRINGTON ACADEMY SCHOOL, SUNDERLAND**

**Date: 05 June 2025**

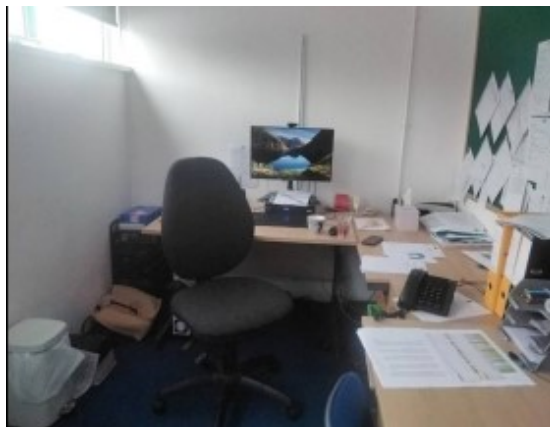
**Item 210 - Ref: NG0023306**

The wall coating in the Assistant Heads Office (Rm G/020) does not contain asbestos.

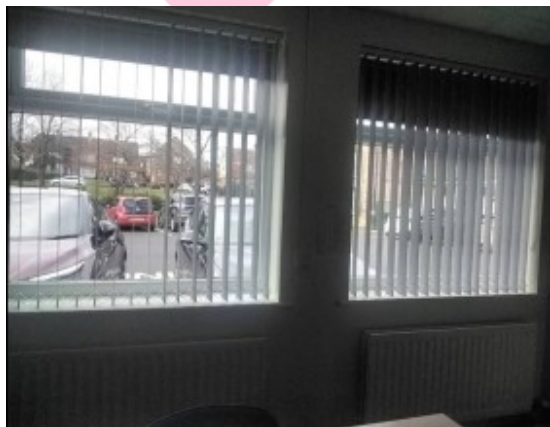
**Item 211 - Ref: NG002307**

The wall coating in the TLR Room (Rm G/021) does not contain asbestos.

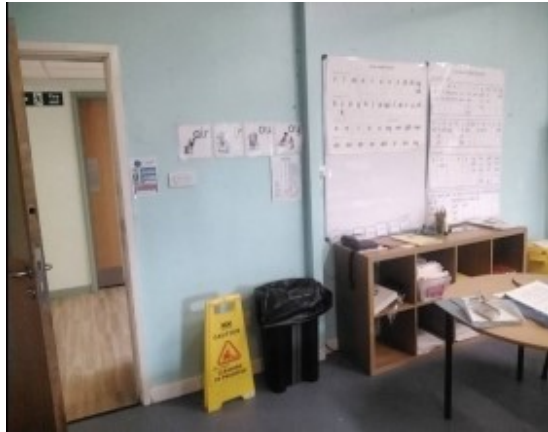
**Item 212 - Ref: NG002301**

The wall coating in the Art Room (Rm G/022) does not contain asbestos.

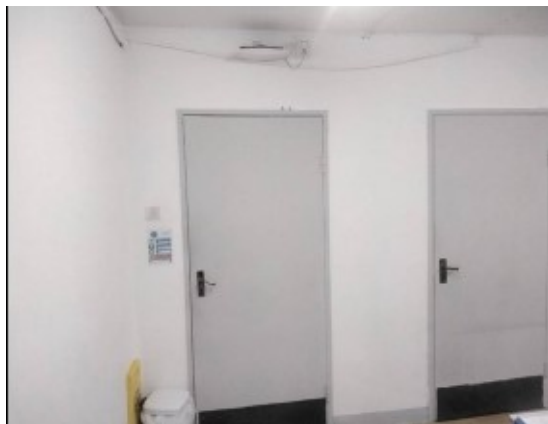
**Item 213 - Ref: NG0023284**

The wall coating in the Phonics Room (Rm G/023) does not contain asbestos.

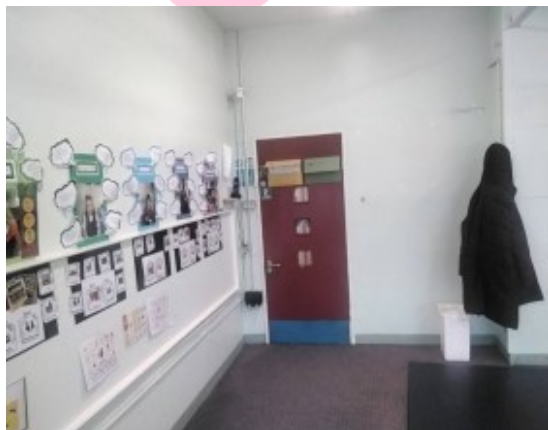
**Item 214 - Ref: NG002285**

The wall coating in the Soft Play (Rm G/024) does not contain asbestos.

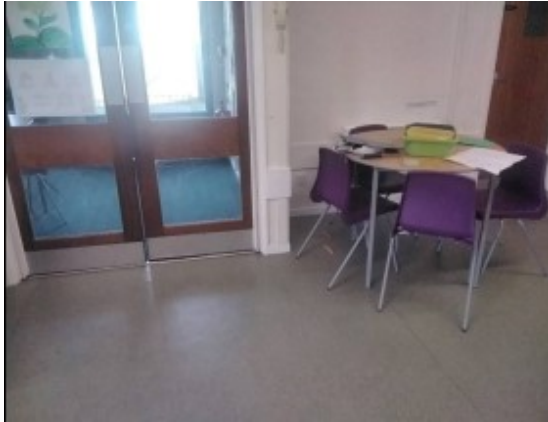
### **Item 215 - Ref: NG002295**

The wall sheet/cladding in the Nurture Room (Rm G/001) does not contain asbestos.

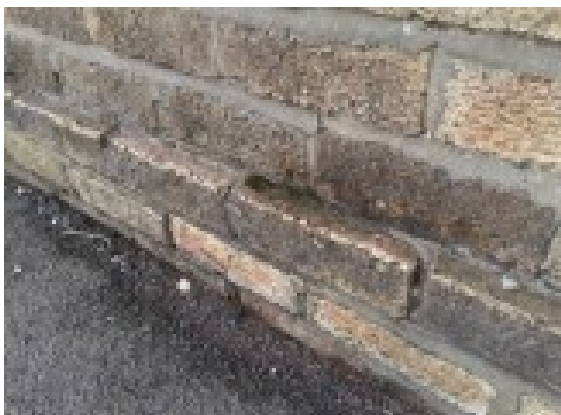
### **Item 217 - Ref: NZ001565**

The Damp proof course (External area 2 pointing E/002).

Any change in appearance should be reported to Property Services.

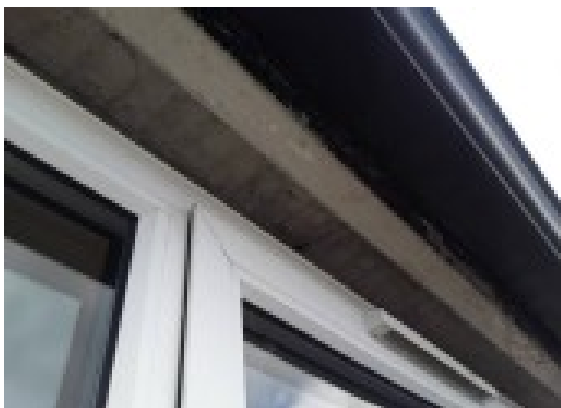
### **Item 220 - Ref: As NZ001566**

The Soffits (External area 1 pointing E/003).

Any change in appearance should be reported to Property Services.

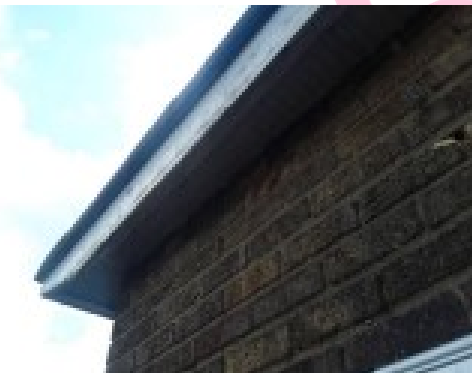
### **Item 222 - Ref: As NZ001566**

The Soffits (External area 3  
Roof E/004).

Any change in appearance  
should be reported to Property  
Services.
