ASBESTOS SURVEY REPORT FOR GILLAS LANE PRIMARY SCHOOL, HOUGHTON

Asbestos Register for

GILLAS LANE PRIMARY SCHOOL HOUGHTON

Date: 10 June 2025

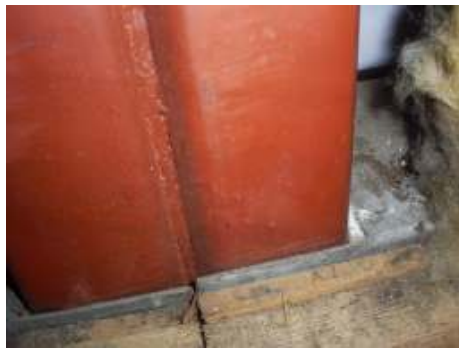
Various Ref: NO08/650

The column insulation to the ceiling void above class 3 does not contain asbestos.

Similar column insulation is located in IT Room, School office, class 4, class 5, girls wc, boys wc, girls wc 2, craft room, class 2, reception, class 2 wash area and kitchen.

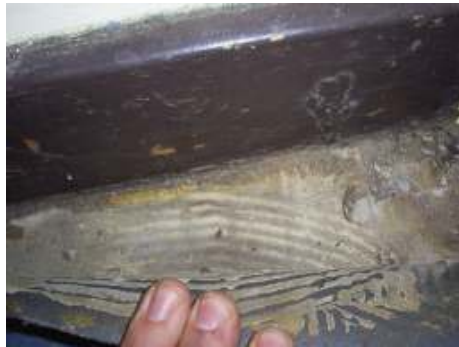
Item 2 - Ref: NO08/651

The floor tiles to class 3 do not contain asbestos.

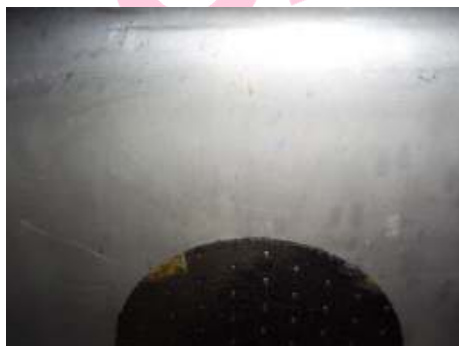
Various - Ref: NO08/652

The sink pad to class 3 does not contain asbestos.

Similar sink pads are located in class 4, class 5, class 2, reception and class 1.

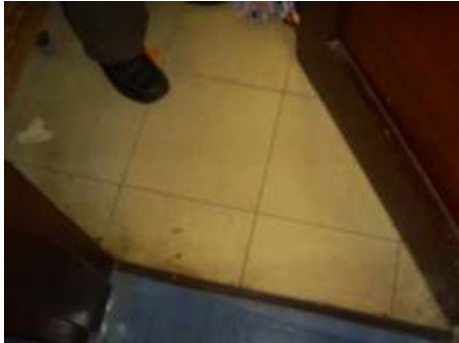
Various - Ref: NO08/654

The floor tiles to store 1 do not contain asbestos.

Similar flooring is located in store 2.

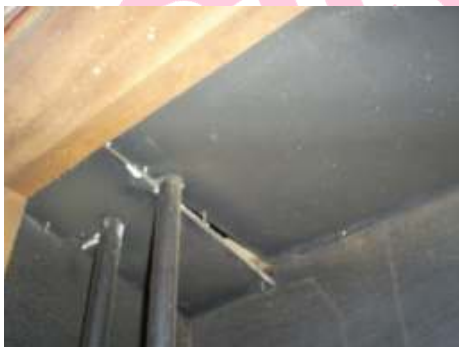
Item 7 - Ref: NO08/655

The ceiling to store 2 contains asbestos.

Please note this was removed in December 2013.

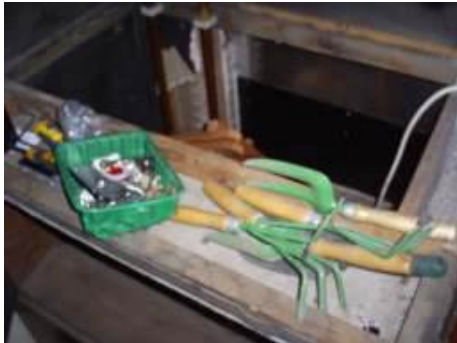
Item 8 - Ref: NO08/656

The shelving to store 2 contains asbestos.

Please note this shelving has now been over boarded but the asbestos remains.

Any change in its appearance should be recorded, and passed to Property Services.

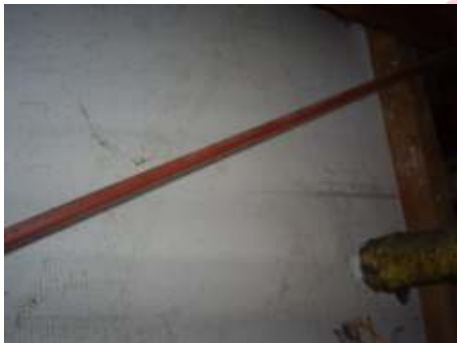
Item 11 - Ref: NO08/657

The insulation boards to the ceiling void between the office and the store contain asbestos.

Any change in its appearance should be recorded, and passed to Property Services.

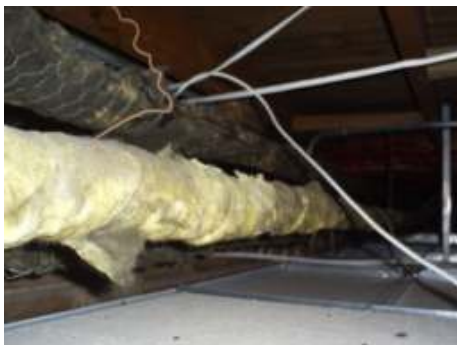
Item 12 - Ref: NO08/658

The pipe insulation to the ceiling void between the office and the store does not contain asbestos.

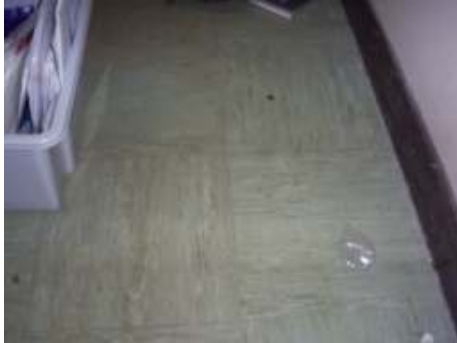
Item 23 - Ref: NO08/659

The floor tiles to the library store do not contain asbestos.

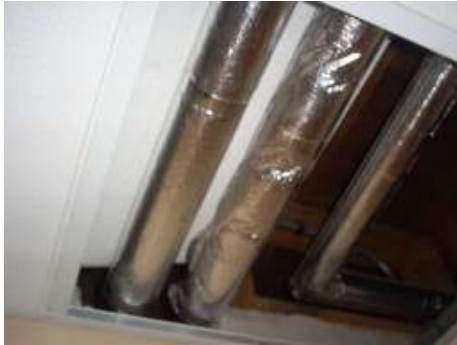
Item 24 - Ref: NO08/660

The pipe insulation in the ceiling void of the new build does not contain asbestos.

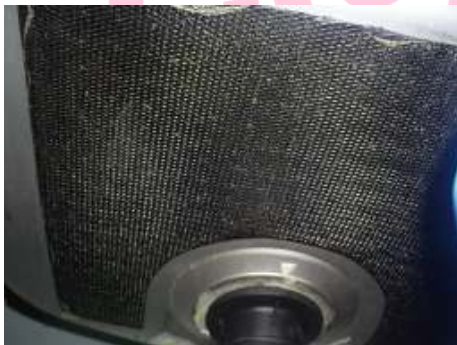
Item 25 - Ref: NO08/661

The sink pad to class 6 does not contain asbestos.

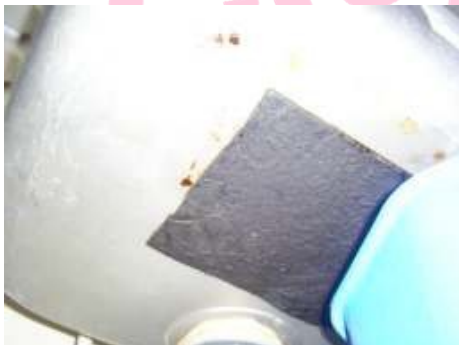
Item 36 - Ref: NO08/664

The sink pad to the kitchen does not contain asbestos.

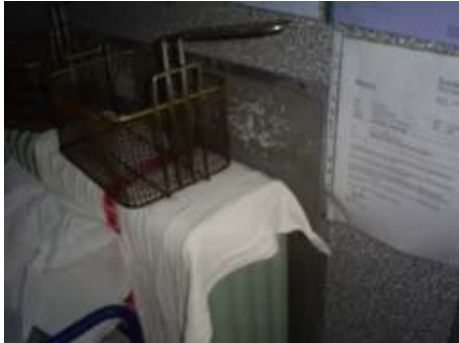
Item 39 - Ref: NO08/666

The board to the radiator in the kitchen contains asbestos.

Any change in its appearance should be recorded, and passed to Property Services.

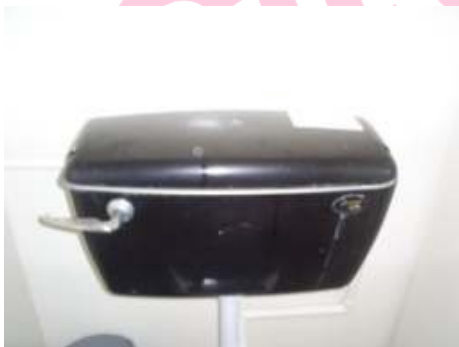
Item 40 - Ref: NO08/667

The toilet cisterns to the kitchen contain asbestos.

Any change in its appearance should be recorded, and passed to Property Services.

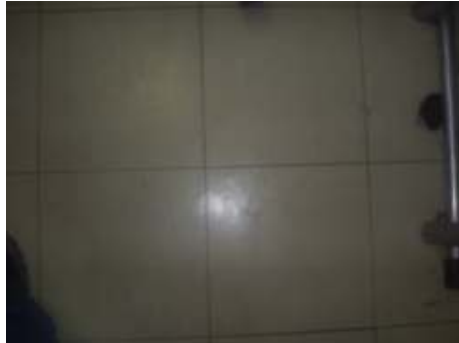
Various - Ref: NO08/668

The floor tiles to hall store 1 contain asbestos.

Similar flooring is located in hall store 2.

Any change in its appearance should be recorded, and passed to Property Services.

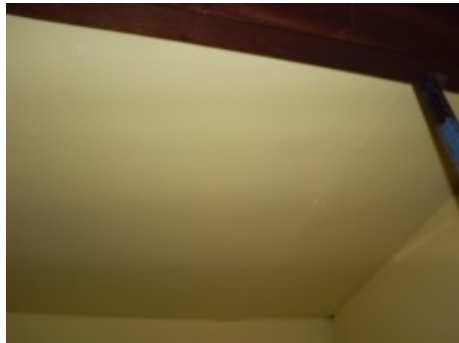
Item 43 - Ref: NO08/669

The ceiling to the hall store 2 contains asbestos.

This was removed in January 2016.

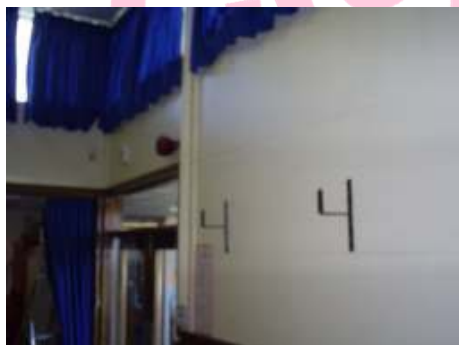
Item 44 - Ref: NO08/670

The wall panels to the hall contain asbestos.

Please note these wall boards have now been over boarded but the asbestos remains.

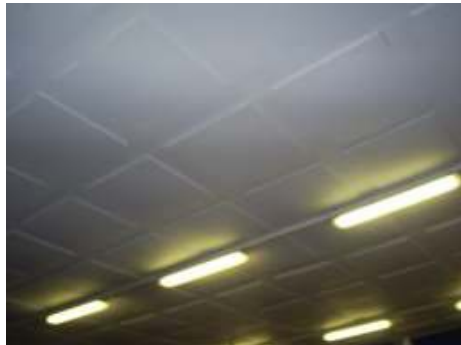
Item 45 - Ref: NO08/671

The ceiling to the hall does not contain asbestos.

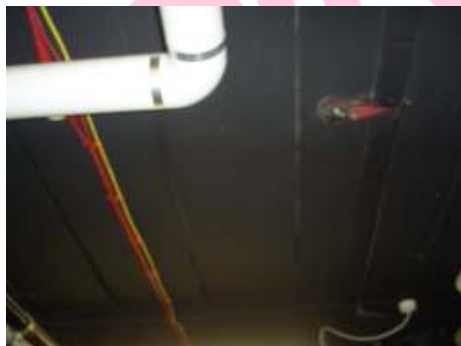
Various - Ref: NO08/674

The ceiling to the boiler room contains asbestos (Removed August 2023).

Similar ceiling is located in the boiler room store (Removed August 2023).

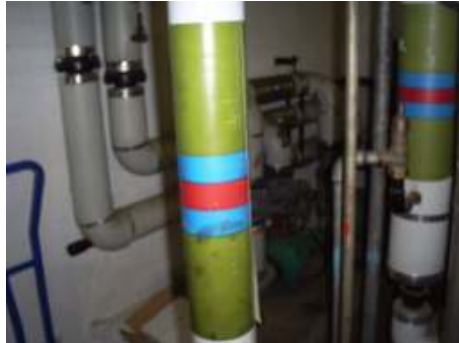
Item 48 - Ref: NO08/675

The pipe and calorifier insulation to the boiler room does not contain asbestos.

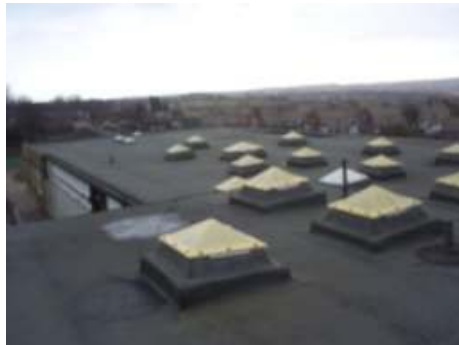
Item 50 - Ref: NO08/683

The roof felt to the external does not contain asbestos.

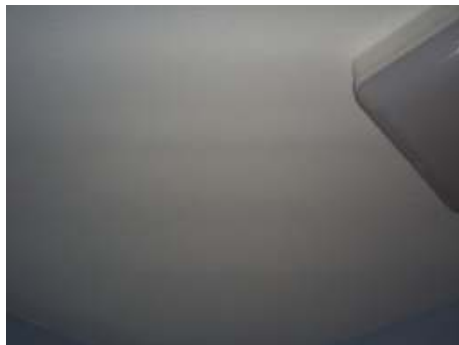
Various – Ref:NO08/677

The textured coating to the ceiling in the shower room contains asbestos.

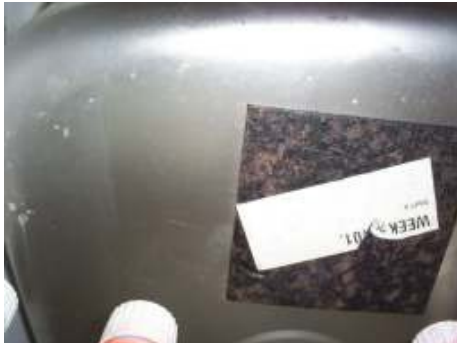
Item 53 - Ref: NO08/678

The sink pad to the main area does not contain asbestos.

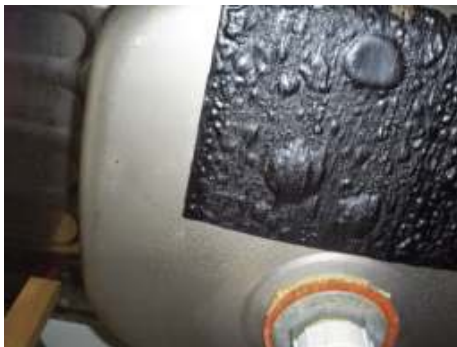
Item 56 – Ref:NO08/679

The sink pad to the kitchen does not contain asbestos.

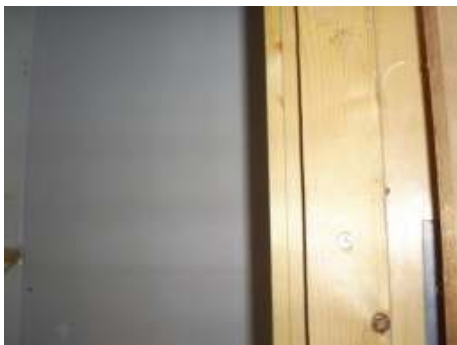
Item 59 - Ref: NO08/680

The lining boards to the electrical intake do not contain asbestos.

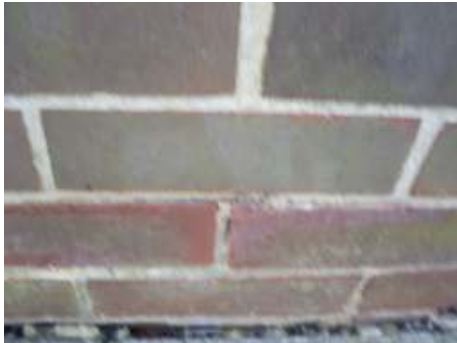
Item 60 - Ref: NO08/681

The external damp proof course does not contain asbestos.

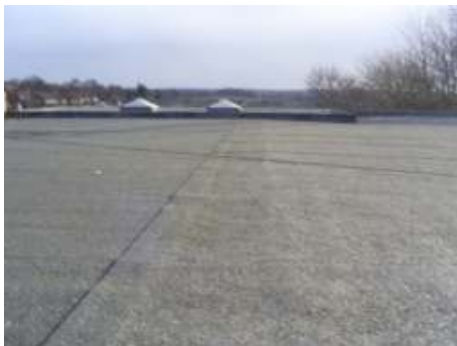
Item 61 – Ref:NO08/682

The felt to the roof does not contain asbestos.

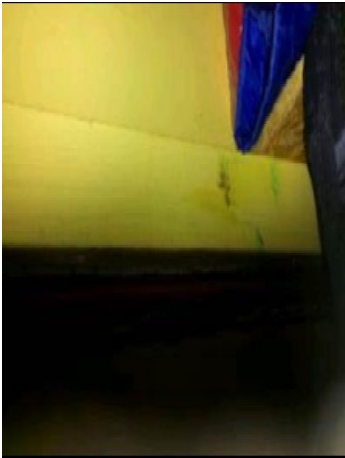
Item 67 – Ref: EA000900

Residue to timber supports from previous shelving was identified in the Hall (Store 1).

Removed August 2023

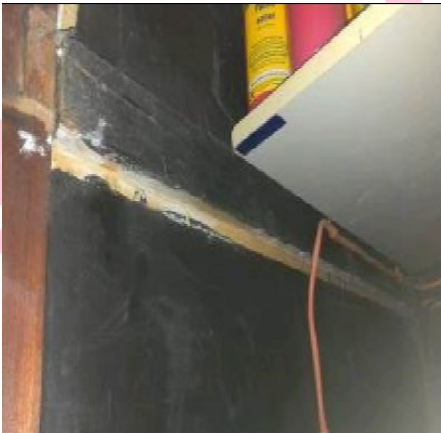
Item 68 - Ref: EA000901

Residue to timber supports from previous shelving was identified in the Room 7 (Store). This does contain asbestos.

Removed August 2023

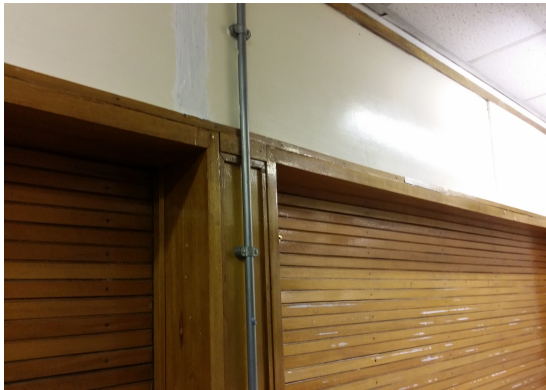
Item 69 - Presumed

Insulation board behind the column claddings in the kitchen area. This is presumed to contain asbestos.

Any change should be recorded and passed to Property Services.

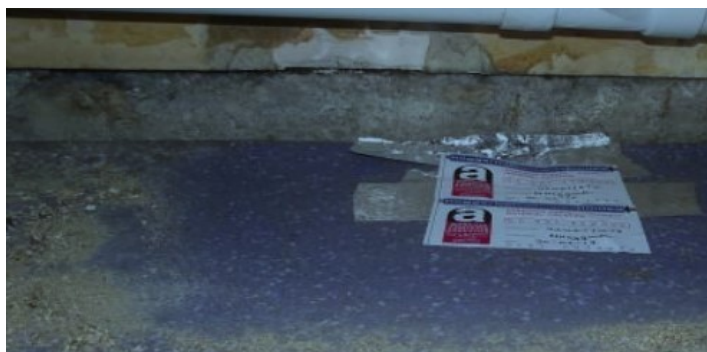
Item 82 – AB487192 474

The floor covering in KS1 Toilets do not contain asbestos.

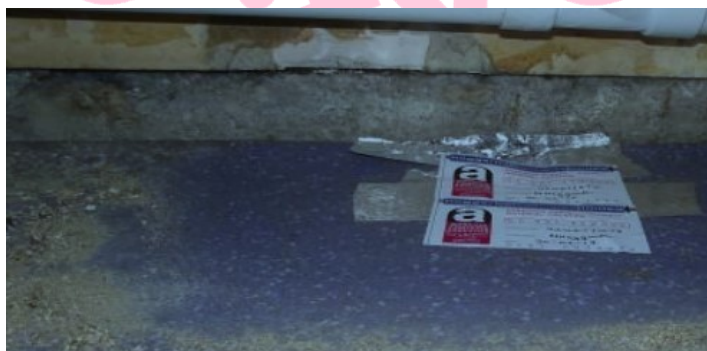
Item 83 – AB487192 475

The adhesive and screed in KS1 Toilets do not contain asbestos.

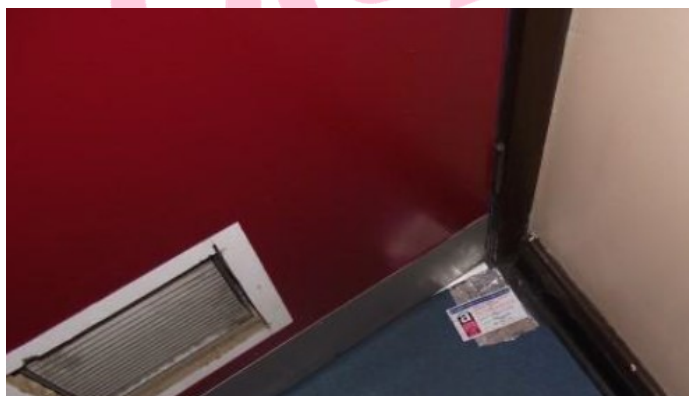
Item 86 – AB487192 476

The floor and adhesive in KS1 Girls Toilets do not contain asbestos.

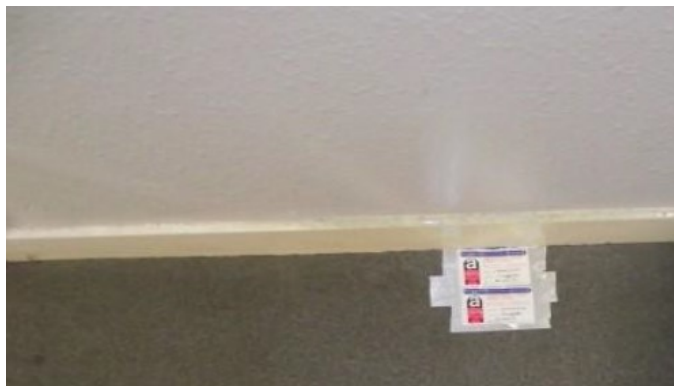
Item 87 – AB487192477

The vinyl sheet in the KS2 WC's corridor does not contain asbestos.

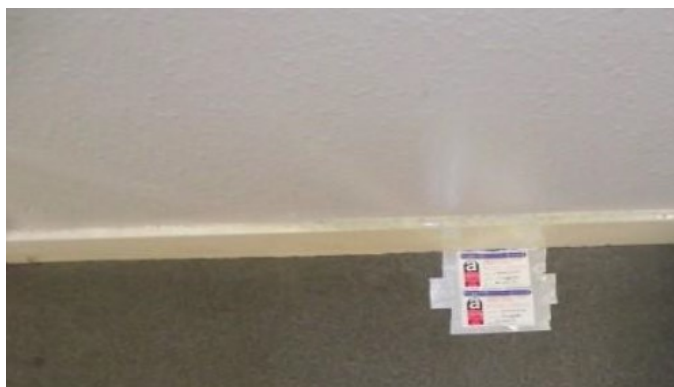
Item 88 – AB487192478

The floor covering adhesive/screed in the KS2 WC's corridor does not contain asbestos.

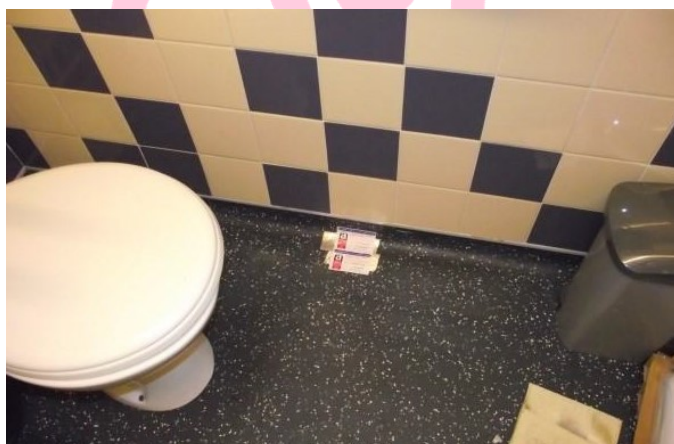
Item 89 – AB487192479

The vinyl sheet in KS2 WC's do not contain asbestos.

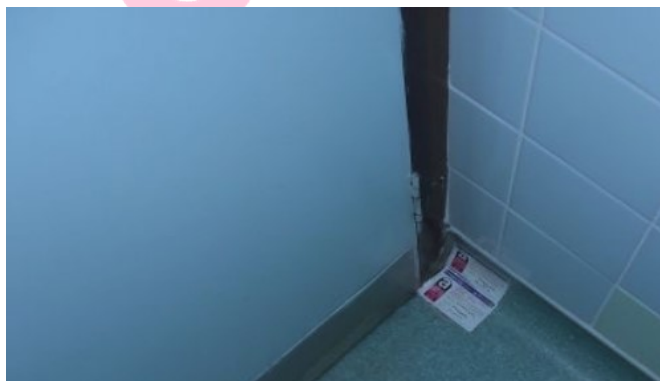
Item 92 – AB487192481

The vinyl sheet in the KS2 Girls WC's does not contain asbestos.

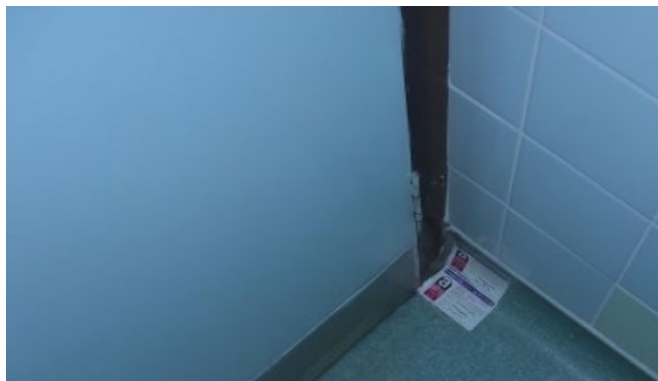
Item 93 – AB487192482

The floor covering adhesive/screed in the KS2 Girls WC's does not contain asbestos.

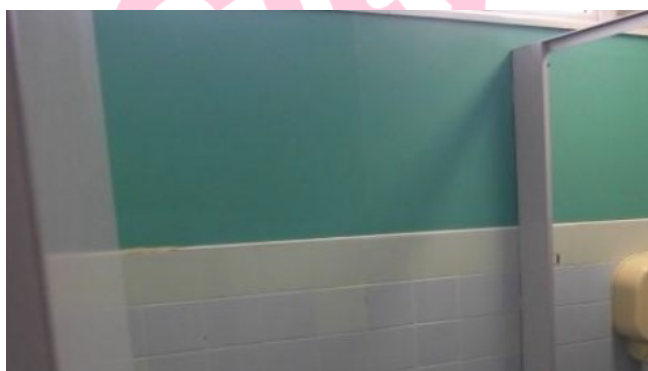
Item 95 – As AB487192481

The vinyl sheet in the KS2 Boys WC's does not contain asbestos.

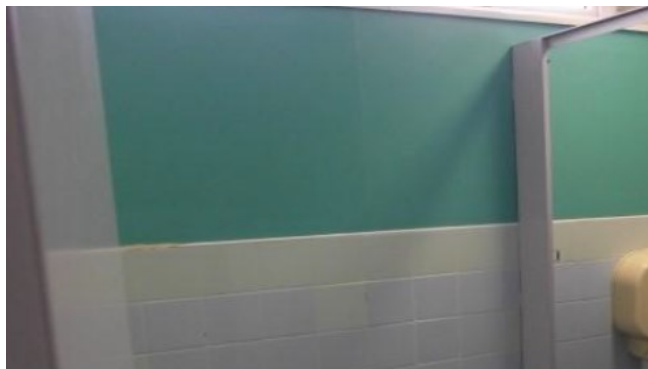
Item 96 – AsAB487192482

The floor covering adhesive/screed in the KS2 Boys WC's does not contain asbestos.

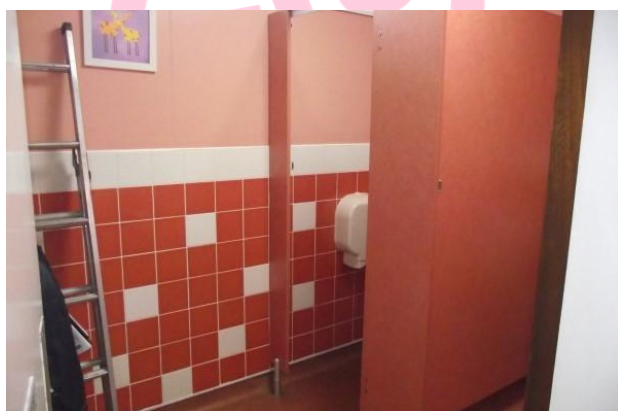
Item 98 – As AB487192483

The vinyl sheet in the KS2 Girls WC's does not contain asbestos.

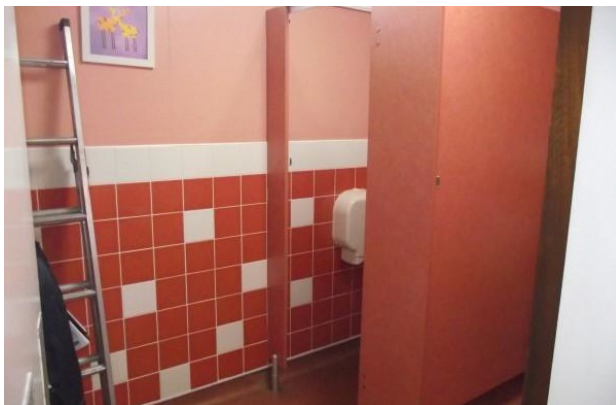
Item 99 – AsAB487192484

The floor covering adhesive/screed in the KS2 Girls WC's does not contain asbestos.

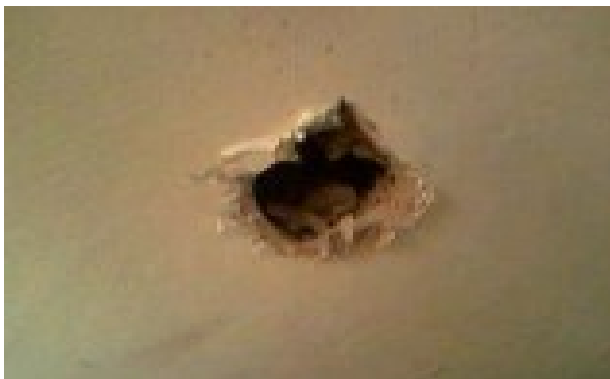
Item 100 – AM000798

The plasterboard wall in Boys WC/Rm 1 does not contain asbestos.

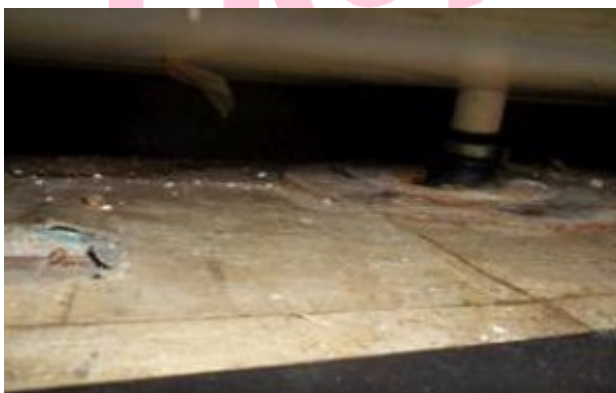
Item 101 – VP004232

The vinyl floor tiles and bitumen adhesive below in Classroom 2/Rm 1 does not contain asbestos.

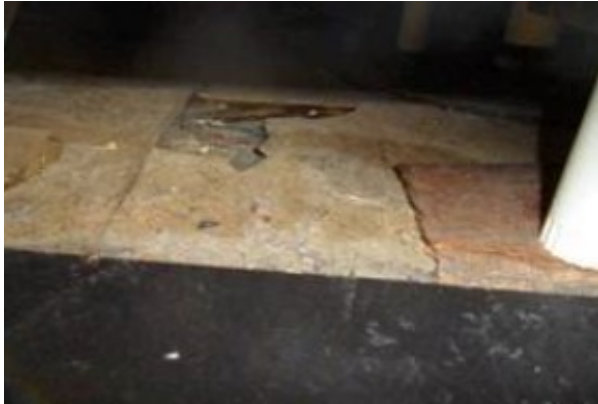
Item 102 – As VP004232

The vinyl floor tiles and bitumen adhesive below in Reception Class/Rm 2 does not contain asbestos.

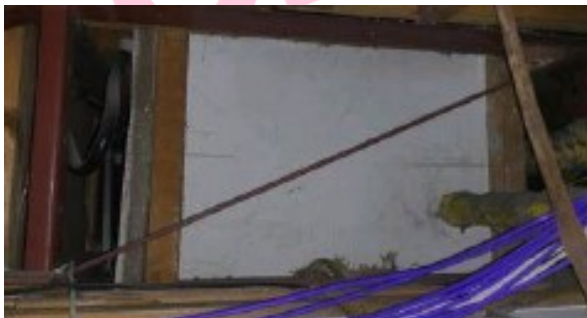
Item 107 – EA003945

The skylight boxing in School Office/Rm 1 contains asbestos.

Any change should be recorded and passed to Property Services.

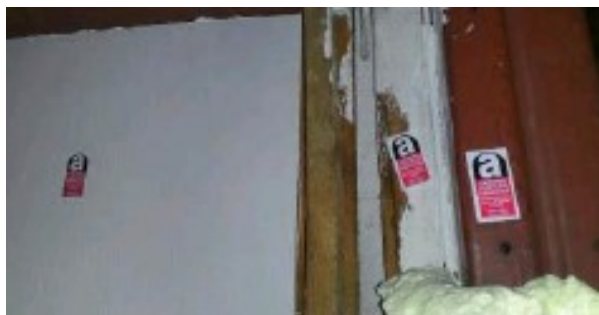
Item 108 – EA003946

The firebreak in the Foyer/Rm 2 contains asbestos.

Any change should be recorded and passed to Property Services.

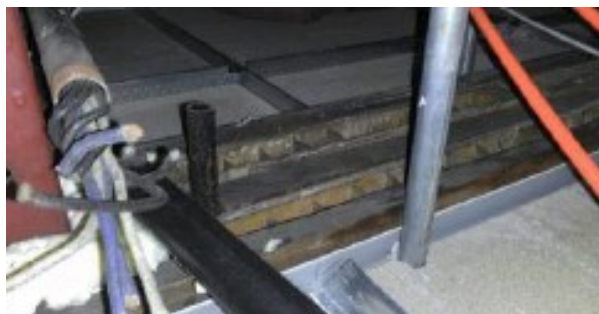
Item 109 – EA003947

The debris to wall in the Foyer/Rm 2 does not contain asbestos.

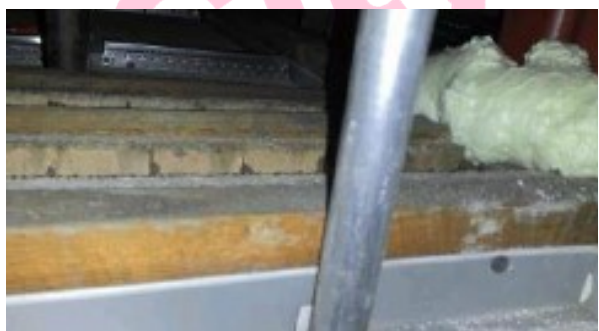
Item 110 – EA003948

The debris to wall in the Foyer/Rm 2 does not contain asbestos.

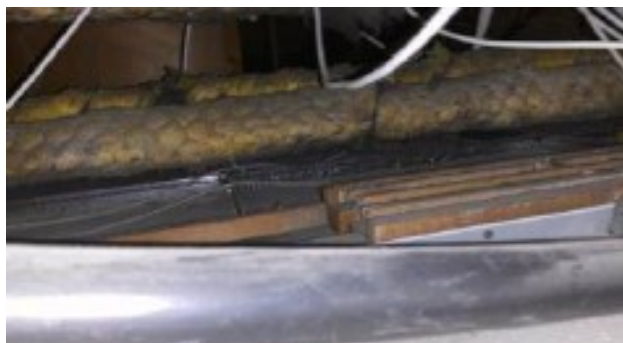
Item 111 – EA003949

The debris to wall in the Foyer/Rm 2 does not contain asbestos.

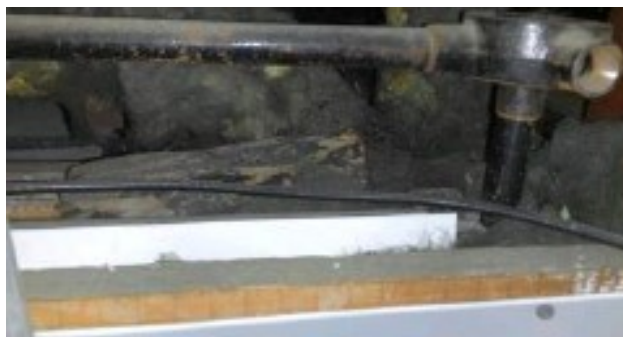
Item 112 – EA003950

The debris to wall in the Foyer/Rm 2 does not contain asbestos.

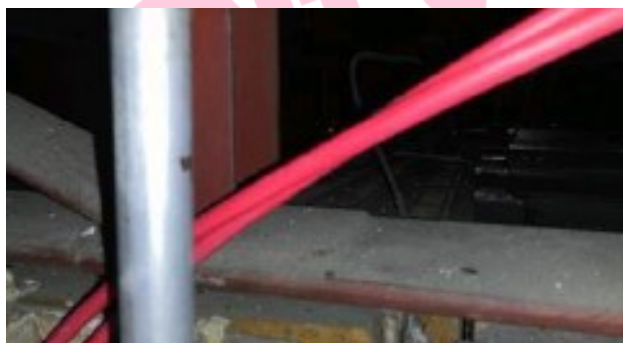
Item 113 – EA003951

The debris to wall in the Foyer/Rm 2 does not contain asbestos.

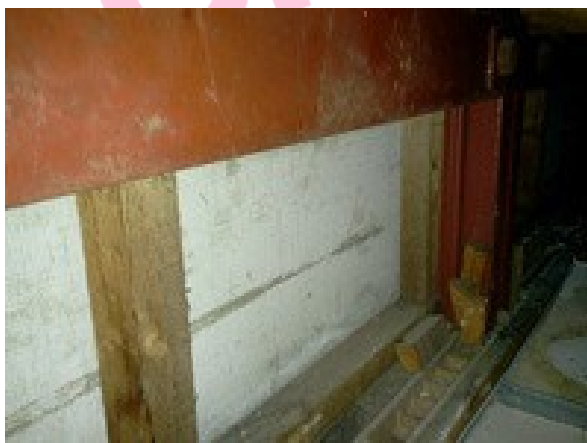
Item 128 – As 47413-7

The unsealed board to rear of main hall wall in the Girls WC void above/Rm 042 contains asbestos.

Any change should be recorded and passed to Property Services.

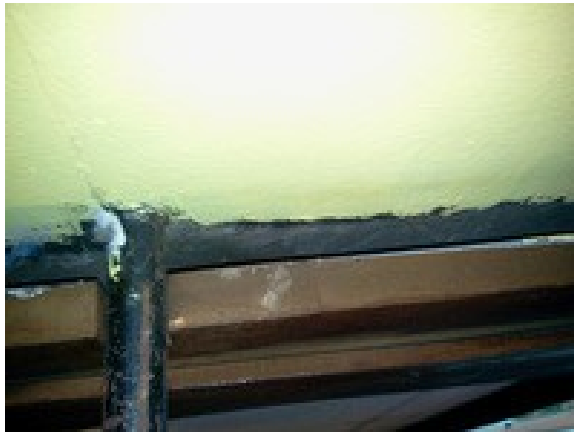
Item 129 – As 47413-3

The ceiling boards in the Former heater cupboard/Rm 043 contain asbestos.

Any change should be recorded and passed to Property Services.

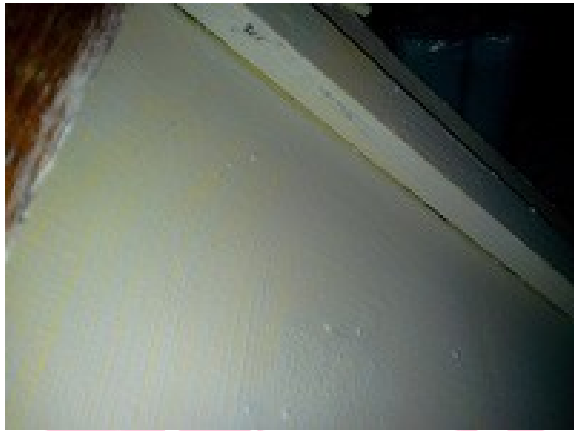
Item 130 – Presumed

The debris in nail holes to battens in the Former heater cupboard/Rm 043 is presumed to contain asbestos.

Any change should be recorded and passed to Property Services.

Removed 2014

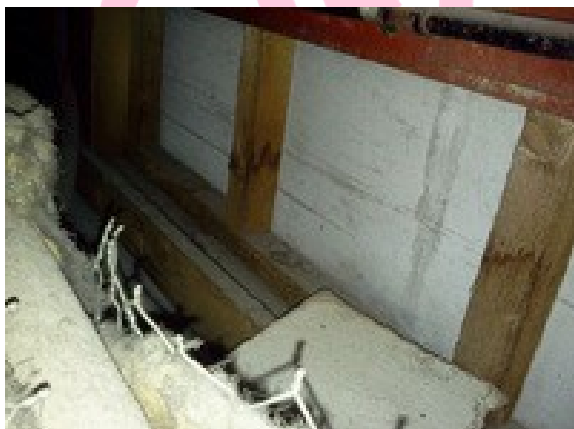
Item 131 – As 47413-7

The unsealed board to rear of main hall wall in the Former heater cupboard/Rm 043 contains asbestos.

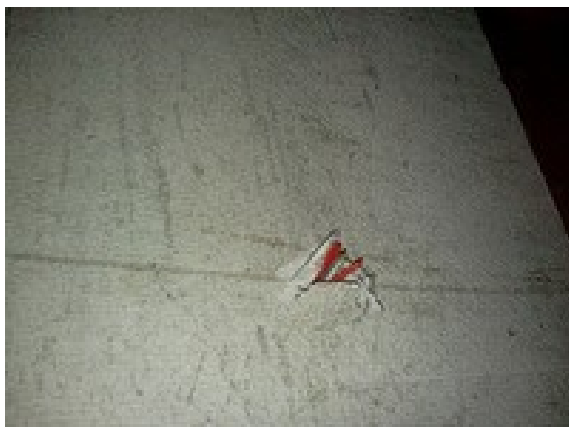
Item 139 – As 47413-7

The unsealed board to rear of main hall wall in the Kitchen void above/Rm 049 contains asbestos.

Item 138	Loose debris (Kitchen void above/Rm 049)	Low		Removed 2014
Item 139	Unsealed board to rear of main hall wall (Kitchen void above/Rm 049)	Low	DO NOT	INSPECT

Any change should be recorded and passed to Property Services.

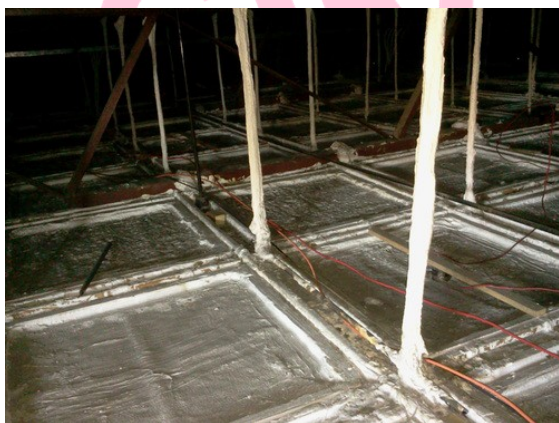
Item 140 – As 47413-8

The suspended ceiling to room below in the Hall void above/Rm 050 does not contain asbestos.

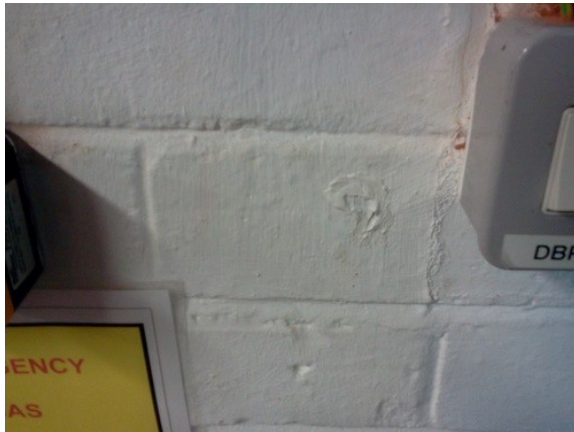
Item 141 – 47413-15

The debris to walls in the Boiler Room/Rm 051 contains asbestos.

Any change should be recorded and passed to Property Services.

Removed 2014

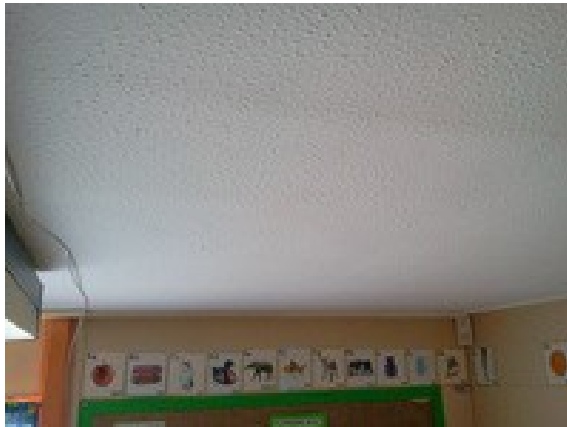
Item 142 – As 47413-13

The coating to plasterboard ceiling in the Office/Rm 001 contains asbestos.

Any change should be recorded and passed to Property Services.

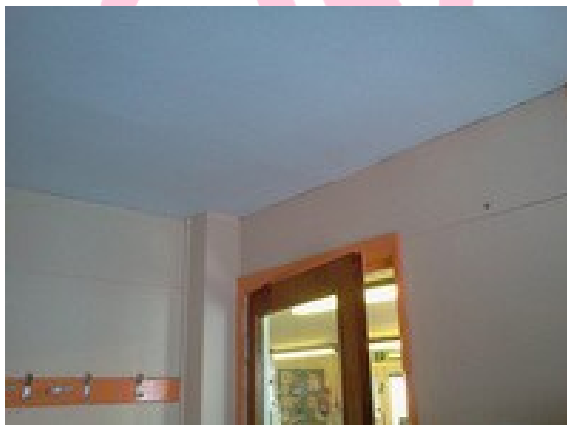
Item 143 – Presumed

The void above fixed ceiling in the Office/Rm 001 is presumed to contain asbestos.

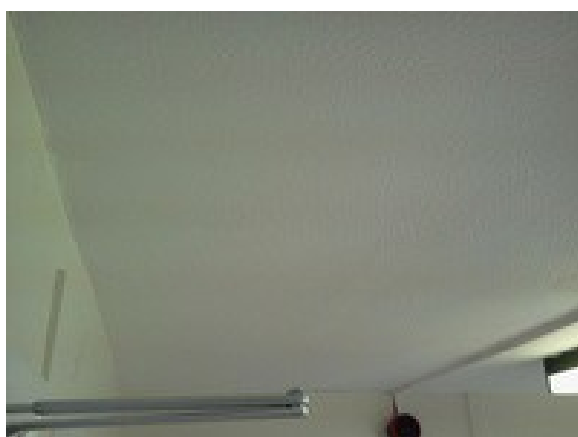
Item 145 – Presumed

The void above fixed ceiling in the Entrance Lobby/Rm 002 is presumed to contain asbestos.

Any change should be recorded and passed to Property Services.

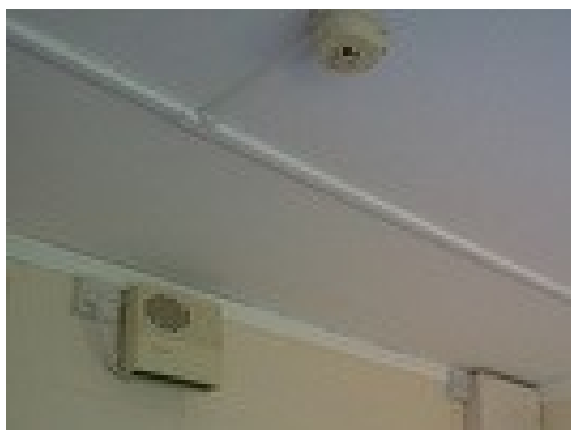
Item 146 – As 47413-13

The coating to plasterboard ceiling in the Kitchen/Rm 003 contains asbestos.

Any change should be recorded and passed to Property Services.

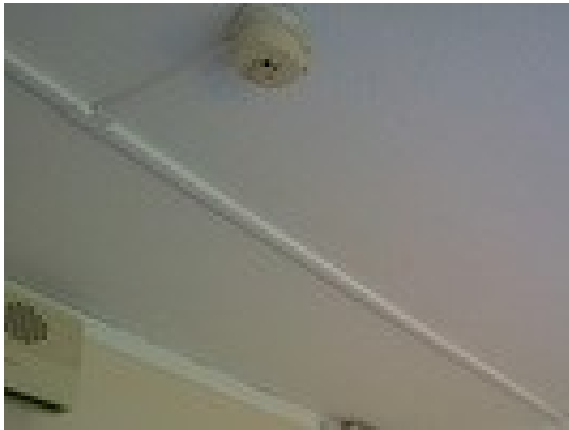
Item 147 – Presumed

The void above fixed ceiling (Kitchen/Rm 003 is presumed to contain asbestos.

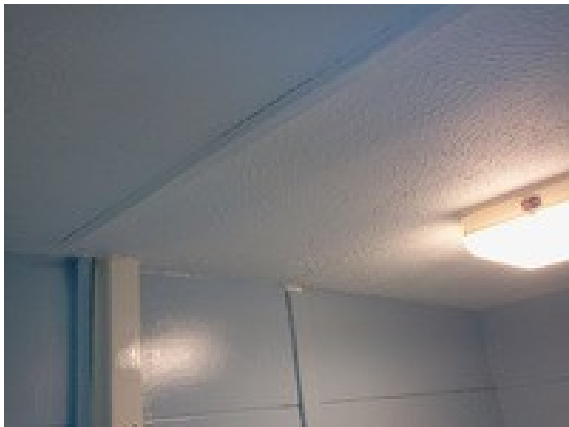
Item 148 – As 47413-12

The coating to plasterboard ceiling in the Rear lobby/Rm 004 contains asbestos.

Any change should be recorded and passed to Property Services.

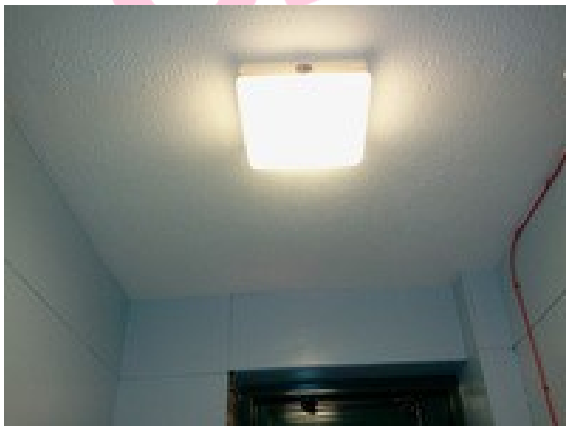
Item 149 – Presumed

The void above fixed ceiling in the Rear lobby/Rm 004 is presumed to contain asbestos.

Any change should be recorded and passed to Property Services.

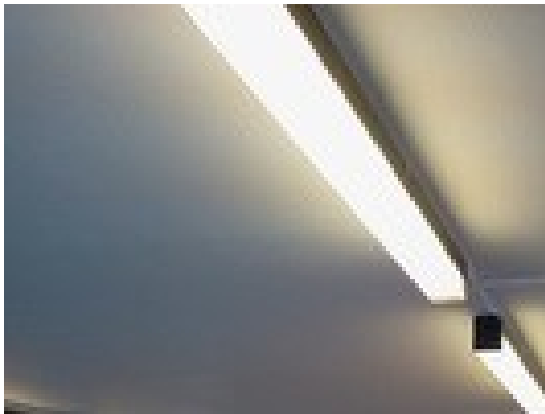
Item 151 – Presumed

The void above fixed ceiling in the Teaching Area/Rm 005 is presumed to contain asbestos.

Any change should be recorded and passed to Property Services.

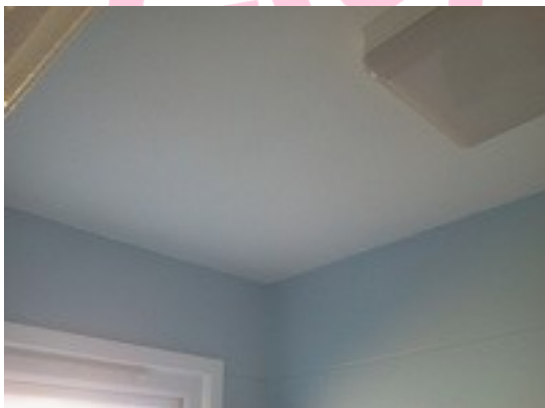
Item 152 – As 47413-12

The coating to plasterboard ceiling in the WC and Shower/Rm 006 contains asbestos.

Any change should be recorded and passed to Property Services.

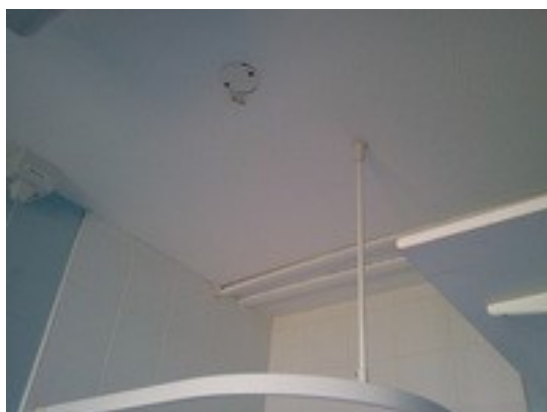
Item 153 – Presumed

The void above fixed ceiling in the WC and Shower/Rm 006 is presumed to contain asbestos.

Any change should be recorded and passed to Property Services.

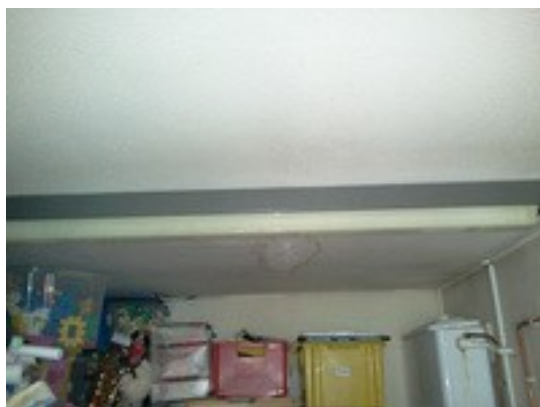
Item 154 – As 47413-11

The coating to plasterboard ceiling in the Toy Store/Rm 007 contains asbestos.

Any change should be recorded and passed to Property Services.

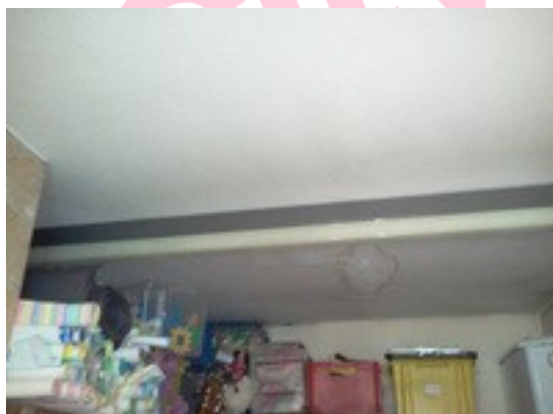
Item 155 – Presumed

The void above fixed ceiling in the Toy Store/Rm 007 is presumed to contain asbestos.

Any change should be recorded and passed to Property Services.

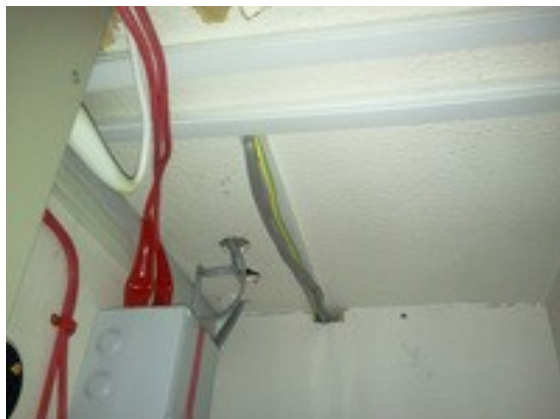
Item 156 – 47413-11

The coating to plasterboard ceiling in the Switch cupboard/Rm 009 contains asbestos.

Any change should be recorded and passed to Property Services.

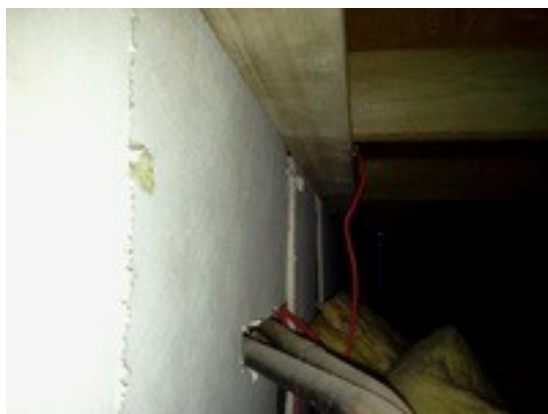
Item 157 – 47413-9

The firebreak in the switch cupboard void above/Rm 009 contains asbestos.

Any change should be recorded and passed to Property Services.

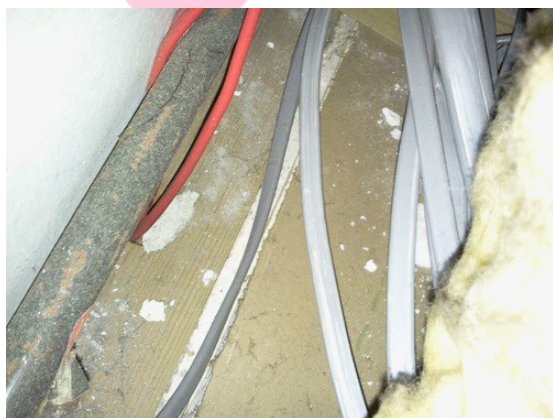
Item 158 – 47413-10

The debris to studwork and top side of fixed ceiling in the switch cupboard void above/Rm 009 contains asbestos.

Any change should be recorded and passed to Property Services.

Removed 2014

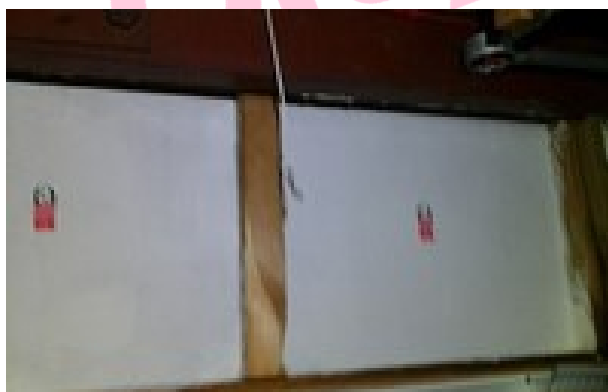
Item 161 – Presumed

The fire break above door way in the Lobby and reception void above/Rm 025 is presumed to contain asbestos.

Any change should be recorded and passed to Property Services.

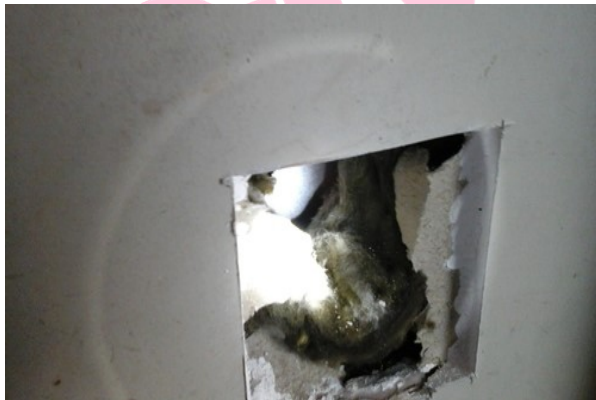
Item 164 – 74282-4

The vertical damp proof course within wall in the Toy Store/Rm 008 does not contain asbestos.

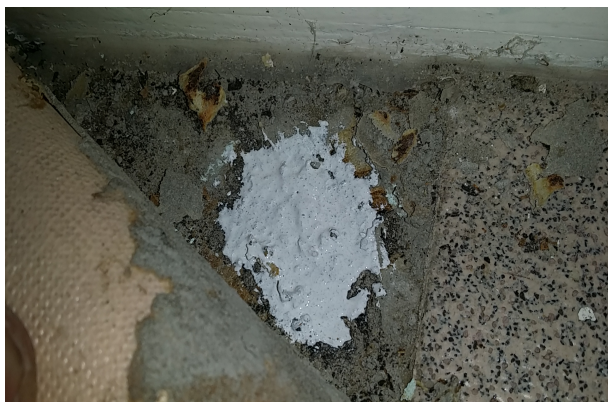
Item 165 – 110187-2

The remnant bitumen to concrete floor in the Kitchen/Rm 003 does not contain asbestos.

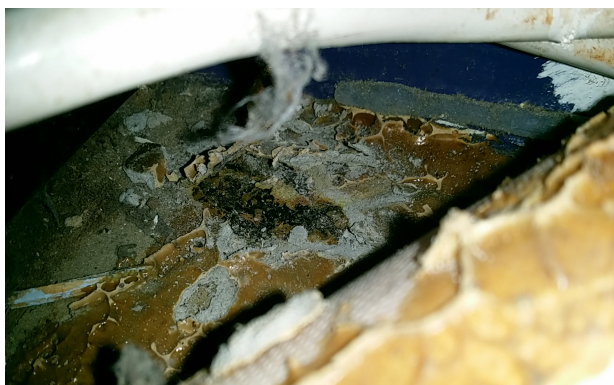
Item 166 – As 110187-2

The remnant bitumen to concrete floor in the Teaching area/Rm 005 does not contain asbestos.

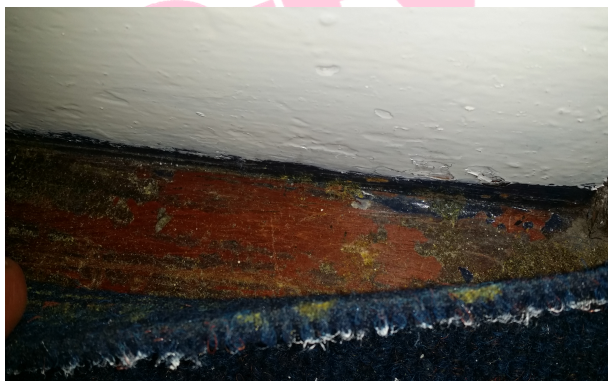
Item 167 – Presumed

The adhesive to parquet flooring in the Headteachers office/Rm 001 is presumed to contain asbestos.

Any change should be recorded and passed to Property Services.

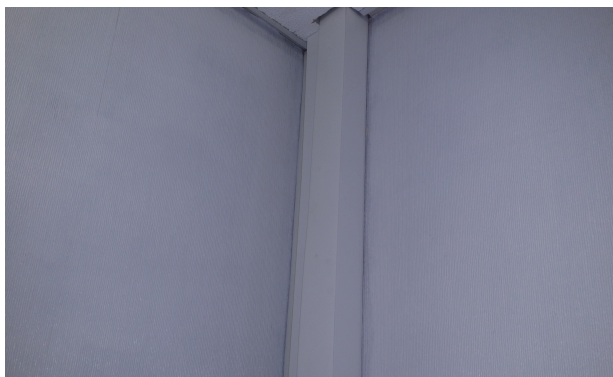
Item 168 – As 230423-1

The cladding to columns behind plasterboard walls in the Headteachers office/Rm 001 contains asbestos.

Any change should be recorded and passed to Property Services.

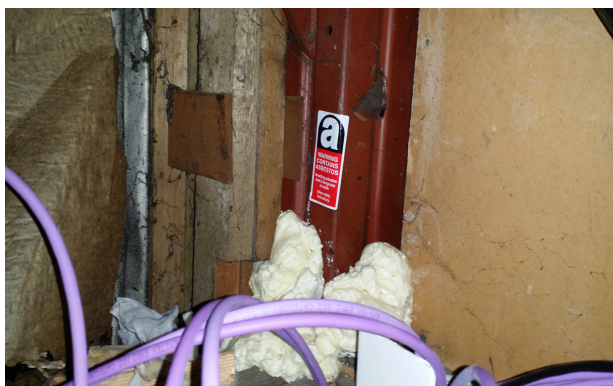
Item 169 – 230423-1

The cladding to columns in the Headteachers office void above/Rm 001 contains asbestos.

Any change should be recorded and passed to Property Services.

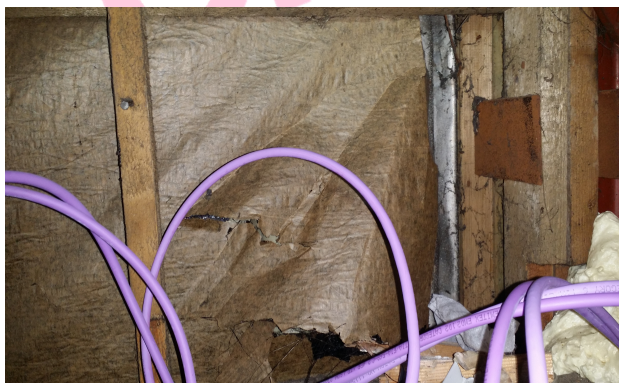
Item 170 – 230423-2

The lining to external wall in the Headteachers office void above/Rm 001 does not contain asbestos.

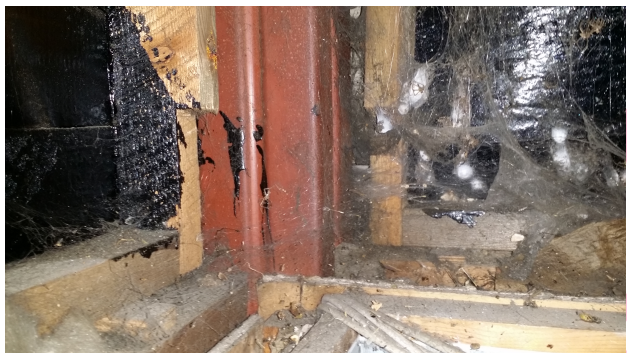
Item 172 – As 230423-1

The cladding to columns in the Corridor void above/Rm 008 contains asbestos.

Any change should be recorded and passed to Property Services.

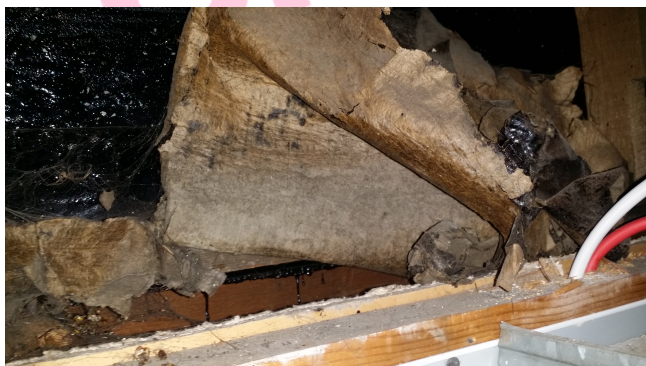
Item 173 – 230423-2

The lining to top of walls in the Corridor void above/Rm 008 does not contain asbestos.

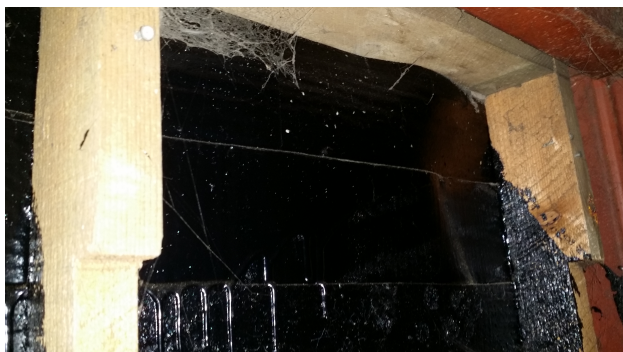
Item 174 – 230423-3

The damp proof membrane in the Corridor void above/Rm 008 does not contain asbestos.

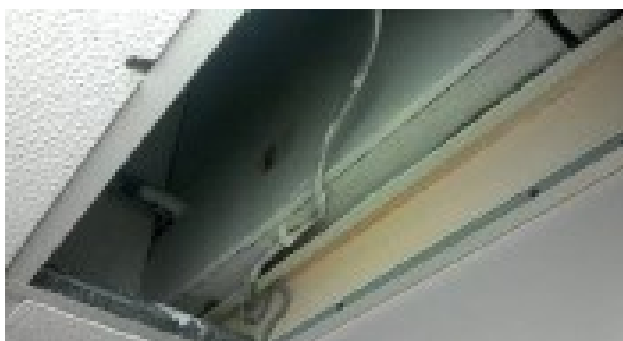
Item 175 – AF002840

The firebreak in the Office void above contains asbestos.

Any change should be recorded and passed to Property Services.

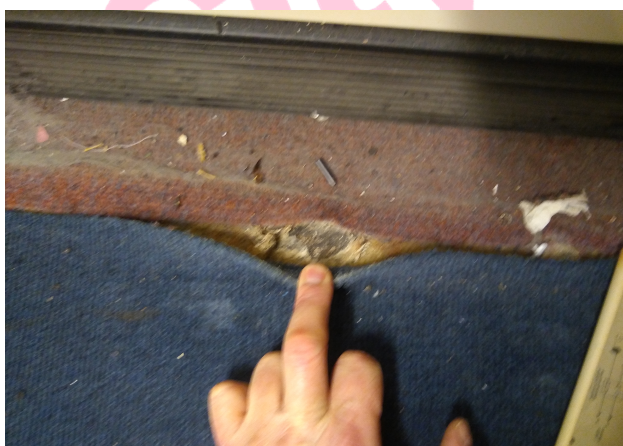
Item 176 – 386839-1

The floor screed in the Classroom/Office Rm 0/001 does not contain asbestos.

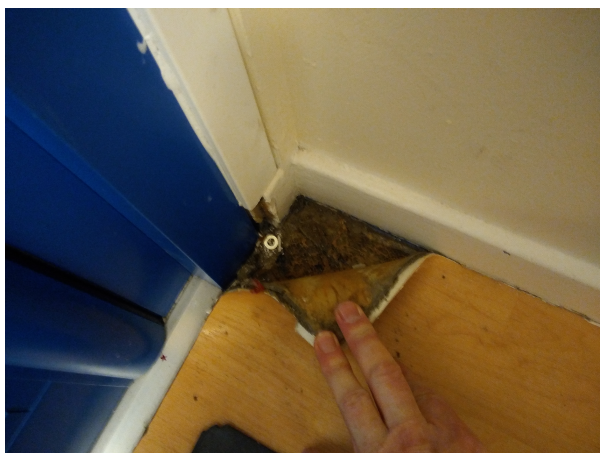
Item 178 – As 386839-1

The floor screed in the Entrance Lobby/Rm 0/002 does not contain asbestos.

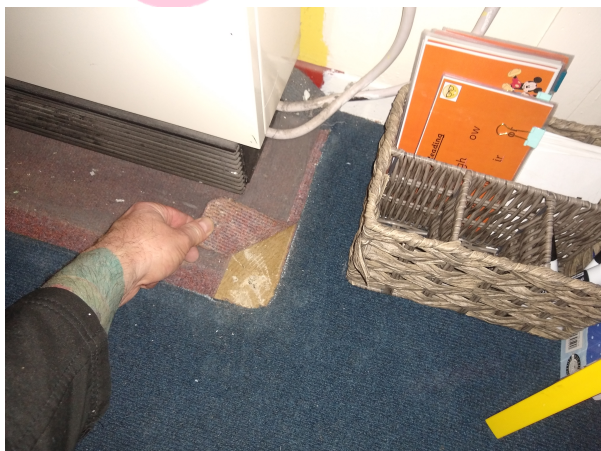
Item 179 – As 386839-1

The floor screed in the Entrance Lobby/Rm 0/002 does not contain asbestos.

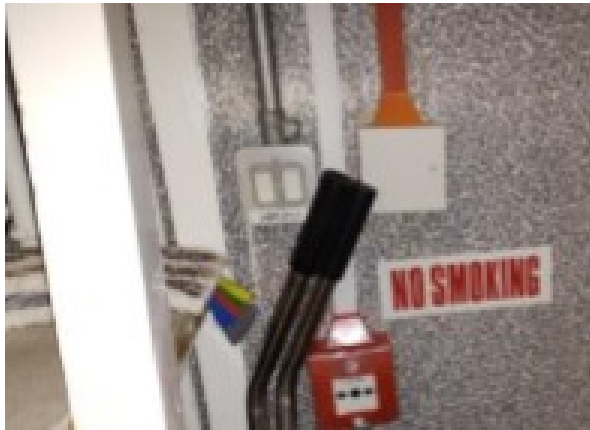
Item 180 – 20-28742-1

The walls in the kitchen do not contain asbestos.

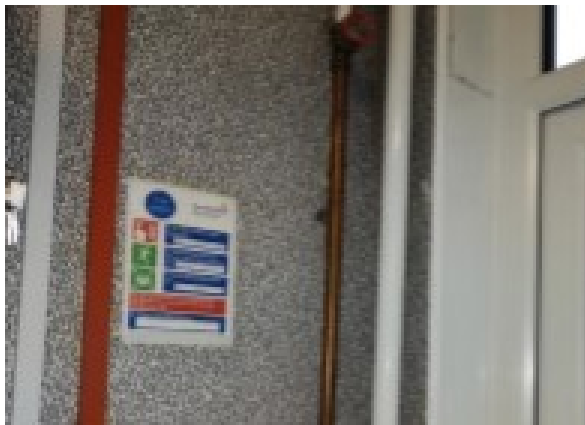
Item 181 – 20-28742-2

The boxing in the kitchen does not contain asbestos.

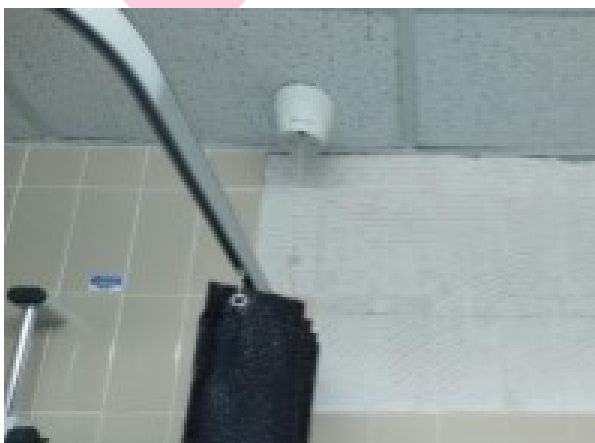
Item 182 – 2-31309-1

The ceramic tile adhesive to the walls in the WC/Shower Room (Area 1) does not contain asbestos.
