ASBESTOS SURVEY REPORT FOR GILLAS LANE PRIMARY SCHOOL, HOUGHTON

Asbestos Register for

GILLAS LANE PRIMARY SCHOOL HOUGHTON

Date: 10 June 2025

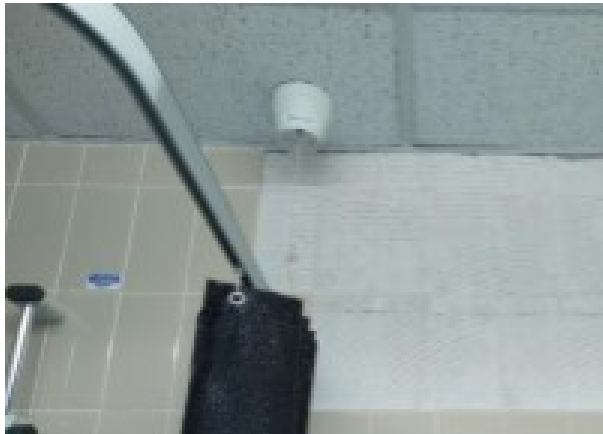
Item 183 – 21-31309-2

The putty to the shower tray in the WC/Shower Room (Area 1) does not contain asbestos.

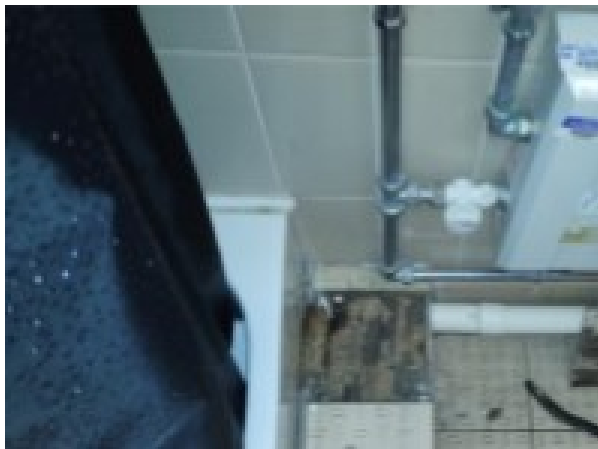
Item 184 – 21-31309-3

The ceramic tile adhesive to the floor in the WC/Shower Room (Area 1) does not contain asbestos.

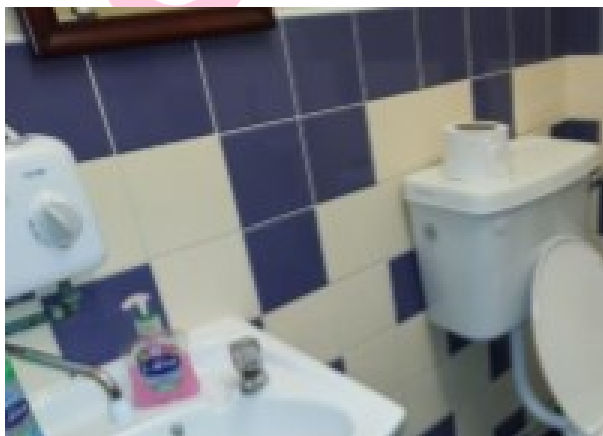
Item 185 – 21-31309-3

The ceramic tile adhesive to the walls in the Toilet (Area 3) does not contain asbestos.

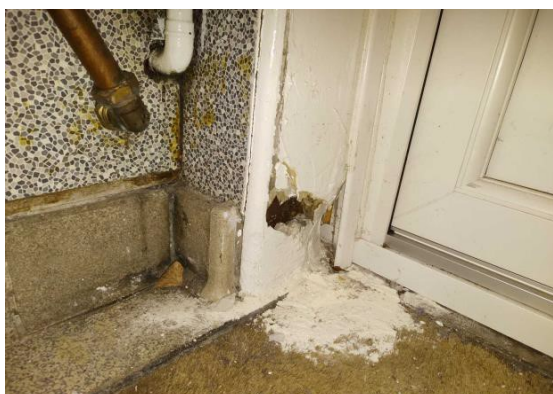
Item 186 – 23-56446

The debris to floor at door reveal (insulation) (Kitchen) does not contain asbestos.

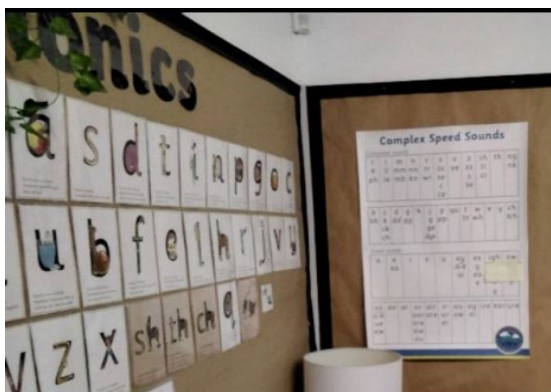
Item 187 – DC003405

The wall plasterboard over mmmf insulation to brick in the small office (Rm G/001) does not contain asbestos.

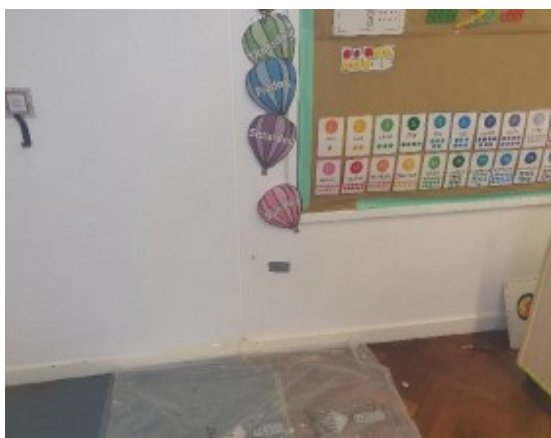
Item 189 – EV006807

The insulating board steel columns in Class 1 (Rm G/001) does contain asbestos.

Any change in appearance should be reported to Property Services.

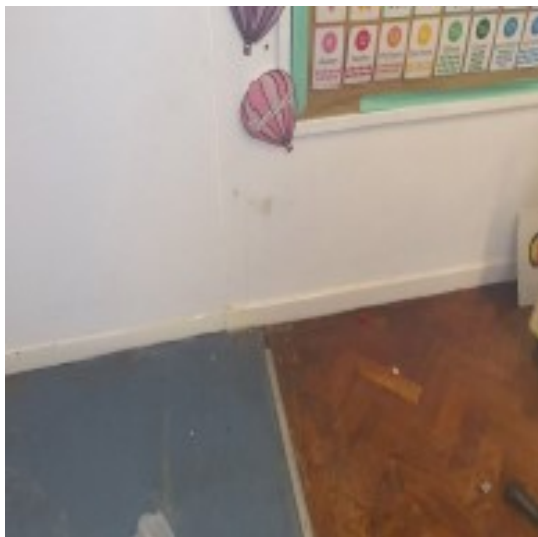
Item 190 – EV006808

The bitumen floor in Class 1 (Rm G/001) does not contain asbestos.

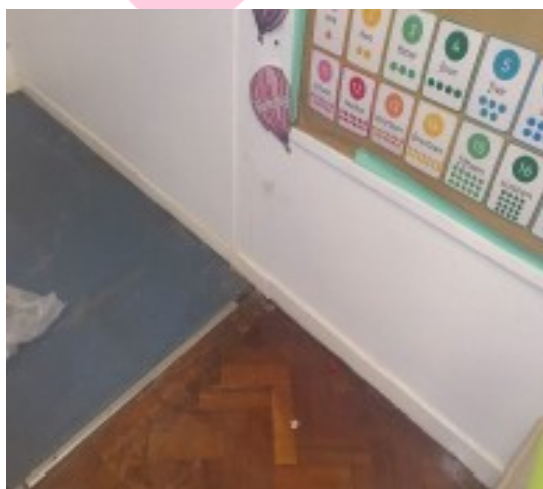
Item 191 – EV006809

The vinyl tiles and bitumen floor in Class 1 (Rm G/001) does not contain asbestos.

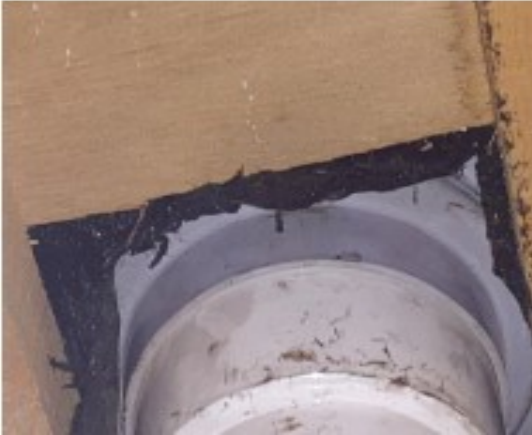
Item 192 – EV006810

The bitumen wrap to plastic soil pipe in Intervention Room (G/02) does not contain asbestos.

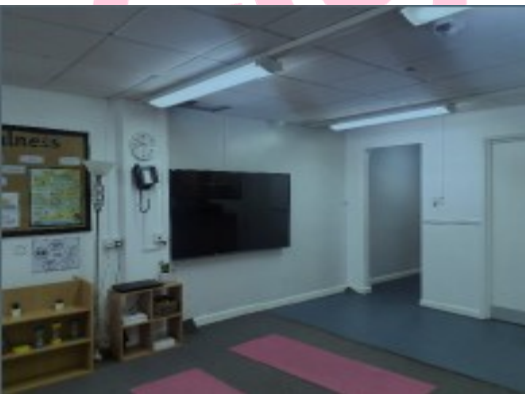
Item 193 – EV006811

The stramit void in Intervention Room (G/02) does not contain asbestos.

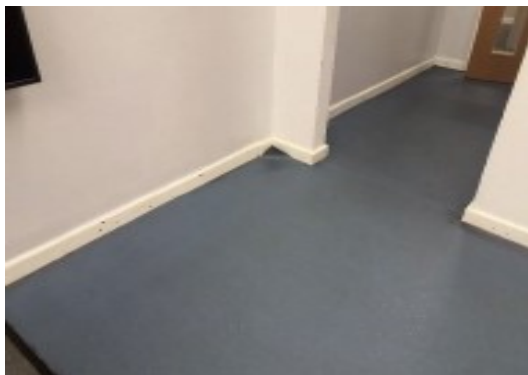
Item 194 – EV006812

The plaster walls in Intervention Room (G/02) does not contain asbestos.

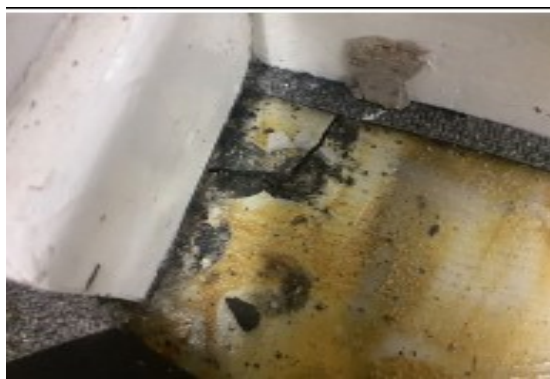
Item 195 – EV006813

The vinyl tiles and bitumen in Intervention Room (G/02) does not contain asbestos.
