### ASBESTOS SURVEY REPORT FOR RICHARD AVENUE PRIMARY SCHOOL, SUNDERLAND

**RICHARD AVENUE PRIMARY SCHOOL**

**Date: 28 May 2026**

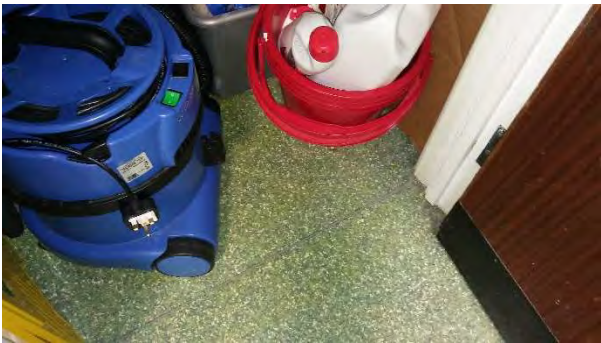
### **Item 22 - Ref: 369924-6**

The floor screed beneath modern screed (015A/ corridor) does not contain asbestos.

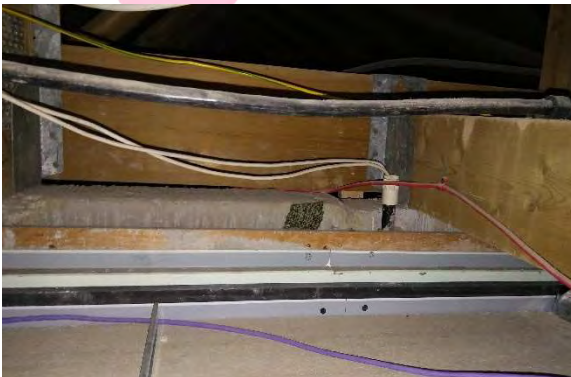
### **Item 33 - Ref: As 369924-8**

The packers to ceiling grid (024/classroom-void above) does not contain asbestos.

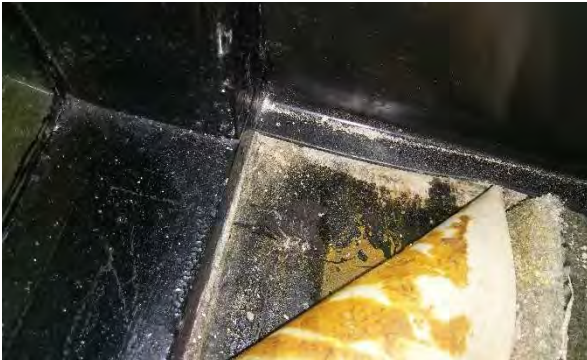
### **Item 34 - Ref: 369924-7**

The screed to floor below floor covering (025/corridor) does not contain asbestos.

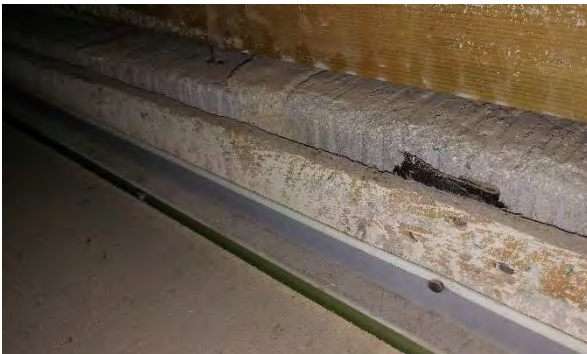
### **Item 35 - Ref: 369924-8**

The felt packers old ceiling tracking (025/classroom-void above) does not contain asbestos.

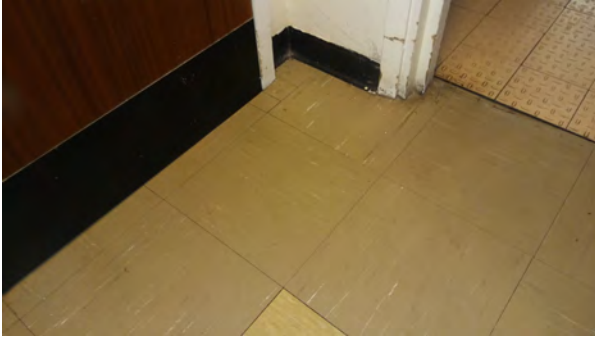
**Item 58 - Ref: As 369924-9**

The floor covering (046/lobby) does not contain asbestos.

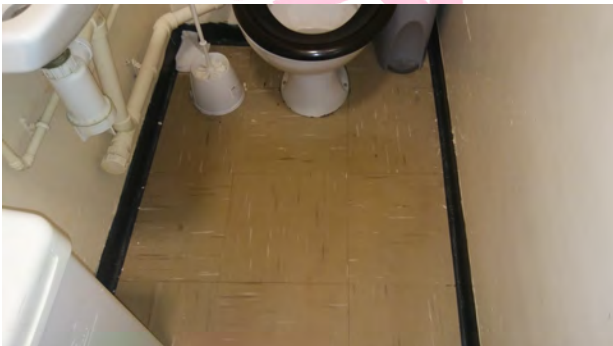
**Item 60 - Ref: As 369924-9**

The floor covering (047/WC) does not contain asbestos.

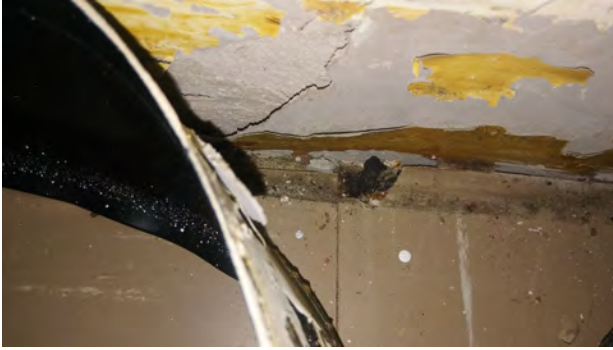
### **Item 61 - Ref: As 369924-7**

The screed to floor below tiles (047/WC) does not contain asbestos.

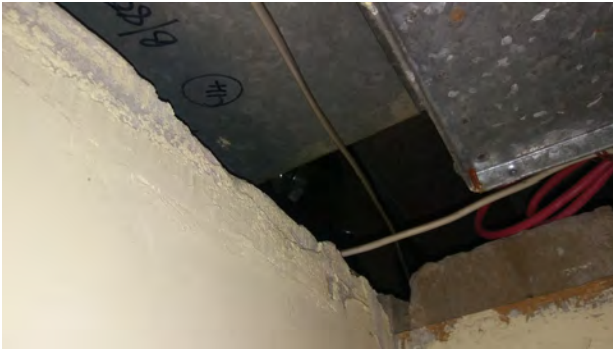
### **Item 62 - Ref: 369924-12**

The red mastic to ductwork (047/WC-void above) contains asbestos.

Any change in its appearance should be recorded and passed to Property Services.

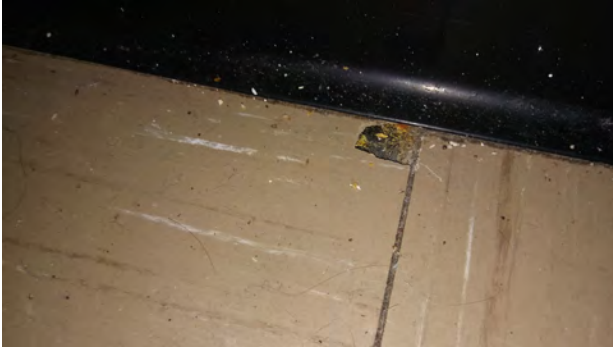
### **Item 64 - Ref: As 369924-7**

The screed to floor below tiles (048/store) does not contain asbestos.

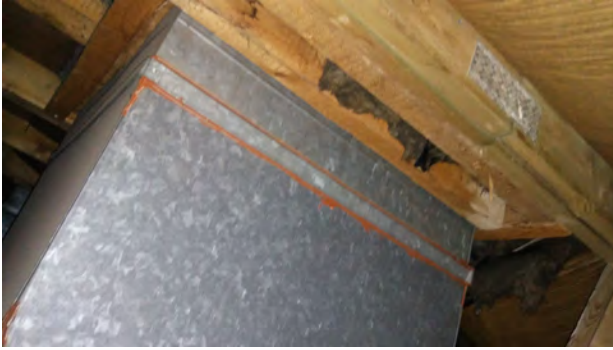
### **Item 67 - Ref: 369924-11**

The red mastic to ductwork (052/store) does not contain asbestos.

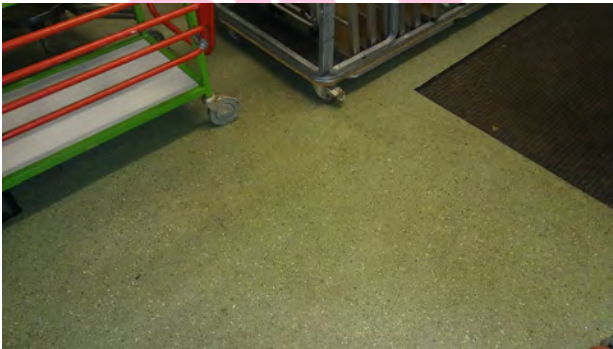
### **Item 69 - Ref: As 369924-5**

The screed under modern screed to perimeter (053/hall store area) does not contain asbestos.

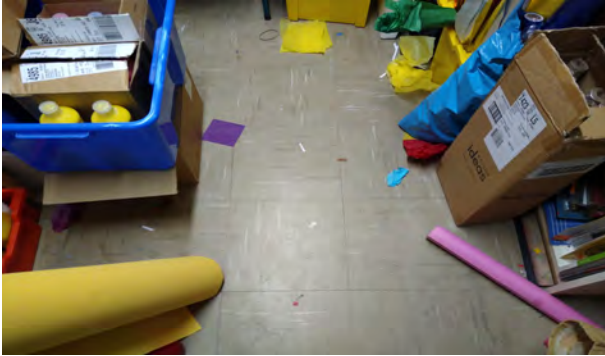
### **Item 70 - Ref: As 369924-9**

The floor covering (054/store) does not contain asbestos.

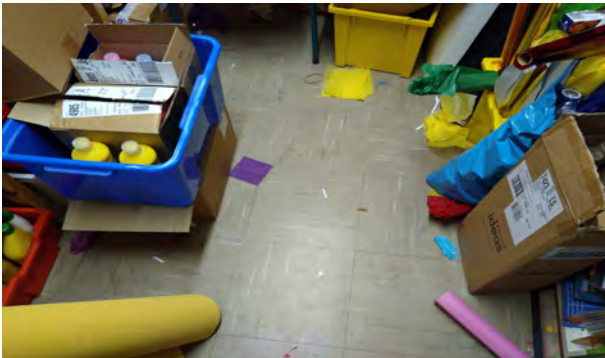
### **Item 71 - Ref: As 369924-13**

The screed under tiles (054/store) does not contain asbestos.

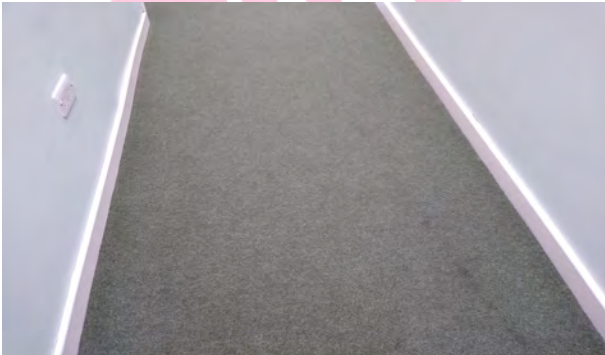
### **Item 72 - Ref: As 369924-13**

The screed under modern screed (055/corridor) does not contain asbestos.

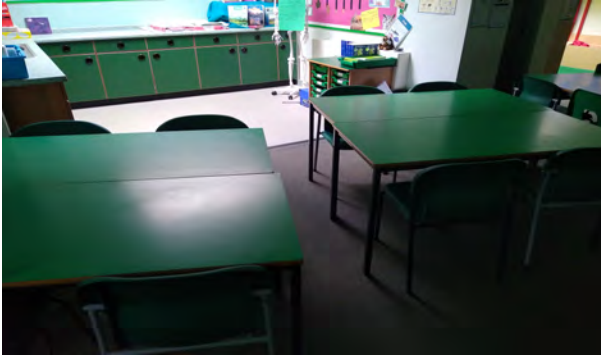
### **Item 73 - Ref: As 369924-13**

The floor covering (056/classroom) does not contain asbestos.

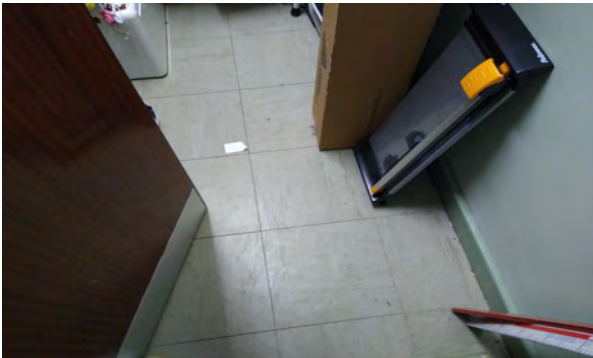
### **Item 74 - Ref: As 369924-13**

The floor covering (057/store) does not contain asbestos.

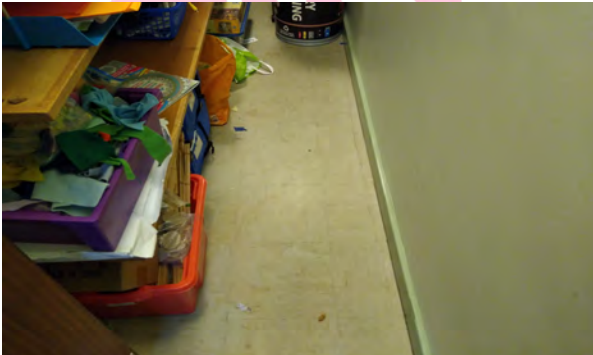
### **Item 75 - Ref: As 369924-13**

The floor covering (058/store) does not contain asbestos.

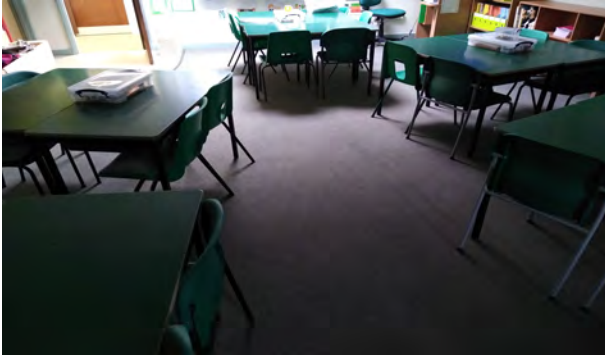
### **Item 76 - Ref: As 369924-13**

The floor covering  
(059/classroom) does not  
contain asbestos.

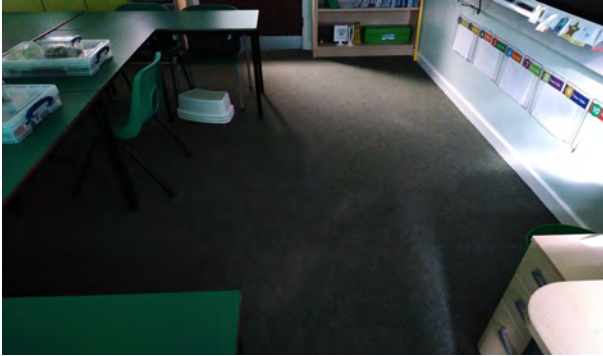
### **Item 79 - Ref: As 369924-13**

The screed under modern screed (062/classroom) does not contain asbestos.

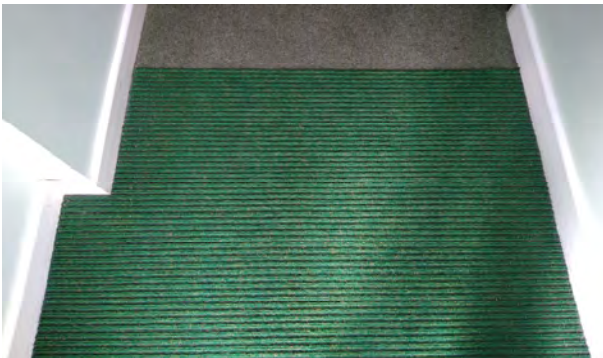
### **Item 80 - Ref: As 369924-13**

The screed under modern screed (063/lobby) does not contain asbestos.

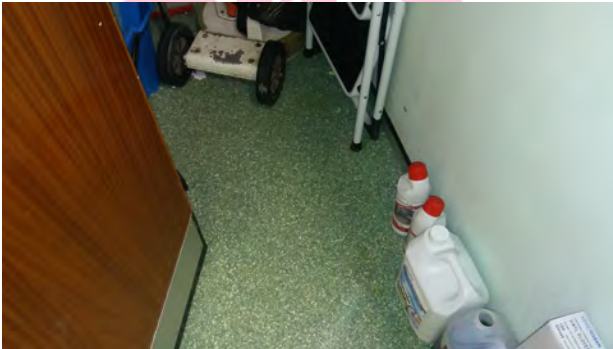
### **Item 81 - Ref: As 369924-13**

The screed under modern screed (064/cleaners store) does not contain asbestos.

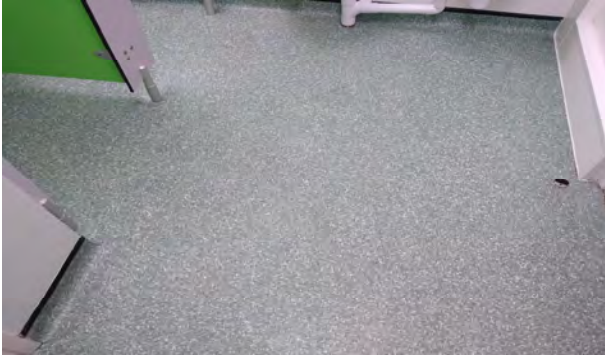
### **Item 82 - Ref: As 369924-13**

The screed under modern screed (065/male WC) does not contain asbestos.

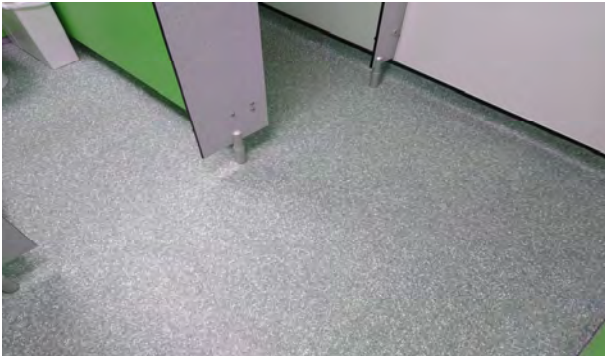
### **Item 83 - Ref: As 369924-13**

The screed under modern screed (066/female WC) does not contain asbestos.

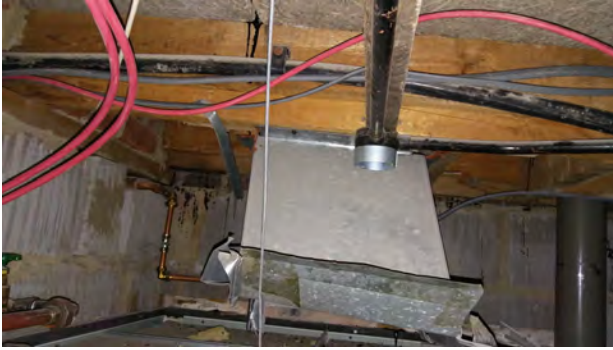
### **Item 88 - Ref: As 369924-11**

The red mastic to ductwork (071/accessible WC-void above) does not contain asbestos.

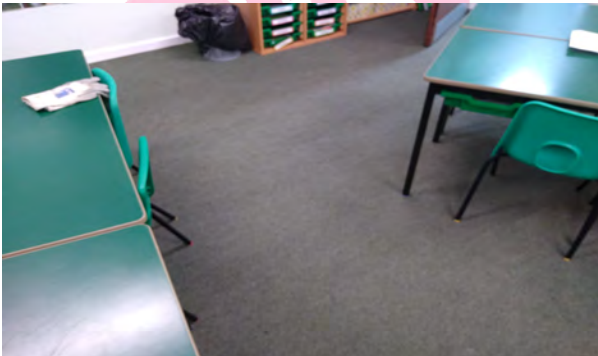
### **Item 90 - Ref: As 369924-13**

The screed under modern screed (072/classroom) does not contain asbestos.

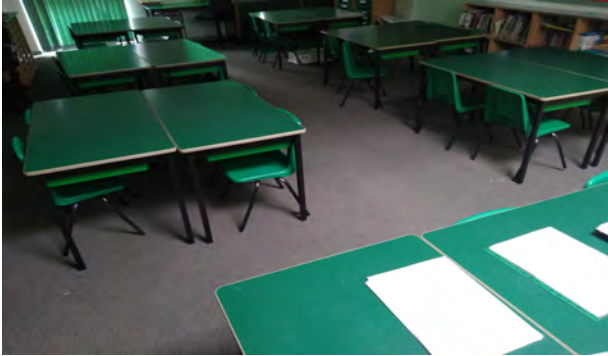
### **Item 91 - Ref: As 369924-13**

The screed under modern screed (073/classroom) does not contain asbestos.

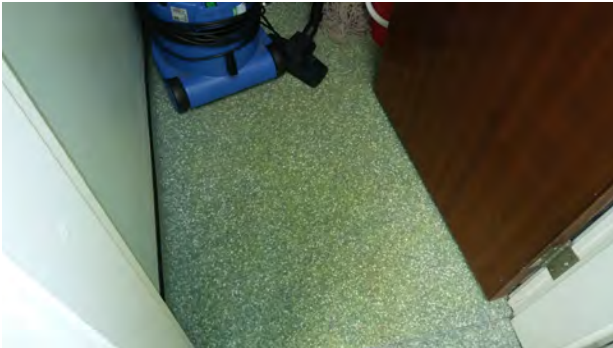
### **Item 95 - Ref: As 369924-13**

The screed under modern screed (077/cleaners store) does not contain asbestos.

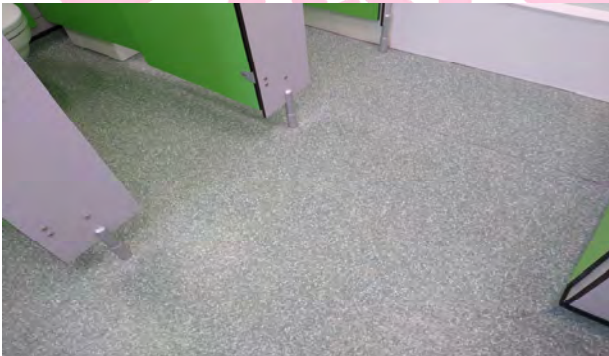
### **Item 96 - Ref: As 369924-13**

The screed under modern screed (078/female WC) does not contain asbestos.

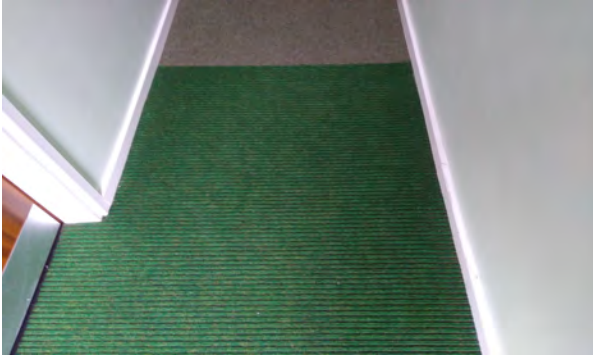
### **Item 97 - Ref: As 369924-13**

The screed under modern screed (079/lobby) does not contain asbestos.

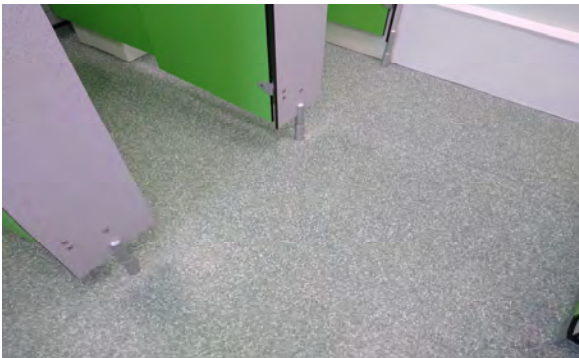
### **Item 98 - Ref: As 369924-13**

The screed under modern screed (079/lobby) does not contain asbestos.

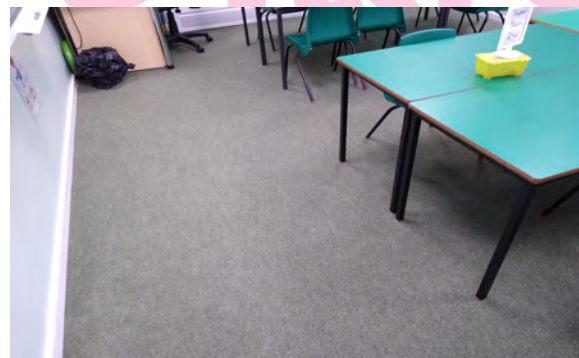
### **Item 99 - Ref: As 369924-13**

The screed under modern screed (080/classroom-void above) does not contain asbestos.

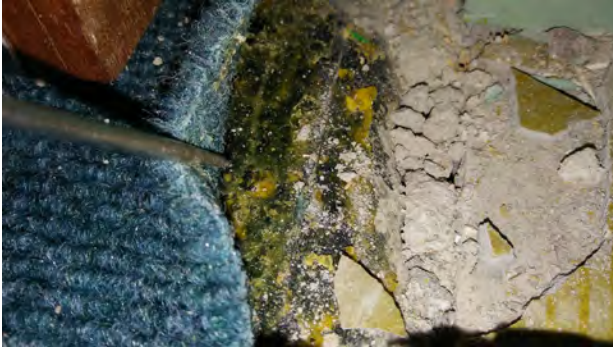
### **Item 100 - Ref: As 369924-13**

The screed under modern screed (081/ICT suite) does not contain asbestos.

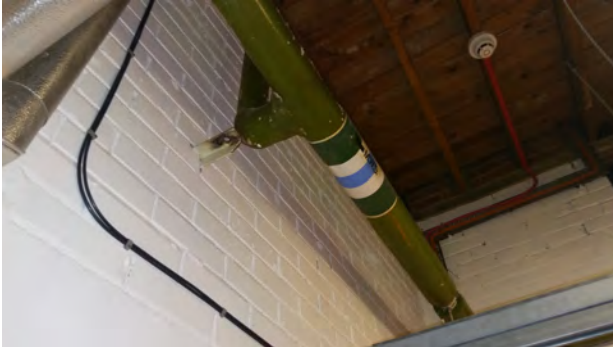
**Item 103 - Ref: 369924-1**

The pipe lagging (084/boiler room) does not contain asbestos.

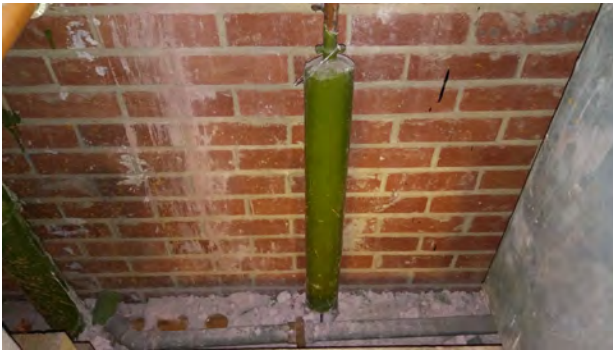
**Item 107 - Ref: 369924-22**

The pipe lagging (084/boiler room – void above) does not contain asbestos.

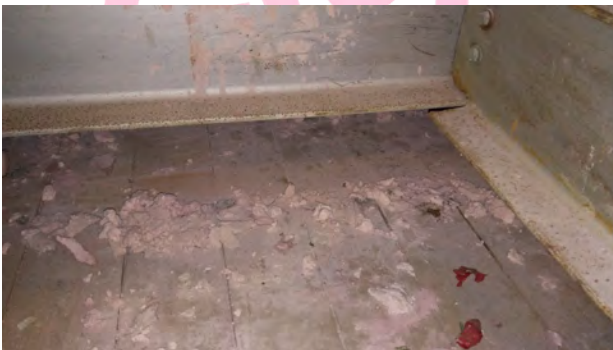
**Item 108 - Ref: As 369924-22**

The debris to floor (084/boiler room – void above) does not contain asbestos.

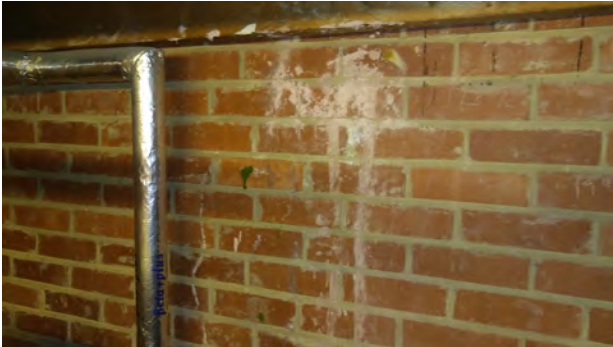
### **Item 109 - Ref: As 369924-22**

The debris to walls (084/boiler room – void above) does not contain asbestos.

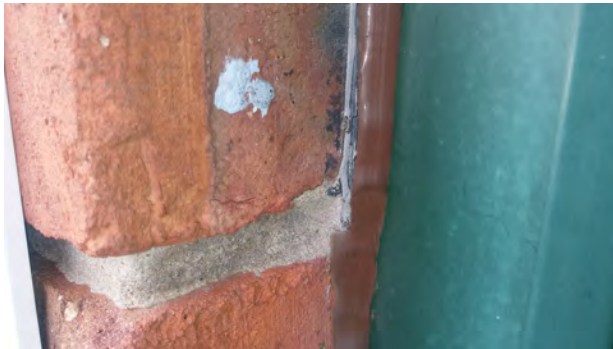
### **Item 110 - Ref: 369924-15**

The grey window sealant behind modern brown mastic (externals) contains asbestos.

Any change in its appearance should be recorded and passed to Property Services.

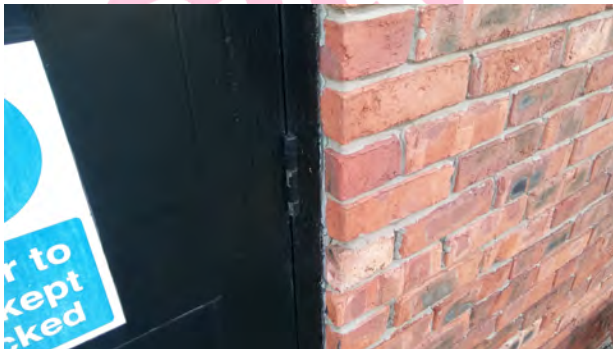
### **Item 111 - Ref: 369924-16**

The sealant to boiler room door frame (externals) contains asbestos.

Any change in its appearance should be recorded and passed to Property Services.

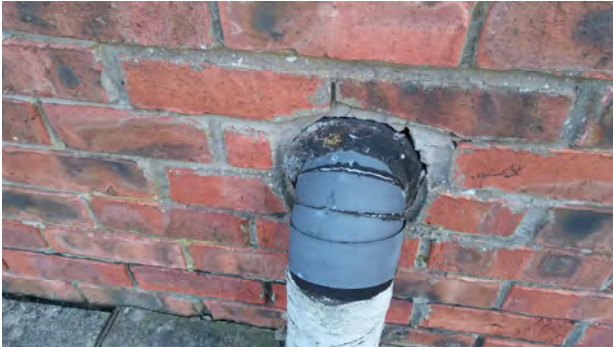
### **Item 112 - Ref: 369924-17**

The sealant to pipe penetration leading into 0/083 (externals) does not contain asbestos.

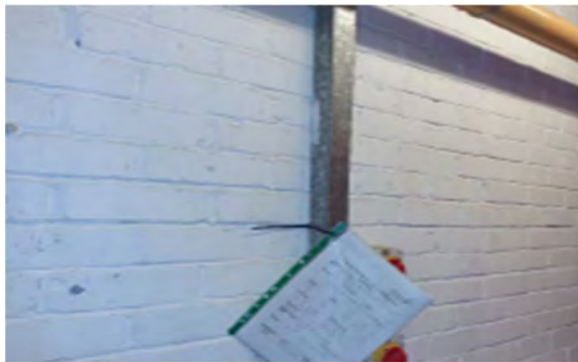
### **Item 116 - Ref: HD000896**

The Thermal installation walls (Boiler Room G/01) does not contain asbestos.

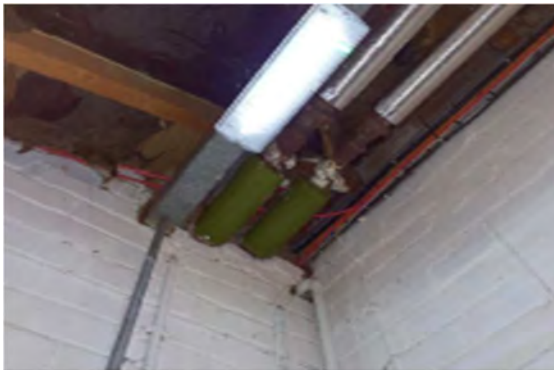
### **Item 119 - Ref: HD000899**

The Thermal installation ceiling (Boiler Room G/01) does not contain asbestos.

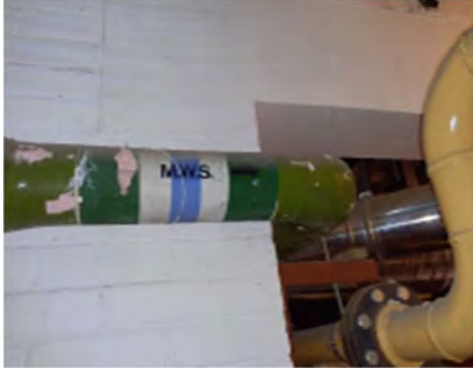
**Item 120 - Ref: HD000901**

The Thermal insulation pipework (Boiler Room G/01) does not contain asbestos.

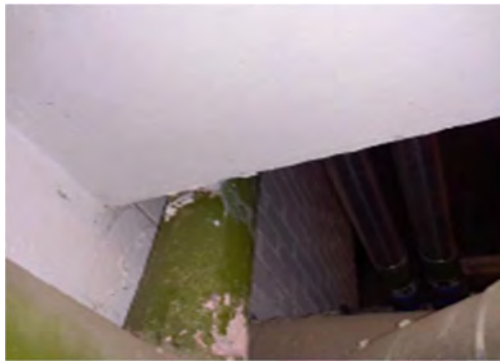
**Item 121 - Ref: HD000902**

The Thermal insulation pipework (Boiler Room G/01) does not contain asbestos.

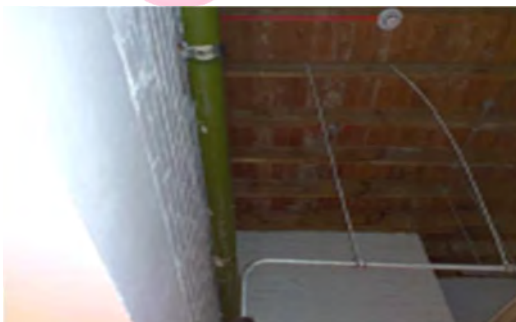
**Item 122 - Ref: HD000903**

The Thermal insulation pipework (Boiler Room G/01) does not contain asbestos.

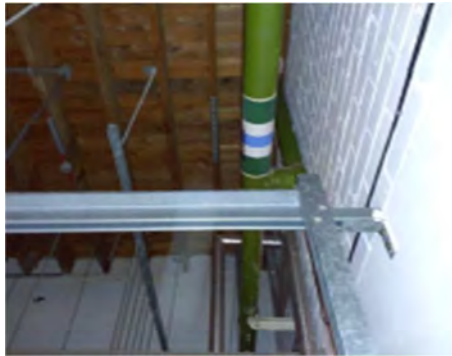
**Item 123 - Ref: HD000904**

The Thermal insulation pipework (Boiler Room G/01) does not contain asbestos.

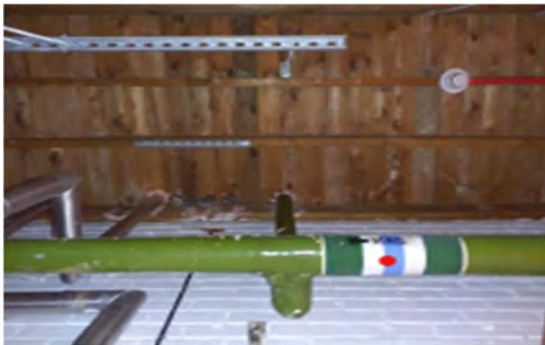
**Item 124 - Ref: HD000905**

The Thermal insulation pipework (Boiler Room G/01) does not contain asbestos.

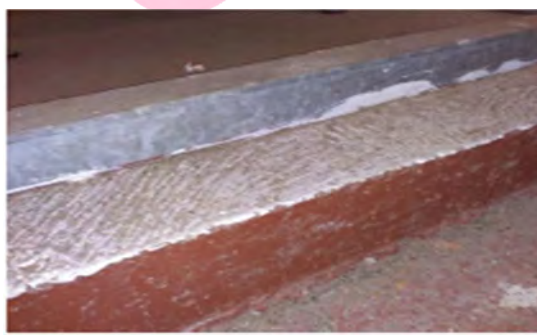
**Item 125 - Ref: HD000906**

The Dust/debris floor (Boiler Room G/01) does not contain asbestos.

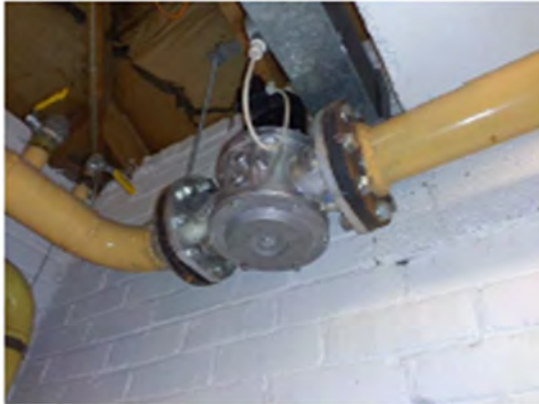
**Item 126 - Ref: HD000907**

The Gasket boilers (Boiler Room G/01) does not contain asbestos.

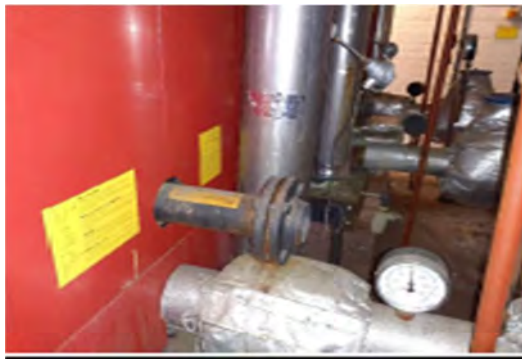
**Item 127 - Ref: HD000909**

The Gaskets to the boilers (Boiler Room G/01) does not contain asbestos.

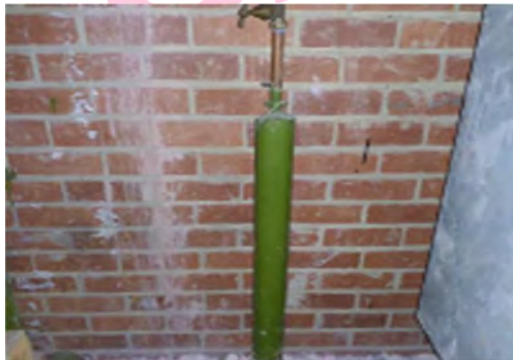
**Item 128 - Ref: HD000910**

The Thermal insulation pipework (Boiler Room Tank Room 1/01) does not contain asbestos.

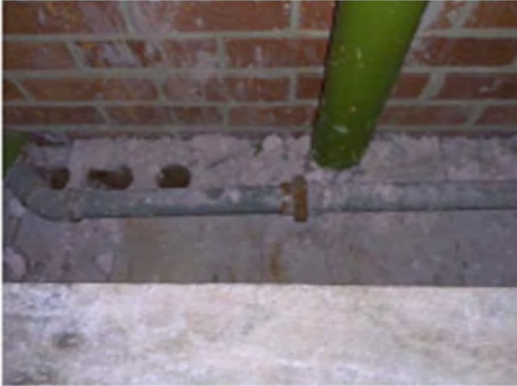
**Item 129 - Ref: HD000911**

The Thermal insulation floor (Boiler Room Tank Room 1/01) does not contain asbestos.

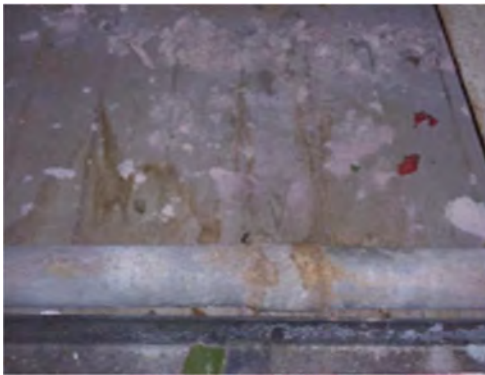
**Item 130 - Ref: HD000912**

The Thermal insulation pipework (Boiler Room Tank Room 1/01) does not contain asbestos.

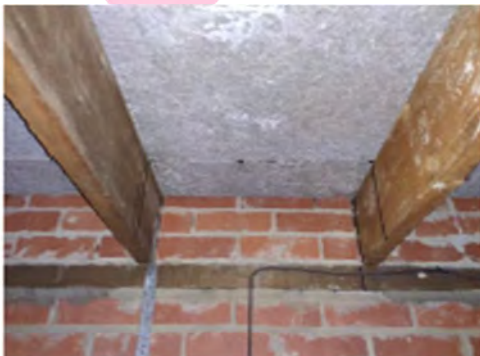
**Item 131 - Ref: HD000913**

The Bitumen wall (Boiler Room Tank Room 1/01) does not contain asbestos.

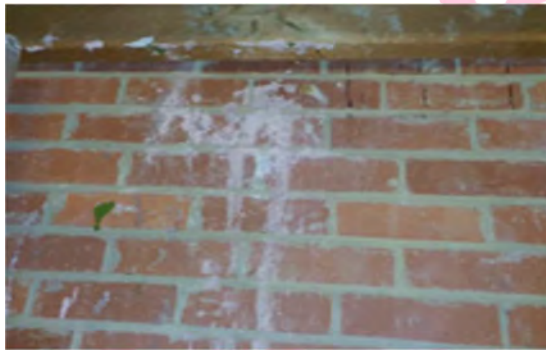
**Item 133 - Ref: HD000915**

The thermal insulation to walls (Boiler Room Tank Room 1/01) does not contain asbestos.
