ASBESTOS SURVEY REPORT FOR RICKLETON PRIMARY SCHOOL,
WASHINGTON, NE38 9EZ.

Rickleton Primary School, Washington, NE38 9EZ

Date: 05 December 2025

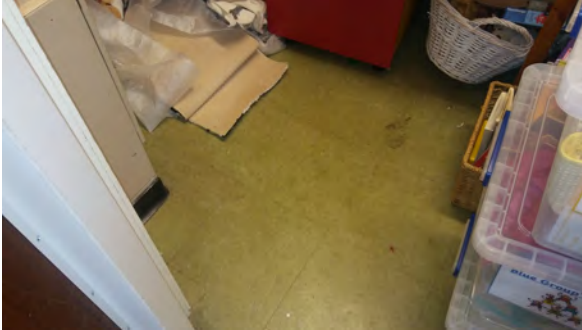
Item 4 Ref: As 412937-3

- (Item 3) Ref: As 412937-4 – Sealant to glazed door panel to 0/009 (0/003 Nursery Classroom) – Very Low Risk
- (Item 4) Ref: As 412937-3 – Floor covering (0/003a deputy) – Very Low Risk

The floor covering in Rm 0/003a Store contains asbestos.

Any change in its appearance should be recorded and passed to Property Services.

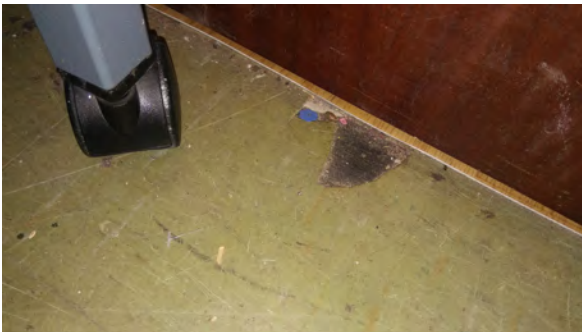
Item 5 Ref: As 412937-1

- (Item 5) Ref: As 412937-1 – Floor screed (0/003a Store) – Very Low Risk
- (Item 6) Ref: 412937-1 – Floor screed (0/004 Cleaners cupboard) – Very Low Risk

The floor screed in Rm 0/003a Store contains asbestos.

Any change in its appearance should be recorded and passed to Property Services.

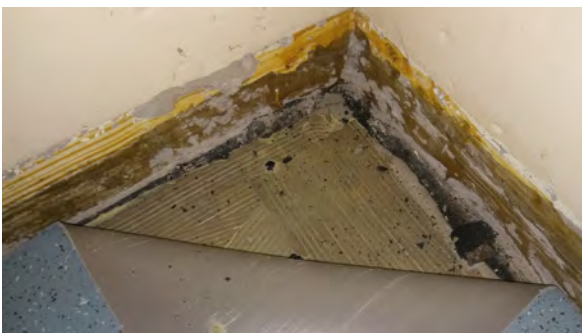
Item 6 Ref: 412937-1

The floor screed in 0/004 Cleaners cupboard contains asbestos.

Any change in its appearance should be recorded and passed to Property Services.

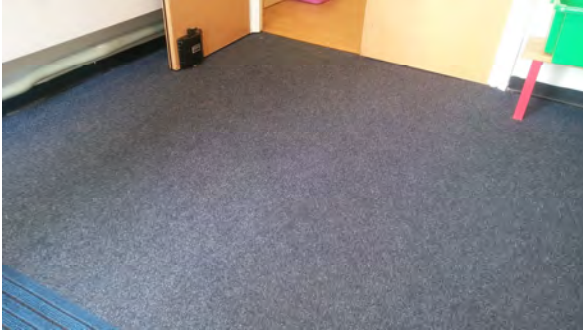
Item 10 Ref: As 412937-1

- (Item 10) Ref: As 412937-1 – Floor screed beneath lino (0/008 Cloakroom) – Very Low Risk
- (Item 11) Ref: As 412937-1 – Floor screed (0/009 Office) – Very Low Risk

The floor screed beneath lino in Rm 0/008 Cloakroom contains asbestos.

Any change in its appearance should be recorded and passed to Property Services.

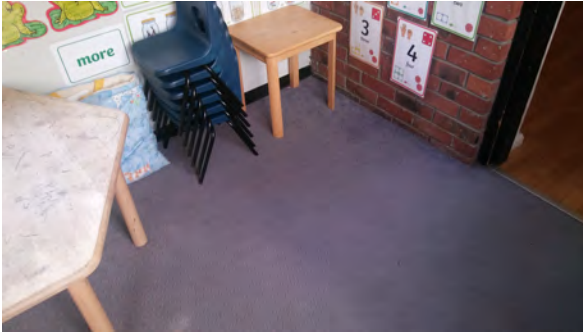
Item 13 Ref: As 412937-1

- (Item 12) Ref: 412937-4 – Sealant to glazed door panel (0/009 Office) – Very Low Risk
- (Item 13) Ref: As 412937-1 – Floor screed beneath lino (0/10 Link Corridor) – Very Low Risk

The floor screed beneath lino in 0/10 Link Corridor contains asbestos.

Any change in its appearance should be recorded and passed to Property Services.

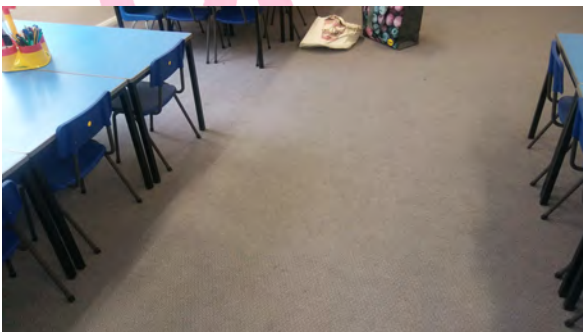
Item 15 Ref: As 412937-5

The floor screed beneath carpet in Rm 0/11 Classroom does not contain asbestos.

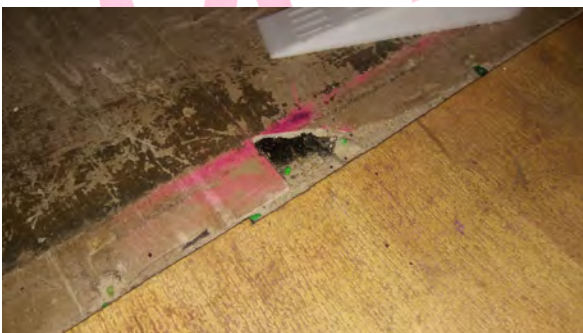
Item 18 Ref: As 412937-5

The floor screed beneath lino in Rm 0/12b Switch Cupboard does not contain asbestos.

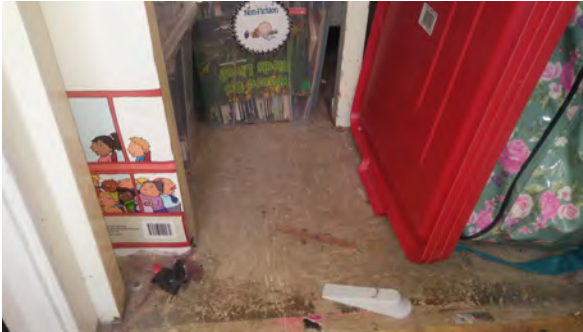
Item 19 Ref: 412937-6

- (Item 18) Ref: As 412937-5 – Floor screed beneath lino (0/12b Switch Cupboard) – No Risk
- (Item 19) Ref: 412937-6 – Floor covering (0/12b Switch Cupboard) – Very Low Risk

The floor covering in Rm 0/12b Switch Cupboard contains asbestos.

Any change in its appearance should be recorded and passed to Property Services.

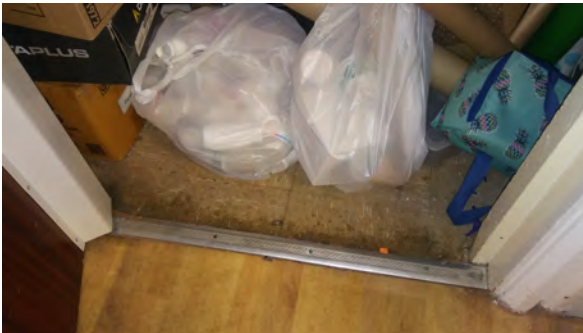
Item 20 Ref: As 412937-5

The floor screed beneath lino in Rm 0/12c Switch Cupboard does not contain asbestos.

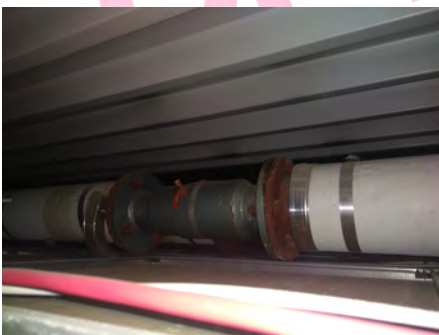
Item 27 Ref: Presumed

- (Item 26) Rf: 412937-8 – Floor screed beneath lino (0/17 Link Corridor) – No Risk
- (Item 27) Ref: Presume – Pipework flange gasket (0/17 link corridor void above) – Very Low Risk

The pipework flange gasket in Rm 0/17 link corridor void above is presumed to contain asbestos.

Any change in its appearance should be recorded and passed to Property Services.

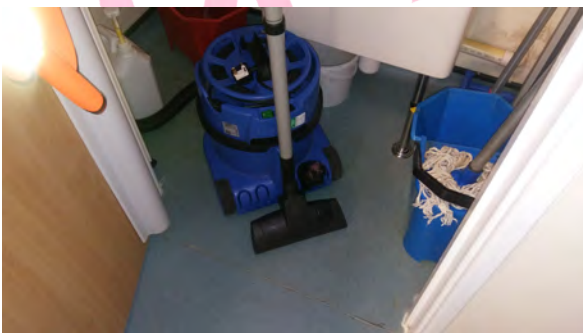
Item 30 Ref: As 412937-7

The floor screed in Rm 021a Cleaners Store does not contain asbestos.

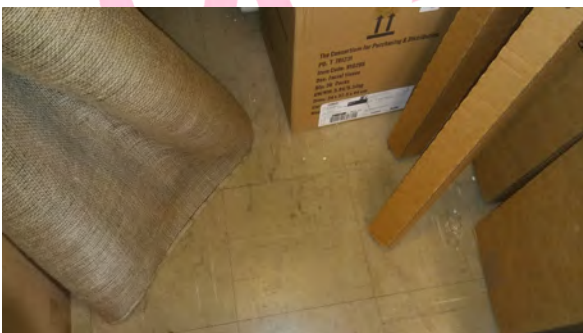
Item 36 Ref: As 412937-8

The floor screed in Rm 0/27a Store does not contain asbestos.

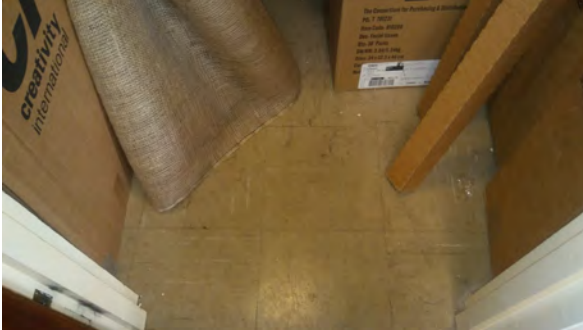
Item 37 Ref: As 412937-12

- (Item 35) Ref: As 412937-8 – Floor screed (0/27 Staff Room) – No Risk
- (Item 36) Ref: As 412937-8 – Floor screed (0/27a Store) – No Risk
- (Item 37) Ref: As 412937-12 – Floor covering (0/27a Store) – Very Low Risk

The floor covering in Rm 0/27a Store contains asbestos.

Any change in its appearance should be recorded and passed to Property Services.

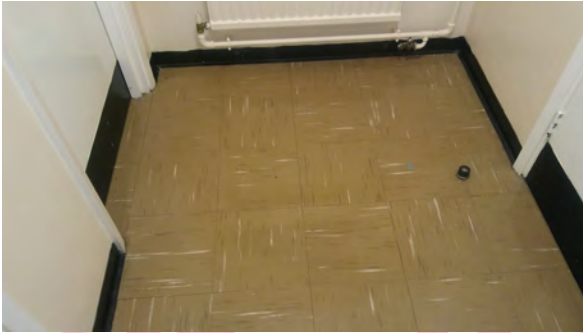
Item 38 Ref: 412937-14

The floor covering in Rm 0/28 Male Staff WC contains asbestos.

Removed March 2021

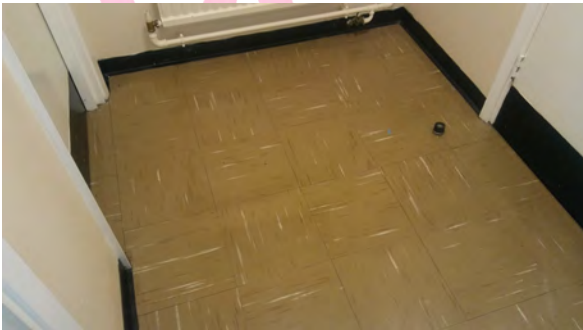
Item 39 Ref: As 412937-8

The floor screed in Rm 0/28 Male Staff WC does not contain asbestos.

Removed March 2021

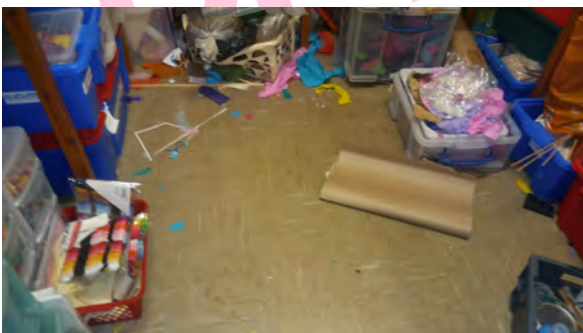
Item 54 Ref: 412937-12

The floor covering in Rm 0/35 Store contains asbestos.

Any change in its appearance should be recorded and passed to Property Services.

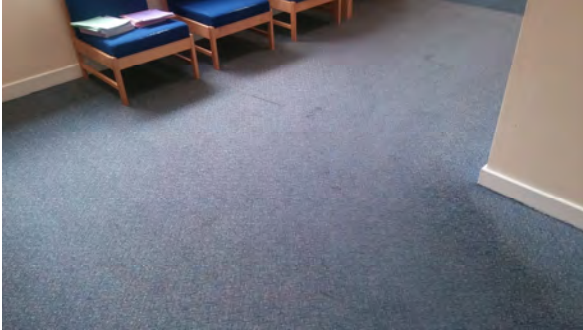
Item 55 Ref: As 412937-8

The floor screed beneath carpet in Rm 0/36 Reception corridor does not contain asbestos.

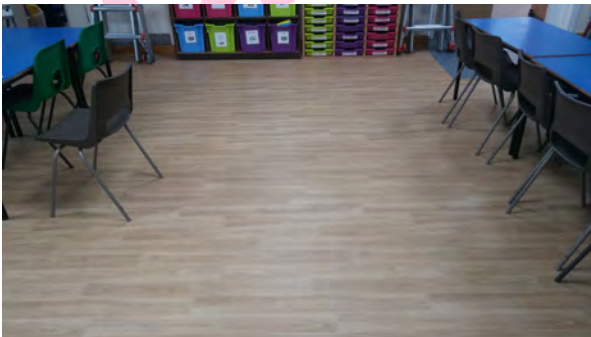
Item 63 Ref: As 412937-15

The floor screed beneath lino in Rm 0/42 Annexe Classroom does not contain asbestos.

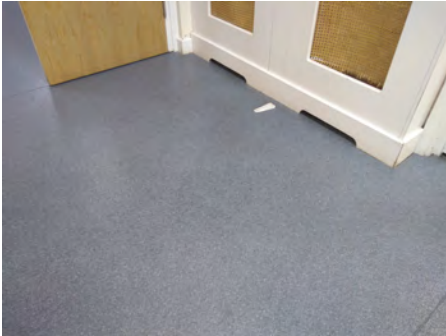
Item 70 Ref: As 412937-15

The floor screed beneath modern lino in Rm 0/43 Lobby does not contain asbestos.

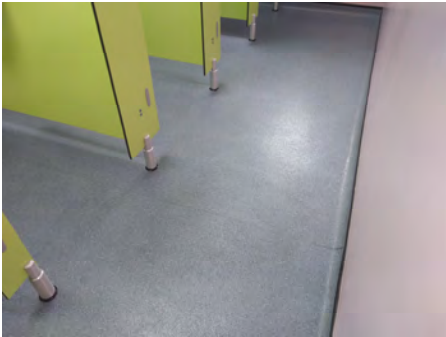
Item 71 Ref: As 412937-15

The floor screed beneath lino in Rm 0/44 Unisex WC does not contain asbestos.

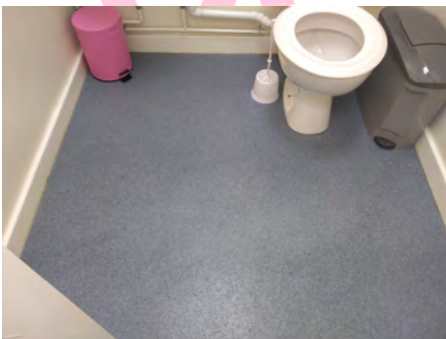
Item 72 Ref: As 412937-15

The floor screed beneath modern lino in Rm 0/45 Disabled WC does not contain asbestos.

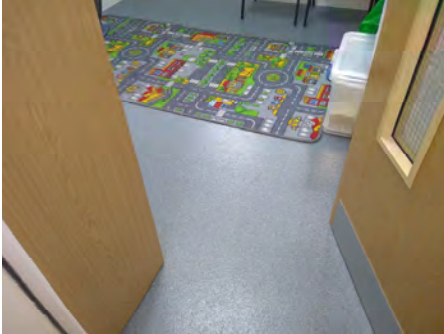
Item 73 Ref: As 412937-15

The floor screed beneath modern lino in Rm 0/45a Playroom does not contain asbestos.

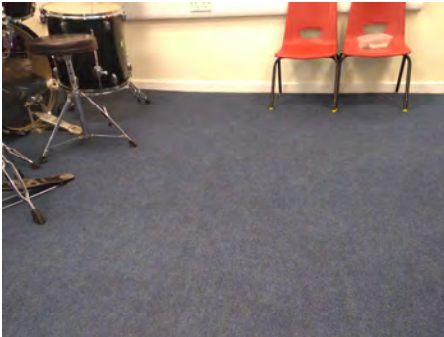
Item 74 Ref: As 412937-15

The floor screed beneath carpet Rm 0/46 Music Room does not contain asbestos.

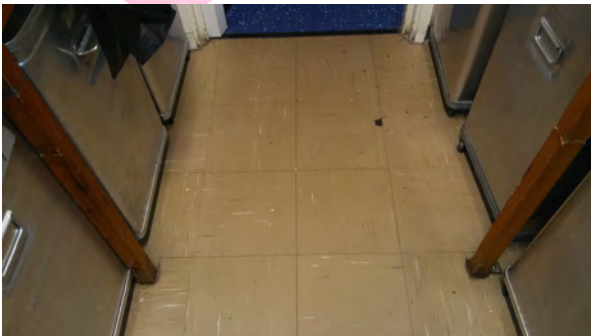
Item 81 Ref: As 412937-15

The floor screed in Rm 0/48 Kitchen Store and void above does not contain asbestos.

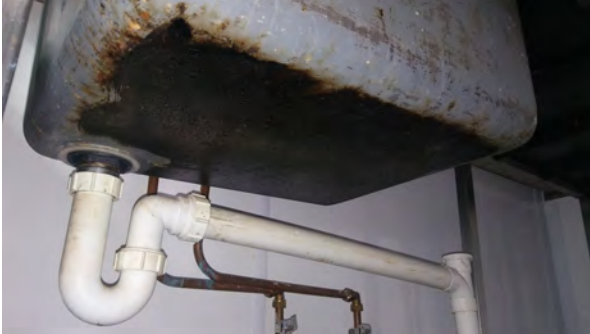
Item 82 Ref: 412937-19

The sink paint in Rm 0/48a Kitchen does not contain asbestos.

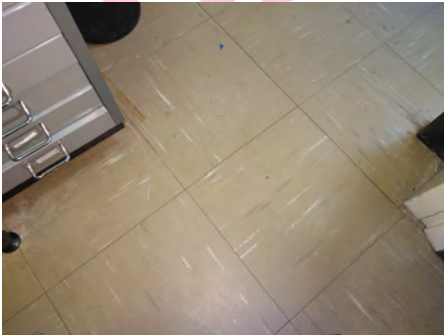
Item 87 Ref: 412937-20

The beige floor tiles in Rm 0/49b Kitchen Office contain asbestos.

Any change in its appearance should be recorded and passed to Property Services.

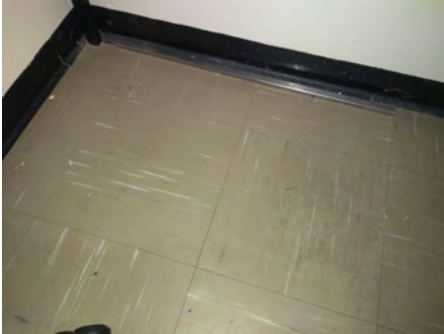
Item 88 Ref: As 412937-15

The floor screed beneath vinyl tiles in Rm 0/49b Kitchen Office does not contain asbestos.

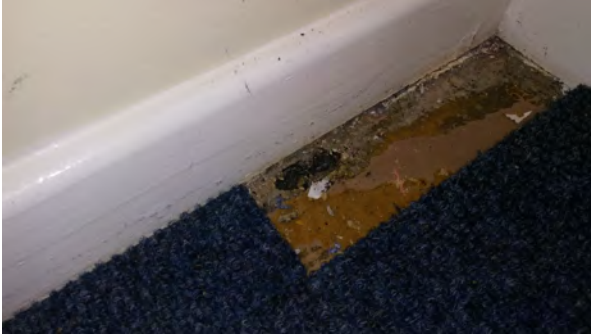
Item 91 Ref: 412937-21

The floor screed in Rm 0/50 Classroom does not contain asbestos.

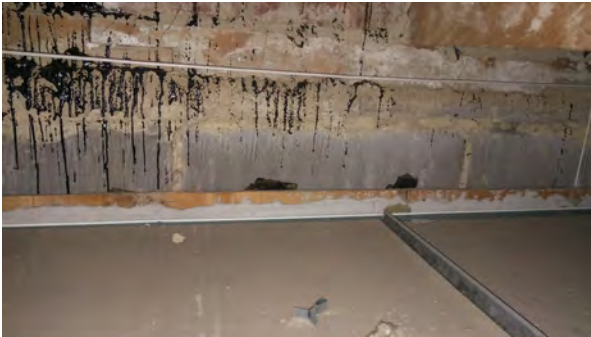
Item 92 Ref: 412937-22

The packing to perimeter of suspended ceiling in Rm 0/50 Classroom void above suspended ceiling adj skylight does not contain asbestos.

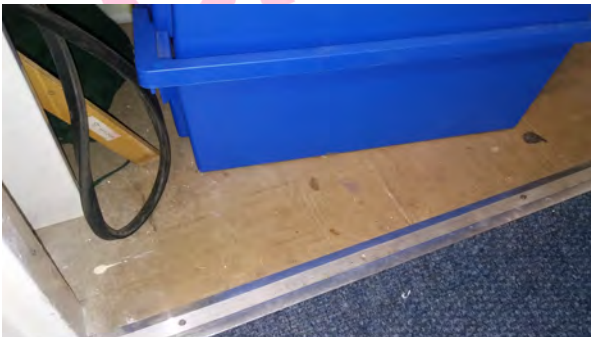
Item 96 Ref: As 412937-21

The floor screed beneath tiles in Rm 0/50b Electric cupboard does not contain asbestos.

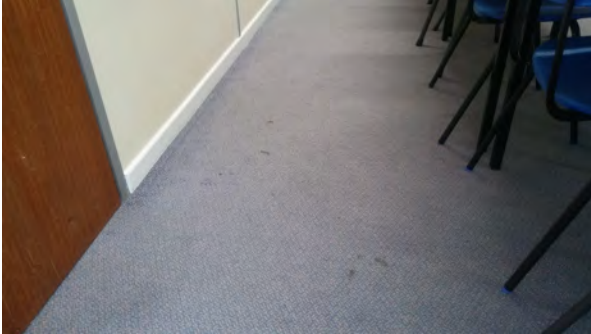
Item 97 Ref: As 412937-21

The floor screed in Rm 0/51 Classroom does not contain asbestos.

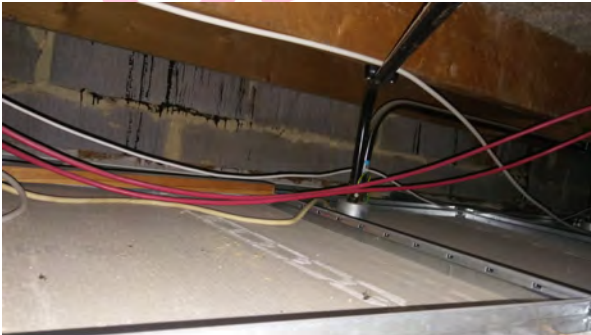
Item 99 Ref: As 412937-22

The packing to perimeter of suspended ceiling in Rm 051a Store void above does not contain asbestos.

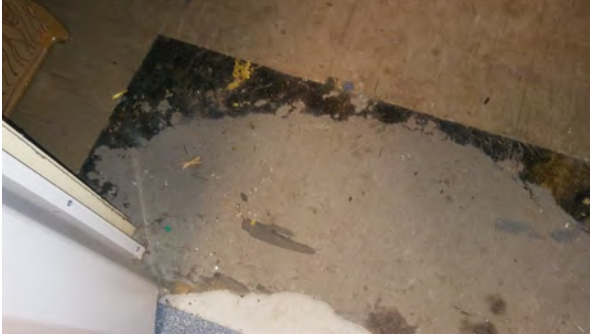
Item 106 Ref: As 412937-21

The floor screed in Rm 0/57
Store does not contain
asbestos.

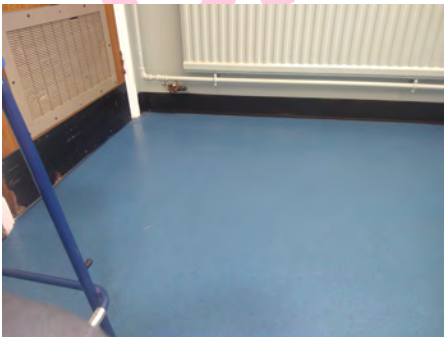
Item 108 Ref: As 412937-25

The floor screed beneath
modern lino in Rm 0/58
Medical Room does not
contain asbestos.

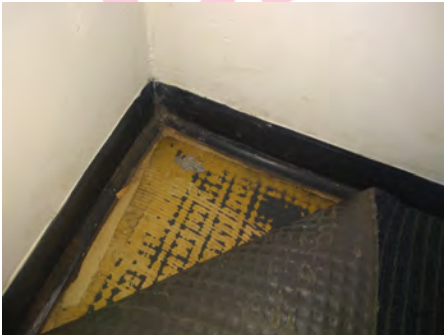
Item 111 Ref: As 412937-25

The floor screed beneath carpet and modern lino in Rm 0/60 Entrance Lobby does not contain asbestos.

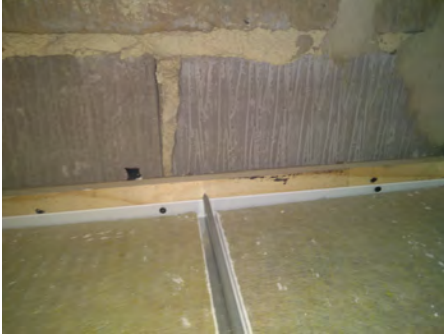
Item 112 Ref: As 412937-26

The packing to perimeter of suspended ceiling in Rm 0/60 Entrance lobby void above does not contain asbestos.

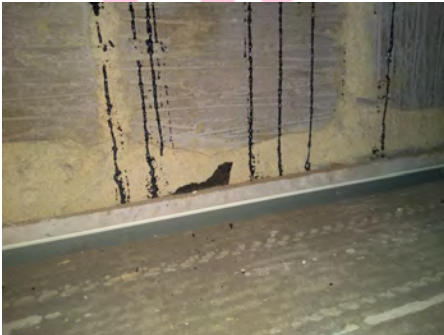
Item 114 Ref: As 412937-26

The packing to perimeter of suspended ceiling in Rm 0/61 Classroom void above does not contain asbestos.

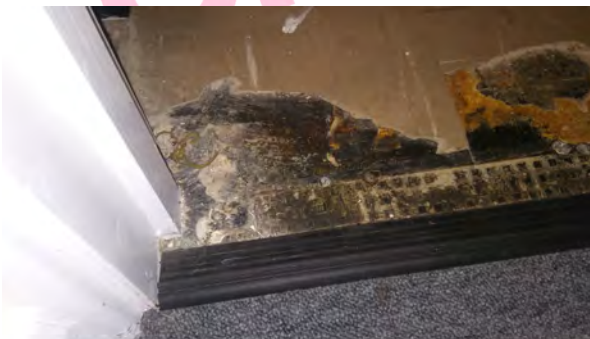
Item 117 Ref: As 412937-25

The floor screed in Rm 0/63 Store does not contain asbestos.

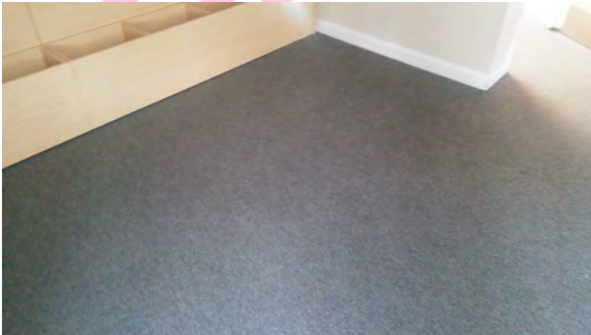
Item 123 Ref: As 412937-25

The floor screed beneath carpet in Rm 0/69 Classroom does not contain asbestos.

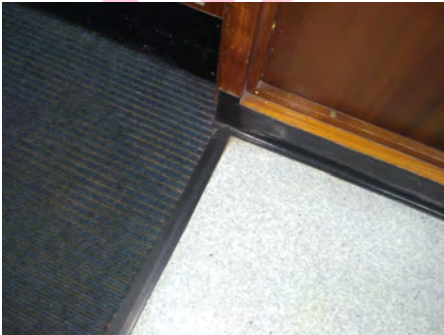
Item 126 Ref: As 412937-25

The floor screed beneath carpet and modern lino in Rm 0/72 Classroom does not contain asbestos.

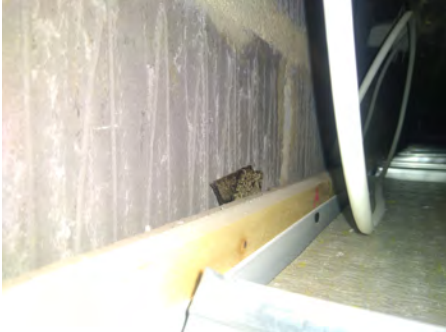
Item 127 Ref: As 412937-26

The packing to perimeter of suspended ceiling in Rm 0/72 Corridor void above does not contain asbestos.

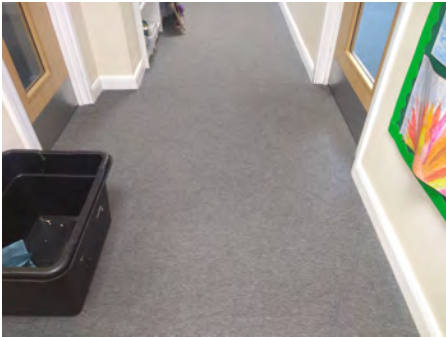
Item 128 Ref: As 412937-25

The floor screed beneath carpet in Rm 0/72a Corridor does not contain asbestos.

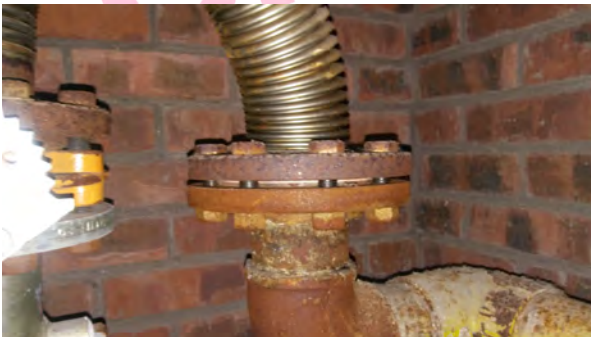
Item 129 Ref: 412937-27

The pipework flange gasket in Rm 0/75 Gas meter store does not contain asbestos.

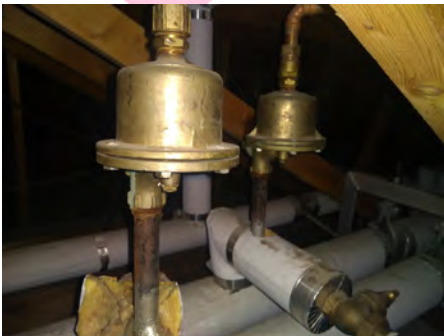
Item 132 Ref: Presumed

The gaskets to bleed valves in Rm 1/001 Nursery block loft void are presumed to contain asbestos.

Any change in its appearance should be recorded and passed to Property Services.

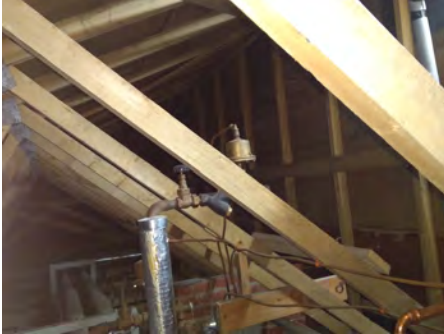
Item 136 Ref: Presumed

The gasket to bleed valves in Rm 1/003 Area 3 Loft void is presumed to contain asbestos.

Any change in its appearance should be recorded and passed to Property Services.

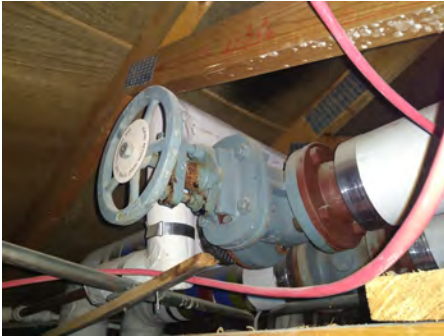
Item 139 Ref: Presumed

The pipework flange gasket in Rm 1/006 Reception block loft void is presumed to contain asbestos.

Any change in its appearance should be recorded and passed to Property Services.

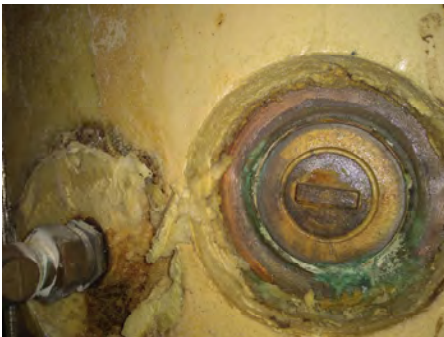
Item 140 Ref: As 412937-2

The gasket to redundant calorifier unit in Rm 1/006 Reception block loft void contains asbestos.

Any change in its appearance should be recorded and passed to Property Services.

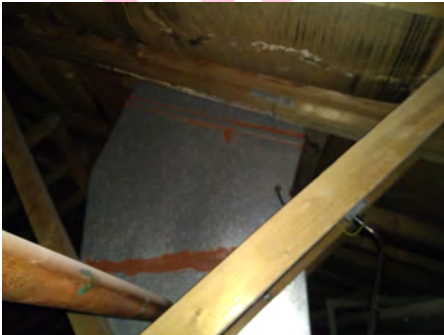
Item 144 Ref: Presumed

The red mastic to ductwork (above kitchen 0/048a extract hood) in Rm 1/007 Annex block loft void was originally presumed to contain asbestos.

Survey J141088 states no asbestos.

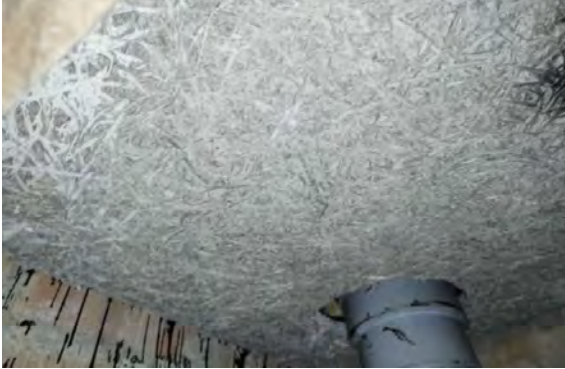
Item 145 Ref: 21-35983-1

The roof underside above the suspended ceiling in Rm 1 PE Store void does not contain asbestos.

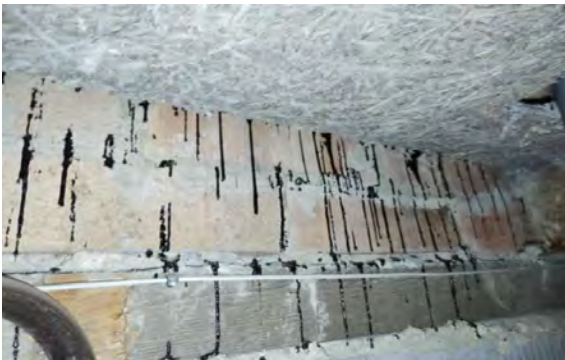
Item 146 Ref: 21-35983-2

The bitumen residue from roof above suspended ceiling in Rm 1 PE Store void does not contain asbestos.

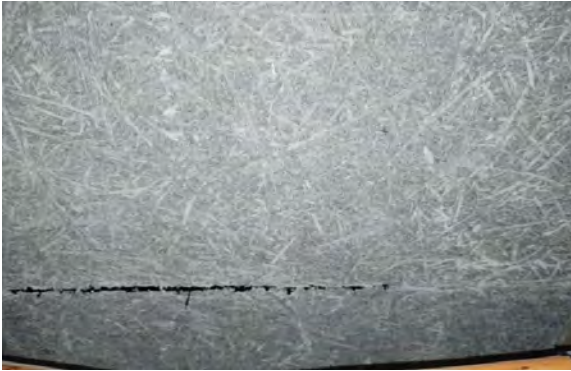
Item 148 Ref: 21-35983-1

The roof underside above the suspended ceiling in Rm 2 Sensory room void does not contain asbestos.

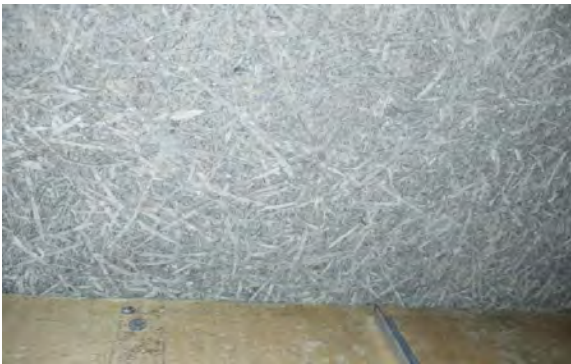
Item 149 Ref: 21-35983-1

The roof underside above the suspended ceiling in Rm 2 Sensory room void does not contain asbestos.

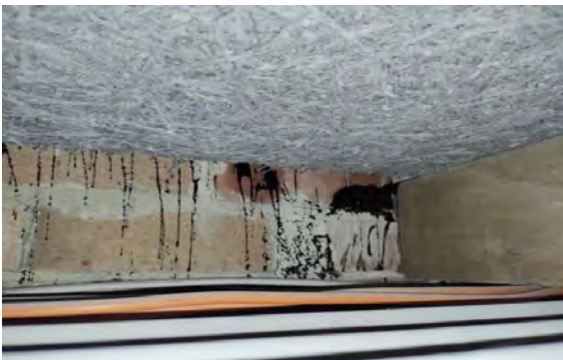
Item 150 Ref: 21-35983-2

The bitumen residue from roof above suspended ceiling in Rm 2 Sensory room void does not contain asbestos.

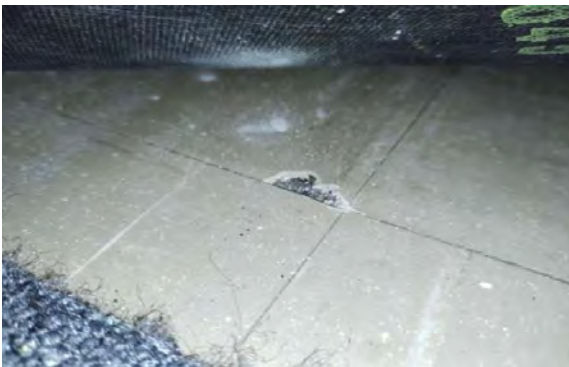
Item 152 Ref: 21-35983-5

The black resin composite floor covering below tiles in Rm 2 Sensory room does not contain asbestos.

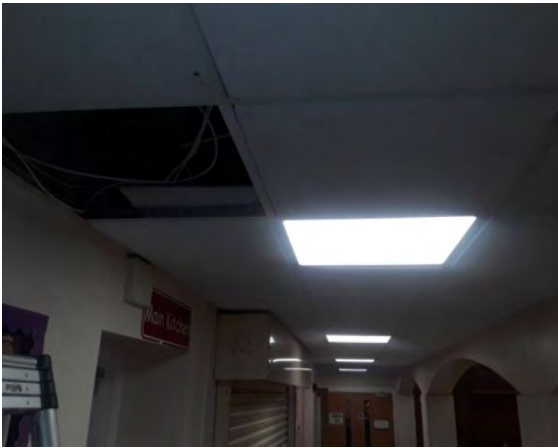
Item 157 Ref: As NZ001617

The ceiling void packers to ceiling track (Main hall lights 8, 9, 10, 11, 12, 13 G/011) does not contain asbestos.

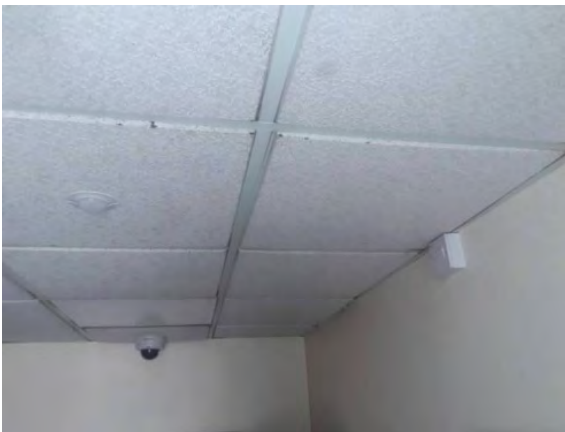
Item 159 Ref: As NX001619

The ceiling void packers to ceiling track (Cloak room light 16 G/013) does not contain asbestos.

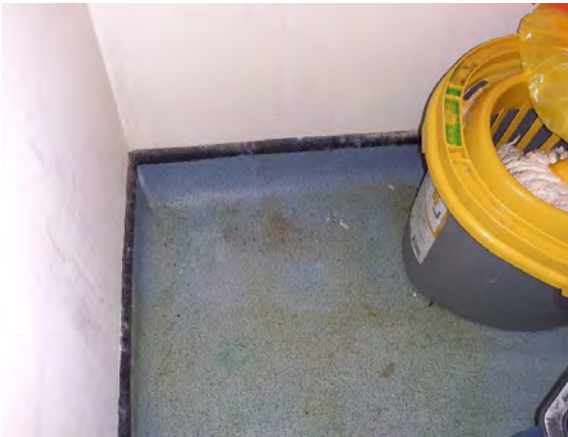
Item 160 Ref: OU003099

The bitumen beneath modern vinyl and screed in the cleaners cupboard G/01 does not contain asbestos.

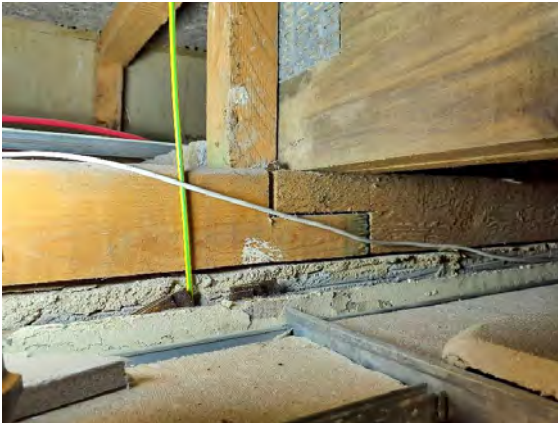
Item 161 Ref: RO001330

The bitumen packer – wall in the Kitchen G/01 does not contain asbestos.

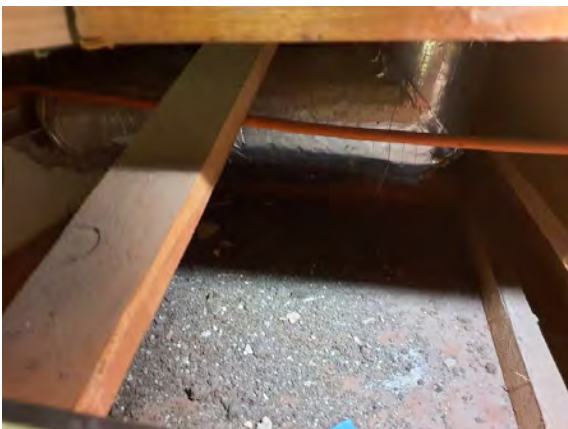
Item 162 Ref: RO001331

The insulation residue – Ceiling void in the Kitchen G/01 does not contain asbestos.

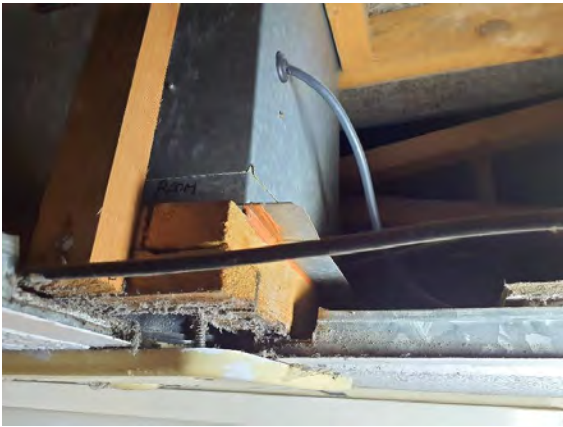
Item 163 Ref: RO001328

The red mastic – ducting in the Store G/02 does not contain asbestos.

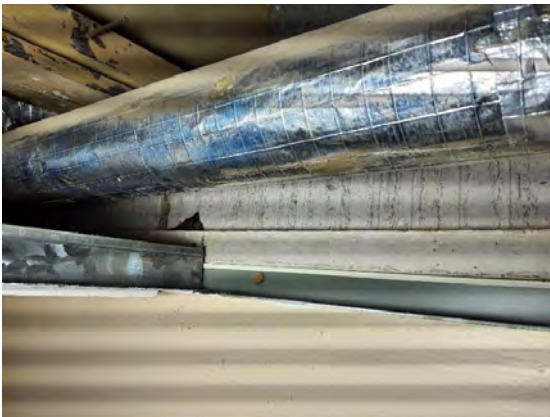
Item 164 Ref: RO001329

The bitumen packer – wall in the Store G/02 does not contain asbestos.
