ASBESTOS SURVEY REPORT FOR BIDDICK PRIMARY SCHOOL, KIRKHAM BIDDICK VILLAGE, WASHINGTON

Asbestos Register for Biddick Primary School

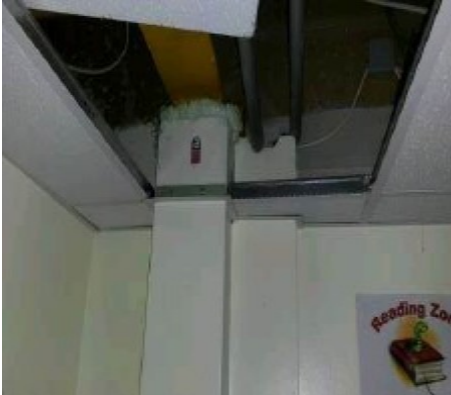
Item 1 As EB002449

The insulating board cladding to the metal columns within Classroom 11 (Room 1) contain asbestos.

Any change in its appearance should be noted and reported to Property Services.

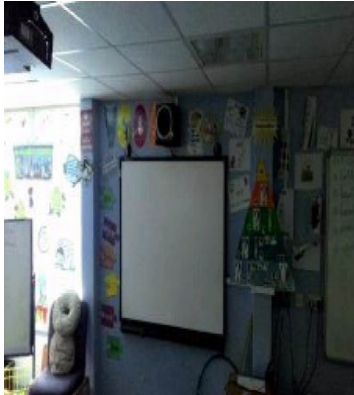
Item 4 As EB002449

The insulating board cladding to the metal columns within Classroom 10 (Room 3) contain asbestos.

Any change in its appearance should be noted and reported to Property Services.

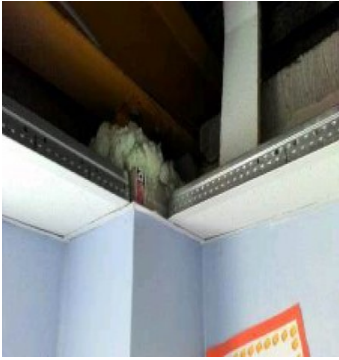
Item 7 As EB002449

The insulating board cladding to the metal columns within the cloak room (Room 5) contain asbestos.

Any change in its appearance should be noted and reported to Property Services.

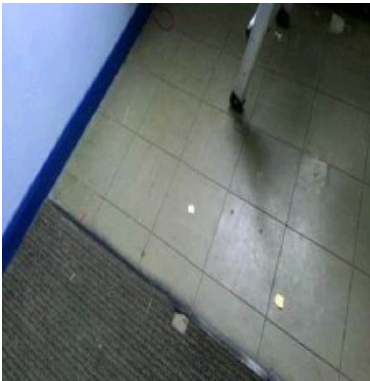
Item 8 As: EB002451

The green floor tiles to the cloak room (Room 5) do not contain asbestos.

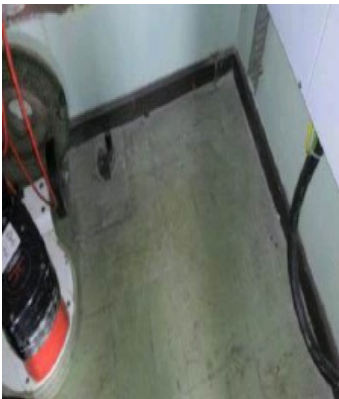
Item 9 As: EB0024501

The green floor tiles to the electrical cupboard (Room 6) do not contain asbestos.

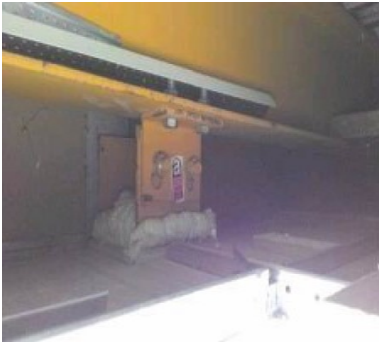
Item 10 As EB002449

The insulating board cladding to the metal columns within the Boys WC (Room 7) contains asbestos.

This was removed in 2014.

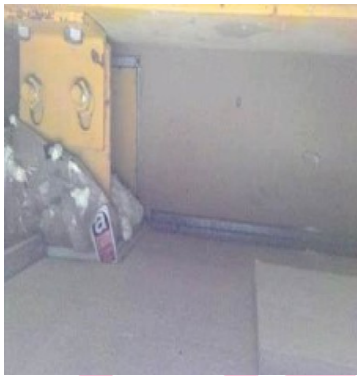
Item 11 As: EB002449

The insulating board cladding to the metal columns within the Girls WC (Room 8) contains asbestos.

Any change in its appearance should be noted and reported to Property Services.

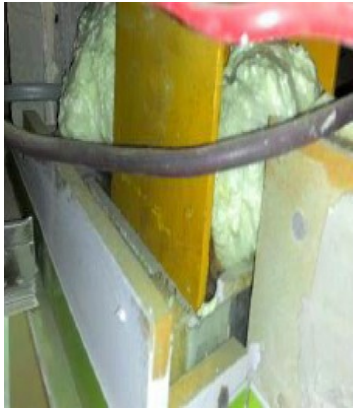
Item 13 As EB002449

The insulating board cladding to the metal columns within the Cloak area (Room 10) contains asbestos.

Any change in its appearance should be noted and reported to Property Services.

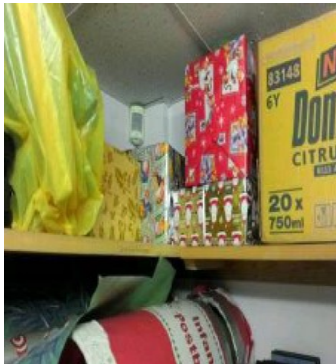
Item 18 As: EB002449

The insulating board cladding to the metal columns within the store (Room 14) contains asbestos.

Any change in its appearance should be noted and reported to Property Services.

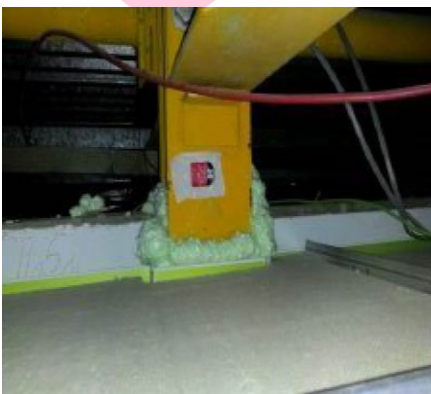
Item 21 As: EB002449

The insulating board cladding to the metal columns within Classroom 8 (Room 16) contains asbestos.

Any change in its appearance should be noted and reported to Property Services.

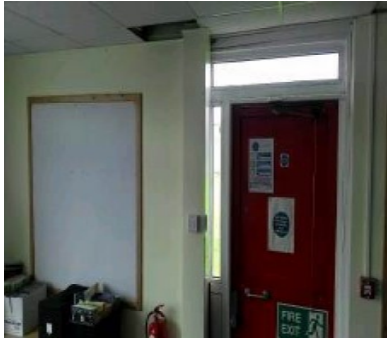
Item 22 As EB002449

The insulating board cladding to the metal columns within the Classroom 8 (Room 16) contains asbestos.

Any change in its appearance should be noted and reported to Property Services.

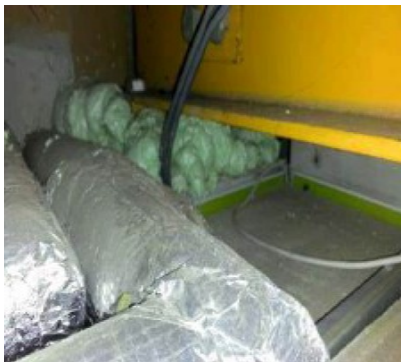
Item 26 As EB002449

The insulating board cladding to the metal columns within Classroom 7 (Room 18) contains asbestos.

Any change in its appearance should be noted and reported to Property Services.

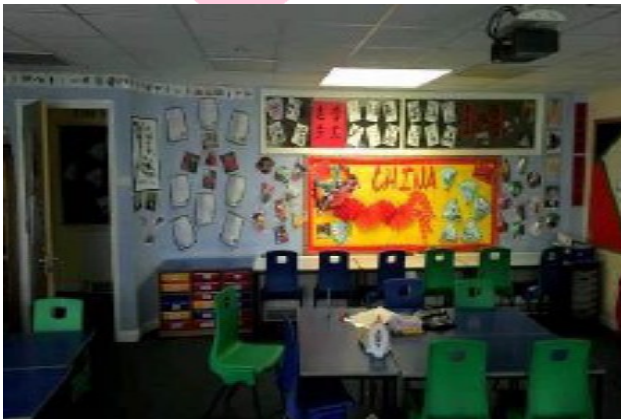
Item 30 As: EB002452

The insulating board panels to the partition wall in Classroom 7 (Room 18) do not contain asbestos.

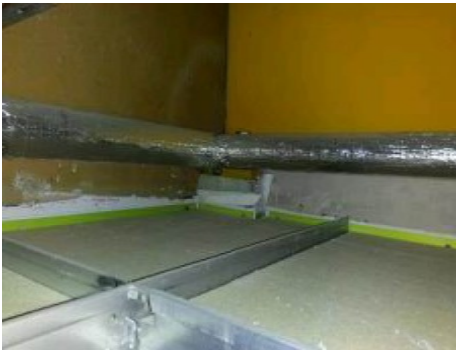
Item 31 As EB002449

The insulating board cladding to the metal columns within the store (Room 19) contains asbestos.

Any change in its appearance should be noted and reported to Property Services.

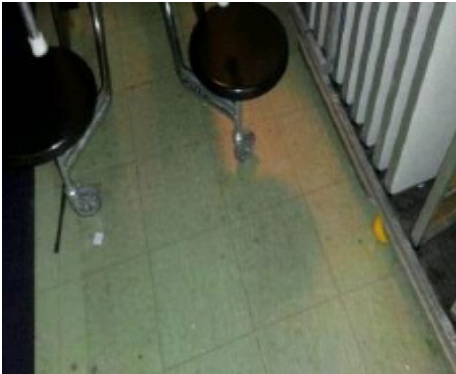
Item 34 Ref: EB002455

The green vinyl floor tiles to the chair store (Room 38) do not contain asbestos.

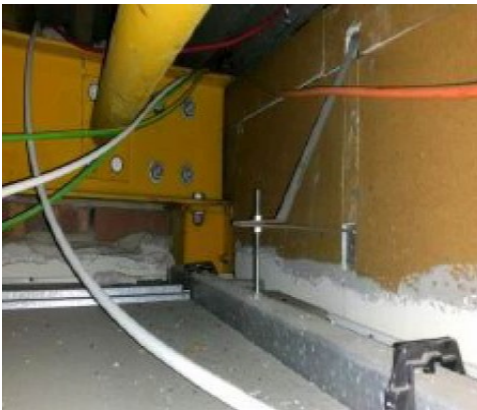
Item 35 Ref: EB002453

The insulating board cladding to the metal columns within the PE store (Room 39) contains asbestos.

Any change in its appearance should be noted and reported to Property Services.

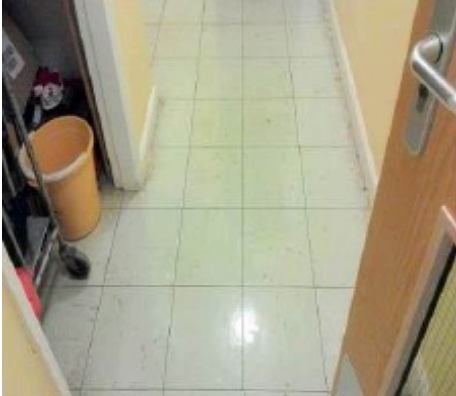
Item 40 Ref: EB002457

The grey vinyl floor tiles to the corridor (Room 42) do not contain asbestos.

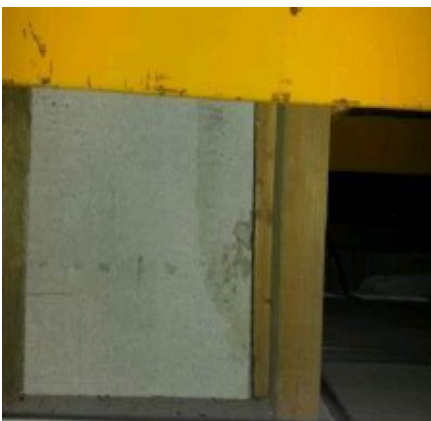
Item 42 As: EB002458

The insulating boards to the skylight upstands to the Ladies WC (Room 44) do not contain asbestos.

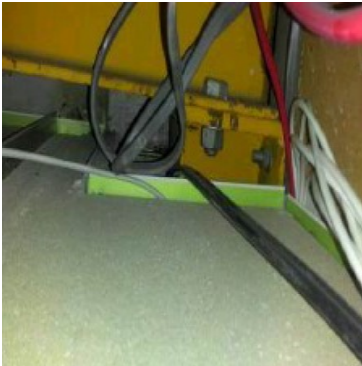
Item 46 Ref: EB002453

The insulating board cladding to the metal columns within the Office (Room 47) contains asbestos.

Any change in its appearance should be noted and reported to Property Services.

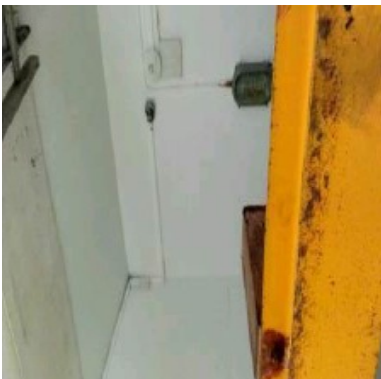
Item 48 Ref: EB002461

The ceiling board panels to the boiler room (External Room 1) contain asbestos.

Any change in its appearance should be noted and reported to Property Services.

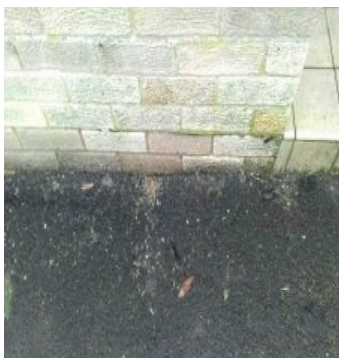
Item 51 Ref: EB002464

The damp proof course to the external of the building contains asbestos.

Any change in its appearance should be noted and reported to Property Services.

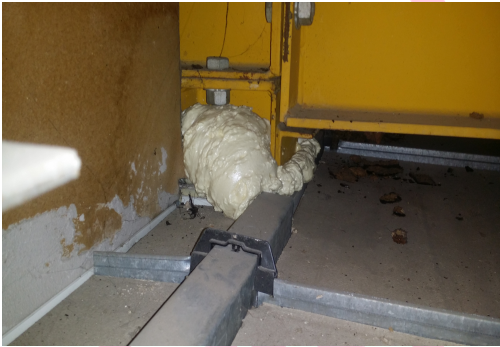
Item 53 Ref: As 203580-1

The insulating board in the girls toilet ceiling void (Room 016) contains asbestos.

This has been partially encapsulated. Any change in its appearance should be reported to Property Services.

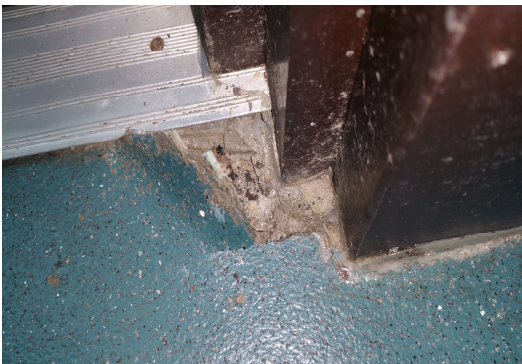
Item 54 Ref: 208189-1

The Subfloor Covering (020/Corridor) does not contain asbestos.

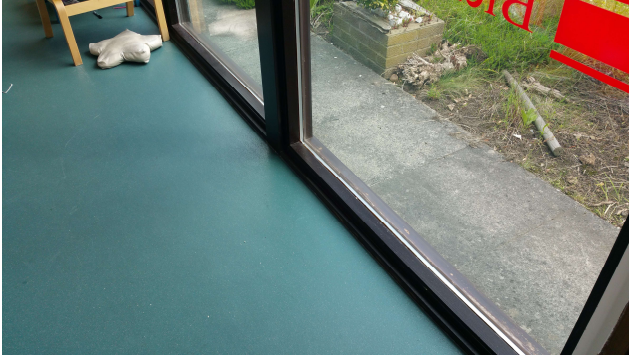
Item 55 Ref: As 208189-1

The Subfloor Covering (032/Corridor) does not contain asbestos.

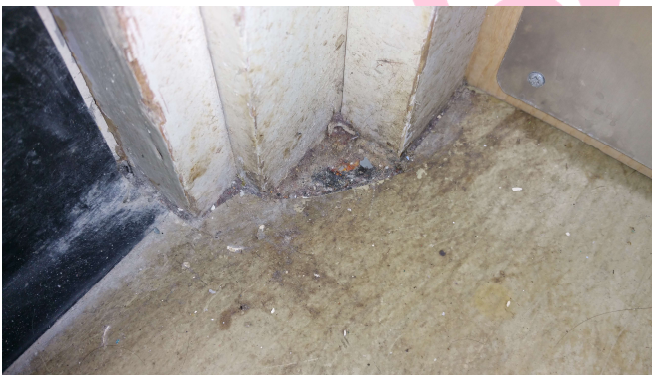
Item 56 Ref: As 208189-1

The Subfloor Covering (090/Caretakers Store) does not contain asbestos.

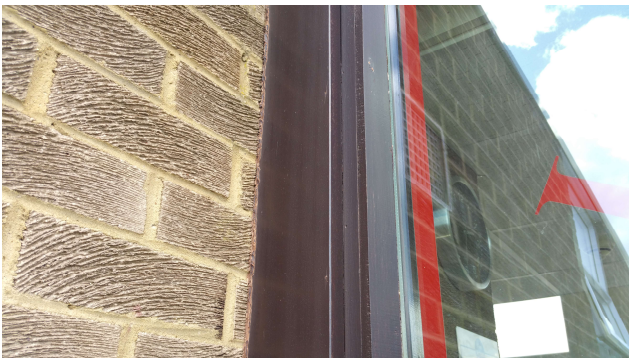
Item 57 Ref: 208189-2

The Sealant to Windows (Externals) does not contain asbestos.

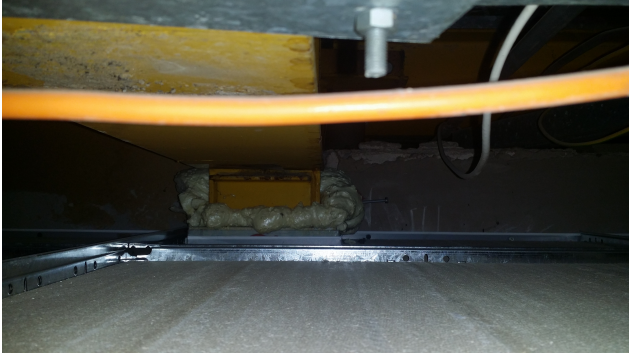
Item 58 Ref: As 316836-1

The lining to columns in the void above the girls toilet (Room 012) does contain asbestos.

Do not inspect. However any change in appearance should be reported to Property Services.

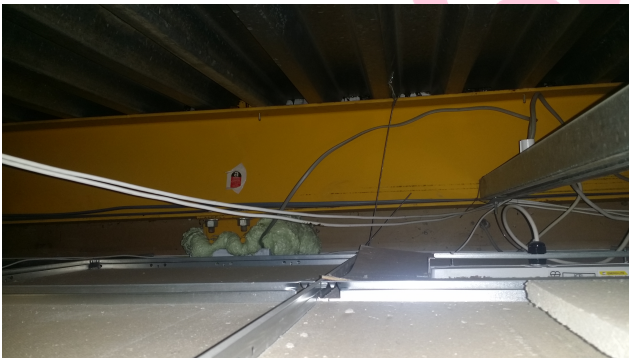
Item 59 Ref: As 316836-1

The lining to columns in the void above the Classroom (Room 018) does contain asbestos.

Do not inspect. However any change in appearance should be reported to Property Services.

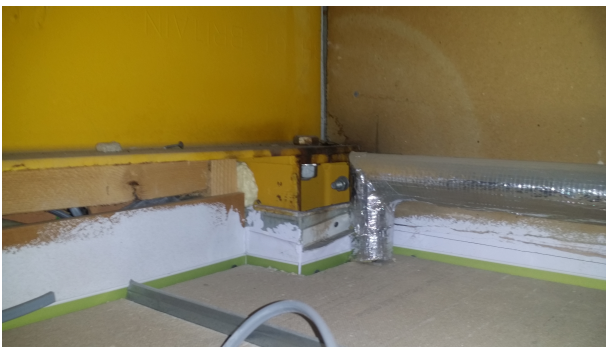
Item 60 Ref: 316836-1

The lining to columns in the void above the Classroom Store (Room 019) does contain asbestos.

Do not inspect. However any change in appearance should be reported to Property Services.

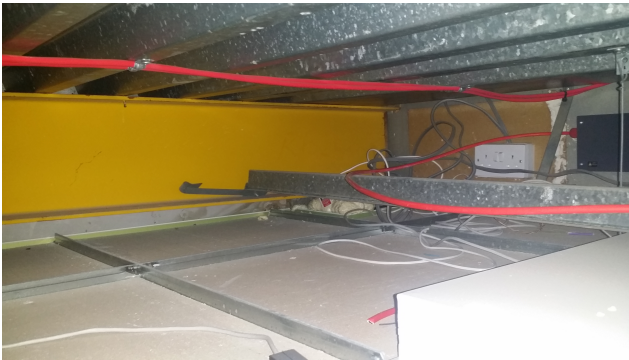
Item 61 Ref: Presumed

The lining to columns in the void above the Head teachers Room (Room 047) is presumed to contain asbestos.

Do not inspect. However any change in appearance should be reported to Property Services.

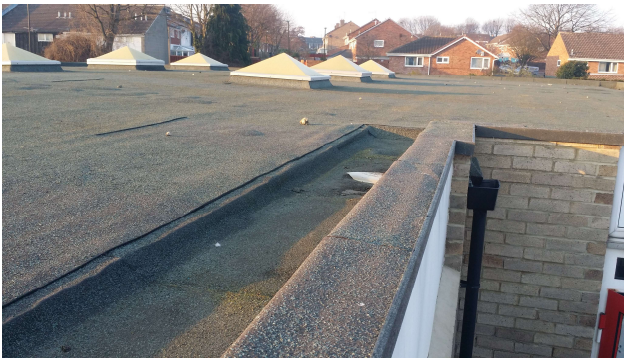
Item 62 Ref: 316836-2

The flat roof core sample (External) does not contain asbestos.

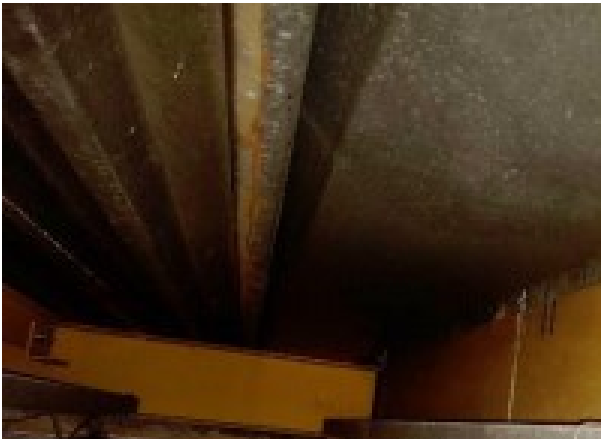
Item 64 Ref: Presumed

The lining to columns in the void above the Ladies toilets (Area 1) is presumed to contain asbestos.

Do not inspect. However any change in appearance should be reported to Property Services.

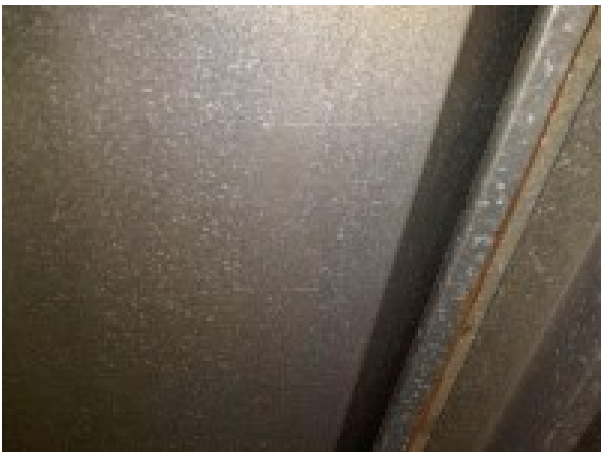
Item 65 Ref: 21-31381-2

The mastic to the metal deck on the ceiling void above the ladies toilet (Area 1) does not contain asbestos.

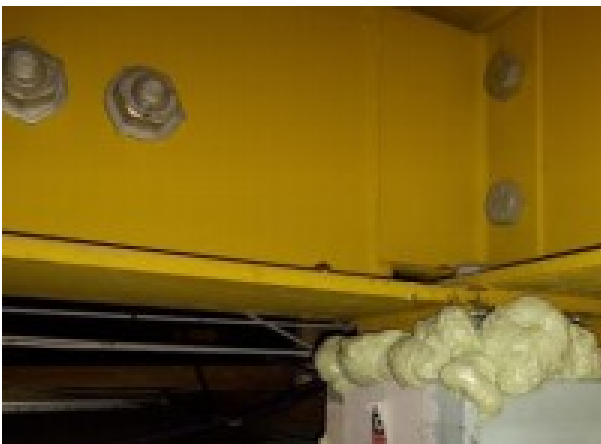
Item 66 Ref: Presumed

The lining to columns in the void above the Ladies toilets (Area 1) is presumed to contain asbestos.

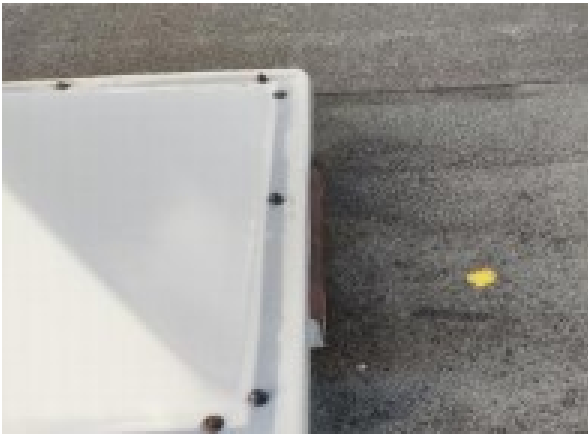
Item 67 Ref: 21-31381-5

The bitumen on the roof areas of extraction installation locations above 26 (Area 4) does not contain asbestos.

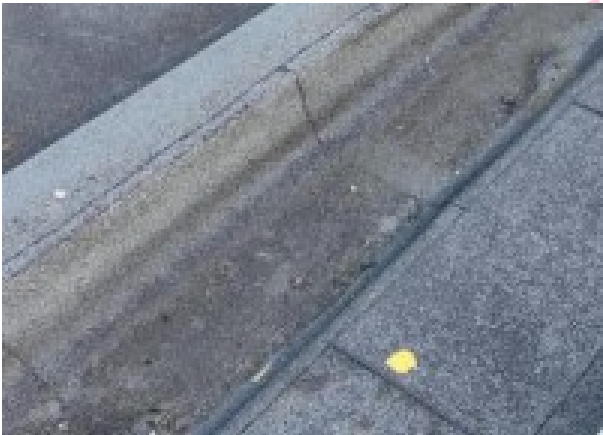
Item 68 Ref: 21-31381-6

The bitumen on the roof areas of extraction installation locations above ladies toilets (Area 4) does not contain asbestos.

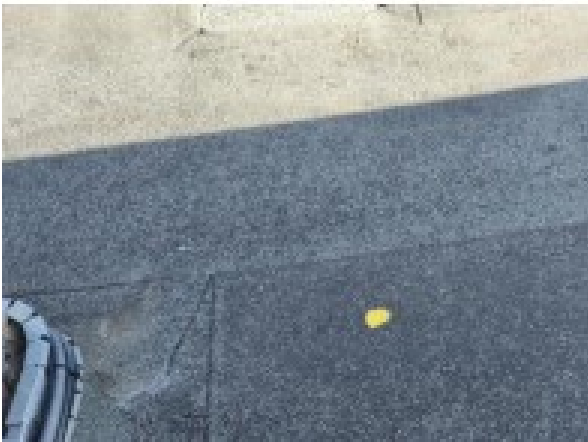
Item 69 Ref: 21-31381-7

The bitumen on the roof areas of extraction installation locations above gents toilets (Area 4) does not contain asbestos.

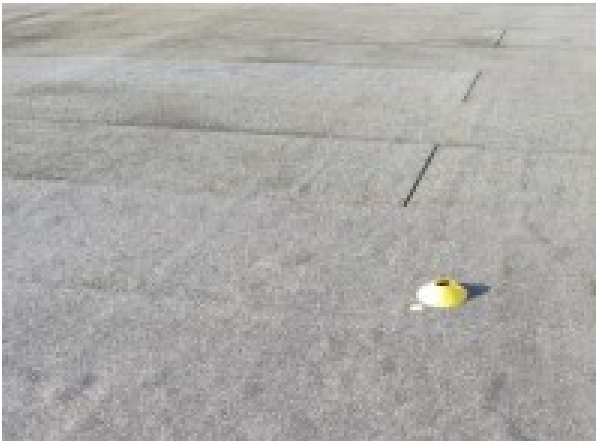
Item 70 Ref: 21-31381-8

The bitumen on the roof areas of extraction installation locations above girls toilets year 3 and 4 (Area 4) does not contain asbestos.

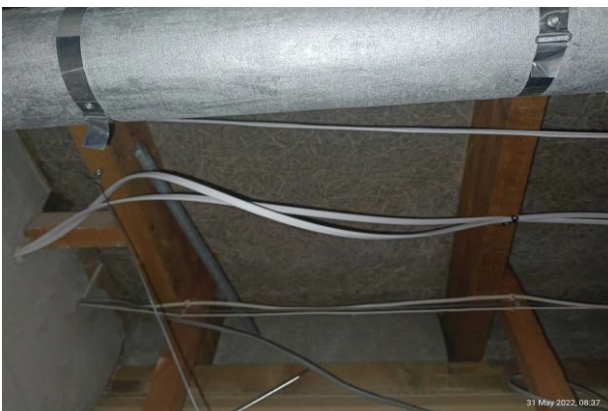
Item 72 Ref: 22-47235-1

The ceiling (Strawboard) (Corridor G0/20 False ceiling void/Area 1) does not contain asbestos.

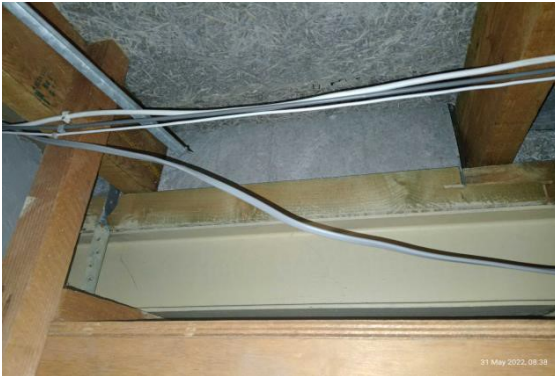
Item 73 Ref: 22-47235-2

The firebreaks (Corridor G0/20 False ceiling void/Area 1) do not contain asbestos.

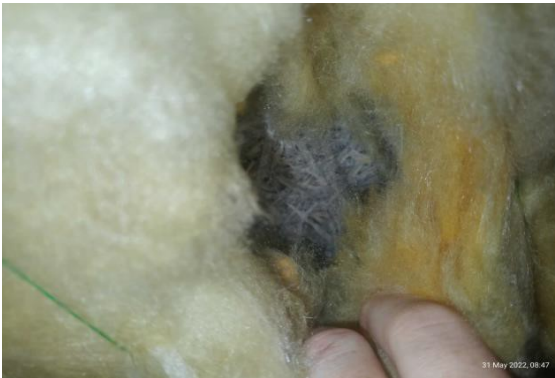
Item 74 Ref: 22-47235-1

The ceiling (Strawboard) (Lobby G0/27 False ceiling void/Area 2) does not contain asbestos.

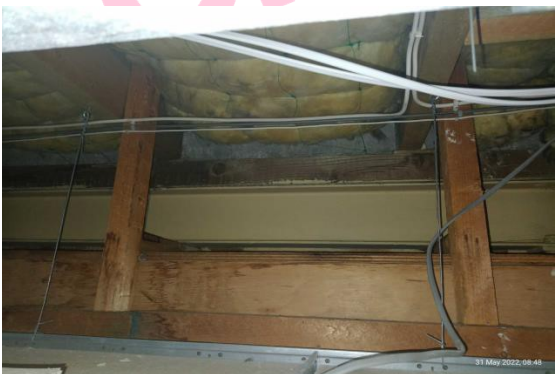
Item 75 Ref: 22-47235-2

The firebreaks (Lobby G0/27 False ceiling void/Area 2) do not contain asbestos.

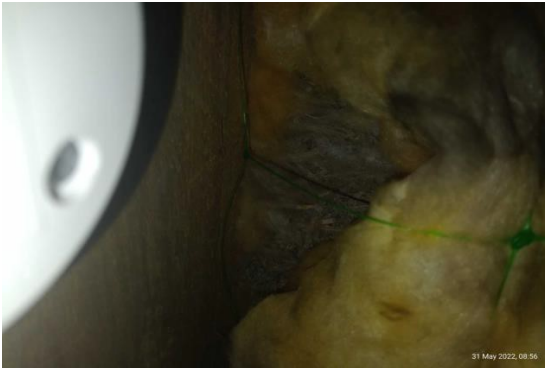
Item 76 Ref: 22-47235-1

The ceiling (Strawboard)
(Classroom 2 G0/26 False
ceiling void/Area 3) does not
contain asbestos.

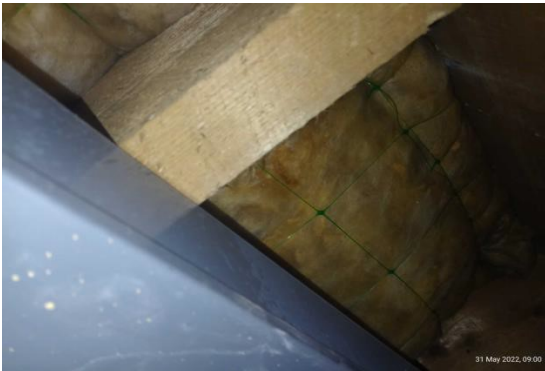
Item 77 Ref: 22-47235-1

The ceiling (Strawboard)
(Classroom 3 G0/23 False
ceiling void/Area 4) does not
contain asbestos.

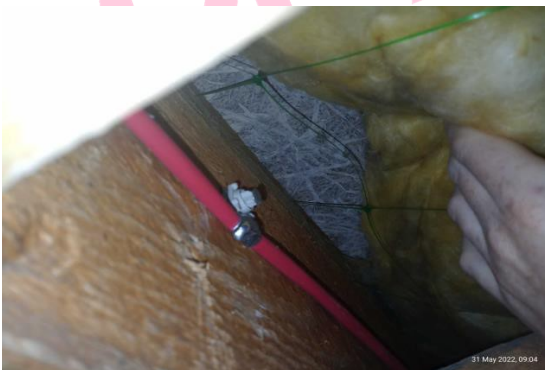
Item 78 Ref: 22-47235-1

The ceiling (Strawboard)
(Classroom 4 G0/25 False
ceiling void/Area 5) does not
contain asbestos.

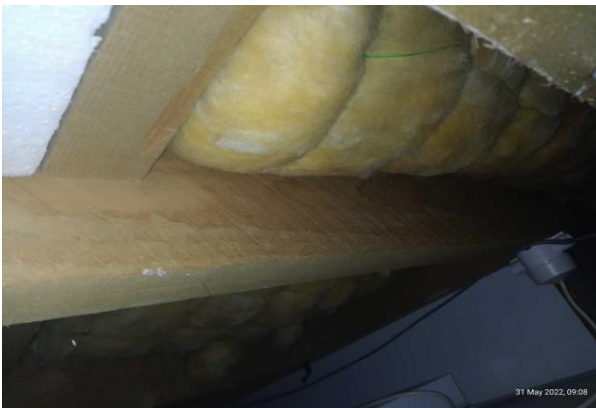
Item 79 Ref: 22-47235-1

The ceiling (Strawboard)
(Classroom 4 G0/29 False
ceiling void/Area 6) does not
contain asbestos.

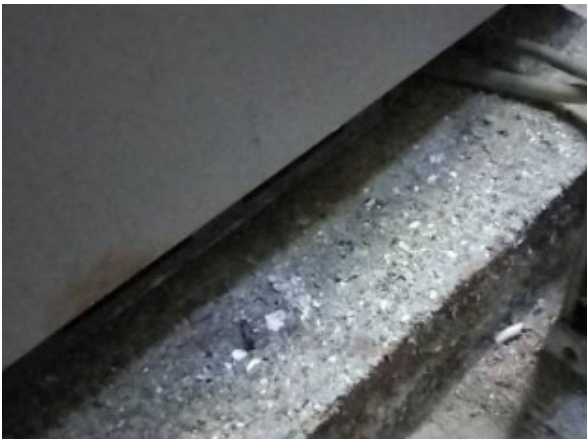
Item 80 Ref: AW005493

The floor debris in the boiler
room (Rm G/001) does not
contain asbestos.

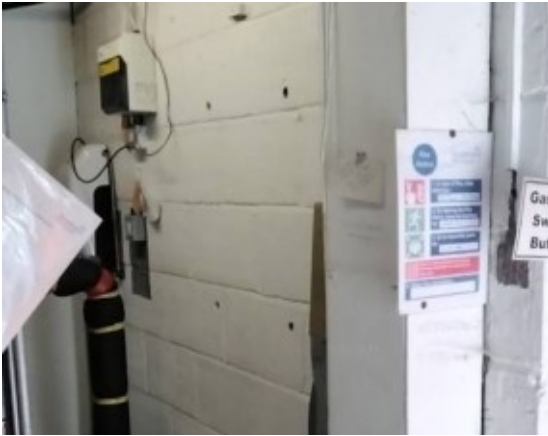
Item 82 Ref: AW005495

The column cladding in the boiler room (Rm G/001) does not contain asbestos.

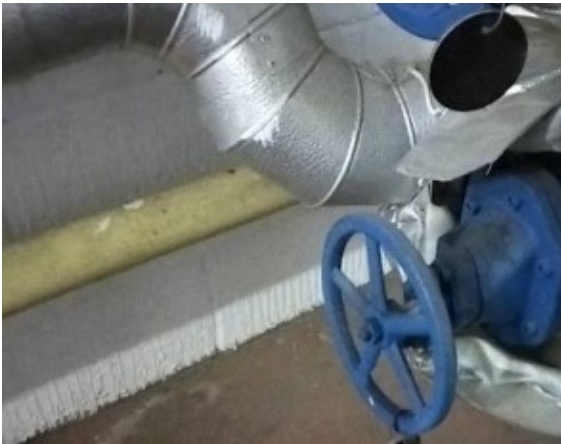
Item 83 Ref: AW005496

The pipework gaskets in the boiler room (Rm G/001) does not contain asbestos.

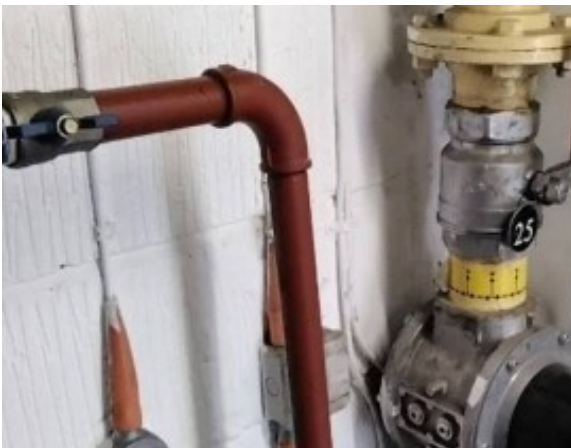
Item 84 Ref: AW005497

The pipework gaskets gas main in the boiler room (Rm G/001) does not contain asbestos.

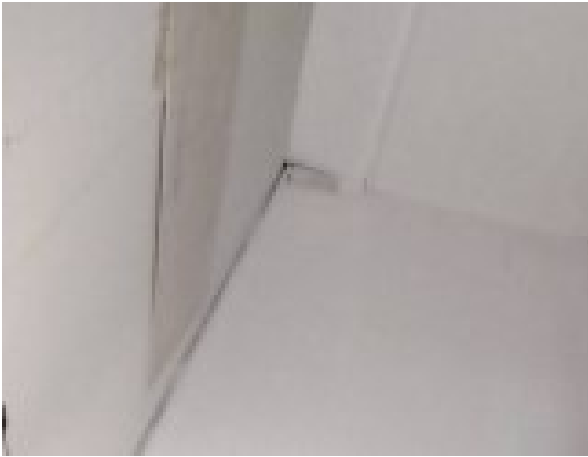
Item 85 Ref: AW005498

The upstands to raised roof area in the boiler room (G/001) contain asbestos.

Any change in appearance should be reported to Property Services.

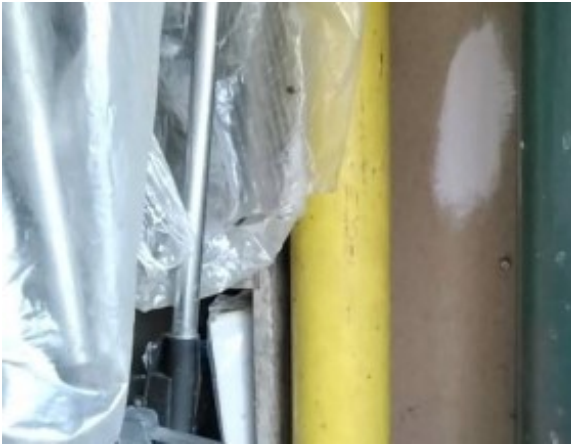
Item 88 Ref: AW005502

The pipework insulation in the Store Room (G/002) does not contain asbestos.

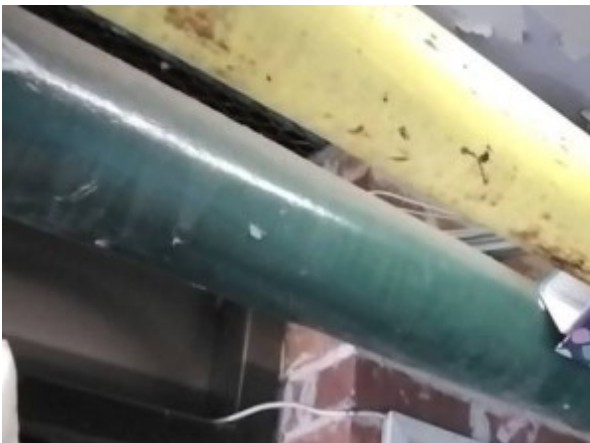
Item 89 Ref: AW005503

The pipework insulation in the Store Room (G/002) does not contain asbestos.

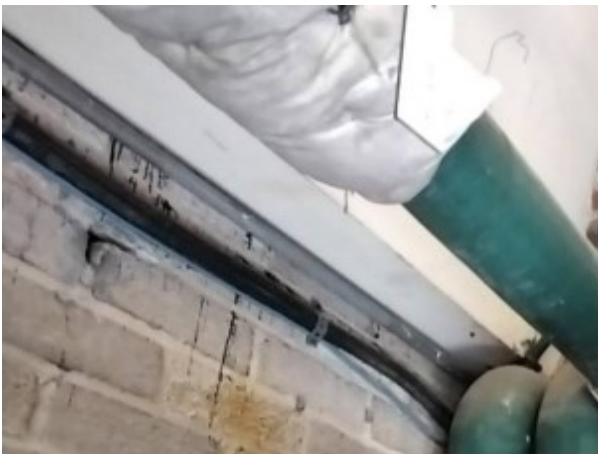
Item 90 Ref: AW005504

The pipework insulation in the Store Room (G/002) does not contain asbestos.

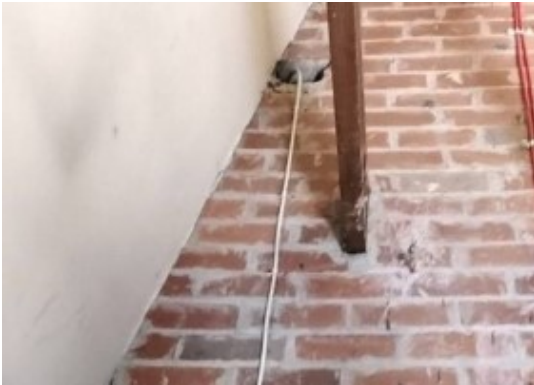
Item 91 Ref: AW005505

The wall debris in the Store Room (G/002) does not contain asbestos.

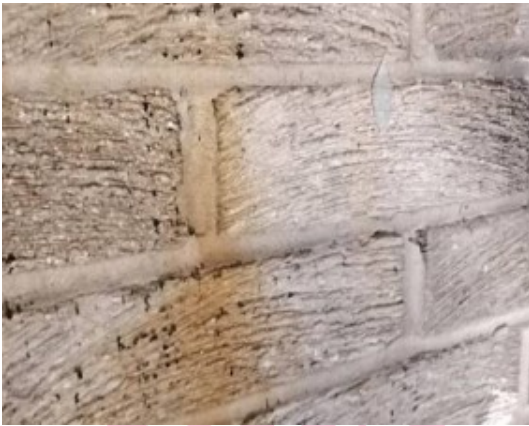
Item 92 Ref: AW005506

The wall debris in the Store Room (G/002) does not contain asbestos.

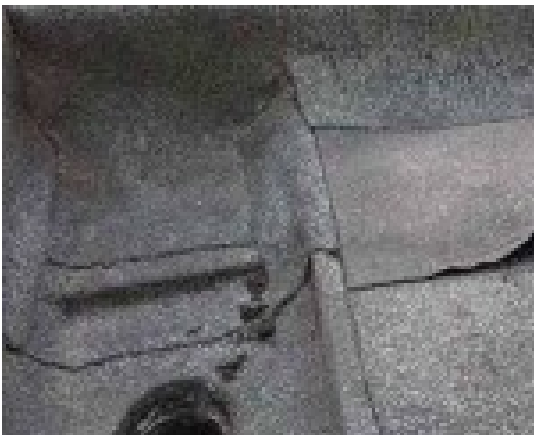
Item 93 Ref: OQ000544

The roof insulation to the felt flat roof (External E/001) does not contain asbestos.

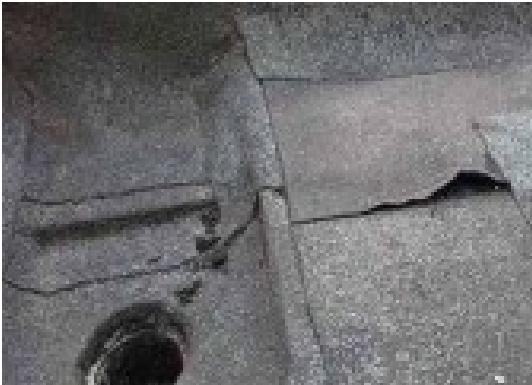
Item 94 Ref: OQ000543

The roof felt top layer to the felt flat roof (External E/001) does not contain asbestos.

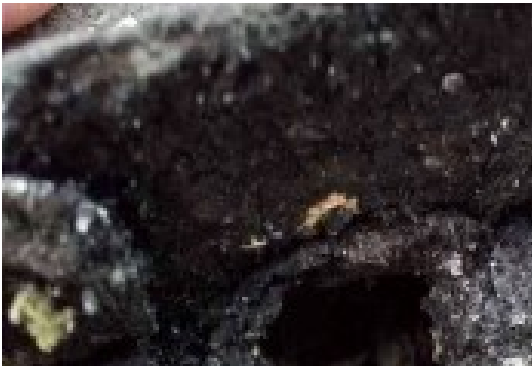
Item 95 Ref: OQ000545

The roof felt bottom layer, beneath insulation to the felt flat roof (External E/001) does not contain asbestos.

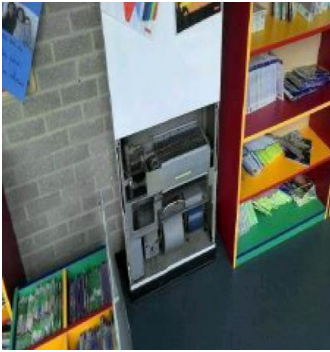
The wall heater to the corridor (Room 20) was accessed and no suspected materials were found.

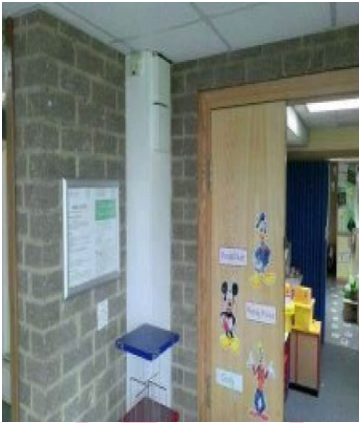
The wood boxing to the corridor (Room 20) was accessed and no suspected materials were found.

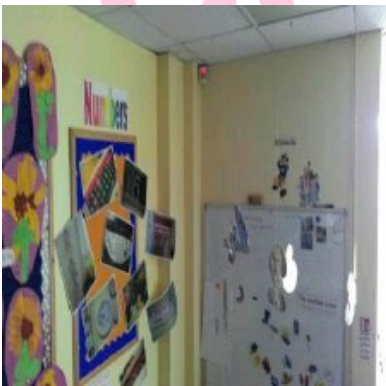
The wood boxing to the Classroom 1 and Lobby (Room 21) was accessed and no suspected materials were found.

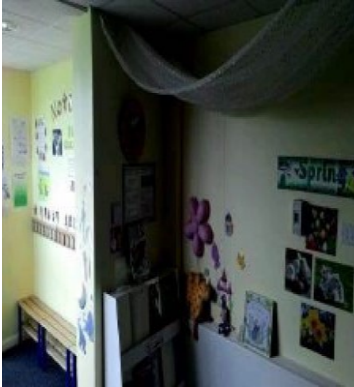
The wood boxing to Classroom 1 and lobby (Room 21) was accessed and no suspected materials were found.

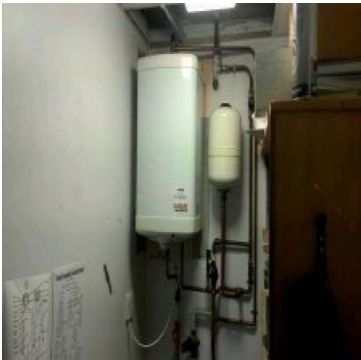
The modern boiler to Classroom 1 and lobby (Room 21) was accessed and no suspected materials were found.

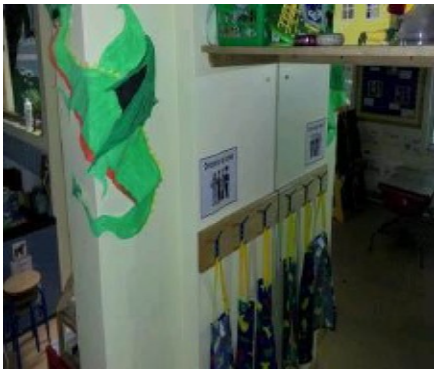
The wood boxing to Classroom 3 (Room 23) was accessed and no suspected materials were found.

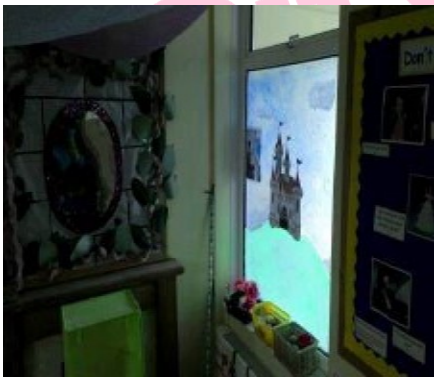
The wood boxing to Classroom 3 (Room 23) was accessed and no suspected materials were found.

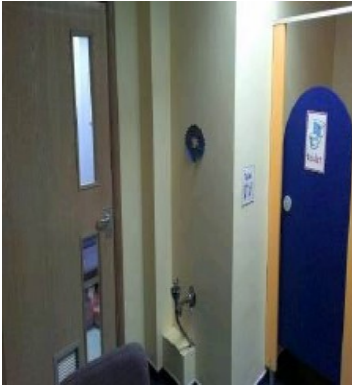
The wood boxing to classroom 3 (Room 23) was accessed and no suspected materials were found.

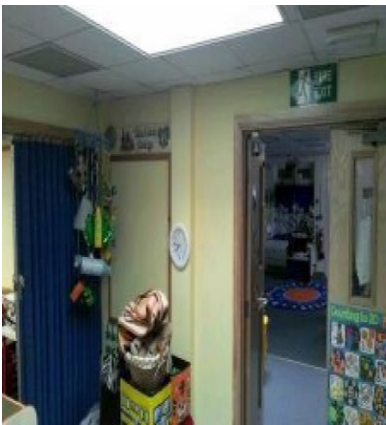
The wood boxing to classroom 3 (Room 23) was accessed and no suspected materials were found.

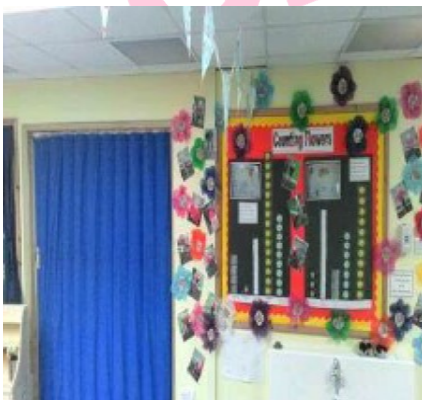
The wood boxing to classroom 3 (Room 23) was accessed and no suspected materials were found.

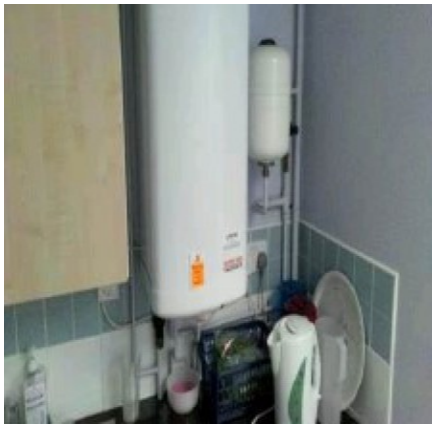
The modern boiler to the staff room (Room 24) was accessed and no suspected materials were found.

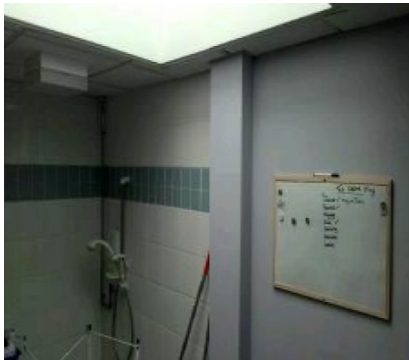
The wood boxing to the staff room (Room 24) was accessed and no suspected materials were found.

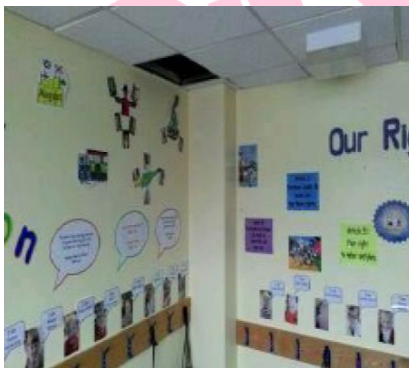
The wood boxing to cloak room area (Room 25) was accessed and no suspected materials were found.

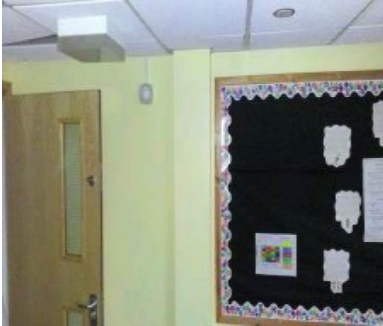
The wood boxing to the cloak room area (Room 25) was accessed and no suspected materials were found.

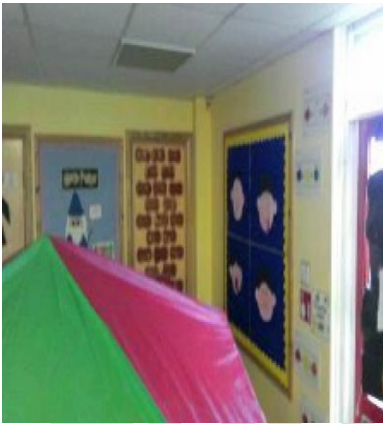
The wood boxing to Classroom 2 (Room 26) was accessed and no suspected materials were found.

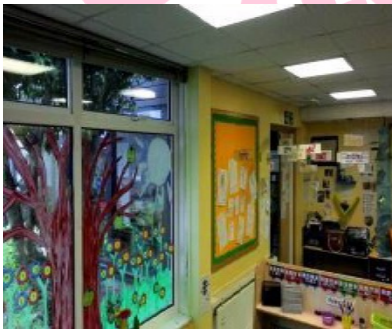
The wood boxing to Classroom 2 (Room 26) was accessed and no suspected materials were found.

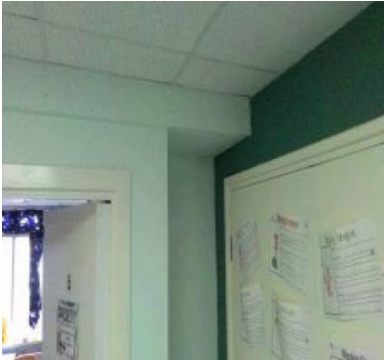
The wood boxing to the Lobby (Room 27) was accessed and no suspected materials were found.

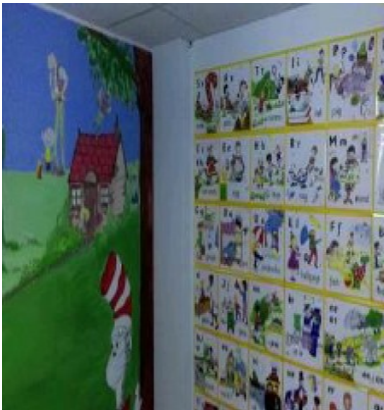
The wood boxing to the lobby (Room 27) was accessed and no suspected materials were found.

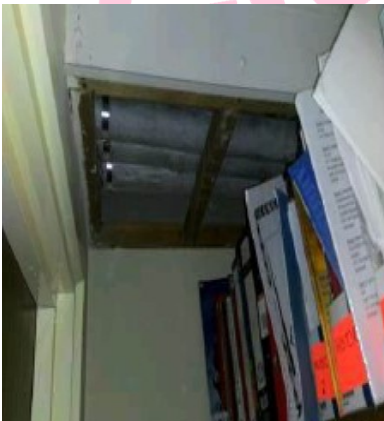
The wood boxing to the store (Room 28) was accessed and no suspected materials were found.

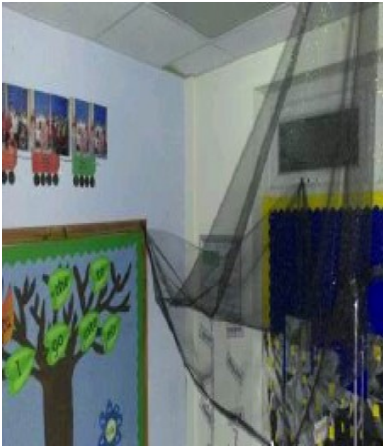
The wood boxing to classroom 4 (Room 29) was accessed and no suspected materials were found.

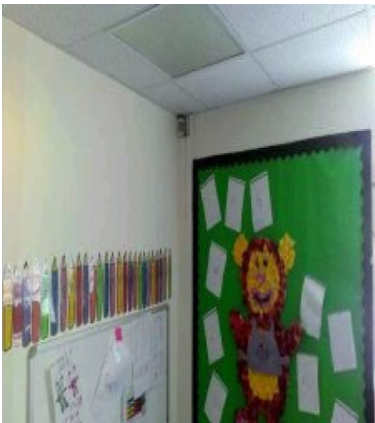
The wood boxing to Classroom 4 (Room 29) was accessed and no suspected materials were found.

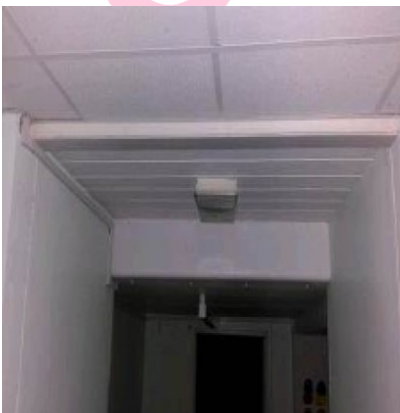
The wood boxing to the cloak room (Room 30) was accessed and no suspected materials were found.

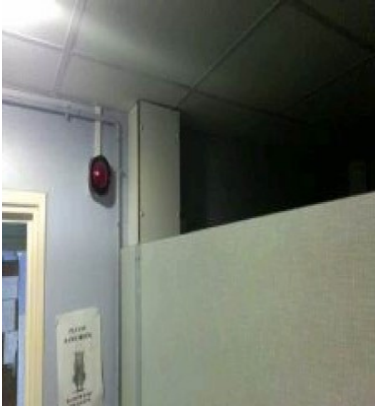
The wood boxing to the Girls WC (Room 32) was accessed and no suspected materials were found.

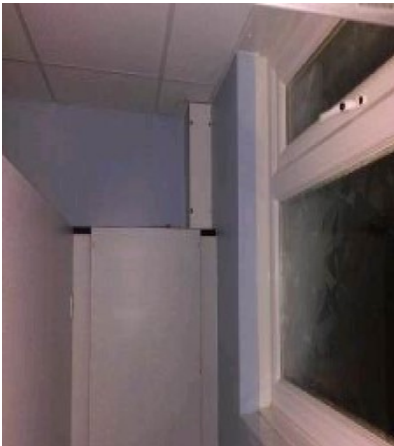
The wood boxing to the Girls WC (Room 32) was accessed and no suspected materials were found.

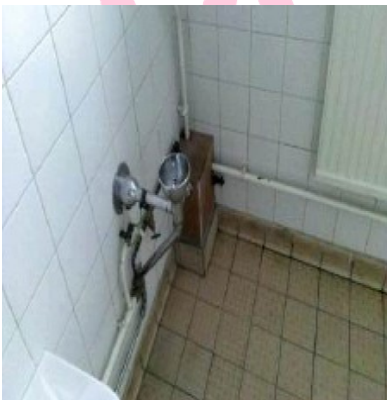
The wood boxing to the Boys WC (Room 33) was accessed and no suspected materials were found.

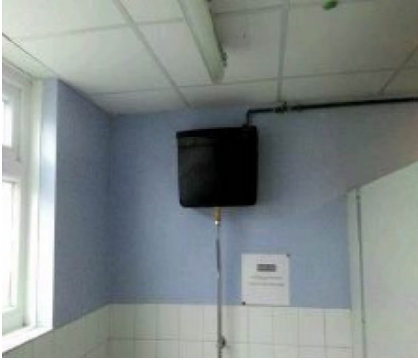
The cistern to Boys WC (Room 33) was accessed and no suspected materials were found.

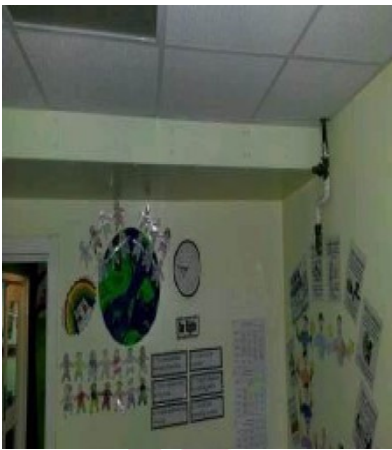
The wood boxing to Classroom 5 (Room 34) was accessed and no suspected materials were found.

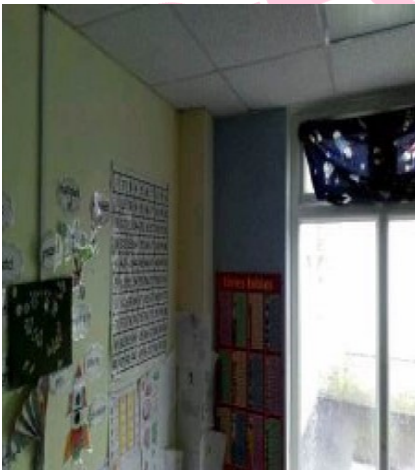
The wood boxing to Classroom 5 (Room 34) was accessed and no suspected materials were found.

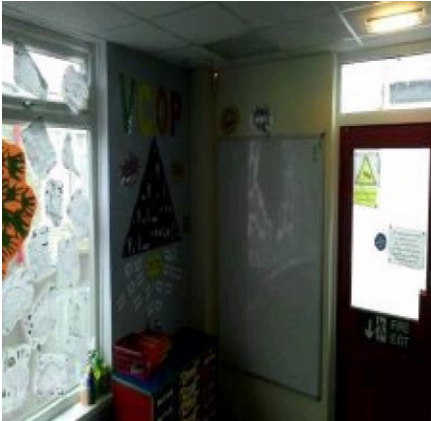
The wood boxing to the Classroom 5 (Room 34) was accessed and no suspected materials were found.

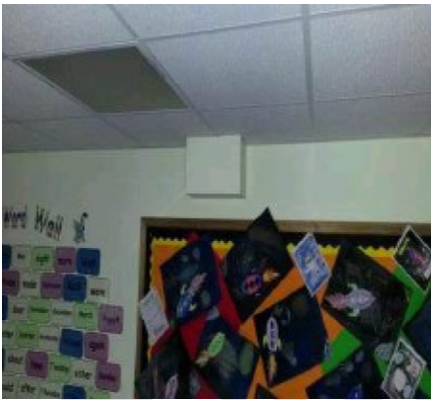
The wood boxing to Classroom 5 (Room 34) was accessed and no suspected materials were found.

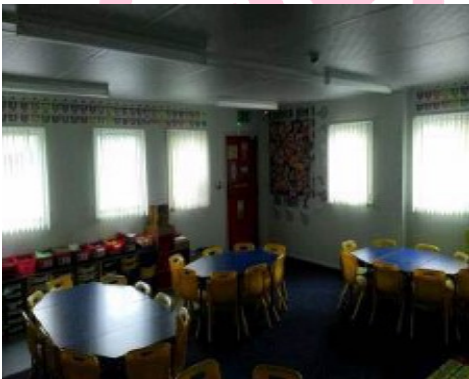
The wood boxing to Classroom A and Cloaks) (Room 35) was accessed and no suspected materials were found.

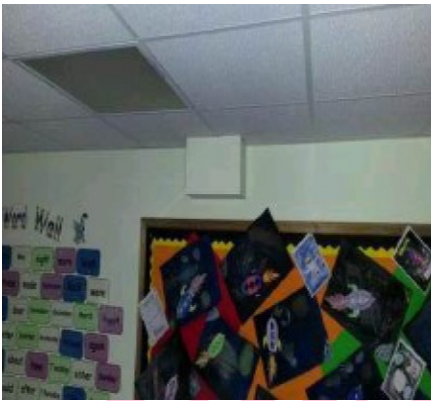
The wood boxing to Classroom 5 (Room 34) was accessed and no suspected materials were found.

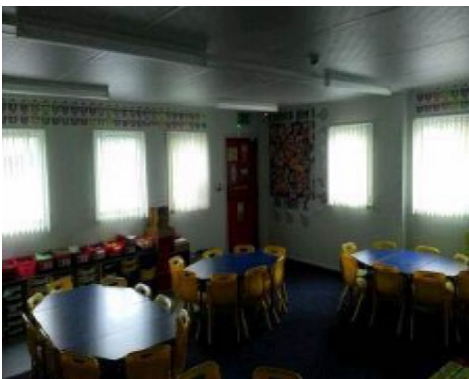
The wood boxing to Classroom A and Cloaks) (Room 35) was accessed and no suspected materials were found.

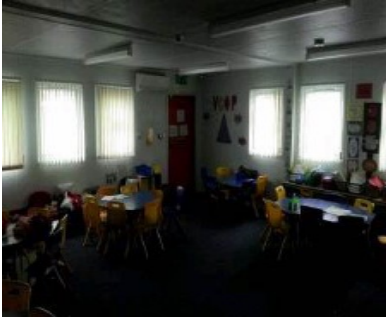
The wood boxing to the Classroom B and the cloaks areas (Room 36) was accessed and no suspected materials were found.

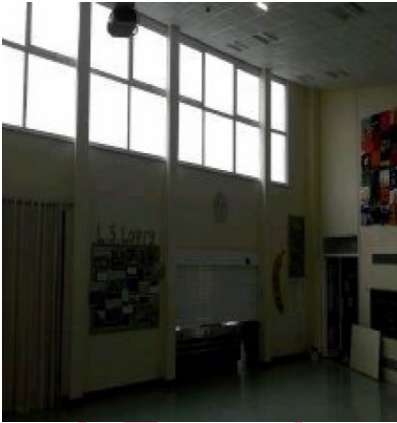
The wood boxing (x 5) to the Assembly Hall (Room 37) was accessed and no suspected materials were found.

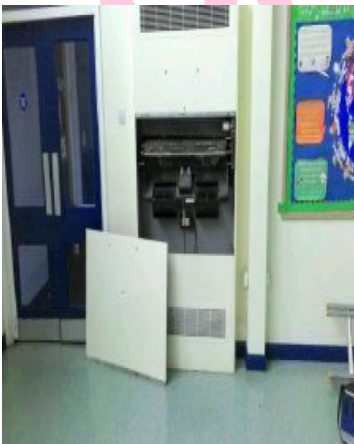
The wall heaters in the assembly hall (Room 37) were accessed and no suspected materials were found.

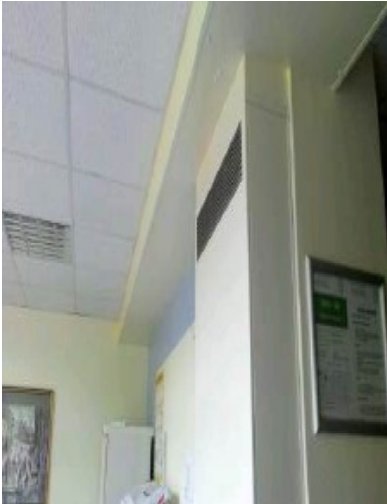
The wood boxing to the Staff Room (Room 41) was accessed and no suspected materials were found.

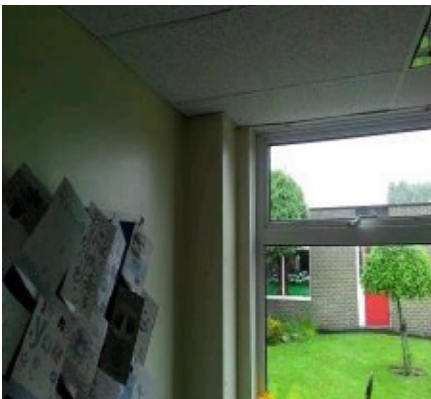
The wood boxing to the Staff Room (Room 41) was accessed and no suspected materials were found.

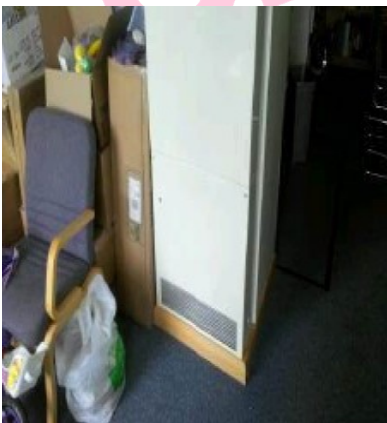
The wall heaters in the staff room (Room 41) were accessed and no suspected materials were found.

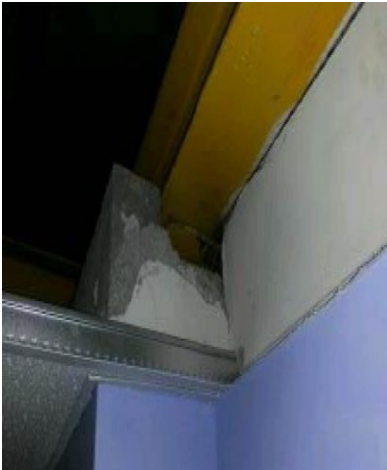
The ceiling void in the Staff Room (Room 41) was accessed and no suspected materials were found.

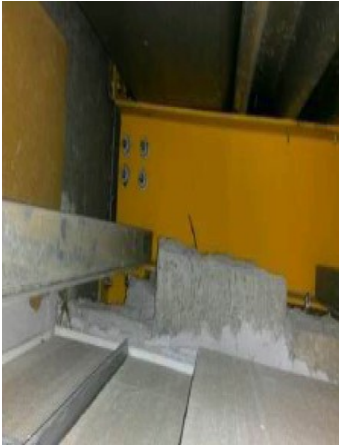
The unclad inspection point in the ceiling void to the Ladies WC (Room 44) was accessed and no suspected materials were found.

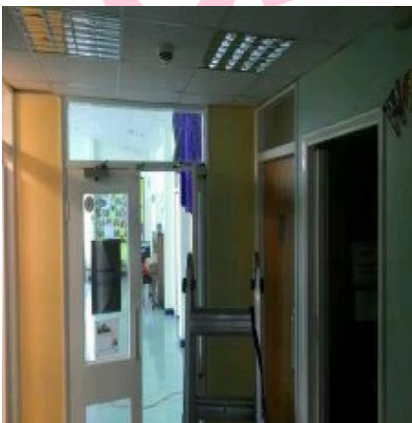
The corridor (Room 45) was accessed and no suspected materials were found.

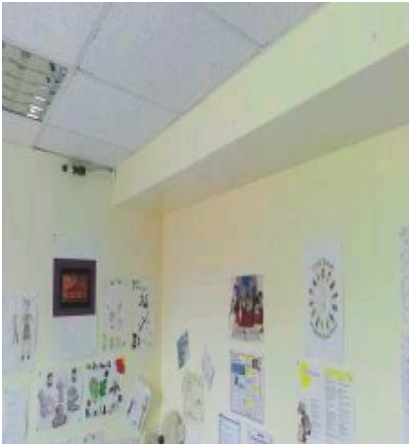
The wood boxing to the Head Teachers Office (Room 49) was accessed and no suspected materials were found.

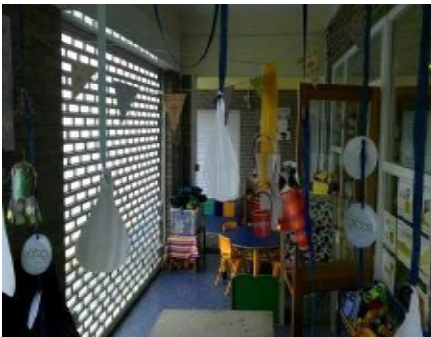
The external play area (Area 50) was accessed and no suspected materials were found.

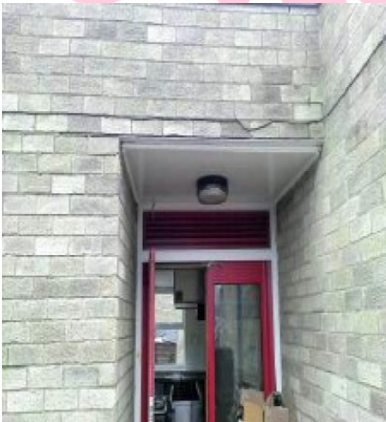
The external canopy above the kitchen door was accessed and no suspected materials were found.
