ASBESTOS SURVEY REPORT FOR BIDDICK PRIMARY SCHOOL, KIRKHAM BIDDICK VILLAGE, WASHINGTON

Asbestos Register for Biddick Primary School

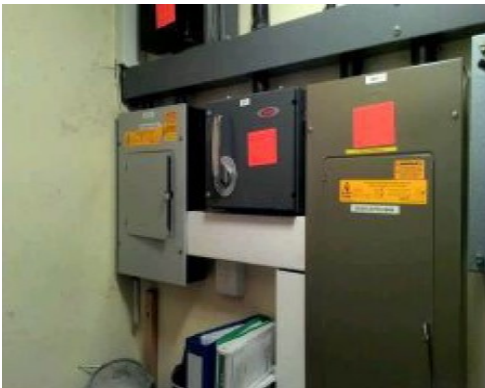
At the time of the survey there was no access to the electrics in the store room (Room 31) due to the electrics being live.

Prior to any works taking place in the store, there needs to be further investigation carried out.
