ASBESTOS SURVEY REPORT FOR BIDDICK PRIMARY SCHOOL, KIRKHAM BIDDICK VILLAGE, WASHINGTON

Asbestos Register for Biddick Primary School

Date: 01 July 2025

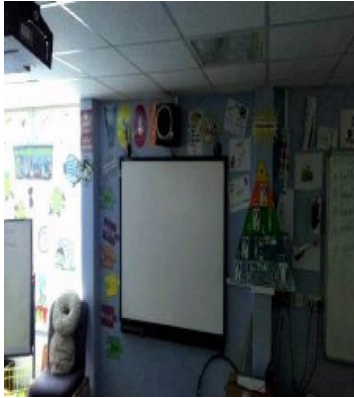
Item 4 As EB002449

The insulating board cladding to the metal columns within Classroom 10 (Room 3) contain asbestos.

Any change in its appearance should be noted and reported to Property Services.

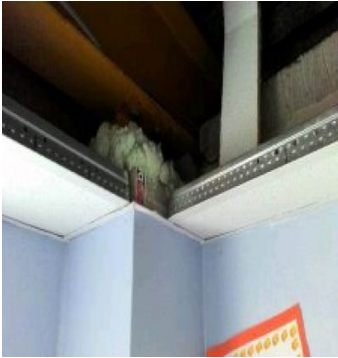
Item 7 As EB002449

The insulating board cladding to the metal columns within the cloak room (Room 5) contain asbestos.

Any change in its appearance should be noted and reported to Property Services.

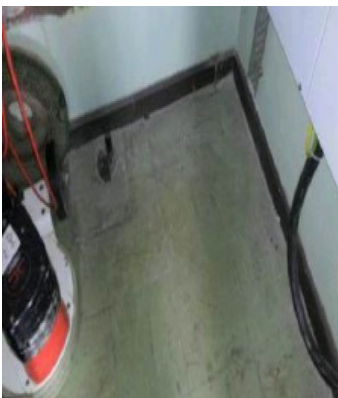
Item 9 As: EB0024501

The green floor tiles to the electrical cupboard (Room 6) do not contain asbestos.

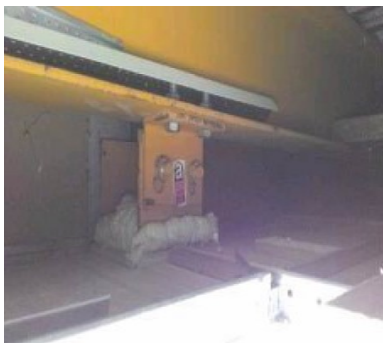
Item 10 As EB002449

The insulating board cladding to the metal columns within the Boys WC (Room 7) contains asbestos.

This was removed in 2014.

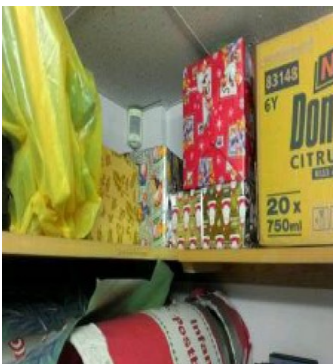
Item 18 As: EB002449

The insulating board cladding to the metal columns within the store (Room 14) contains asbestos.

Any change in its appearance should be noted and reported to Property Services.

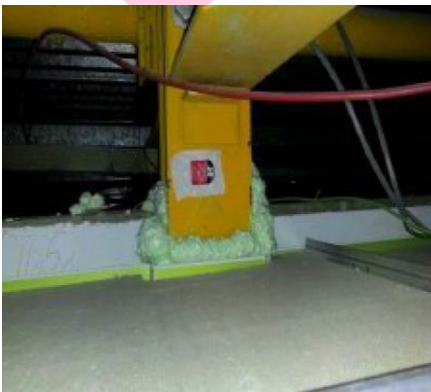
Item 21 As: EB002449

The insulating board cladding to the metal columns within Classroom 8 (Room 16) contains asbestos.

Any change in its appearance should be noted and reported to Property Services.

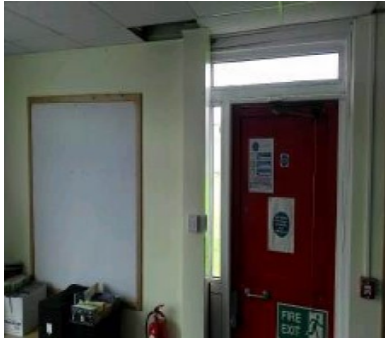
Item 22 As EB002449

The insulating board cladding to the metal columns within the Classroom 8 (Room 16) contains asbestos.

Any change in its appearance should be noted and reported to Property Services.

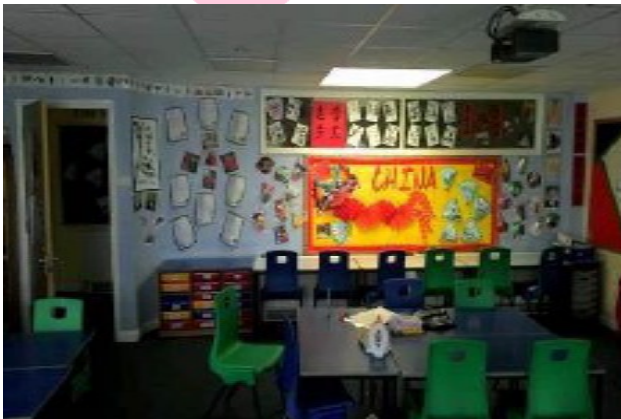
Item 30 As: EB002452

The insulating board panels to the partition wall in Classroom 7 (Room 18) do not contain asbestos.

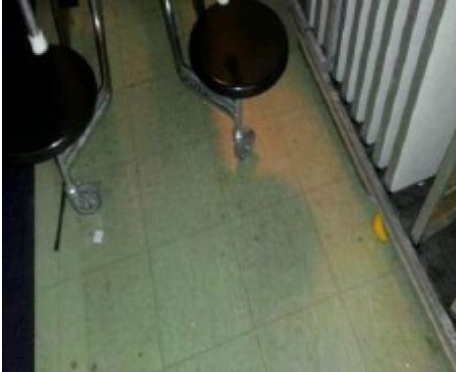
Item 34 Ref: EB002455

The green vinyl floor tiles to the chair store (Room 38) do not contain asbestos.

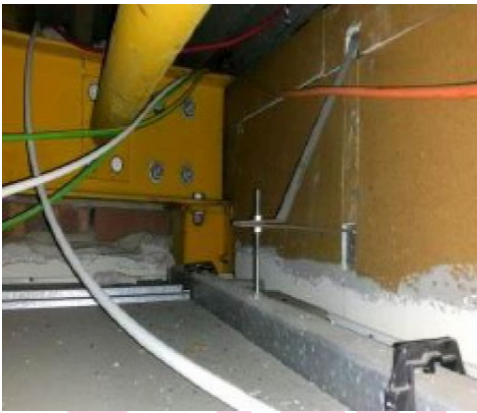
Item 35 Ref: EB002453

The insulating board cladding to the metal columns within the PE store (Room 39) contains asbestos.

Any change in its appearance should be noted and reported to Property Services.

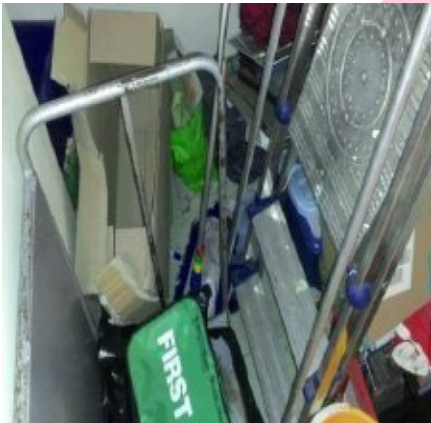
Item 41 Ref: EB002457

The grey vinyl floor tiles to the store (Room 43) do not contain asbestos.

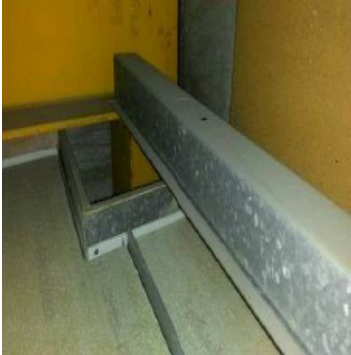
Item 43 Ref: EB002453

The insulating board cladding to the metal columns within the Ladies WC (Room 44) contains asbestos.

Any change in its appearance should be noted and reported to Property Services.

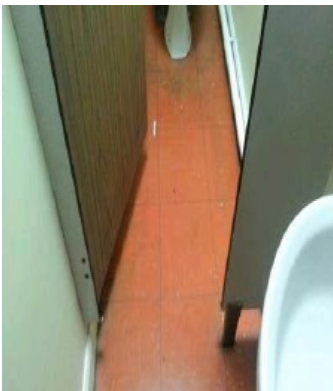
Item 45 As: EB002459

The orange vinyl floor tiles to the Gents WC (Room 46) do not contain asbestos.

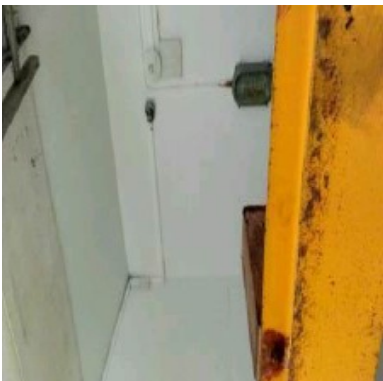
Item 48 Ref: EB002461

The ceiling board panels to the boiler room (External Room 1) contain asbestos.

Any change in its appearance should be noted and reported to Property Services.

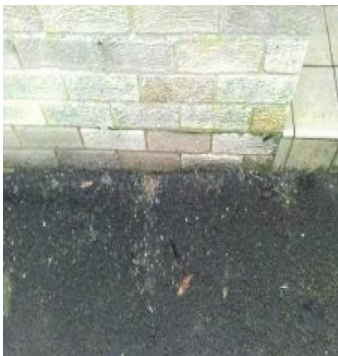
Item 51 Ref: EB002464

The damp proof course to the external of the building contains asbestos.

Any change in its appearance should be noted and reported to Property Services.

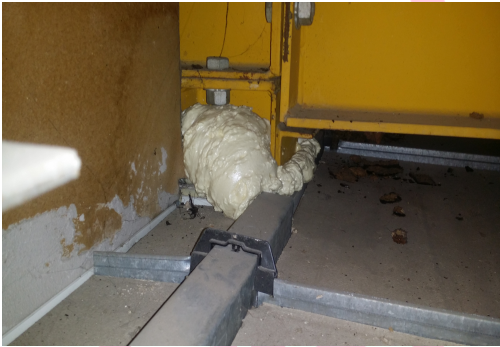
Item 53 Ref: As 203580-1

The insulating board in the girls toilet ceiling void (Room 016) contains asbestos.

This has been partially encapsulated. Any change in its appearance should be reported to Property Services.

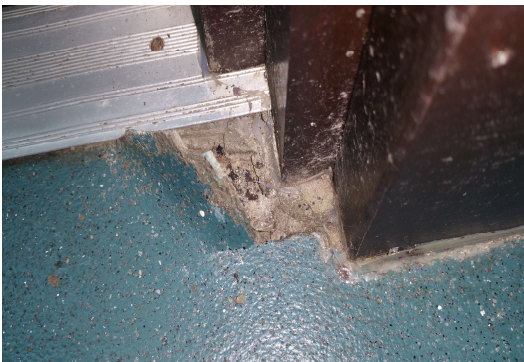
Item 54 Ref: 208189-1

The Subfloor Covering (020/Corridor) does not contain asbestos.

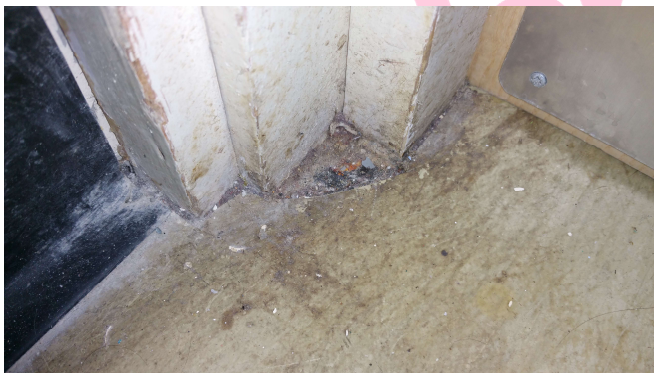
Item 56 Ref: As 208189-1

The Subfloor Covering
(090/Caretakers Store) does
not contain asbestos.

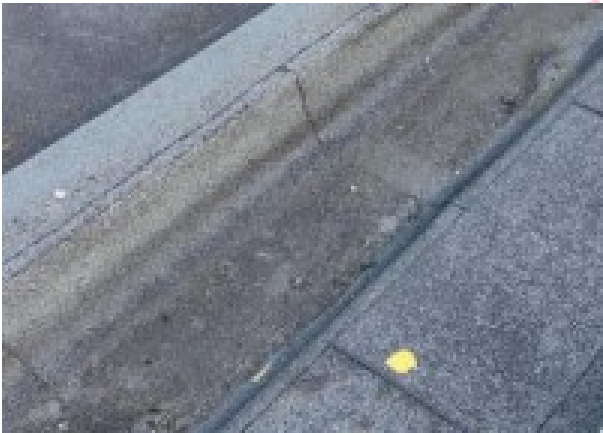
Item 68 Ref: 21-31381-6

The bitumen on the roof areas of extraction installation locations above ladies toilets (Area 4) does not contain asbestos.

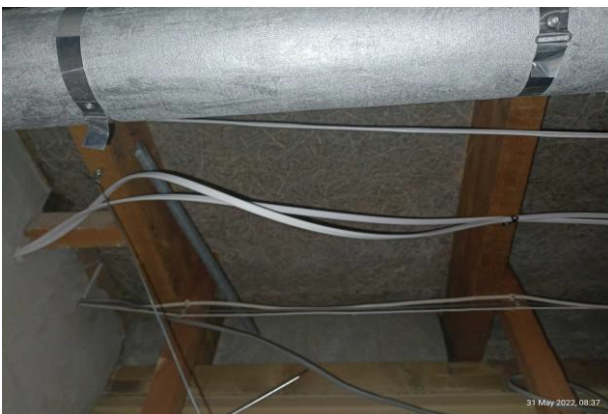
Item 72 Ref: 22-47235-1

The ceiling (Strawboard) (Corridor G0/20 False ceiling void/Area 1) does not contain asbestos.

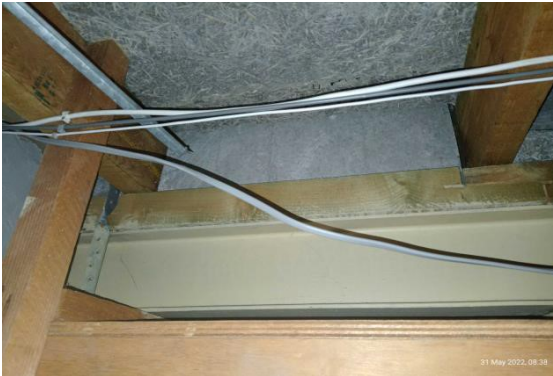
Item 73 Ref: 22-47235-2

The firebreaks (Corridor G0/20 False ceiling void/Area 1) do not contain asbestos.

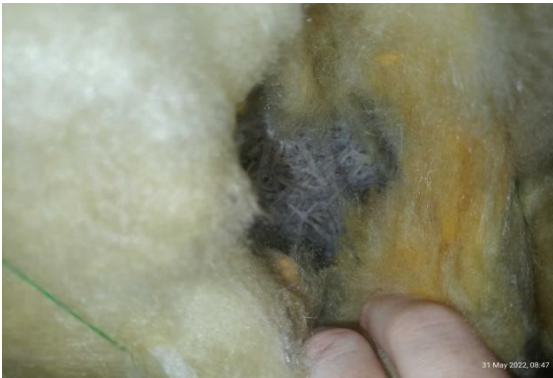
Item 74 Ref: 22-47235-1

The ceiling (Strawboard) (Lobby G0/27 False ceiling void/Area 2) does not contain asbestos.

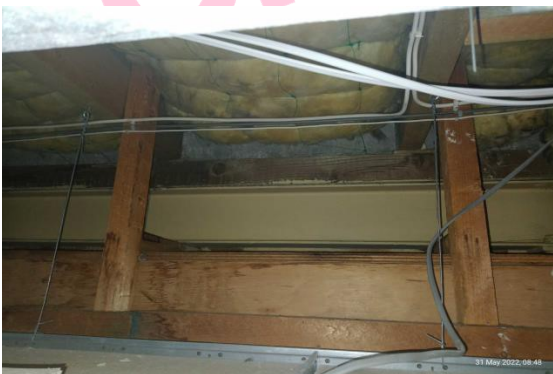
Item 75 Ref: 22-47235-2

The firebreaks (Lobby G0/27 False ceiling void/Area 2) do not contain asbestos.

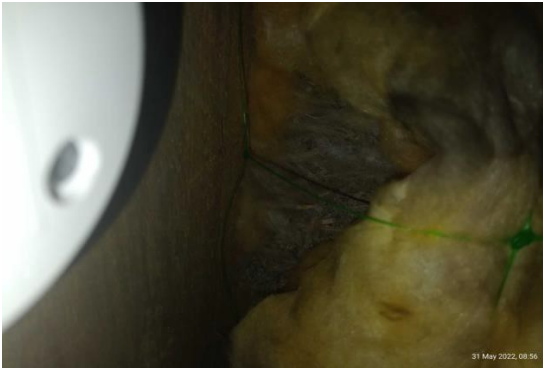
Item 76 Ref: 22-47235-1

The ceiling (Strawboard)
(Classroom 2 G0/26 False
ceiling void/Area 3) does not
contain asbestos.

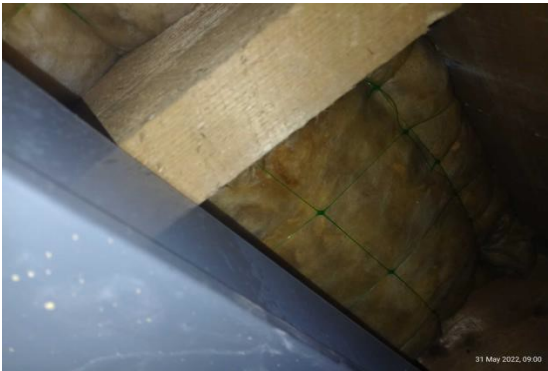
Item 77 Ref: 22-47235-1

The ceiling (Strawboard)
(Classroom 3 G0/23 False
ceiling void/Area 4) does not
contain asbestos.

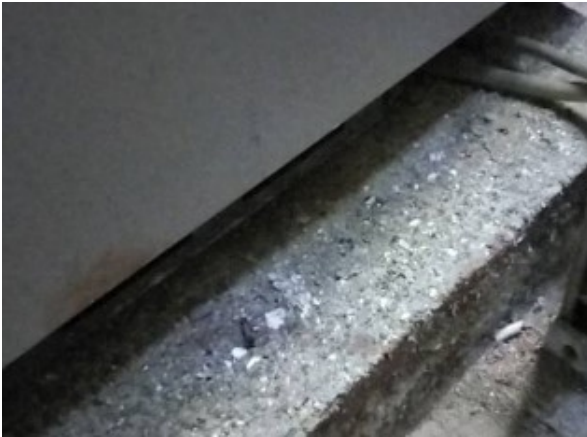
Item 80 Ref: AW005493

The floor debris in the boiler
room (Rm G/001) does not
contain asbestos.

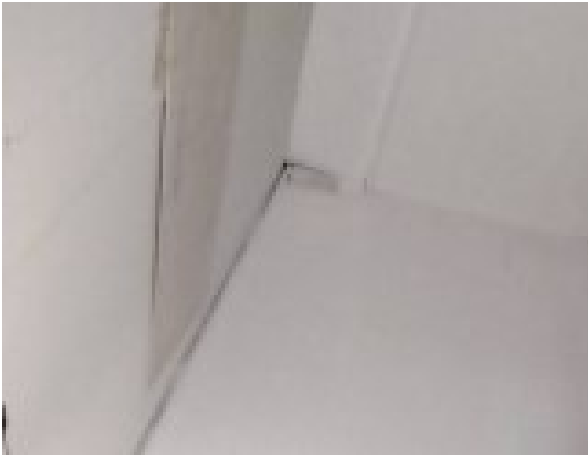
Item 85 Ref: AW005498

The upstands to raised roof area in the boiler room (G/001) contain asbestos.

Any change in appearance should be reported to Property Services.

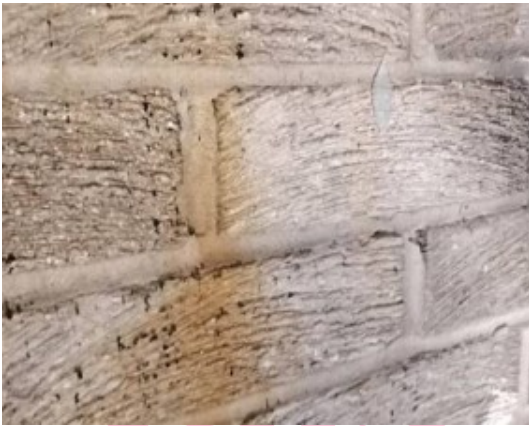
Item 92 Ref: AW005506

The wall debris in the Store Room (G/002) does not contain asbestos.

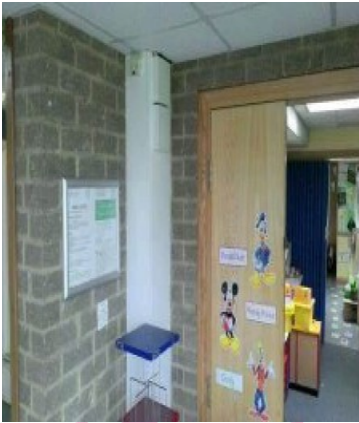
The wood boxing to the corridor (Room 20) was accessed and no suspected materials were found.

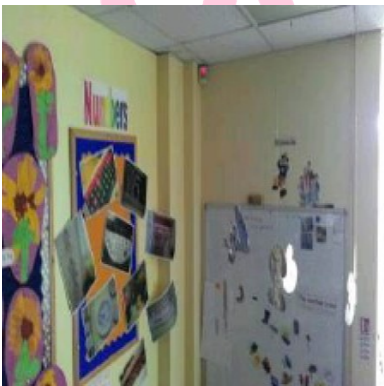
The wood boxing to the Classroom 1 and Lobby (Room 21) was accessed and no suspected materials were found.

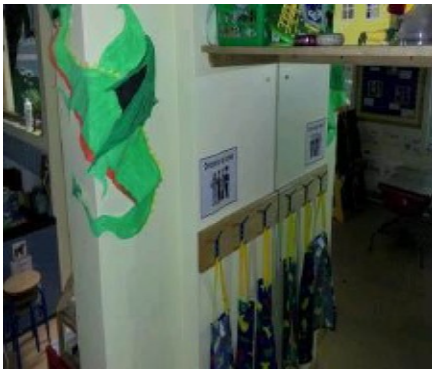
The wood boxing to Classroom 3 (Room 23) was accessed and no suspected materials were found.

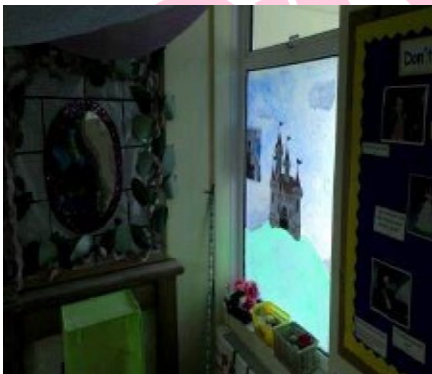
The wood boxing to Classroom 3 (Room 23) was accessed and no suspected materials were found.

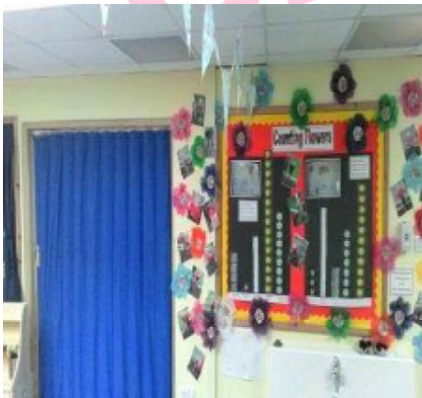
The wood boxing to classroom 3 (Room 23) was accessed and no suspected materials were found.

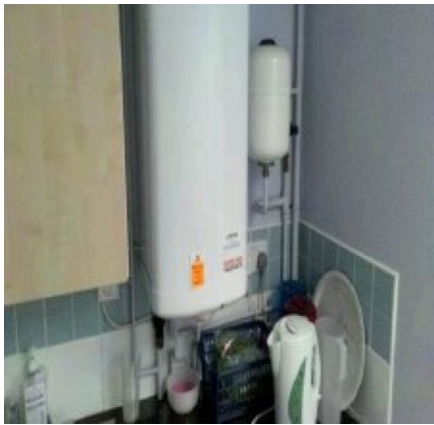
The modern boiler to the staff room (Room 24) was accessed and no suspected materials were found.

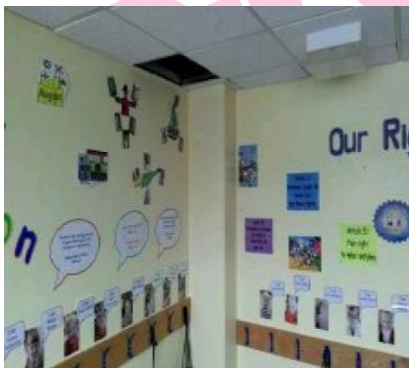
The wood boxing to cloak room area (Room 25) was accessed and no suspected materials were found.

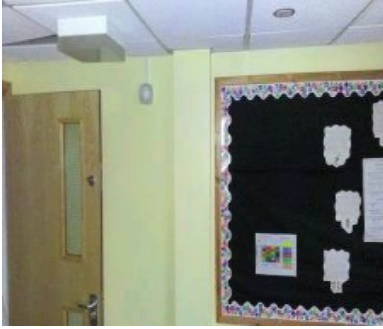
The wood boxing to the cloak room area (Room 25) was accessed and no suspected materials were found.

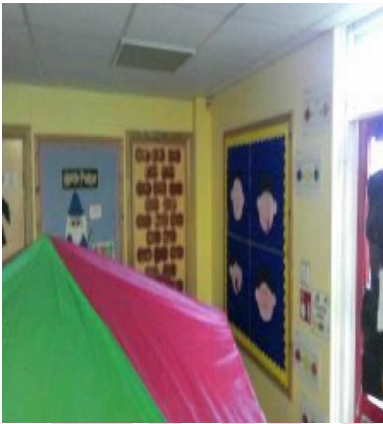
The wood boxing to Classroom 2 (Room 26) was accessed and no suspected materials were found.

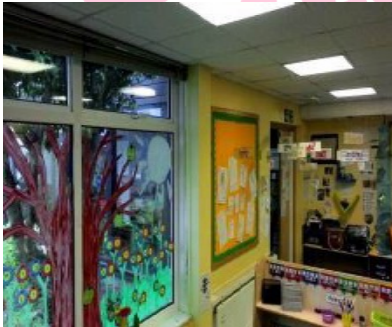
The wood boxing to Classroom 2 (Room 26) was accessed and no suspected materials were found.

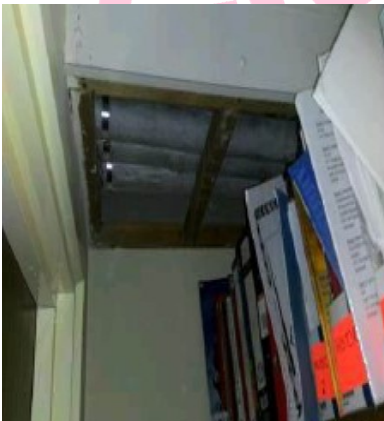
The wood boxing to the store (Room 28) was accessed and no suspected materials were found.

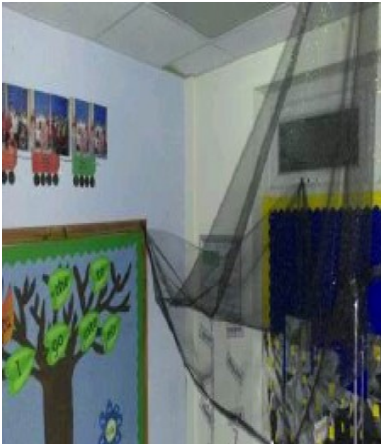
The wood boxing to classroom 4 (Room 29) was accessed and no suspected materials were found.

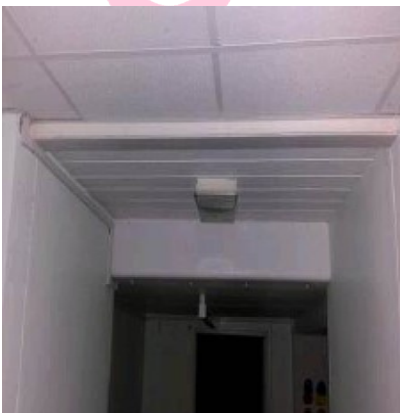
The wood boxing to the cloak room (Room 30) was accessed and no suspected materials were found.

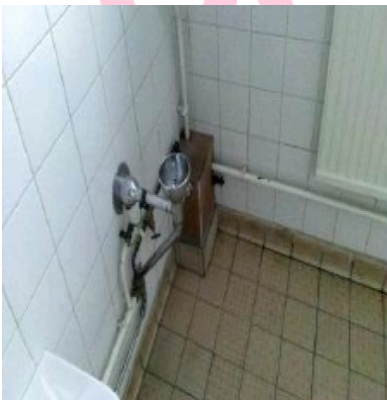
The wood boxing to the Boys WC (Room 33) was accessed and no suspected materials were found.

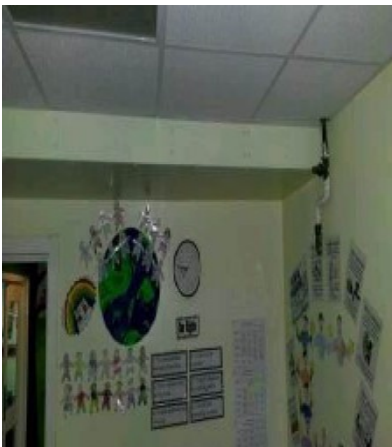
The wood boxing to Classroom 5 (Room 34) was accessed and no suspected materials were found.

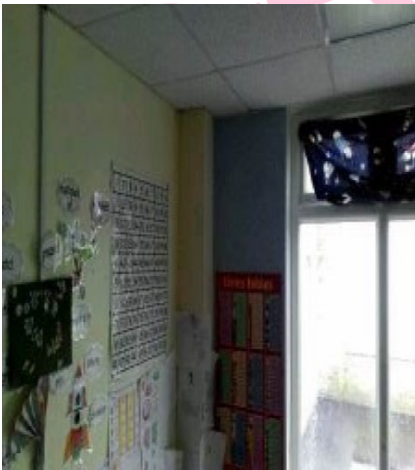
The wood boxing to Classroom 5 (Room 34) was accessed and no suspected materials were found.

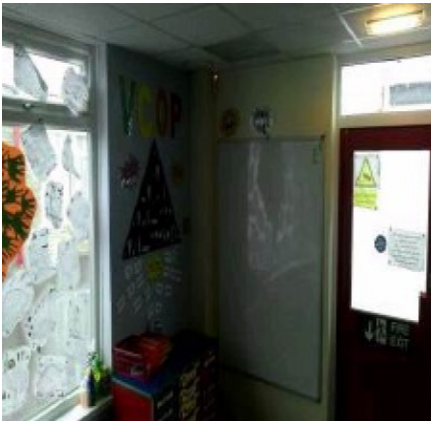
The wood boxing to the Classroom 5 (Room 34) was accessed and no suspected materials were found.

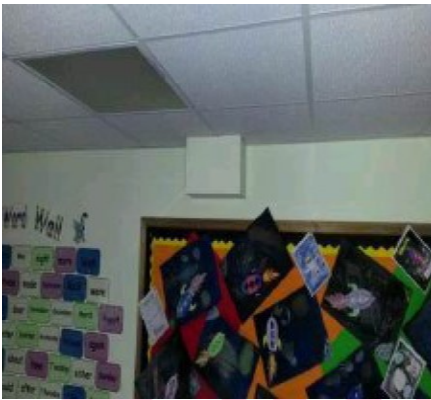
The wood boxing to Classroom 5 (Room 34) was accessed and no suspected materials were found.

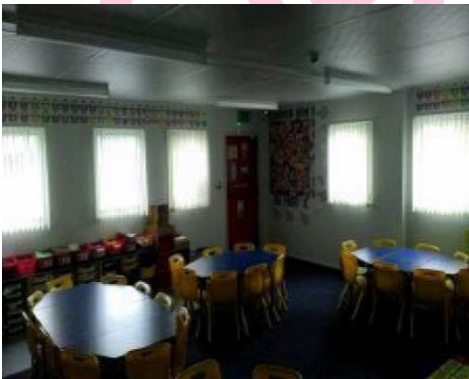
The wood boxing to Classroom A and Cloaks) (Room 35) was accessed and no suspected materials were found.

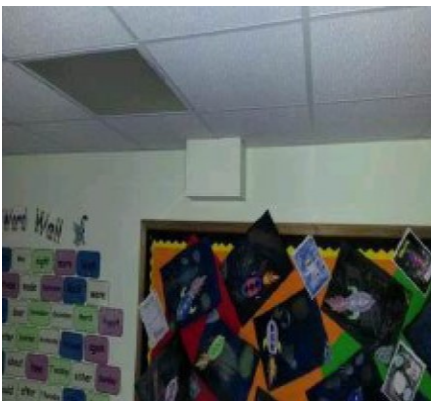
The wood boxing to Classroom 5 (Room 34) was accessed and no suspected materials were found.

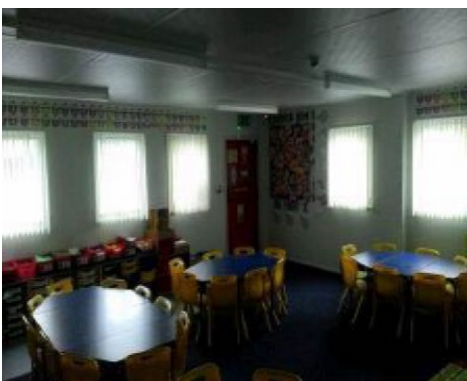
The wood boxing to Classroom A and Cloaks) (Room 35) was accessed and no suspected materials were found.

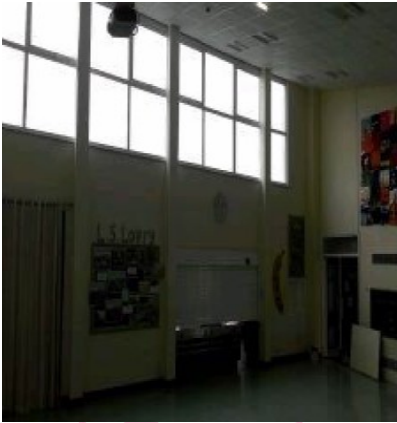
The wood boxing (x 5) to the Assembly Hall (Room 37) was accessed and no suspected materials were found.

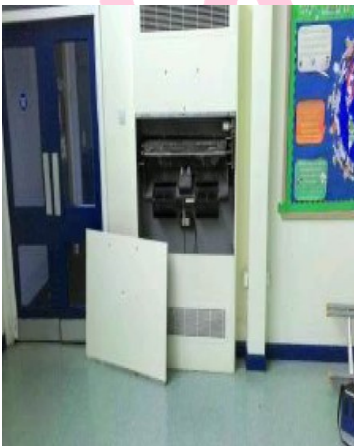
The wall heaters in the assembly hall (Room 37) were accessed and no suspected materials were found.

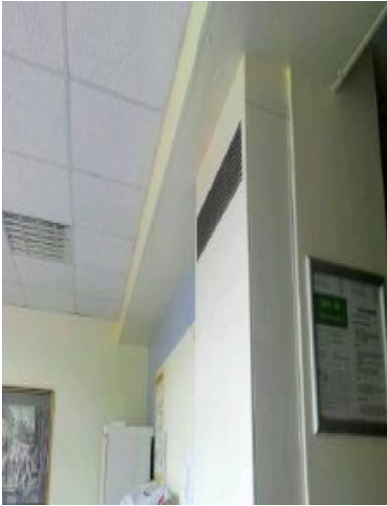
The wood boxing to the Staff Room (Room 41) was accessed and no suspected materials were found.

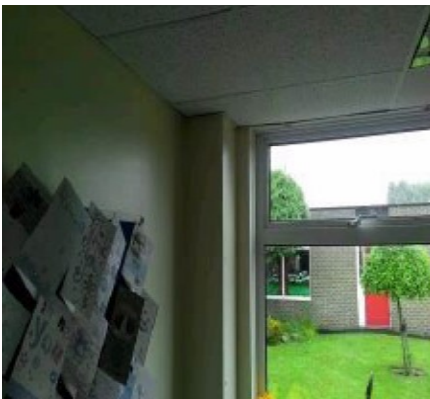
The wood boxing to the Staff Room (Room 41) was accessed and no suspected materials were found.

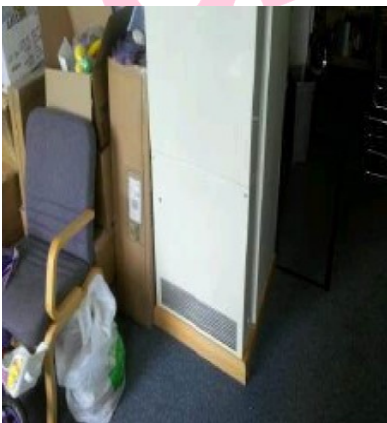
The wall heaters in the staff room (Room 41) were accessed and no suspected materials were found.

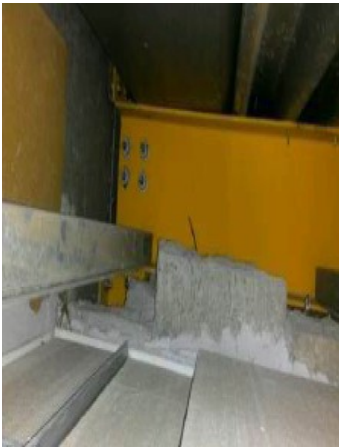
The unclad inspection point in the ceiling void to the Ladies WC (Room 44) was accessed and no suspected materials were found.

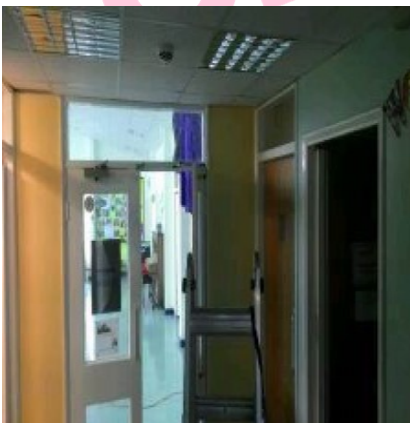
The corridor (Room 45) was accessed and no suspected materials were found.

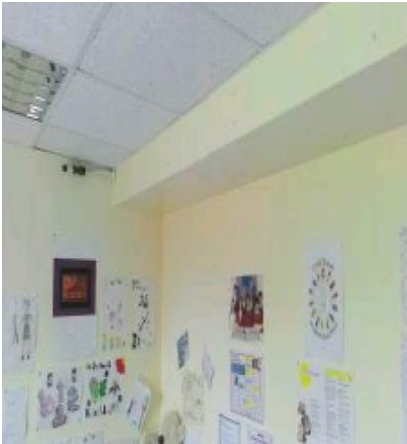
The wood boxing to the Head Teachers Office (Room 49) was accessed and no suspected materials were found.

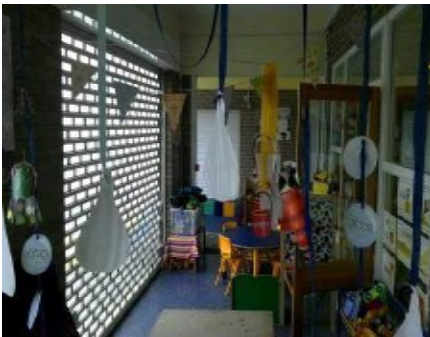
The external play area (Area 50) was accessed and no suspected materials were found.

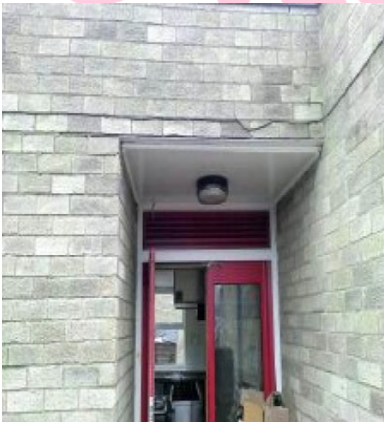
The external canopy above the kitchen door was accessed and no suspected materials were found.
