ASBESTOS SURVEY REPORT FOR SPRINGWELL DENE SCHOOL, SUNDERLAND

Asbestos Register for SPRINGWELL DENE SCHOOL, SUNDERLAND

Date: 11 March 2025

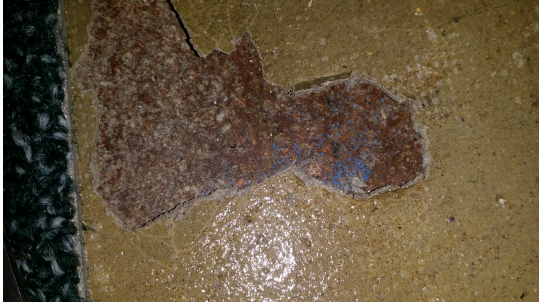
Item 1 Ref: 291230-1

Subfloor in 003/corridor does not contain asbestos.

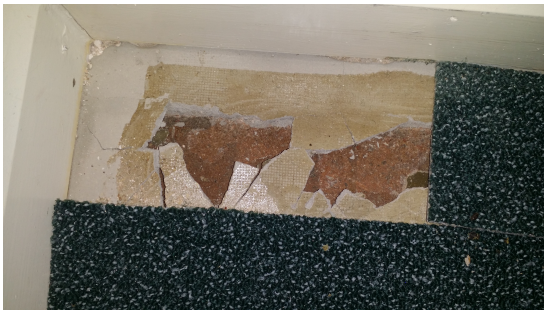
Item 2 Ref: As 291230-1

Subfloor in 005/dep. Head teachers office does not contain asbestos.

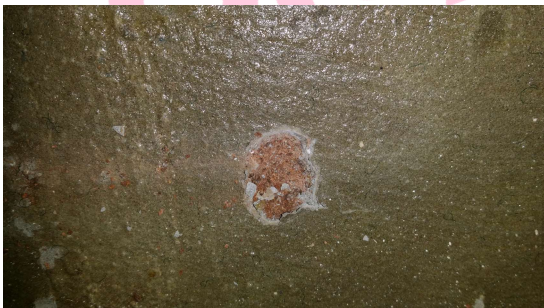
Item 3 Ref: As 291230-1

Subfloor in 006/office does not contain asbestos.

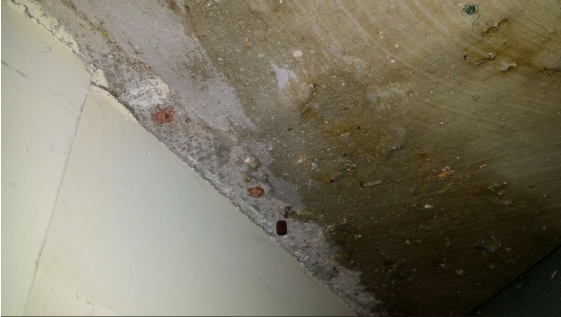
Item 4 Ref: As 291230-1

Subfloor in 007/store does not contain asbestos.

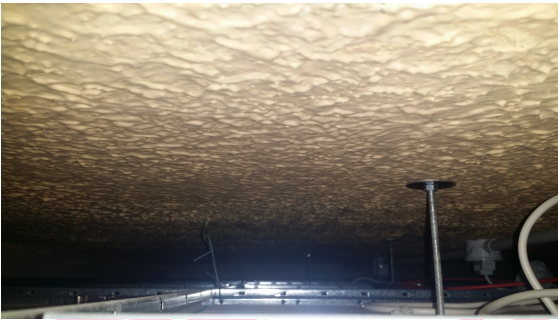
Item 5 Ref: 291230-2

Textured coating to ceiling & wall tops in 008/lobby-void above does not contain

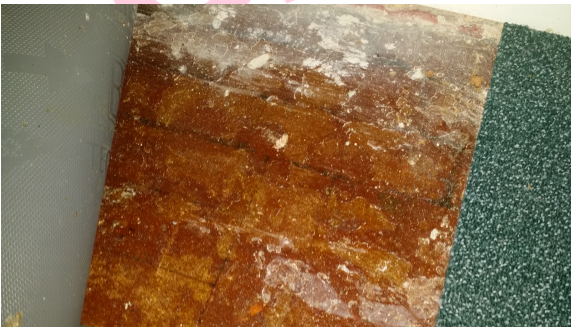
Item 6 Ref: As 291230-1

Subfloor in 009/corridor does not contain asbestos.

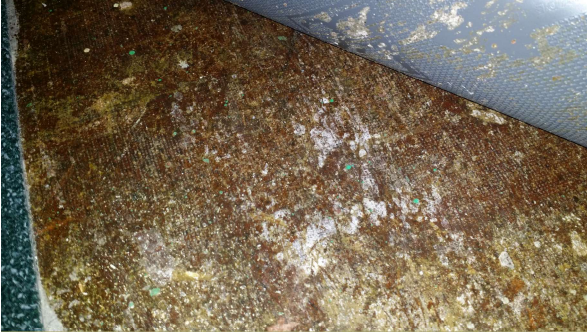
Item 7 Ref: As 291230-1

Subfloor in 011/reception store does not contain asbestos.

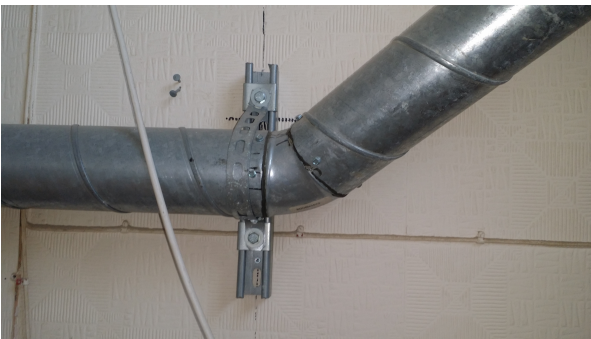
Item 8 Ref: 291230-5

Sealant to ductwork in 012/parent room-void above does not contain asbestos.

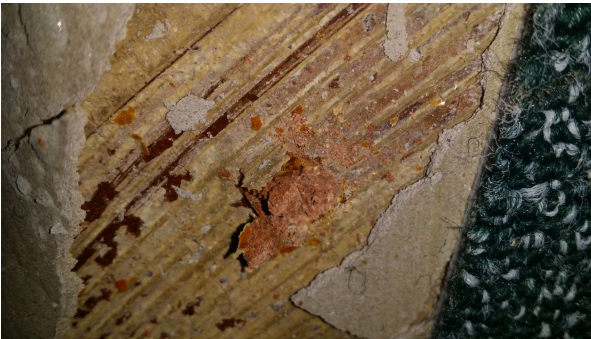
Item 9 Ref: 291230-3

Subfloor in 013/quiet room does not contain asbestos.

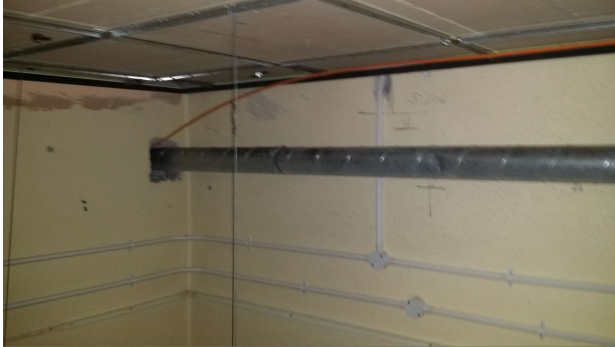
Item 10 Ref: As 291230-5

Sealant to ductwork in 013/quiet room-void above does not contain asbestos.

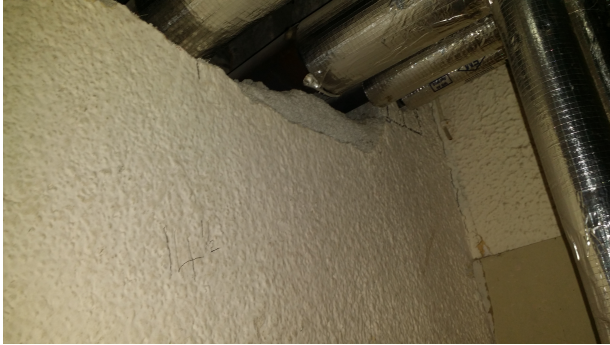
Item 25 Ref: As 291230-10

Sprayed coating to walls in 018/kitchen toilet-void above contain asbestos.

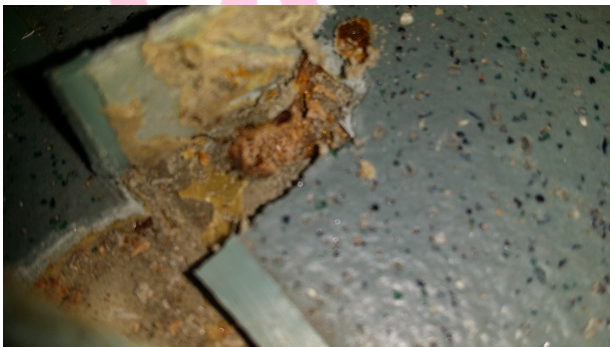
Item 27 Ref: As 291230-7

Subfloor in 019/kitchen office does not contain asbestos.
