ASBESTOS SURVEY REPORT FOR BARNWELL ACADEMY, PENSHAW

Asbestos Register for

BARNWELL ACADEMY, PENSRAW

Date: 04 June 2025

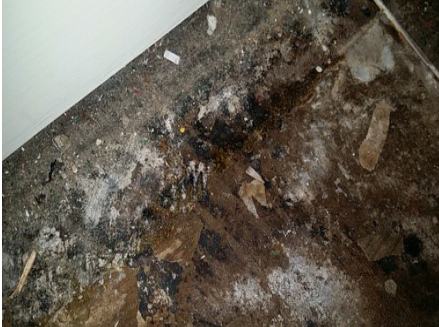
Item 24 – 80235-4

The remnant adhesive to the floor in the cupboard area (to be made a disabled WC) contained asbestos.

This was screeded over and new flooring laid in August 2015.

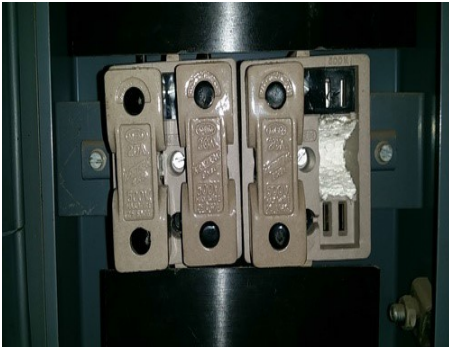
Item 25 – 80235-5

The flashguards within the distribution panel to the cupboard area (To become disabled WC) contained asbestos.

These were removed in August 2015.

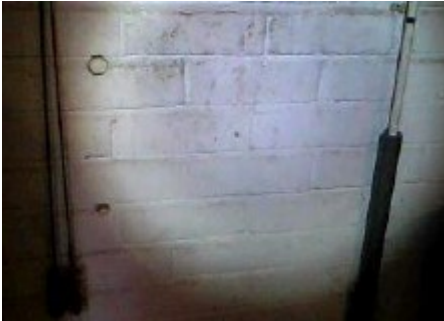
Item 46 Ref: AD000532

The debris to wall in Room 1 Boiler House does not contain asbestos.

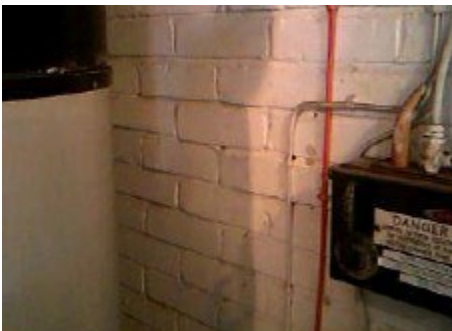
Item 47 Ref: AD000533

The debris to wall in Room 1 Boiler House does not contain asbestos.

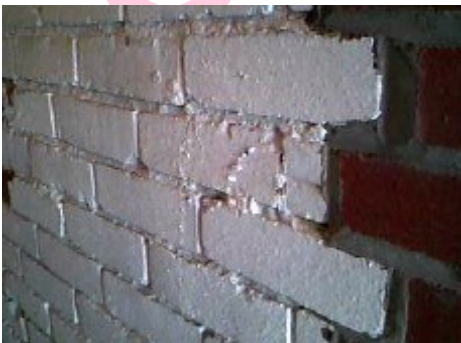
Item 48 Ref: AD000534

The debris to wall in Room 1 Boiler House does not contain asbestos.

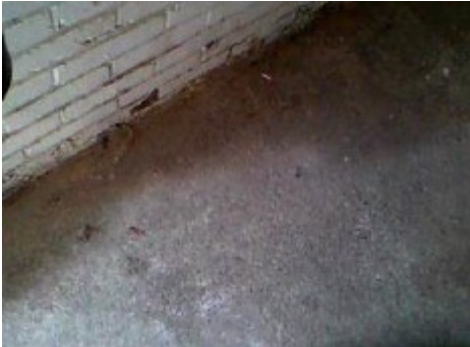
Item 49 Ref: AD000535

The debris to wall in Room 1 Boiler House does not contain asbestos.

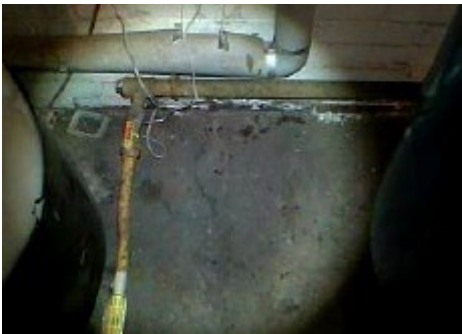
Item 50 Ref: AD000536

The debris to wall in Room 1 Boiler House does not contain asbestos.

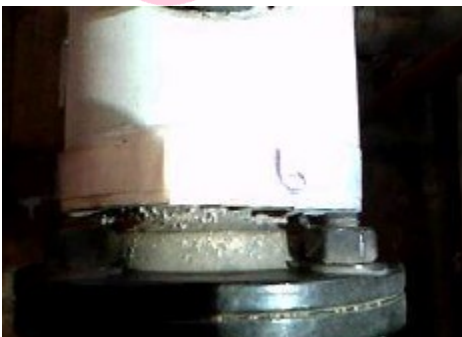
Item 51 Ref: AD000537

The debris around gasket in Room 1 Boiler House does not contain asbestos.

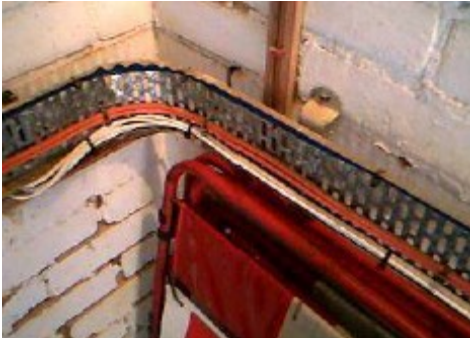
Item 52 Ref: AD000538

The debris to cable tray in Room 1 Boiler House does not contain asbestos.

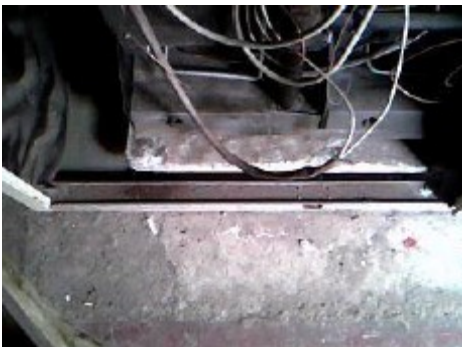
Item 53 Ref: AD000539

The insulating board plinth to boiler 1 in Room 1 Boiler House does not contain asbestos.

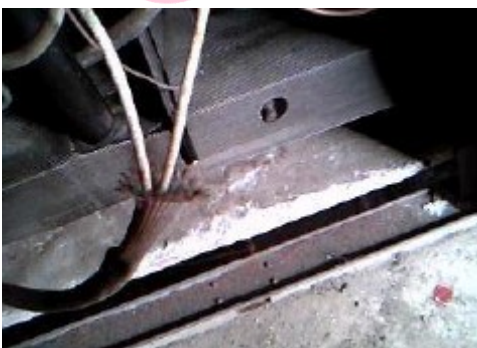
Item 54 Ref: AD000540

The rope to boiler 1 in Room 1 Boiler House does not contain asbestos.

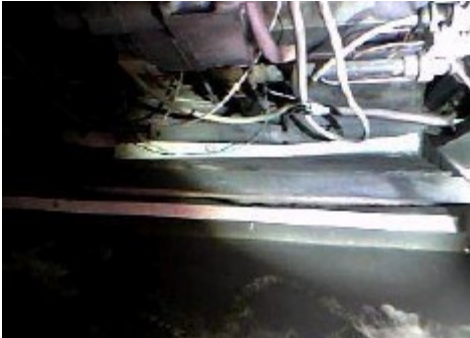
Item 55 Ref: As AD000539

The insulating board plinth to boiler 2 in Room 1 Boiler House does not contain asbestos.

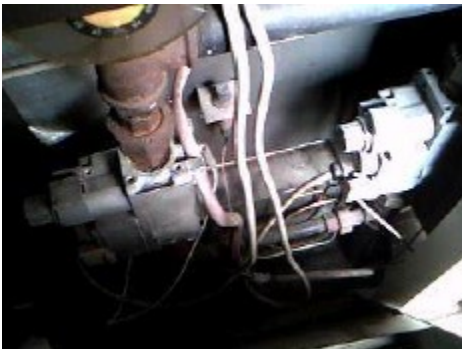
Item 56 Ref: As AD000540

The rope to boiler 2 in Room 1 Boiler House does not contain asbestos.

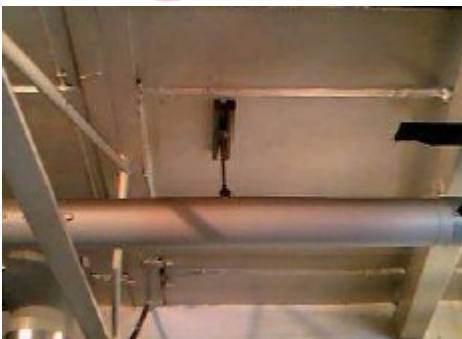
Item 57 Ref: AD000542

The debris to pipework Room 1 Boiler House does not contain asbestos.

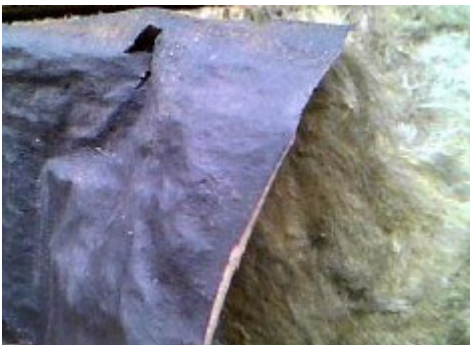
Item 60 Ref: BB002313

The builders paper in Room 6 external does not contain asbestos.

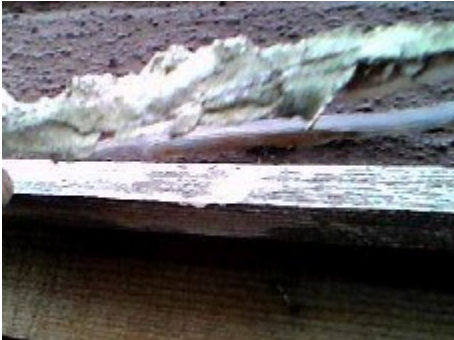
Item 61 Ref: BB002314

The sealant in Room 6 external does not contain asbestos.
