### ASBESTOS SURVEY REPORT FOR BARNWELL ACADEMY, PENSHAW

*Control of Asbestos  
Regulations 2012*

**BARNWELL ACADEMY,  
PENSHAW**

**Date: 14 May 2026**

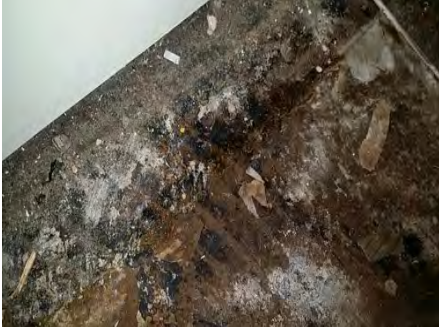
### **Item 24 – 80235-4**

The remnant adhesive to the floor in the cupboard area (to be made a disabled WC) contained asbestos.

This was screeded over and new flooring laid in August 2015.

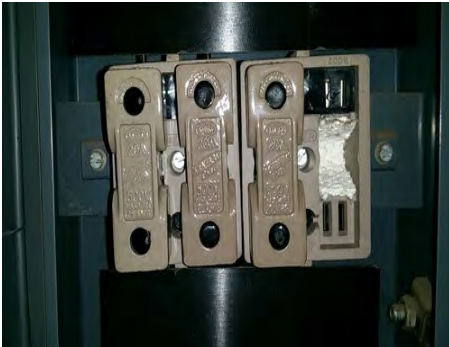
### **Item 25 – 80235-5**

The flashguards within the distribution panel to the cupboard area (To become disabled WC) contained asbestos.

*These were removed in August 2015.*

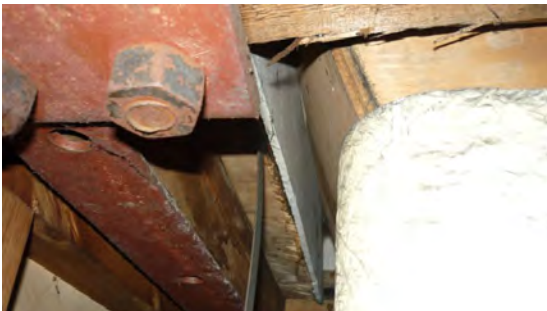
### **Item 31 Ref: AW0703/11**

The skylight surrounds in 0/32 Kitchen void above contain asbestos.

Any change in its appearance should be recorded and passed to Property Services.

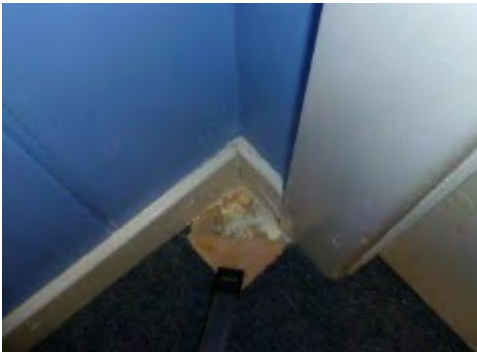
**Item 38 Ref: AC000357**

The concrete floor under carpet in Room 1 office off reception does not contain asbestos.

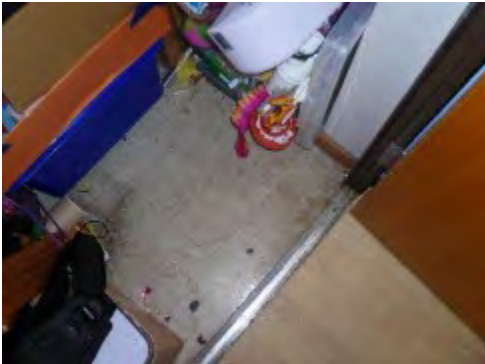
### **Item 41 Ref: AC000359**

The vinyl floor tiles & bitumen adhesive below in Room 2 cupboard to class 1 contain asbestos.

Removed 2012

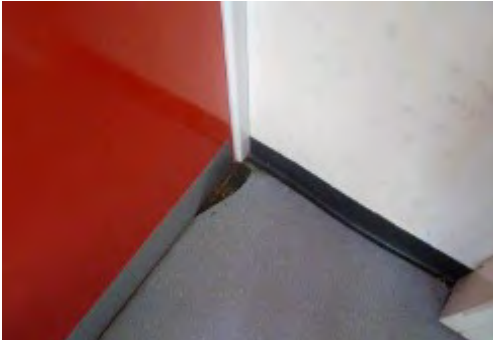
**Item 43 Ref: AC000361**

The vinyl floor sheeting in Room 3 Boys toilet does not contain asbestos.

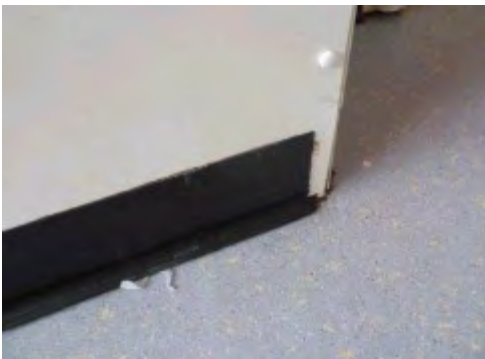
**Item 44 Ref: AC000362**

The vinyl skirting in Room 3 Boys toilet does not contain asbestos.

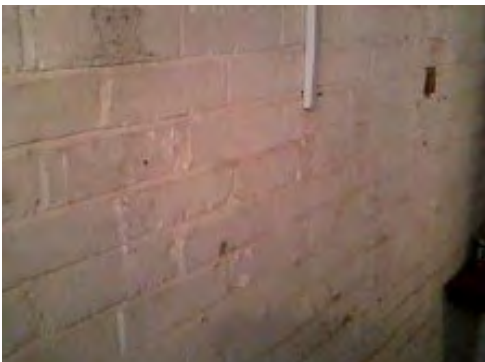
**Item 45 Ref: AD000531**

The debris to wall in Room 1 Boiler House does not contain asbestos.

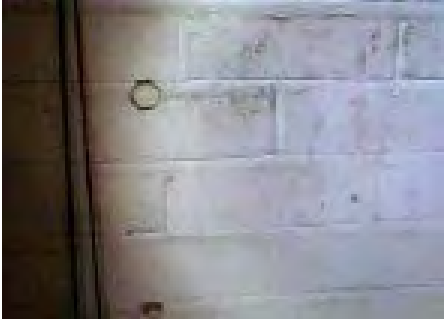
**Item 46 Ref: AD000532**

The debris to wall in Room 1 Boiler House does not contain asbestos.

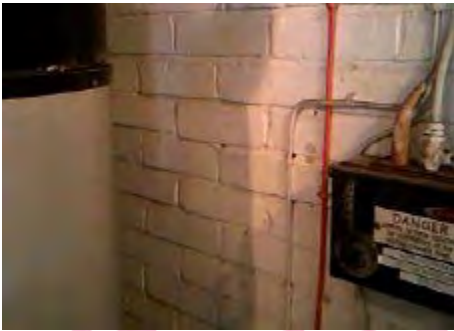
**Item 47 Ref: AD000533**

The debris to wall in Room 1 Boiler House does not contain asbestos.

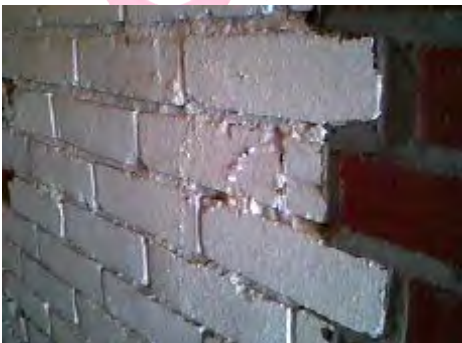
**Item 48 Ref: AD000534**

The debris to wall in Room 1 Boiler House does not contain asbestos.

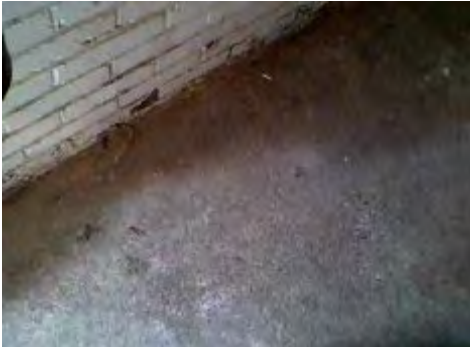
**Item 49 Ref: AD000535**

The debris to wall in Room 1 Boiler House does not contain asbestos.

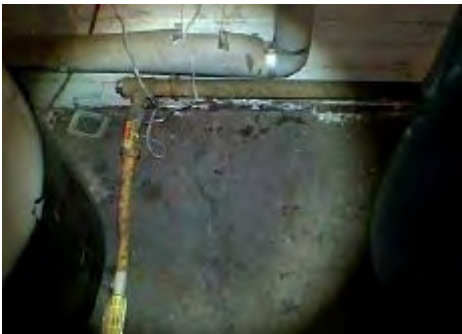
**Item 50 Ref: AD000536**

The debris to wall in Room 1 Boiler House does not contain asbestos.

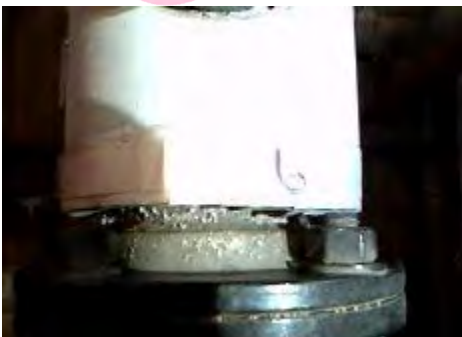
**Item 51 Ref: AD000537**

The debris around gasket in Room 1 Boiler House does not contain asbestos.

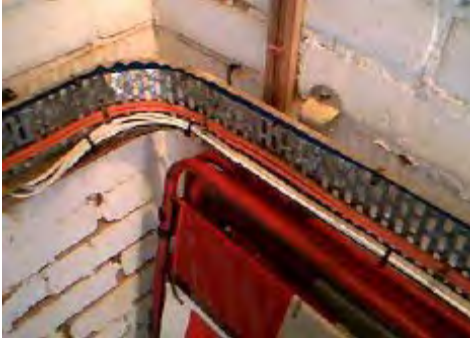
**Item 52 Ref: AD000538**

The debris to cable tray in Room 1 Boiler House does not contain asbestos.

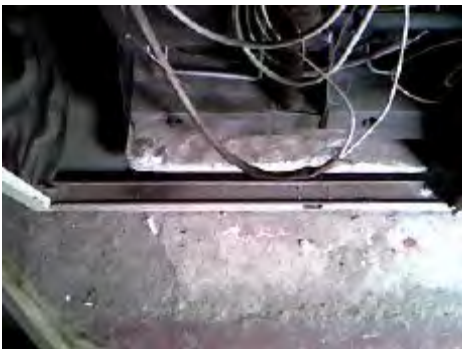
**Item 53 Ref: AD000539**

The insulating board plinth to boiler 1 in Room 1 Boiler House does not contain asbestos.

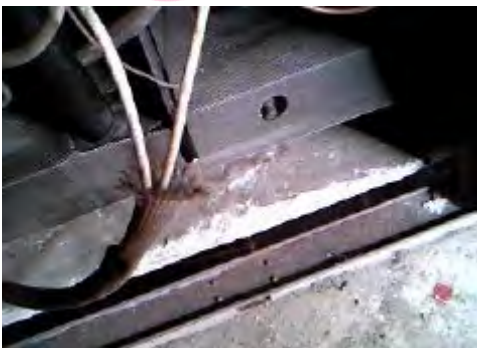
**Item 54 Ref: AD000540**

The rope to boiler 1 in Room 1 Boiler House does not contain asbestos.

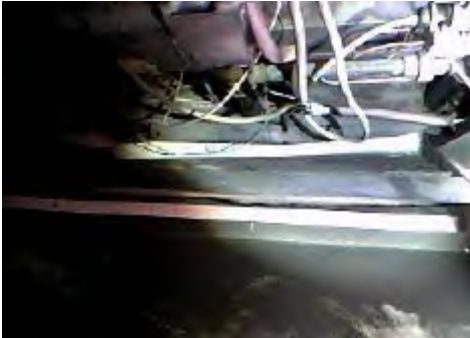
**Item 55 Ref: As AD000539**

The insulating board plinth to boiler 2 in Room 1 Boiler House does not contain asbestos.

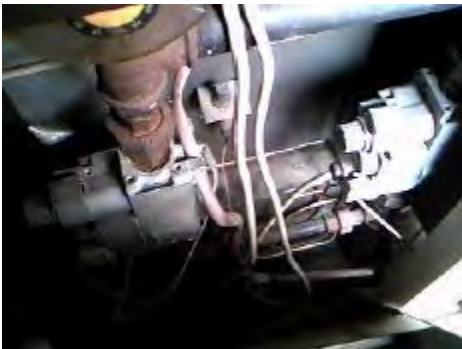
**Item 56 Ref: As AD000540**

The rope to boiler 2 in Room 1 Boiler House does not contain asbestos.

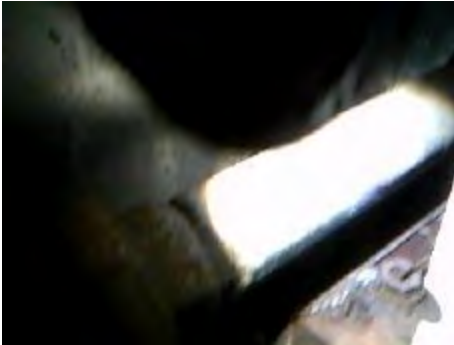
**Item 58 Ref: AD000543**

The rope to boiler 3 in Room 1 Boiler House does not contain asbestos.

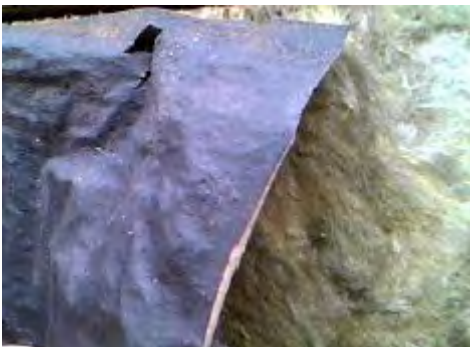
**Item 60 Ref: BB002313**

The builders paper in Room 6 external does not contain asbestos.

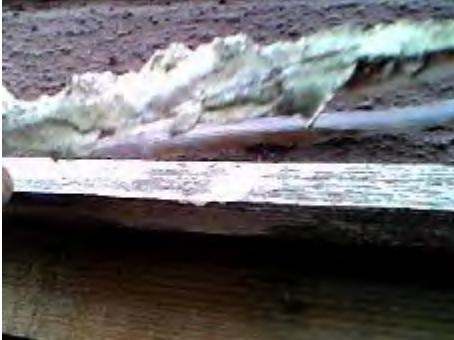
**Item 61 Ref: BB002314**

The sealant in Room 6 external does not contain asbestos.
