### **ASBESTOS SURVEY REPORT FOR BARNWELL ACADEMY, PENSHAW**

### BARNWELL ACADEMY, PENSCHAW

**Date: 25 July 2025**

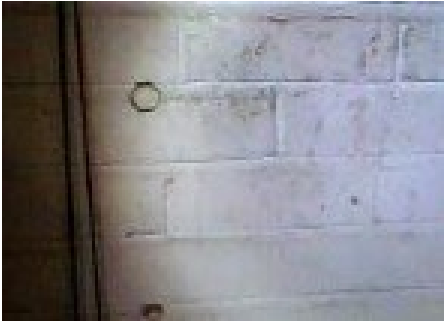
### **Item 46 Ref: AD000532**

The debris to wall in Room 1 Boiler House does not contain asbestos.

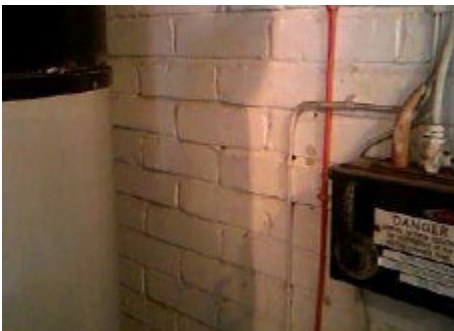
### **Item 47 Ref: AD000533**

The debris to wall in Room 1 Boiler House does not contain asbestos.

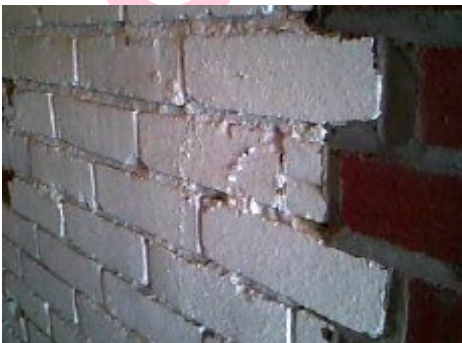
### **Item 48 Ref: AD000534**

The debris to wall in Room 1 Boiler House does not contain asbestos.

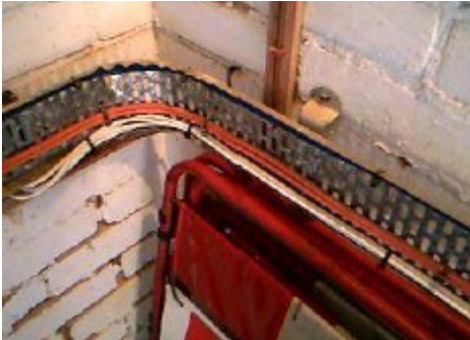
### **Item 52 Ref: AD000538**

The debris to cable tray in Room 1 Boiler House does not contain asbestos.

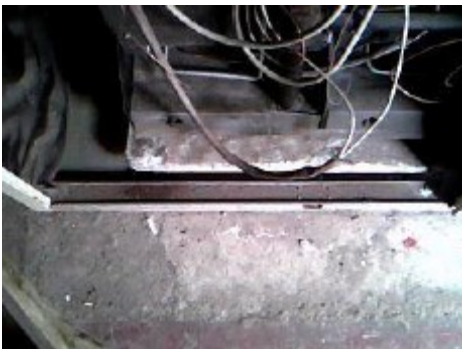
### **Item 53 Ref: AD000539**

The insulating board plinth to boiler 1 in Room 1 Boiler House does not contain asbestos.

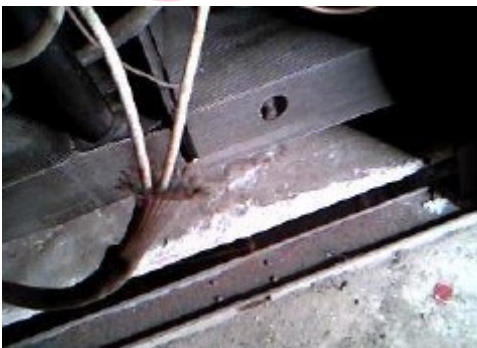
### **Item 54 Ref: AD000540**

The rope to boiler 1 in Room 1 Boiler House does not contain asbestos.

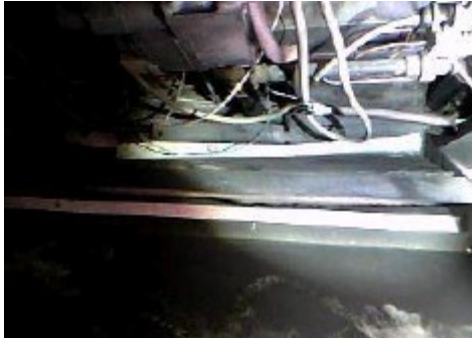
### **Item 55 Ref: As AD000539**

The insulating board plinth to boiler 2 in Room 1 Boiler House does not contain asbestos.

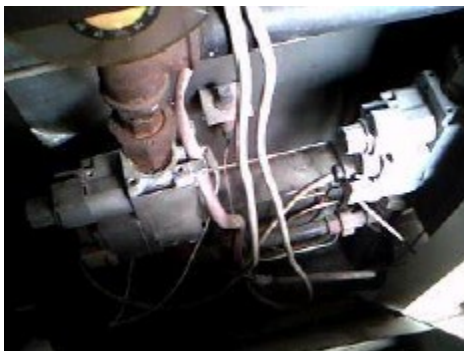
### **Item 56 Ref: As AD000540**

The rope to boiler 2 in Room 1 Boiler House does not contain asbestos.
