ASBESTOS SURVEY REPORT FOR EAST HERRINGTON ACADEMY, SUNDERLAND

Asbestos Register for EAST HERRINGTON ACADEMY, SUNDERLAND

Date: 30 May 2025

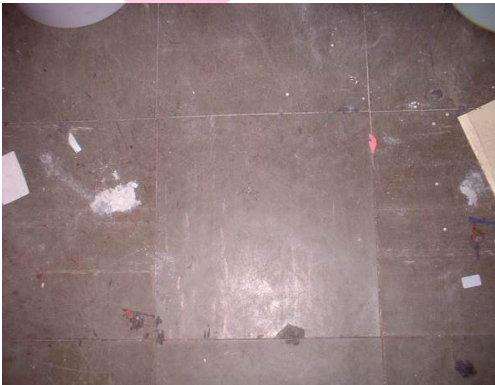
Item 3- As Sample 02

The floor covering to the infant school store room (Room 0/11) contains asbestos.

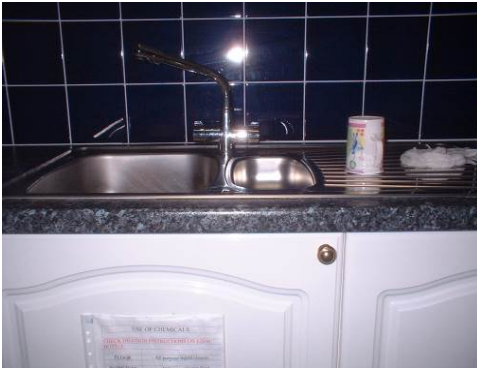
Item 4 - Ref: Sample 03

The sink pad in the after school kitchen (Room 0/06) does not contain asbestos.

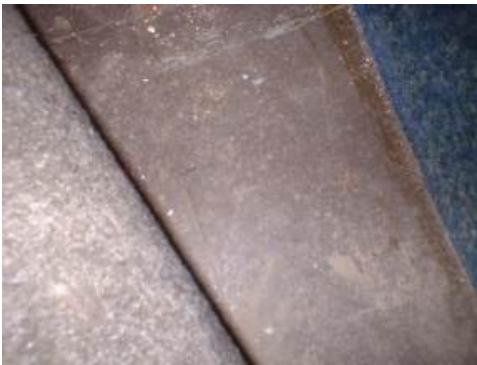
As Sample 02

The floor covering to the electrical intake cupboard (Room 0/07) contained asbestos.

Removed in October 2006

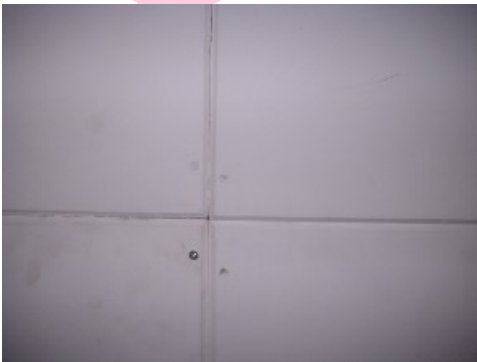
Sample 04

The ceiling to the electrical intake cupboard (Room 0/07) contained asbestos.

Removed in October 2006

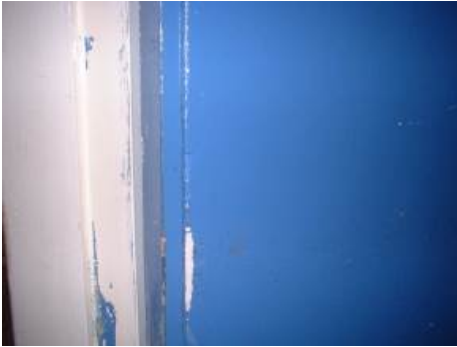
Sample 05

The door panel to the electrical intake cupboard (Room 0/07) contained asbestos.

Removed in October 2006

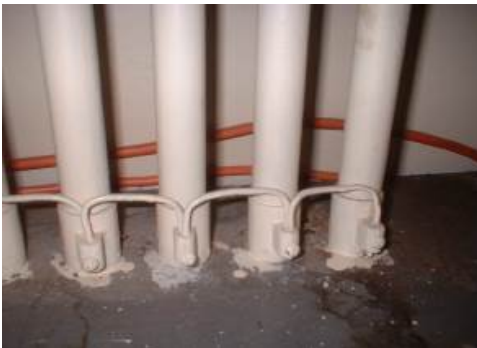
Sample 06

The debris to the electrical intake cupboard (Room 0/07) did not contain asbestos.

Removed in October 2006

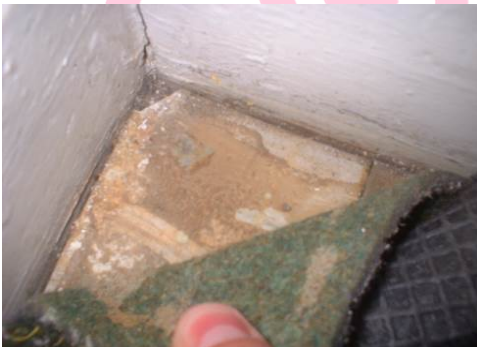
Item 5 - Ref: Sample 07

The vinyl flooring to the conservatory (Room 0/13) does not contain asbestos.

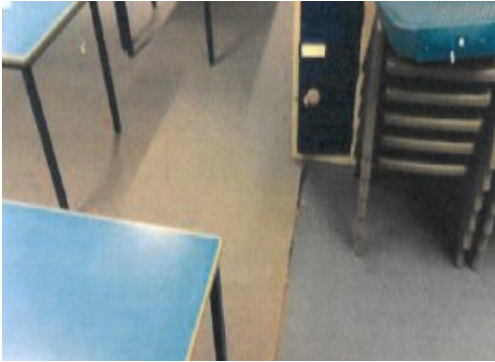
Item 6 - Ref: Sample 08 & AQ000123

The floor covering (vinyl tiles & adhesive below lino & carpet) (Room 0/11 Y2 classroom) contains asbestos.

Any change in its appearance should be recorded and passed to Property Services.

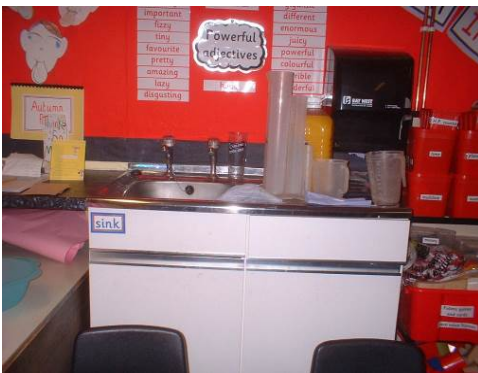
Item 8 - Ref: Sample 09

The sink pad in the infant school classroom (Room 0/14) does not contain asbestos.

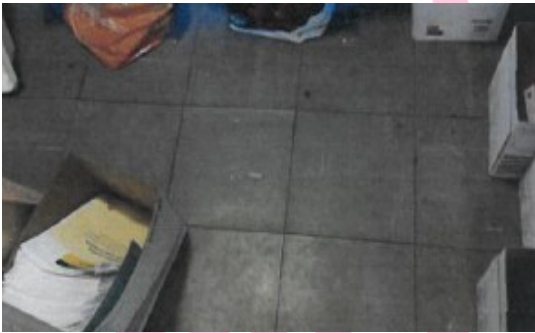
Item 10 – As Sample 10 & As AQ000124

The floor covering (vinyl tiles & adhesive) (Room 0/13 Y2 classroom stationary cupboard) contains asbestos.

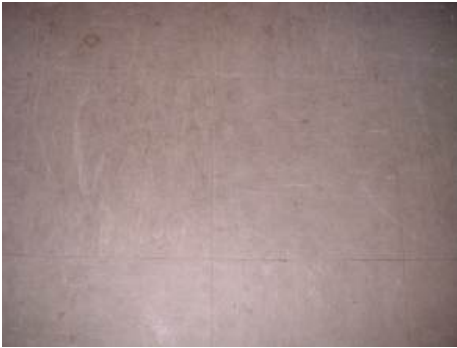
Item 21 - As Sample 18

The vinyl flooring in the infant classroom store (Room 0/32) does not contain asbestos.

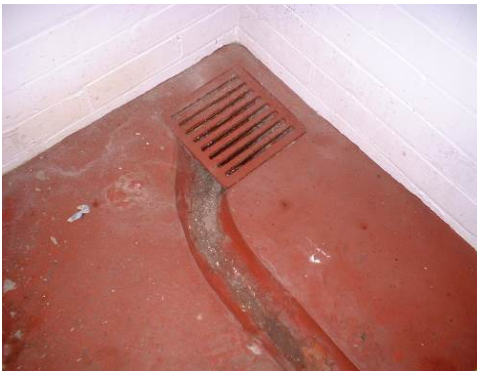
Item 22 - Ref: Sample 21

The debris to the floor in the infant school boiler house (Room 0/33) does not contain asbestos.

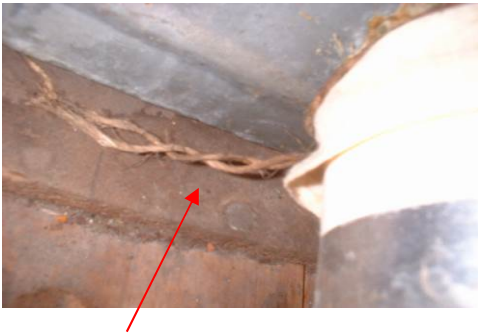
Item 27 - Ref: Sample 26

The redundant rope in the main hall ceiling void (Room 1/01) does not contain asbestos.

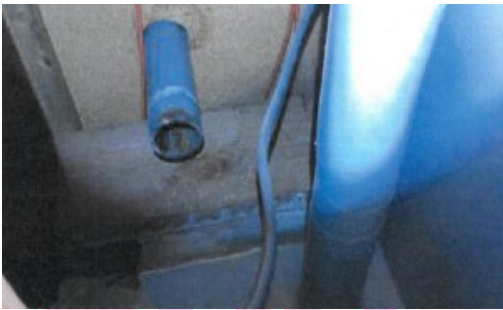
Item 28 - Ref: AQ000120

The disabled toilet ceiling void redundant flue (Room 0/06 cleaners cupboard & toilets) contains asbestos.

Any change in its appearance should be recorded and passed to Property Services.

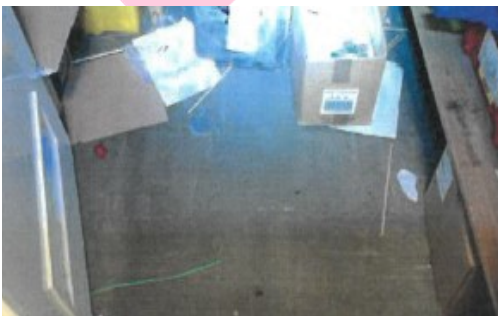
Item 29 - Ref: AQ000121

The floor covering (vinyl tiles & adhesive) (Room 0/07 store rooms) contains asbestos.

Any change in its appearance should be recorded and passed to Property Services.

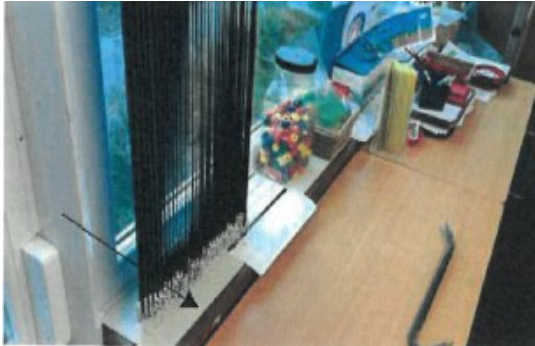
Item 30 - Ref: AQ000115

The window sill covering (composite material) (Room 0/01 Reception classroom) does not contain asbestos.

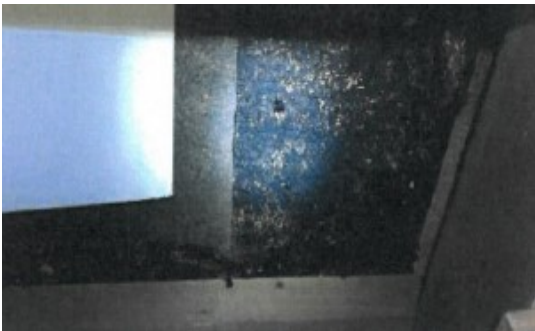
Item 31 - Ref: AQ000116

The ceiling void flat roof felt-bitumen (Room 0/02 Reception toilets & cloakroom) does not contain asbestos.

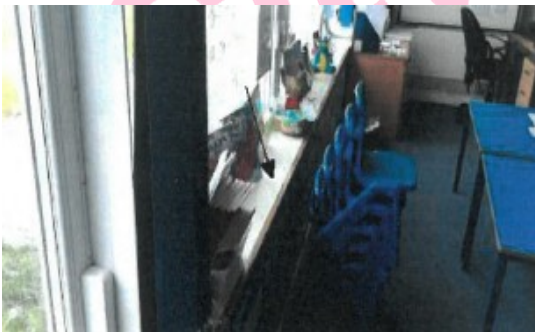
Item 32 - Ref: As AQ000115

The window sill covering (composite material) (Room 0/03 classroom) does not contain asbestos.

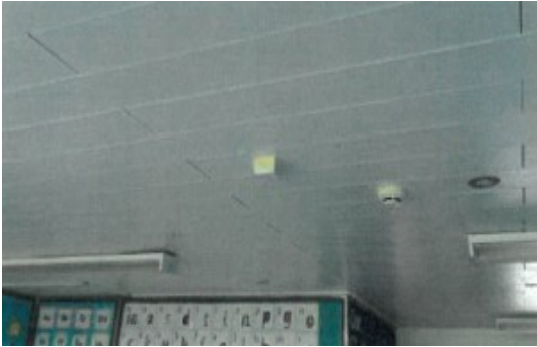
Item 33 - Ref: AQ000117

The Suspended ceiling tiles (Room 0/03 classroom) does not contain asbestos.

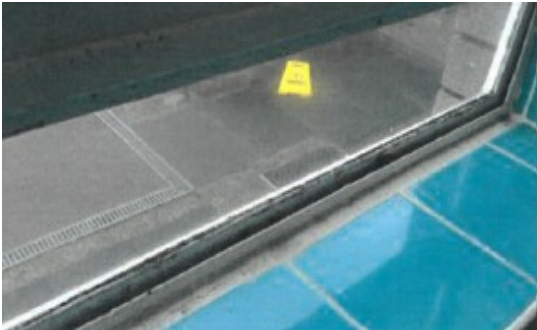
Item 34 - Ref: AQ000118

The Window putty (Room 0/04 Toilets & Cloakroom) does not contain asbestos.

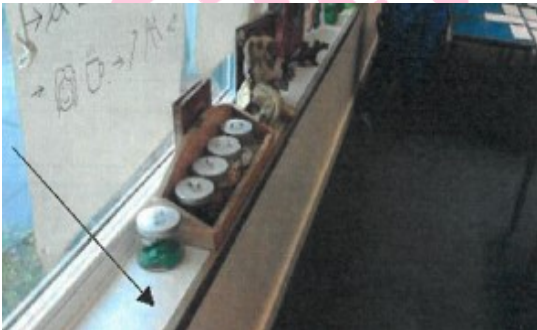
Item 35 - Ref: As AQ000115

The Window sill covering (composite material) (Room 0/05 classroom) does not contain asbestos.

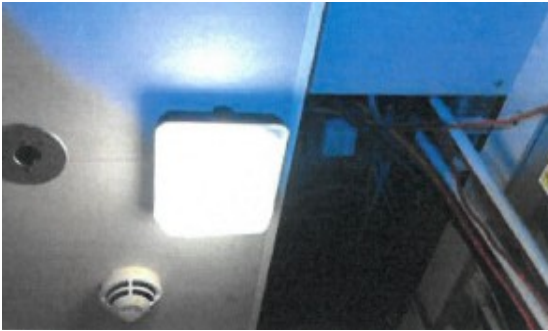
Item 36 - Ref: AQ000122

The Suspended Ceiling – Supalux (Room 0/09 electric cupboard) does not contain asbestos.

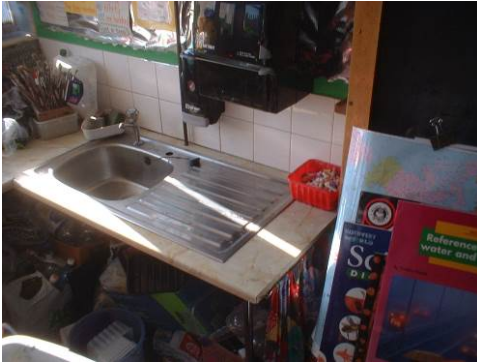
Item 1 - Ref: Sample 27

The sink pad in this primary school classroom (Room 0/34) does not contain asbestos.

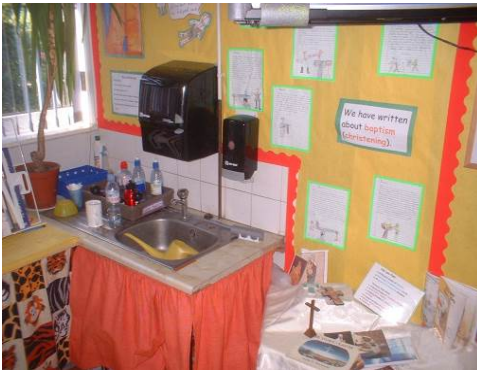
Item 2 – Ref: Sample 28

The sink pad in this primary school classroom (Room 0/35) does not contain asbestos.

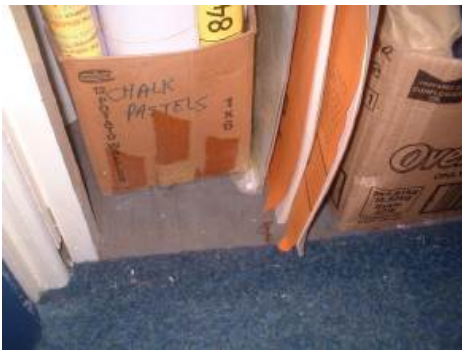
Item 5 - As Sample 29

The vinyl floor tiles in the primary school classroom store (Room 0/36) do not contain asbestos.

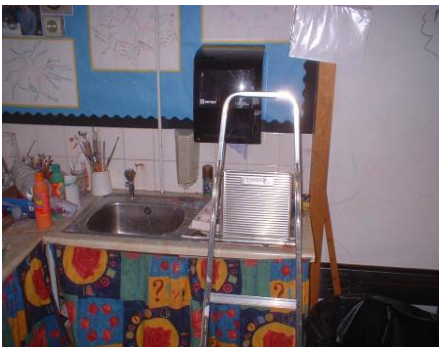
Item 6 – Ref: Sample 31

The sink pad in this primary school classroom (Room 0/37) does not contain asbestos.

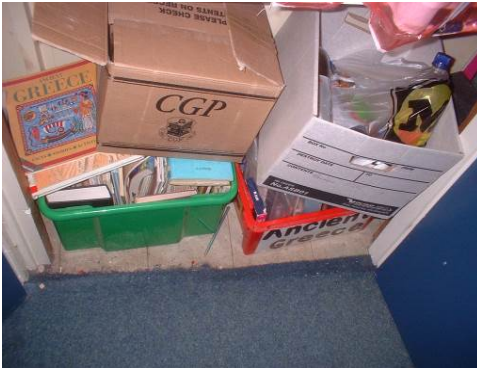
Item 7 - Ref: Sample 32

The vinyl flooring in this primary school classroom (Room 0/37) does not contain asbestos.

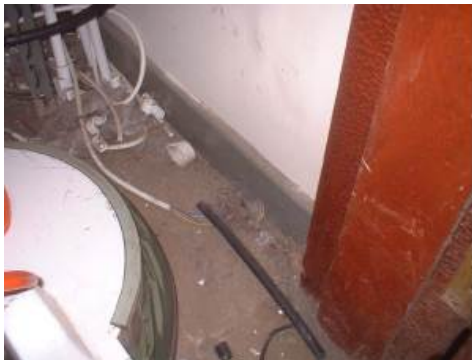
Ref: Sample 37

The debris to the floor in the electrical cupboard (Room 0/43) did not contain asbestos.

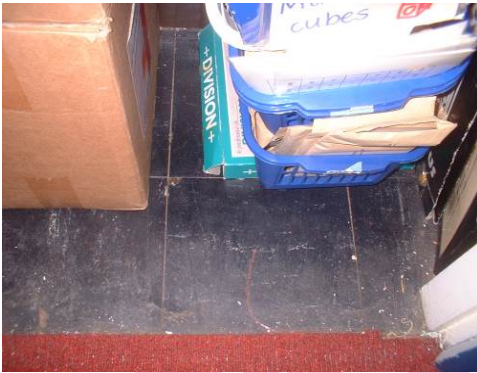
Item 12 - Ref: Sample 39

The vinyl flooring to classroom 8 (Room 0/56) in the primary school contains asbestos.

Any change in its appearance should be recorded and passed to Property Services.

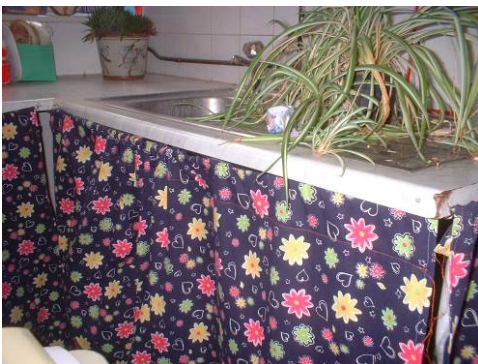
Item 16 – Ref: Sample 43

The sink pad in classroom 5 (Room 0/59) does not contain asbestos.

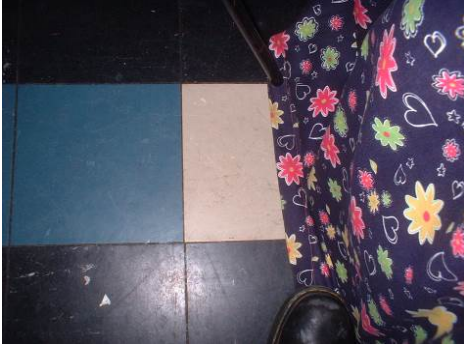
Item 17 - Ref: Sample 44

The vinyl flooring to classroom 5 (Room 0/59) does not contain asbestos.

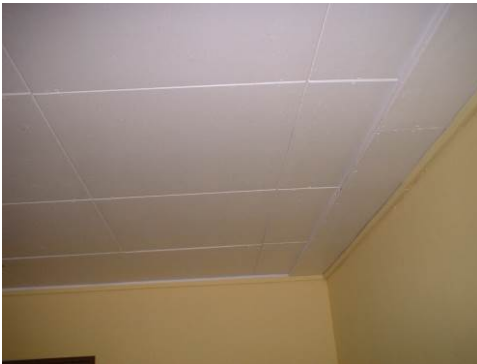
Item 18 - Ref: Sample 45

The ceiling in the staff room (Room 0/51) does not contain asbestos.

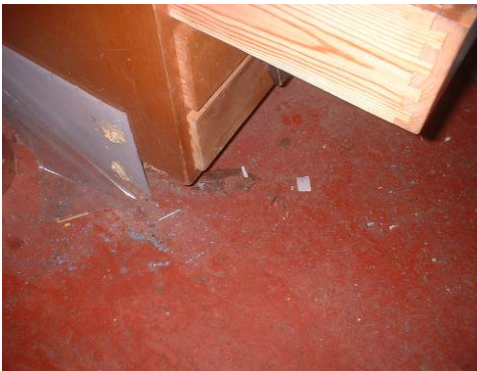
Item 19 – Ref: Sample 46

The debris to the floor in the primary school boiler room (Room 0/68) does not contain asbestos.

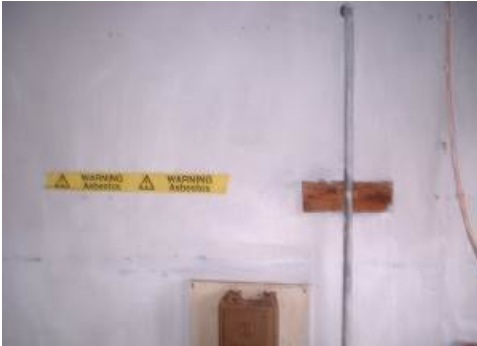
Ref: Sample 47

The wall lining boards to the boiler room in the annexe (Room 0/69) contained asbestos.

These have been removed.

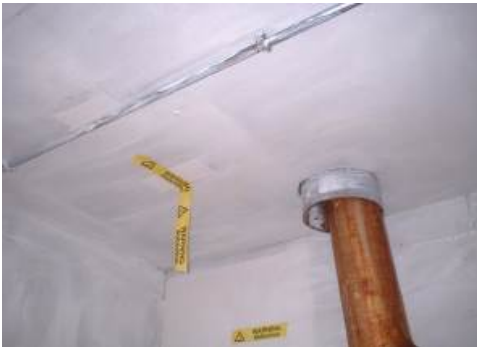
Ref: Sample 48

The ceiling boards to the boiler room in the annexe (Room 0/69) contained asbestos.

These have been removed.

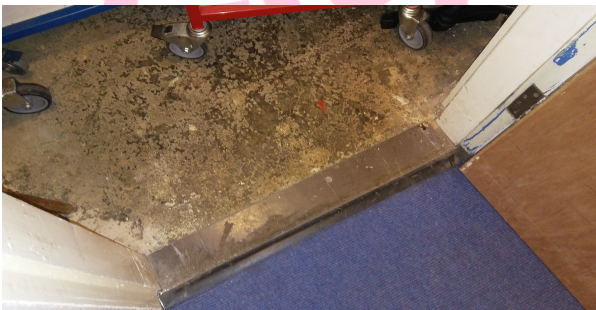
Item 32 - Ref: 182913-8

The bitumen adhesive to the floor in the electric cupboard (Rm 0/18) contains asbestos.

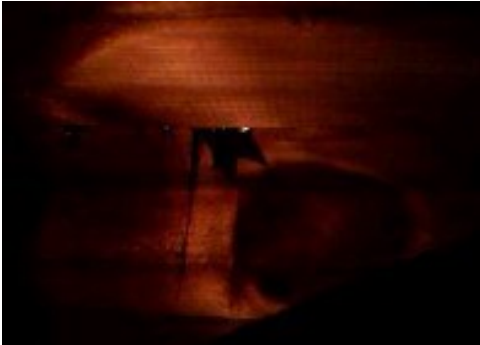
Item 36 Ref: CB000088

The bitumen from between wood roof in Store bottom of kitchen hatch does not contain asbestos.

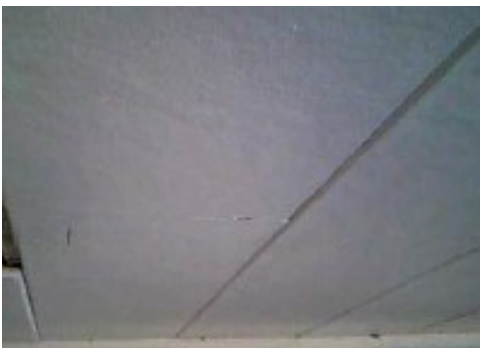
Item 38 Ref: As BB000951

The fibreboard ceiling in Practical Area does not contain asbestos.

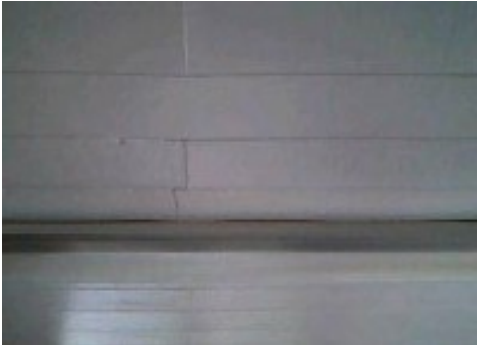
Item 39 Ref: As BB000951

The fibreboard ceiling in Reception Classroom does not contain asbestos.

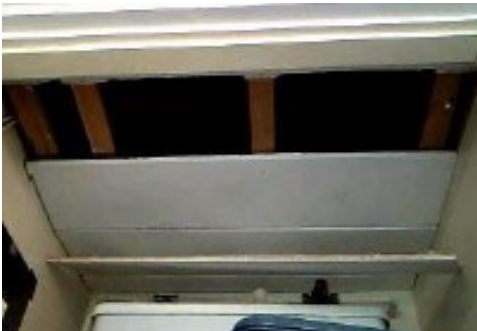
Item 40 Ref: As BB000951

The fibreboard ceiling in Reception Tank Cupboard does not contain asbestos.

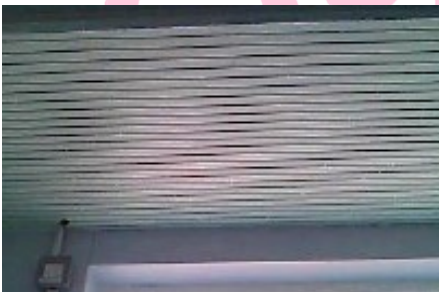
Item 44 Ref: As BB000951

The fibreboard ceiling in Boys Toilet does not contain asbestos.

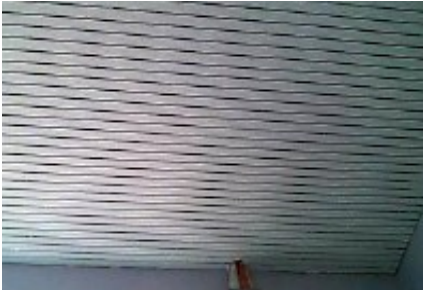
Item 45 Ref: As BB000951

The fibreboard ceiling in Girls Toilet does not contain asbestos.

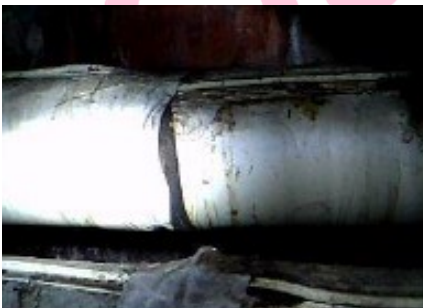
Item 47 Ref: BB000953

The black foam lagging to pipes in Water tank void does not contain asbestos.

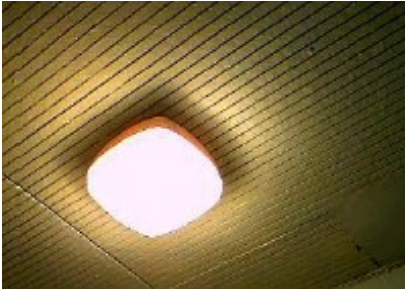
Item 48 Ref: As BB000951

The fibreboard ceiling in Corridor does not contain asbestos.

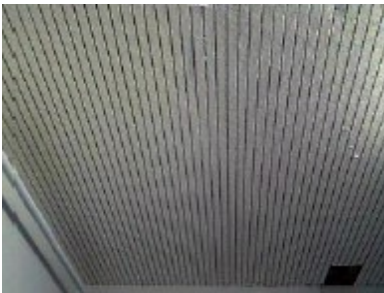
Item 49 Ref: As BB000951

The fibreboard ceiling in IT Suite does not contain asbestos.

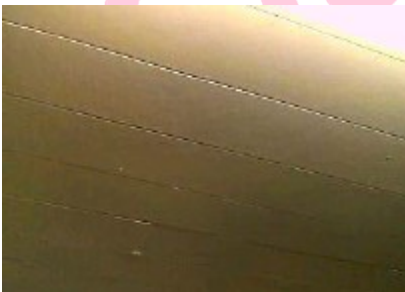
Item 50 Ref: As BB000951

The fibreboard ceiling in Year 2 Classroom does not contain asbestos.

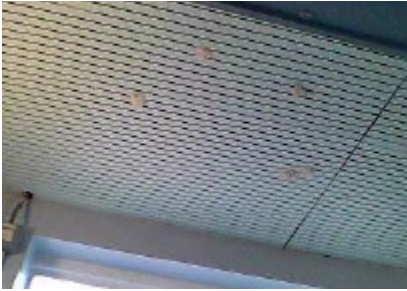
Item 51 Ref: As BB000951

The fibreboard ceiling in Toilet does not contain asbestos.

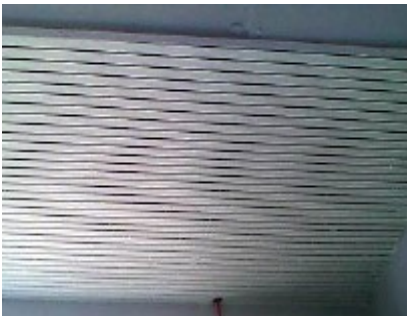
Item 52 Ref: As BB000951

The fibreboard ceiling in Toilet does not contain asbestos.

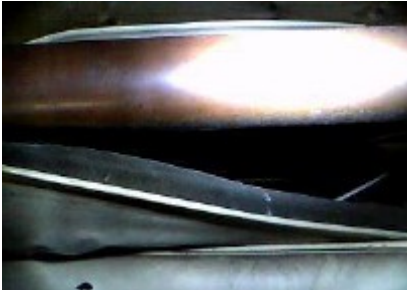
Item 54 Ref: As BB000953

The black foam lagging to pipes in Water Tank void 2 does not contain asbestos.

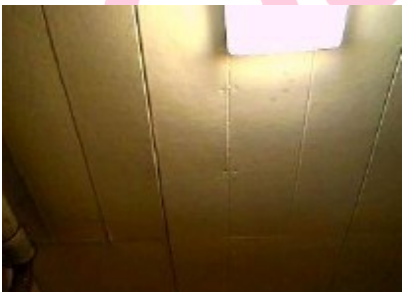
Item 56 Ref: As BB000951

The fibreboard ceiling in Year 2 Classroom 2 Store does not contain asbestos.

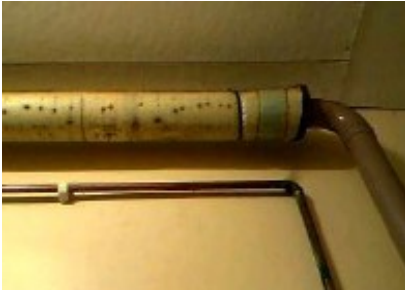
Item 57 Ref: As BB000953

The pipe lagging in Year 2 Classroom 2 Store does not contain asbestos.

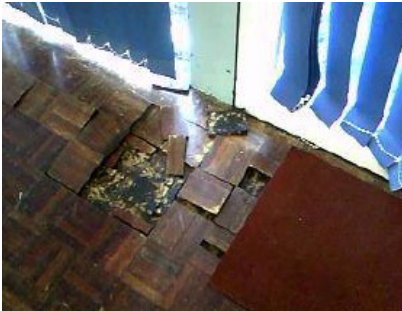
Item 58 Ref: AC001852

The parquet flooring and bitumen below in Key Stage 1 Hall does not contain asbestos.

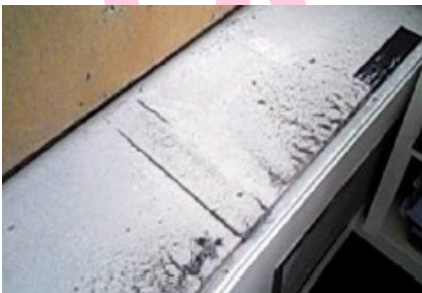
Item 59 Ref: EB000075

The insulation board to lining panels underside of heater cover in Print Room does not contain asbestos.

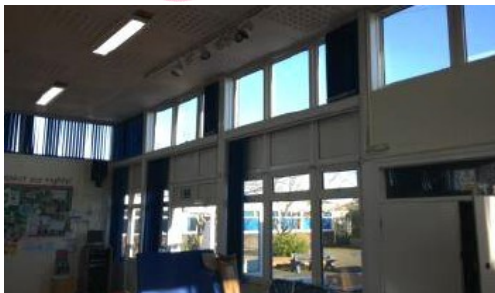
Item 62 Ref: AD000724

The column and beam cladding behind modern cappings in Main Hall contain asbestos.

Any change in its appearance should be recorded and passed to Property Services.

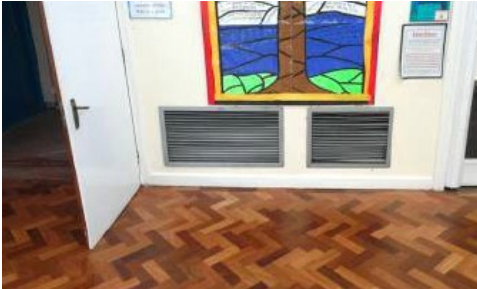
Item 63 Ref: AD000720

The wall heater internal ceiling soffit panels in Main Hall does not contain asbestos.

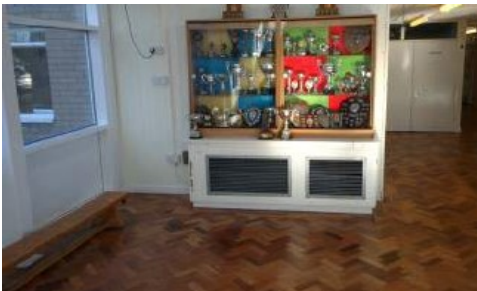
Item 64 Ref: As AD000720

The wall heater internal ceiling soffit panels in Main Hall beneath trophy display does not contain asbestos.

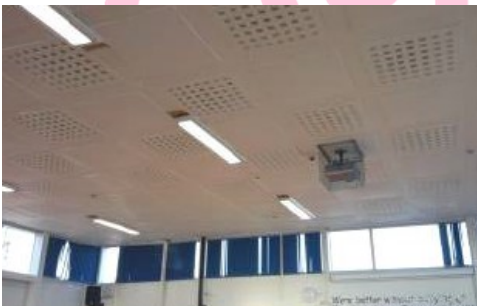
Item 65 Ref: AD000722

The ceiling tiles in Main Hall does not contain asbestos.

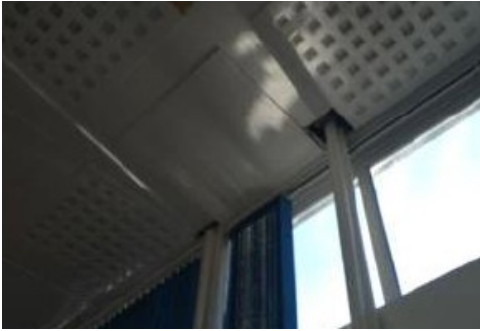
Item 66 Ref: AD000723

The ceiling void pipework insulation in Main Hall does not contain asbestos.

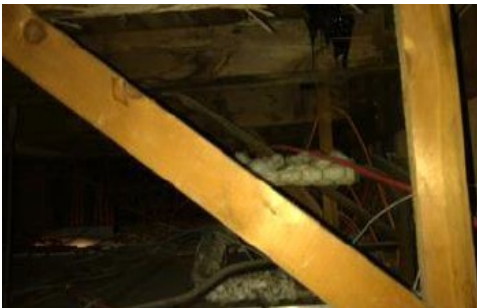
Item 67 Ref: AD000725

The ceiling void pipework insulation in PE Cupboard does not contain asbestos.

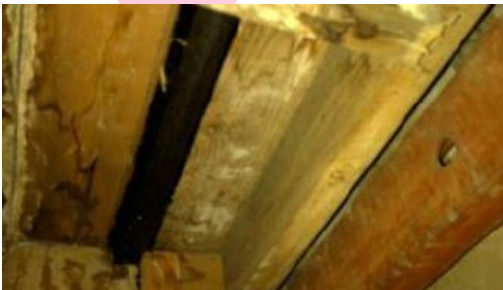
Item 68 Ref: AD000726

The ceiling void soffit felt wrap in PE Cupboard does not contain asbestos.

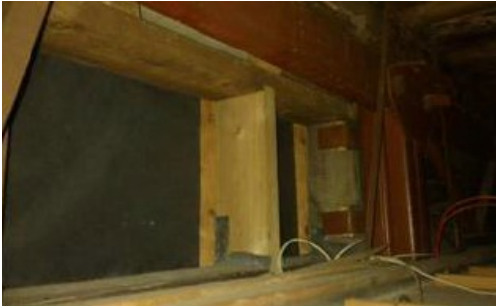
Item 69 Ref: AD000727

The wall covering behind cladding in PE Cupboard does not contain asbestos.

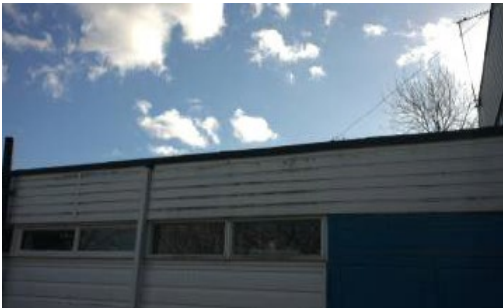
Item 70 Ref: AD000728

The flat roof coverings (External) does not contain asbestos.

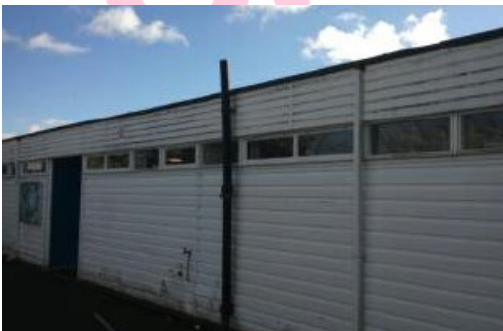
Item 71 Ref: AD000729

The window putty (External) does not contain asbestos.

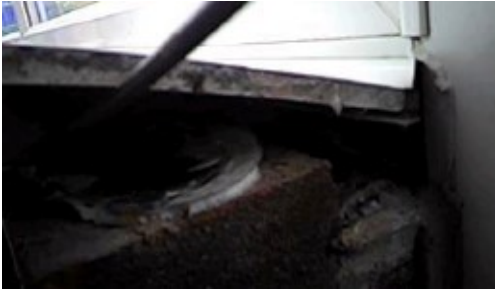
Item 72 Ref: EA000243

The low level conservatory wall cavity Insulation in Reception conservatory area does not contain asbestos.

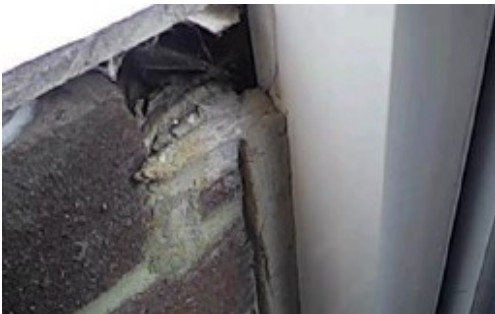
Item 73 Ref: EA000244

The damp proof course beneath window sills in Reception conservatory area does not contain asbestos.

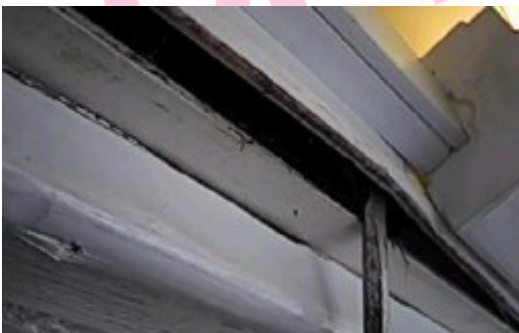
Item 74 Ref: EA000244

The damp proof course between class and conservatory wall in Reception conservatory area does not contain asbestos.

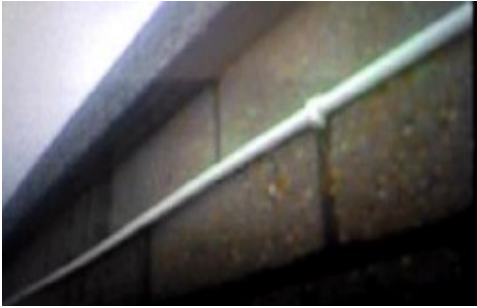
Item 75 Ref: EA000246

The bitumen felt to flat roof in Reception conservatory area does not contain asbestos.

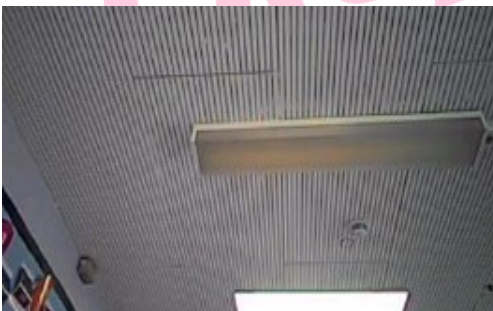
Item 77 Ref: EA000248

The suspended ceiling tiles in Year 1 Cloakroom does not contain asbestos.

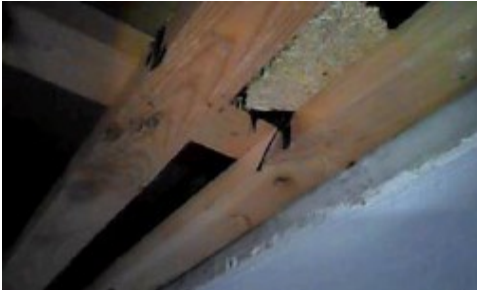
Item 78 Ref: EA000249

The bitumen debris from flat roof in Year 1 Cloakroom does not contain asbestos.

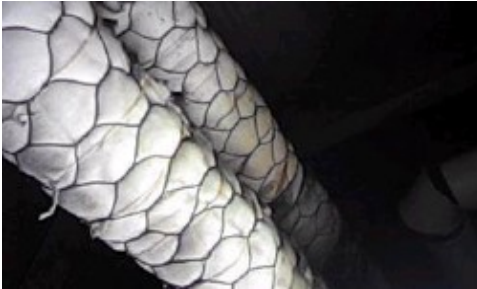
Item 81 Ref: EA000253

The lagging to pipework within ceiling void in Corridor adj Kitchen does not contain asbestos.

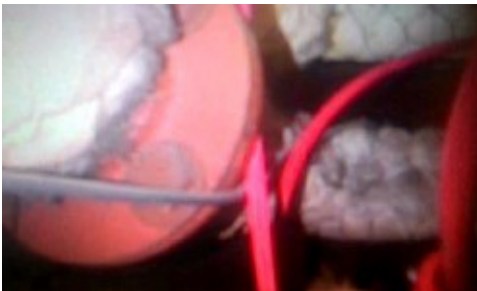
Item 82 Ref: Presumed

The gasket to pipework in Corridor adj Kitchen is presumed to contain asbestos.

Any change in its appearance should be recorded and passed to Property Services.

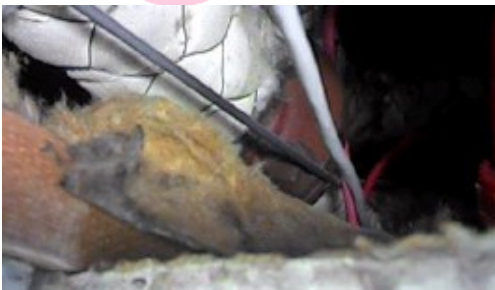
Item 83 Ref: EA000254

The tar paper to mmmf firebreak blankets in Corridor adj Kitchen does not contain asbestos.

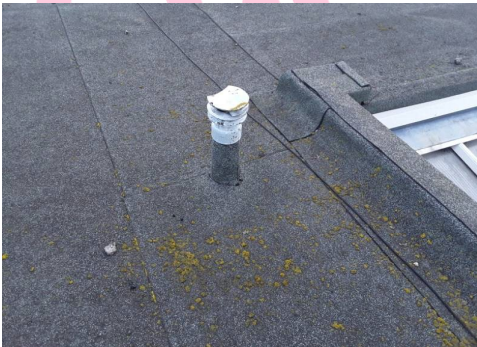
Item 98 Ref: PE001548

The cement flue
(External/Roof 7) contains
asbestos.

*Removed April 2022 – waiting
WCN*

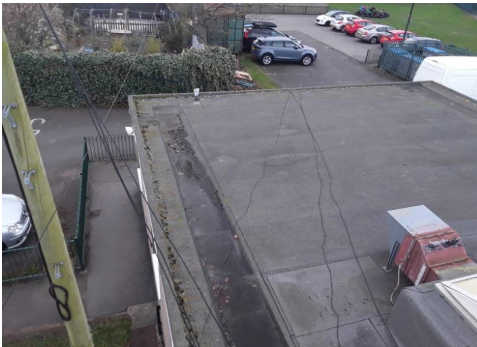
Item 103 Ref: As PE001548

The cement flue (External/Roof 5) contains asbestos.

Removed April 2022 – waiting WCN

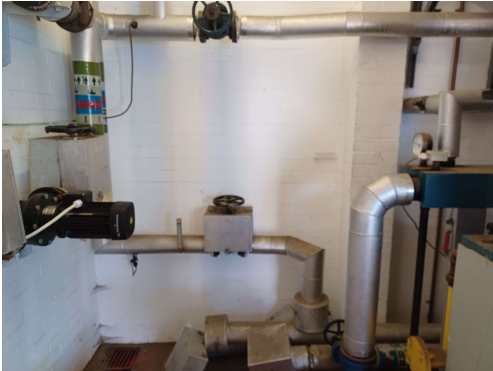
Item 108 Ref: 581161-1

The debris to walls behind boilers (Rm 0/26 KS1 Boiler Room) contains asbestos.

Removed January 2024.

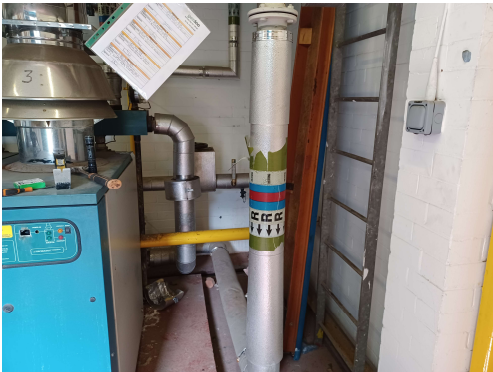
Item 109 Ref: 581161-2

The debris to wall RHS of boilers (Rm 0/26 KS1 Boiler Room) contains asbestos.

Removed January 2024.

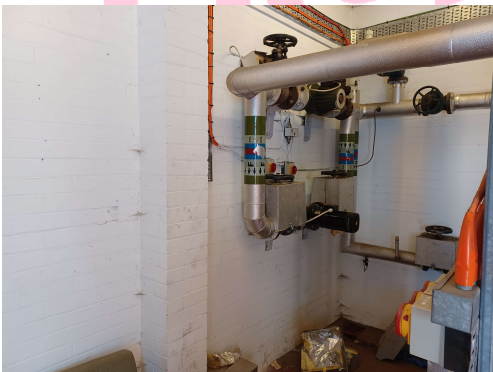
Item 110 Ref: 581161-3

The debris to wall LHS of boilers (Rm 0/26 KS1 Boiler Room) contains asbestos.

Removed January 2024.

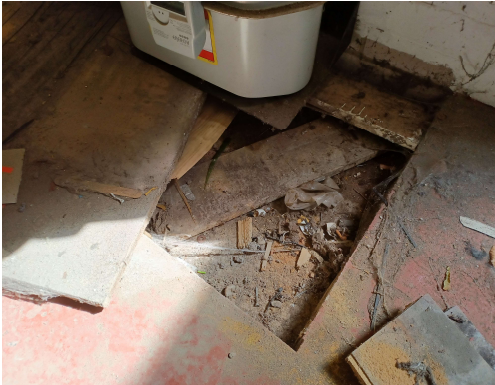
Item 112 Ref: 581161-6

The debris within gas box sump (Rm 0/26 KS1 Boiler Room) does not contain asbestos.

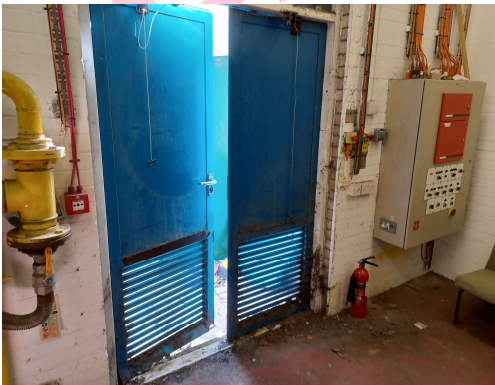
Item 113 Ref: 581161-7

The debris to entrance wall (Rm 0/26 KS1 Boiler Room) contains asbestos.

Removed January 2024.

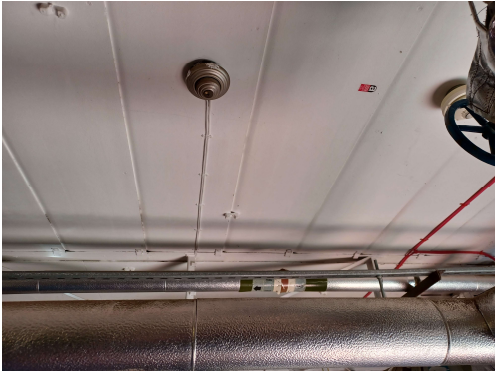
Item 114 Ref: 581161-10

The underside of roof (Rm 0/27 Boiler Room adj Kitchen) contains asbestos.

Removed October 2023.

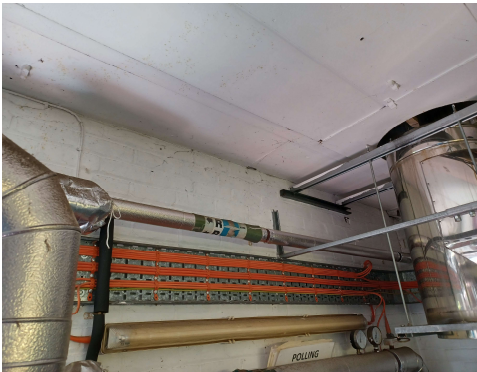
Item 115 Ref: 581161-11

The flat ceiling panels (Rm 0/27 Boiler Room adj Kitchen) contains asbestos.

Removed October 2023.

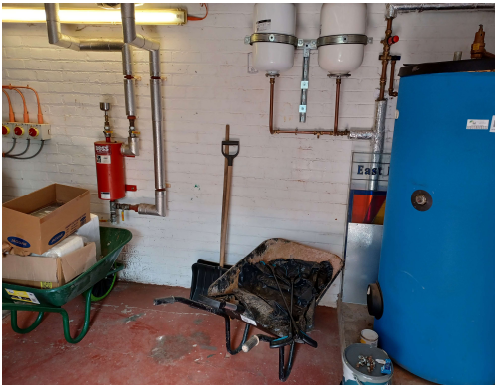
Item 118 Ref: 581161-13

The debris to wall opposite entrance wall (Rm 0/27 Boiler Room adj Kitchen) contains asbestos.

Removed October 2023.

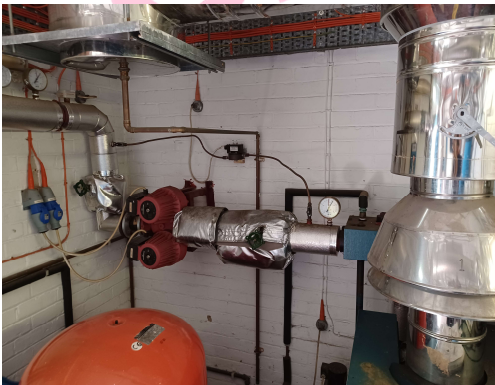
Item 119 Ref: As 581161-14

The debris to walls behind boilers (Rm 0/27 Boiler Room adj Kitchen) contains asbestos.

Removed October 2023.

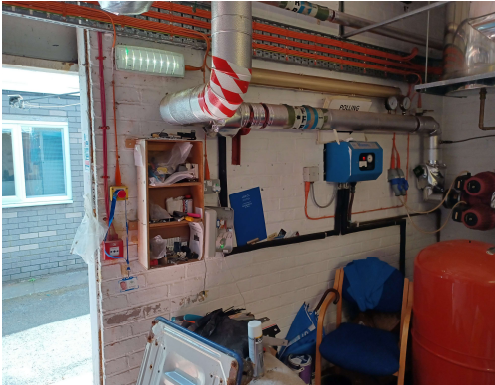
Item 121 Ref: 581161-16

The debris to entrance wall
(Rm 0/27 Boiler Room adj
Kitchen) contains asbestos.

Removed October 2023.

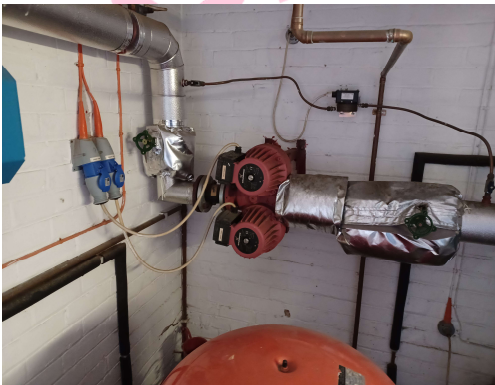
Item 122 Ref: 581161-17

The pipework flange gasket
(Rm 0/27 Boiler Room adj
Kitchen) does not contain
asbestos.

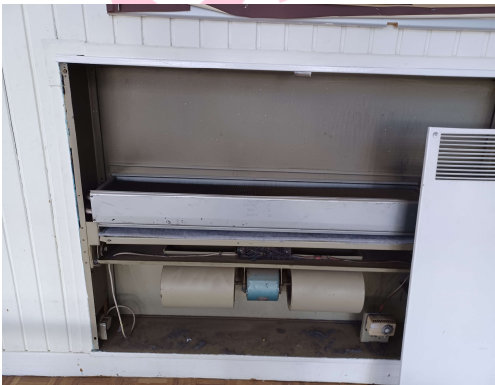
Item 125 Ref: Presumed

The panels behind heaters (Rm 0/29 Assembly Hall) contains asbestos.

Any change in its appearance should be recorded and passed to Property Services.

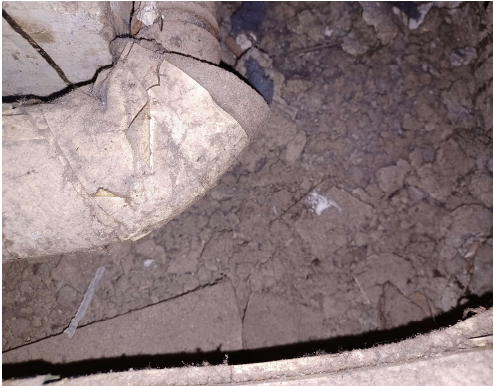
Item 126 Ref: 581161-8

The debris to floor (Rm 0/29 Assembly Hall – pipework trench below) contains asbestos.

Any change in its appearance should be recorded and passed to Property Services.

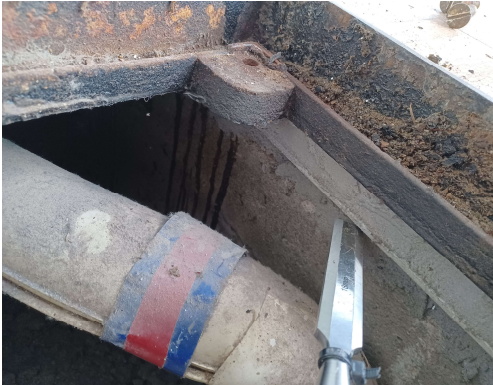
Item 127 Ref: 581161-9

The shuttering to floor slabs running below heaters (Rm 0/29 Assembly Hall – pipework trench below) contains asbestos.

Any change in its appearance should be recorded and passed to Property Services.

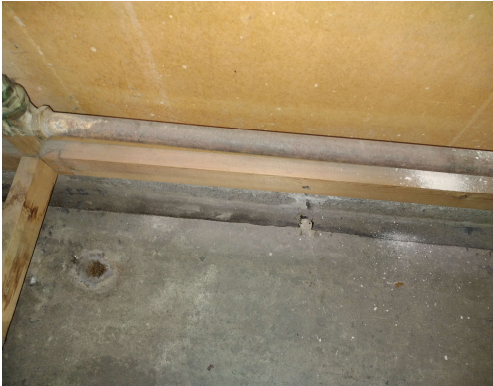
Item 132 Ref: 581161-19

The damp proof course (Rm 0/36 Classroom) contains asbestos.

Any change in its appearance should be recorded and passed to Property Services.

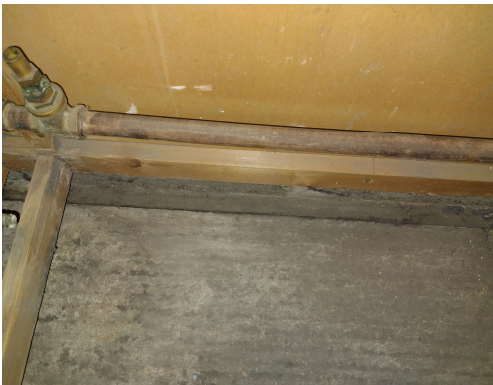
Item 134 Ref: As 581161-19

The damp proof course (Rm 0/37 Classroom) contains asbestos.

Any change in its appearance should be recorded and passed to Property Services.

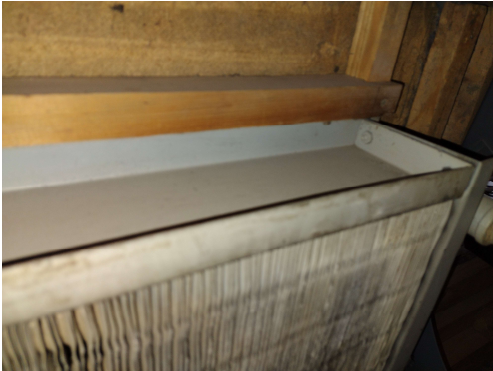
Item 135 Ref: As 581161-20

The sealant surrounding convector (Rm 0/37 Classroom) contains asbestos.

Any change in its appearance should be recorded and passed to Property Services.

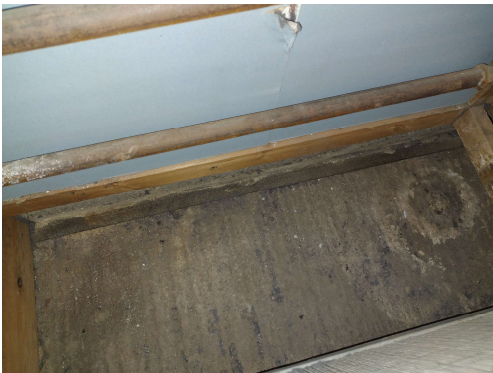
Item 136 Ref: As 581161-19

The damp proof course (Rm 0/38 Classroom) contains asbestos.

Any change in its appearance should be recorded and passed to Property Services.

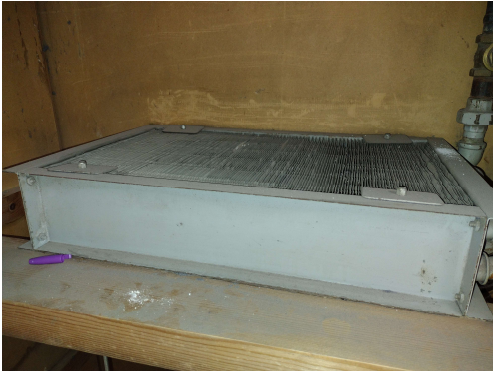
Item 138 Ref: As 581161-20

The sealant surrounding convector (Rm 0/39 Corridor) contains asbestos.

Any change in its appearance should be recorded and passed to Property Services.

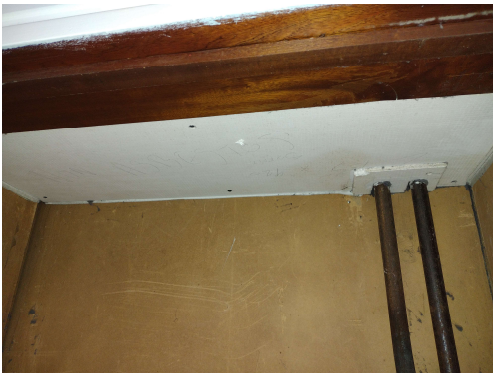
Item 139 Ref: 581161-21

The ceiling & service penetration infill (Rm 0/39 Corridor) does not contain asbestos.

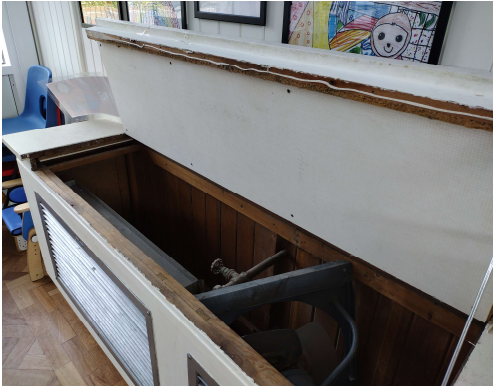
Item 141 Ref: As 581161-21

The cabinet soffit lining (Rm 0/40 Dining Hall) does not contain asbestos.

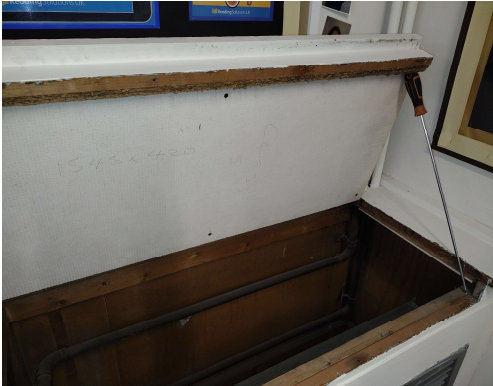
Item 144 Ref: As 581161-21

The cabinet soffit lining (Rm 0/42 Classroom) does not contain asbestos.
