ASBESTOS SURVEY REPORT FOR EAST HERRINGTON ACADEMY, SUNDERLAND

Asbestos Register for EAST HERRINGTON ACADEMY, SUNDERLAND

Date: 21 July 2025

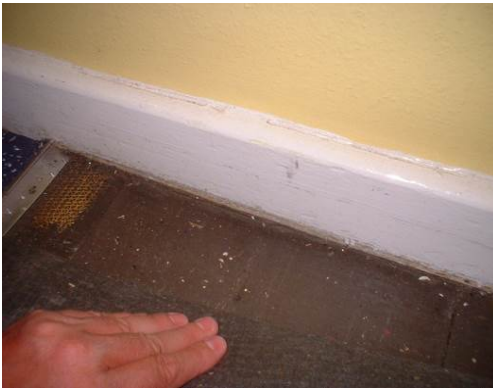
Item 2 - Ref: Sample 02

The vinyl flooring to the infant school corridor (Room 0/04) contains asbestos.

Any change in its appearance should be recorded and passed to Property Services.

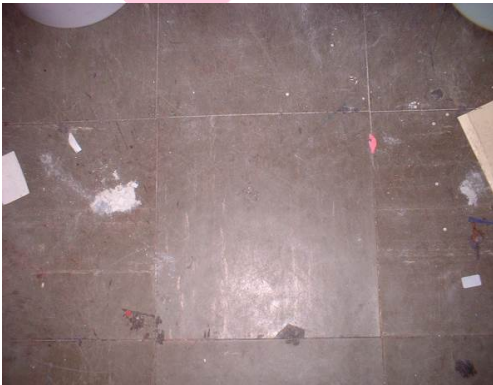
Item 3- As Sample 02

The floor covering to the infant school store room (Room 0/11) contains asbestos.

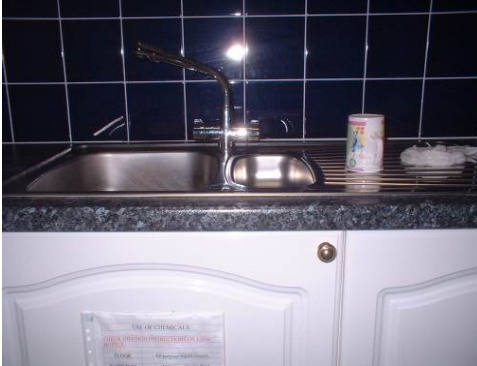
Item 4 - Ref: Sample 03

The sink pad in the after school kitchen (Room 0/06) does not contain asbestos.

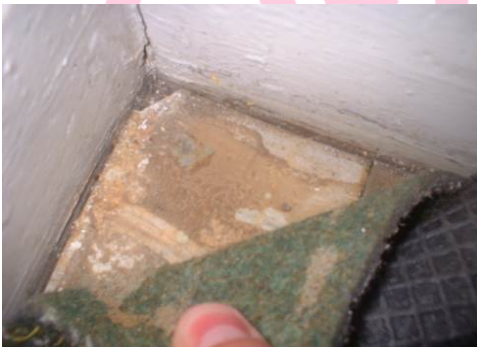
Item 5 - Ref: Sample 07

The vinyl flooring to the conservatory (Room 0/13) does not contain asbestos.

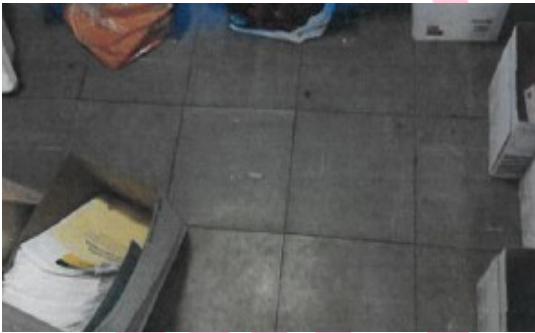
Item 10 – As Sample 10 & As AQ000124

The floor covering (vinyl tiles & adhesive) (Room 0/13 Y2 classroom stationary cupboard) contains asbestos.

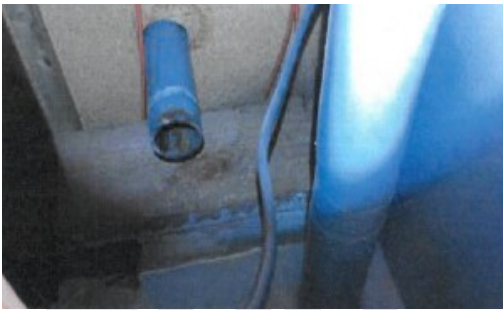
Item 28 - Ref: AQ000120

The disabled toilet ceiling void redundant flue (Room 0/06 cleaners cupboard & toilets) contains asbestos.

Any change in its appearance should be recorded and passed to Property Services.

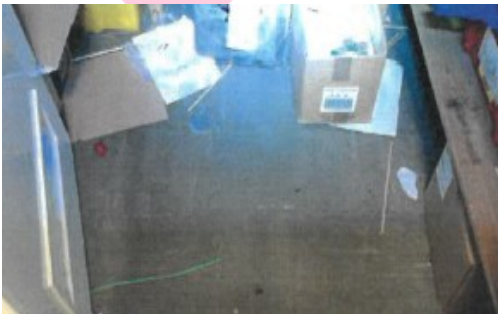
Item 29 - Ref: AQ000121

The floor covering (vinyl tiles & adhesive) (Room 0/07 store rooms) contains asbestos.

Any change in its appearance should be recorded and passed to Property Services.

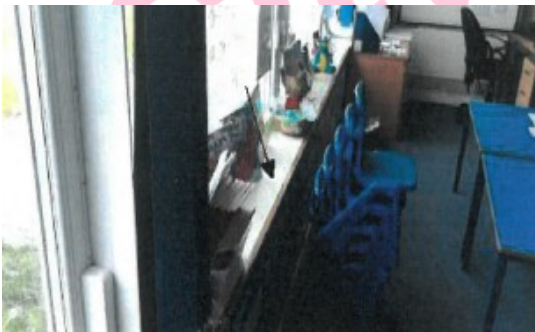
Item 32 - Ref: As AQ000115

The window sill covering (composite material) (Room 0/03 classroom) does not contain asbestos.

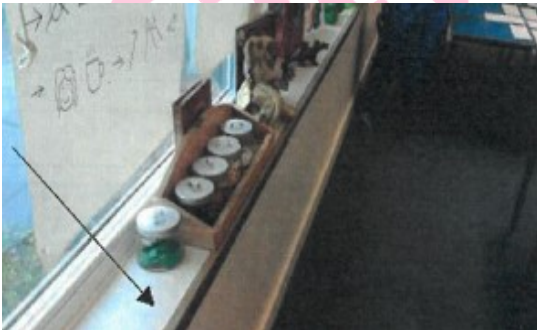
Item 35 - Ref: As AQ000115

The Window sill covering (composite material) (Room 0/05 classroom) does not contain asbestos.

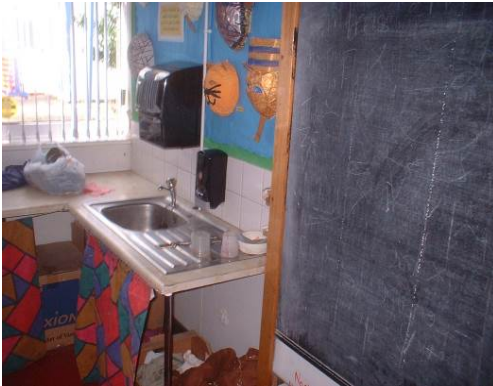
Item 4 - Ref: Sample 30

The sink pad in this primary school classroom (Room 0/36) does not contain asbestos.

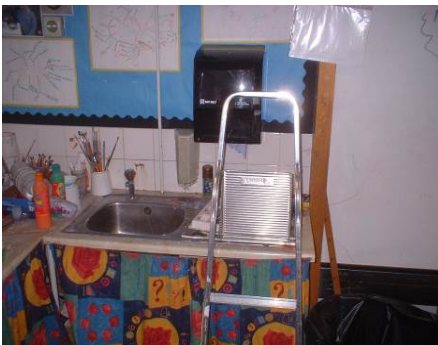
Item 6 – Ref: Sample 31

The sink pad in this primary school classroom (Room 0/37) does not contain asbestos.

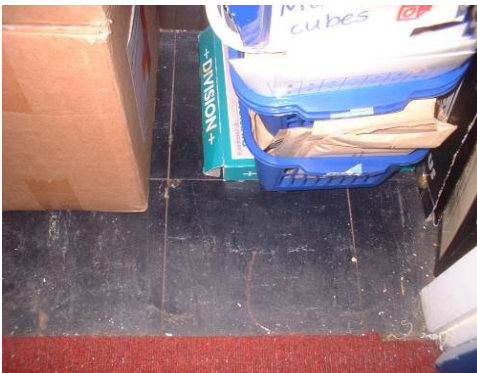
Item 12 - Ref: Sample 39

The vinyl flooring to classroom 8 (Room 0/56) in the primary school contains asbestos.

Any change in its appearance should be recorded and passed to Property Services.

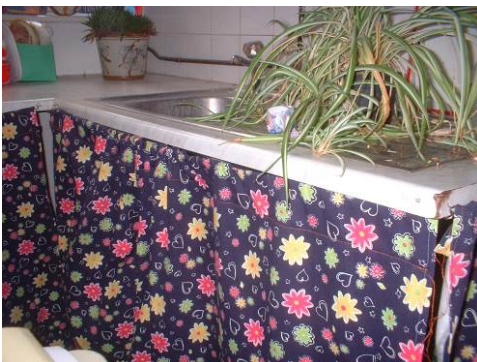
Item 16 – Ref: Sample 43

The sink pad in classroom 5 (Room 0/59) does not contain asbestos.

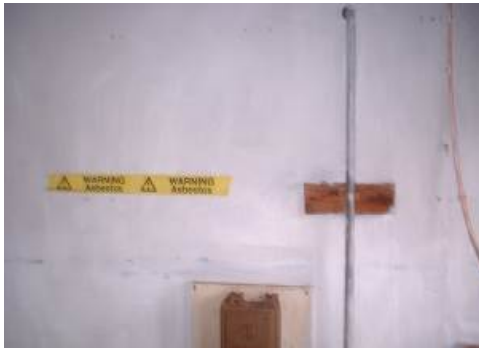
Ref: Sample 47

The wall lining boards to the boiler room in the annexe (Room 0/69) contained asbestos.

These have been removed.

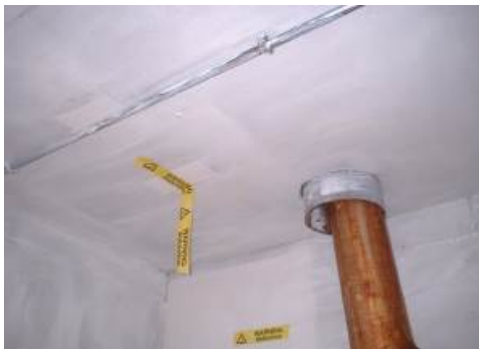
Ref: Sample 48

The ceiling boards to the boiler room in the annexe (Room 0/69) contained asbestos.

These have been removed.

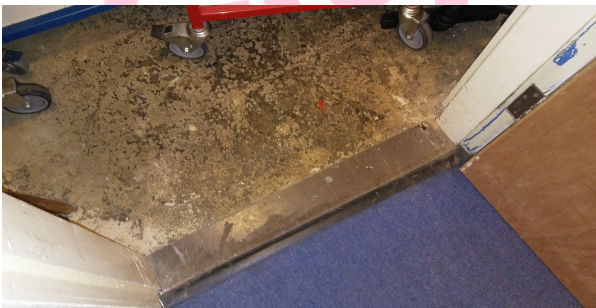
Item 32 - Ref: 182913-8

The bitumen adhesive to the floor in the electric cupboard (Rm 0/18) contains asbestos.

Any change in its appearance should be recorded and passed to Property Services.

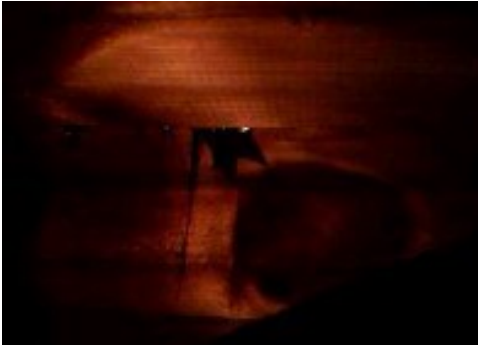
Item 36 Ref: CB000088

The bitumen from between wood roof in Store bottom of kitchen hatch does not contain asbestos.

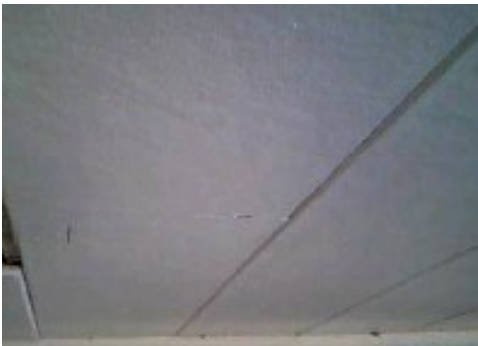
Item 38 Ref: As BB000951

The fibreboard ceiling in Practical Area does not contain asbestos.

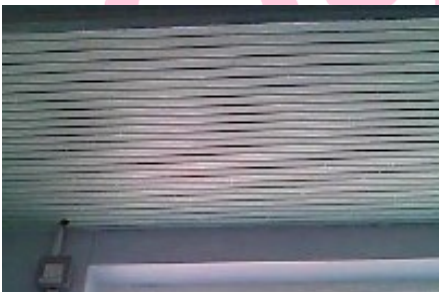
Item 44 Ref: As BB000951

The fibreboard ceiling in Boys Toilet does not contain asbestos.

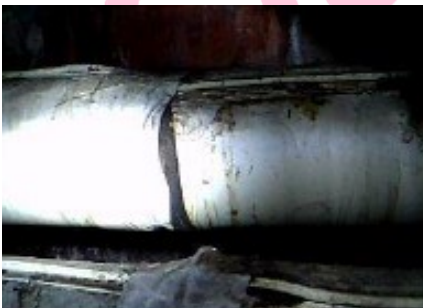
Item 47 Ref: BB000953

The black foam lagging to pipes in Water tank void does not contain asbestos.

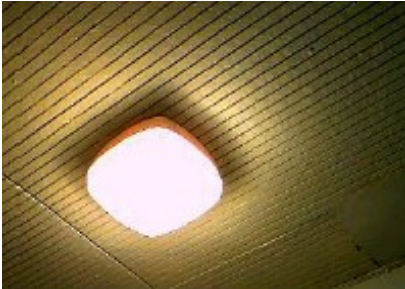
Item 48 Ref: As BB000951

The fibreboard ceiling in Corridor does not contain asbestos.

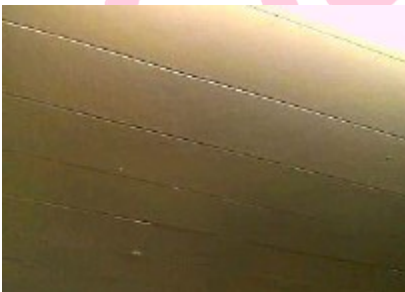
Item 50 Ref: As BB000951

The fibreboard ceiling in Year 2 Classroom does not contain asbestos.

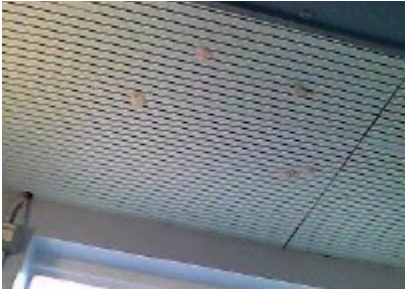
Item 51 Ref: As BB000951

The fibreboard ceiling in Toilet does not contain asbestos.

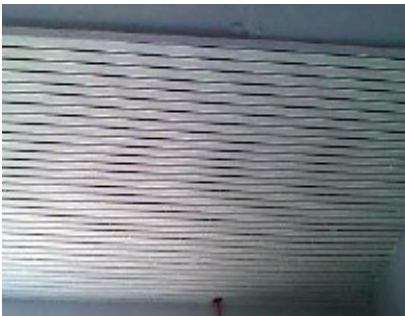
Item 52 Ref: As BB000951

The fibreboard ceiling in Toilet does not contain asbestos.

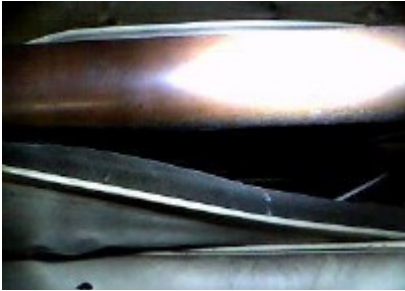
Item 54 Ref: As BB000953

The black foam lagging to pipes in Water Tank void 2 does not contain asbestos.

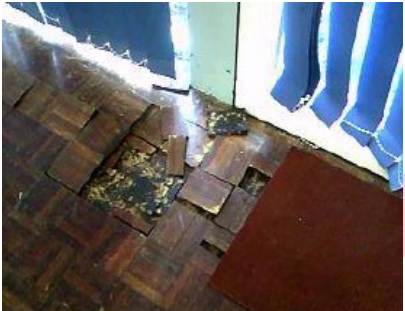
Item 58 Ref: AC001852

The parquet flooring and bitumen below in Key Stage 1 Hall does not contain asbestos.

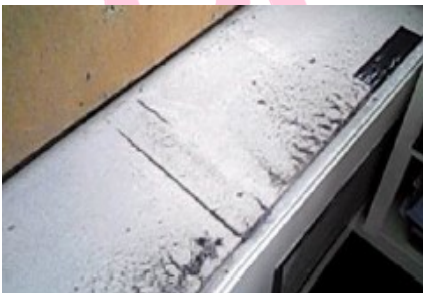
Item 59 Ref: EB000075

The insulation board to lining panels underside of heater cover in Print Room does not contain asbestos.

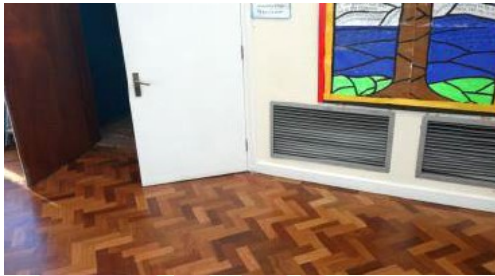
Item 61 Ref: AD000721

The left hand wall heater internal wall linings in Main Hall contain asbestos.

Any change in its appearance should be recorded and passed to Property Services.

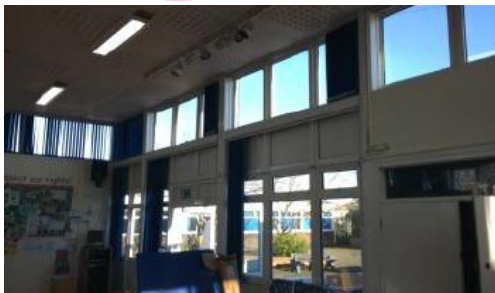
Item 62 Ref: AD000724

The column and beam cladding behind modern cappings in Main Hall contain asbestos.

Any change in its appearance should be recorded and passed to Property Services.

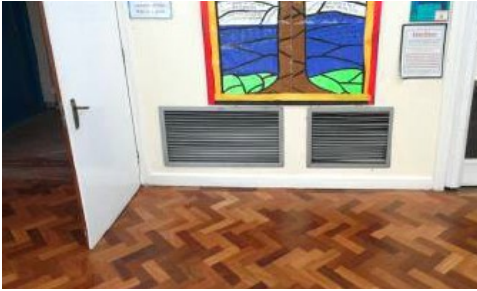
Item 63 Ref: AD000720

The wall heater internal ceiling soffit panels in Main Hall does not contain asbestos.

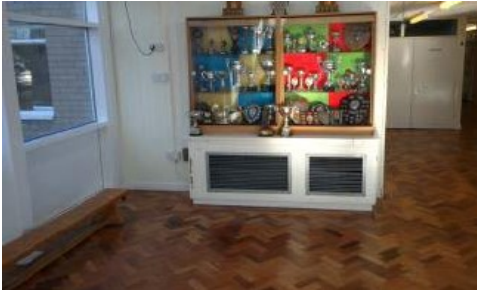
Item 64 Ref: As AD000720

The wall heater internal ceiling soffit panels in Main Hall beneath trophy display does not contain asbestos.

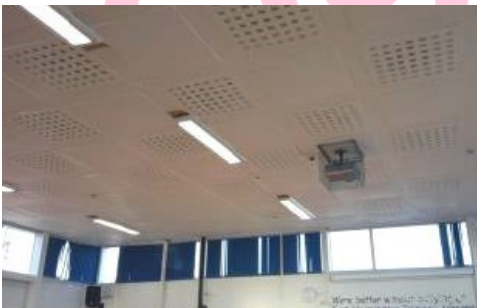
Item 65 Ref: AD000722

The ceiling tiles in Main Hall does not contain asbestos.

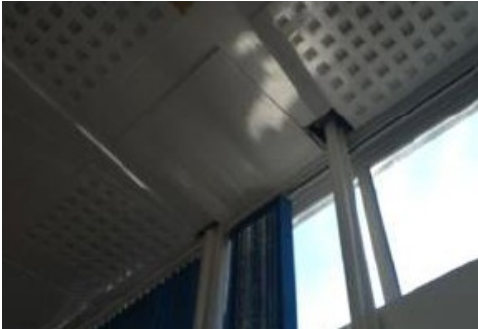
Item 66 Ref: AD000723

The ceiling void pipework insulation in Main Hall does not contain asbestos.

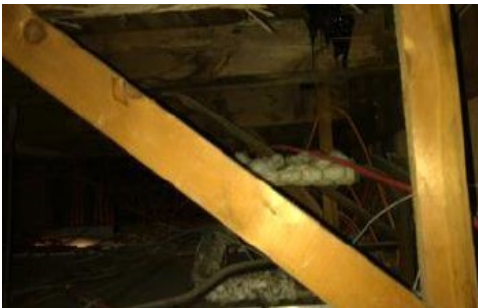
Item 67 Ref: AD000725

The ceiling void pipework insulation in PE Cupboard does not contain asbestos.

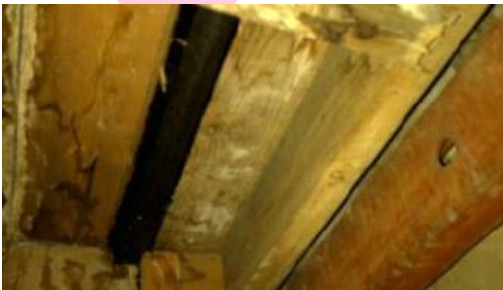
Item 68 Ref: AD000726

The ceiling void soffit felt wrap in PE Cupboard does not contain asbestos.

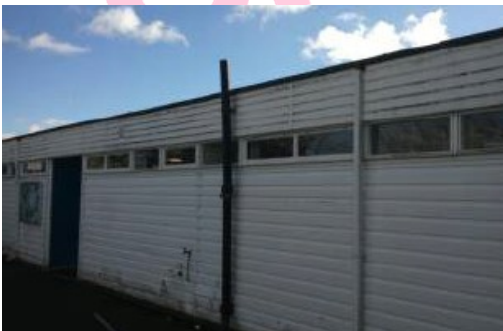
Item 71 Ref: AD000729

The window putty (External) does not contain asbestos.

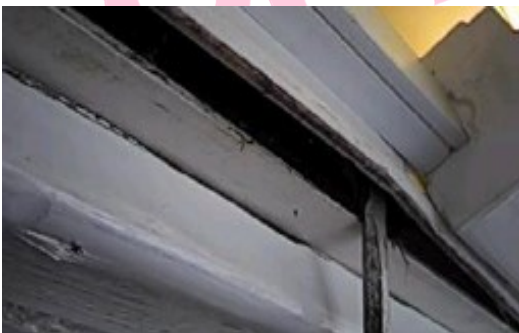
Item 74 Ref: EA000244

The damp proof course between class and conservatory wall in Reception conservatory area does not contain asbestos.

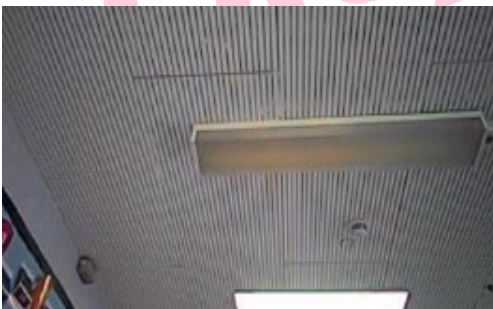
Item 77 Ref: EA000248

The suspended ceiling tiles in Year 1 Cloakroom does not contain asbestos.

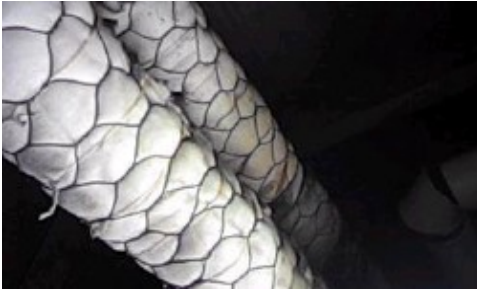
Item 81 Ref: EA000253

The lagging to pipework within ceiling void in Corridor adj Kitchen does not contain asbestos.

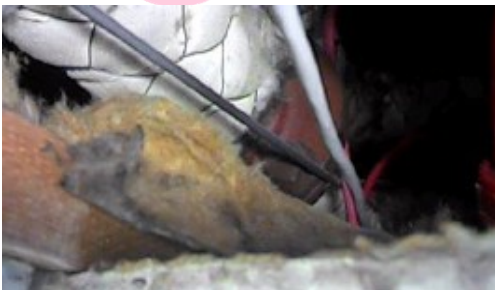
Item 83 Ref: EA000254

The tar paper to mmmf firebreak blankets in Corridor adj Kitchen does not contain asbestos.

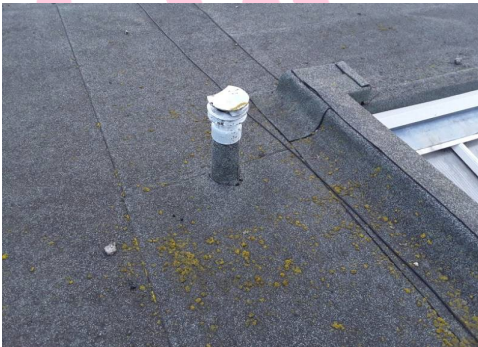
Item 98 Ref: PE001548

The cement flue
(External/Roof 7) contains
asbestos.

*Removed April 2022 – waiting
WCN*

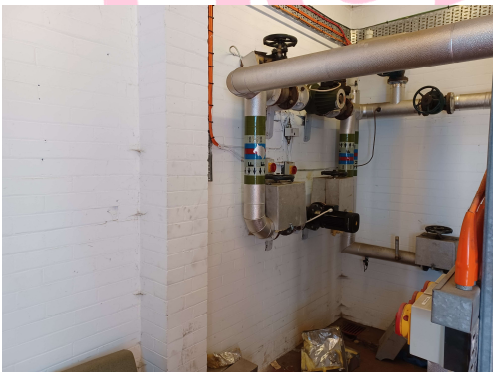
Item 110 Ref: 581161-3

The debris to wall LHS of boilers (Rm 0/26 KS1 Boiler Room) contains asbestos.

Removed January 2024.

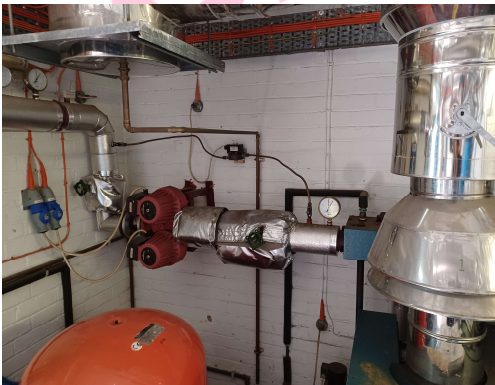
Item 119 Ref: As 581161-14

The debris to walls behind boilers (Rm 0/27 Boiler Room adj Kitchen) contains asbestos.

Removed October 2023.

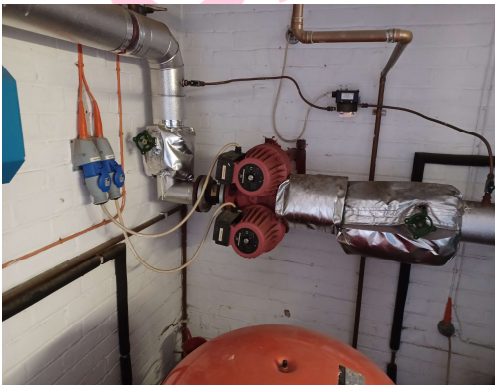
Item 122 Ref: 581161-17

The pipework flange gasket
(Rm 0/27 Boiler Room adj
Kitchen) does not contain
asbestos.

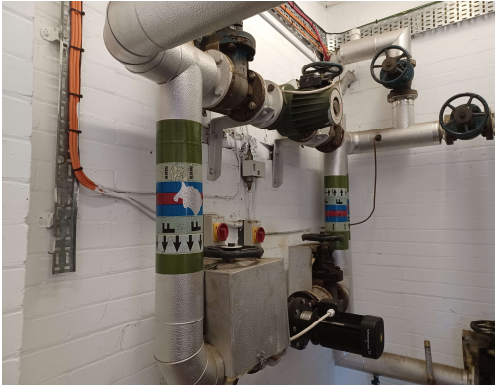
Item 124 Ref: 581161-5

The pipework flange gasket where accessible (Rm 0/28 Reception Classroom) does not contain asbestos.

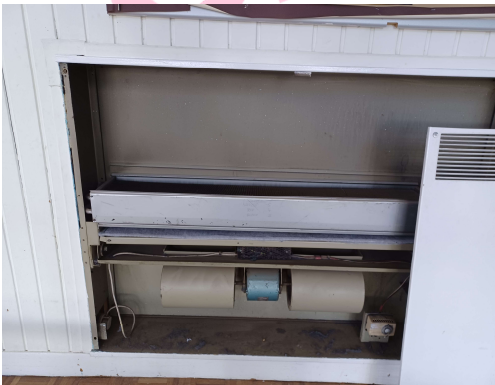
Item 125 Ref: Presumed

The panels behind heaters (Rm 0/29 Assembly Hall) contains asbestos.

Any change in its appearance should be recorded and passed to Property Services.

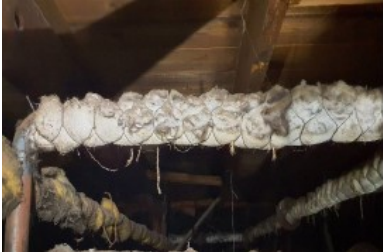
Item 162 Ref: FJ0007759

The rope pipework insulation (Classroom 8 G/04) does not contain asbestos.
