ASBESTOS SURVEY REPORT FOR EAST HERRINGTON ACADEMY, SUNDERLAND

Asbestos Register for

EAST HERRINGTON ACADEMY, SUNDERLAND

Date: 28 May 2026

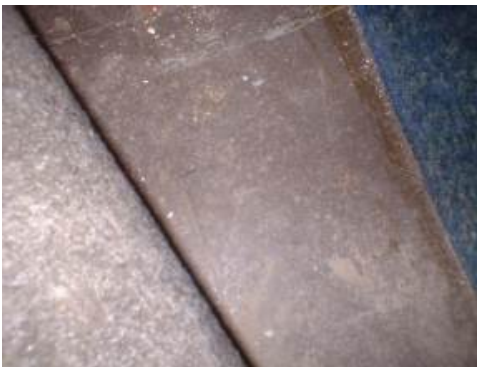
As Sample 02

The floor covering to the electrical intake cupboard (Room 0/07) contained asbestos.

Removed in October 2006

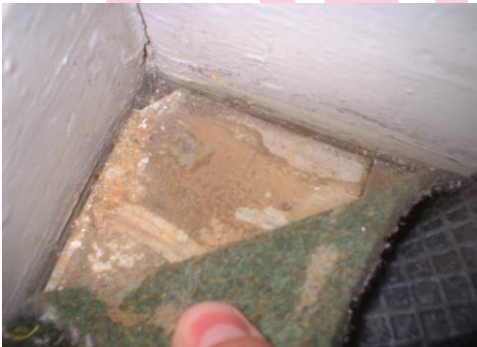
Item 5 - Ref: Sample 07

The vinyl flooring to the conservatory (Room 0/13) does not contain asbestos.

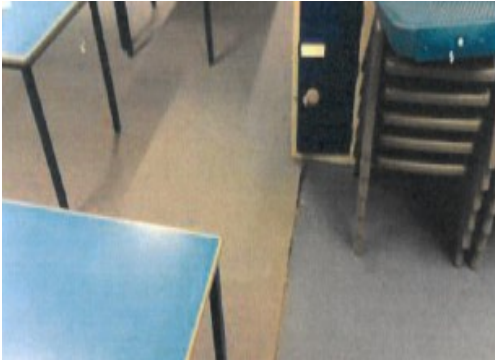
Item 6 - Ref: Sample 08 & AQ000123

The floor covering (vinyl tiles & adhesive below lino & carpet) (Room 0/11 Y2 classroom) contains asbestos.

Any change in its appearance should be recorded and passed to Property Services.

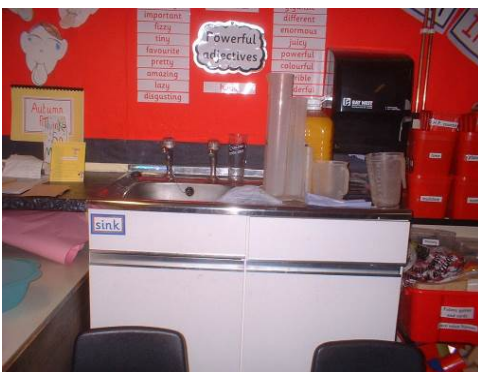
Item 8 - Ref: Sample 09

The sink pad in the infant school classroom (Room 0/14) does not contain asbestos.

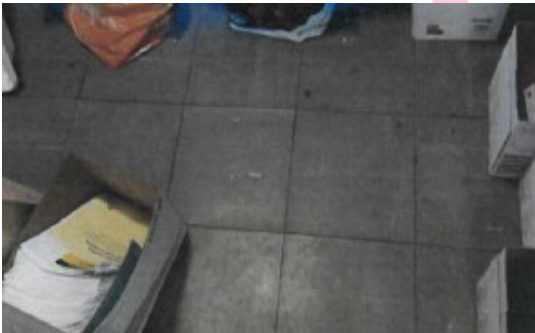
Item 10 – As Sample 10 & As AQ000124

The floor covering (vinyl tiles & adhesive) (Room 0/13 Y2 classroom stationary cupboard) contains asbestos.

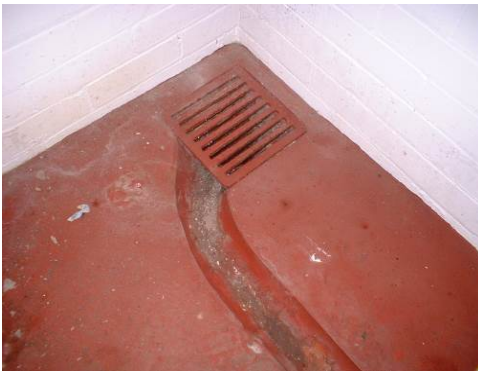
Item 22 - Ref: Sample 21

The debris to the floor in the infant school boiler house (Room 0/33) does not contain asbestos.

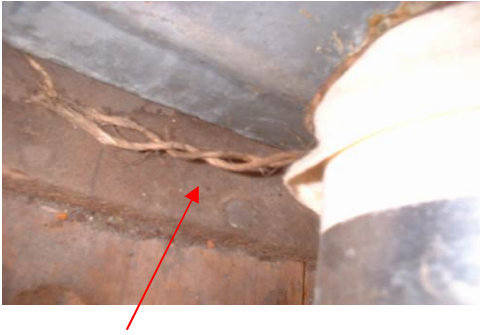
Item 27 - Ref: Sample 26

The redundant rope in the main hall ceiling void (Room 1/01) does not contain asbestos.

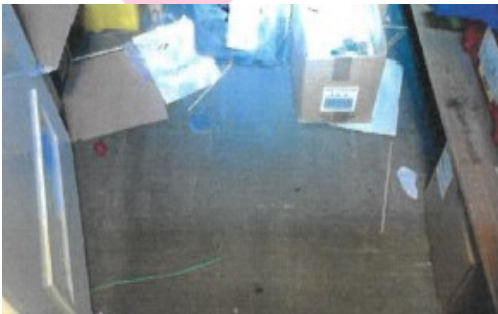
Item 29 - Ref: AQ000121

The floor covering (vinyl tiles & adhesive) (Room 0/07 store rooms) contains asbestos.

Any change in its appearance should be recorded and passed to Property Services.

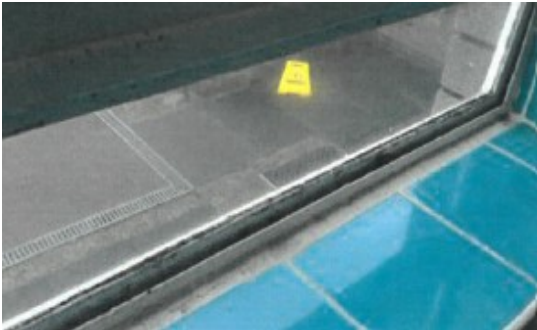
Item 34 - Ref: AQ000118

The Window putty (Room 0/04 Toilets & Cloakroom) does not contain asbestos.

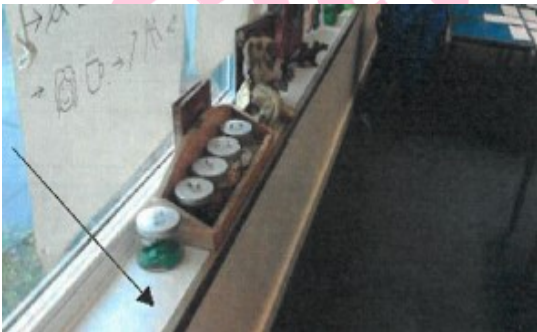
Item 35 - Ref: As AQ000115

The Window sill covering (composite material) (Room 0/05 classroom) does not contain asbestos.

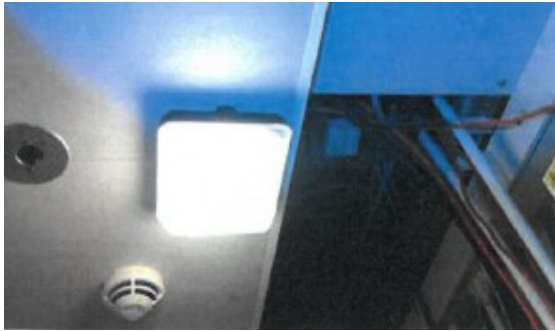
Item 36 - Ref: AQ000122

The Suspended Ceiling – Supalux (Room 0/09 electric cupboard) does not contain asbestos.

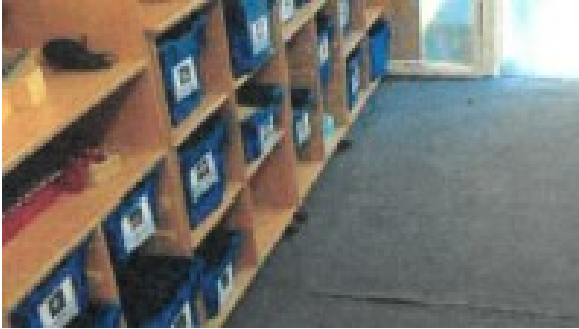
Item 39 - Ref: AQ000125

The Vinyl tile below carpet (Room 0/15 music room lobby) does not contain asbestos.

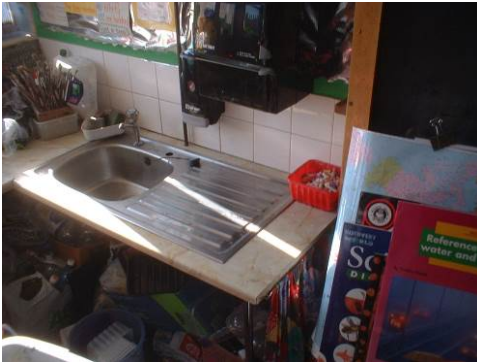
Item 1 - Ref: Sample 27

The sink pad in this primary school classroom (Room 0/34) does not contain asbestos.

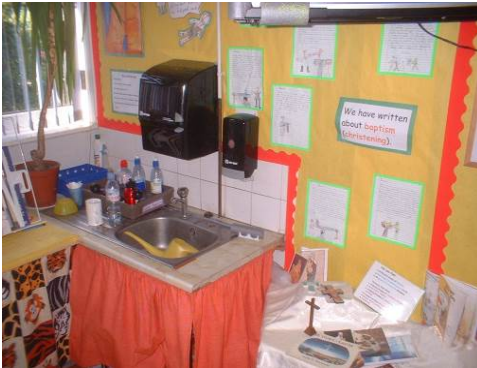
Item 2 – Ref: Sample 28

The sink pad in this primary school classroom (Room 0/35) does not contain asbestos.

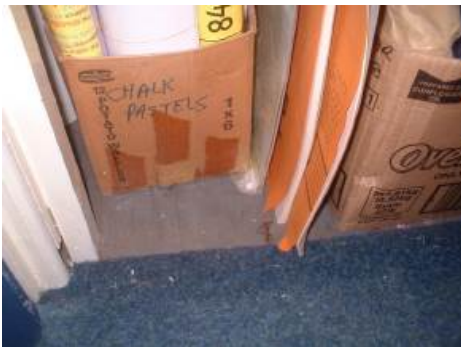
Item 5 - As Sample 29

The vinyl floor tiles in the primary school classroom store (Room 0/36) do not contain asbestos.

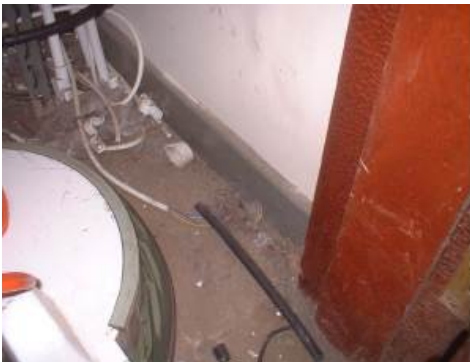
Ref: Sample 37

The debris to the floor in the electrical cupboard (Room 0/43) did not contain asbestos.

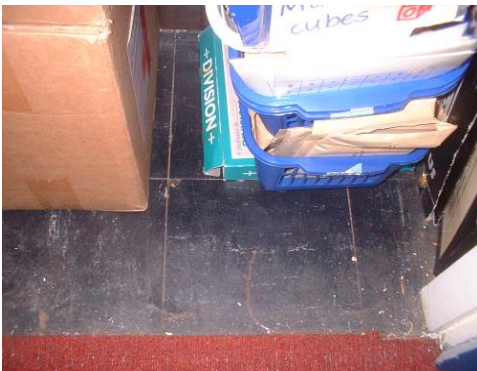
Item 12 - Ref: Sample 39

The vinyl flooring to classroom 8 (Room 0/56) in the primary school contains asbestos.

Any change in its appearance should be recorded and passed to Property Services.

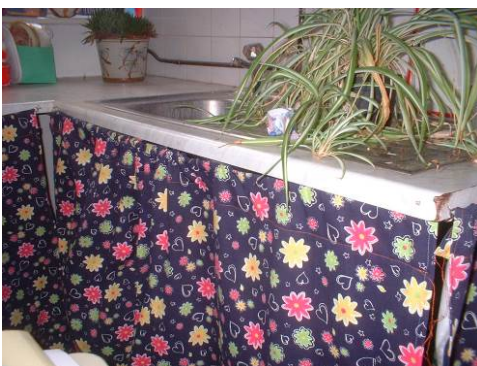
Item 16 – Ref: Sample 43

The sink pad in classroom 5 (Room 0/59) does not contain asbestos.

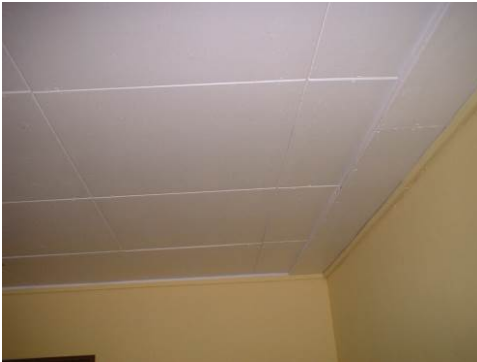
Item 18 - Ref: Sample 45

The ceiling in the staff room (Room 0/51) does not contain asbestos.

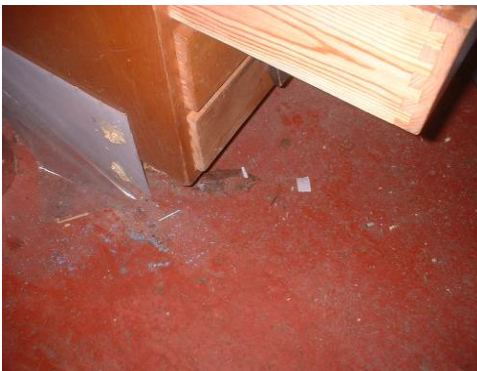
Item 19 – Ref: Sample 46

The debris to the floor in the primary school boiler room (Room 0/68) does not contain asbestos.

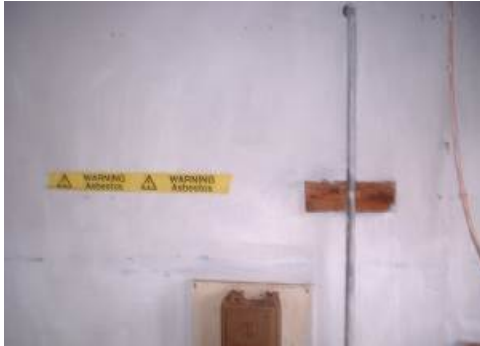
Ref: Sample 47

The wall lining boards to the boiler room in the annexe (Room 0/69) contained asbestos.

These have been removed.

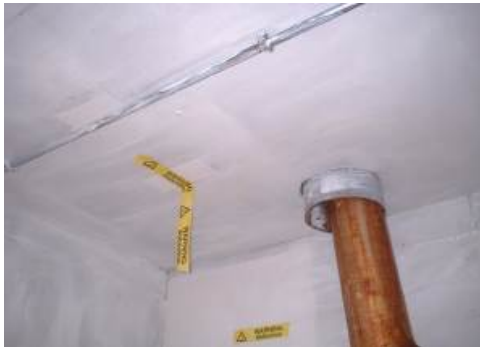
Ref: Sample 48

The ceiling boards to the boiler room in the annexe (Room 0/69) contained asbestos.

These have been removed.

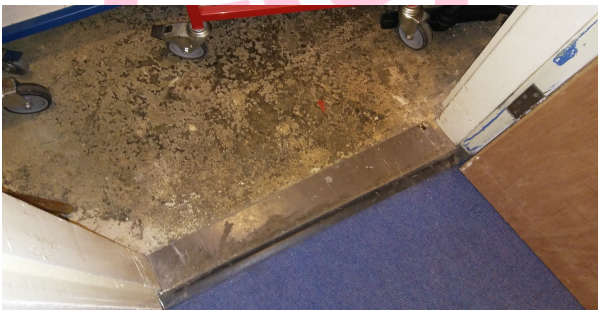
Item 32 - Ref: 182913-8

The bitumen adhesive to the floor in the electric cupboard (Rm 0/18) contains asbestos.

Any change in its appearance should be recorded and passed to Property Services.

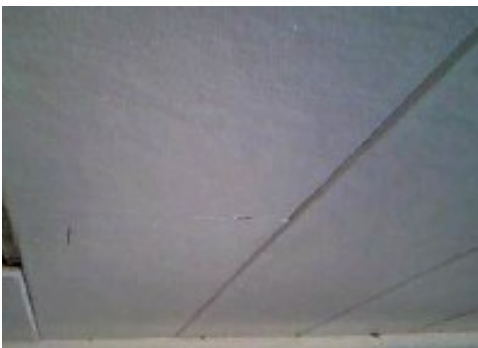
Item 38 Ref: As BB000951

The fibreglass ceiling in Practical Area does not contain asbestos.

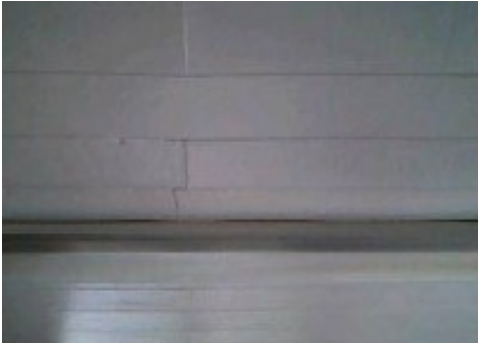
Item 39 Ref: As BB000951

The fibreboard ceiling in Reception Classroom does not contain asbestos.

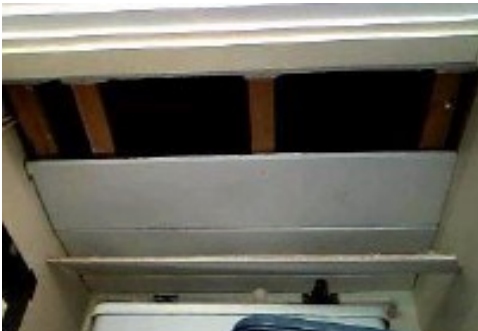
Item 40 Ref: As BB000951

The fibreboard ceiling in Reception Tank Cupboard does not contain asbestos.

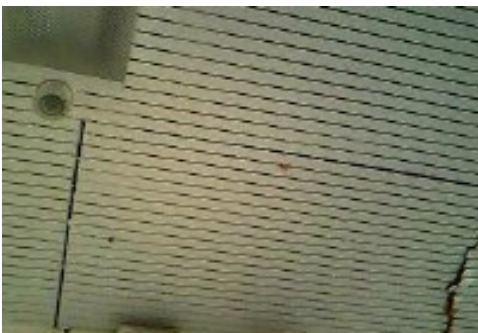
Item 41 Ref: As BB000951

The fibreboard ceiling in Cloaks does not contain asbestos.

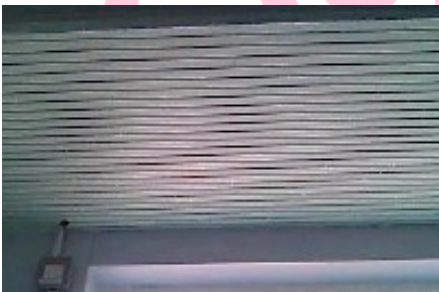
Item 44 Ref: As BB000951

The fibreboard ceiling in Boys Toilet does not contain asbestos.

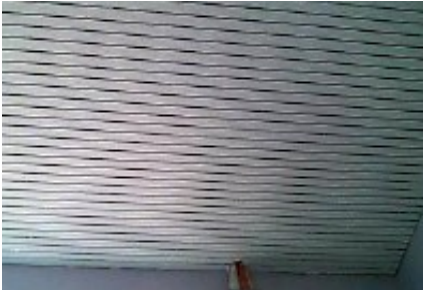
Item 45 Ref: As BB000951

The fibreglass ceiling in Girls Toilet does not contain asbestos.

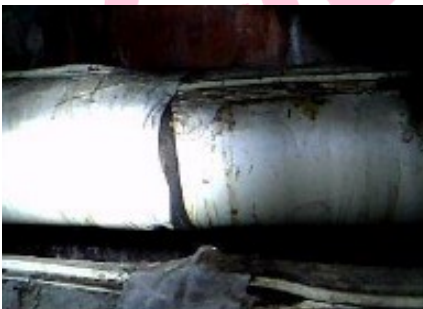
Item 47 Ref: BB000953

The black foam lagging to pipes in Water tank void does not contain asbestos.

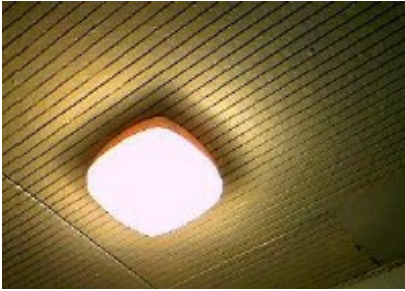
Item 48 Ref: As BB000951

The fibreboard ceiling in Corridor does not contain asbestos.

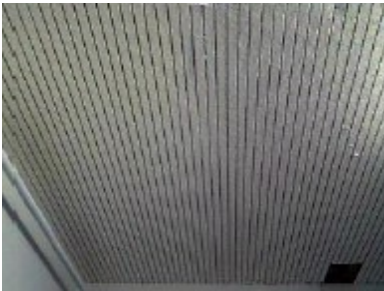
Item 49 Ref: As BB000951

The fibreboard ceiling in IT Suite does not contain asbestos.

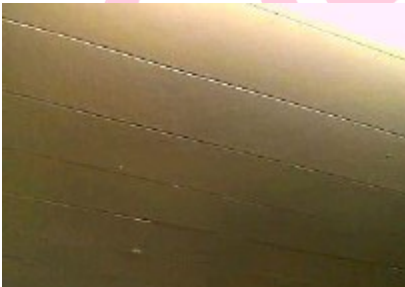
Item 50 Ref: As BB000951

The fibreboard ceiling in Year 2 Classroom does not contain asbestos.

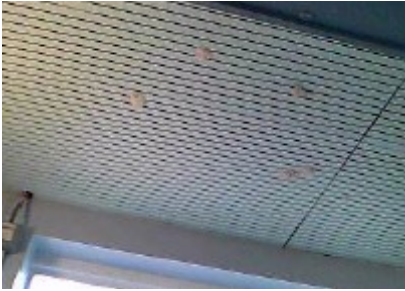
Item 51 Ref: As BB000951

The fibreboard ceiling in Toilet does not contain asbestos.

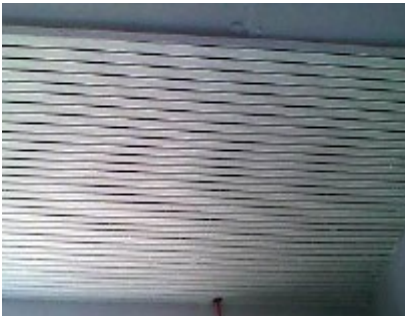
Item 52 Ref: As BB000951

The fibreboard ceiling in Toilet does not contain asbestos.

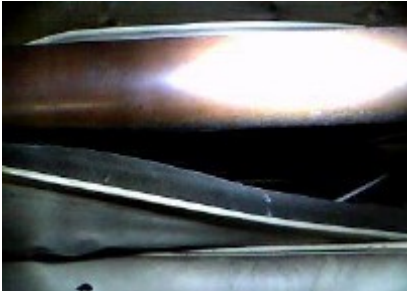
Item 54 Ref: As BB000953

The black foam lagging to pipes in Water Tank void 2 does not contain asbestos.

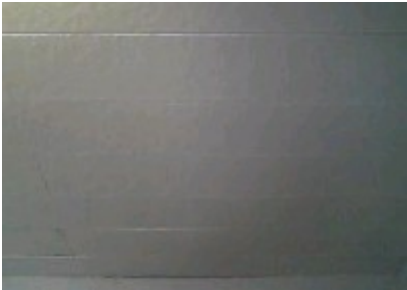
Item 55 Ref: As BB000951

The fibreboard ceiling in Year 2 Classroom 2 does not contain asbestos.

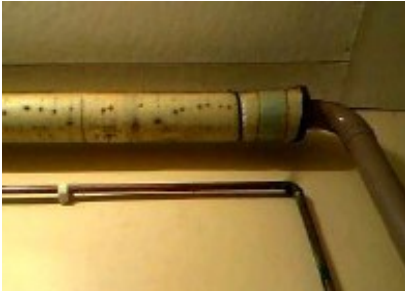
Item 57 Ref: As BB000953

The pipe lagging in Year 2 Classroom 2 Store does not contain asbestos.

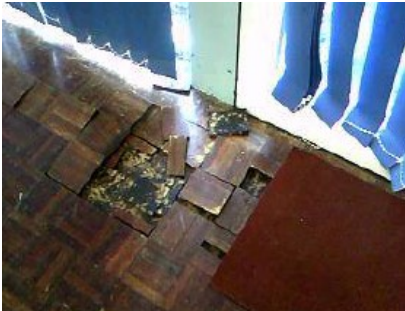
Item 58 Ref: AC001852

The parquet flooring and bitumen below in Key Stage 1 Hall does not contain asbestos.

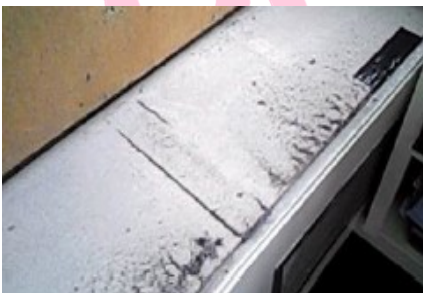
Item 59 Ref: EB000075

The insulation board to lining panels underside of heater cover in Print Room does not contain asbestos.

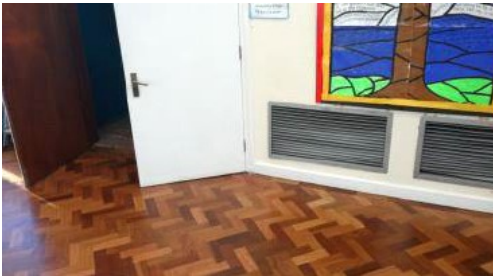
Item 61 Ref: AD000721

The left hand wall heater internal wall linings in Main Hall contain asbestos.

Remove refer to survey J150351.

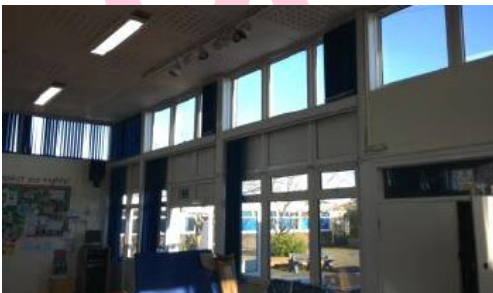
Item 62 Ref: AD000724

The column and beam cladding behind modern cappings in Main Hall contain asbestos.

Any change in its appearance should be recorded and passed to Property Services.

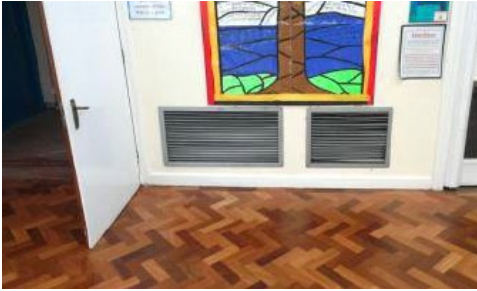
Item 63 Ref: AD000720

The wall heater internal ceiling soffit panels in Main Hall does not contain asbestos.

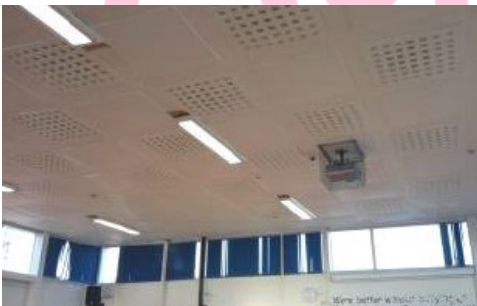
Item 65 Ref: AD000722

The ceiling tiles in Main Hall does not contain asbestos.

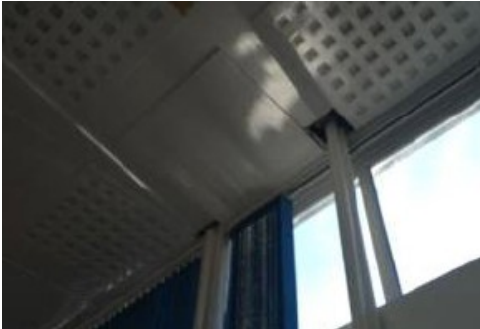
Item 66 Ref: AD000723

The ceiling void pipework insulation in Main Hall does not contain asbestos.

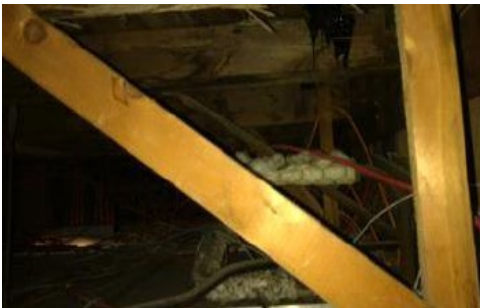
Item 67 Ref: AD000725

The ceiling void pipework insulation in PE Cupboard does not contain asbestos.

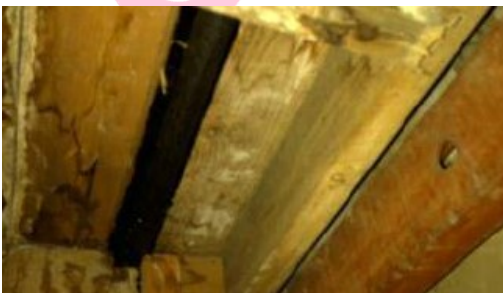
Item 68 Ref: AD000726

The ceiling void soffit felt wrap in PE Cupboard does not contain asbestos.

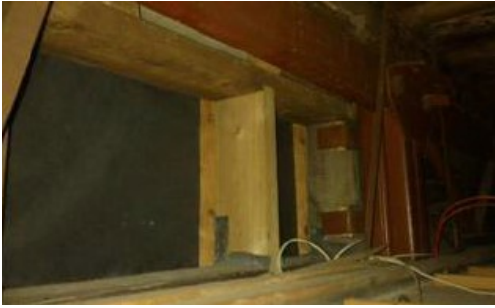
Item 69 Ref: AD000727

The wall covering behind cladding in PE Cupboard does not contain asbestos.

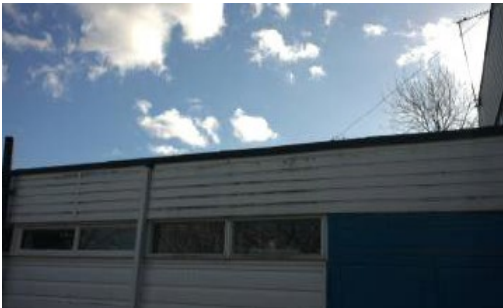
Item 70 Ref: AD000728

The flat roof coverings (External) does not contain asbestos.

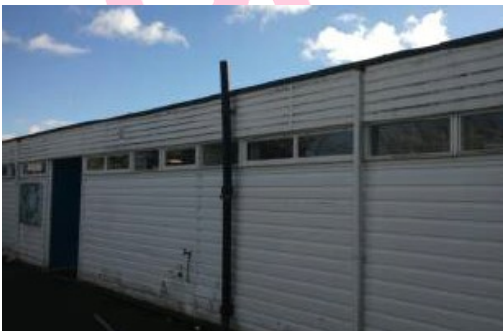
Item 71 Ref: AD000729

The window putty (External) does not contain asbestos.

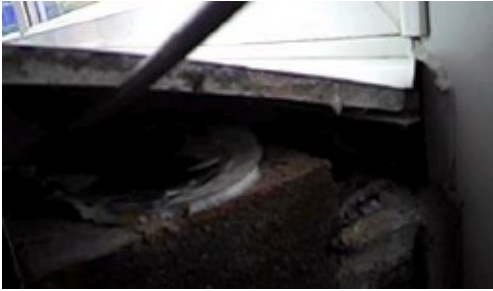
Item 72 Ref: EA000243

The low level conservatory wall cavity Insulation in Reception conservatory area does not contain asbestos.

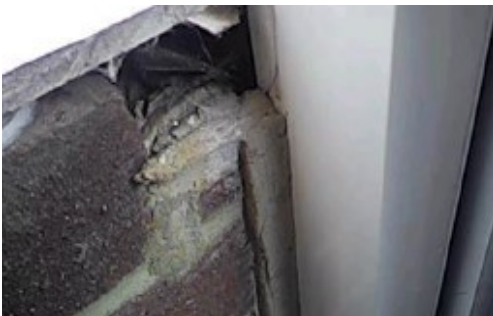
Item 73 Ref: EA000244

The damp proof course beneath window sills in Reception conservatory area does not contain asbestos.

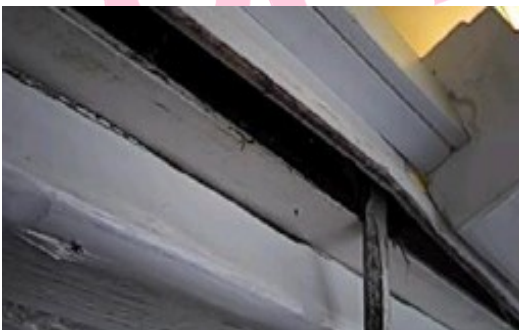
Item 74 Ref: EA000244

The damp proof course between class and conservatory wall in Reception conservatory area does not contain asbestos.

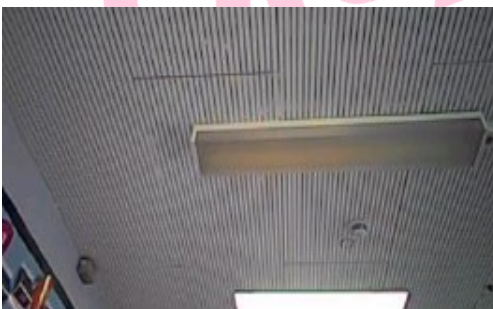
Item 77 Ref: EA000248

The suspended ceiling tiles in Year 1 Cloakroom does not contain asbestos.

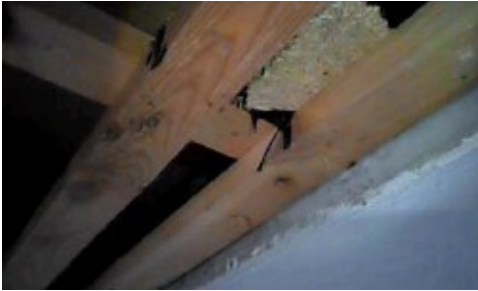
Item 78 Ref: EA000249

The bitumen debris from flat roof in Year 1 Cloakroom does not contain asbestos.

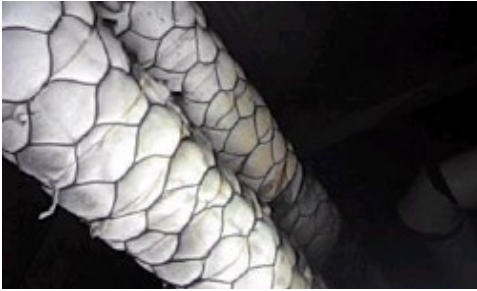
Item 81 Ref: EA000253

The lagging to pipework within ceiling void in Corridor adj Kitchen does not contain asbestos.

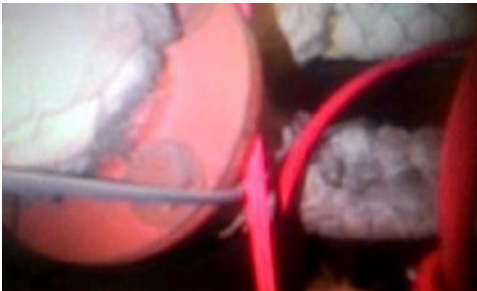
Item 82 Ref: Presumed

The gasket to pipework in Corridor adj Kitchen is presumed to contain asbestos.

Any change in its appearance should be recorded and passed to Property Services.

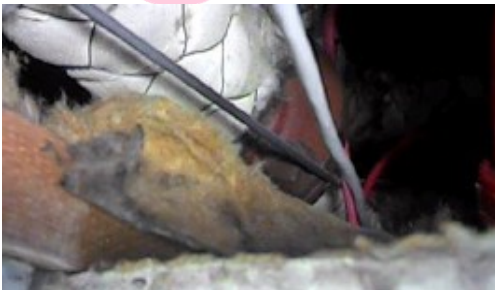
Item 83 Ref: EA000254

The tar paper to mmmf firebreak blankets in Corridor adj Kitchen does not contain asbestos.

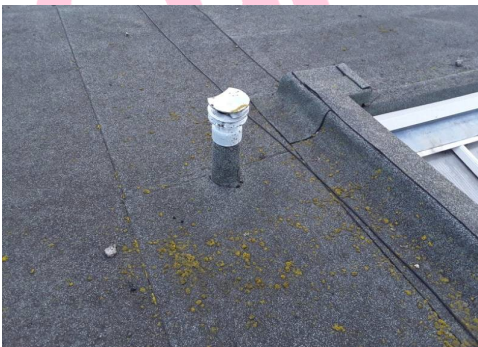
Item 98 Ref: PE001548

The cement flue (External/Roof 7) contains asbestos.

Removed April 2022 – waiting WCN

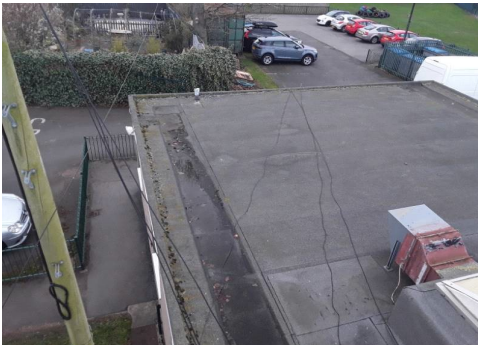
Item 103 Ref: As PE001548

The cement flue (External/Roof 5) contains asbestos.

Removed April 2022 – waiting WCN

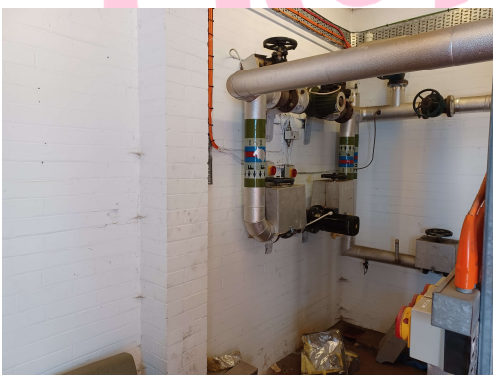
Item 110 Ref: 581161-3

The debris to wall LHS of boilers (Rm 0/26 KS1 Boiler Room) contains asbestos.

Removed January 2024.

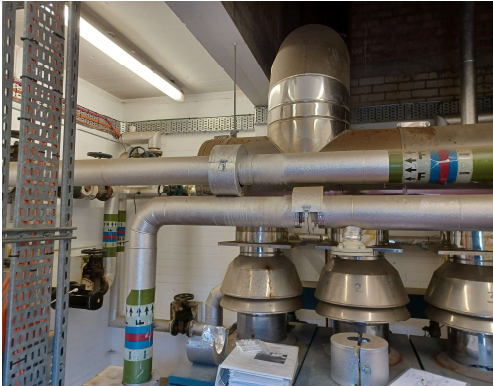
Item 111 Ref: Presumed

The debris to pipework below armer cladding (Rm 0/26 KS1 Boiler Room) is presumed to contain asbestos.

Removed January 2024.

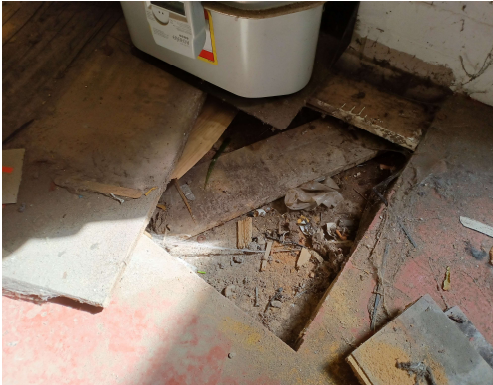
Item 112 Ref: 581161-6

The debris within gas box sump (Rm 0/26 KS1 Boiler Room) does not contain asbestos.

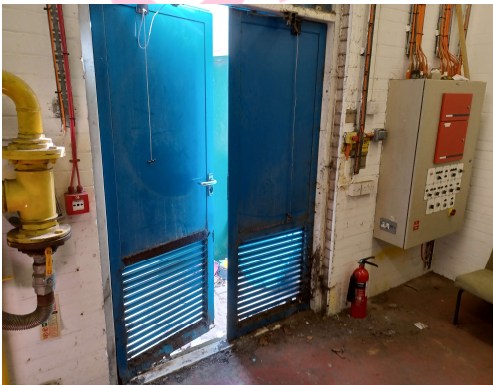
Item 113 Ref: 581161-7

The debris to entrance wall (Rm 0/26 KS1 Boiler Room) contains asbestos.

Removed January 2024.

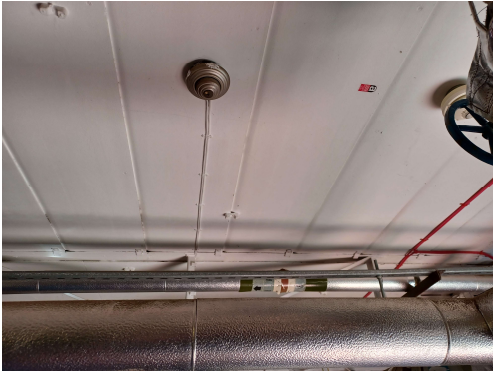
Item 114 Ref: 581161-10

The underside of roof (Rm 0/27 Boiler Room adj Kitchen) contains asbestos.

Removed October 2023.

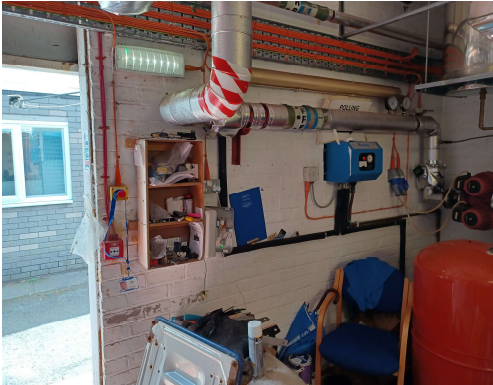
Item 121 Ref: 581161-16

The debris to entrance wall (Rm 0/27 Boiler Room adj Kitchen) contains asbestos.

Removed October 2023.

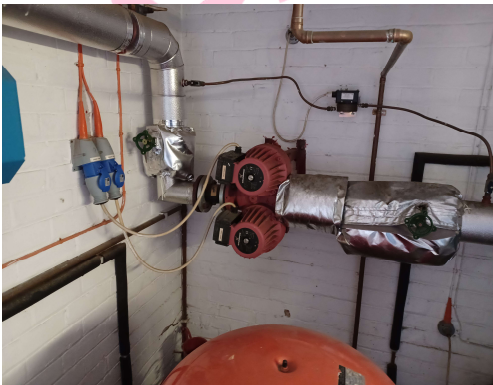
Item 122 Ref: 581161-17

The pipework flange gasket (Rm 0/27 Boiler Room adj Kitchen) does not contain asbestos.

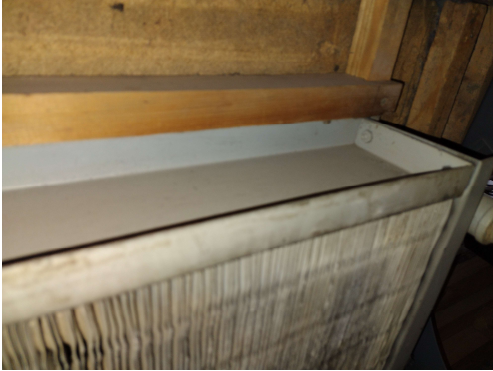
Item 135 Ref: As 581161-20

The sealant surrounding convector (Rm 0/37 Classroom) contains asbestos.

Removed refer to survey J150351.

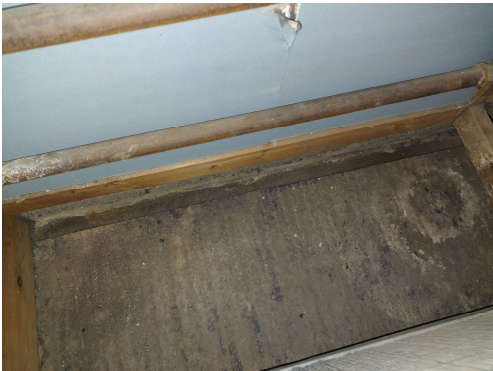
Item 136 Ref: As 581161-19

The damp proof course (Rm 0/38 Classroom) contains asbestos.

Any change in its appearance should be recorded and passed to Property Services.

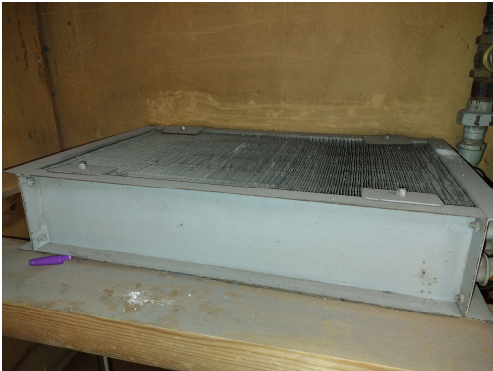
Item 138 Ref: As 581161-20

The sealant surrounding convector (Rm 0/39 Corridor) contains asbestos.

Removed refer to survey J150351.

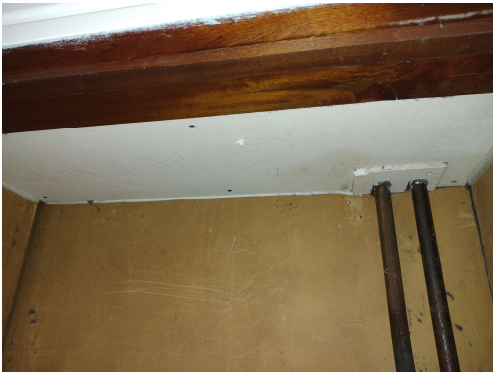
Item 139 Ref: 581161-21

The ceiling & service penetration infill (Rm 0/39 Corridor) does not contain asbestos.

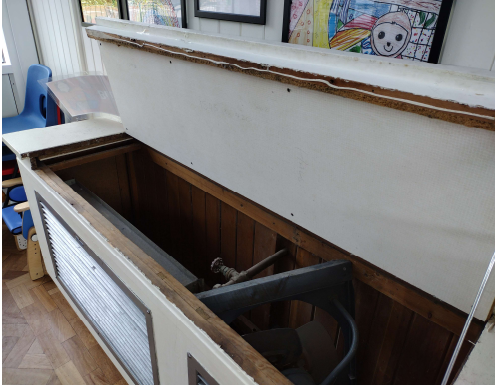
Item 141 Ref: As 581161-21

The cabinet soffit lining (Rm 0/40 Dining Hall) does not contain asbestos.

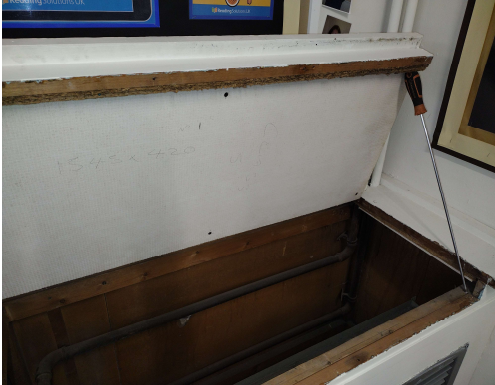
Item 144 Ref: As 581161-21

The cabinet soffit lining (Rm 0/42 Classroom) does not contain asbestos.

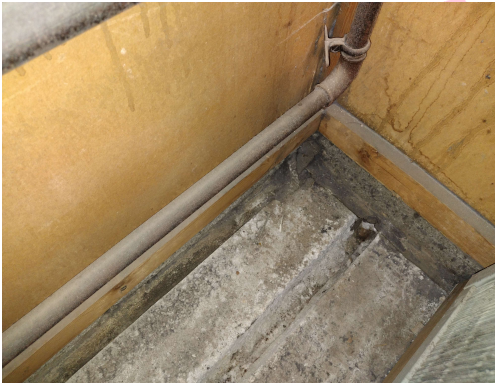
Item 145 Ref: As 581161-19

The damp proof course (Rm 0/42 Classroom) contains asbestos.

Any change in its appearance should be recorded and passed to Property Services.

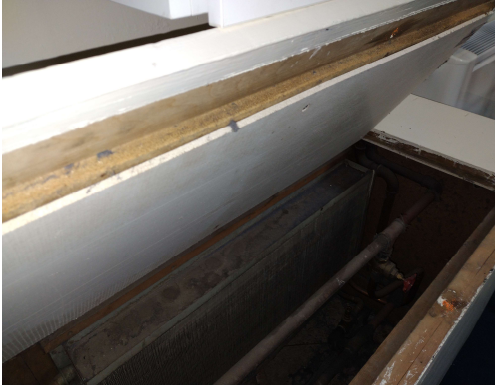
Item 147 Ref: As 581161-21

The cabinet soffit lining (Rm 0/43 Classroom) does not contain asbestos.
