### ASBESTOS SURVEY REPORT FOR FULWELL INFANT ACADEMY SCHOOL, SUNDERLAND

**Asbestos Register for**

**FULWELL INFANT ACADEMY**

**Date: 11 February 2026**

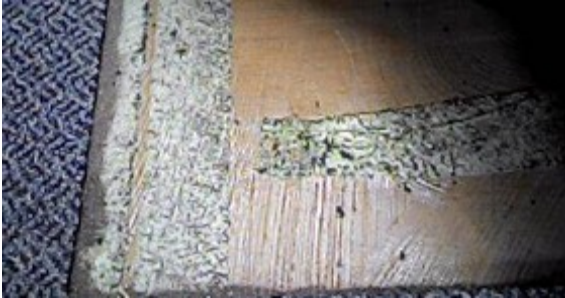
### **Item 70 – Ref: As EB000313**

The Beige vinyl tiles in Room 3 Class 2 do not contain asbestos.
