ASBESTOS SURVEY REPORT FOR THE HARRATON CENTRE, FIRTREE AVENUE, WASHINGTON, TYNE & WEAR, NE38 9BA

**The Harraton Centre, Washington. NE38 9BA**

**Date: 08 July 2025**

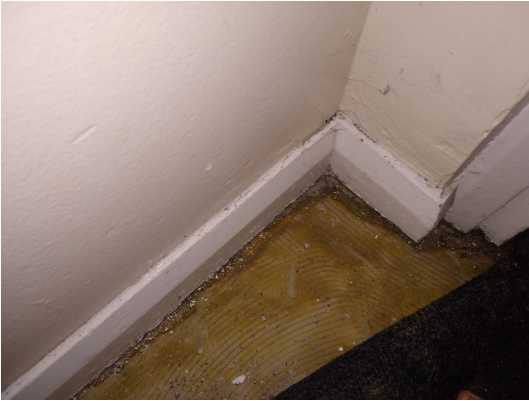
### **Item 1 Ref: 365647-1**

The remnant adhesive below floor screed in room 001/ community room contains asbestos.

Any change in its appearance should be recorded and passed to Property Services.

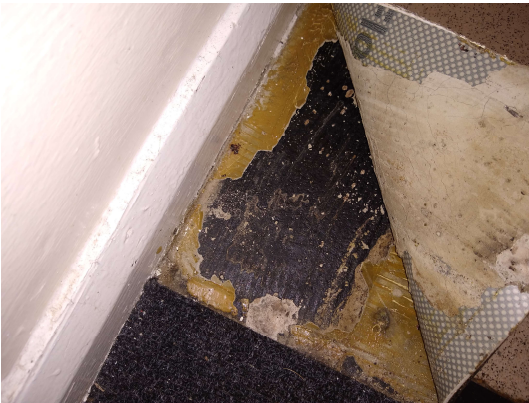
### **Item 2 Ref: As 365647-1**

The remnant adhesive to floor in room 002/kitchen contains asbestos.

Any change in its appearance should be recorded and passed to Property Services.

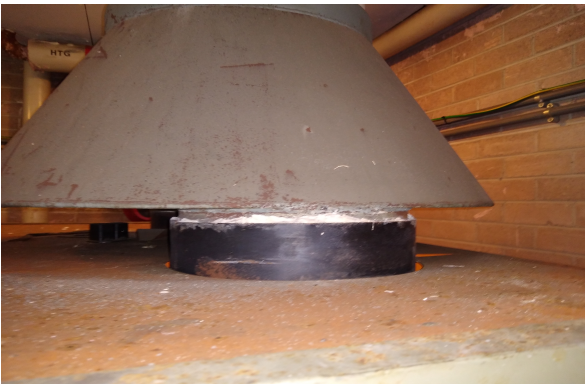
### **Item 32 Ref: 365647-23**

The packing to the boiler flue (outside of boiler) in room 47/boiler room does not contain asbestos.

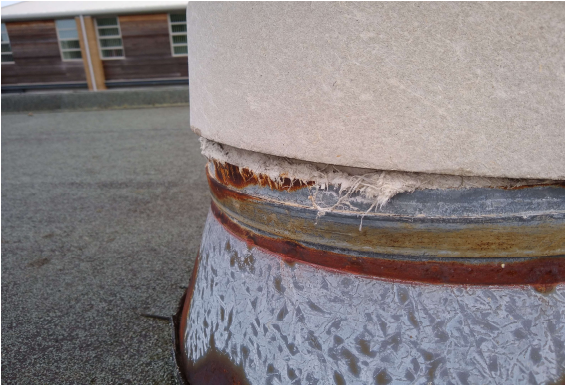
### **Item 46 Ref: 365647-13**

The rope seal to flue cowl (external) does contain asbestos.

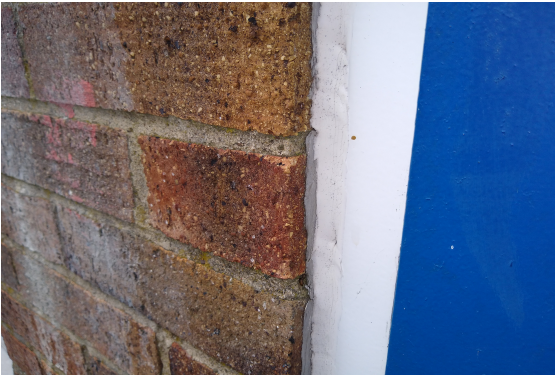
### **Item 50 Ref: As 365647-16**

The remnant seal to kiln room frame (external) does not contain asbestos.

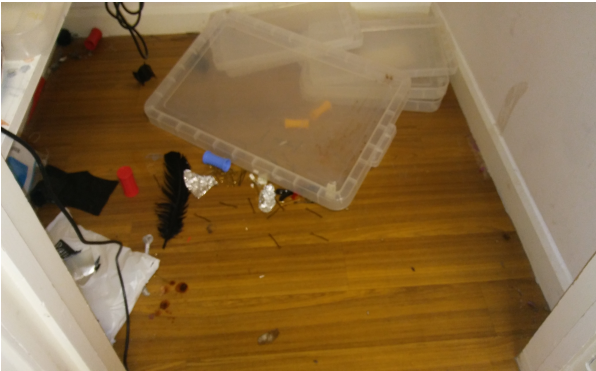
### **Item 61 Ref: As 412164-5**

The adhesive to floor beneath linoleum in the store (Rm 0/24a) does contain asbestos.

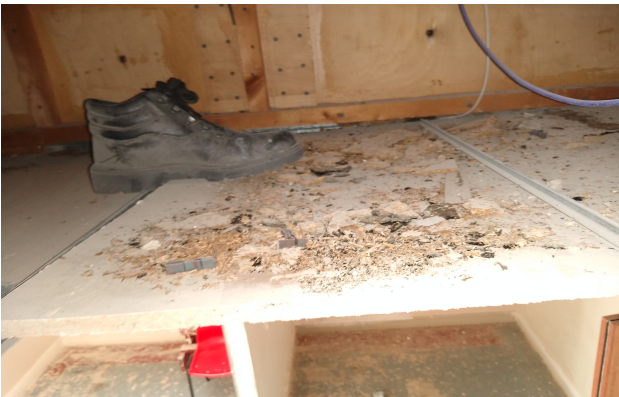
### **Item 69 Ref: 412164-1**

The remnant bitumen from roof topside of suspended ceiling in the workshop – void above (Rm 0/45) does contain asbestos.

Any change in appearance should be reported to Property Services.

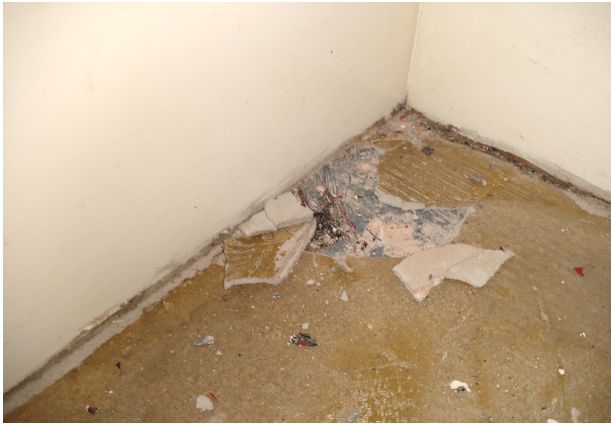
### **Item 70 Ref: 412164-2**

The remnant bitumen adhesive below modern linoleum in office (Rm 0/46) does contain asbestos.

Any change in appearance should be reported to Property Services.

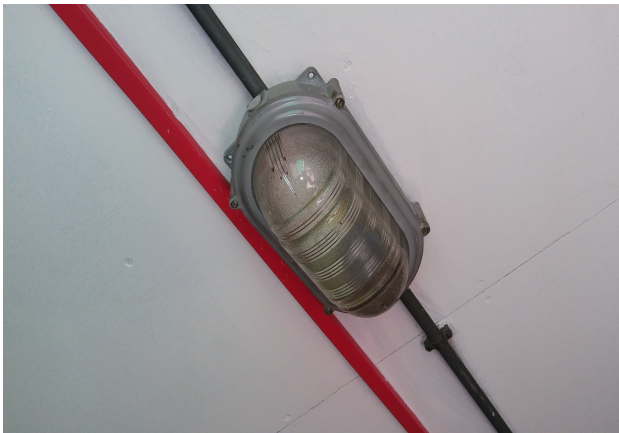
### **Item 71 Ref: 412164-10**

The seal to light fittings in the boiler room (Rm 0/47) does contain asbestos.

Any change in appearance should be reported to Property Services.

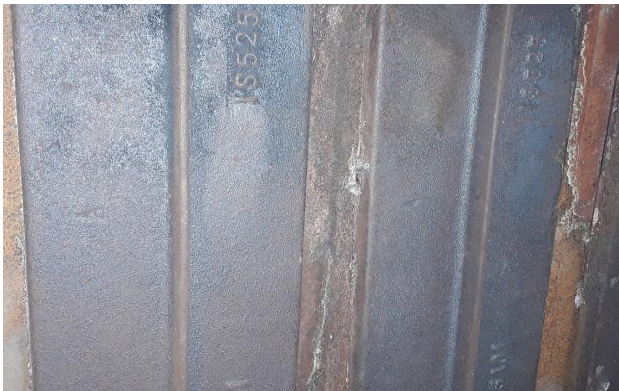
### **Item 72 Ref: 20-27353-1**

The vessels seal to metal boiler section access plates in Boiler Room contains asbestos.

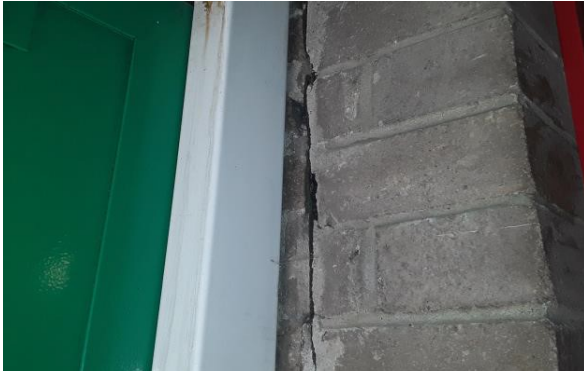
### **Item 73 Ref: 20-27353-2**

The damp proof to cavity around door in Boiler Room does not contain asbestos.

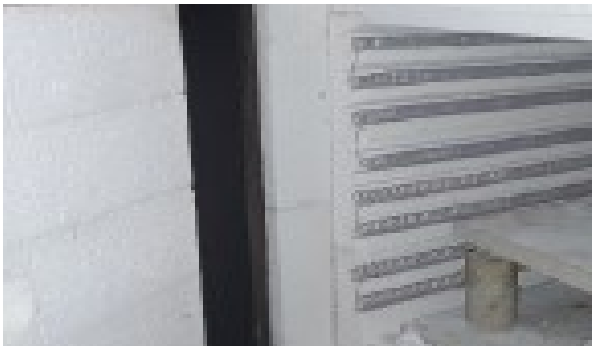
### **Item 74 Ref: 20-27245-1**

The vessel internal lining to kiln in Kiln Room does not contain asbestos.

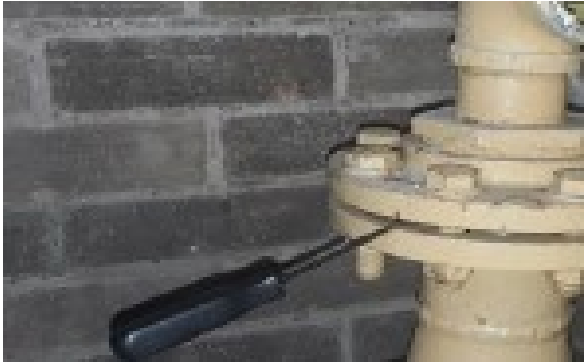
### **Item 76 Ref: 20-27245-3**

The metal flanges (top flange) in Gas Meter cupboard do not contain asbestos.

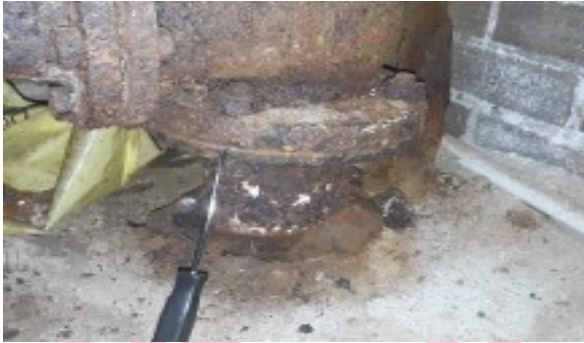
### **Item 77 Ref: 20-27245-4**

The metal flanges (bottom gasket) in Gas Meter cupboard do not contain asbestos.

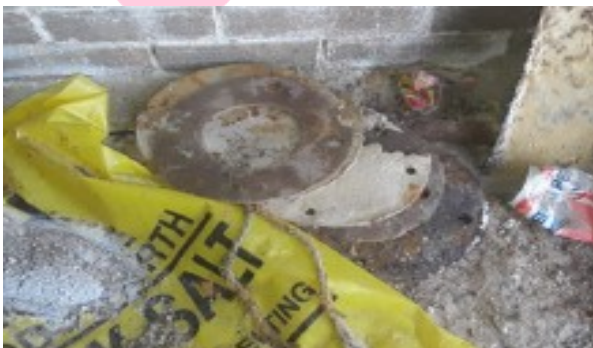
### **Item 78 Ref: 20-27245-5**

The redundant flange gaskets to floor in Gas Meter cupboard do not contain asbestos.

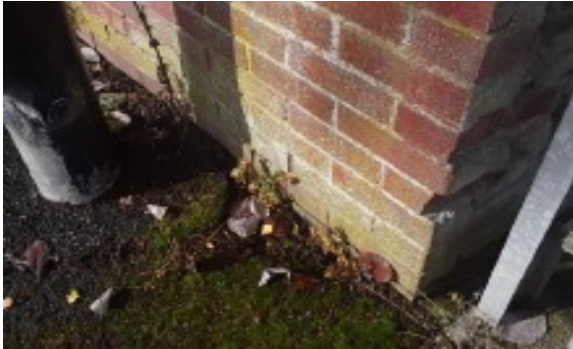
### **Item 79 Ref: 20-27245-6**

The wall damp proof course in Gas Meter cupboard contains asbestos.

Any change in appearance should be reported to Property Services.

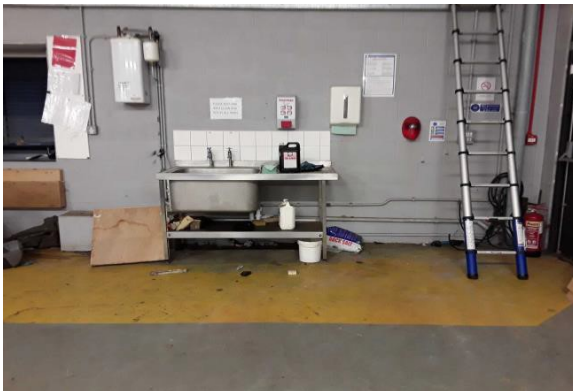
### **Item 80 Ref: 22-43761-1**

The sink pad to drainer (Area 1/Garage) contains asbestos.

Any change in appearance should be reported to Property Services.
