### ASBESTOS SURVEY REPORT FOR HILL VIEW INFANT SCHOOL, SUNDERLAND

**Asbestos Register for**

**HILL VIEW INFANT SCHOOL, SUNDERLAND**

**Date: 23 March 2026**

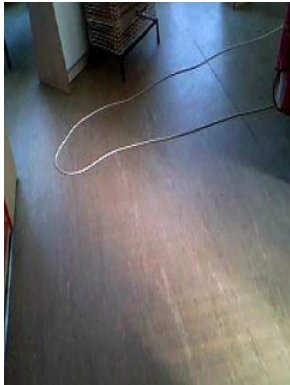
### **Item 4 - Ref: BB000804**

The floor tiles to room 17 do not contain asbestos.

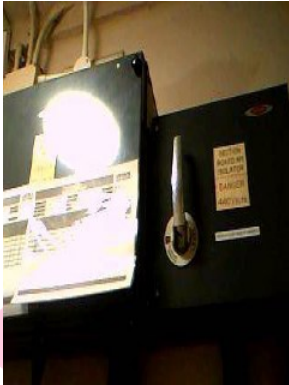
### **Item 5 – Presumed**

The flash guards to the fuse box in the corridor (Rm 0/24) were strongly presumed to contain asbestos.

***These were removed 8<sup>th</sup> July 2013.***

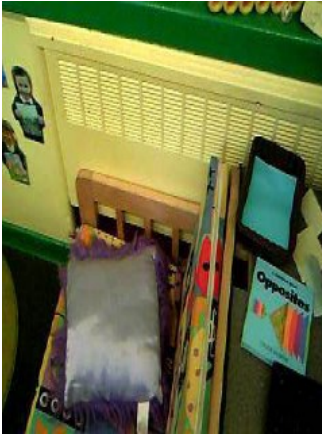
**Item 7 – As BB000791**

The insulation board between the old heater and the brick work to the wall in Room 0/29 does not contain asbestos.

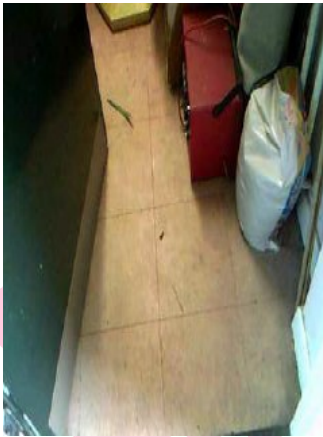
**Item 8 – As BB000802**

The floor tiles to room 0/30 do not contain asbestos.

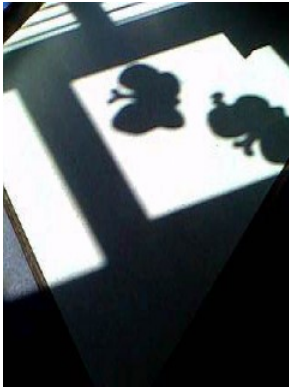
**Item 10 – As BB000801**

The lino to room 0/34 does not contain asbestos.

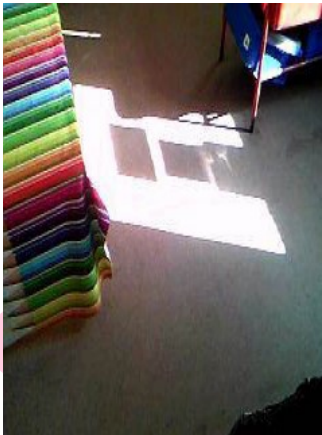
**Item 11 – Ref: BB000801**

The lino to room 0/35 does not contain asbestos.

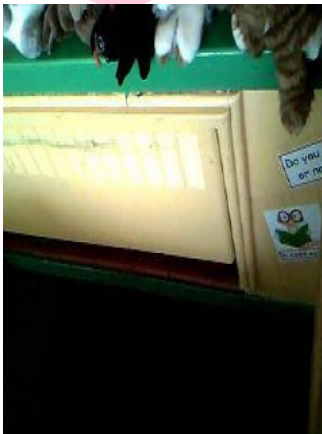
**Item 12 – As BB000791**

The insulation panel between the heater and the brickwork to the wall in room 0/39 does not contain asbestos.

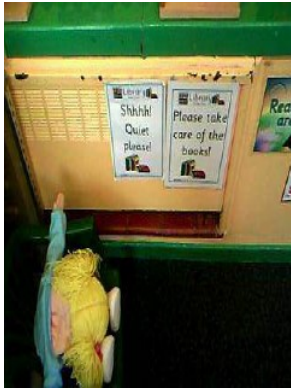
### **Item 13 – As BB000791**

The insulation panel between the heater and the brickwork to the wall in room 0/42 does not contain asbestos.

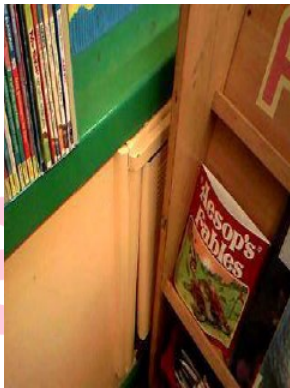
### **Item 14 – As BB000791**

The insulation panel between the heater and the brickwork to the wall in room 0/45 does not contain asbestos.

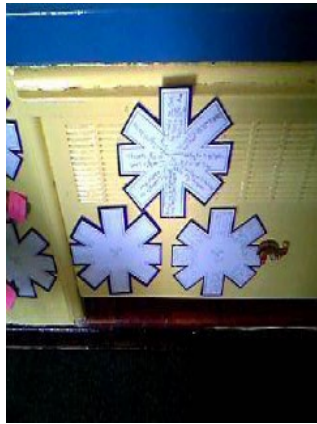
**Item 16 – As BB000791**

The insulation panel between the heater and the brickwork to the wall in room 0/51 does not contain asbestos.

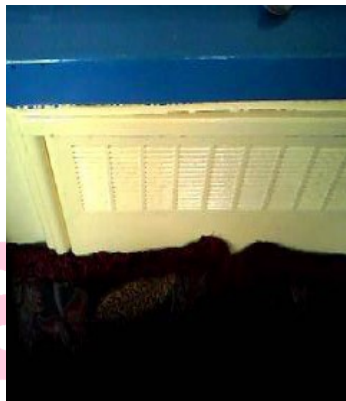
**Item 17 – As BB000791**

The insulation panel between the heater and the brickwork to the wall in room 0/53 does not contain asbestos.

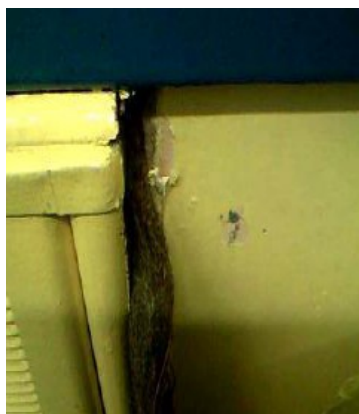
**Item 18 – Ref: BB000791**

The insulation panel between the heater and the brickwork to the wall in room 0/55 does not contain asbestos.

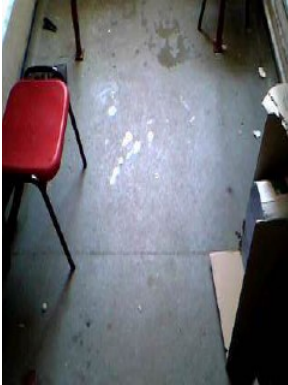
**Item 19 – As BB000801**

The lino to room 0/75 does not contain asbestos.

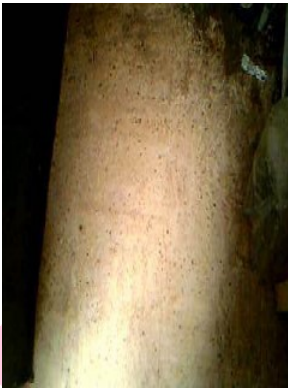
**Item 20 – Ref: BB000802**

The floor tiles to room 0/76 do not contain asbestos.

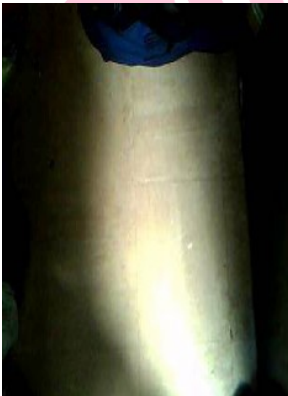
**Item 21 – As: BB000802**

The floor tiles to room 0/78 do not contain asbestos.

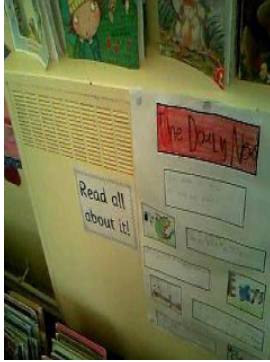
### **Item 22 – As: BB000791**

The insulation panel between the heater and the brickwork to the wall in room 0/83 does not contain asbestos.

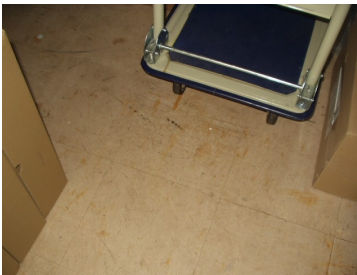
### **Item 23 - Ref: AW0838/08**

The beige floor tiles to the store room (Rm 0/84) do not contain asbestos.

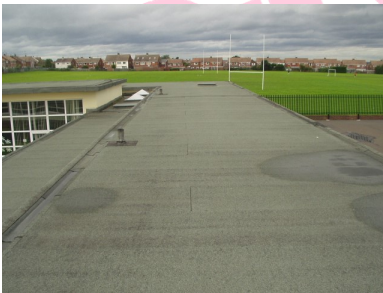
### **Item 24 - Ref: AW0840/08**

The roof felt to the external of the building does not contain asbestos.

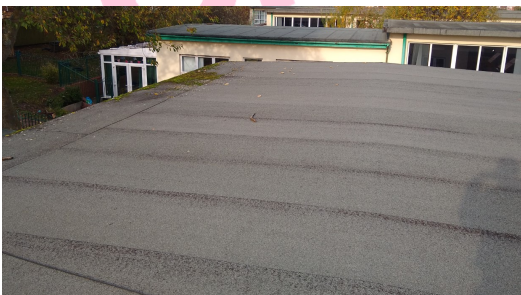
### **Item 45 Ref: 437902-5**

The flat roof (External Roof 1) does not contain asbestos.

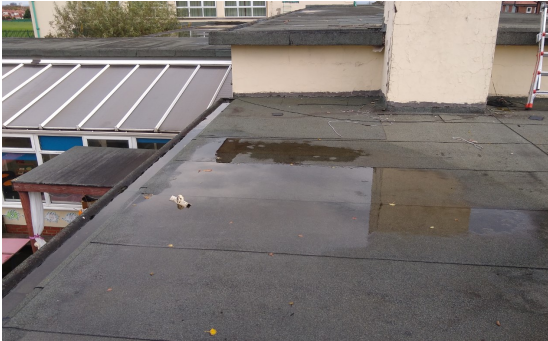
**Item 46 Ref: 437902-6**

The flat roof (External Roof 2) does not contain asbestos.

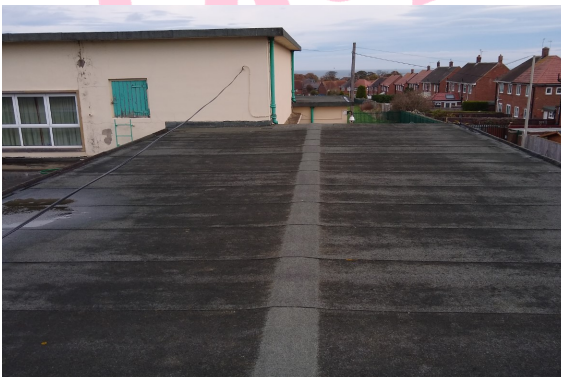
**Item 48 Ref: 437902-8**

The flat roof (External Roof 3) does not contain asbestos.

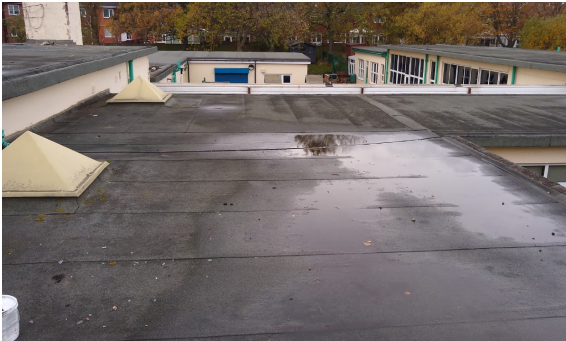
**Item 50 Ref: 437902-10**

The flat roof (External Roof 4) does not contain asbestos.

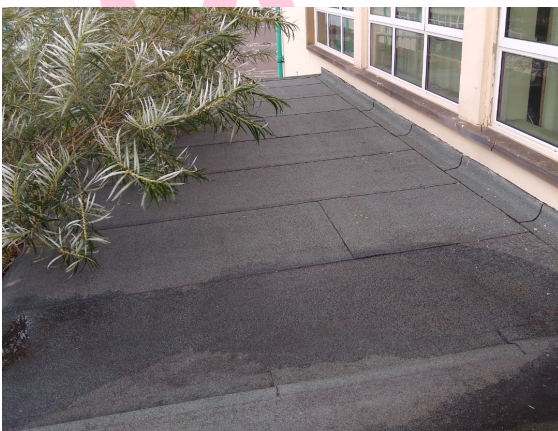
**Item 51 Ref: 437902-11**

The flat roof (External Roof 5) does not contain asbestos.

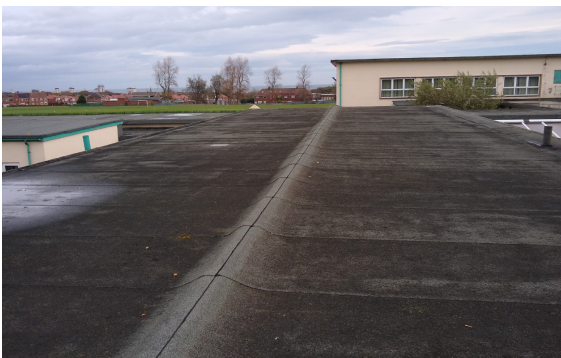
**Item 53 Ref: 437902-13**

The flat roof (External Roof 7) does not contain asbestos.

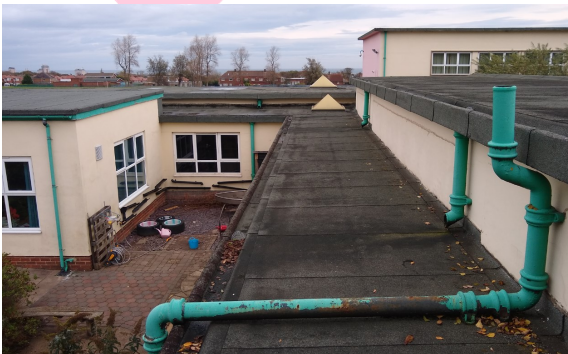
**Item 54 Ref: 437902-14**

The flat roof (External Roof 8) does not contain asbestos.

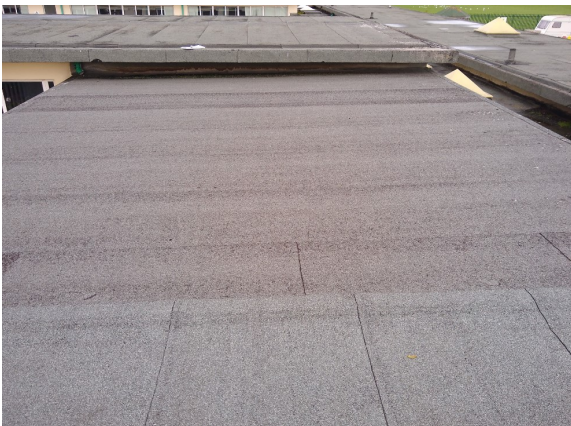
**Item 56 Ref: 437902-16**

The flat roof (External Roof 9) does not contain asbestos.

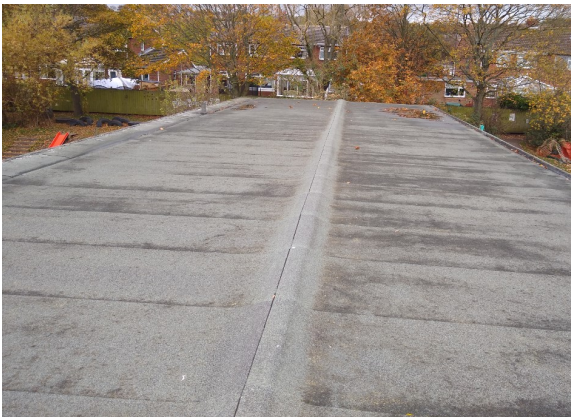
**Item 57 Ref: 437902-17**

The flat roof (External Roof 10) does not contain asbestos.

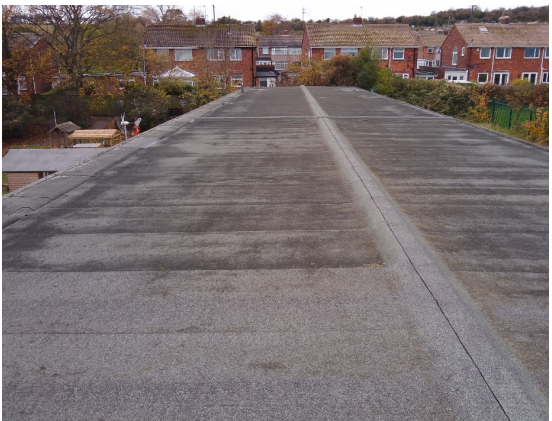
**Item 60 Ref: 437902-19**

The flat roof (External Roof 12) does not contain asbestos.

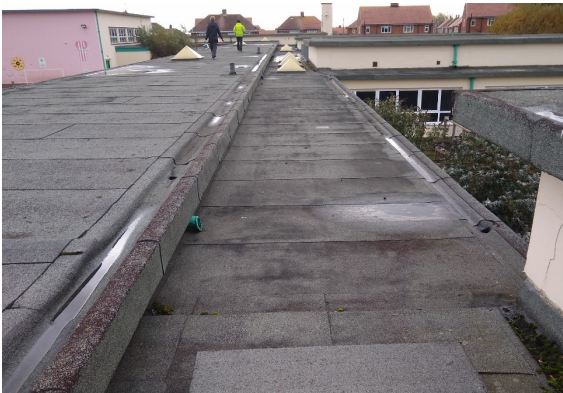
**Item 65 Ref: 437902-23**

The flat roof (External Roof 15) does not contain asbestos.

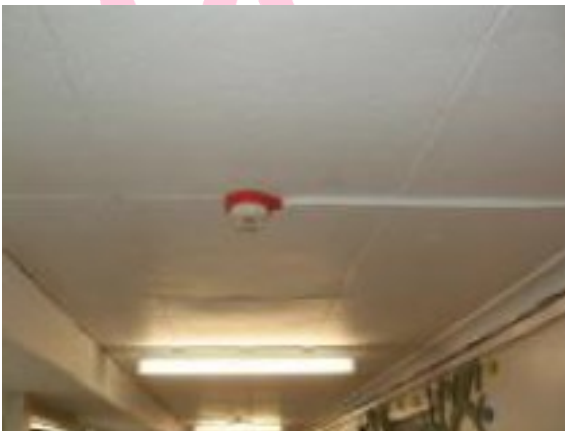
**Item 72 Ref: SC17530**

The ceiling board (Corridor 2/022) does not contain asbestos.

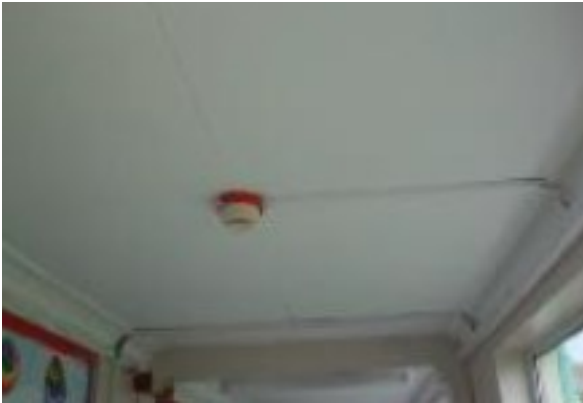
**Item 73 Ref: SC17531**

The ceiling board (Corridor 3/048) does not contain asbestos.

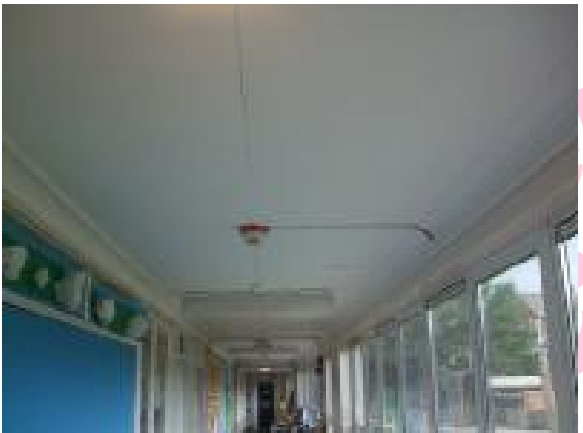
**Item 74 Ref: SC17532**

The ceiling board (Corridor 4/060) does not contain asbestos.

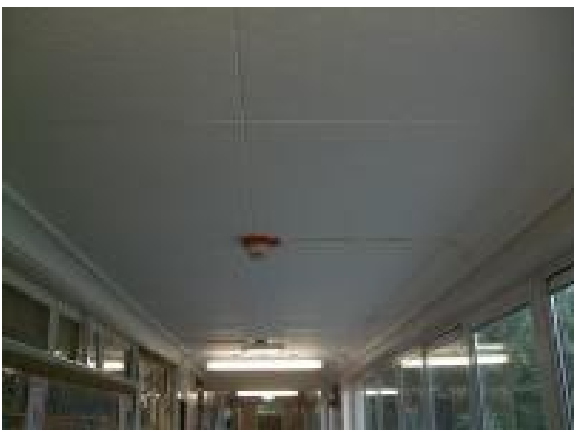
**Item 75 Ref: SC17533**

The ceiling board (Corridor 5/075) does not contain asbestos.

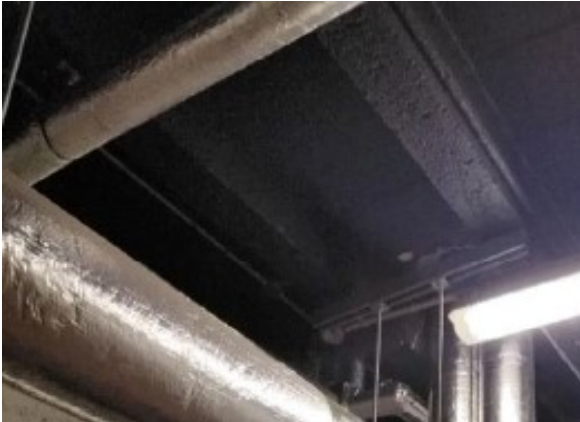
**Item 76 Ref: NO000535**

The debris/residue to the ceiling in the Boiler Room Z/001 does not contain asbestos.

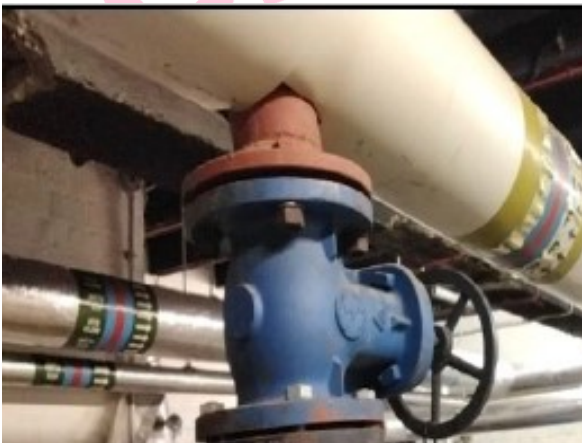
**Item 81 Ref: NO000540**

The pipework gaskets valve over boiler in the Boiler Room Z/001 does not contain asbestos.

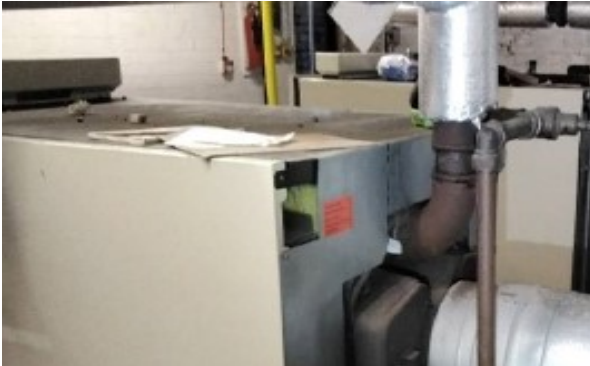
### **Item 85 Ref: NO000544**

The boiler sealant at boiler HW outlet in the Boiler Room Z/001 does not contain asbestos.
