### **ASBESTOS SURVEY REPORT FOR JOHN F KENNEDY PRIMARY SCHOOL, WASHINGTON**

### **JOHN F KENNEDY PRIMARY SCHOOL, WASHINGTON**

**Date: 02 July 2025**

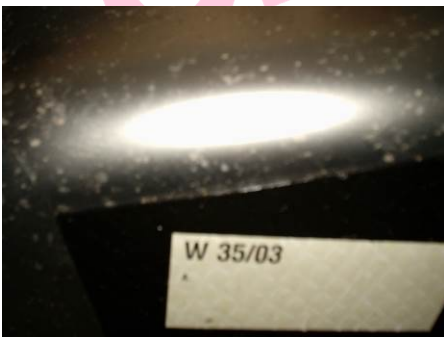
### **Item 3 - Ref: JP0651/07**

The sink pad to the classroom (Room 0/17) does not contain asbestos.

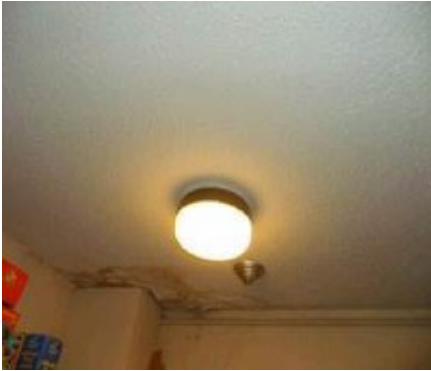
### **Item 25 - As:VP003646**

*The textured coating to the ceiling within the Domestic Service Room contains asbestos.*

*Removed July 2024*

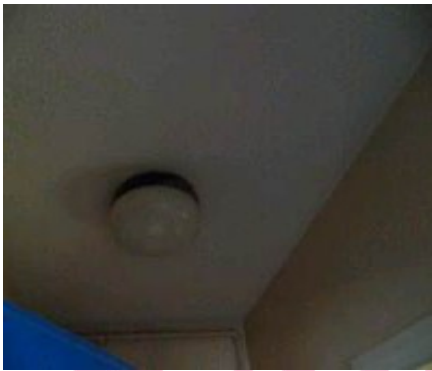
### **Item 26 - As:VP003646**

*The textured coating to the ceiling within the toilets contains asbestos.*

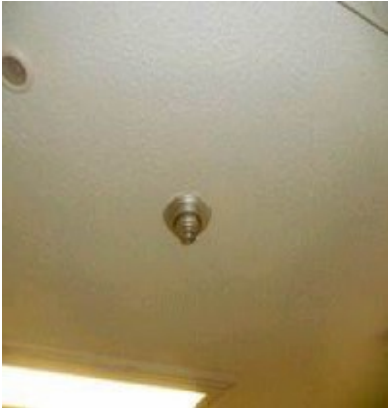
### **Item 28 - As:VP003646**

*The textured coating to the ceiling within the entrance lobby contains asbestos.*

*Removed July 2024*

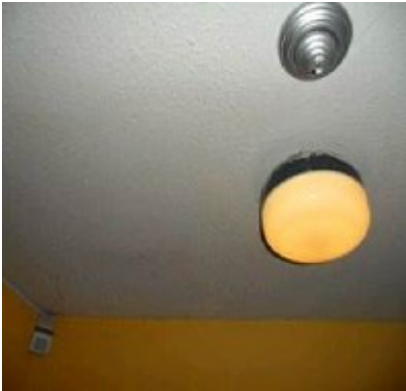
### **Item 29 - As:VP003646**

*The textured coating to the ceiling within the store room contains asbestos.*

*Removed July 2024*

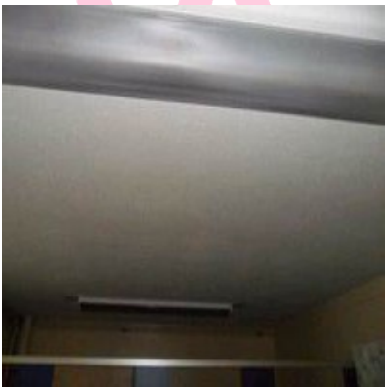
### **Item 30: As VP003646**

*The textured coating to the ceiling within the toilets contains asbestos.*

*Removed July 2024*

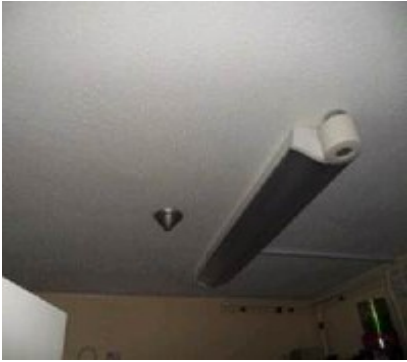
### **Item 31 - As:VP003646**

*The textured coating to the ceiling within the utility contains asbestos.*

*Removed July 2024*

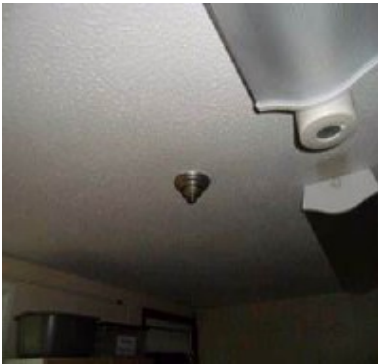
### **Item 32 - As:VP003646**

*The textured coating to the ceiling within the kitchen contains asbestos.*

*Removed July 2024*

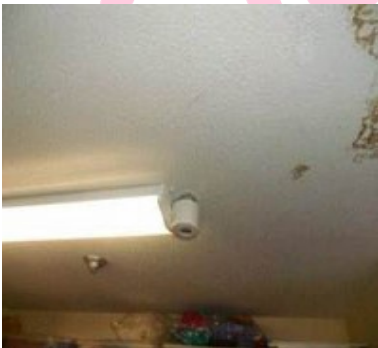
### **Item 33: As VP003646**

*The textured coating to the ceiling within the store contains asbestos.*

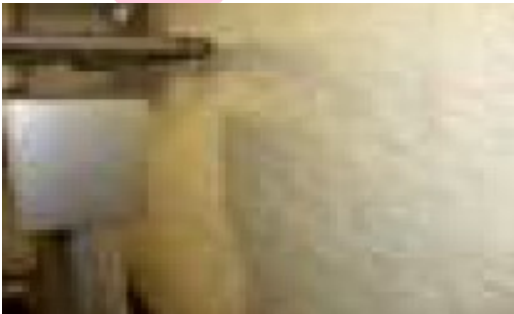
### **Item 51 Ref: BS004217**

The Residue to wall (Boiler Room 1) does not contain asbestos.

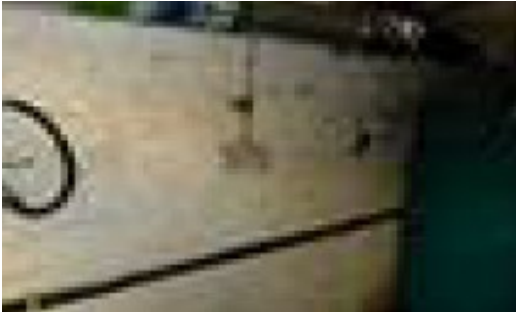
### **Item 58 Ref: BS004224**

The Residue to wall (Boiler Room 2) does not contain asbestos.

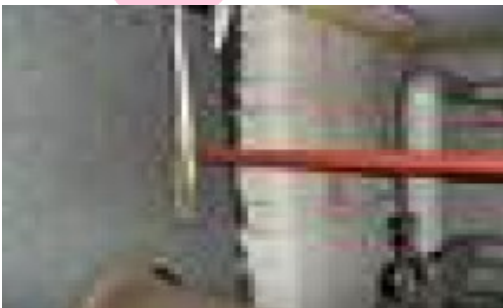
### **Item 63 Ref: BS004229**

The Residue to wall (Boiler  
Room 3) does not contain  
asbestos.

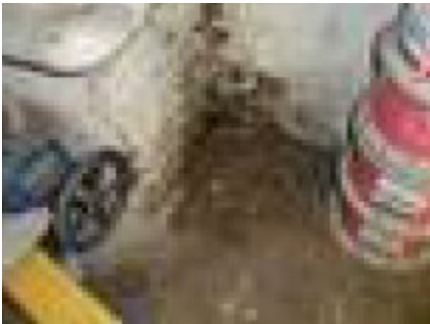
### **Item 68 Ref: BS004235**

The Debris to floor (Boiler Room 3) does not contain asbestos.

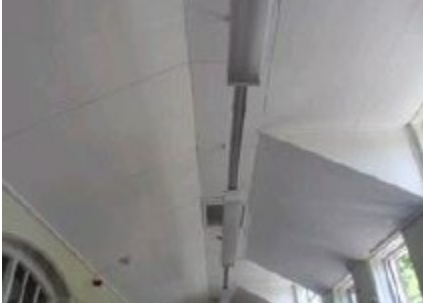
### **Item 77 Ref: As VP003636**

The Fibreboard ceiling panel (Year 1 Corridor) does not contain asbestos.

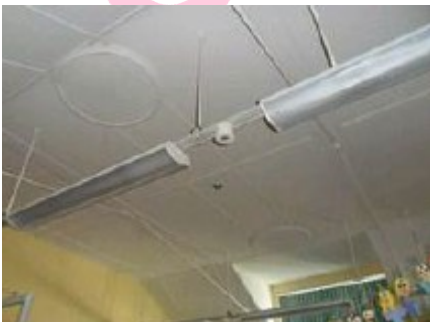
### **Item 78 Ref: As VP003636**

The Fibreboard ceiling panel (Teaching Area 1B) does not contain asbestos.

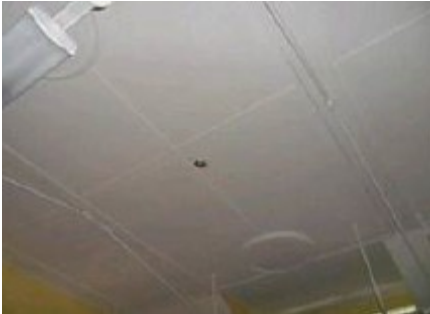
### **Item 79 Ref: As VP003636**

The Fibreboard ceiling panel (Teaching Area 1A) does not contain asbestos.

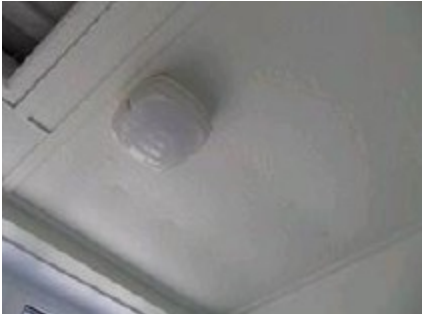
### **Item 82 Ref: As VP003636**

The Fibreboard ceiling panel (Staff Toilet) does not contain asbestos.

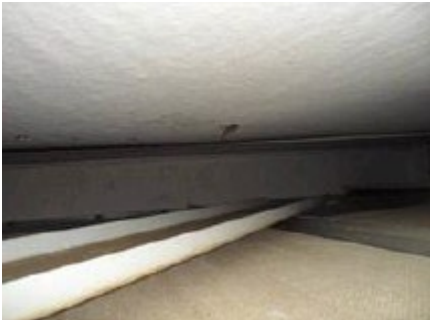
### **Item 83 Ref: As VP003636**

The Fibreboard ceiling panel (Caretakes Room) does not contain asbestos.

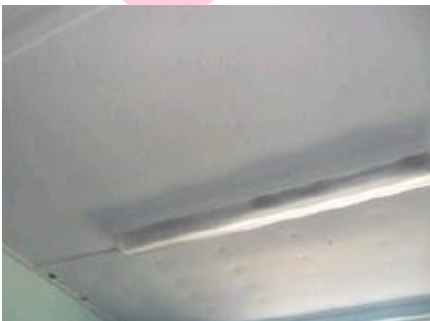
### **Item 84 Ref: As VP003636**

The Fibreboard ceiling panel (Girls Toilet) does not contain asbestos.

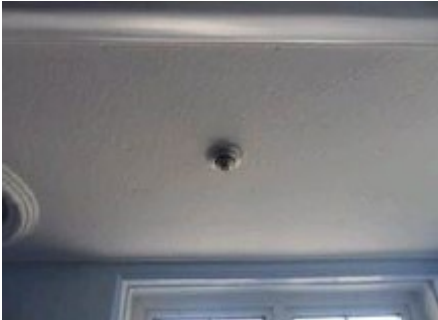
### **Item 85 Ref: As VP003636**

The Fibreboard ceiling panel (Boys Toilet) does not contain asbestos.

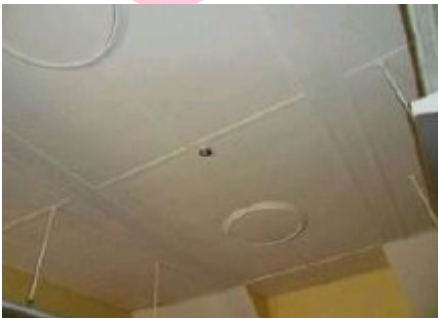
### **Item 87 Ref: As VP003636**

The Fibreboard ceiling panel (Library L1) does not contain asbestos.

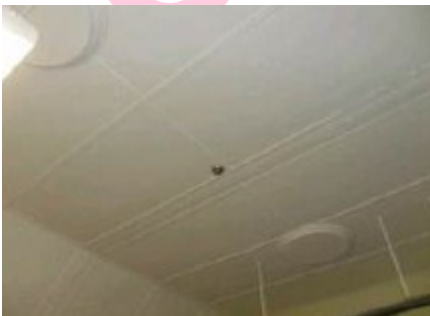
### **Item 90 Ref: As VP003637**

The Fibreboard Ceiling Panels (Library L1) does not contain asbestos.

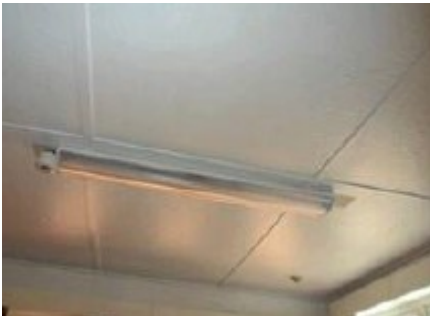
### **Item 92 Ref: As VP003637**

The Fibreboard Ceiling Panels (Store) does not contain asbestos.

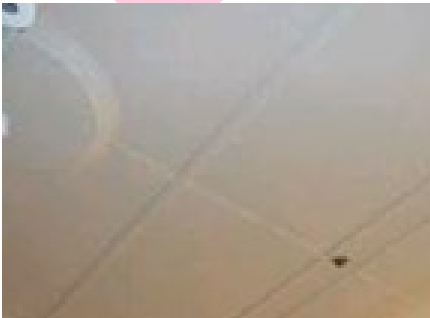
### **Item 93 Ref: As VP003637**

The Fibreboard Ceiling Panels (Teaching Area 3) does not contain asbestos.

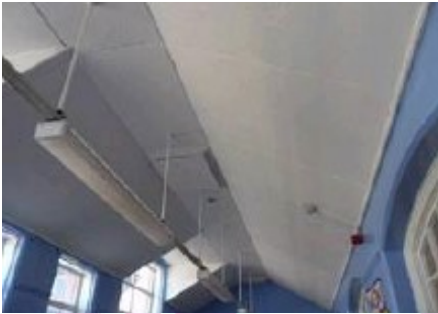
### **Item 95 Ref: As VP003637**

The Fibreboard Ceiling Panels (Year 4 Corridor) does not contain asbestos.

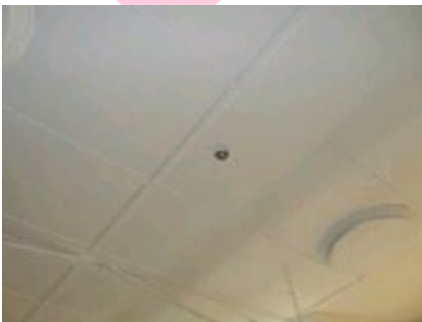
### **Item 96 Ref: As VP003637**

The Fibreboard Ceiling Panels (Teaching Area 4A) does not contain asbestos.

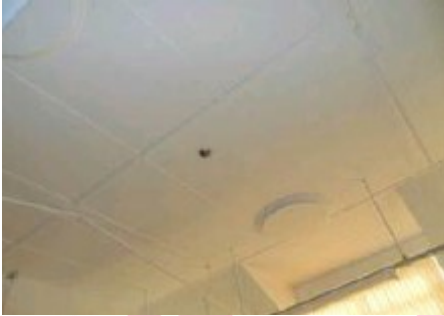
### **Item 98 Ref: As VP003637**

The Fibreboard Ceiling Panels (Art Studio) does not contain asbestos.

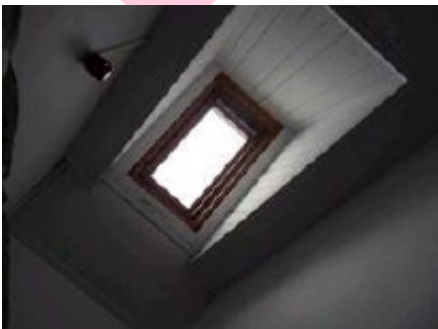
### **Item 99 Ref: As VP003637**

The Fibreboard Ceiling Panels (Year 5 Corridor) does not contain asbestos.

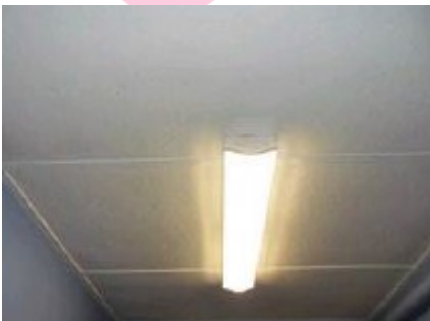
### **Item 102 Ref: As VP003637**

The Fibreboard Ceiling Panels (Circulation) does not contain asbestos.

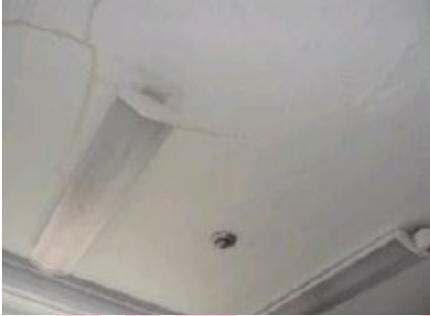
### **Item 104 Ref: As VP003644**

The Textured coating to ceiling (Girls Toilet) does not contain asbestos.

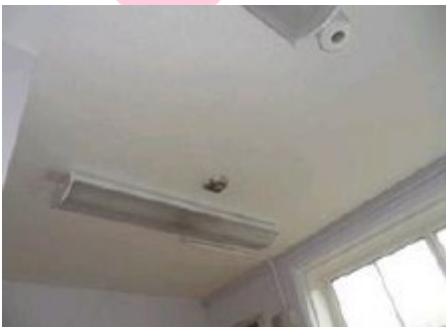
### **Item 105 Ref: As VP003644**

The Textured coating to ceiling (Boys Toilet) does not contain asbestos.

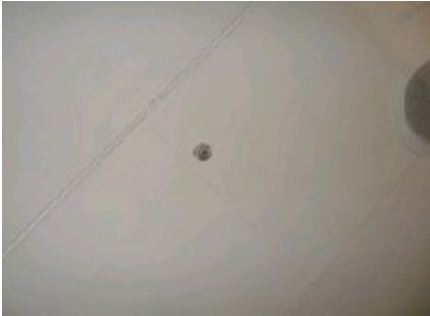
### **Item 106 Ref: VP003645**

The Fibreboard ceiling panels (Teaching Area 6C) does not contain asbestos.

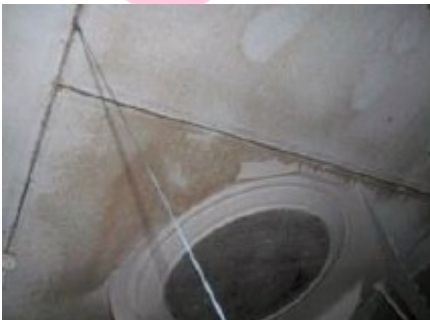
### **Item 108 Ref: As VP003645**

The Fibreboard ceiling panels (Teaching Area 6A) does not contain asbestos.

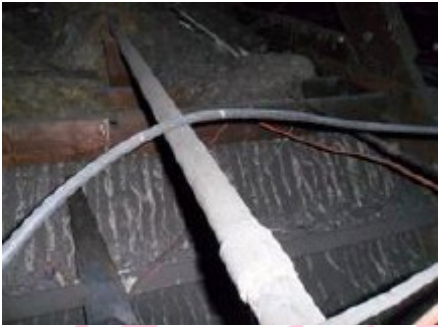
### **Item 110 Ref: VP003657**

The Residue to pipework (Loft 1) does not contain asbestos.

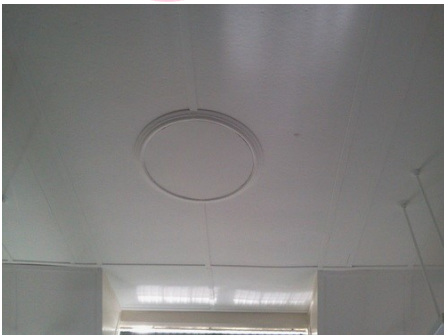
### **Item 111 Ref: 47656-15**

The Ceiling (Classroom/003) does not contain asbestos.

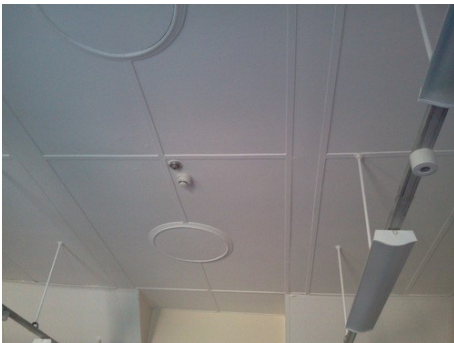
### **Item 116 Ref: As 47656-17**

The Ceiling (Classroom/009)  
does not contain asbestos.

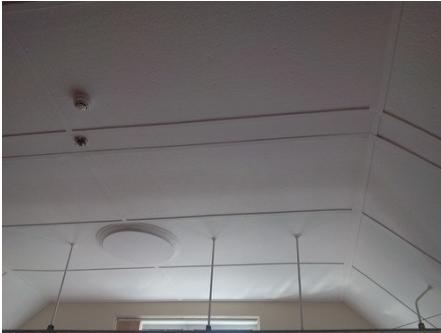
### **Item 121 Ref: As 47656-19**

The Ceiling (Classroom/021)  
does not contain asbestos.

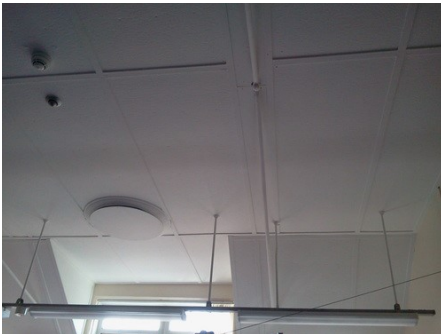
### **Item 122 Ref: As 47656-19**

The Ceiling (Classroom/022)  
does not contain asbestos.

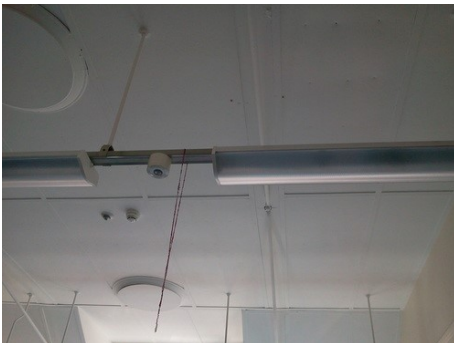
### **Item 123 Ref: 47656-20**

The Ceiling (Classroom/023)  
does not contain asbestos.

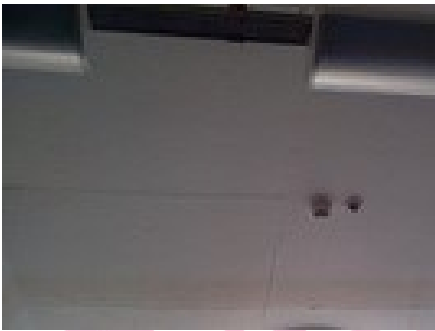
### **Item 125 Ref: 47656-21**

The Ceiling (Classroom/026)  
does not contain asbestos.

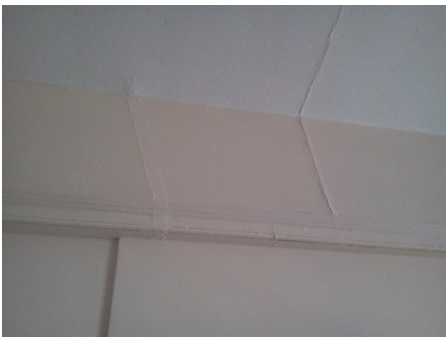
### **Item 129 Ref: As 47656-9**

The High level panels (Classroom/033) does not contain asbestos.

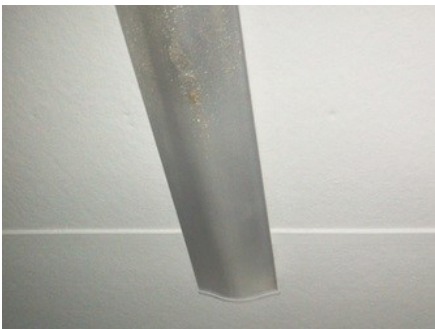
### **Item 132 Ref: 47656-12**

The Ceiling (Corridor/036) does not contain asbestos.

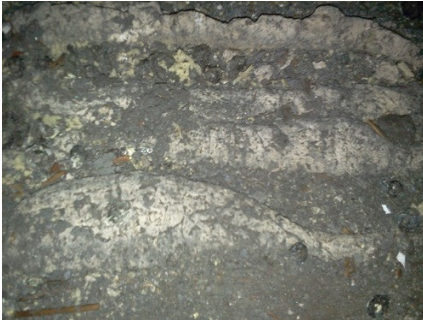
### **Item 136 Ref: 47656-4**

The Debris to ceiling below year 5 (Loft Space/ 1/002) does not contain asbestos.

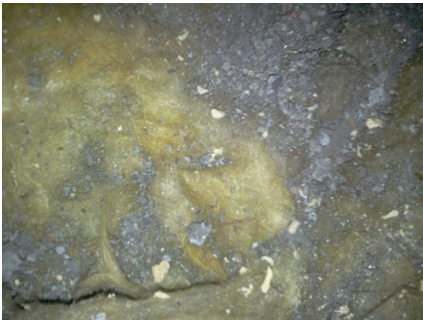
### **Item 137 Ref: 47656-5**

The Debris to ceiling below year 4 (Loft Space/ 1/002) does not contain asbestos.
