### ASBESTOS SURVEY REPORT FOR JOHN F KENNEDY PRIMARY SCHOOL, WASHINGTON

*Control of Asbestos  
Regulations 2012*

### JOHN F KENNEDY PRIMARY SCHOOL, WASHINGTON

**Date: 03 March 2026**

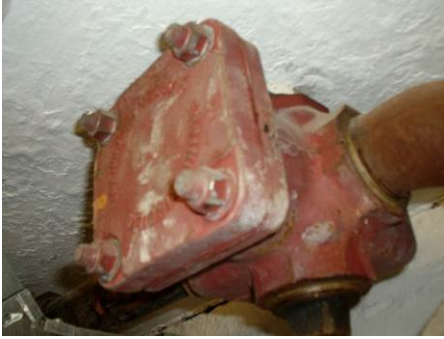
### **Item 1 Ref: JP0672/07**

The gasket to the pipe joints in the boiler room (Room B1/1) does not contain asbestos.

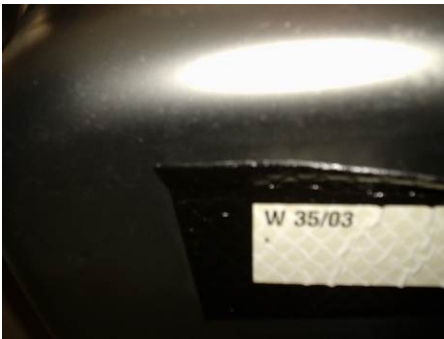
### **Item 2 - Ref: JP0650/07**

The sink pad from the classroom (Room 0/16) does not contain asbestos.

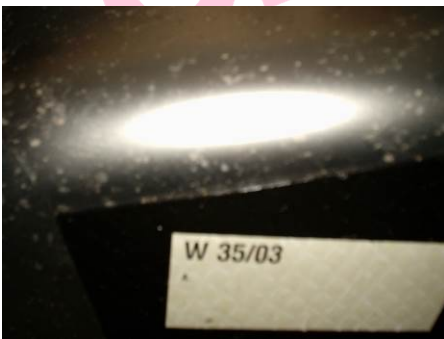
### **Item 3 - Ref: JP0651/07**

The sink pad to the classroom (Room 0/17) does not contain asbestos.

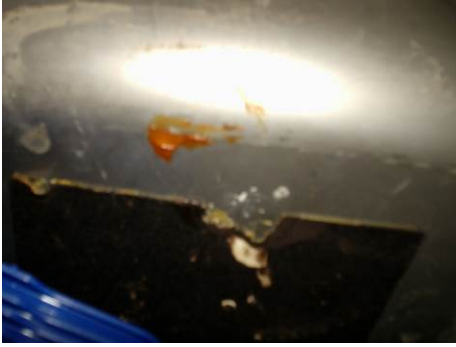
**Item 10 - Ref: JP0658/07**

The sink pad to the classroom (Room 0/54) does not contain asbestos.

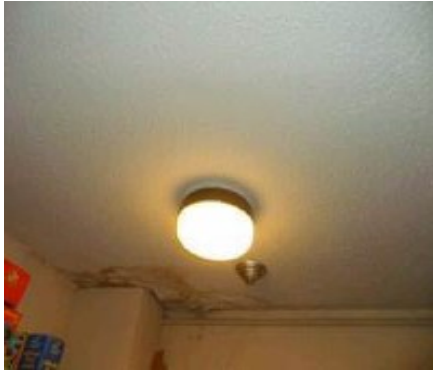
**Item 25 - As:VP003646**

*The textured coating to the ceiling within the Domestic Service Room contains asbestos.*

*Removed July 2024*

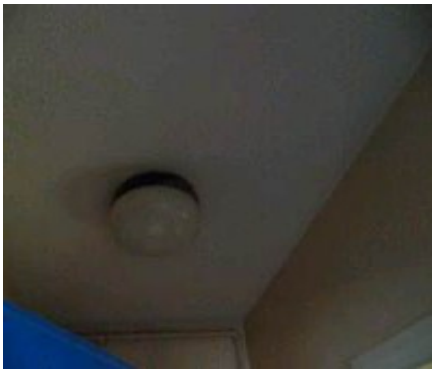
**Item 26 - As:VP003646**

*The textured coating to the ceiling within the toilets contains asbestos.*

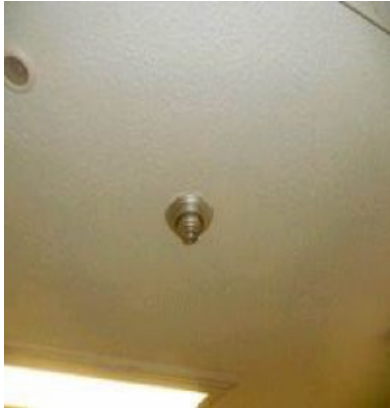
**Item 28 - As:VP003646**

*The textured coating to the ceiling within the entrance lobby contains asbestos.*

*Removed July 2024*

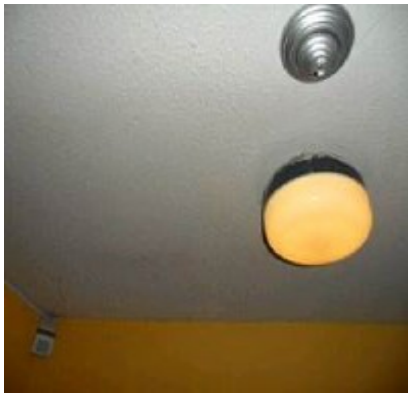
**Item 29 - As:VP003646**

*The textured coating to the ceiling within the store room contains asbestos.*

*Removed July 2024*

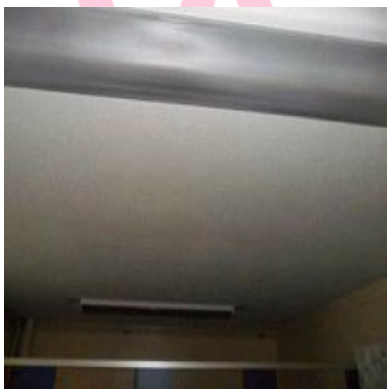
**Item 30: As VP003646**

*The textured coating to the ceiling within the toilets contains asbestos.*

*Removed July 2024*

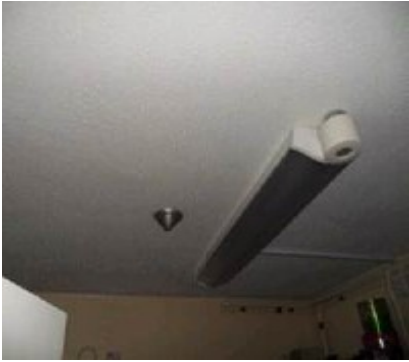
**Item 31 - As:VP003646**

*The textured coating to the ceiling within the utility contains asbestos.*

*Removed July 2024*

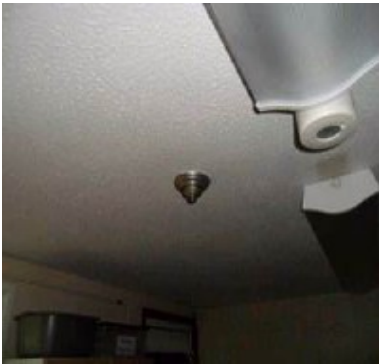
**Item 32 - As:VP003646**

*The textured coating to the ceiling within the kitchen contains asbestos.*

*Removed July 2024*

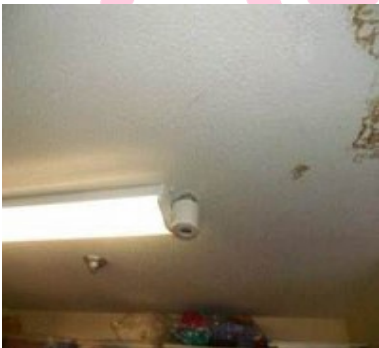
**Item 33: As VP003646**

*The textured coating to the ceiling within the store contains asbestos.*

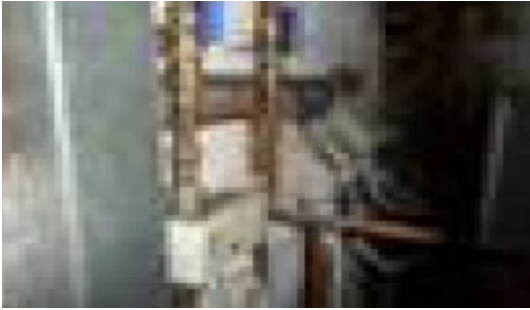
**Item 49 Ref: BS004215**

The Residue to wall (Boiler Room 1) does not contain asbestos.

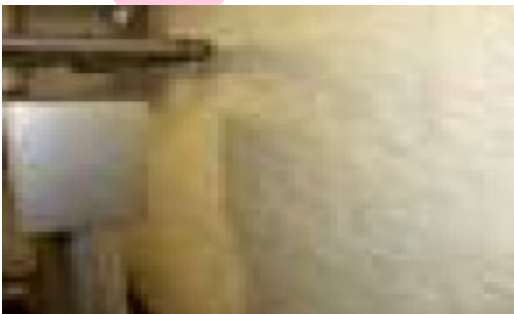
**Item 51 Ref: BS004217**

The Residue to wall (Boiler Room 1) does not contain asbestos.

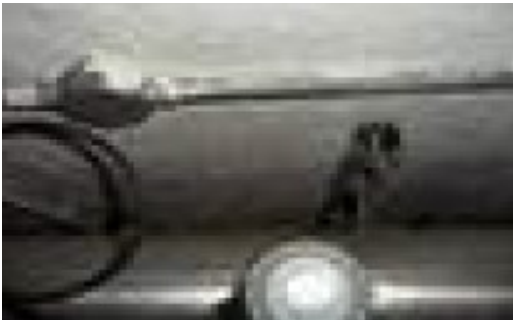
**Item 53 Ref: BS004219**

The Residue to Ceiling (Boiler Room 1) does not contain asbestos.

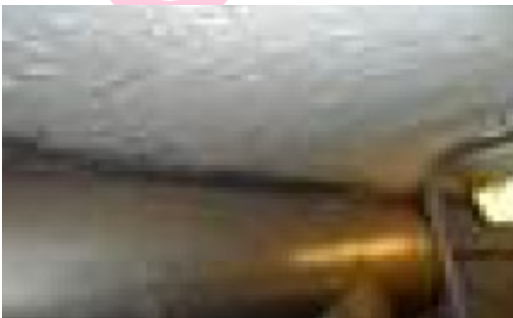
**Item 54 Ref: BS004220**

The Residue to Ceiling (Boiler Room 1) does not contain asbestos.

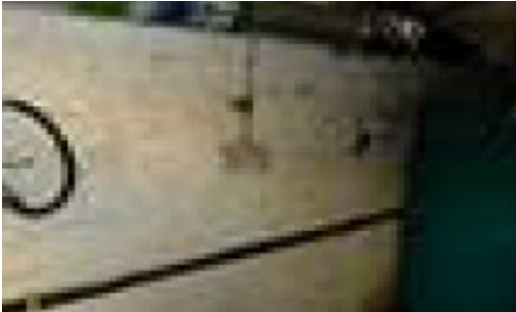
**Item 58 Ref: BS004224**

The Residue to wall (Boiler Room 2) does not contain asbestos.

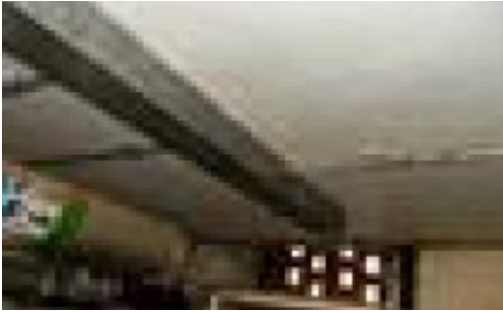
**Item 61 Ref: BS004227**

The Residue to ceiling (Boiler Room 2) does not contain asbestos.

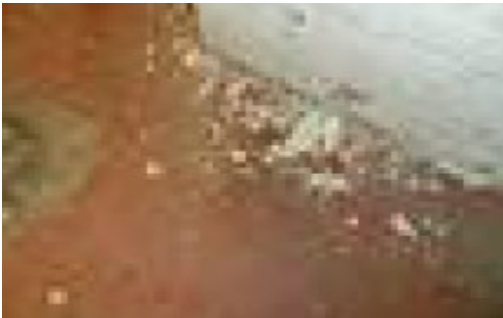
**Item 62 Ref: BS004228**

The Debris to floor (Boiler Room 2) does not contain asbestos.

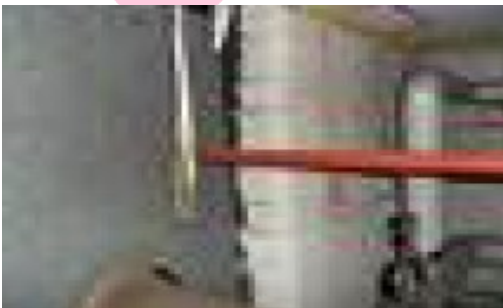
**Item 63 Ref: BS004229**

The Residue to wall (Boiler Room 3) does not contain asbestos.

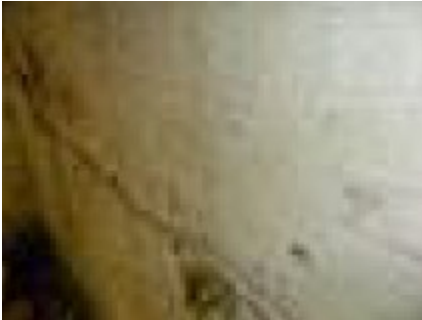
**Item 64 Ref: BS004230**

The Residue to wall (Boiler Room 3) does not contain asbestos.

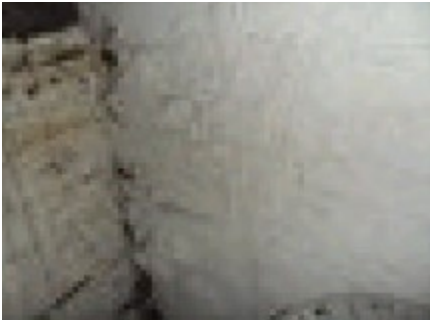
**Item 65 Ref: BS004231**

The Residue to wall (Boiler Room 3) contains asbestos.

Any change in its appearance should be recorded and passed to Property Services.

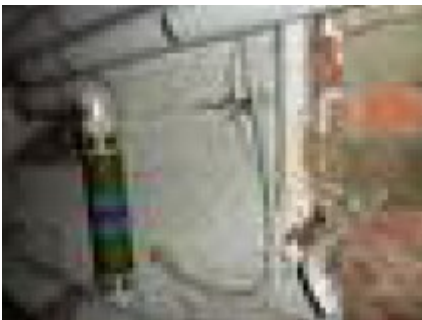
**Item 66 Ref: BS004232**

The Residue to wall (Boiler Room 3) does not contain asbestos.

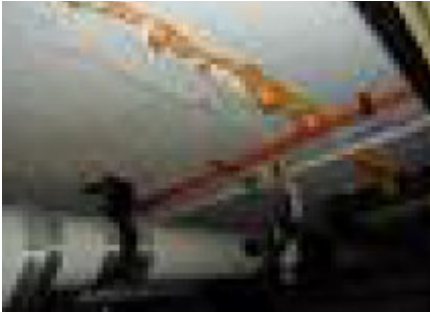
**Item 67 Ref: BS004234**

The Residue to ceiling (Boiler Room 3) contains asbestos.

Any change in its appearance should be recorded and passed to Property Services.

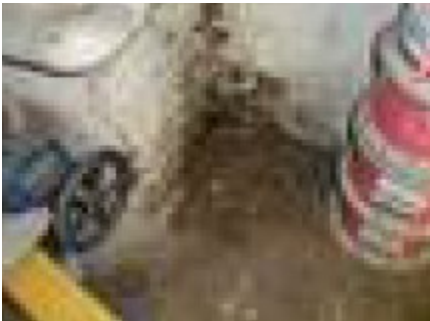
**Item 68 Ref: BS004235**

The Debris to floor (Boiler Room 3) does not contain asbestos.

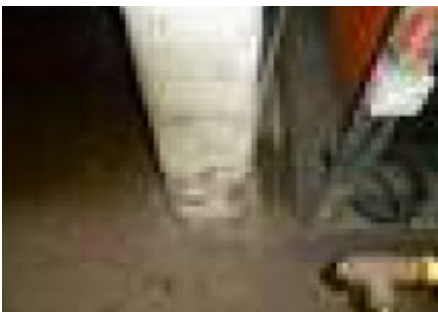
**Item 69 Ref: BS004236**

The Debris to floor (Boiler Room 3) does not contain asbestos.

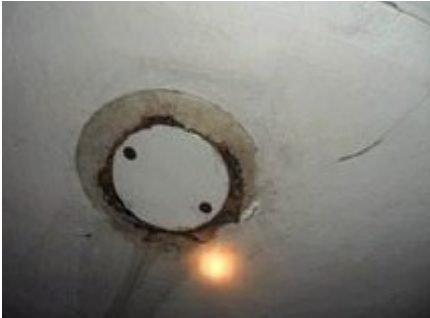
**Item 70 Ref: VP003636**

The Ceiling panels above s-ceiling (Corridor) do not contain asbestos.

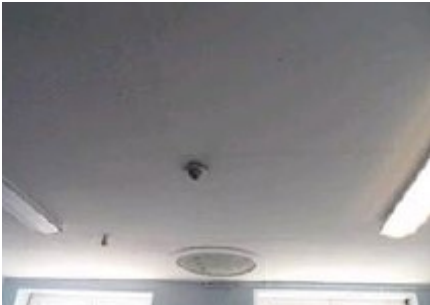
**Item 71 Ref: As VP003636**

The Fibreboard ceiling panel (Boys Toilet) does not contain asbestos.

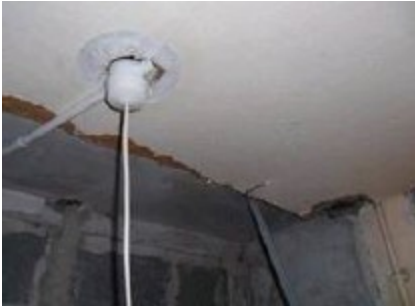
**Item 73 Ref: As VP003636**

The Fibreboard ceiling panel (Staff Toilet) does not contain asbestos.

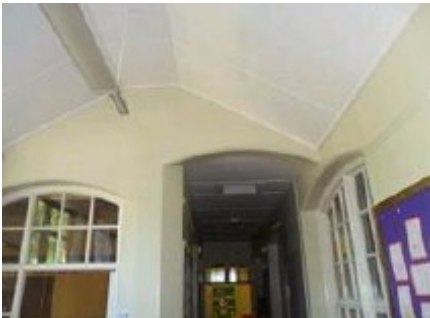
**Item 74 Ref: As VP003636**

The Fibreboard ceiling panel (Year 2 Corridor) does not contain asbestos.

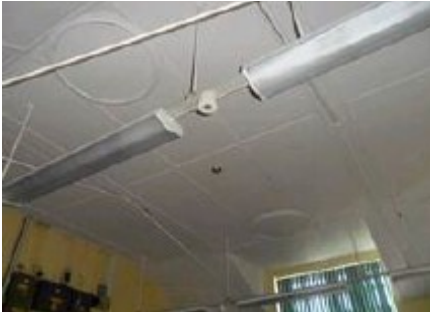
**Item 76 Ref: As VP003636**

The Fibreboard ceiling panel (Teaching Area 2A) does not contain asbestos.

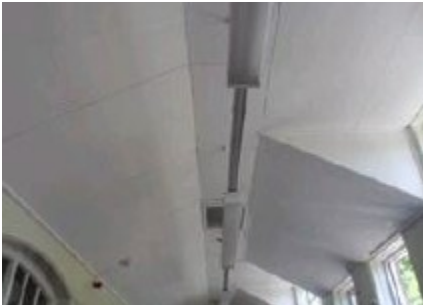
**Item 78 Ref: As VP003636**

The Fibreboard ceiling panel (Teaching Area 1B) does not contain asbestos.

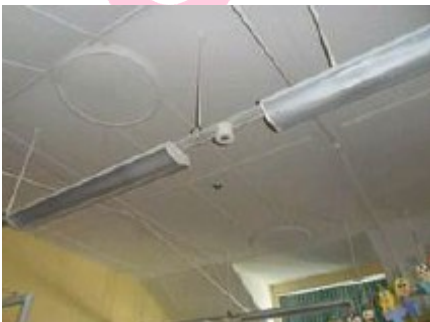
**Item 79 Ref: As VP003636**

The Fibreboard ceiling panel (Teaching Area 1A) does not contain asbestos.

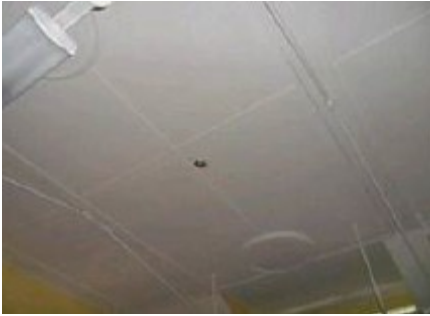
**Item 80 Ref: As VP003636**

The Fibreboard ceiling panel (Reception Corridor) does not contain asbestos.

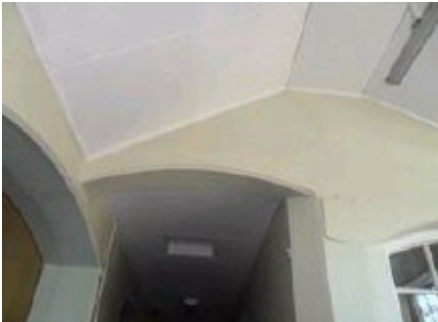
**Item 81 Ref: As VP003636**

The Fibreboard ceiling panel (Lobby) does not contain asbestos.

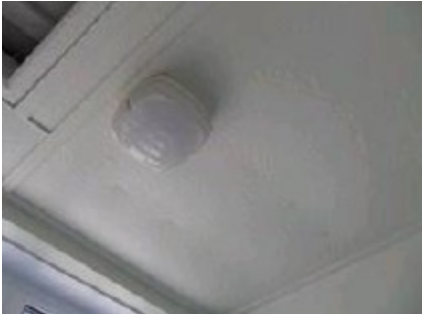
**Item 83 Ref: As VP003636**

The Fibreboard ceiling panel (Caretaker's Room) does not contain asbestos.

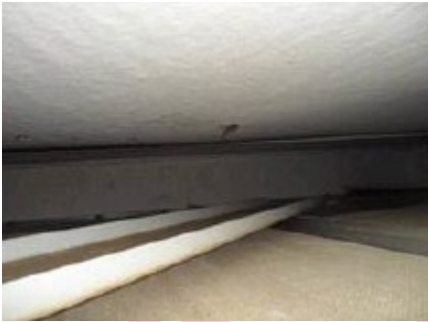
**Item 84 Ref: As VP003636**

The Fibreboard ceiling panel (Girls Toilet) does not contain asbestos.

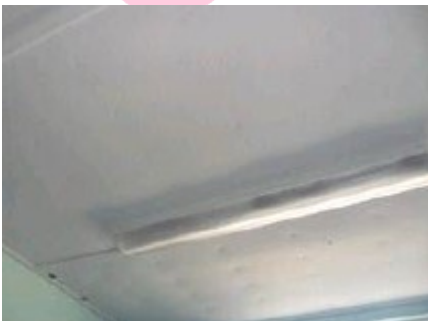
**Item 85 Ref: As VP003636**

The Fibreboard ceiling panel (Boys Toilet) does not contain asbestos.

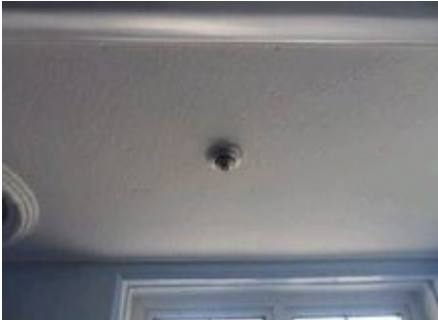
**Item 86 Ref: As VP003636**

The Fibreboard ceiling panel (Reception Class R3) does not contain asbestos.

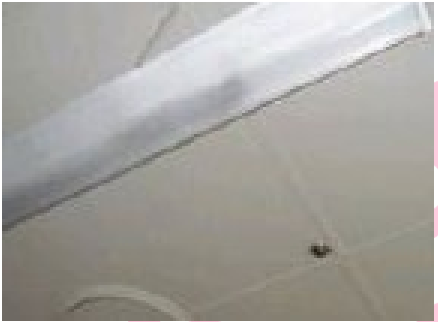
**Item 87 Ref: As VP003636**

The Fibreboard ceiling panel (Library L1) does not contain asbestos.

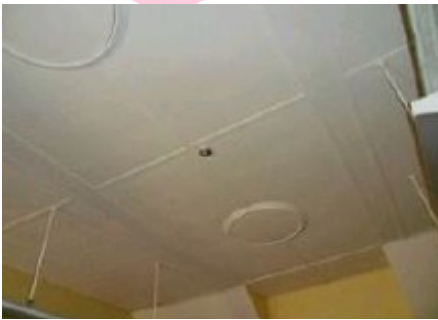
**Item 88 Ref: As VP003636**

The Fibreboard ceiling panel (Circulation) does not contain asbestos.

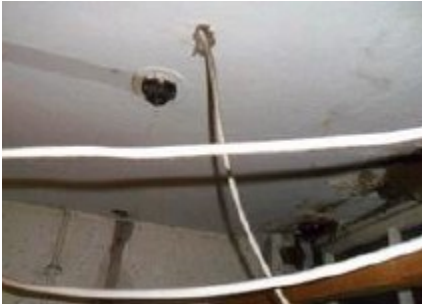
**Item 89 Ref: VP003637**

The Fibreboard Ceiling Panels (Year 3 Corridor) does not contain asbestos.

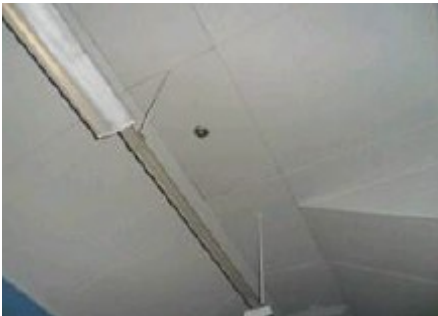
**Item 90 Ref: As VP003637**

The Fibreboard Ceiling Panels (Library L1) does not contain asbestos.

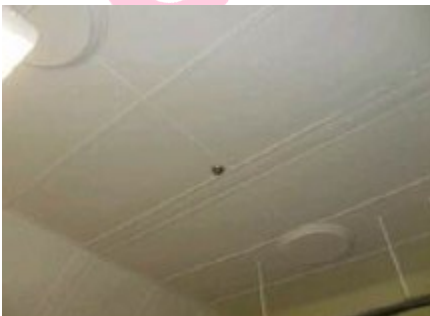
**Item 91 Ref: As VP003637**

The Fibreboard Ceiling Panels (Circulation) does not contain asbestos.

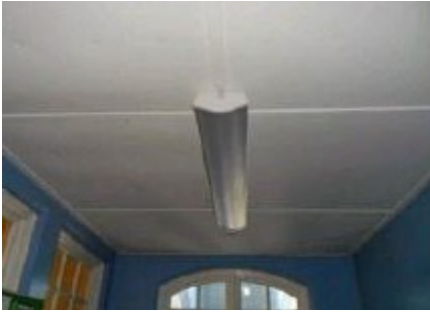
**Item 92 Ref: As VP003637**

The Fibreboard Ceiling Panels (Store) does not contain asbestos.

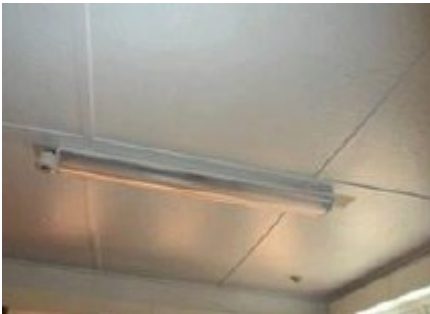
**Item 93 Ref: As VP003637**

The Fibreboard Ceiling Panels (Teaching Area 3) does not contain asbestos.

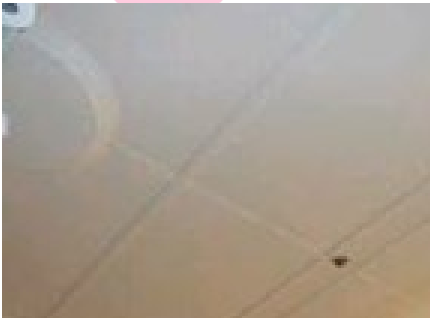
**Item 94 Ref: As VP003637**

The Fibreboard Ceiling Panels (Teaching Area 3B) does not contain asbestos.

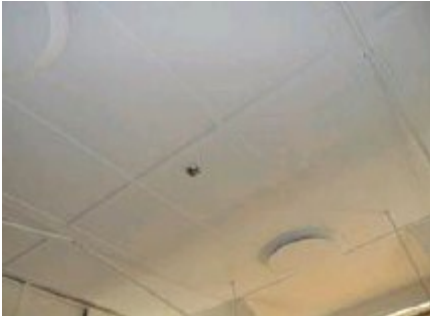
**Item 95 Ref: As VP003637**

The Fibreboard Ceiling Panels (Year 4 Corridor) does not contain asbestos.

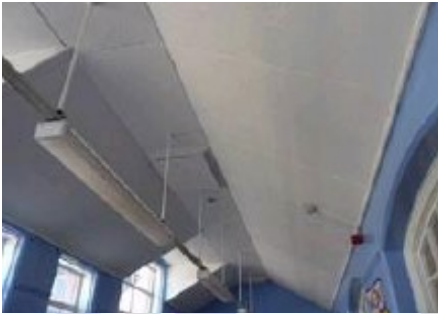
**Item 96 Ref: As VP003637**

The Fibreboard Ceiling Panels (Teaching Area 4A) does not contain asbestos.

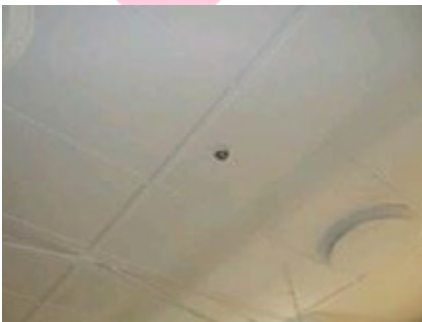
**Item 97 Ref: As VP003637**

The Fibreboard Ceiling Panels (Art Corridor) does not contain asbestos.

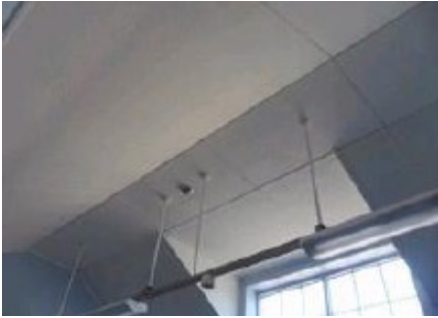
**Item 98 Ref: As VP003637**

The Fibreboard Ceiling Panels (Art Studio) does not contain asbestos.

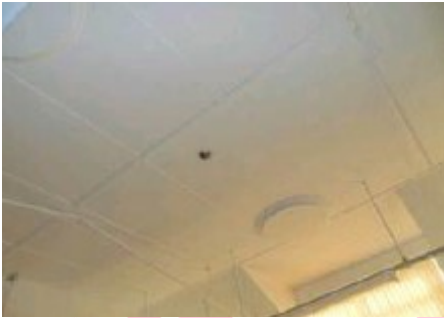
**Item 99 Ref: As VP003637**

The Fibreboard Ceiling Panels (Year 5 Corridor) does not contain asbestos.

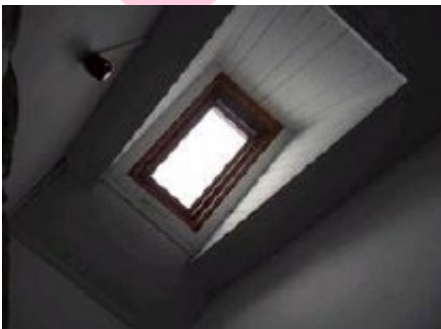
**Item 100 Ref: As VP003637**

The Fibreboard Ceiling Panels (Teaching Area 5A) does not contain asbestos.

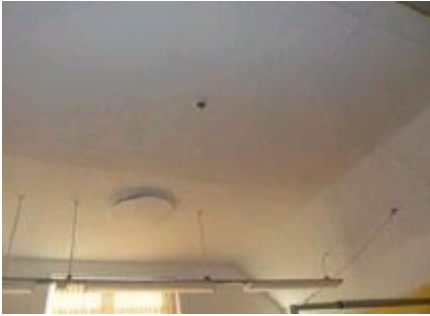
**Item 101 Ref: As VP003637**

The Fibreboard Ceiling Panels (Teaching Area 5B) does not contain asbestos.

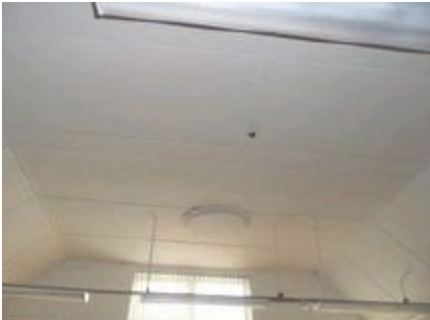
**Item 102 Ref: As VP003637**

The Fibreboard Ceiling Panels (Circulation) does not contain asbestos.

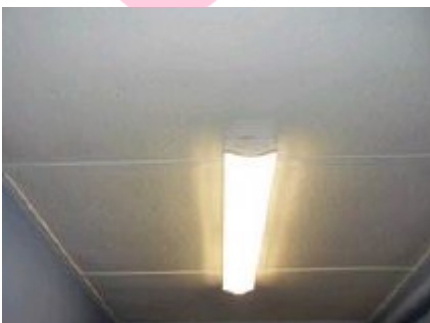
**Item 103 Ref: VP003644**

The Textured coating to ceiling (Circulation) does not contain asbestos.

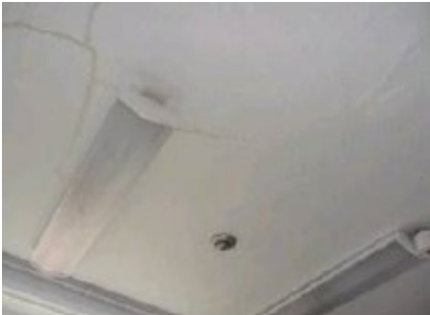
**Item 105 Ref: As VP003644**

The Textured coating to ceiling (Boys Toilet) does not contain asbestos.

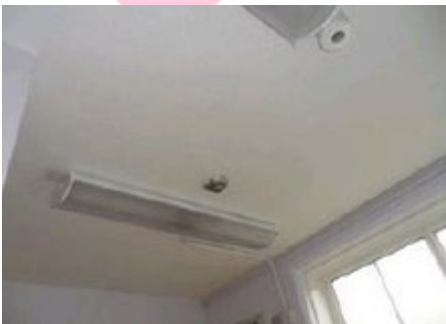
**Item 106 Ref: VP003645**

The Fibreboard ceiling panels (Teaching Area 6C) does not contain asbestos.

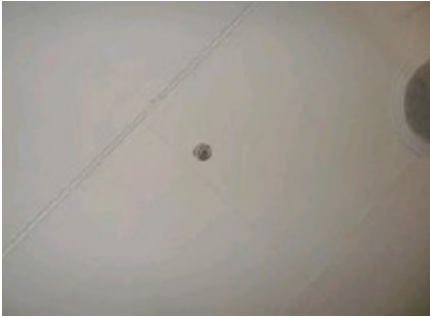
**Item 107 Ref: As VP003645**

The Fibreboard ceiling panels (Parents Room) does not contain asbestos.

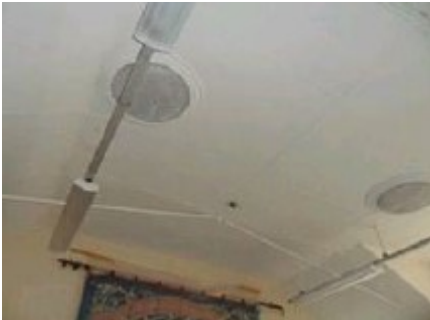
**Item 108 Ref: As VP003645**

The Fibreboard ceiling panels (Teaching Area 6A) does not contain asbestos.

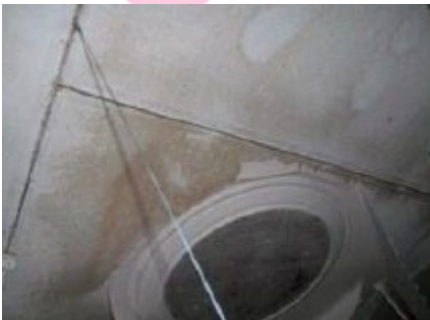
**Item 109 Ref: As VP003645**

The Fibreboard ceiling panels (Store) does not contain asbestos.

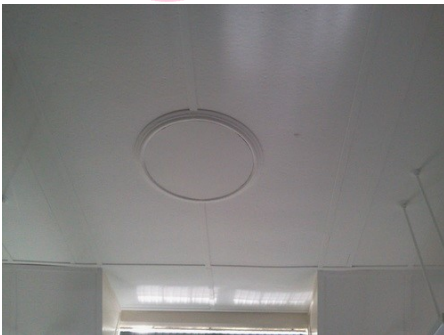
**Item 112 Ref: 47656-16**

The Ceiling (Classroom/005)  
does not contain asbestos.

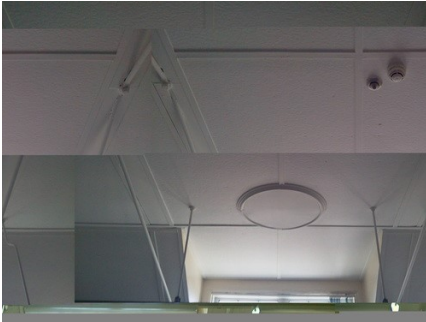
**Item 113 Ref: As 47656-16**

The Ceiling (Classroom/006)  
does not contain asbestos.

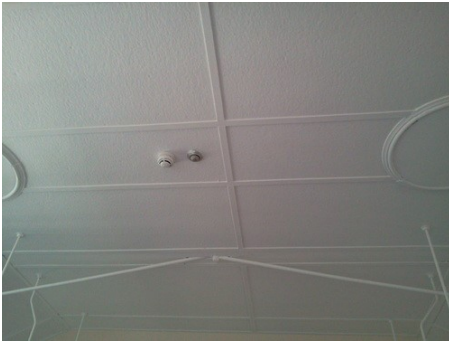
**Item 114 Ref: 47656-15**

The Ceiling (Classroom/007)  
does not contain asbestos.

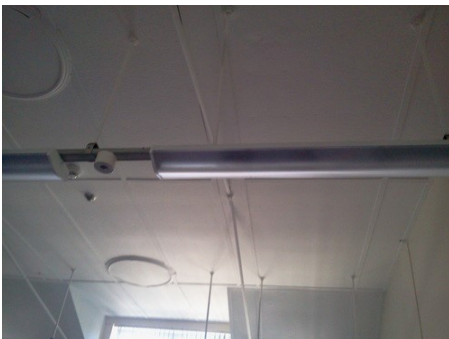
**Item 115 Ref: 47656-17**

The Ceiling (Classroom/008)  
does not contain asbestos.

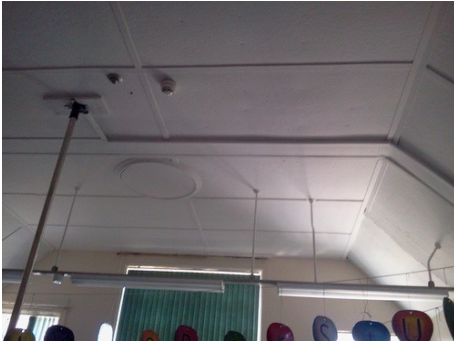
**Item 116 Ref: As 47656-17**

The Ceiling (Classroom/009)  
does not contain asbestos.

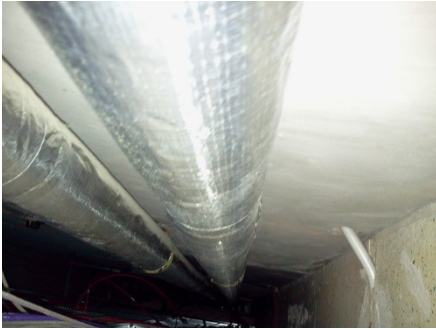
**Item 118 Ref: As 47656-13**

The Fixed ceiling (Corridor void above/012) does not contain asbestos.

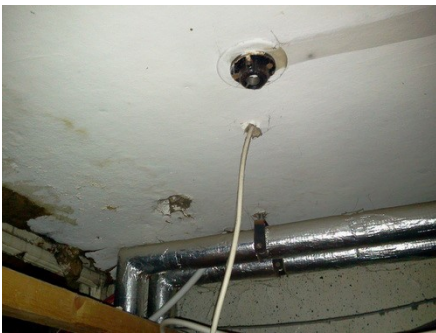
**Item 119 Ref: 47656-13**

The Fixed ceiling (Corridor void above/013) does not contain asbestos.

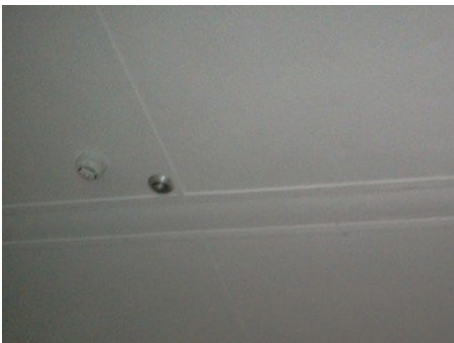
**Item 120 Ref: 47656-19**

The Ceiling (Classroom/019) does not contain asbestos.

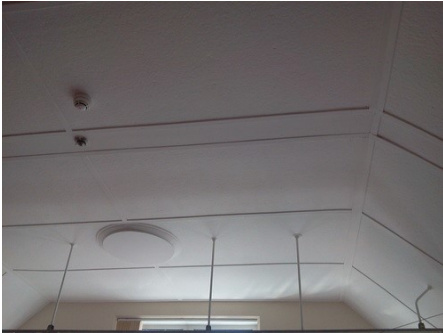
**Item 121 Ref: As 47656-19**

The Ceiling (Classroom/021)  
does not contain asbestos.

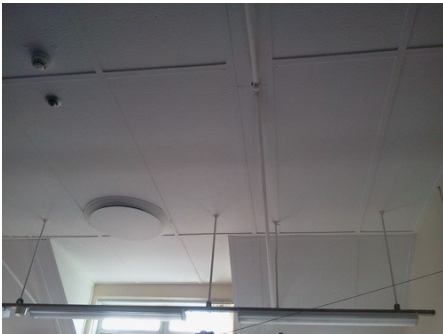
**Item 122 Ref: As 47656-19**

The Ceiling (Classroom/022)  
does not contain asbestos.

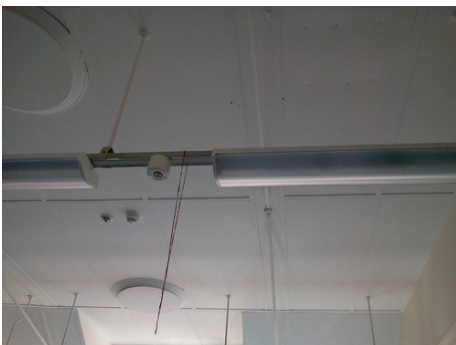
**Item 123 Ref: 47656-20**

The Ceiling (Classroom/023)  
does not contain asbestos.

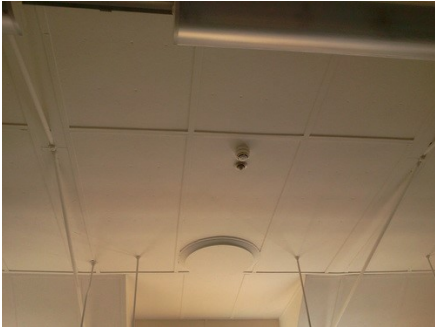
**Item 124 Ref: As 47656-20**

The Ceiling (Classroom/025)  
does not contain asbestos.

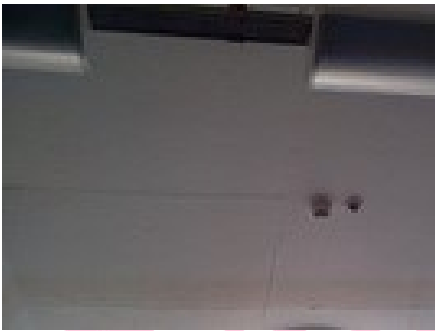
**Item 125 Ref: 47656-21**

The Ceiling (Classroom/026)  
does not contain asbestos.

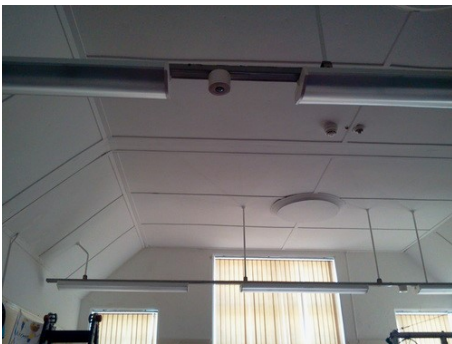
**Item 126 Ref: As 47656-20**

The Ceiling (Classroom/028)  
does not contain asbestos.

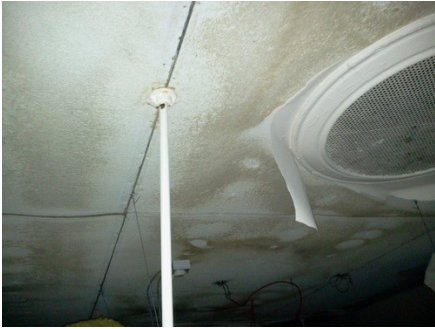
**Item 127 Ref: 47656-22**

The Ceiling (Classroom/032 void above) does not contain asbestos.

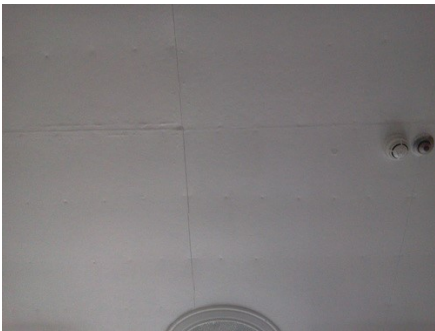
**Item 128 Ref: As 47656-9**

The Ceiling (Classroom/033) does not contain asbestos.

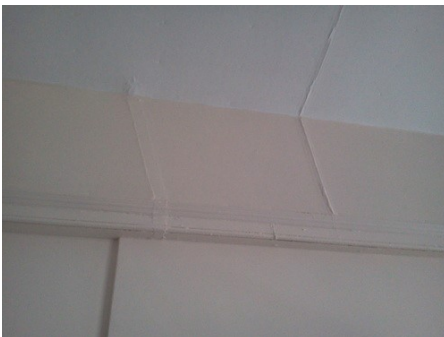
**Item 129 Ref: As 47656-9**

The High level panels (Classroom/033) does not contain asbestos.

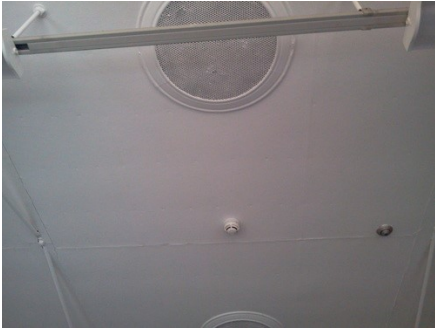
**Item 130 Ref: 47656-9**

The Ceiling (Community Room/034) does not contain asbestos.

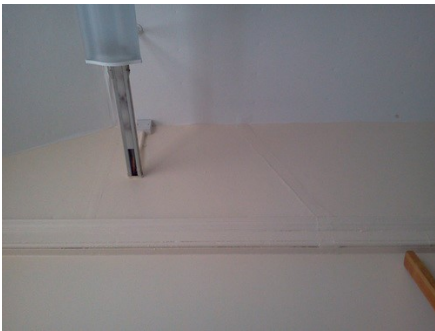
**Item 131 Ref: As 47656-9**

The High level panels (Community Room/034) does not contain asbestos.

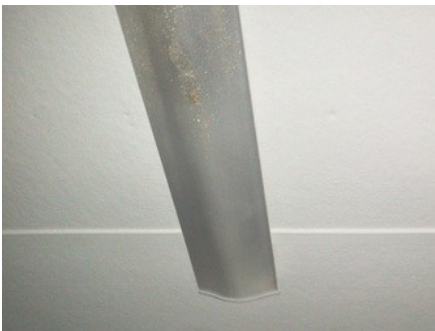
**Item 132 Ref: 47656-12**

The Ceiling (Corridor/036) does not contain asbestos.

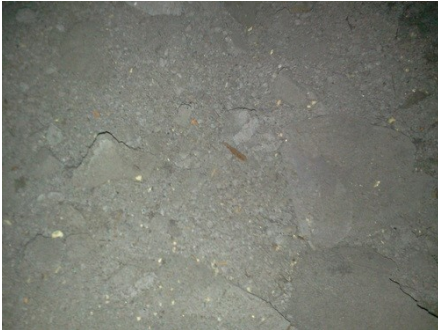
**Item 133 Ref: 47656-1**

The Debris to ceiling below reception (Loft Space/ 1/001) does not contain asbestos.

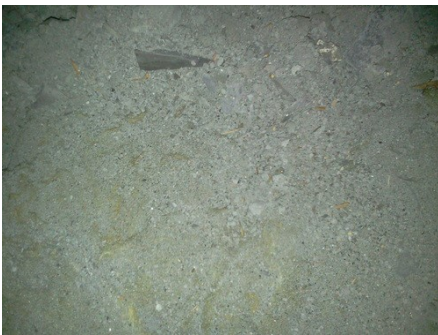
**Item 134 Ref: 47656-2**

The Debris to ceiling below year 1 (Loft Space/ 1/001) does not contain asbestos.

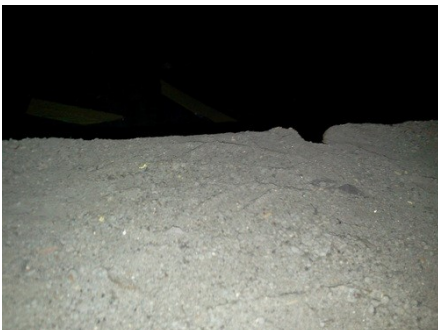
**Item 135 Ref: 47656-3**

The Debris to ceiling below year 2 (Loft Space/ 1/001) does not contain asbestos.

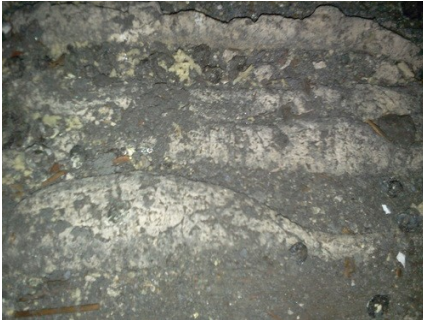
**Item 136 Ref: 47656-4**

The Debris to ceiling below year 5 (Loft Space/ 1/002) does not contain asbestos.

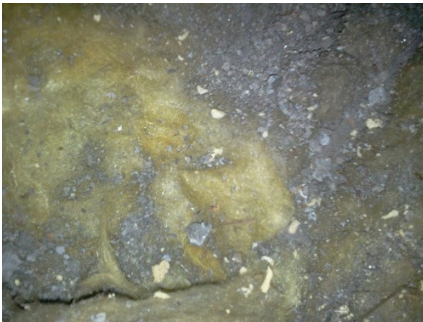
**Item 137 Ref: 47656-5**

The Debris to ceiling below year 4 (Loft Space/ 1/002) does not contain asbestos.

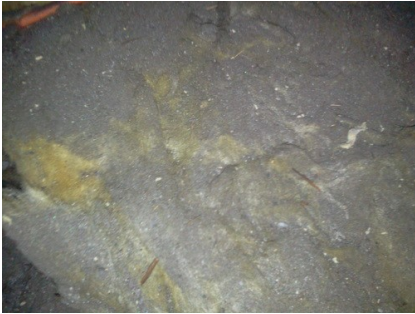
**Item 139 Ref: 47656-7**

The Debris to ceiling below equipment store (Loft Space/ 1/003) does not contain asbestos.

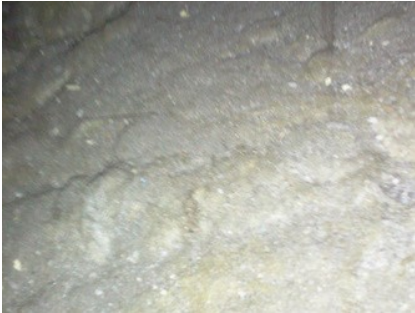
**Item 140 Ref: 47656-8**

The Debris to ceiling below community room (Loft Space/ 1/003) does not contain asbestos.

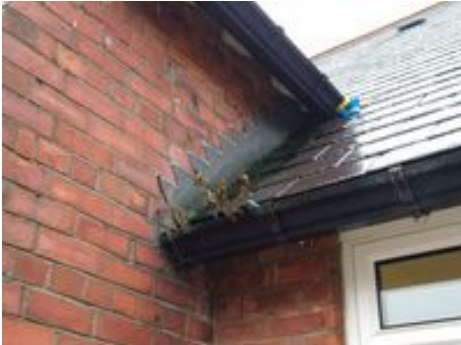
**Item 142 Ref: 451175-1**

The flashing to roof (External main building slated roofs) does not contain asbestos.

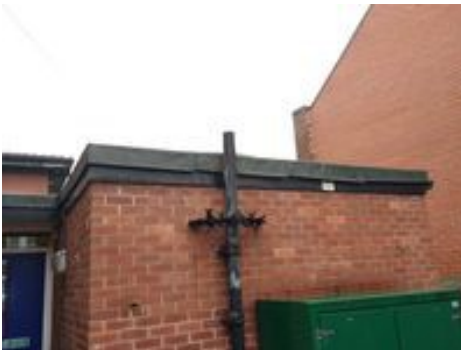
**Item 143 Ref: 451175-3**

The roof covering (External Roof 5) does not contain asbestos.
