ASBESTOS SURVEY REPORT FOR ST ANNES RC PRIMARY, SUNDERLAND

Asbestos Register for ST ANNES RC PRIMARY, SUNDERLAND

Date: 04 March 2026

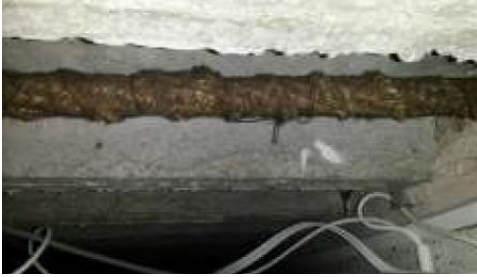
Item 7 Ref: 15-19198/8

The textile string to the pipe to the pipework to the void above the corridor (Room 21) does not contain asbestos.

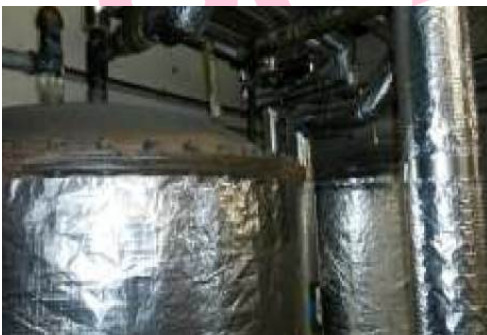
Item 9 Ref: 15-19198/5

The gaskets to the tanks in the boiler house (Room 23) do not contain asbestos.

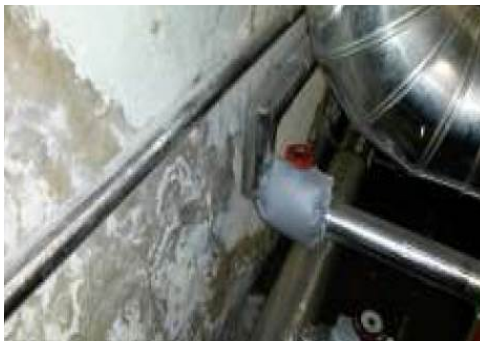
Item 12 Ref: 15-19198/6

The debris to walls removed and walls encapsulated (Room 23) (Item 12) – Aug 2024 – waiting WCN's.

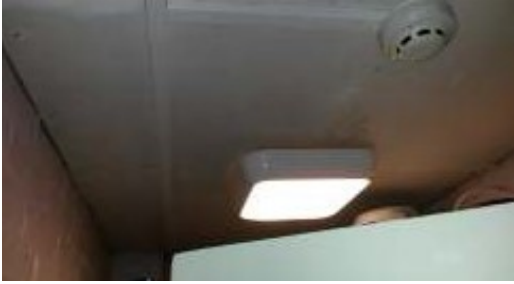
Item 19 Ref: 15-19198/15

The insulation board ceiling to the cleaners cupboard (Room 35) does not contain asbestos.

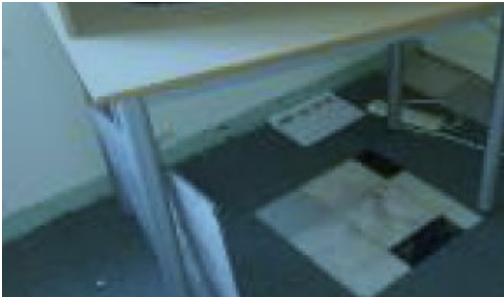
Item 20 Ref: 15-19198/16

The floor tiles and the adhesive to the Rainbow Room (Room 38) contain asbestos.

Any change in its appearance should be recorded and passed to Property Services.

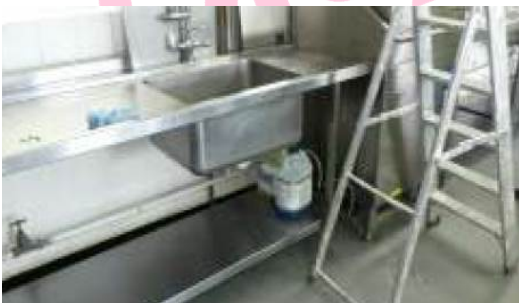
Item 21 Ref: 15-19198/17

The sink pad to the kitchen (Room 42) does not contain asbestos.

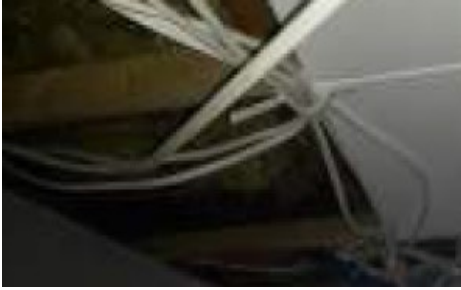
Item 22 Ref: 15-19198/18

The insulation board ceiling to the cleaners cupboard (Room 48) does not contain asbestos.

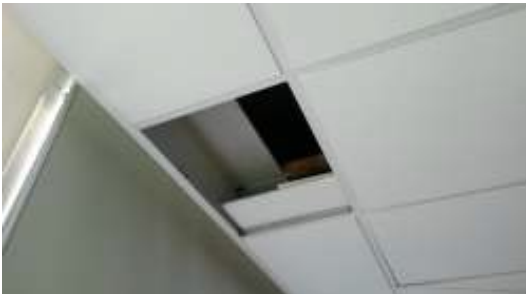
Item 27 Ref: 15-19198/23

The insulation board to the void above year 2 classroom (Room 74) does not contain asbestos.

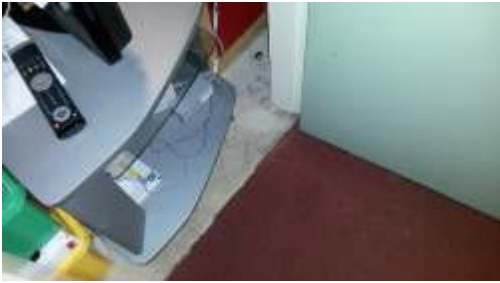
Item 28 Ref: 15-19198/24

The floor tiles and adhesive to the store (Room 82) contain asbestos.

Any change in its appearance should be noted and passed to Property Services.

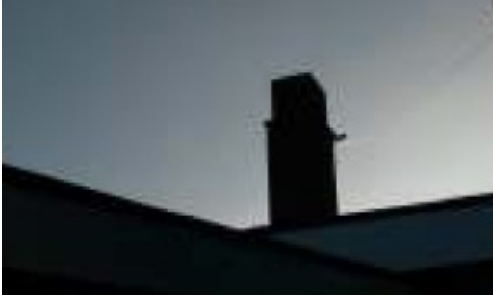
Item 34 Ref: 15-19198/27

The roof felt (external) does not contain asbestos.

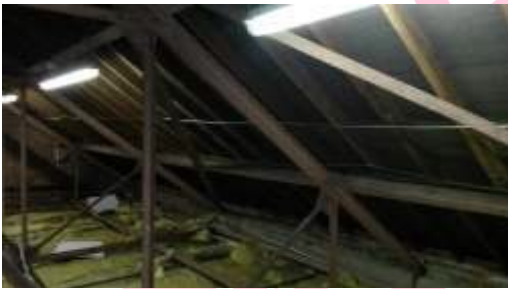
Item 38 Ref: 15-19198/34

The sarking felt to the roof tank room does not contain asbestos.

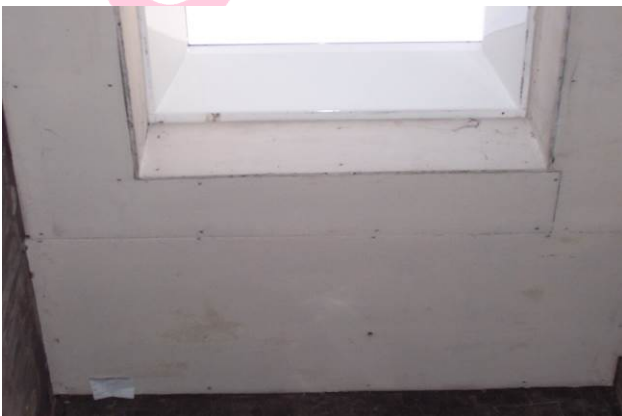
Ref: 037SW9

The ceiling boards to the plant room (Room 23) contained asbestos.
