ASBESTOS SURVEY REPORT FOR WESSINGTON PRIMARY SCHOOL
LANERCOST, WASHINGTON, TYNE AND WEAR, NE38 7QA.

Asbestos Register for

**Wessington Primary School, Washington,
NE38 7QA**

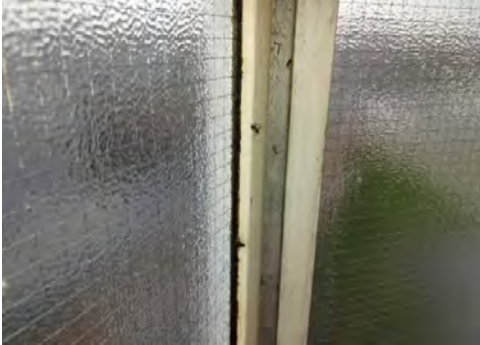
Item 43 Ref: 20-28462-19

The sealant to glass panes (Area 107/Tank Room) contains asbestos.

Any change in its appearance should be recorded and passed to Property Services.

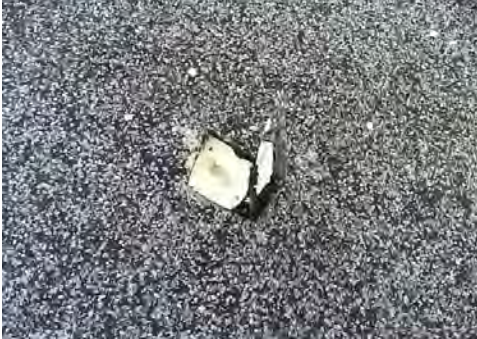
Item 61 Ref: 22-47238-2

The bitumen roof felt (Area 1/External) does not contain asbestos.

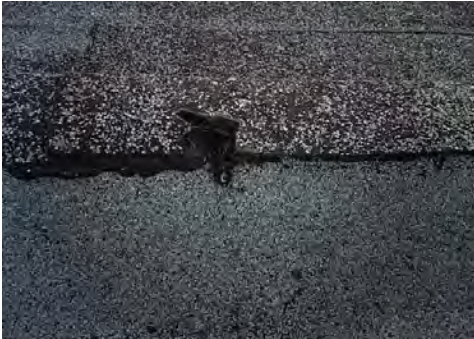
Item 64 Ref: 22-47238-5

The bitumen roof felt (Area 1/External) does not contain asbestos.

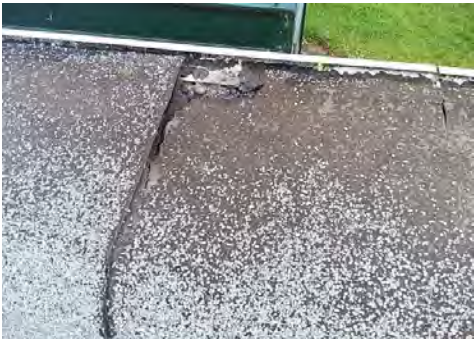
Item 65 Ref: 22-47238-6

The bitumen roof felt (Area 1/External) does not contain asbestos.

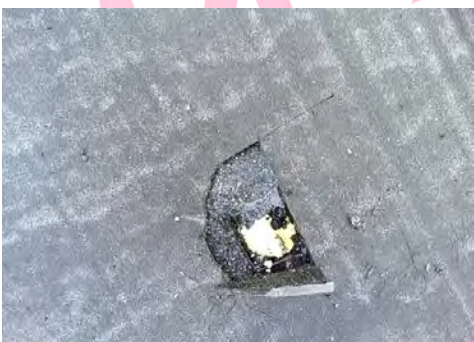
Item 66 Ref: 22-47238-7

The bitumen roof felt (Area 1/External) does not contain asbestos.

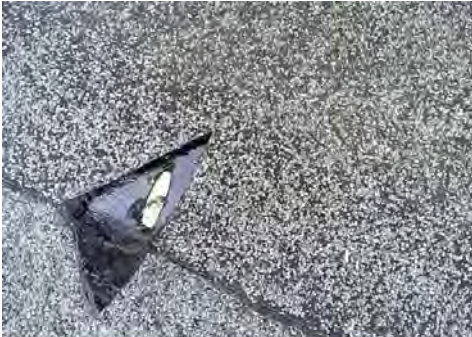
Item 67 Ref: 22-47238-8

The bitumen roof felt (Area 1/External) does not contain asbestos.

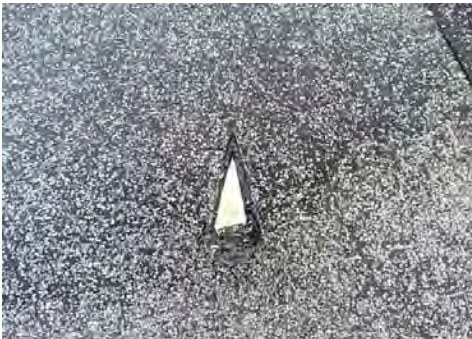
Item 68 Ref: 22-47238-9

The bitumen roof felt (Area 1/External) does not contain asbestos.

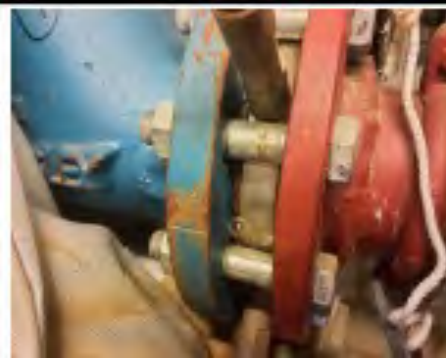
Item 73 Ref: RC000280

The Gaskets pipework far side of room (Keystage 1 Plant Room G/01) does not contain asbestos.

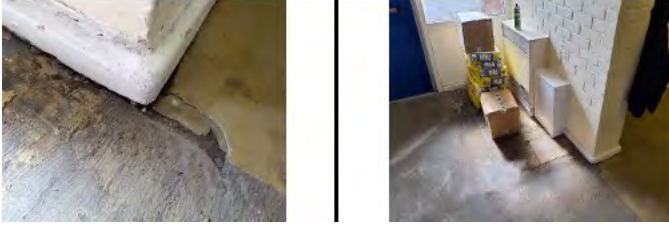
Item 82 Ref: NX000767

The floor tile and adhesive below screed in KS 2 Corridor (G/01) does not contain asbestos.
